Appendix E – Myrtle Creek Rehabilitation Report

TAH5179A_Rev1

UPDATE OF REMEDIATION OUTCOMES AT POOL 23 ON MYRTLE CREEK

Please find herein an update of remediation outcomes at Pool 23 on Myrtle Creek following Stage 1 of the Corrective Management Action Plan (CMAP) for Myrtle Creek.

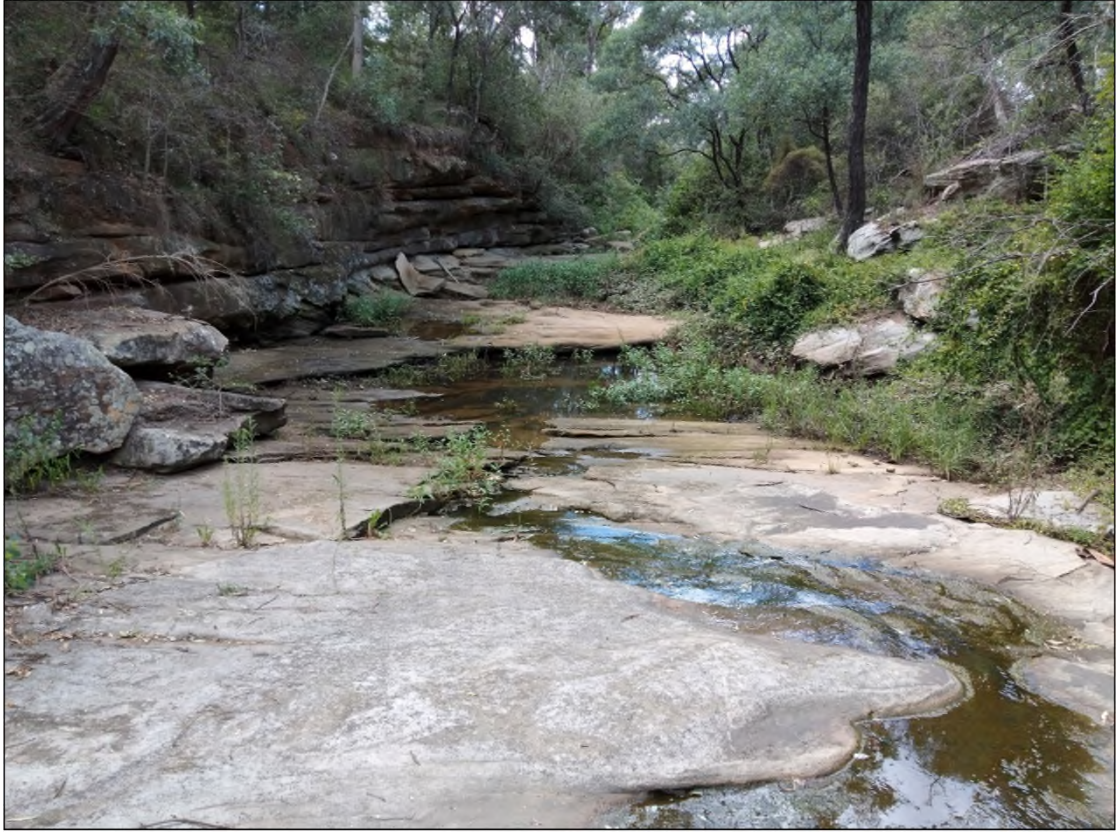
a) 15 February 2019.

Figure 1: Comparative photographs of Pool 23 before and after remediation.

Pool 23 was incrementally impacted by the subsidence associated with longwall mining at Tahmoor Coal Mine from Longwall 26 to Longwall 28 leading to cracking of rock in the creek bed and loss of surface water from the creek so that Pool 23 was mostly dry. Myrtle Creek was undermined by Longwall 26 during mid – end August 2011, Longwall 27 early – late March 2013, and Longwall 28 mid-May – early June 2014.

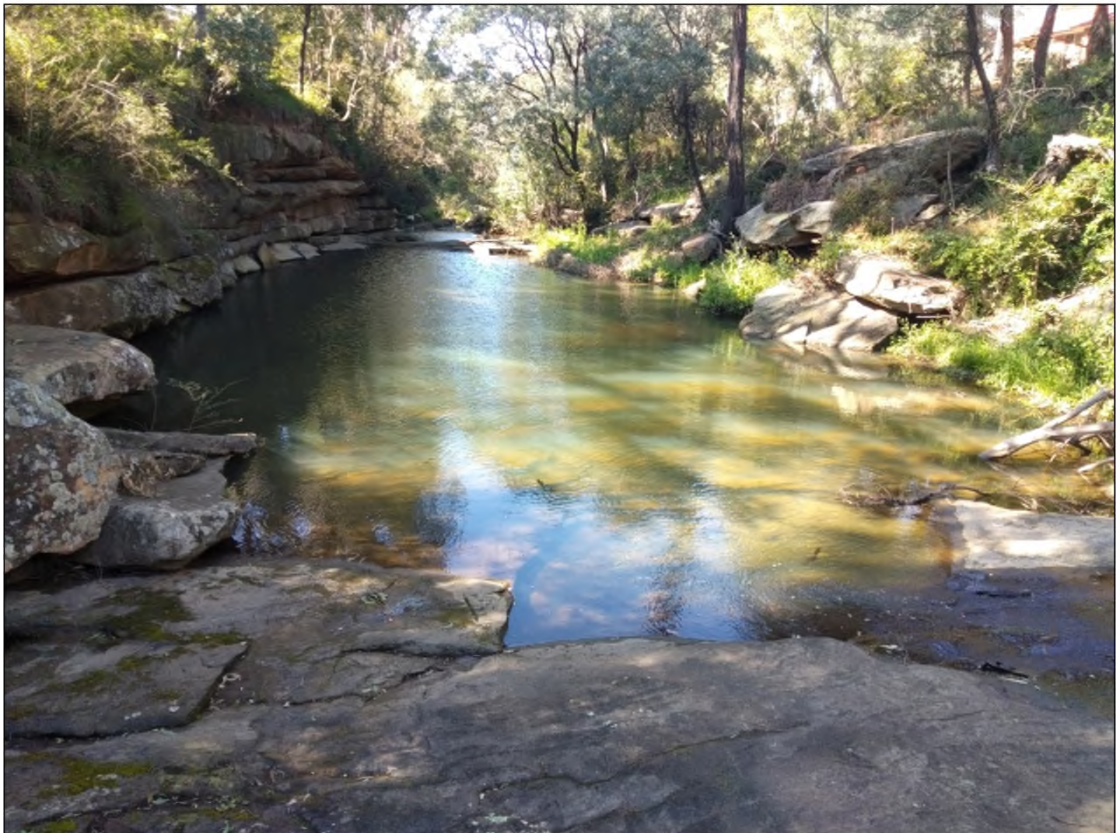
b) 20 August 2020.

The remediation trial at the Pool 23 rock bar on Myrtle Creek has shown a pattern of polyurethane injection into the fracture network to be effective as a strategy to maintain water in a subsidence impacted pool for an extended period. Aesthetic values have improved since remediation was completed and the pool returned to overflow level. SCT understands that the boreholes used for the remediation have been filled with textured concrete blend to reduce any signs of the work having taken place.

Monitoring indicates that the water level in Pool 23 has remained full or close to full since the work was completed and a heavy rainfall event on 6 February 2020 filled the pool. A grout curtain wall in a similar arrangement however with less emphasis on characterisation is likely to be effective at other sites where remedial action may be required.

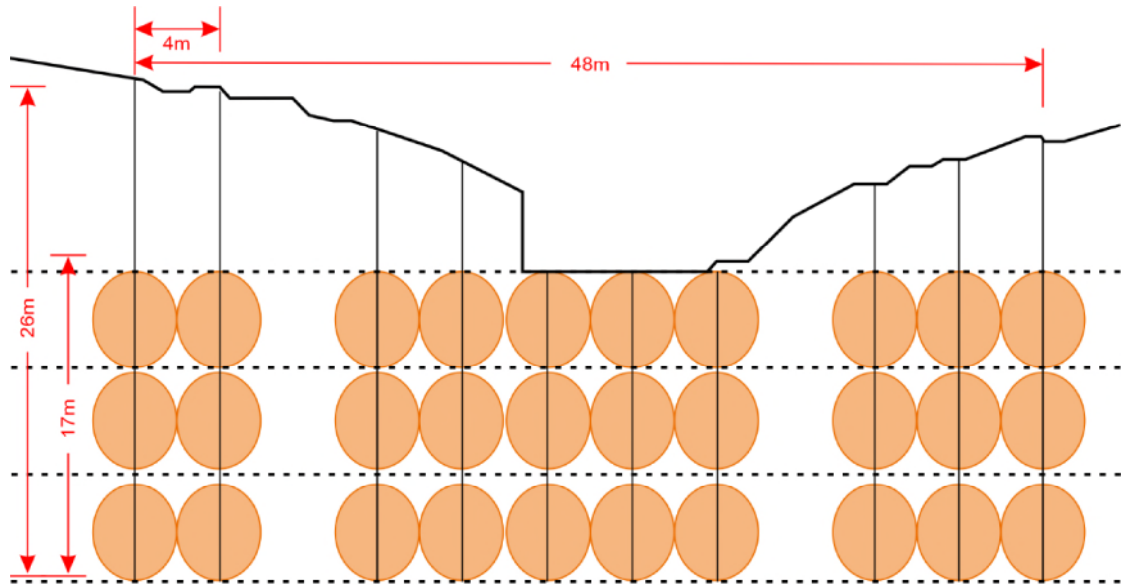
a) Stage 1.

Stage 1 grouting involved injection into the characterisation boreholes in three intervals from the bottom up. Although 1200 litres of PUR were injected, the cross flow between holes limited the effectiveness of this initial treatment. No change in PRR was observed.

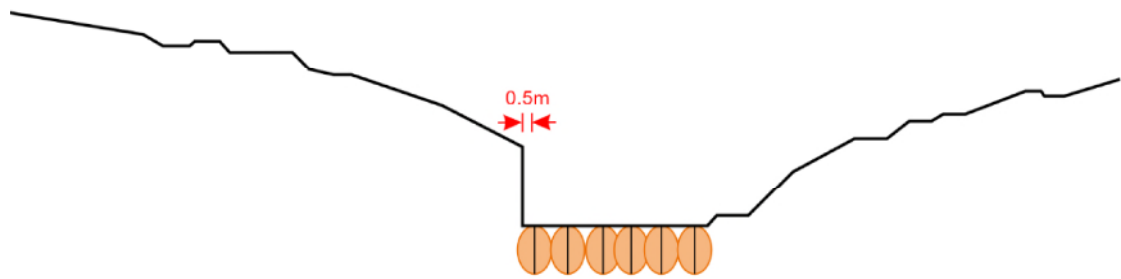
b) Stage 2.

Stage 2 grouting involved injecting 400 litres of PUR into twenty, 38mm diameter holes drilled to 2m below surface of the rock bar using a pneumatic hammer. The initial line of holes across the rock bar was split and secondary, tertiary, and quaternary holes drilled and injected at a final spacing of approximately 0.5 m. A reduction in PRR was observed with the water level taking 20 hours to drop to empty.

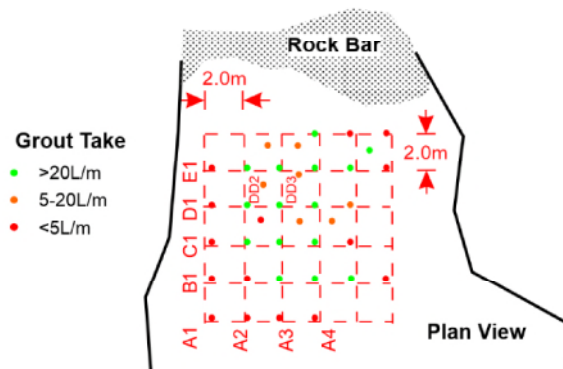
c) Stage 3.

Stage 3 grouting involved injecting 450 litres of PUR into 37, 1m deep holes drilled into the floor of Pool 23 on an approximately 2m grid extending 12m by 14m with some infill holes. A further reduction in PRR was observed with the water level taking approximately 100 hours to drop to a residual level.

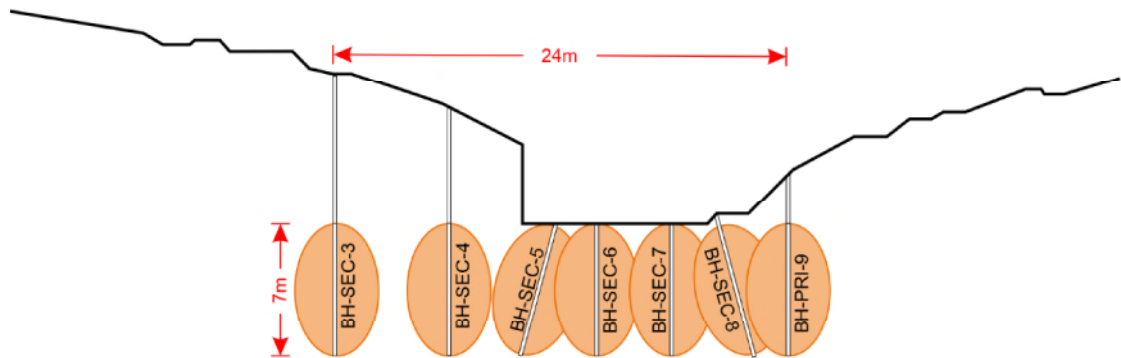
d) Stage 4.

Initial characterisation drilling confirmed the presence of a significant fracture system at approximately 6m below the surface of the rock bar. Stage 4 grouting targeted this fracture system. Seven, 76mm diameter boreholes were drilled to a depth of 7m below the rock bar along a 24m section along the alignment of the Stage 1 grouting. The holes were drilled using a portable drill rig and mud flush system. In total, approximately 1500 litres of PUR in total were injected into these holes.

A heavy rainfall event commencing 7 February 2020 that continued for nearly a fortnight coincided with the end of the Stage 4 injection. Pool 23 filled during that event and has remained full since.

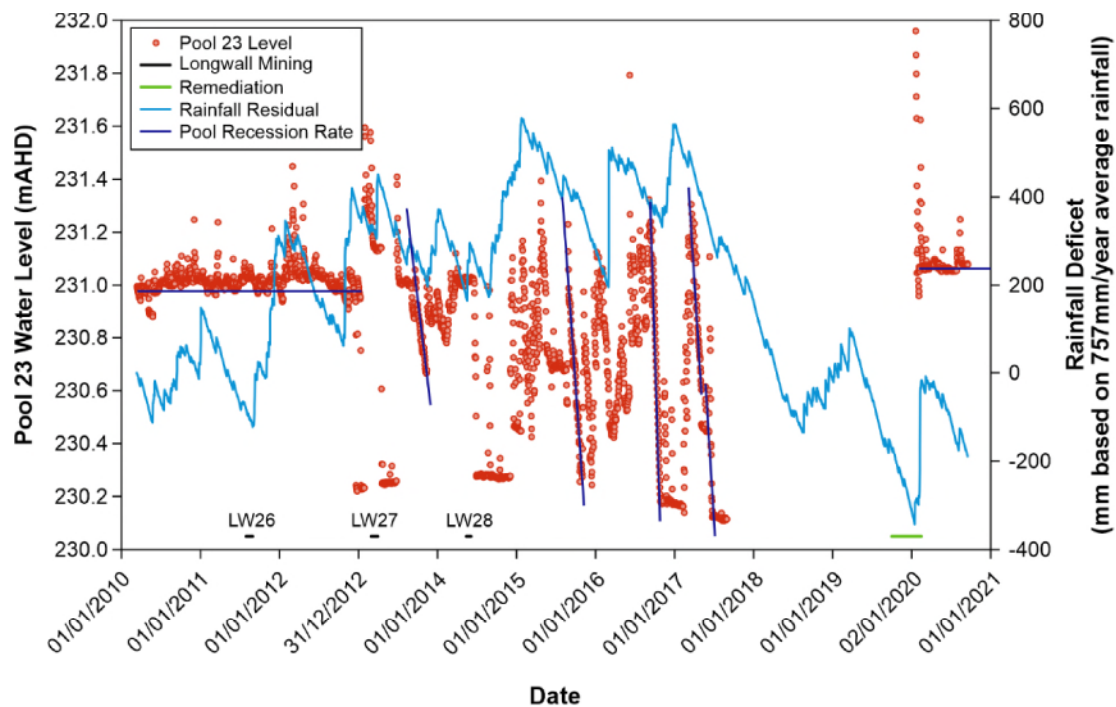
Figure 5: Water level in Pool 23 observed since 2010 and rainfall deficit over the same period.

Figure 5 shows the water level measured in Pool 23 since 2010 and the rainfall residual over the same period. Prior to mining beneath Myrtle Creek, Pool 23 remained substantially full, even during extended periods without rain. The progressive impacts of mining Longwalls 26, 27 and 28 are apparent in the water level of Pool 23. Between September 2011 and completion of remediation in February 2020, increasingly rapid drops in pool level following flow events associated with heavy rainfall and extended periods when the pool was empty are evidence of the increased fracturing associated with mining each successive longwall panel.

Remediation activities in late 2019 and early 2020 show an increase in pool level back to slightly above pre-mining levels. The discrepancy between pre and post mining levels is most likely a result of subsidence movements and re-establishment of the flow level monitoring device.

Since the beginning of 2017, there has been an ongoing trend of below average rainfall. Lower rainfall residual is expected to result in lower flows in Myrtle Creek and increased potential for Pool 23 to fall below full. However, since the remediation was completed in early 2020, there is no evidence of Pool 23 dropping below full even though the rainfall residual remains low and cumulative rainfall below long-term average.
