Report on
Geotechnical Assessment
Longwalls W3 and W4, Picton

Prepared for
Tahmoor Coal Pty Ltd

Project 89541.06
March 2021

Longwalls W3 and W4, Picton

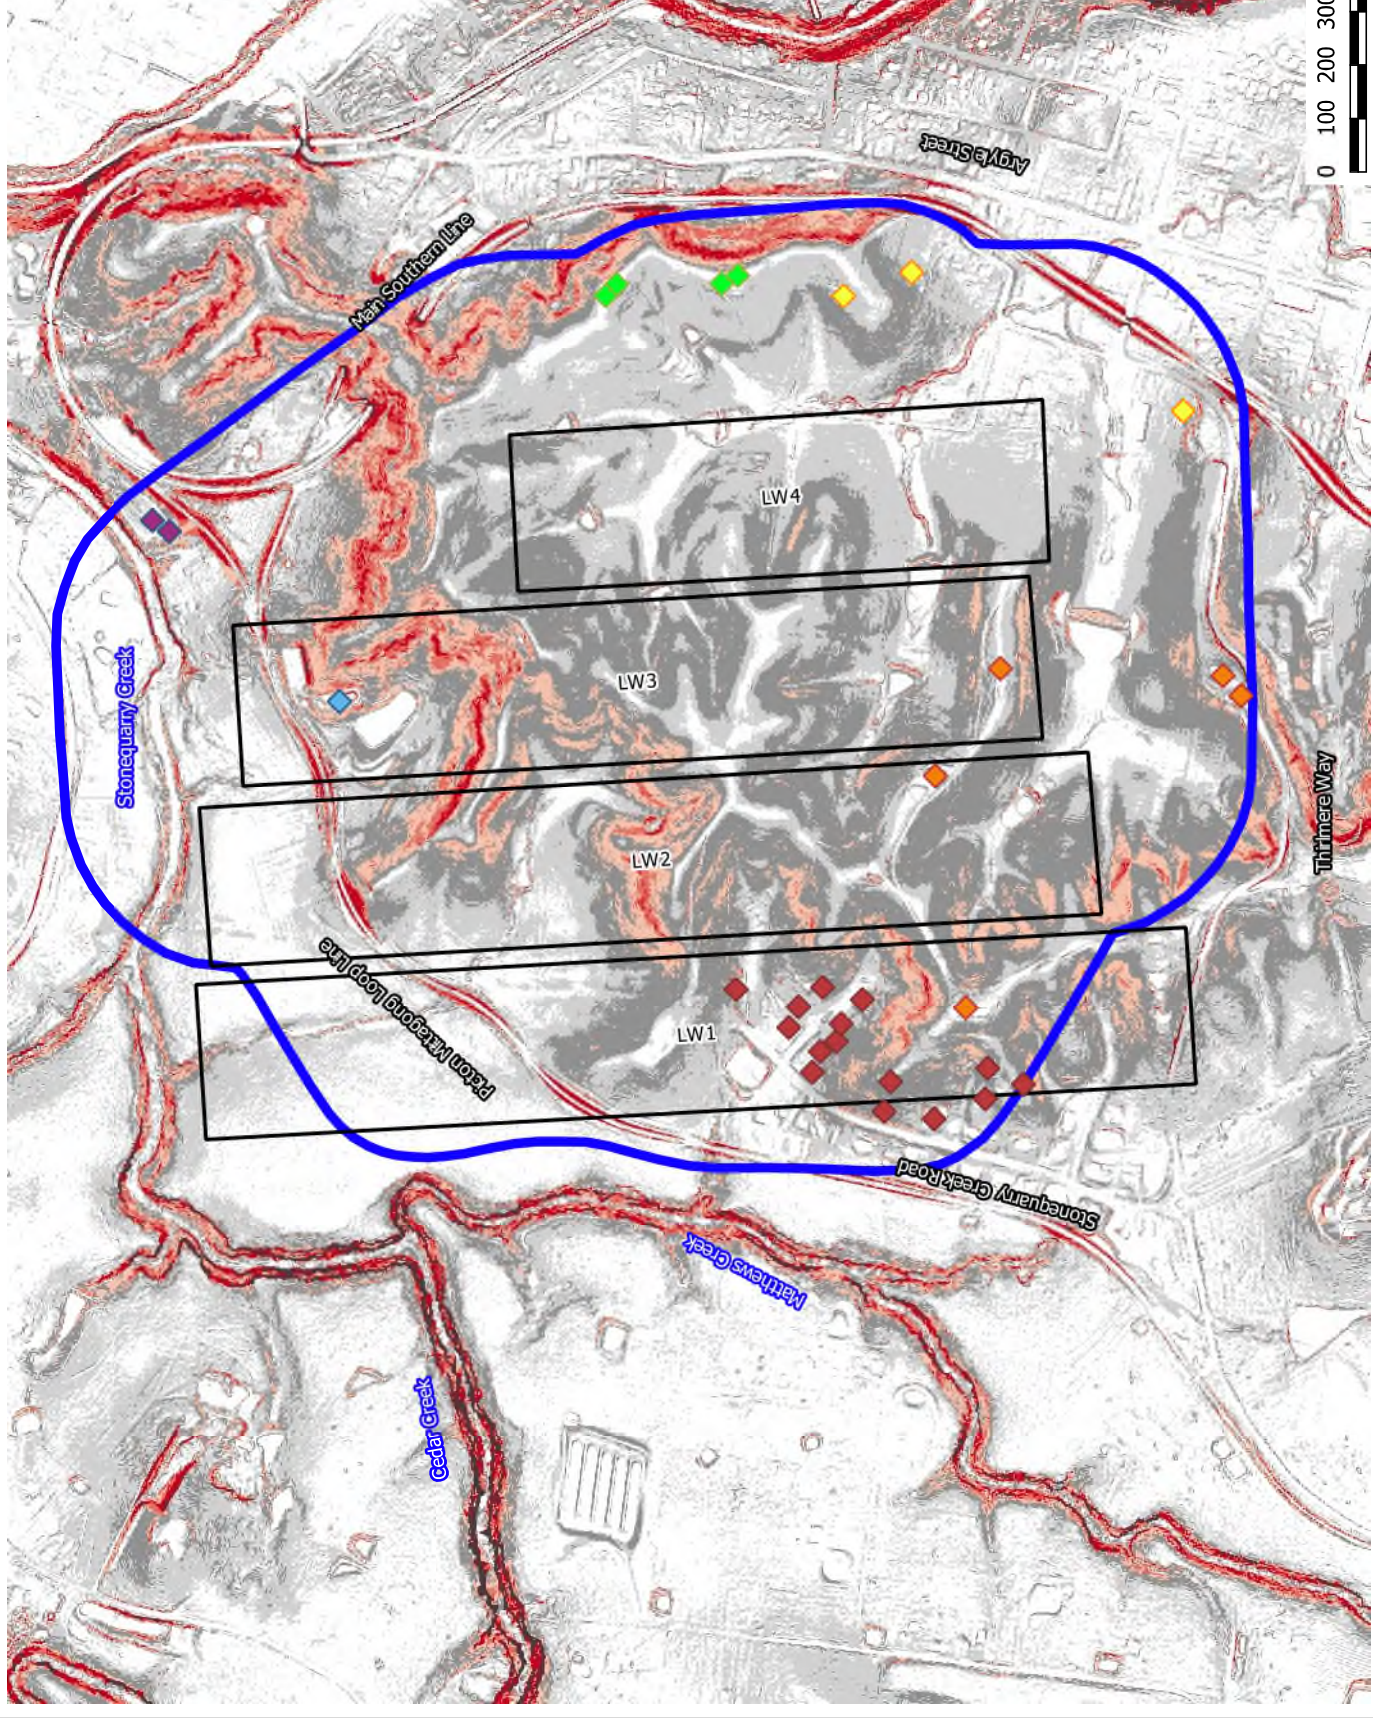
TITLE: Structures Near Steep Slopes
 Geotechnical Land Management Plan
 Longwalls W3 and W4, Picton

Structures in Regions 1 – 5 (refer Drawing 2 in Appendix B) have the potential slope instability Types 1 – 4. Region 6 has the potential for Type 5 slope instability. The trigger for such failures can include major storms, extended periods of rainfall and earthquake events. Poor development practices in adjacent areas can also increase the risk of slope instability.
