Tahmoor Mine Extraction Plan West 1 - West 2

Historical Heritage Technical Report

Prepared for Tahmoor Coal Pty Ltd
June 2019

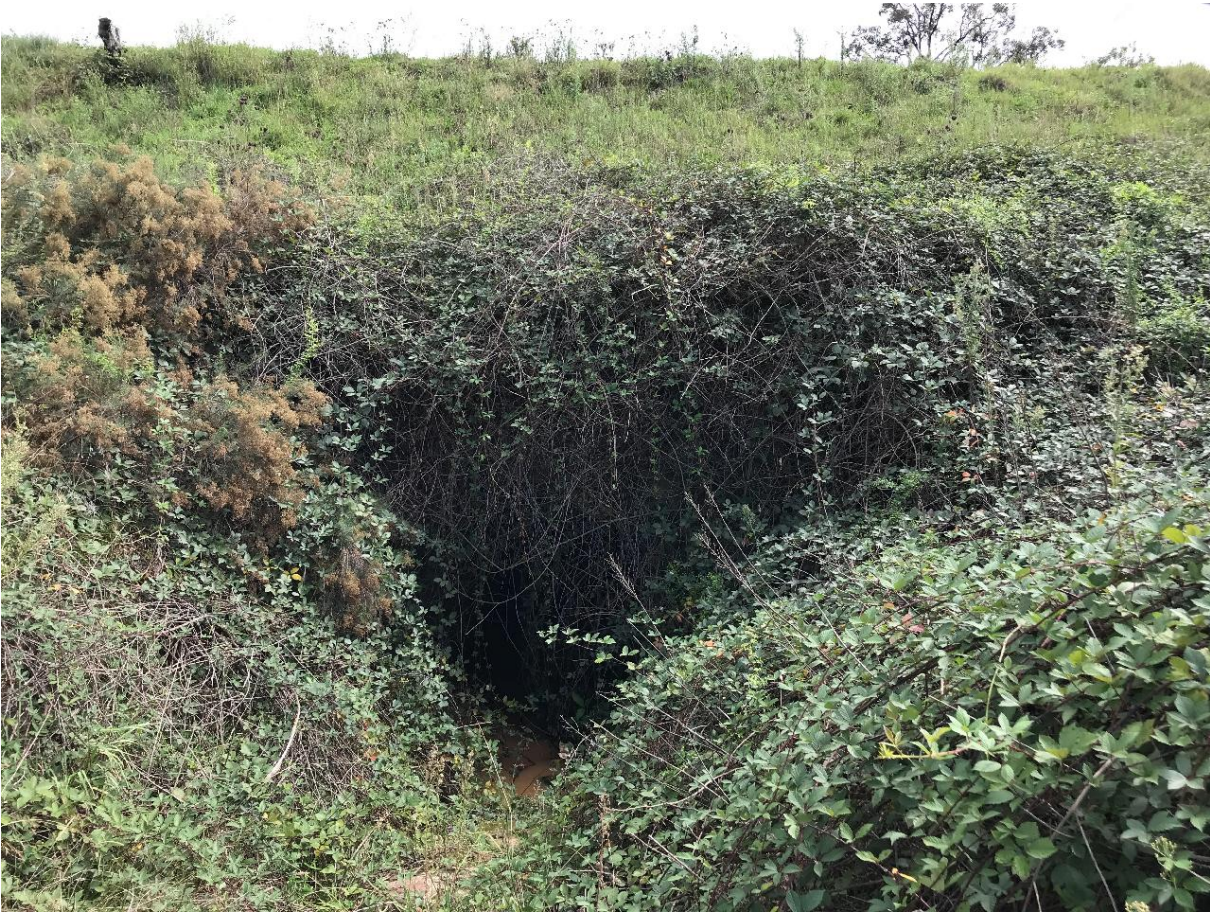
Plate 3.1 Sandstone culvert, chainage 88.400, overgrown with weeds and brambles. View west.

The main risk identified with the brick arch and stone culverts is the potential for these culverts to experience some cracking and spalling of the masonry, or the dislodgement of bricks or stones as a result of the extraction of LW W1–W2. Cracking may occur in the masonry arches or in the headwalls. Overall, the probability of subsidence impacts to most of the culverts is predicted by MSEC (2019) to be *unlikely*. The exception is the culvert at chainage 88.400 which is directly above LW W1 (Plate 3.1). Impacts to this culvert are predicted to be *possible* (MSEC 2019).

This culvert is predicted by MSEC to be at possible risk of subsidence impacts. It is currently infested with weeds (Plate 3.1) and it is recommended that a comprehensive structural assessment be conducted and a plan developed for possible mitigation stabilisation works. Any structural reinforcement or stabilisation installed prior to the commencement of mining should avoid damaging the fabric of the culvert or compromising its historical heritage values.

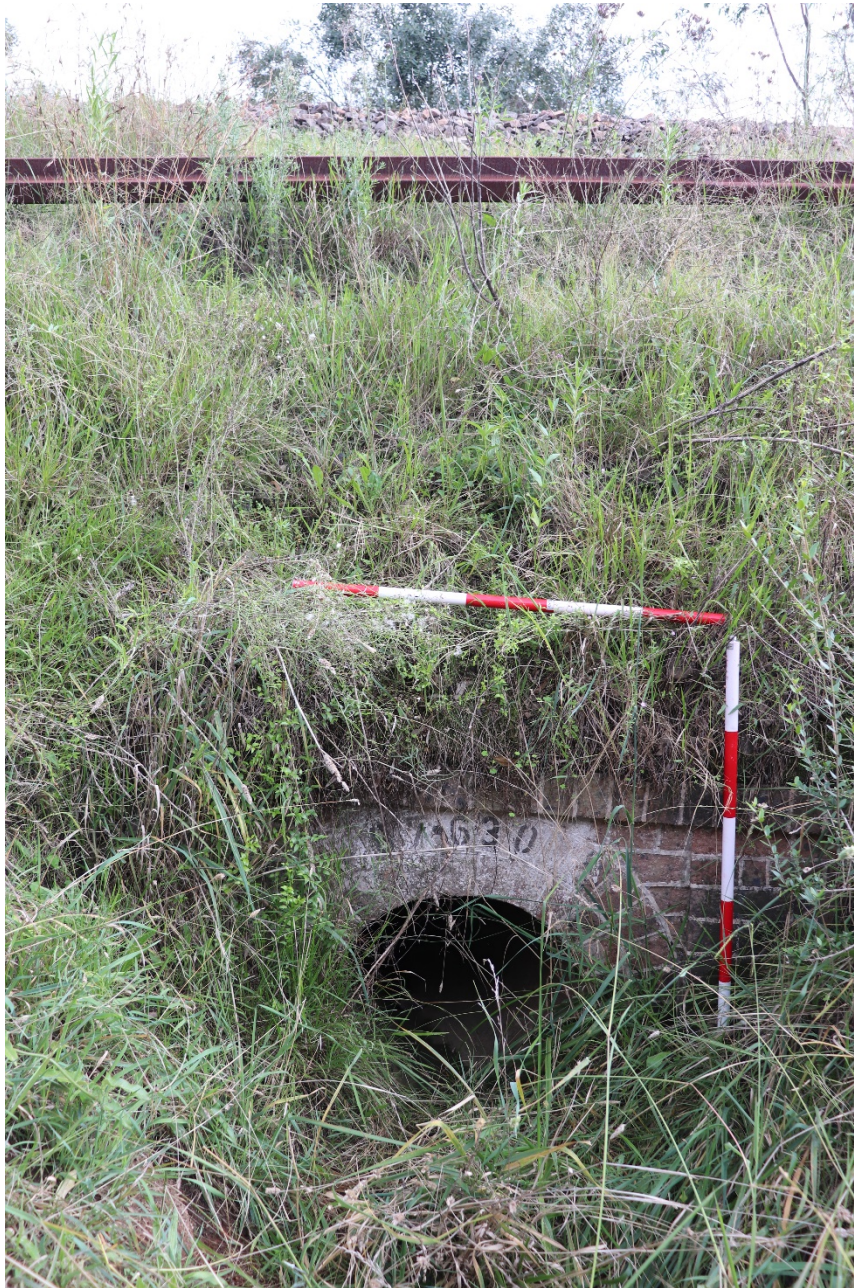
Plate 3.2 Brick culvert (chainage 87.630). View north west.

87.630	Brick culvert	c.1919	Concrete skin on base and rubble at the mouth. Mortar tuck pointed. Headwall and abutment in good condition. Recent embankment to the south-east means water is largely diverted away from the culvert.	Entrance dimensions 3.2 m x 1.5 m	Local

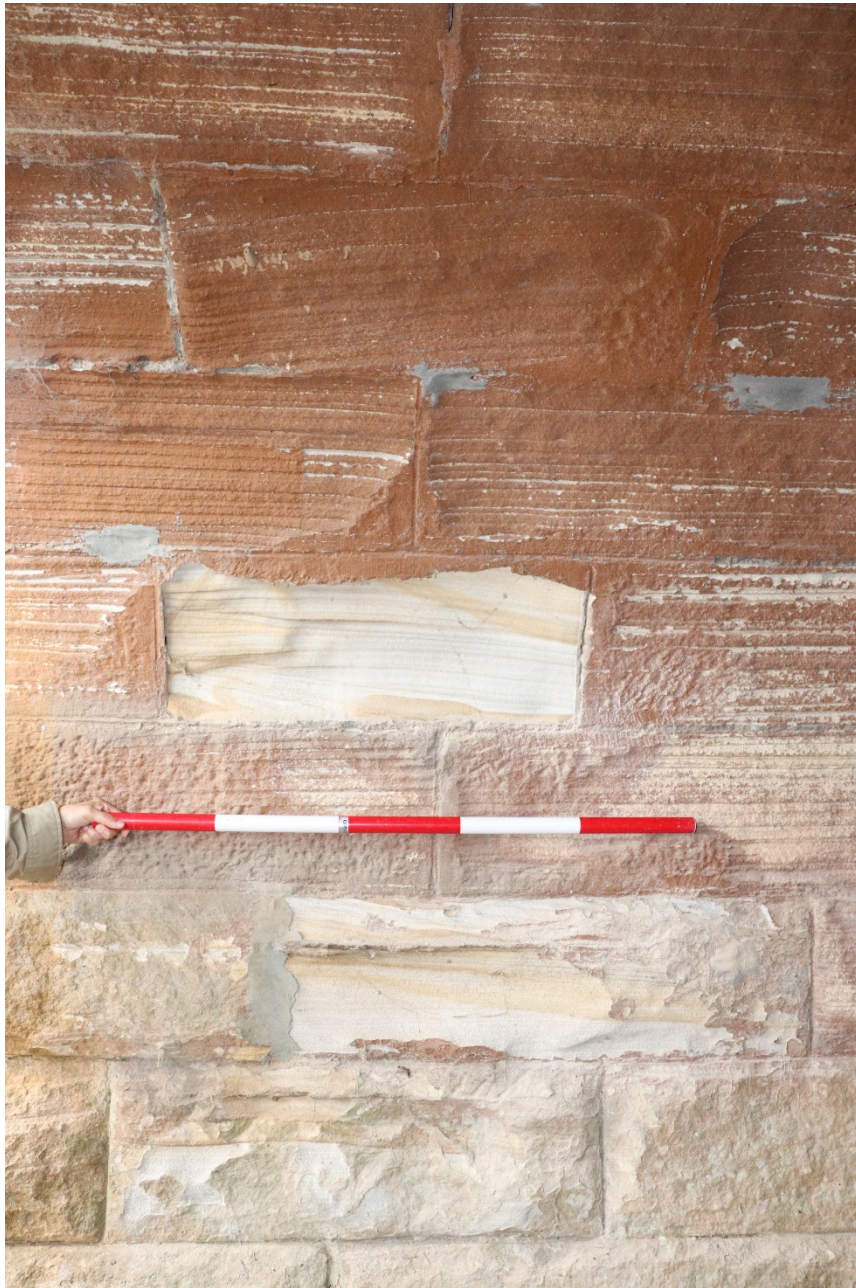
The culverts were found to be generally in fair to good condition except for the sandstone culvert at chainage 88.980 which has been subject to ‘restoration’ work resulting in damage to the sandstone, specifically exfoliation and more rapid deterioration of the sandstone (Plate 3.3).

Plate 3.3 Damage to sandstone culvert, chainage 88.980.

88.980	Sandstone culvert	c.1867	Poorly “restored” as part of the Stonequarry Estate Development, resulting in exfoliation of sandstone blocks particularly on the roof of the culvert	2.44 m diameter	Local

Culvert 88.980 (Plate 3.3) is in poorer condition than the other sandstone culverts due to previous attempts at restoration including the application of paint which has resulted in increased exfoliation of the sandstone (Plate 3.3). In addition, JMA Solutions (2019) noted the severe loss of wall thickness in some blocks along the roof of the culvert, most likely caused by salt-laden groundwater permeating through the barrel of the culvert. This has resulted in expansive salt crystallization within the surface stone and subsequent exfoliation. This culvert will need an assessment by a structural engineer prior to the commencement of mining and monitoring during mining.

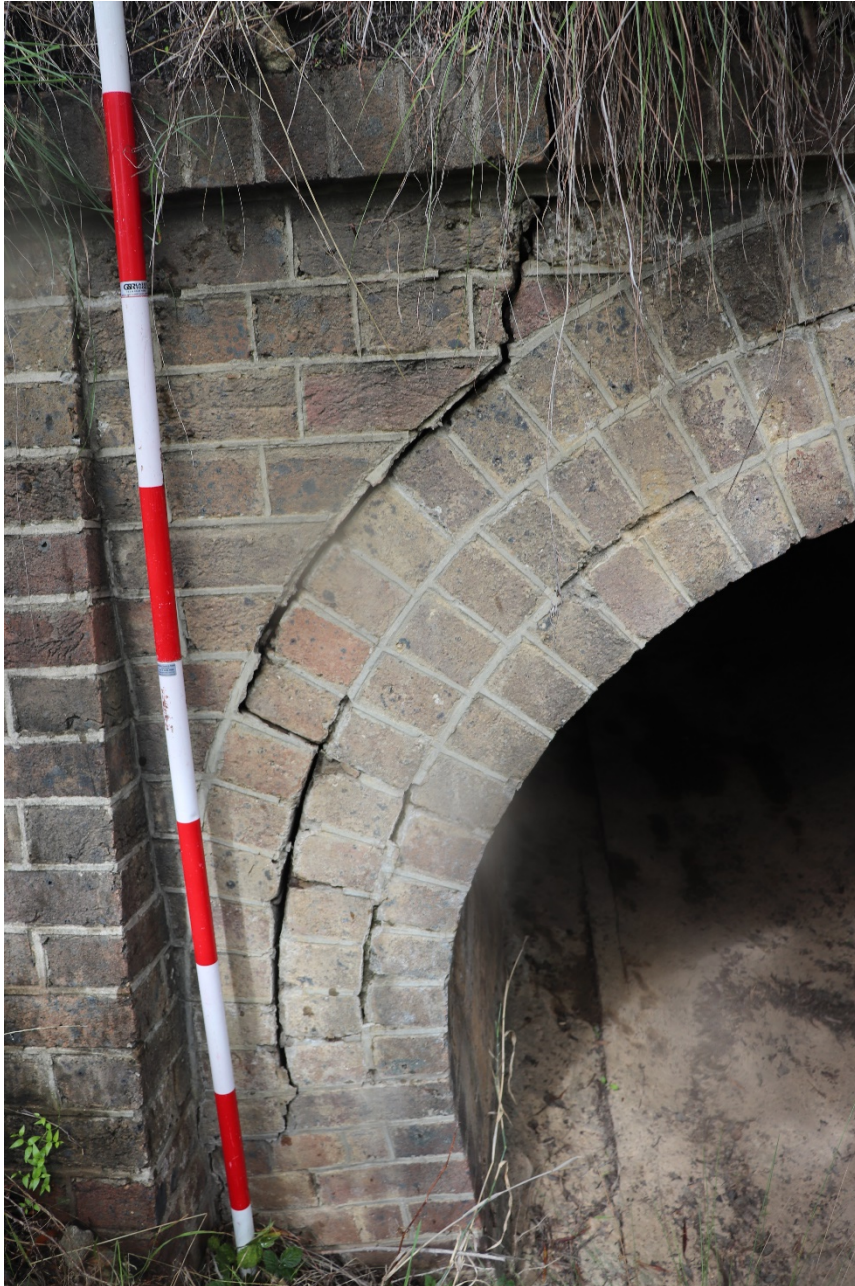
While cracking of the brick culverts along the Loop Line was mostly confined to the mortar, the brick culvert at chainage 87.300 under the disused embankment for the original railway alignment displayed additional cracking to the bricks themselves around the entrance to the culvert (Plate 3.4).

Plate 3.4 Cracking on north entrance to culvert at chainage 87.300. View south.

Chainage	Item	Construction date	Notes	Dimensions	Significance
87.300	Brick culvert	c.1919	Located beneath the disused embankment for the original railway alignment. Bricks cracked at northern headwall.	Entrance 1.2 m high	Local

Culvert 87.300 is (Plate 3.4) is located outside the Study Area and is considered to be at low risk of impact from longwall mining of LW W1-W2. Nevertheless, cracking of the fabric on the north entrance to the culvert is not only along the mortar between the bricks but also through some of the bricks themselves and will need to be monitored and potentially reinforced (see section 6.2.2).

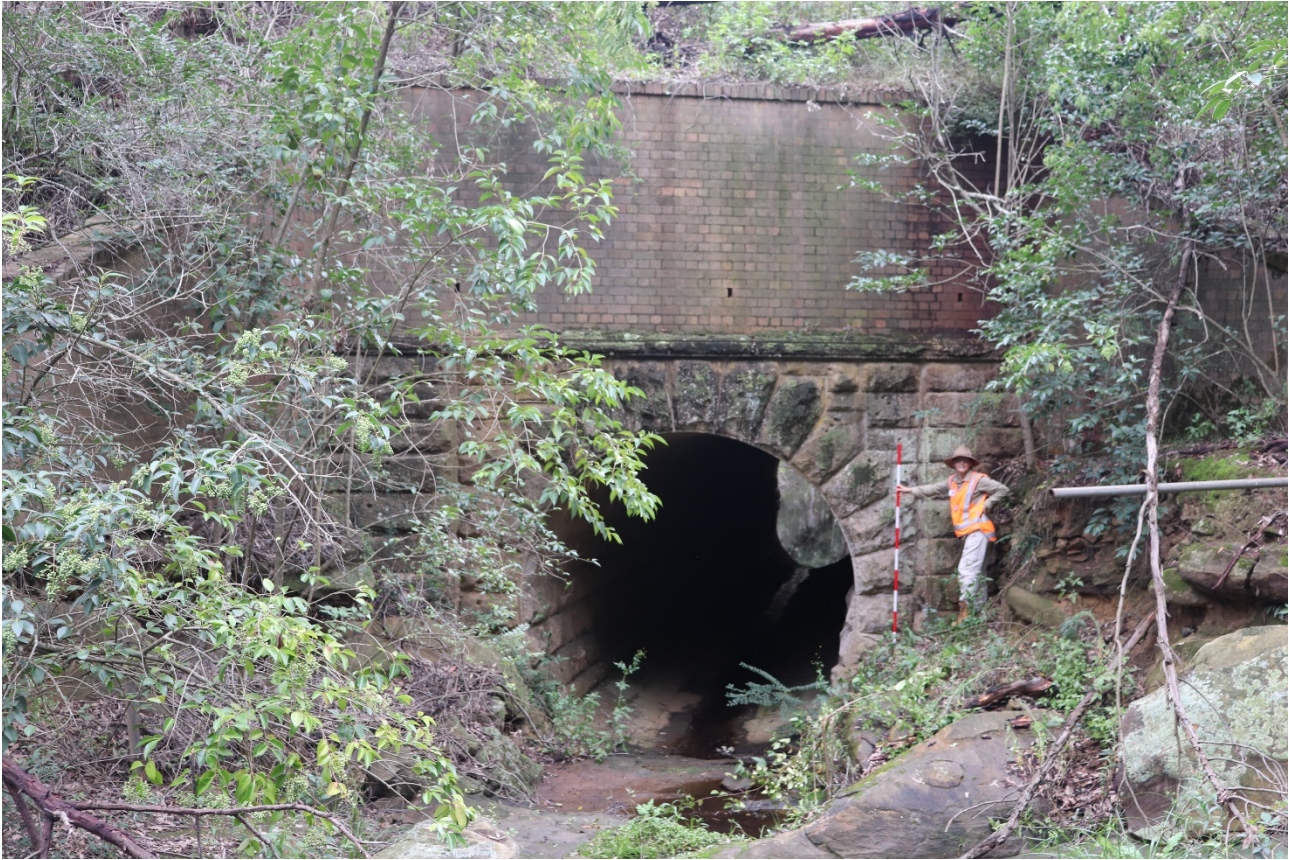
89.629	Sandstone culvert	c.1867	Very little cracking or dilapidation of sandstone or mortar. Brick wingwalls and headwall (c.1919) on the upstream side to support vehicle track (Plate 3.5). Southern wingwall has been undercut by erosion and has some cracking.	3.062 m diameter	Local

Plate 3.5 Sandstone culvert with the later addition of brick wingwalls and head wall (chainage 89.629). View west.

The headwalls of culvert 89.629 (Plate 3.5) may need to be reinforced prior to mining or subsequently repaired as required.
