**CENTENNIAL TAHMOOR
LONGWALL PANELS 22, 23A and 23B
SURFACE WATER, DAMS & GROUNDWATER
END OF PANEL MONITORING REPORT
Tahmoor, NSW**

TA5-R1
15 JANUARY, 2007

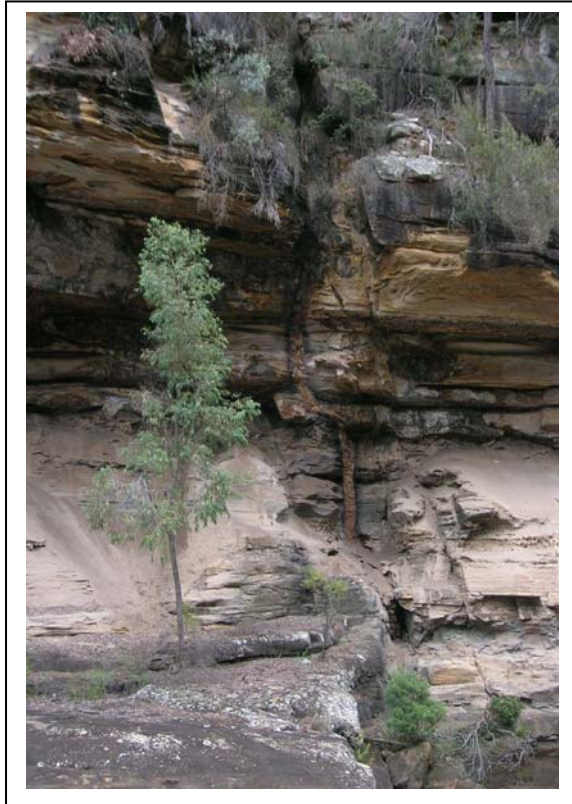
PHOTOGRAPH 1 Pool U Dyke

Three additional dykes are exposed in the west scarp and bed of the Bargo River between Rock Bar V and Pool U as shown in **Photograph 1**. No seepage from the cliff walls has been observed directly associated with the dykes.

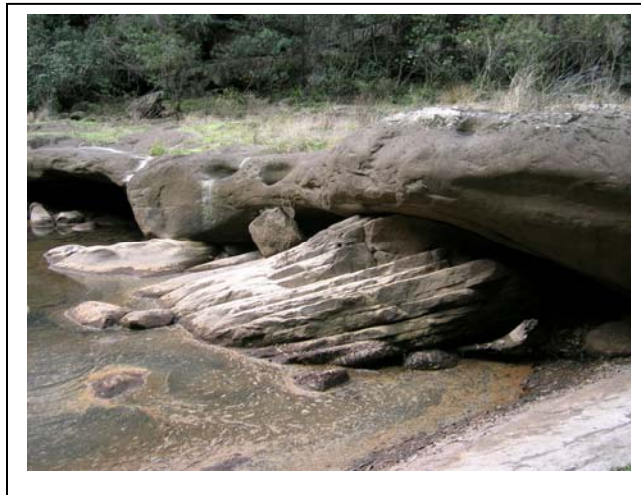
PHOTOGRAPH 2 Rock Bar G Throughflow

The most notable diversion in the study area is between Pools H and F, through Rock Bar G, where all flow monitored to date passes through cross bedded laminae with a bedding discontinuity at the top and base of the cross set as shown in **Photograph 2**.

No overland flow has been observed over Rock Bar G during the monitoring period, where maximum daily flow reached up to 16.56ML/day in Pool H, indicating that more than at least 16.6ML/day of flow is required for Pool H to be full, with ongoing monitoring required to assess the pools “cease to flow” rate. **(HCS TO CONFIRM)**

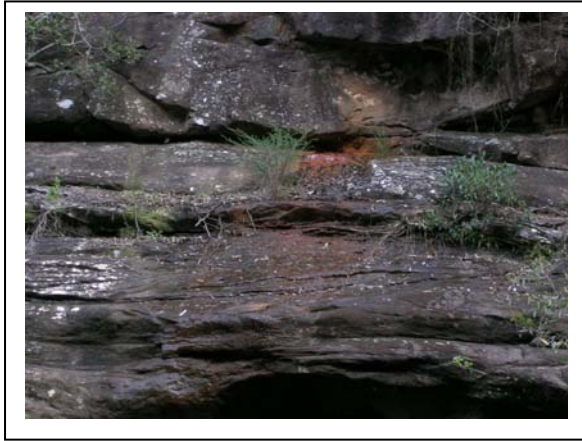
PHOTOGRAPH 3 POOL F Seep

Five pools within the study area were observed to contain ferruginous seeps as shown in **Drawing 4, Photographs 3 to 8** and **Table 5**. Seepage rates are all very low (<0.5L/sec), with the flows occurring as a “slow bleed” from joints and bedding discontinuities, and occur as thin sheet films of outflow water.

Mixing zones within the river pools are also very limited to less than 1m from the source discharge point, with discolouration of the river bank at the outflow point, although no discolouration or “plumes” within the main river or its substrate have been observed under current flow conditions.

No changes to seep flow rate, seepage outflow points or water quality effects in the Bargo River have been observed during extraction of Panels 22, 23A and 23B.

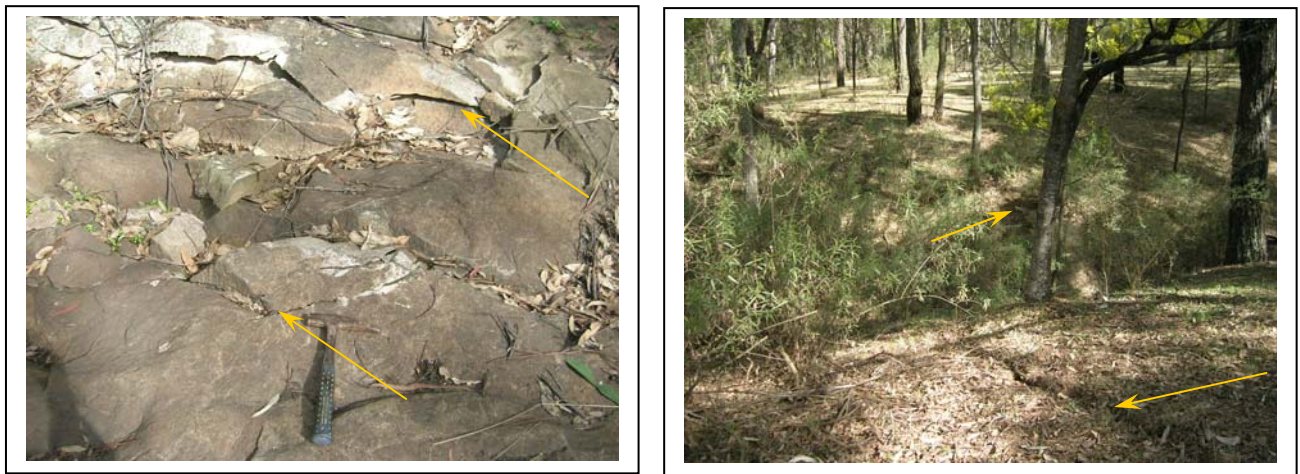
PHOTOGRAPH 9 Myrtle Creek Cracks

Cracking of the soil and bedrock over Panels 22 and 23B have been observed in Myrtle Creek as shown in **Photograph 9** from locations shown in **Drawing 2**.

The bedrock cracking is up to 10mm wide and is limited to the base of the creek within a small rock bar over Panel 22, whilst the soil cracking occurred at the southern end of Panel 23B, close to the barrier pillar between Panels 23A and 23B.

The soil cracking was up to 65mm wide and extended into the soil an unknown depth (>1.5m) over an approximate length of 40m, however, the crack did not develop within the channel bed of Myrtle Creek, even though it was observed on both the upper banks and flank of the creek channel.

Even though soil cracking has been noted in Myrtle Creek over Panel 23B, it is not anticipated that the bed or bank stability will be adversely affected as the crack can be easily rehabilitated and revegetated prior to the next main flow event.

The bedrock crack located over Panel 22 is within a small, restricted sandstone rock bar outcrop and is not anticipated to have an adverse effect on stream flow when the creek runs after sufficient rain, and therefore, no rehabilitation of the cracking is proposed.

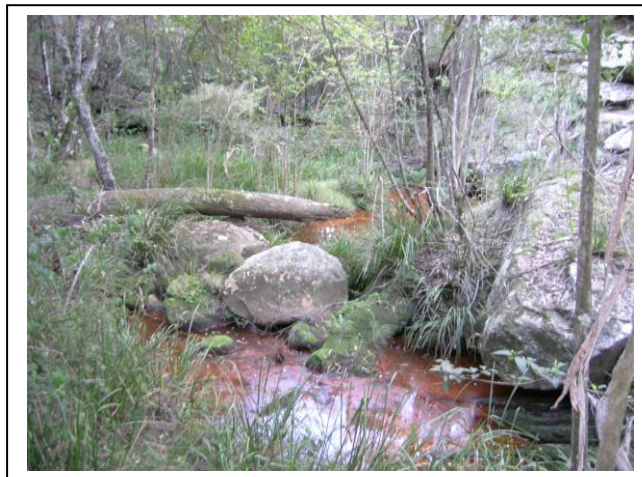
PHOTOGRAPH 10 Iron Hydroxide in Redbank Creek (RC2)

Redbank Creek has a pH range between 4.15 and 6.95, with EC between 211uS/cm and 1950uS/cm, with the creek becoming distinctly acid and saline at RC2, where a ferruginous seep maintains ponded water as shown in **Photograph 10**.

Redbank Creek has more frequent water availability compared to Myrtle Creek, with Total N up to 7.6mg/l, Total P to 0.14mg/L as well as potentially having filterable manganese, copper, zinc and nickel above ANZECC 2000 trigger levels.
