TAHMOOR COLLIERY LONGWALL 22

**END OF PANEL MONITORING REPORT
FOR LONGWALL 22
AT TAHMOOR COLLIERY**

REPORT NO. MSEC200-02

September 2005

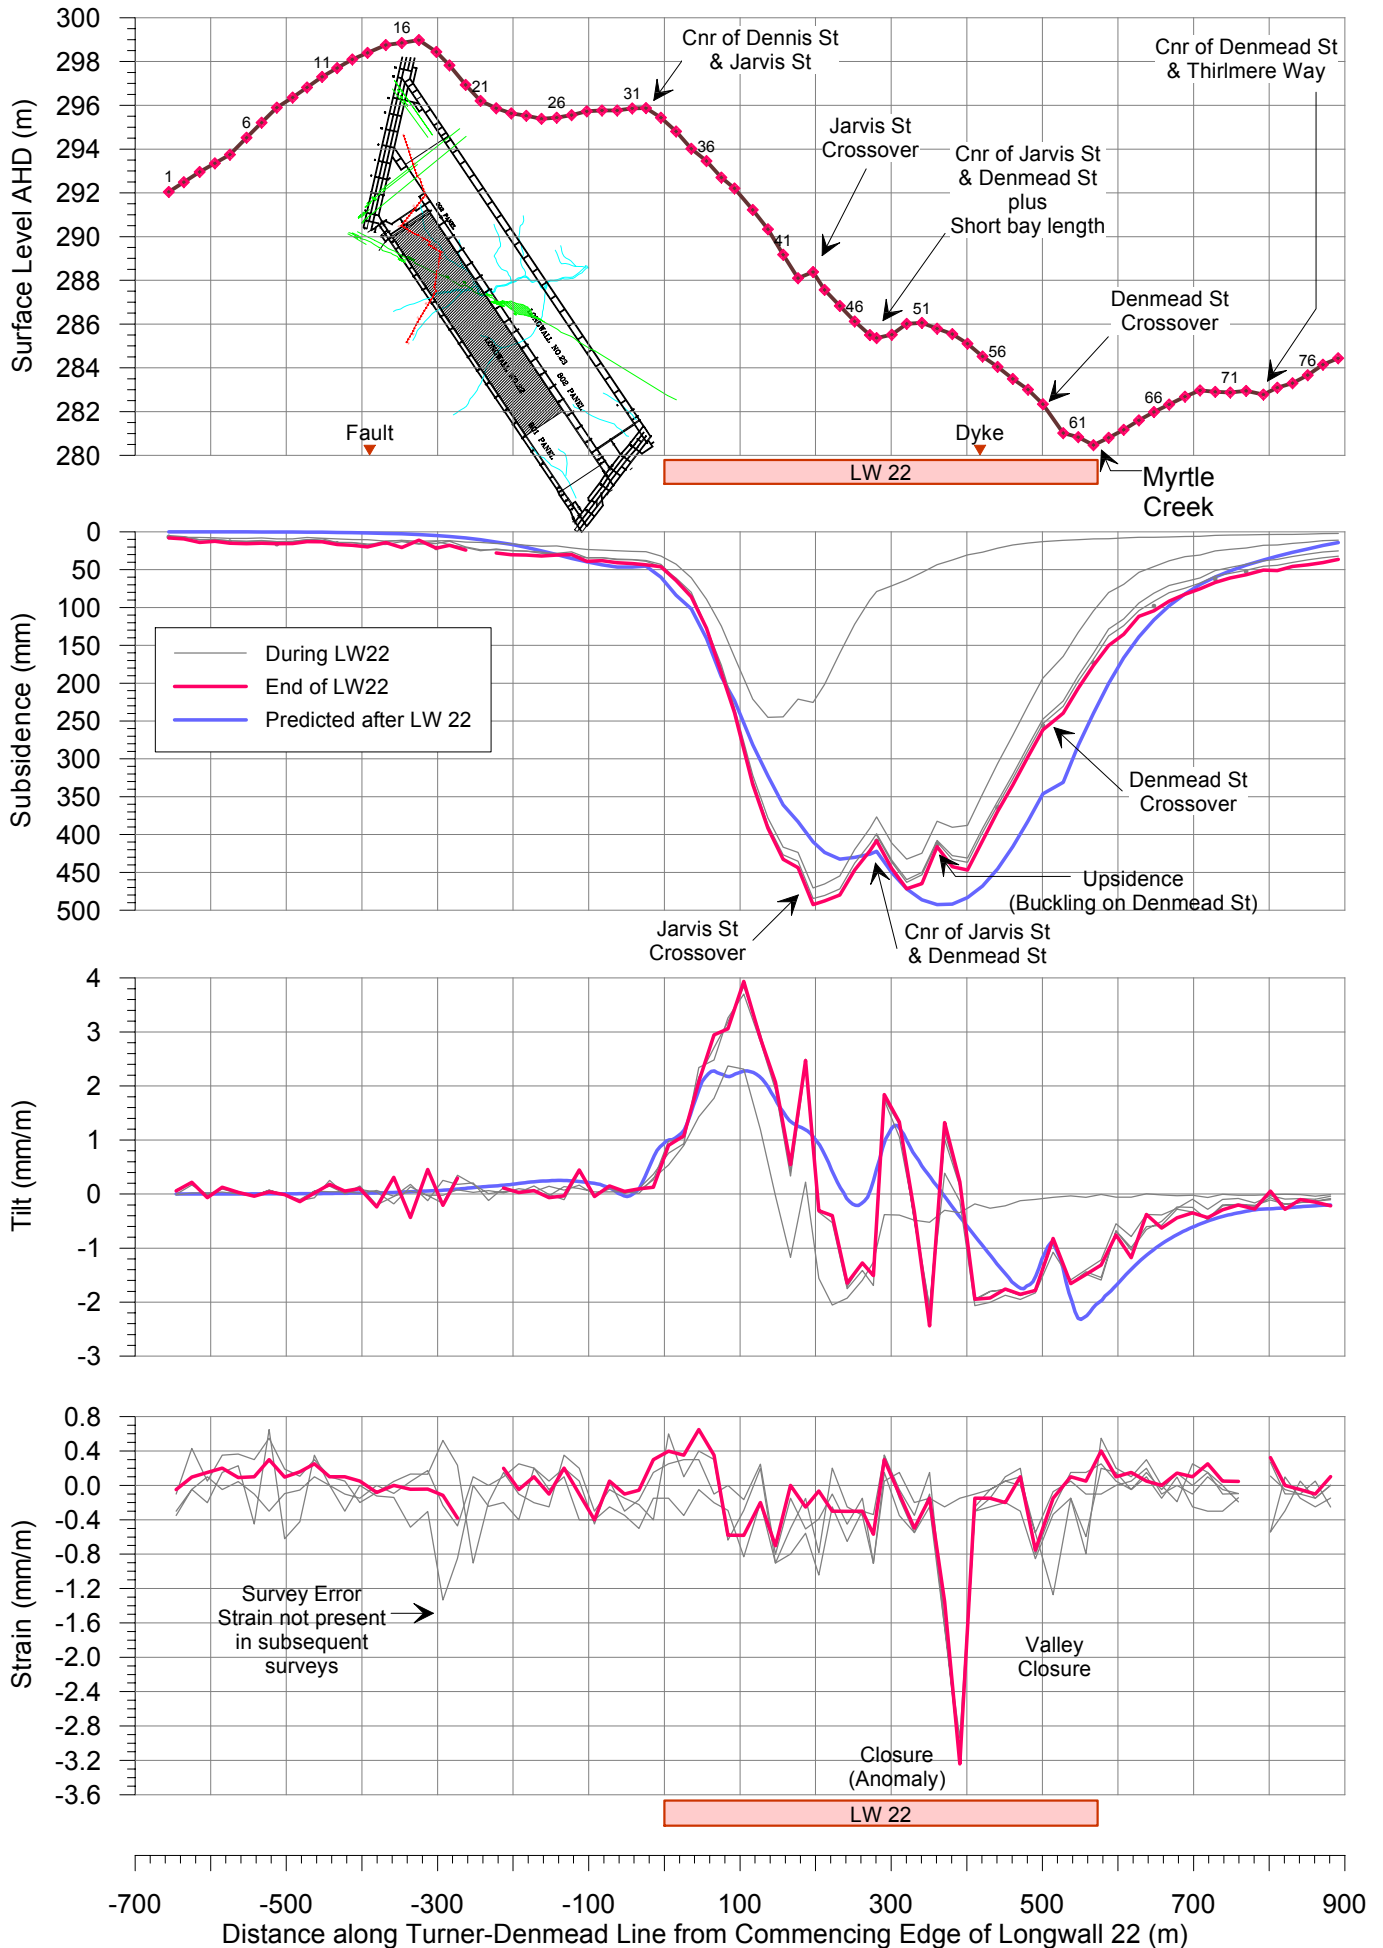
Tahmoor Colliery - Observed Subsidence, Tilt & Strain along Turner-Denmead Monitoring Line

Monitoring Line	Maximum Upsidence (mm)	Maximum Strain (mm/m)	Maximum Tilt (mm/m)	Type	Impacts to Surface
Turner-Denmead	50	-3.2	2.2	Anomaly	Buckling and cracking to road pavement Cracks in paddock Impact to one house
Thirlmere Way	35	-1.6	2.5	Valley closure	No impacts observed
Macquarie Place	None	+2.0	9.0	Igneous intrusion	Cracking to road pavement Impact to one house
Milne Street	40	-1.9	1.3	Anomaly	Cracking and spalling of concrete kerb and gutter Impacts to eight gates and one house
Fraser Street	30	-1.3	1.4	Anomaly	No impacts observed
Fraser Street	30	+0.3	1.5	Possible anomaly	No impacts observed

- The majority of anomalous movements appear to have occurred near the centre of the panel. This trend is observed in Denmead, Milne and Fraser Streets. The anomalies are relatively small and the impacts to surface features have been minor, when compared to those that have occurred at previous anomalies over Longwalls 5, 6 and 16 at Tahmoor Colliery and Longwall 5A3 at West Cliff Colliery.
Whilst anomalous movements have not been observed along the Market Street monitoring line, three houses on this street, which are located near the centre of the panel, have experienced impacts which could also be attributed to anomalous movements.

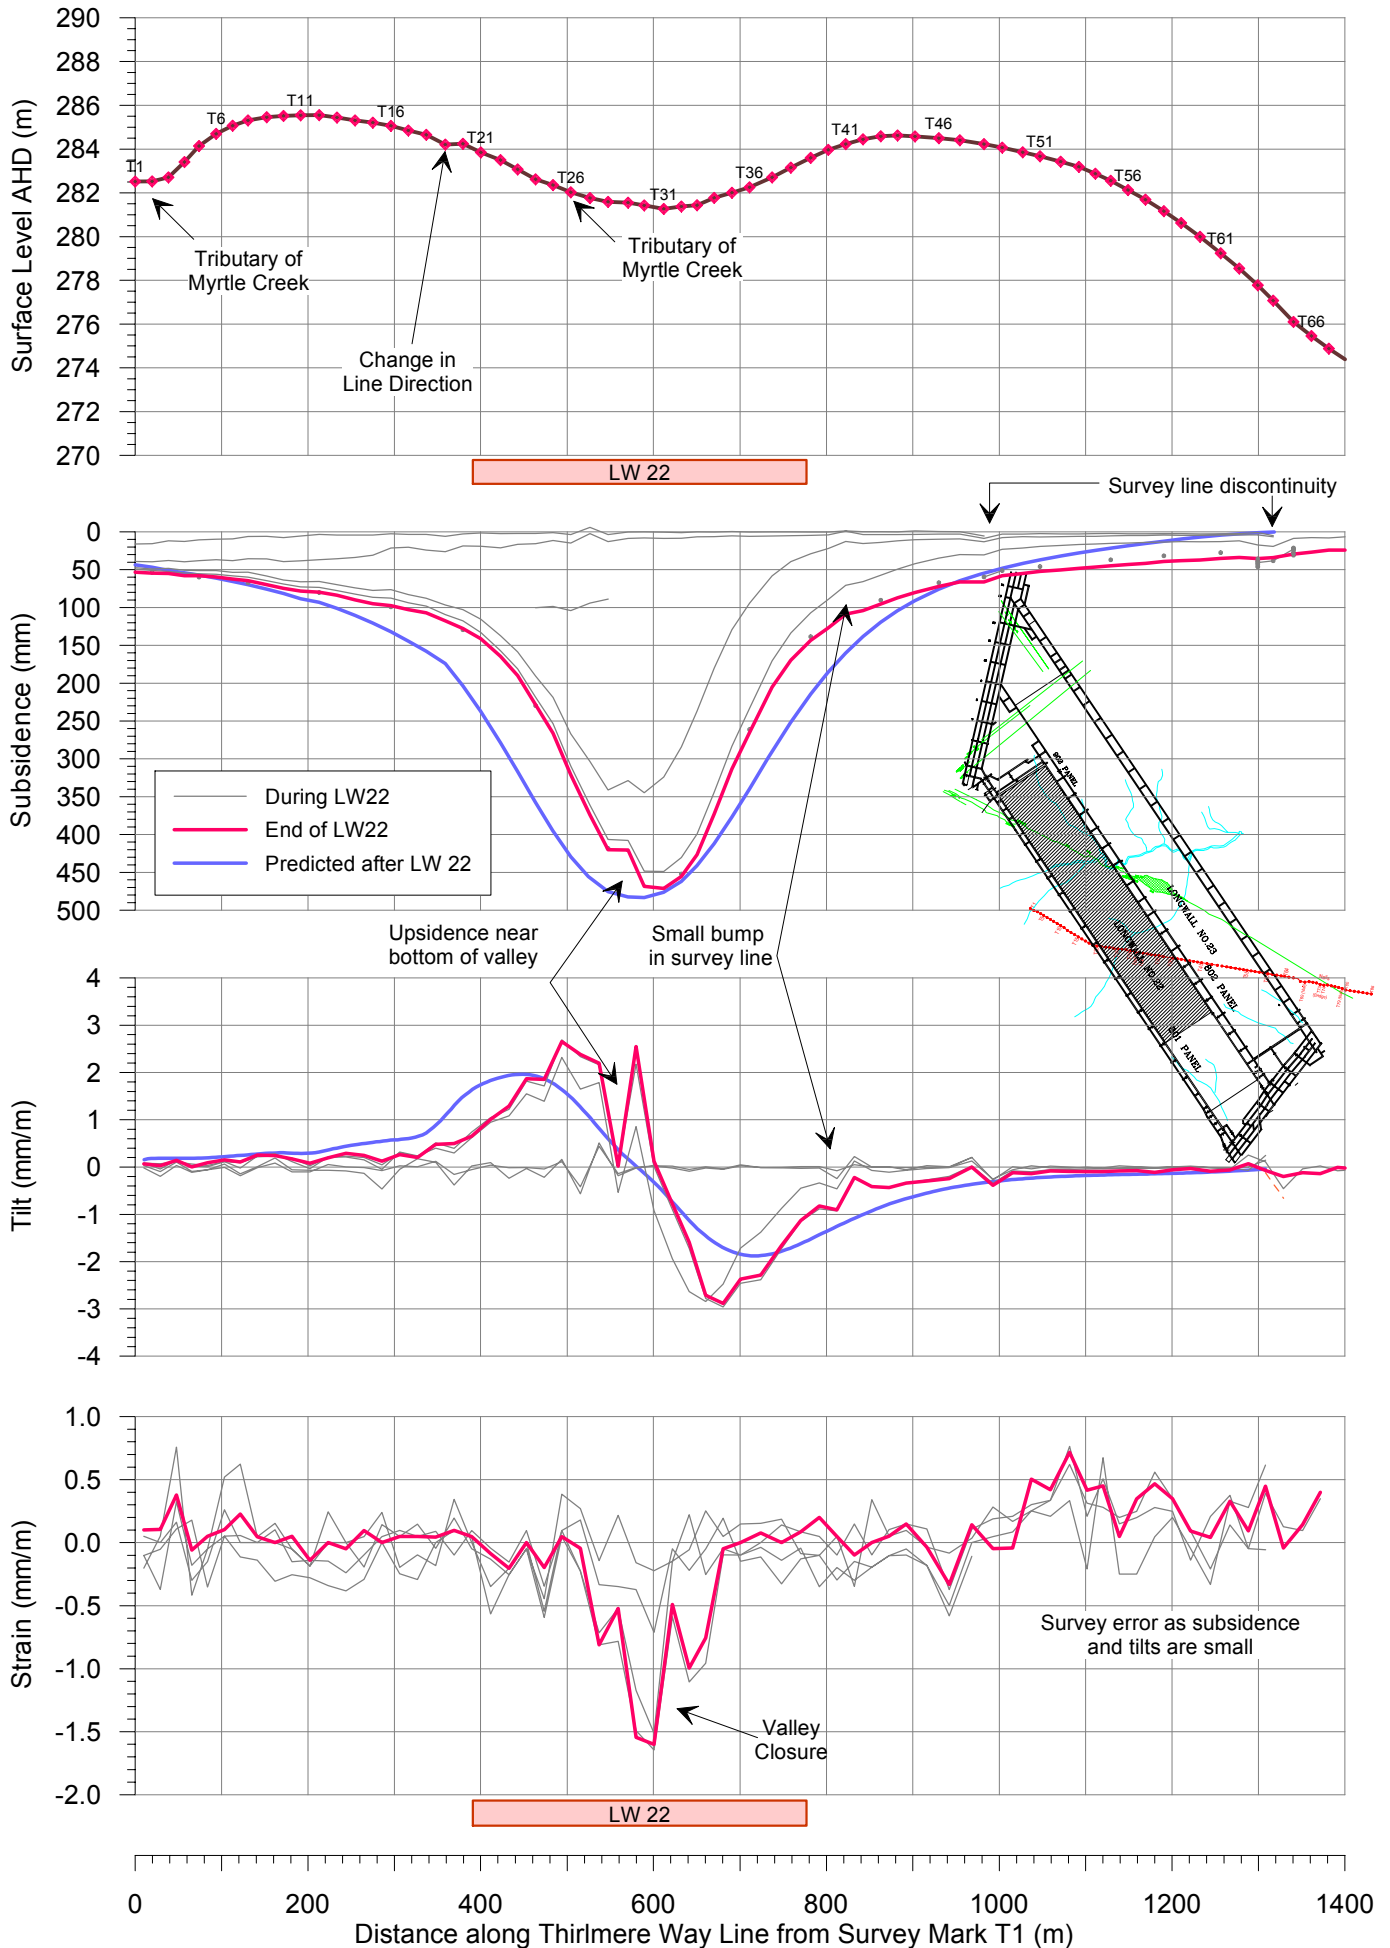
Tahmoor Colliery - Observed Subsidence, Tilt & Strain along Thirlmere Way Line

- Valley closure and upsidence movements appear to have occurred in a tributary to Myrtle Creek, near the centre of the panel.
- The reduced subsidence observed on Macquarie Place is due to the presence of a substantial igneous intrusion beneath Macquarie Place and Stuart Place. The main effect of the reduced subsidence is an increased tilt into the subsidence bowl of approximately 9 mm/m. The observed strains are less than 2 mm/m. A coal barrier has been introduced in Longwall 23 due to the presence of this intrusion.

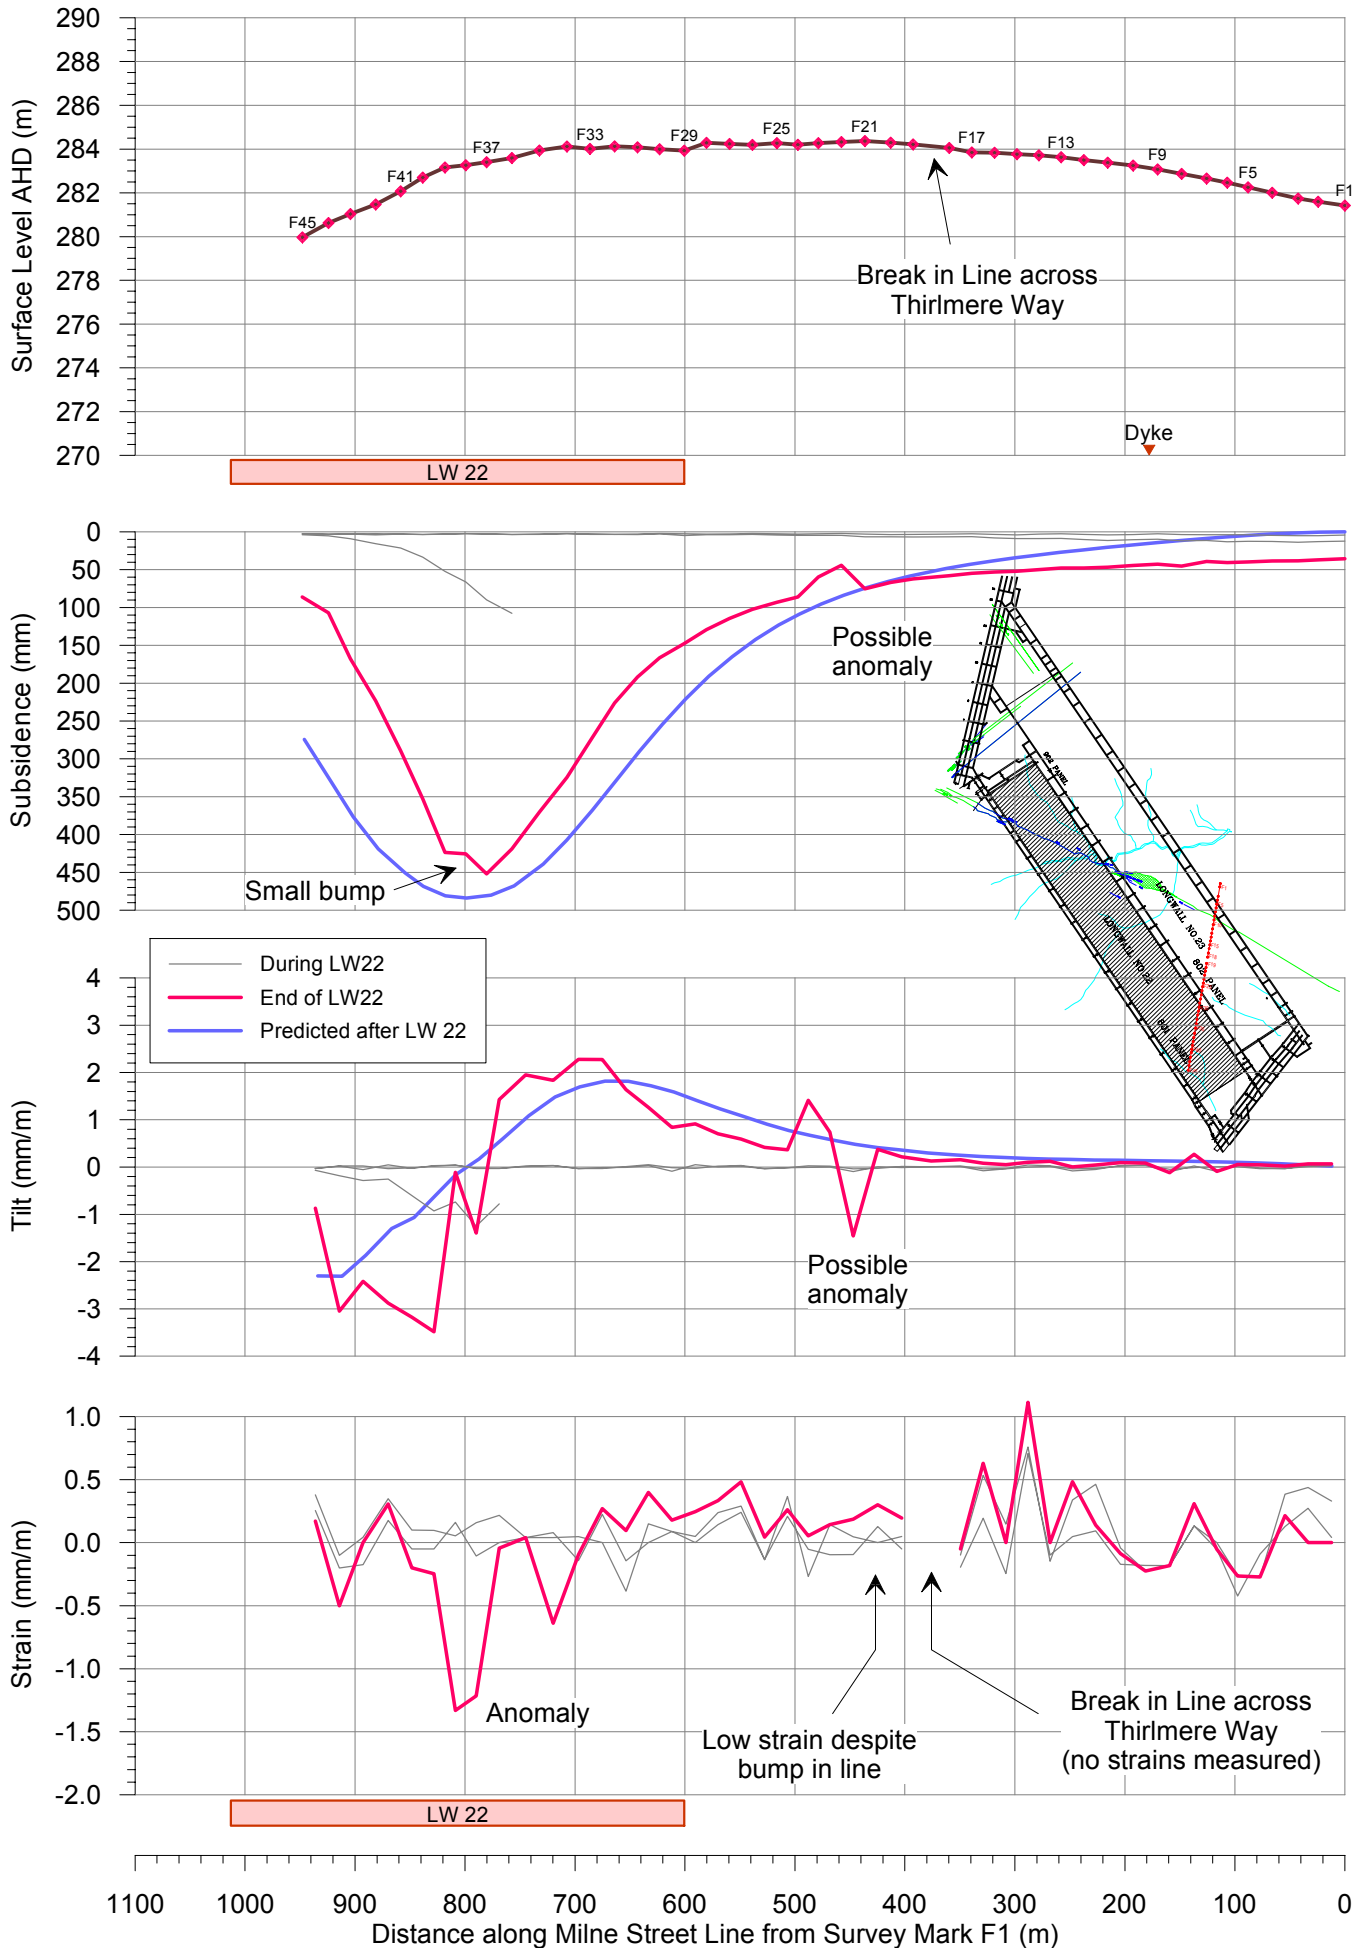
Tahmoor Colliery - Observed Subsidence, Tilt & Strain along Fraser Street Line

- There is one possible anomaly on Fraser Street, which is located beyond the goaf edge of Longwall 22. This anomaly demonstrates an upsidence bump of approximately 30 mm, although there is no significant ground strain associated with this bump. Field investigations of the affected pegs do not reveal any damage, although some minor tampering may have occurred on one peg. Tahmoor Colliery will check the survey result with a repeat survey within the next two weeks. If the survey result is confirmed, increased monitoring will be undertaken in the vicinity of this possible anomaly, as Longwall 23A will directly mine beneath this peg.

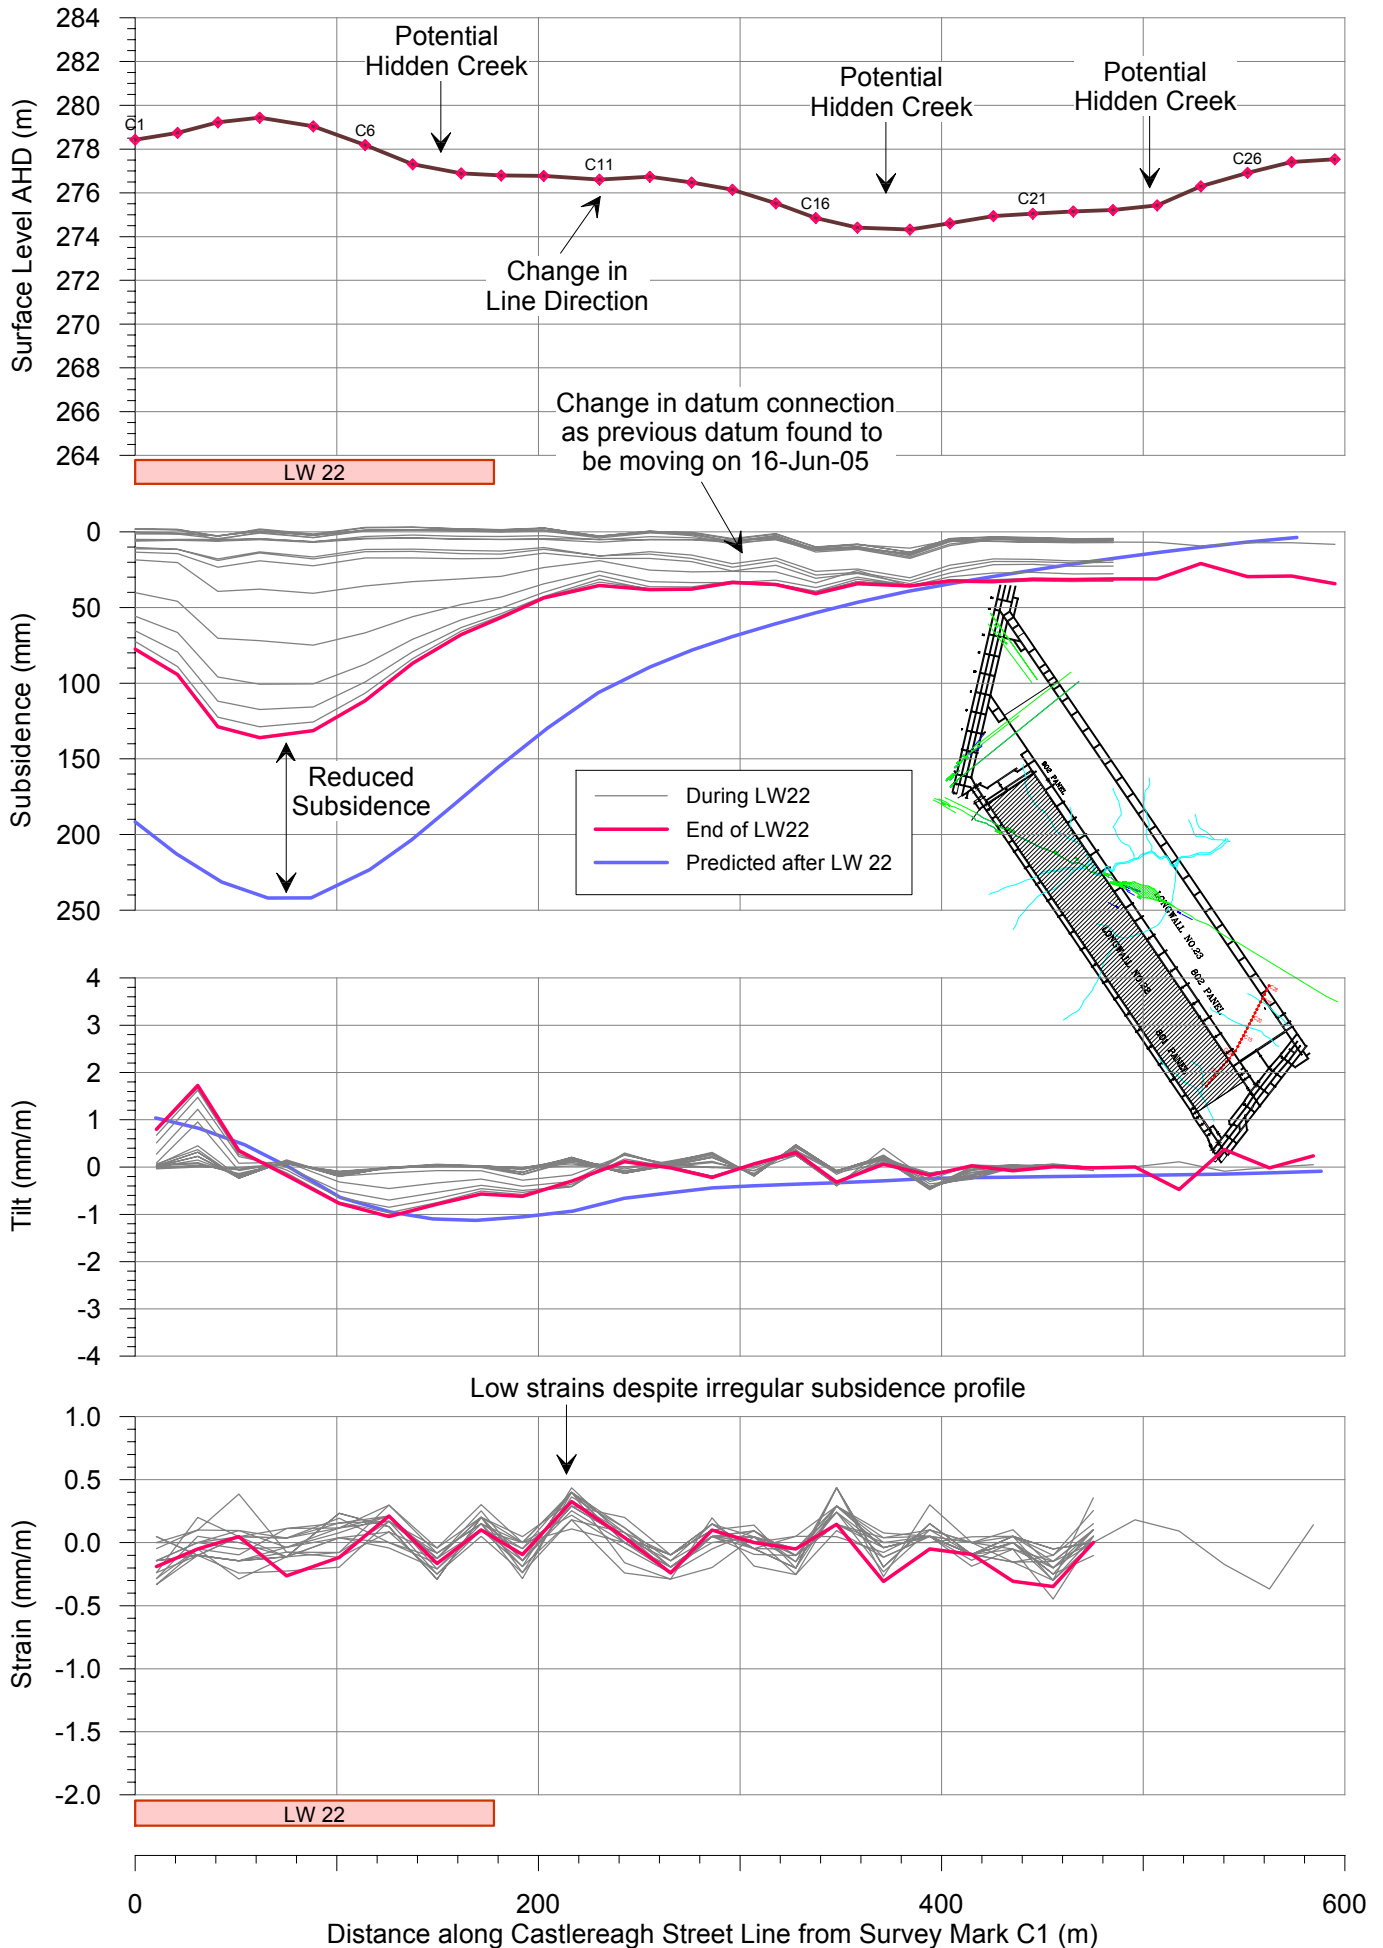
Tahmoor Colliery - Observed Subsidence, Tilt & Strain along Castlereagh Street Line

- Reduced subsidence is evident near the finishing end of Longwall 22, along Castlereagh Street, Bronzewing Street and the Main Southern Railway. A number of potential causes have been discussed in previous reports (MSEC212). The most likely reason is that the ground could be behaving differently due to a redistribution of in-situ horizontal compressive stresses at that location. The redistribution of stress could be occurring near the surface or between the surface and the mined void. It is worth noting that the finishing end is located near a rock mass that is wedged between the mined voids of Longwall 22 to the north, Panels 201 to 204 to the south, and Longwall 3 to the west. This rock mass has progressively been reduced in size as Longwall 22 has been mined, and stress redistribution is likely to have occurred to some extent.

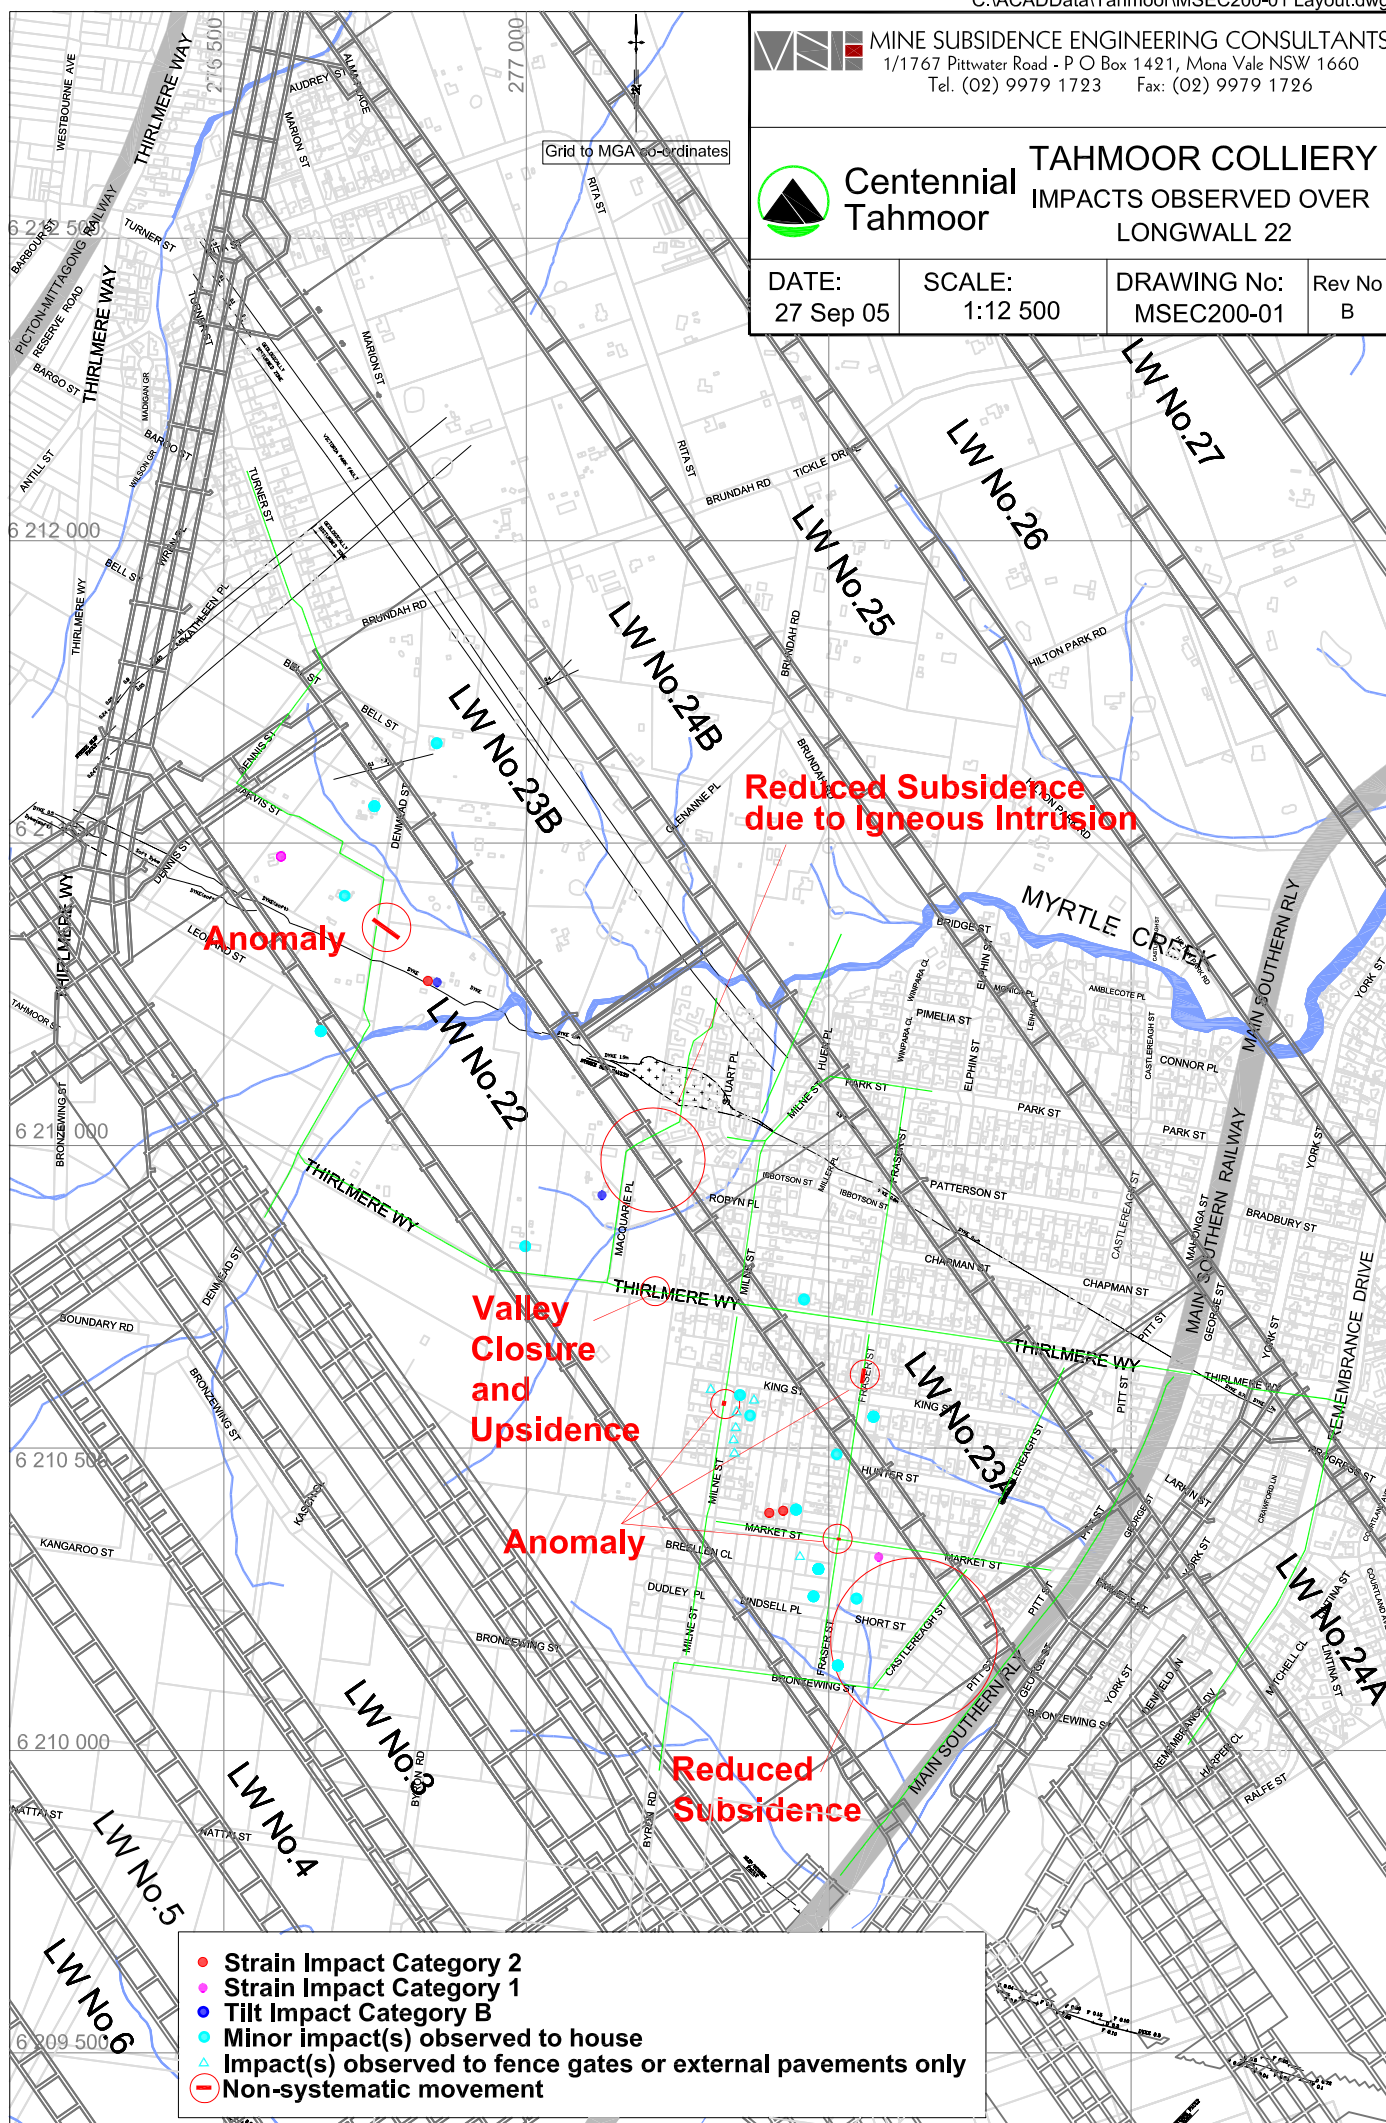
TAHMOOR COLLIERY IMPACTS OBSERVED OVER LONGWALL 22

A total of six (6) locations have been identified where non-systematic movements have occurred, and these are summarised in Table 2.1. The locations of these non-systematic movements are shown in Drawing No. MSEC200-02.

The locations of affected houses are shown in Drawing No. MSEC200-02. It can be seen from this drawing that many of the houses are located near the centre of the longwall panel, where small anomalous movements have been consistently observed along monitoring lines. Both of the houses that have experienced Category B tilt impacts are located near non-systematic movements. It is therefore concluded that whilst some houses have experienced greater impacts when compared to their predicted impact assessments, the impacts are mainly due to non-systematic movements, which were not expected to occur prior to the commencement of Longwall 22.
