**TAHMOOR COLLIERY
LONGWALL 23A**

**END OF PANEL MONITORING REPORT
FOR LONGWALL 23A
AT TAHMOOR COLLIERY**

REPORT NO. MSEC235-03

March 2006

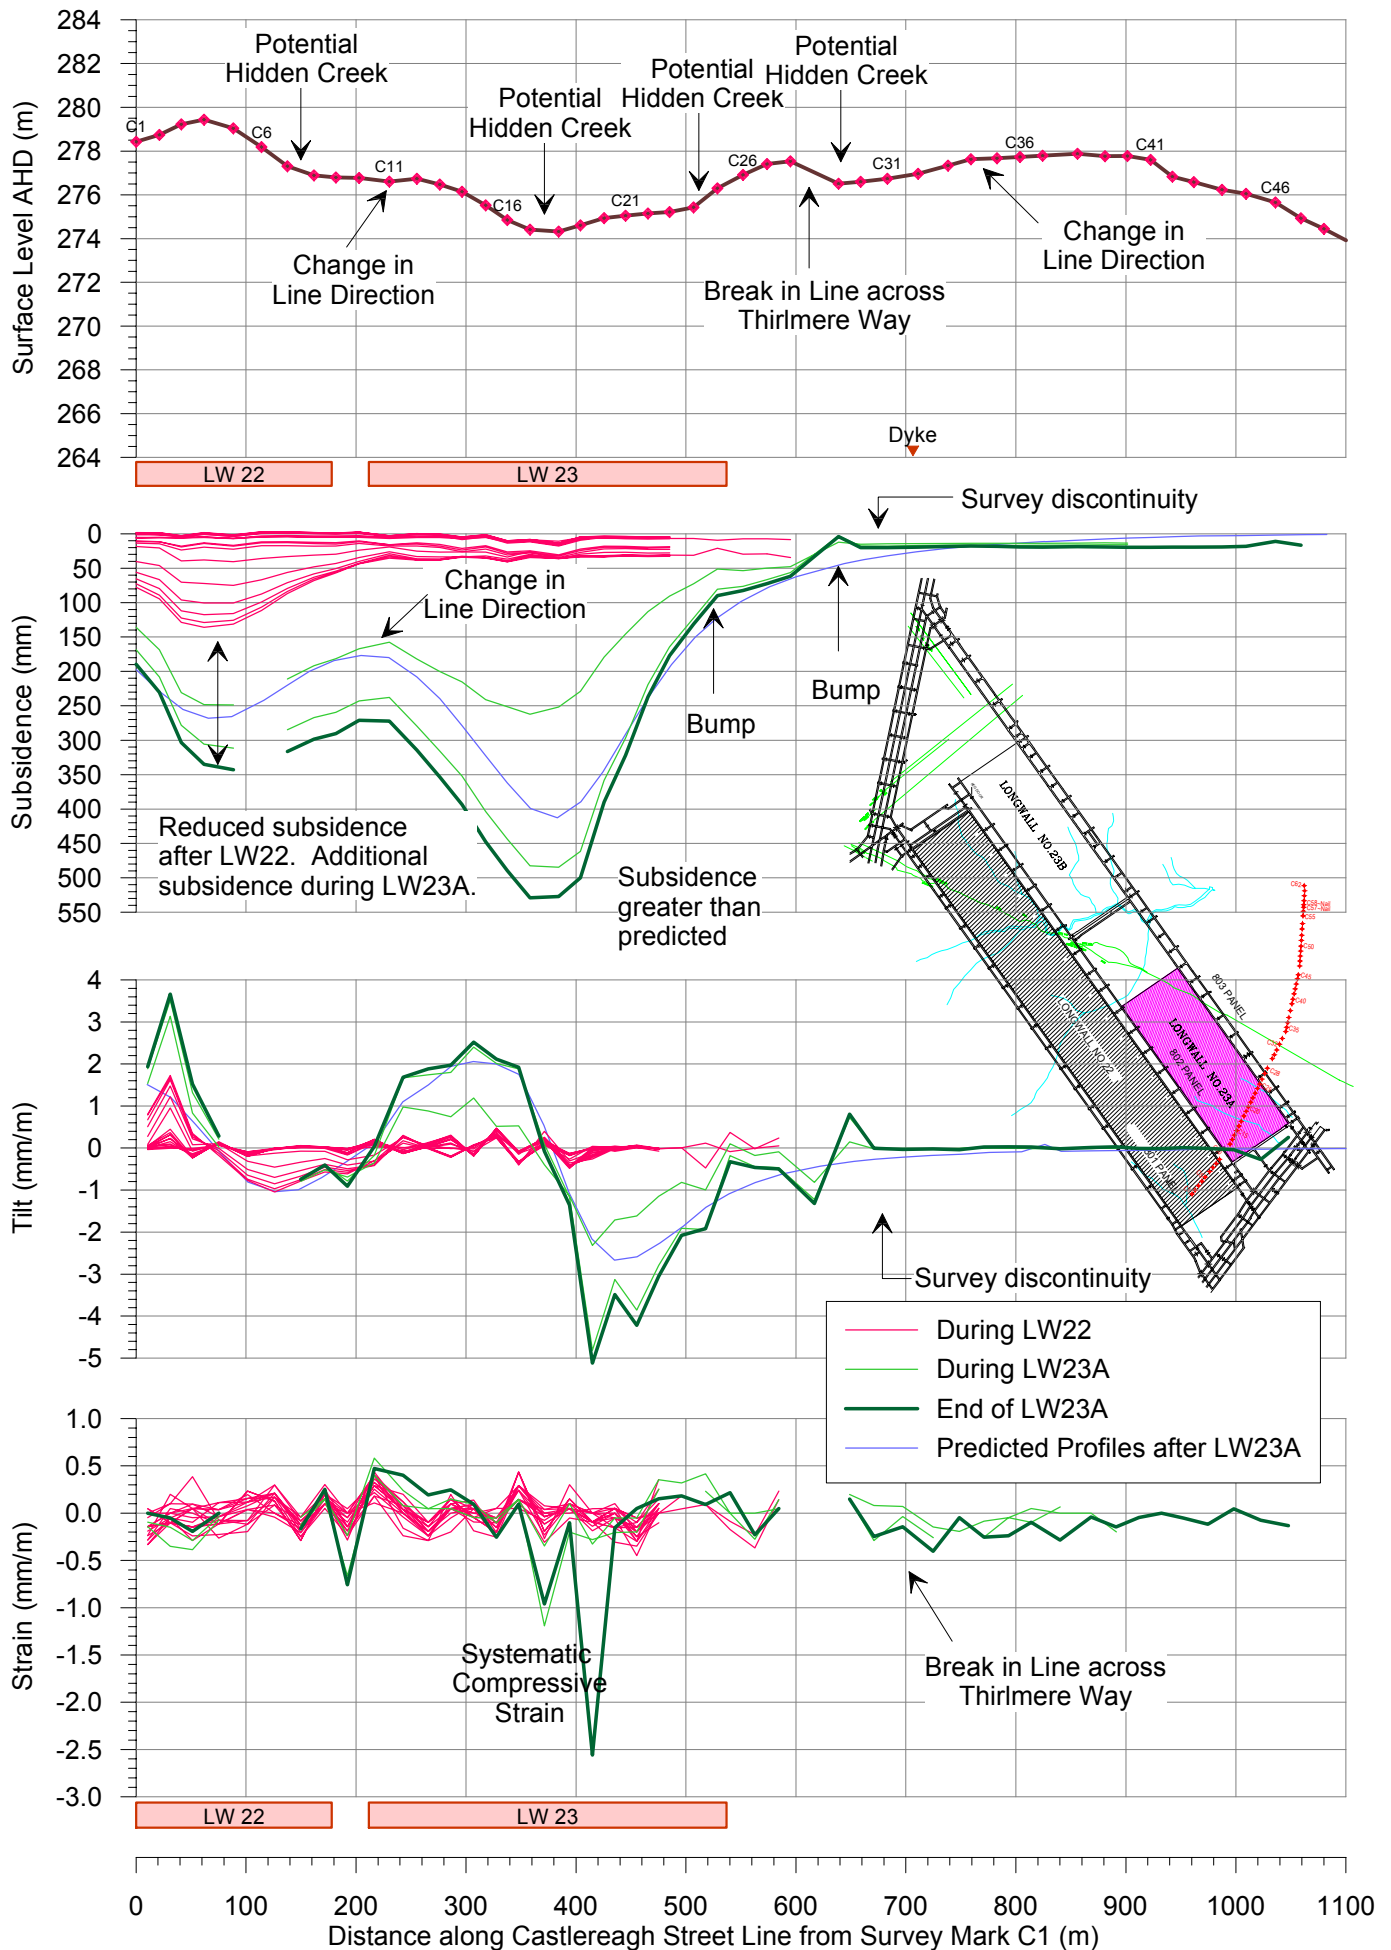
Tahmoor Colliery - Total Subsidence Profiles along Castlereagh Street Line

- There is a high observed compressive strain of 2.6 mm/m between pegs C19 and C20, which coincides with an impact to the concrete kerb and minor impacts to two houses. There is a small amount of upsidence observed in the subsidence and tilt profiles. The cause of the non-systematic movement is unclear, as the movements have occurred near two small watercourses, are almost in line with the observed anomaly on Market and Hunter Streets and are located within an area which experienced greater subsidence movements than expected.

- There are irregular bumps along Castlereagh Street near Peg C25 and Peg C29. A small amount of upsidence is observed, although no irregular strains are observed.

Observed subsidence has exceeded predicted subsidence along the Castlereagh Street monitoring line between Pegs C2 and C21. The difference between observed and predicted subsidence is relatively uniform and approximately 100 to 130 mm at most points along the line.

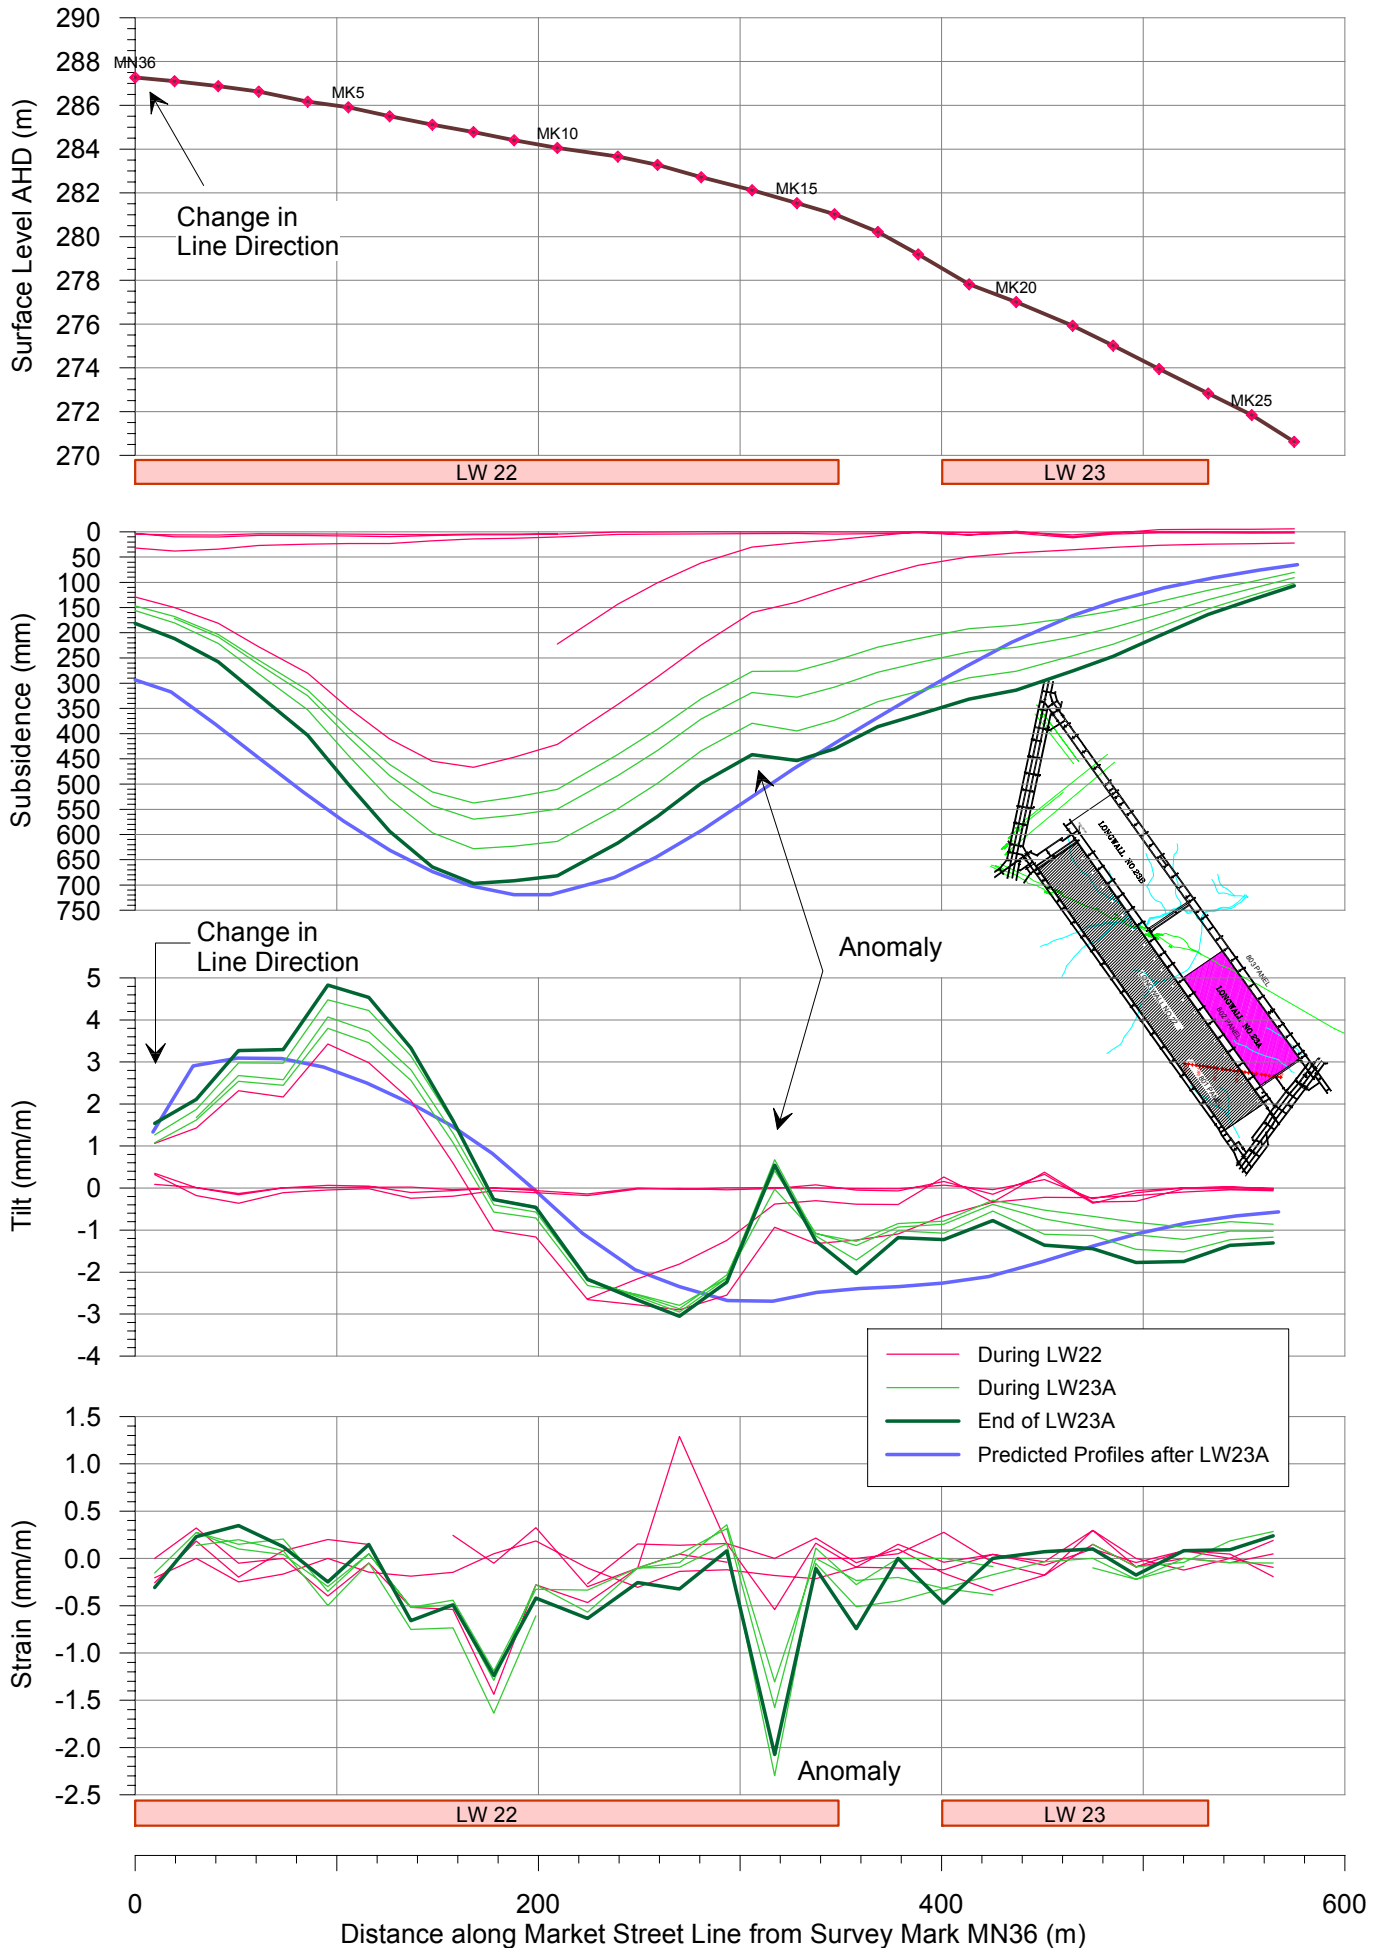
Tahmoor Colliery - Total Subsidence Profiles along Market Street Line

- The anomaly identified along the Market Street monitoring line between Pegs MK14 and MK15 appears to coincide with observed impacts to two houses on Market Street and one house on Hunter Street, as shown in Drawing No. MSEC235-02. The anomaly is relatively small and the impacts to surface features have been minor to moderate and substantially less than those that have occurred at previous anomalies over Longwalls 5, 6 and 16 at Tahmoor Colliery and Longwall 5A3 at West Cliff Colliery. All three houses have experienced Category 3 cracks in isolated locations in their external walls, and other minor impacts to internal linings, doors and windows. There are no impacts observed or reported in the pavements or kerbs along Market or Hunter Streets, nor any of the neighbouring properties. No faults have been reported by any of the service infrastructure owners.
The movements are considered anomalous as they are not coincident with a creek valley and no geological structures have been identified in this area. The orientation of the anomaly appears to be relatively linear at a bearing of approximately 45 degrees (ie north east). It is noted that the irregularity could be identified in earlier ground surveys during the extraction of Longwall 22. The magnitude of the upsidence bump in the observed subsidence profile in Market Street does not appear to have changed since the previous survey, even though subsidence has increased by approximately 60 mm, which is an increase of approximately 15%. Compressive strains have reduced by approximately 0.2 mm/m since the previous survey. The three affected houses have reported minor additional impacts since the previous survey.

Observed subsidence has exceeded predicted subsidence along the Market Street monitoring line between Pegs MK16 and MK26. The difference between observed and predicted subsidence is varies between 20 to 110 mm along this section of the monitoring line.

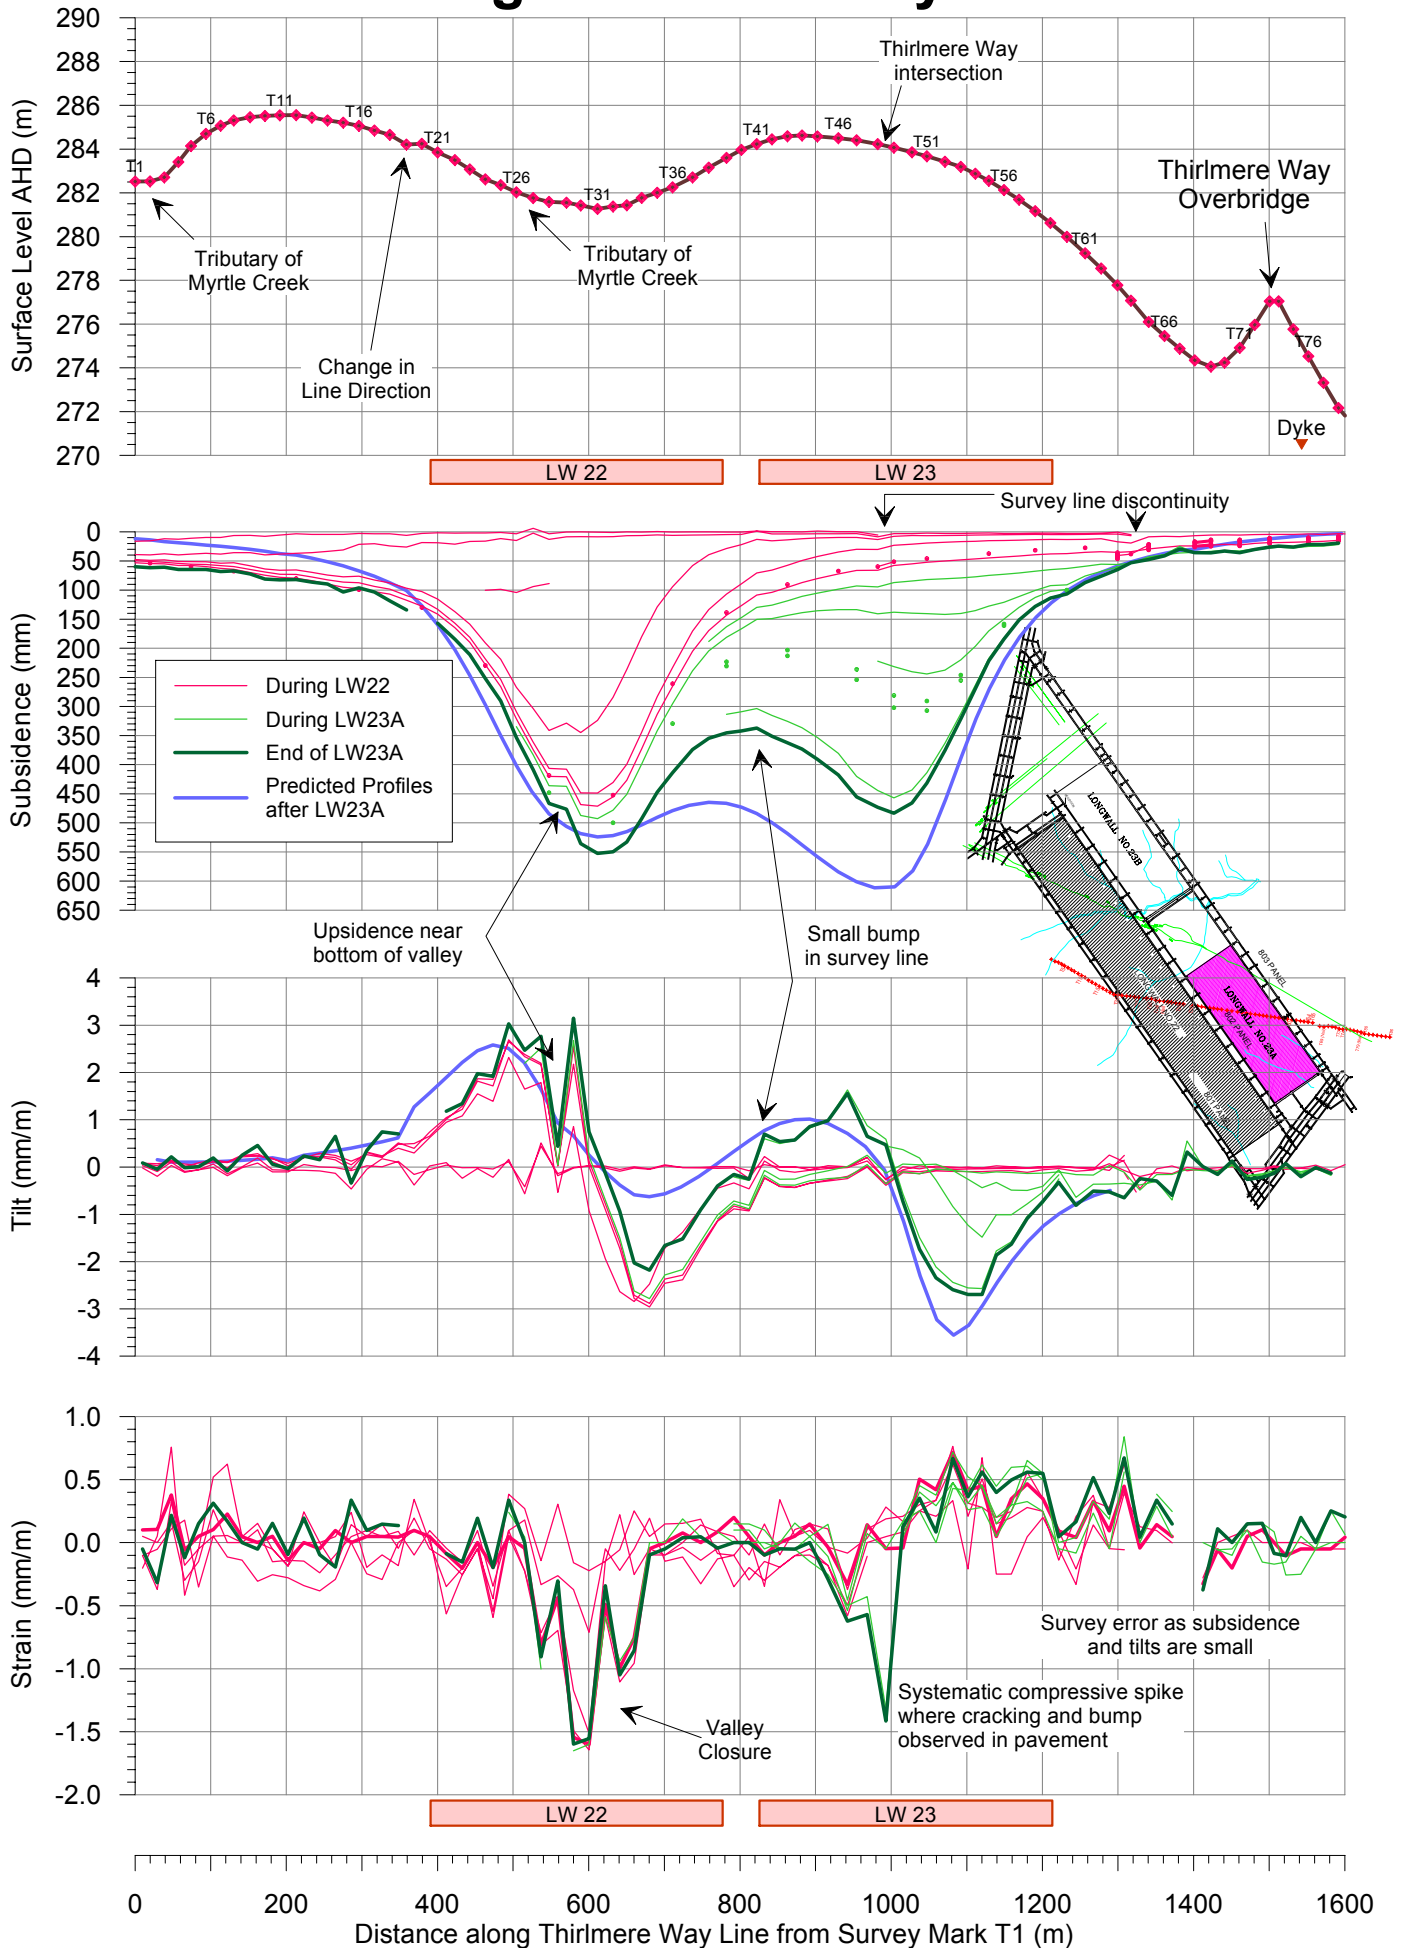
Tahmoor Colliery - Total Subsidence Profiles along Thirlmere Way Line

- There is an observed compressive strain of 1.4 mm/m along Thirlmere Way between pegs T48 and T49, which coincides with a bump and cracks to the pavement. There does not appear to be any upsidence along the subsidence profile. The observed compressive strain is located where maximum systematic compressive strains are expected to occur. The maximum predicted compressive strain following the extraction of Longwall 23A is 1.6 mm/m, which is similar in magnitude to the observed strain. The observed strain is therefore considered to be systematic.

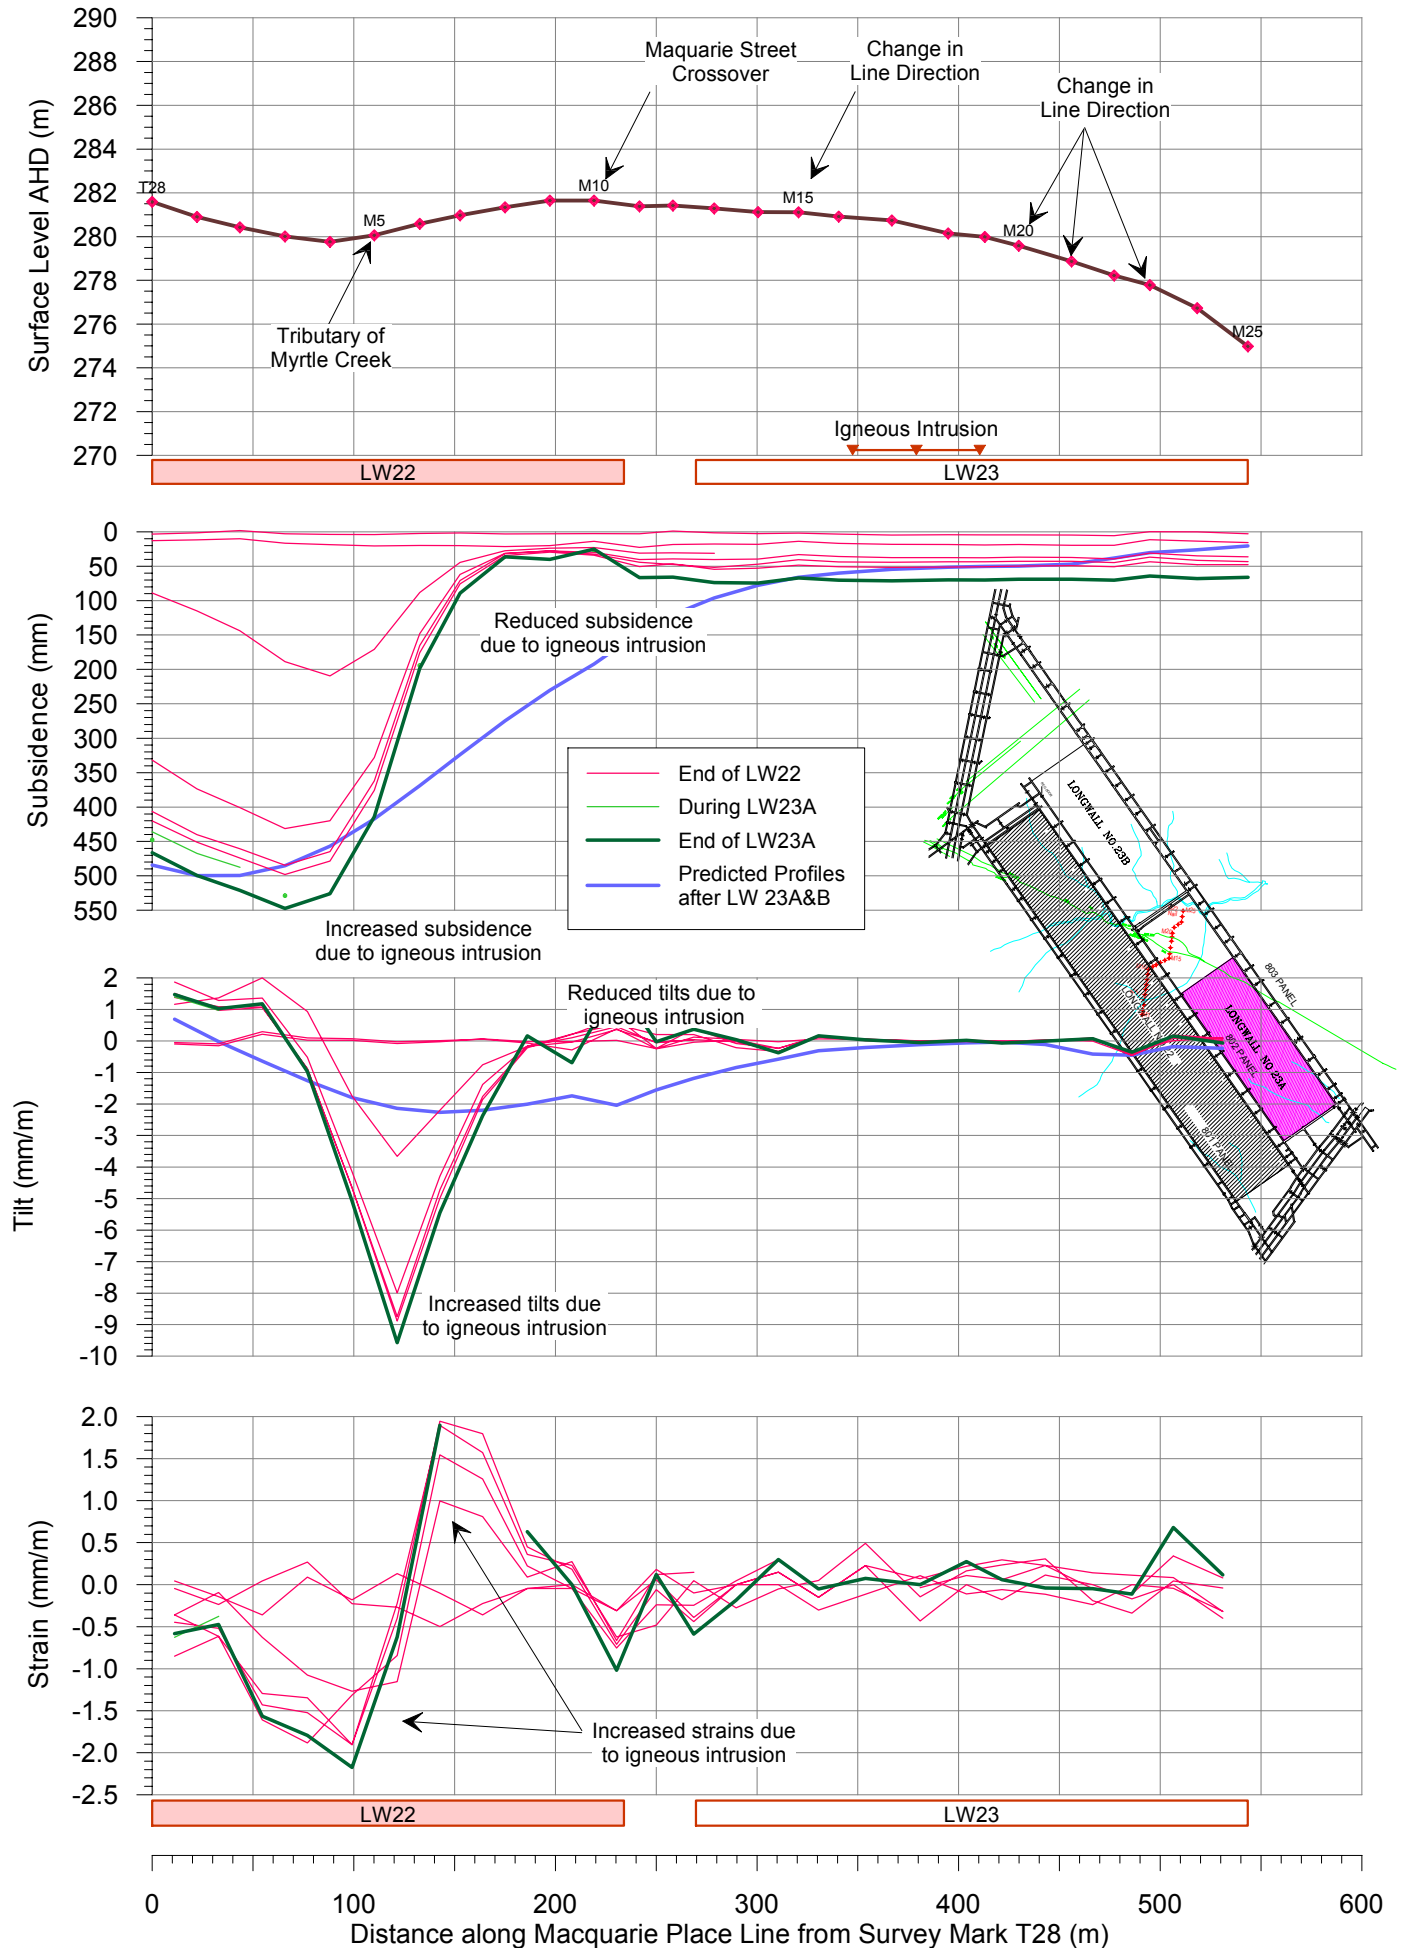
Tahmoor Colliery - Total Subsidence Profiles along Macquarie Place Line

- There is generally a reasonable correlation between observed and predicted subsidence and tilt profiles. The main exception to this observation is the Macquarie Place monitoring line, which is influenced by the igneous intrusion in Longwall 23.

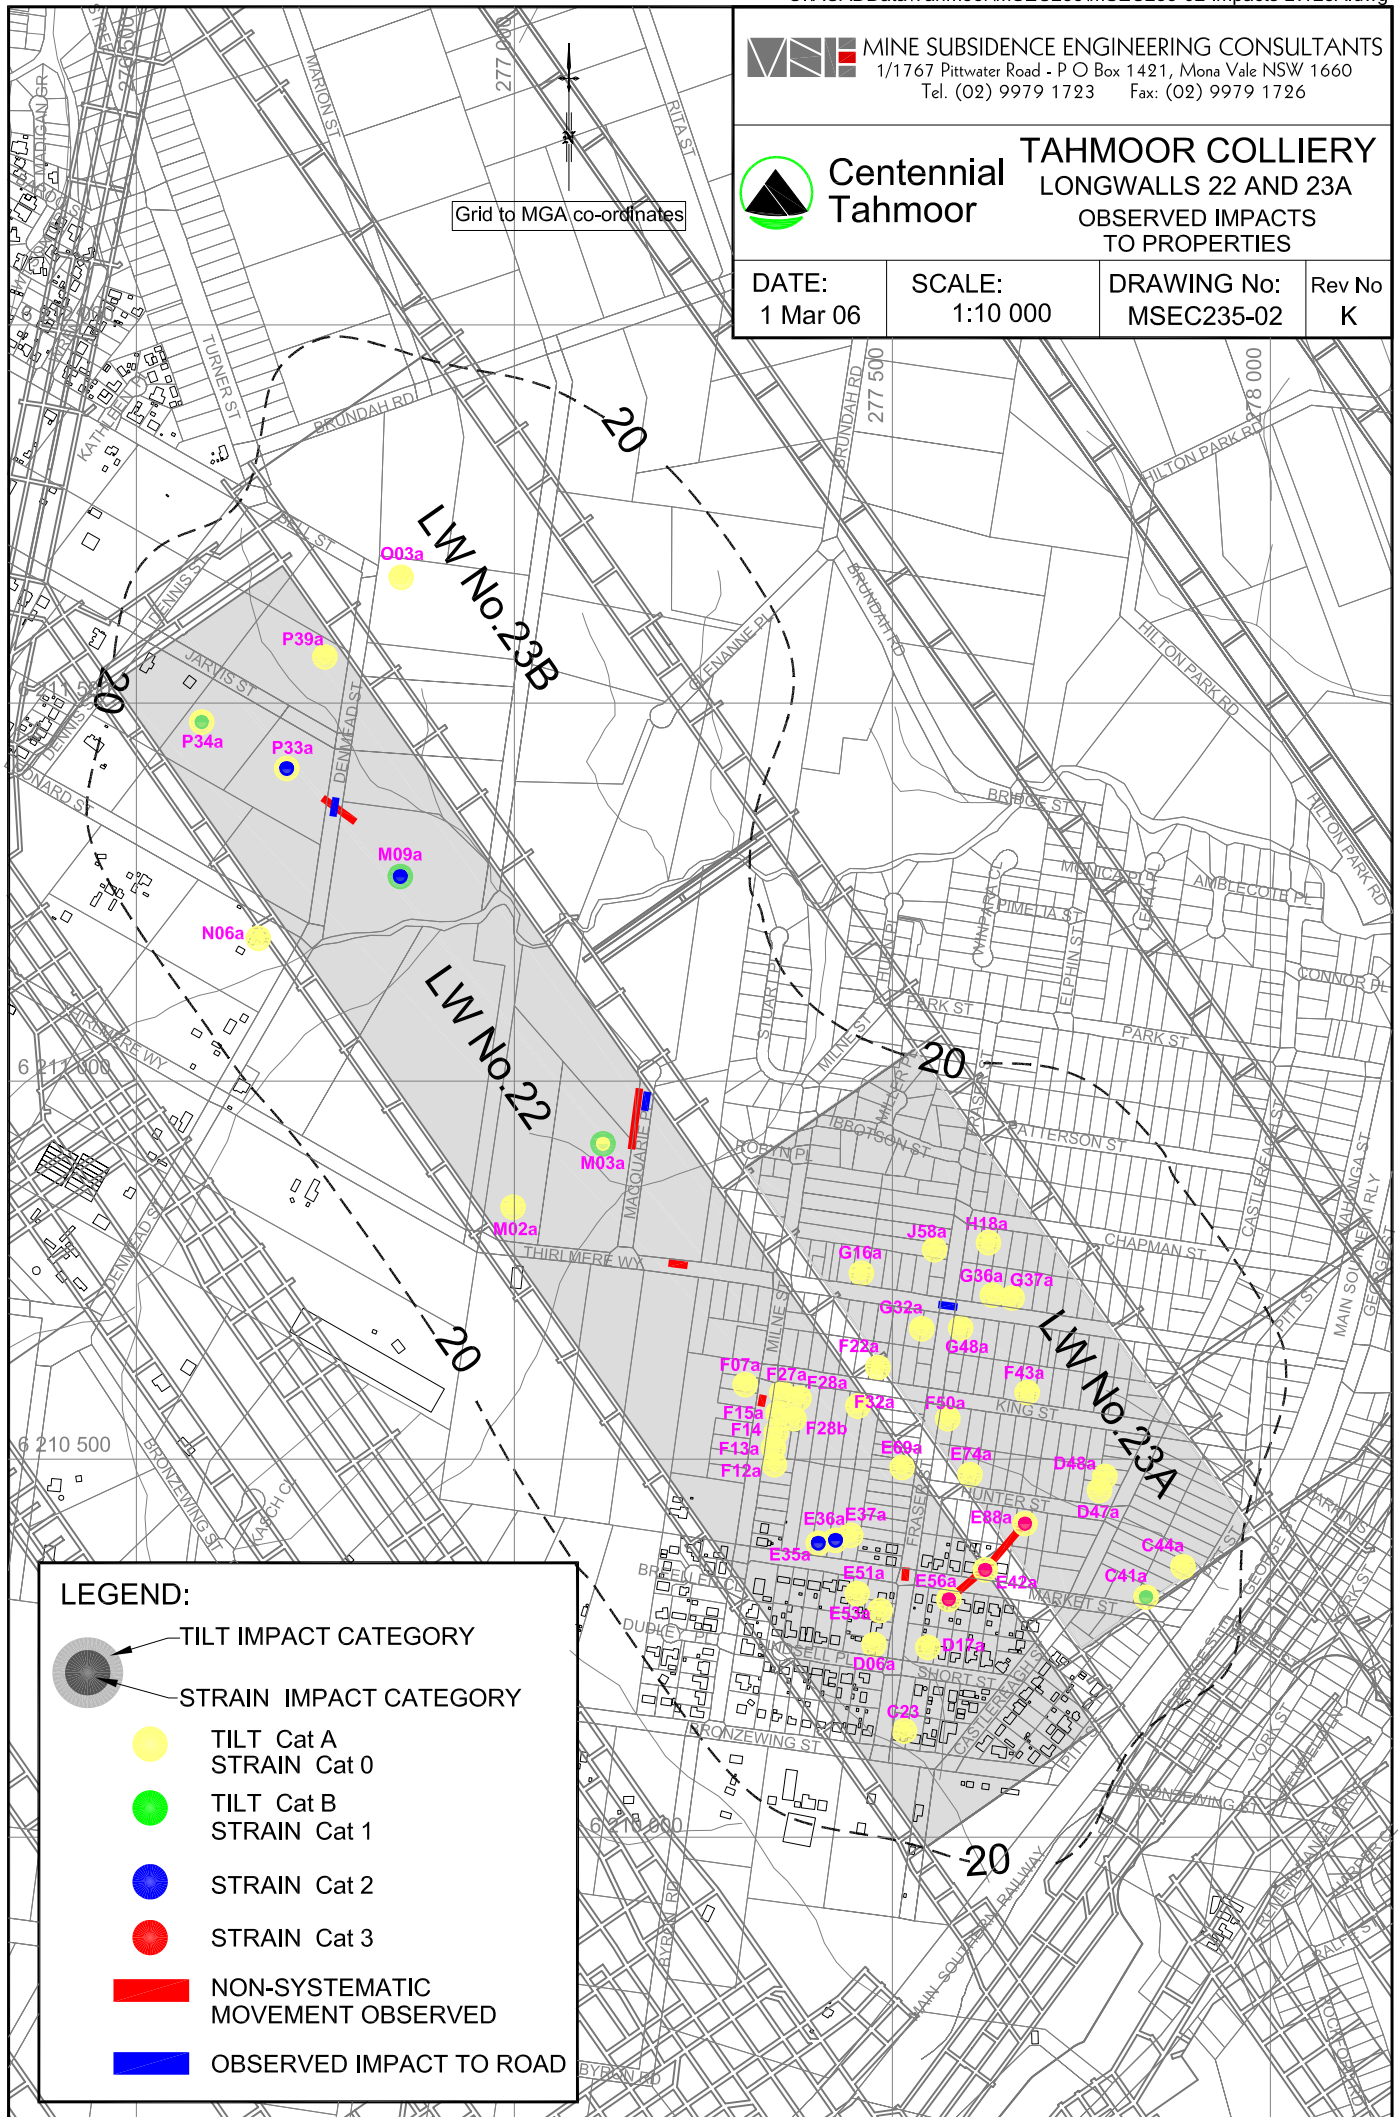
DRAWING No:
MSEC235-02

There are two (2) locations at which non-systematic movements have occurred during the extraction of Longwall 23A, and the movements are summarised in Table 2.1. The location at which the non-systematic movements occurred is shown in Drawing No. MSEC235-02, together with the five other sites where non-systematic movements were identified during or following the extraction of Longwall 22.

The locations of affected houses and public amenity are shown in Drawing No. MSEC235-02. It can be seen from this drawing that many of the impacts are located near the centre of the Longwall 22, where small anomalous movements have been consistently observed along monitoring lines. The three houses with Category 3 cracks to external walls have experienced non-systematic movements. Both of the houses that have experienced Category B tilt impacts are located near non-systematic movements. It is therefore concluded that whilst some houses have experienced greater impacts when compared to their predicted impact assessments, the impacts are mainly due to non-systematic movements, which cannot be predicted prior to the commencement of Longwalls 22 and 23A.

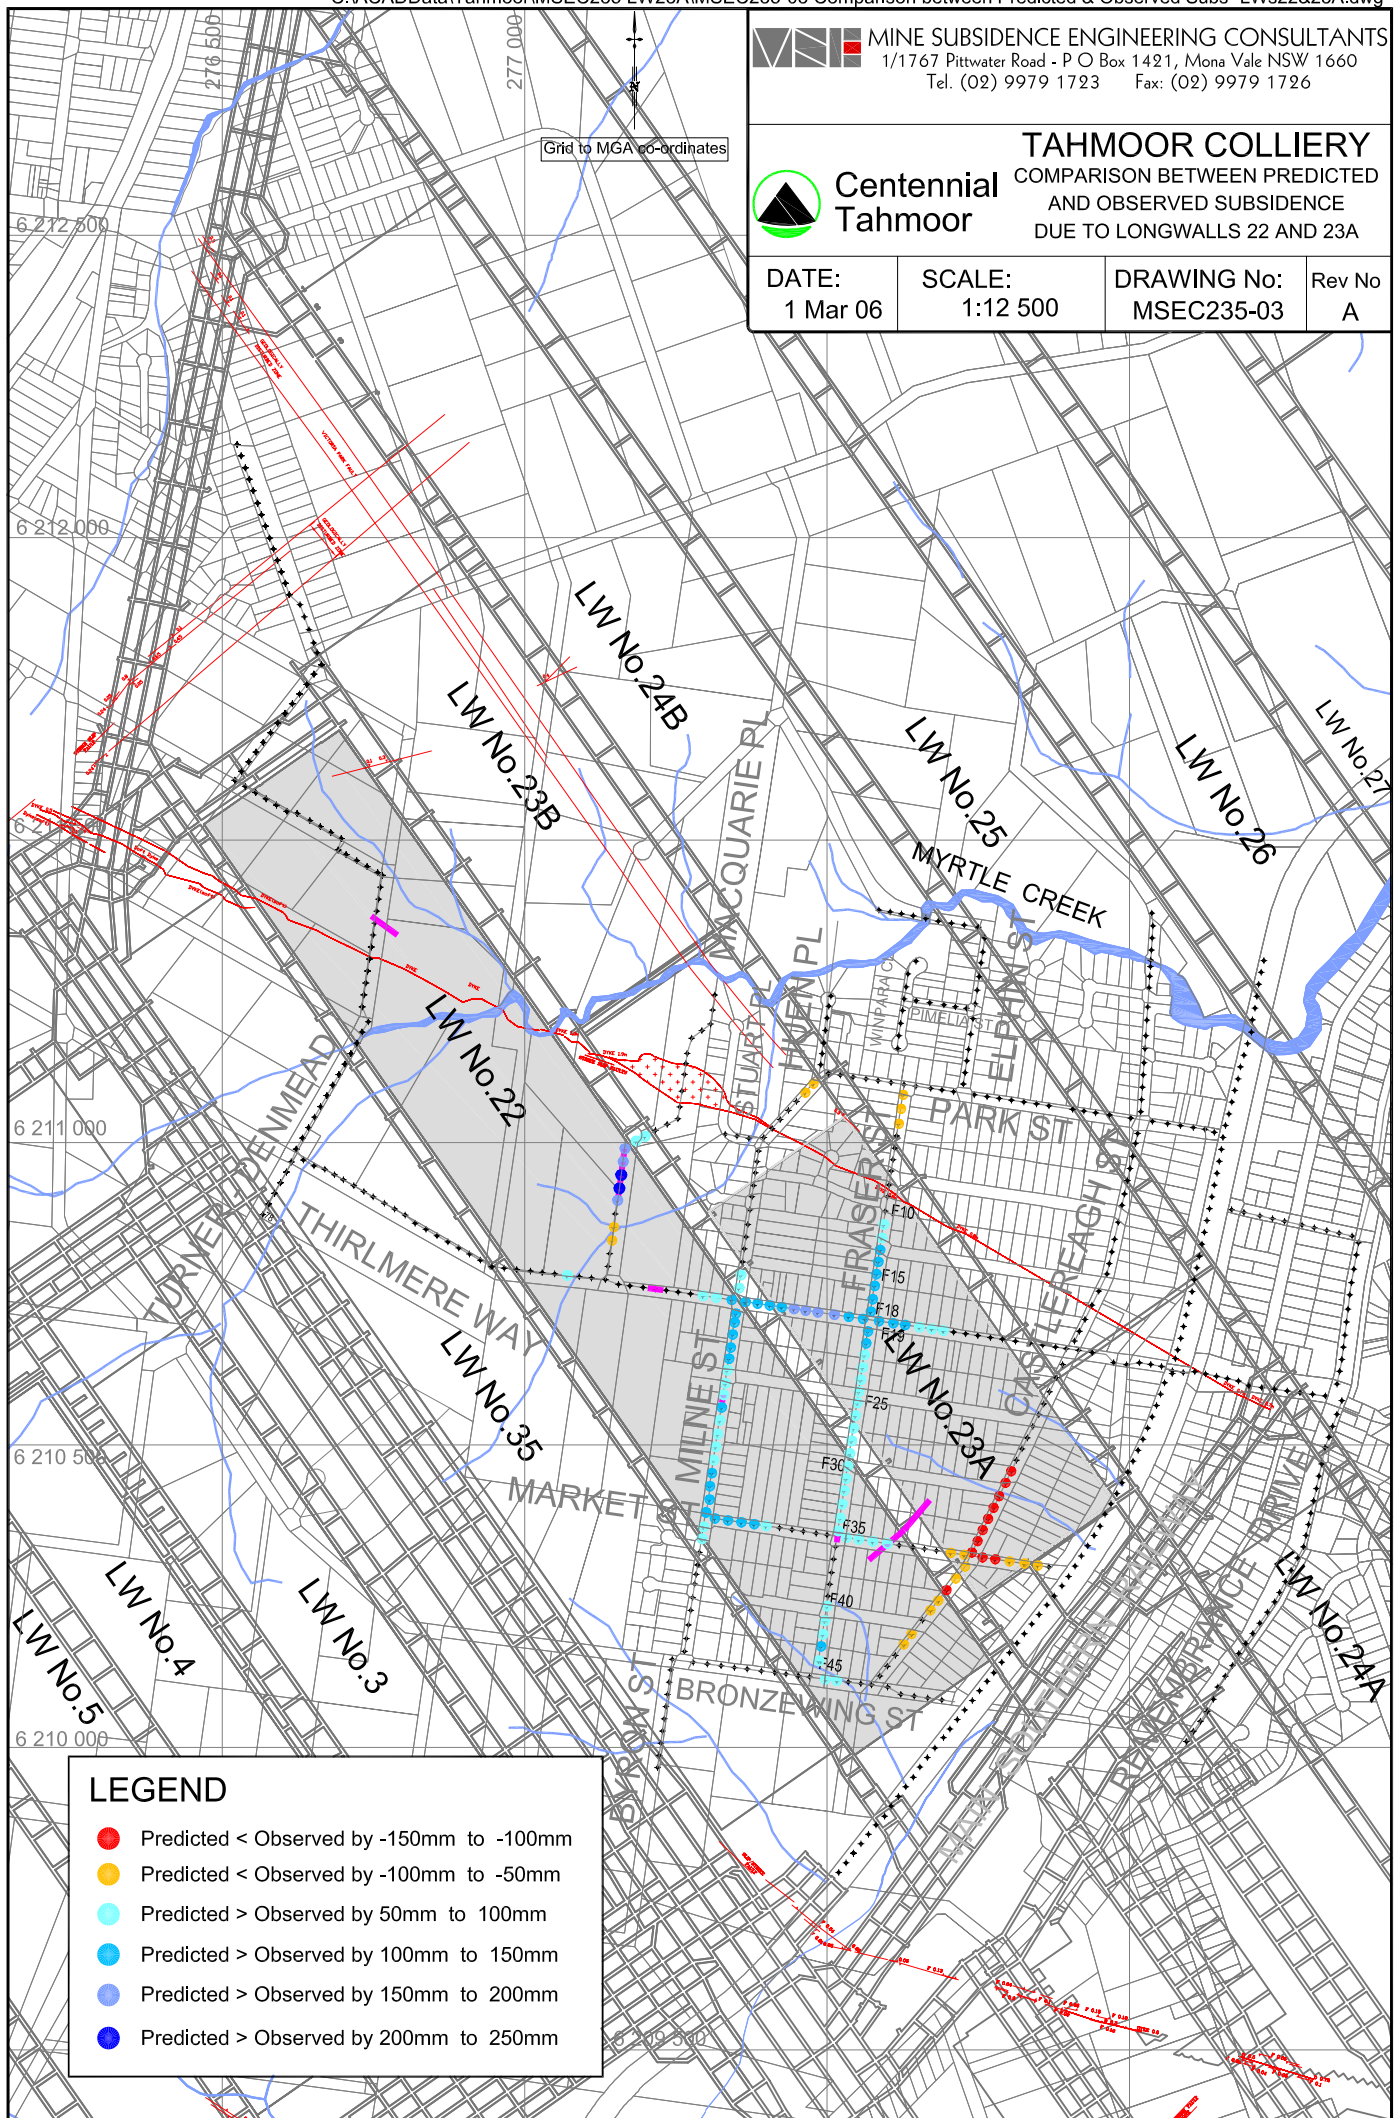
DRAWING No:
MSEC235-03

- It can be seen from Drawing No. MSEC235-03 that observed subsidence has exceeded predicted subsidence above the commencing end (southeastern end) of Longwall 23A, and the finishing end (southeastern end) of Longwall 22.

The actual extracted seam thicknesses appear to be slightly greater than the seam thicknesses adopted for the predictions, which can partially account for the difference between predicted and observed subsidence in this area.

Given that these sections of the monitoring line run near the staggered ends of Longwalls 22 and 23A, the predictions of subsidence along this line is complicated. It is therefore possible that the difference between observed and predicted profiles have occurred because the predictions have underestimated the steepness of the shape of the subsidence profile at this end. This has not occurred, however, at the finishing end (northwestern end) of Longwall 23A.
