# **TAHMOOR COLLIERY LONGWALL 24A**

**END OF PANEL  
SUBSIDENCE MONITORING REPORT  
FOR LONGWALL 24A  
AT TAHMOOR COLLIERY**

**REPORT NO. MSEC335**

**January 2009**

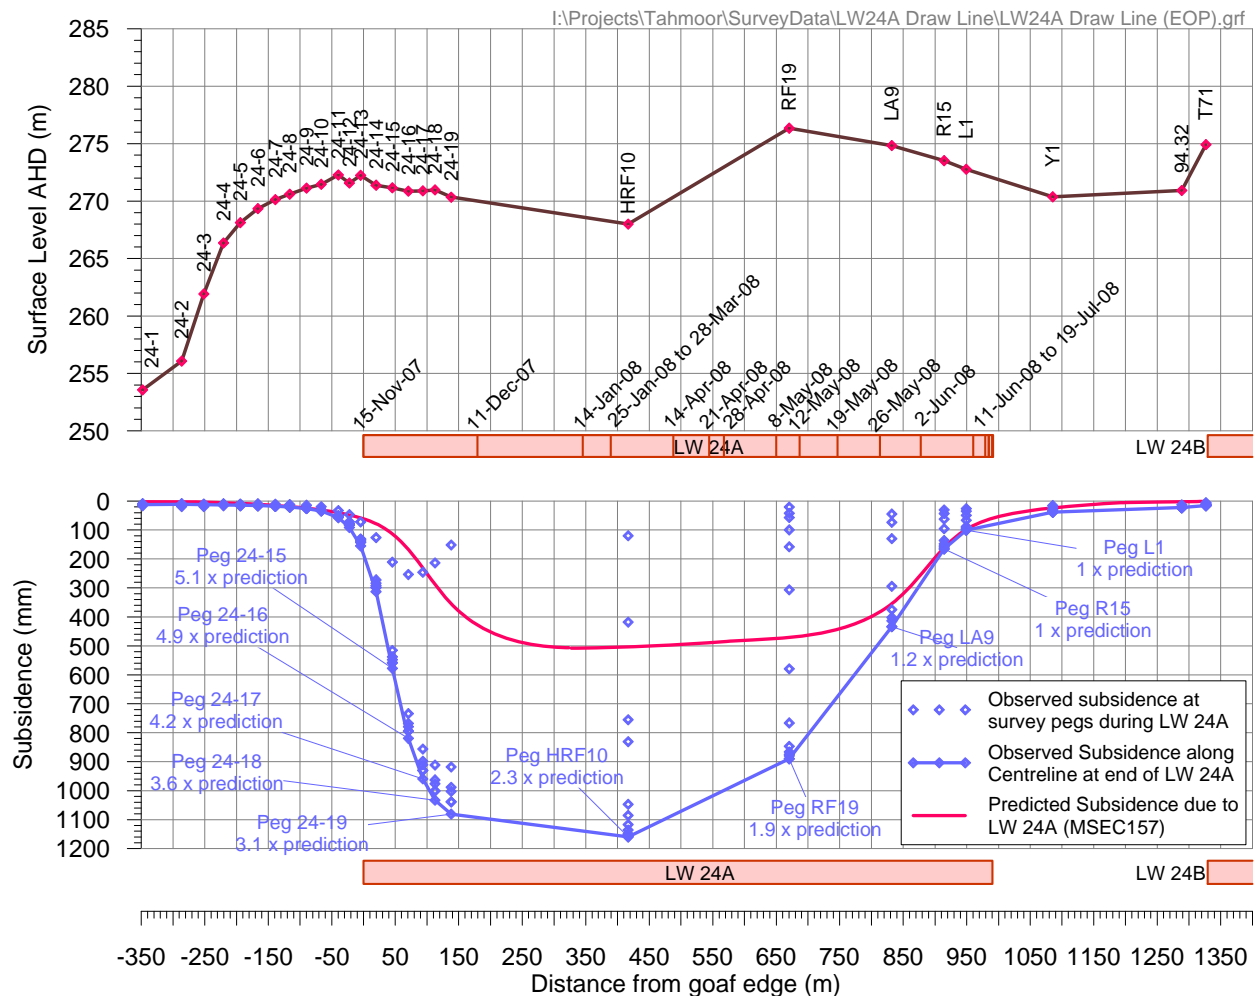
**Figure 2.1 Observed Subsidence along Centreline of Longwall 24A**

Observed subsidence, tilt and curvature due to the mining of Longwall 24A have substantially exceeded predictions. Maximum observed subsidence was 1169 mm, which was more than double the maximum predicted subsidence of 509 mm. While observed tilts and curvature were also substantially greater than predicted, observed ground strains were within the normal range.

It can be seen from Figure 2.1 that while observed subsidence was substantially greater than predicted above the commencing end of the longwall, observed subsidence compared reasonably well with predictions towards the finishing end of Longwall 24A.

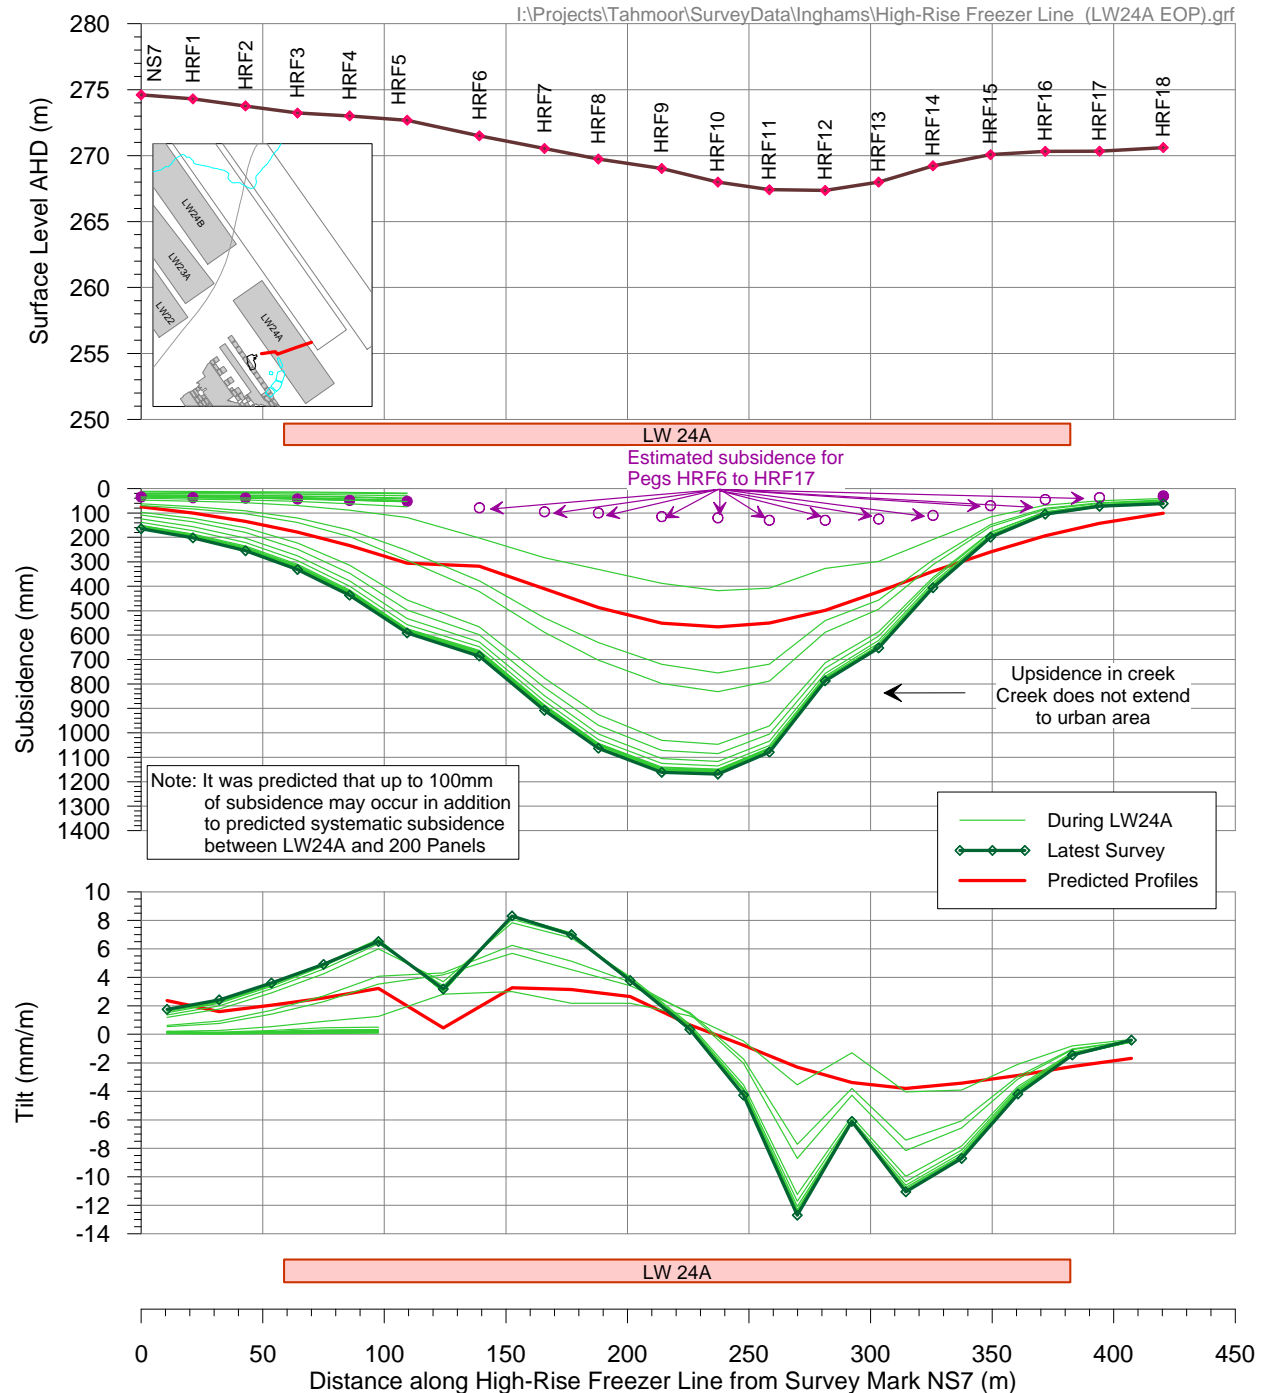
**Figure 2.2 Observed Subsidence along the High-Rise Freezer Line during Longwall 24A**

The distribution of subsidence transverse to the longwalls is illustrated by the results along the High-Rise Freezer Line (Figure 2.2). This shows that subsidence on the tailgate side (Inghams side) was greater than the subsidence on the maingate side (Progress Street side). The potential for increased subsidence on the tailgate side was anticipated as the tailgate side is located above mostly solid, unmined coal reserves that lie between a previously mined area (200 Panels) and the currently mined Longwall 24A. Observations of increased subsidence have been experienced in similar previous mining situations.

While subsidence is greater on the tailgate side, tilts and curvatures on the tailgate side are comparatively less than on the maingate side as the shape of the subsidence profile is flatter. For example, maximum tilts on the tailgate side are approximately 8 mm/m, compared to over 10 mm/m on the maingate side along the High-Rise Freezer line.

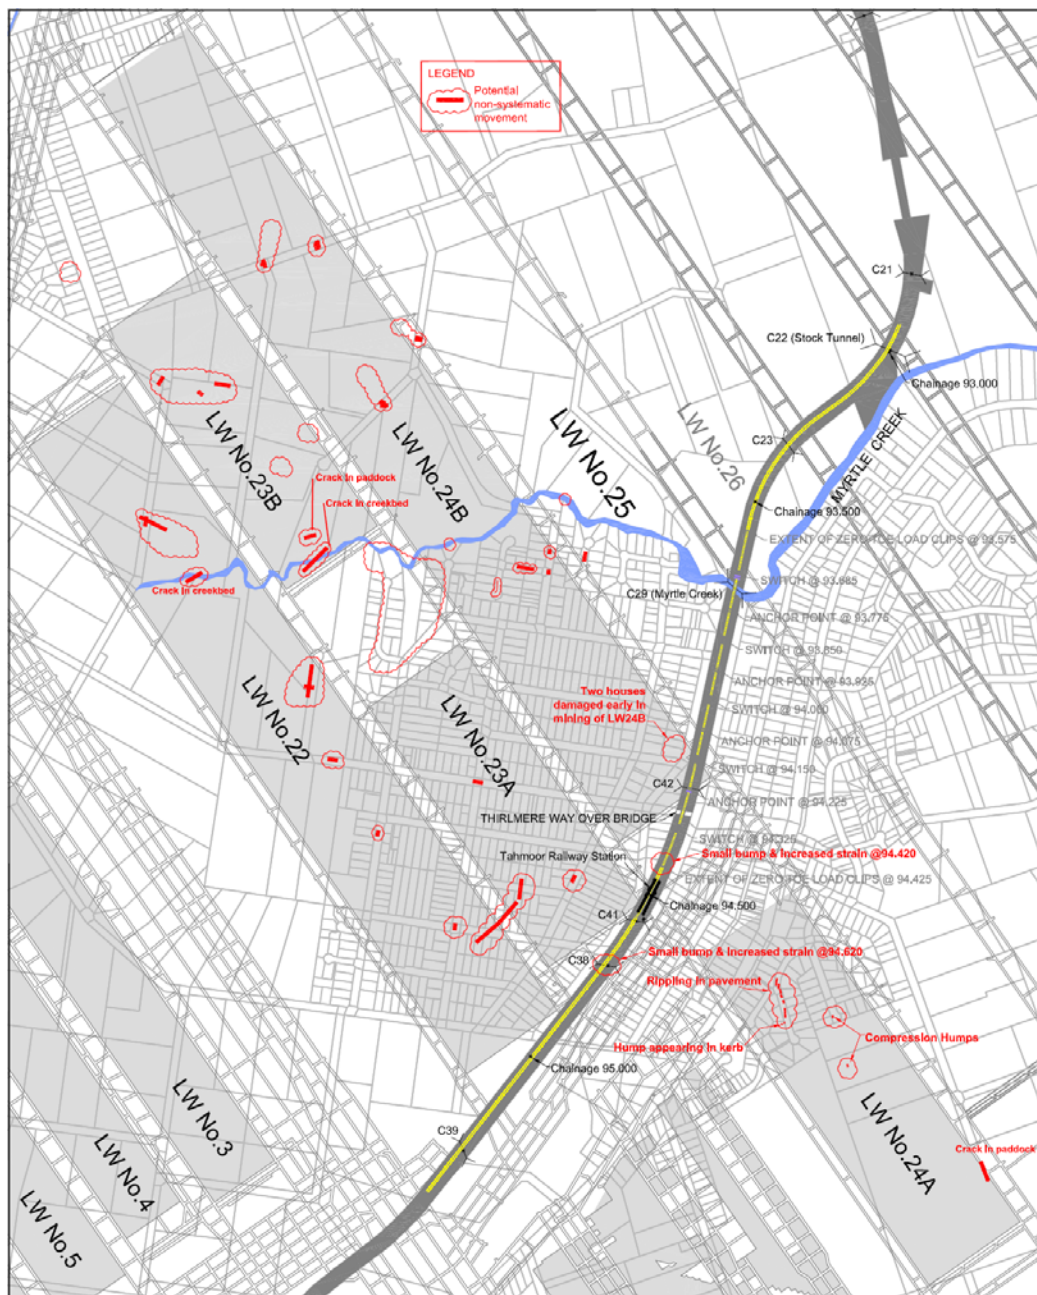
**Figure 2.3 Map of locations of potential non-systematic movement**

A plan showing the locations of potential non-systematic movements observed at Tahmoor is shown in Figure 2.3. The locations were selected based on ground monitoring results or observed impacts that appear to have been caused by non-systematic movement. A total of approximately 30 locations (not including valleys) have been identified over the four extracted Longwalls 22 to 24, of which 3 locations are located above Longwall 24A.

The most severe non-systematic movement observed during the mining of Longwall 24A occurred along Lintina Street. The road pavement experienced severe cracking. The movements developed gradually over time and the pavement was repaired on a number of occasions as mining progressed. Photographs of the impacts are shown in Figure 4.1.

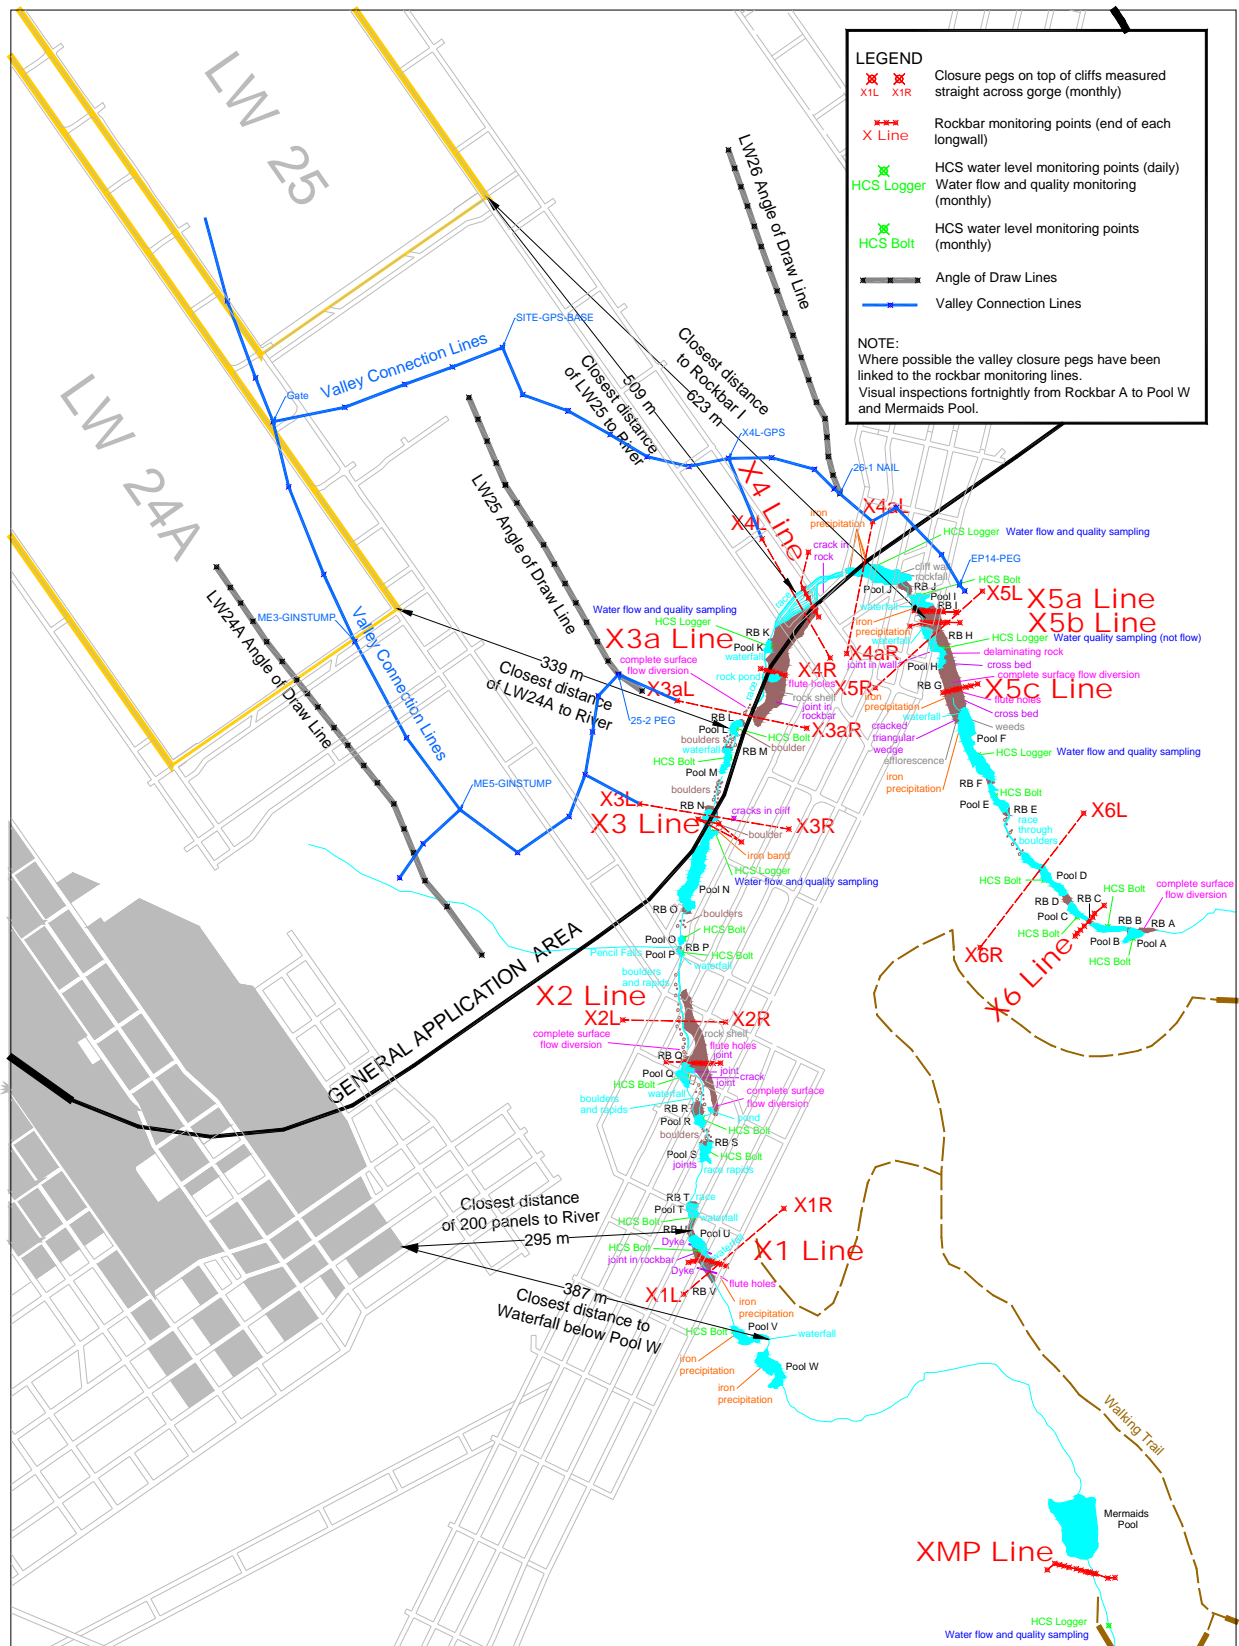
**Figure 2.4 Location of Longwall 24A in relation to the Bargo River**

The observed subsidence is less than 20 mm as predicted. The results indicate that the Gorge may be experiencing a small amount of vertical subsidence of approximately 11 mm or less, based on the more accurate surveys at the tops of the Gorge.

The current observed movements during the mining of Longwall 24A are less than the predicted Longwall 24A maximum incremental upsidence of 20 mm and maximum incremental closure of 50 mm. Given the incised nature of the Gorge and its significant valley height, it was considered possible that actual upsidence and closure movements might exceed predictions but this does not appear to have occurred.

The reason for the lack of valley bulging movement is not known. It is possible that the strata above Longwall 24A had already been stress-relieved by past geological activity. An unusually large amount of vertical subsidence has been observed directly above Longwall 24A. The combination of increased subsidence, tilt and curvature without increased ground strain directly above the goaf suggests that horizontal movements into the goaf have not been substantial, with the predominant direction of ground movement being vertical. The lack of significant differential horizontal movement suggests that mining, therefore, may not have significantly changed the stress environment in the overlying strata in the base of the valley.

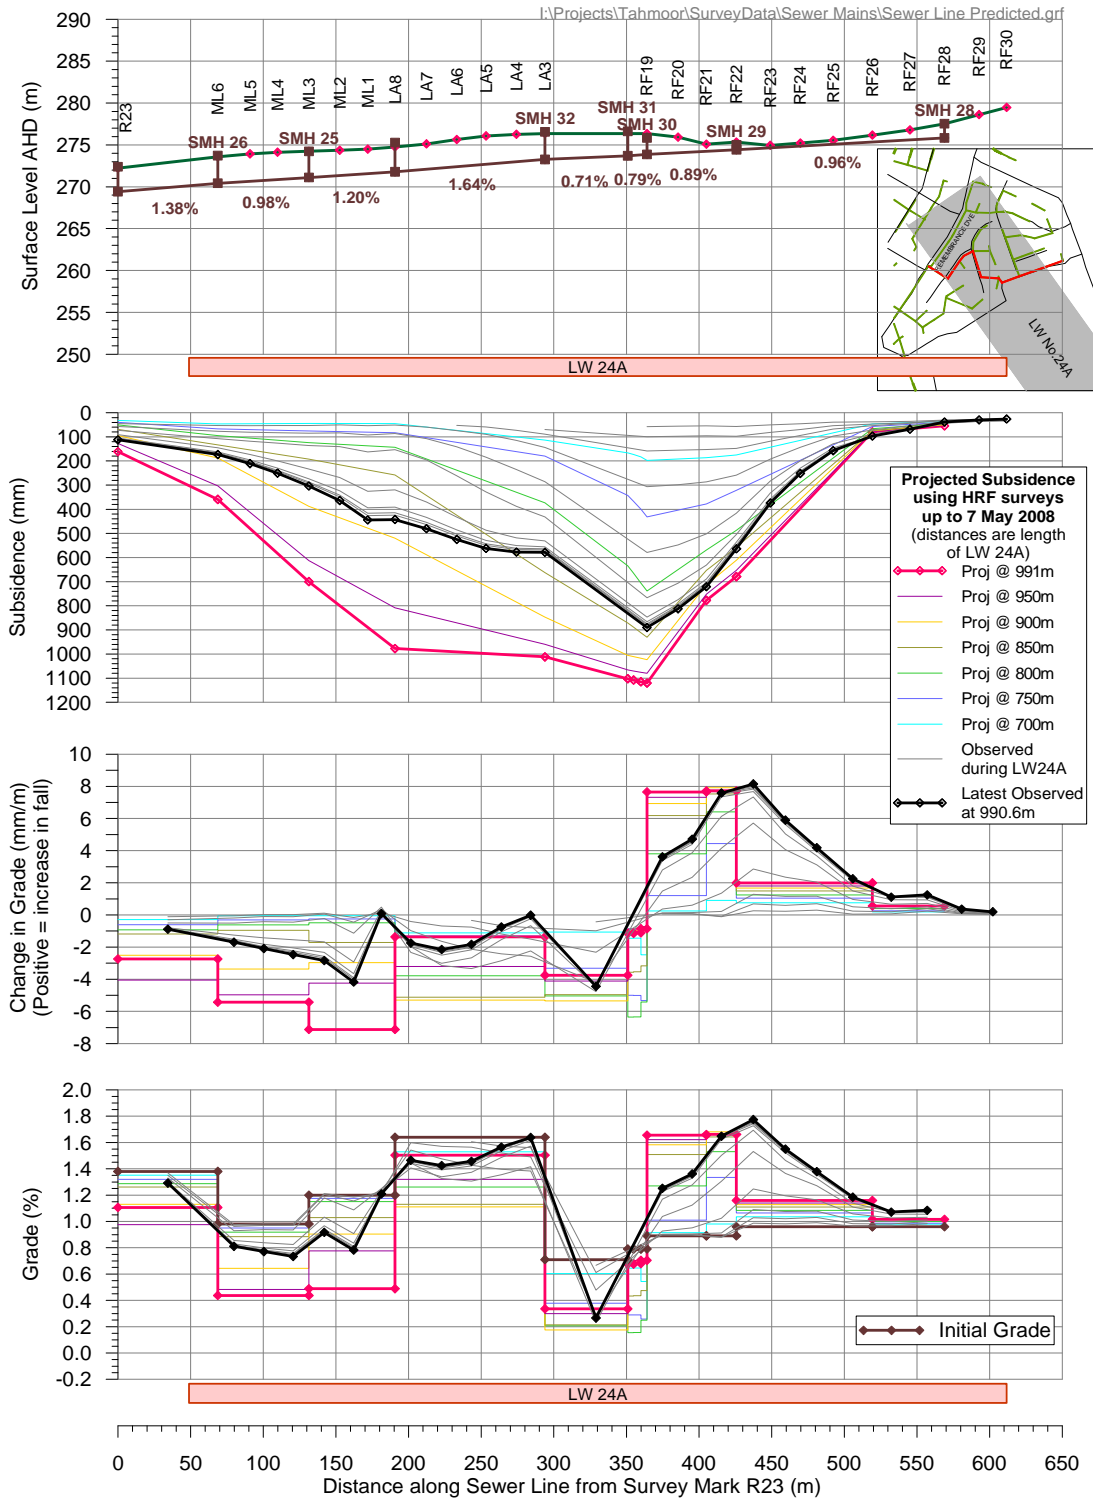
**Figure 2.5 Projected & Observed Subsidence Profiles along selected Sewer Line during LW 24A**

A plot of projected changes in grade and projected grades during and after the mining of Longwall 24A is provided in Figure 2.5. The projected changes in grade are primarily based on observed monitoring results along the High-Rise Freezer Line. The projected values were compared with observations based on subsidence measured at nearby survey marks, which are also shown in Figure 2.5.

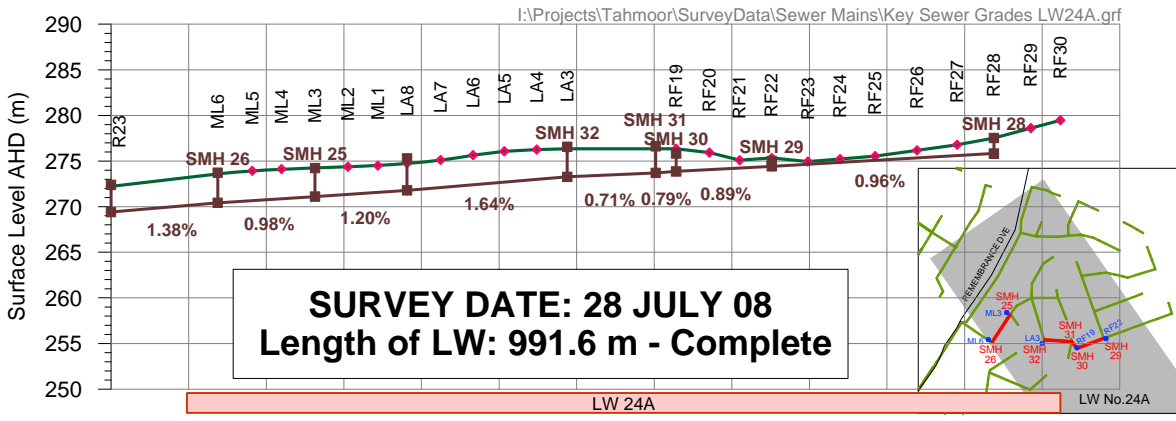
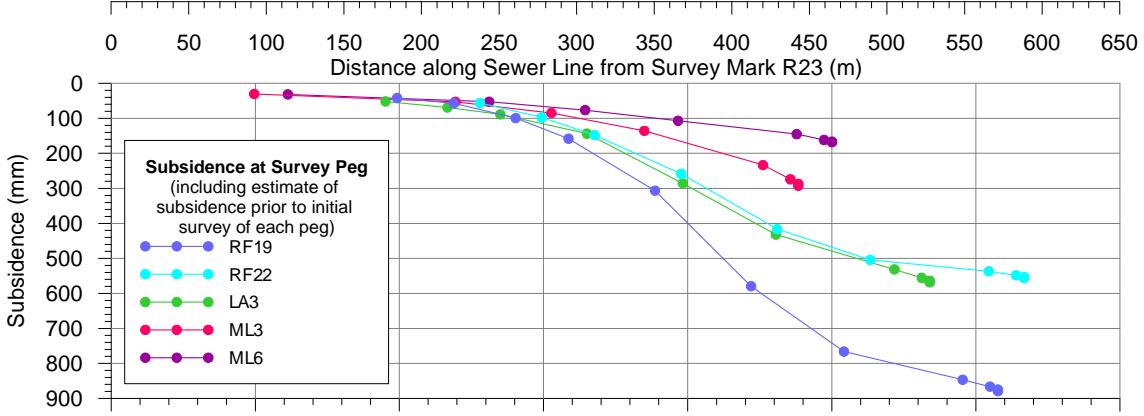
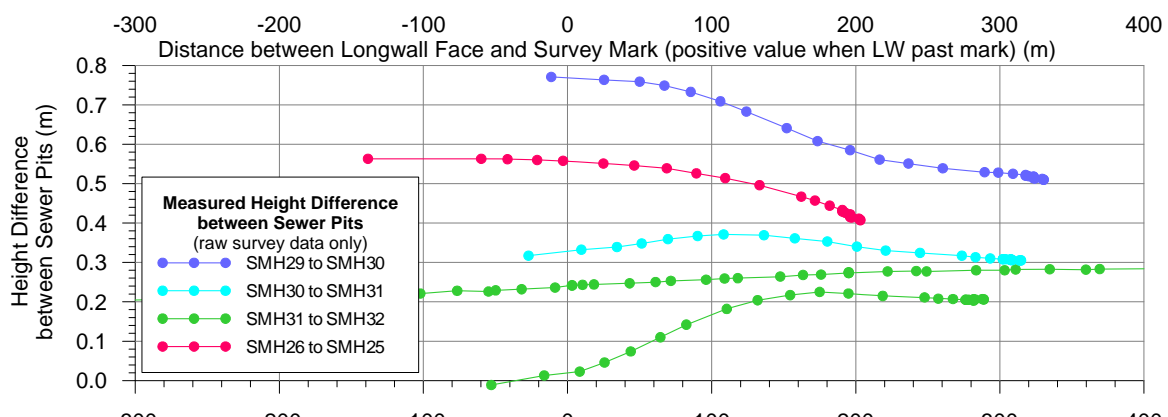
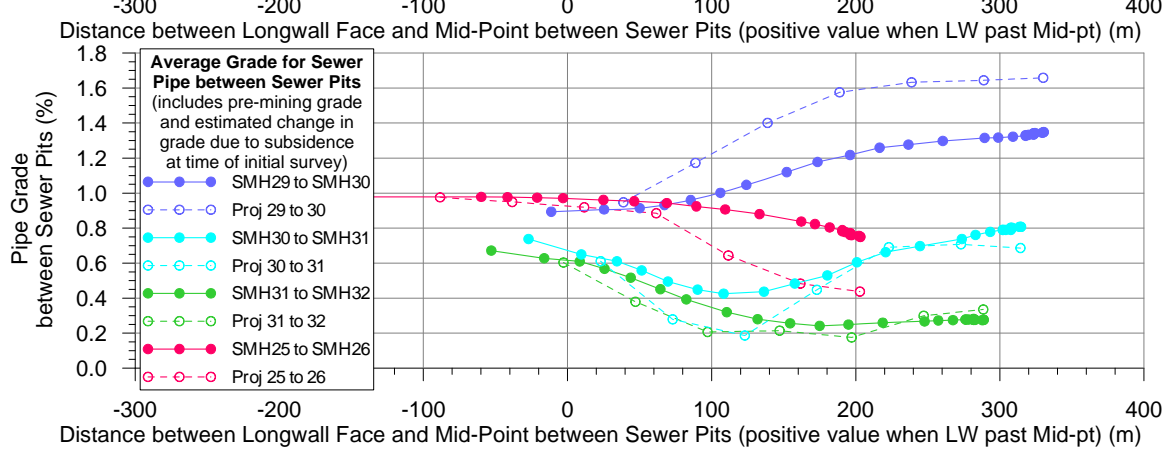
**Figure 2.6 Projected and Observed Changes in Grade between selected Sewer Pits**

It can be seen from Figure 2.6 that changes in sewer grade have occurred and the changes in grade appear to be less than the grades that have been projected to develop based on observed monitoring results along the High-Rise Freezer Line.

It can be seen that the pipes between SMH30 and SMH31, and SMH31 to SMH32 had initially reduced as the longwall passed directly beneath it, but the grade has gradually improved as the longwall progressed away from the pipe. The pipe section is located near the centre of the longwall and is oriented almost parallel to the longitudinal direction of the longwall. The observed grades were expected as the pipe section was largely influenced by travelling tilts as the subsidence wave approached and passed the pipes. All grades remained positive and self-cleansing.

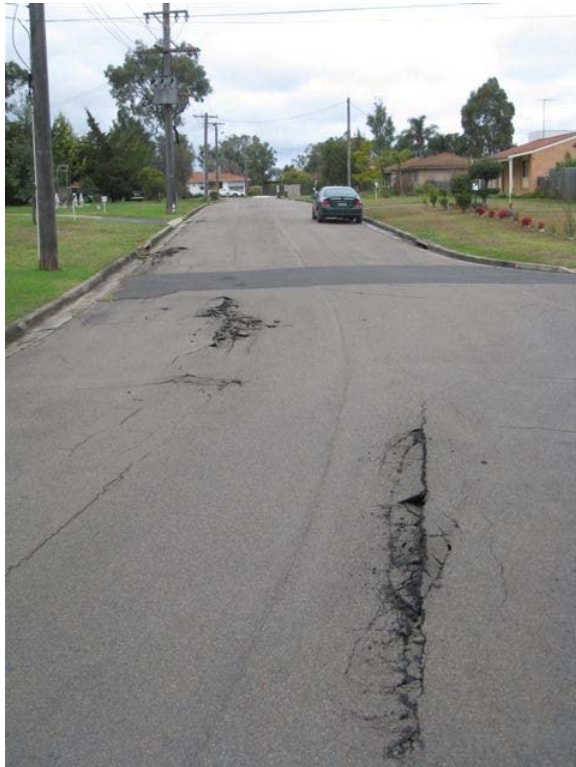
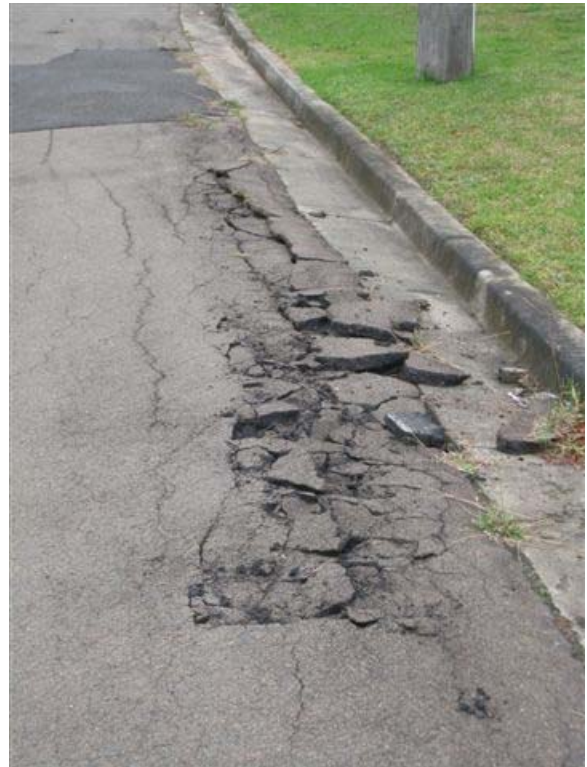
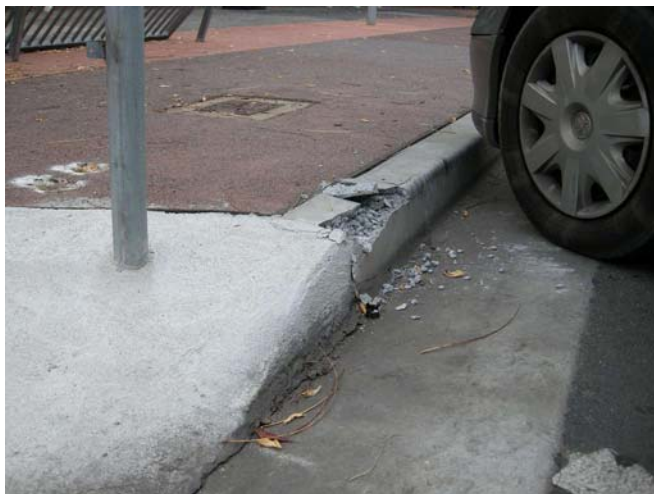
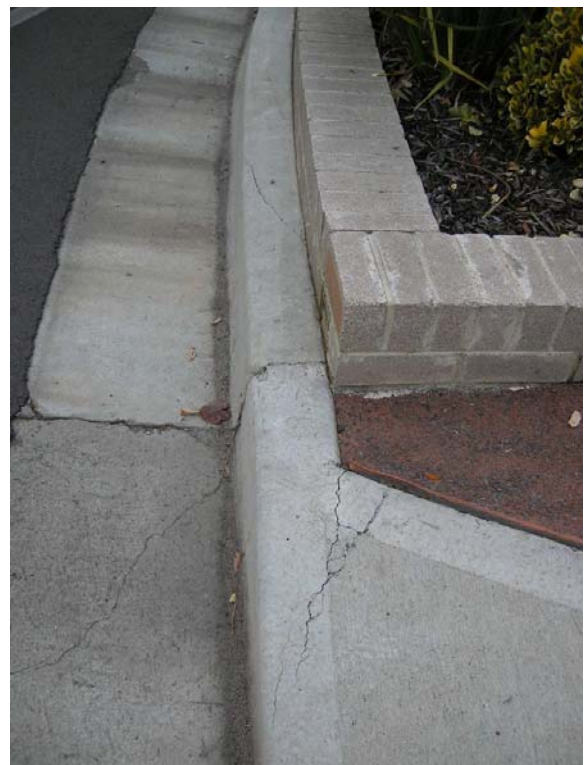
**Figure 4.1 Photographs of impacts to road pavements and kerbs during Longwall 24A**

During the mining of Longwall 24A one of the triggers associated with the *Tahmoor Colliery Longwalls 24 to 26, Wollondilly Shire Council Roads, Bridges and Culverts, Surface Safety Serviceability and Management Plan (Rev B)* was exceeded. The trigger exceeded was impacts to road pavements. The impacts have been recorded by the MSB and will be repaired. Temporary repairs have been conducted along Lintina Street.

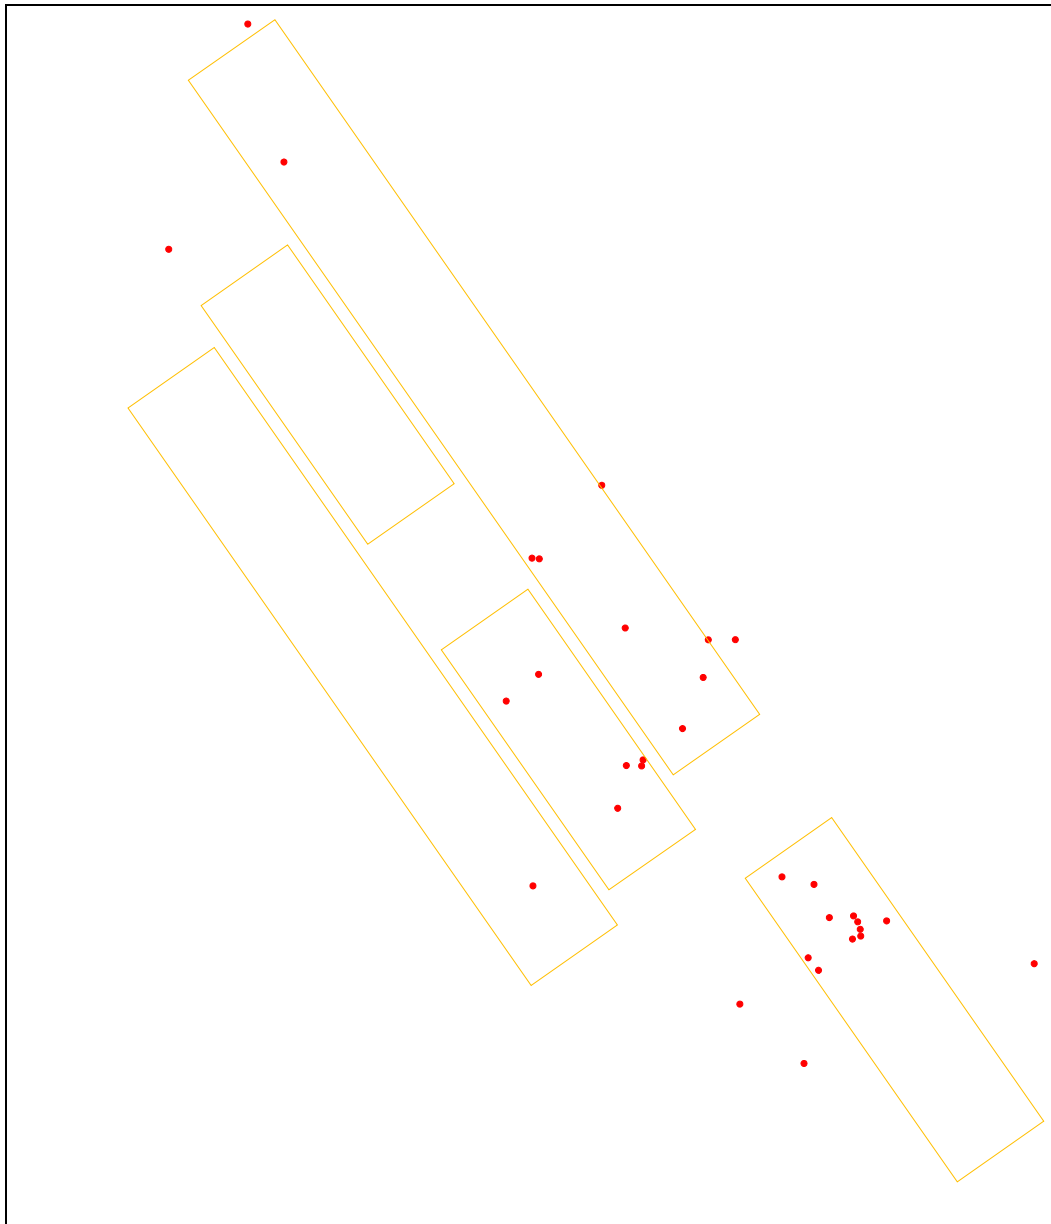
**Figure 4.2 Locations of Impacts during the mining of Longwall 24A**

This is illustrated by a spatial plot of locations of impacts reported during the mining of Longwall 24A in Figure 4.2. A total of 18 of 32 claims related to the mining of Longwalls 22 to 24B, rather than the active Longwall 24A.
