**XSTRATA COAL – TAHMOOR COLLIERY
END OF LONGWALL 24A
SURFACE WATER, DAMS & GROUNDWATER
MONITORING REPORT
Tahmoor, NSW**

TA8-R2
16 JANUARY 2009

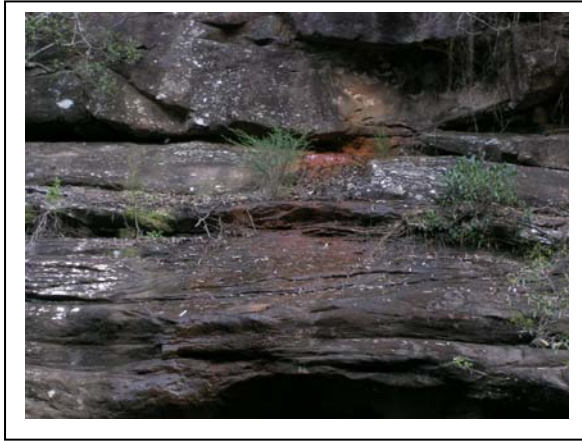
PHOTOGRAPH 1 POOL F Seep

Five pools within the study area were observed to contain small ferruginous seeps as

Mixing zones within the river pools are also very limited to being less than 1m from the source discharge point, with discolouration of the river bank at the outflow point, although no discolouration or “plumes” within the main river or its substrate have been observed to date.

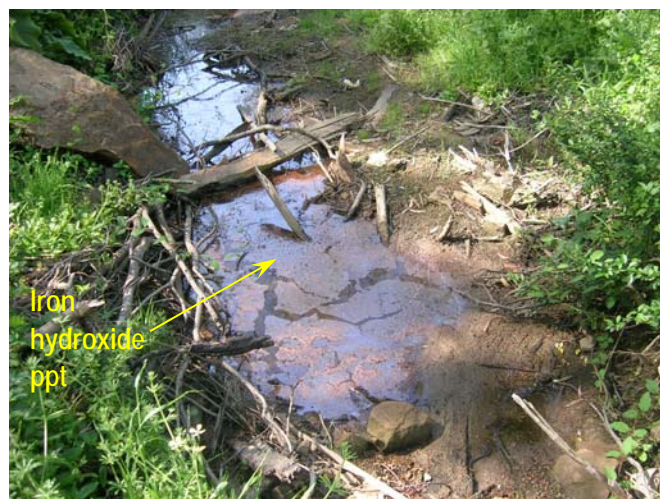
A section of Redbank Creek near Windeyer Street often shows a red iron hydroxide precipitate floating on the stream surface (**Photograph 8**) after heavier rain periods in the vicinity of a leaking sewer pipe that crosses under the creek and is leaking into the stream. The iron hydroxide precipitate can also be observed in the creek bed upstream of the sewer pipe following heavier rain events where leaking house sewer lines overflow into the stream.

PHOTOGRAPH 8 Windeyer Street (Redbank Ck) Iron Hydroxide Precipitate

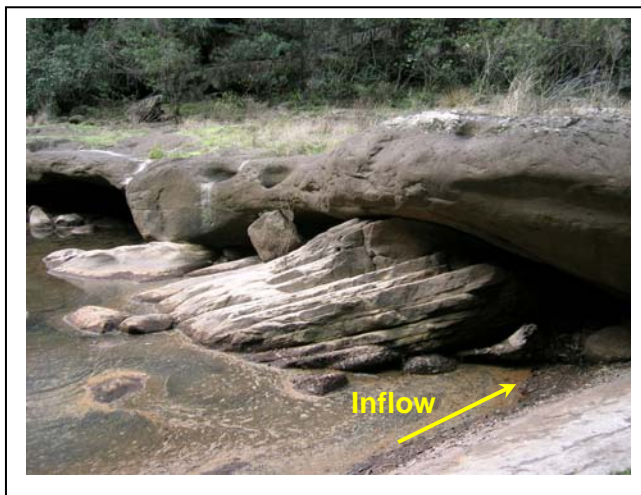
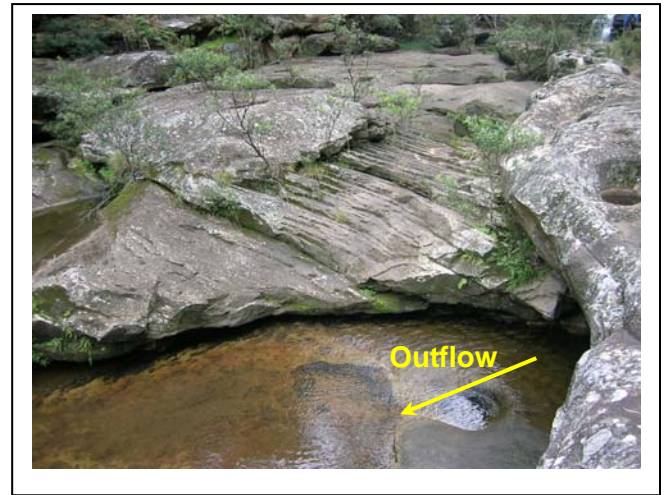
No overland flow has been observed over Rock Bar G during the monitoring period, however it is likely to have occurred during flood events when gauging access to the site was not possible. With current data, at least 16.6ML/day of flow is required for Pool H to be full and overflowing, with a cease to flow rate at around ?ML/day (HCS????).

It should be noted that no fresh cracking was observed in the base of the Bargo River gorge prior to extraction of Panel 24A, and no new cracks have been observed since Panel 24A was completed.

In addition, no visual change in change in stream flow diversions has been observed since extraction of Panel 24A was completed.

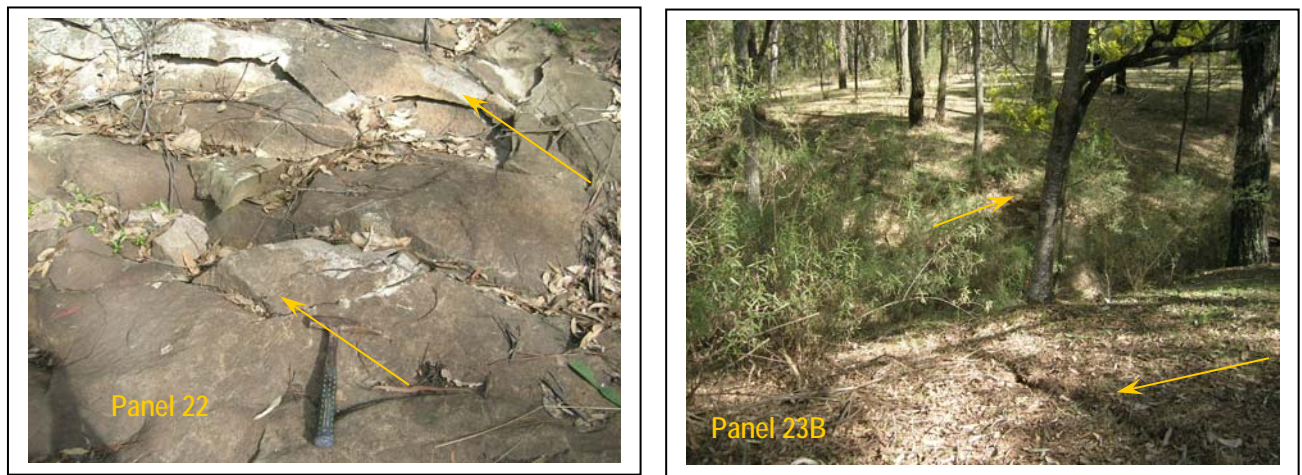
PHOTOGRAPH 10 Myrtle Creek Cracks

Up to 10mm wide bedrock cracking was observed, although was limited to the base of the creek within a small rock bar over Panel 22, whilst the soil cracking occurred at the southern end of Panel 23B, close to the barrier pillar between Panels 23A and 23B.

The soil cracking was up to 65mm wide and extended into the soil to approximately 1.5m - 2.0m over an approximate length of 40m, however, the crack did not develop within the bed of Myrtle Creek, even though it was observed on both the upper banks and flank of the creek.

The bedrock crack located over Panel 22 is within a small, restricted sandstone rock bar outcrop and has not observably had an adverse effect on stream flow, and therefore, no rehabilitation of the Panel 22 cracking is proposed.

Even though soil cracking has been noted in Myrtle Creek over Panel 23B, it is not anticipated that the bed or bank stability will be adversely affected as the crack can be easily rehabilitated and revegetated prior to the next main flow event.

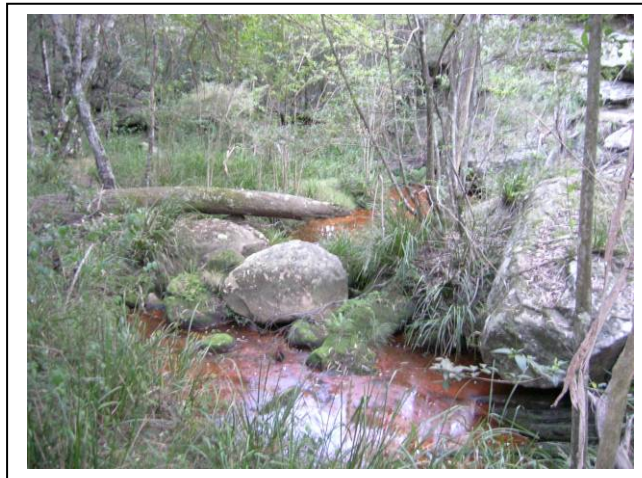
pH range between 4.15 and 7.38, with EC between 163uS/cm and 1950uS/cm, with the creek becoming generally more acidic and saline in the RC2 pond, which also contains high levels of iron from a permanent groundwater seep into the creek as shown in **Photograph 11** and **Table 11**.

PHOTOGRAPH 11 Iron Hydroxide in Redbank Creek (RC2)
