TAHMOOR COLLIERY LONGWALL 24B

**END OF PANEL
SUBSIDENCE MONITORING REPORT
FOR LONGWALL 24B
AT TAHMOOR COLLIERY**

REPORT NO. MSEC272-06

February 2008

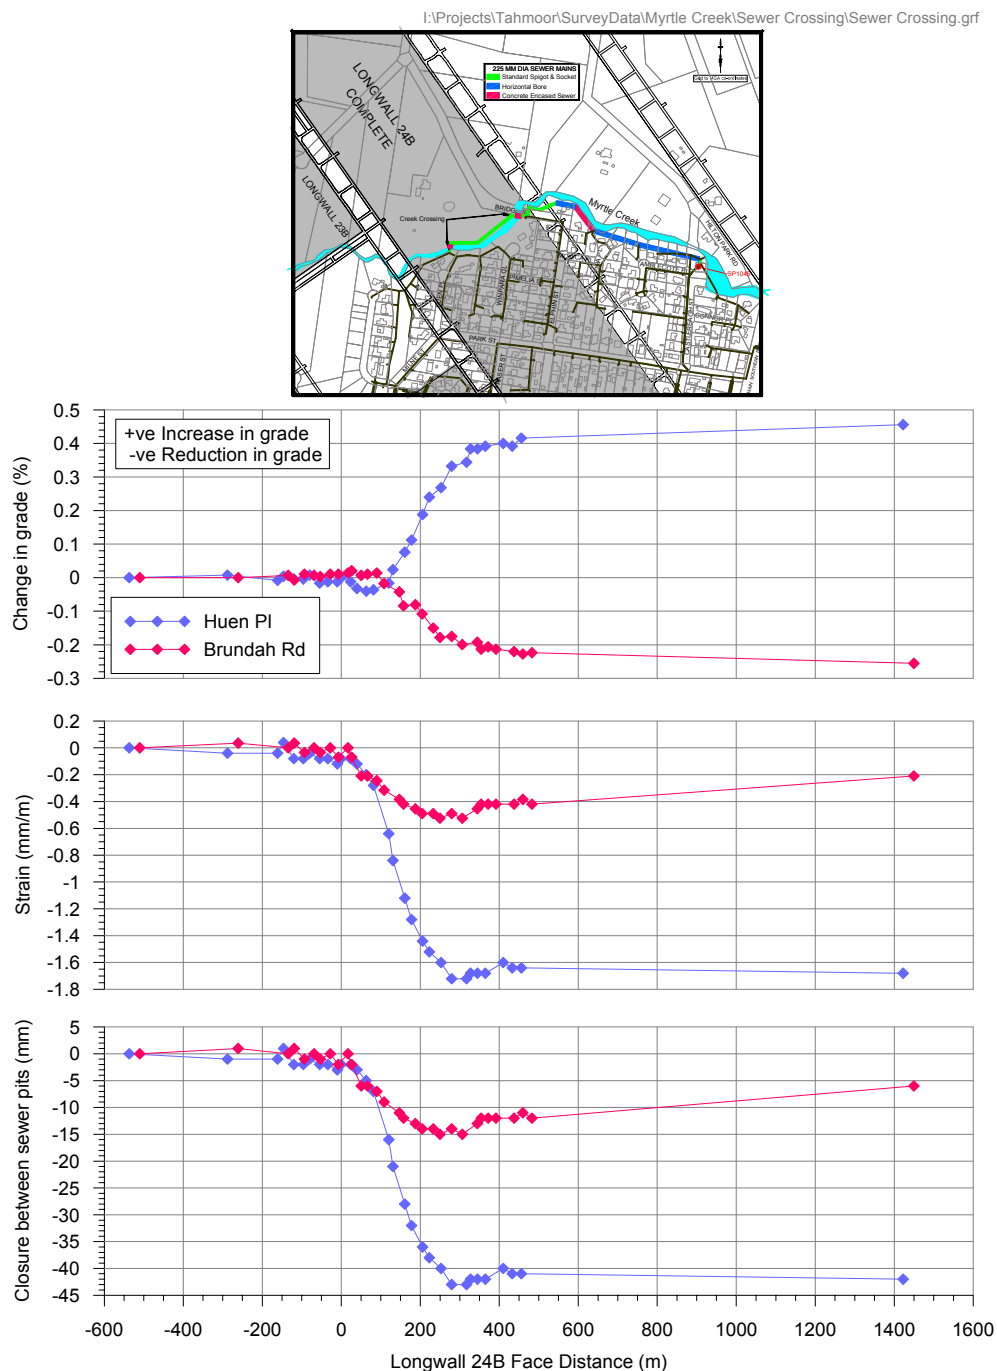
Fig. 2.2 Observed Strain and Closure along Sewer Pipes that cross Myrtle Creek

A total of 28 surveys along two sewer pipes that cross Myrtle Creek were conducted on a weekly and twice weekly basis in accordance with the agreed management plan with Sydney Water. No impacts were observed to any sewer infrastructure during the mining of Longwall 24B.

In accordance with the management plan, daily visual inspections were conducted once observed closures exceeded 20 mm. A total of 128 visual inspections were made during mining. While no impacts were recorded during mining, the observed amount of closure in the pipes is significant and it is possible that impacts may be experienced during the mining of Longwall 25. It is recommended that Tahmoor Colliery consider implementing measures to prevent this potential impact.

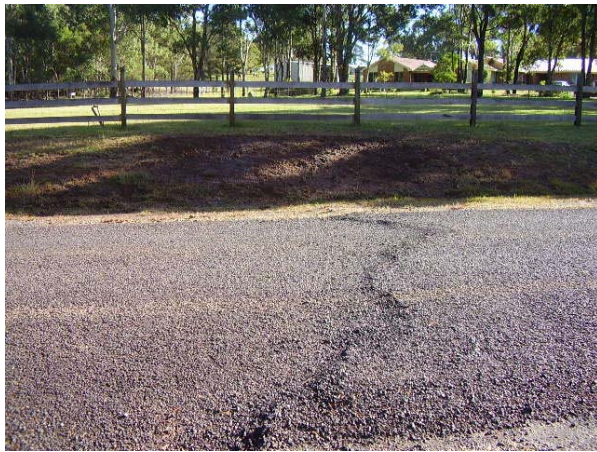
- Four impacts were observed in close proximity on Glenanne Place. Longwalls 22 to 24B have directly mined beneath over 2 kilometres of water main pipework and this is the only site to have experienced impacts. In addition to this, the road pavement cracked and buckled at the same localised location, as did some timber rails on a fence, and minor impacts were experienced in a nearby house. While no ground surveys have been conducted along this street, the nature of the impacts suggest significant anomalous movements. A photograph of impacts to the pavement is shown in Fig. 4.1.

Impact to pavement on Glenanne Place. Repaired fence and water main beneath bare patch in grass beyond. Only water main damage above longwalls to date. (Impact possibly due to anomalous non-systematic movement)

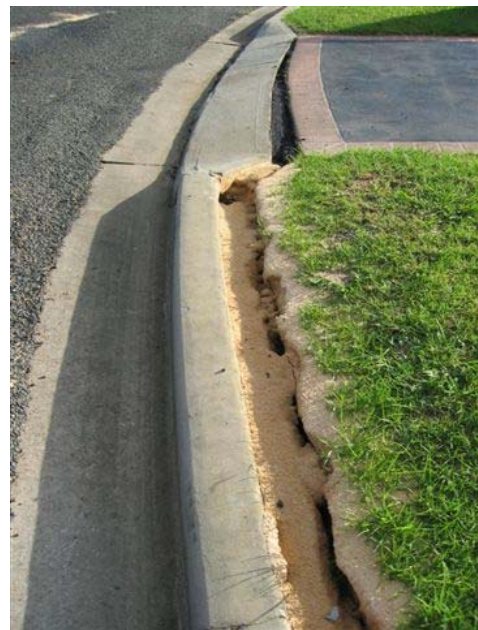
- Non-systematic movement along the Winpara Close monitoring line was first observed following the 900 metre survey. The profiles for Winpara Close show some minor upsidence which has developed slightly since the 1100 metre survey. The movements have results in irregular surface impacts to the pavement and kerb and gutter and a photograph is shown in Fig. 4.1.

Gap formed between behind kerb on Winpara Close. Size of gap not seen above longwalls in other locations (Impact possibly due to anomalous non-systematic movement)

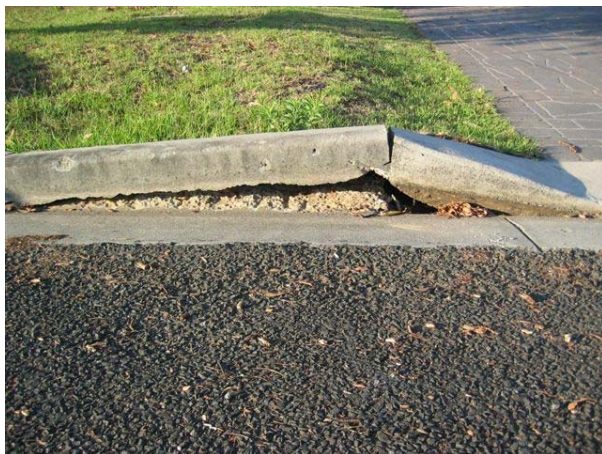
Typical impact to kerb (Patterson Street)

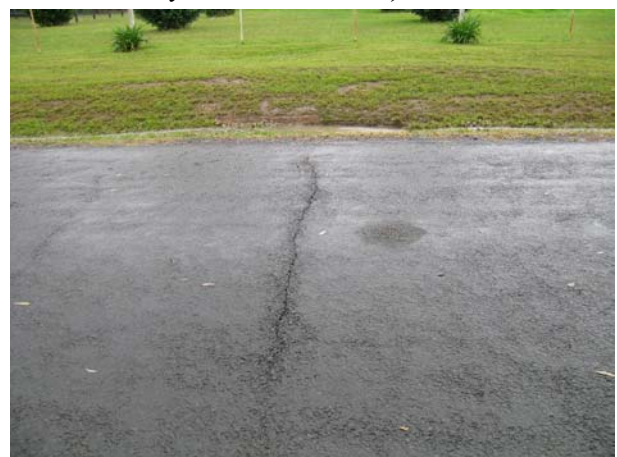
- Anomalous movements have been observed in two locations along Brundah Road. The movements were first apparent following the 1900 metre survey. The movements have resulted in impacts to the road pavement, which are shown in Fig. 4.1. Relative level surveys around a nearby house indicate a lifting of the walls and slab in one corner. The slab feels uneven and slippage has occurred to the damp proof course in this same corner. One sewer pipe has also experienced reverse gradient and had to be re-laid. It is therefore considered that this house has also experienced anomalous non-systematic movements.

Impact to pavement on Brundah Road (Impact possibly due to anomalous non-systematic movement)
