XSTRATA COAL:
Tahmoor Colliery - Longwall 25

End of Panel Subsidence Monitoring Report for Tahmoor Longwall 25

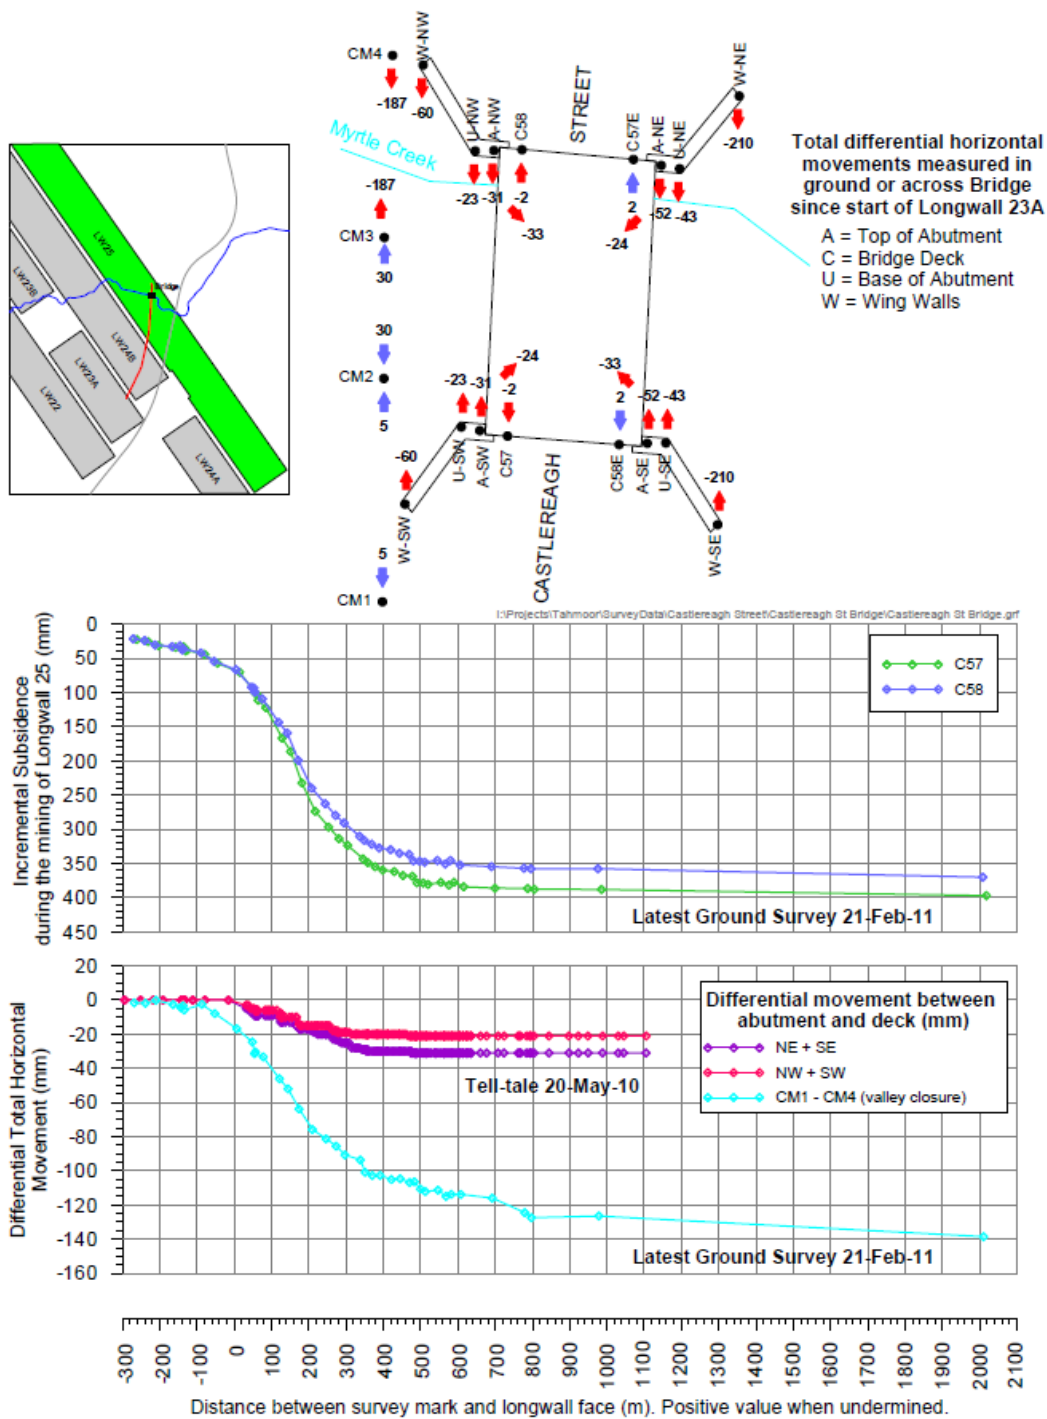
Fig. 2.19 Observed Subsidence and Horizontal Movement at Castlereagh Street Bridge

The survey results for Castlereagh Street Bridge show that while the creek sides have closed considerably, the bridge has closed significantly less with the exception of the end of the south-eastern wing wall, as shown in Fig. 2.19. The resistance of the bridge structure to closure has resulted in compressive heaving in the road pavement on the southern side of the bridge and damage to the telecommunications conduit at the north-western abutment. Existing cracks on the southern abutment have been observed to extend slowly during mining, particularly at the interface between the abutment and south-eastern wing wall.

Differential movements between the bridge deck and the abutments have been observed to gradually increase and exceed the BLUE trigger level. The brackets were cut and set back from the southern abutment on Monday, 7 September 2009. Further small movements have been observed since the brackets were removed. There is currently a small air gap between the abutment walls and the bracket supports so that there is no pressure on the brackets, abutments or bridge deck.

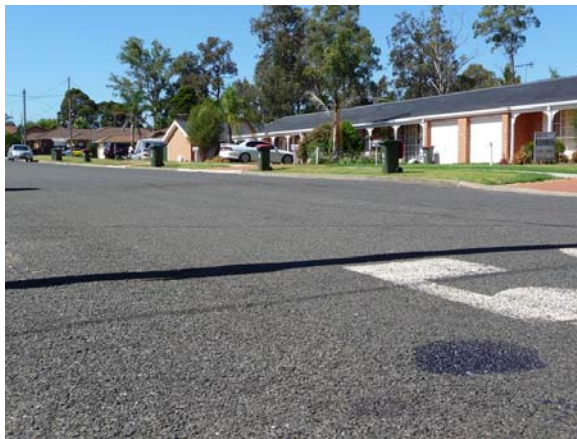
At Abelia Street, a large hump developed in the road pavement and vertical bending was observed in a sewer pipe. These irregular, non-systematic movements extended to Remembrance Drive, where a hump was observed in the roundabout at the intersection with Thirlmere Way. A number of houses and units experienced impacts in this area, two of which were severely impacted. Photographs of the impacts are shown in Fig. 4.1.

The impacts to road pavement and kerbs were generally similar to previous experiences during the mining of Longwalls 22 to 24 in frequency and extent. It is noted, however, that the severity of impacts at Abelia Street (hump in pavement) and at the corner of Remembrance Drive and Thirlmere Way (hump in roundabout) were greater than previously experienced. The impacts have been recorded by the MSB and have been repaired.

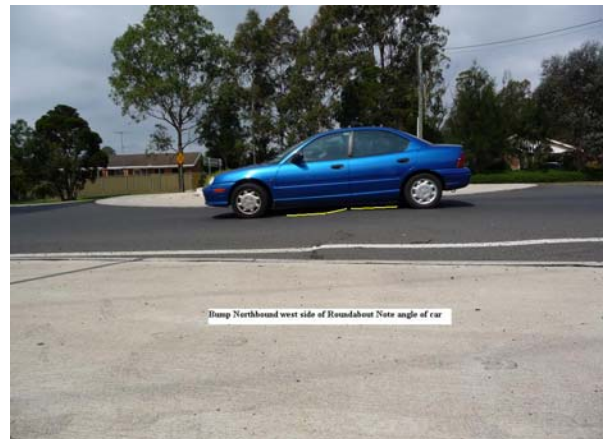
Remembrance Drive

Remembrance Dve (Pegs R1 to RE1)	10	-2.8	1.0	Anomaly	Damage to roundabout, kerbs and pavements. Impacts on sewer pipe Distortion of fences.
Remembrance Dve (Pegs RE4 to RE5)	20	-1.5	1.6	Anomaly	Minor impacts to road pavement and kerbs

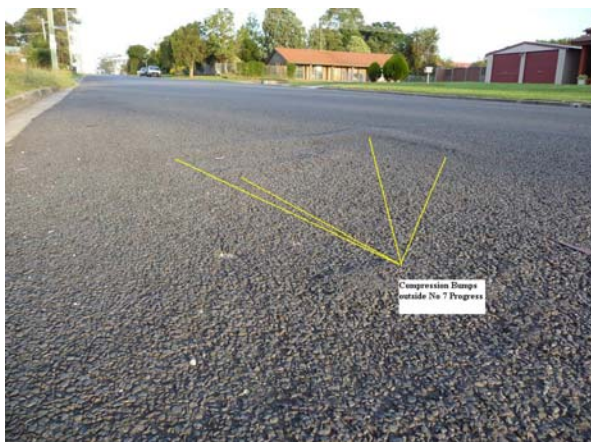
The most severe non-systematic movement observed during the mining of Longwall 25 occurred along Progress Street and Abelia Street. At Progress Street, three houses experienced severe impacts during mining, where the MSB and landowners agreed to rebuild them as the cost of repair exceeded the cost of replacement. Small bumps and cracks were observed in the road pavement.
