GLENCORE:
Tahmoor Colliery - Longwall 27

End of Panel Subsidence Monitoring Report for Tahmoor Longwall 27

This report has been prepared by Mine Subsidence Engineering Consultants (MSEC) for Glencore Tahmoor Colliery to comply with conditions of the SMP Approval set by the NSW Department of Trade and Investment, Regional Infrastructure and Services, Division of Resources and Energy (DTIRIS).

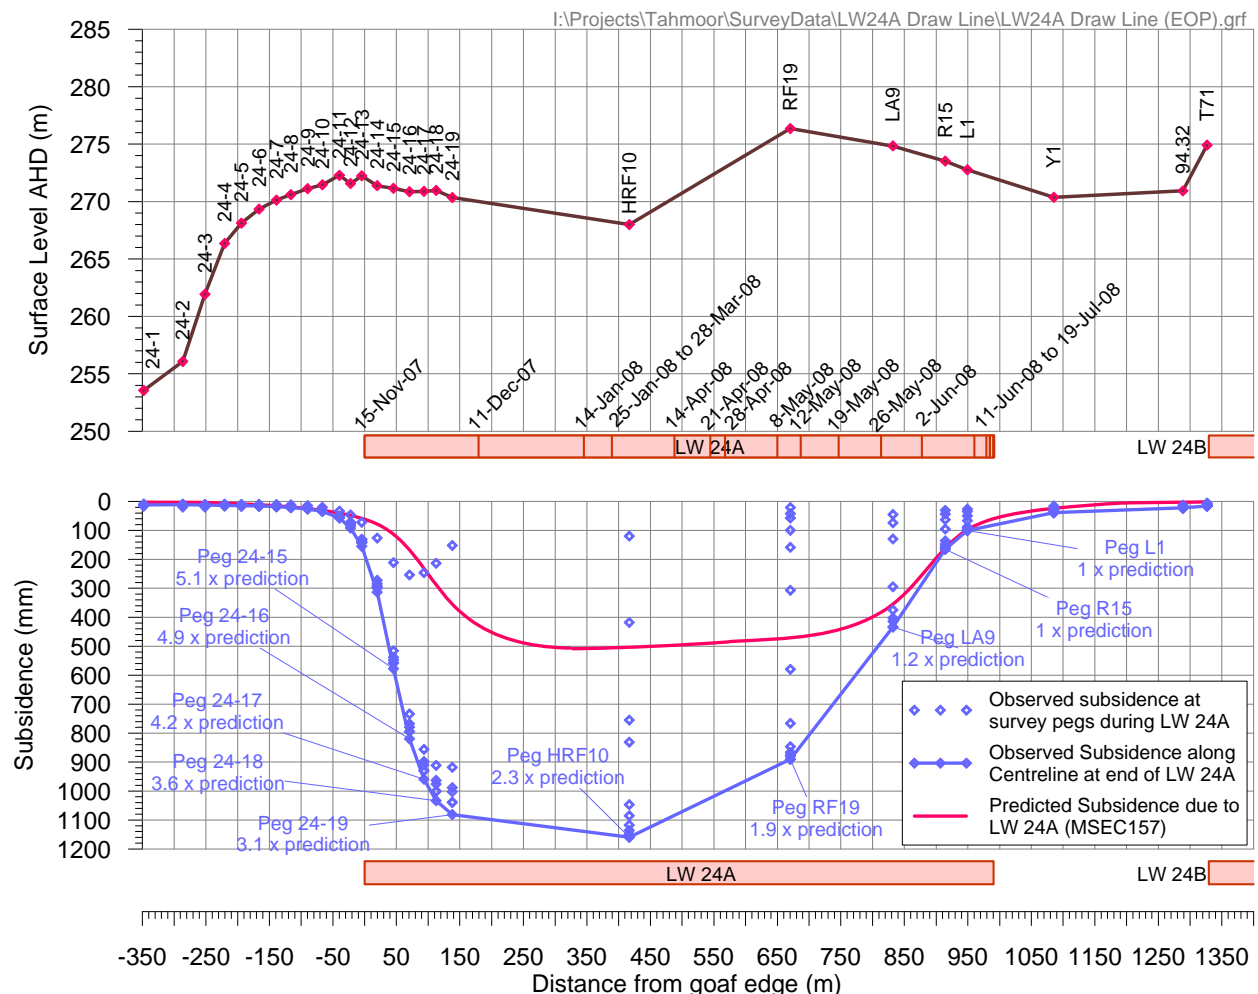
Fig. 2.1 Observed Subsidence along Centreline of Longwall 24A

It can be seen from Fig. 2.1 that observed subsidence was more than twice the predicted maximum value, reaching to a maximum of 1169 mm at Peg HRF10. It is possible that actual maximum subsidence developed somewhere between Pegs HRF10 and RF19, though this was not measured. Observed subsidence was similar to prediction near Peg R15 on Remembrance Drive. Survey pegs RF19 and LA9 are located within a transition zone where subsidence gradually reduced from areas of maximum increased subsidence to areas of normal subsidence.

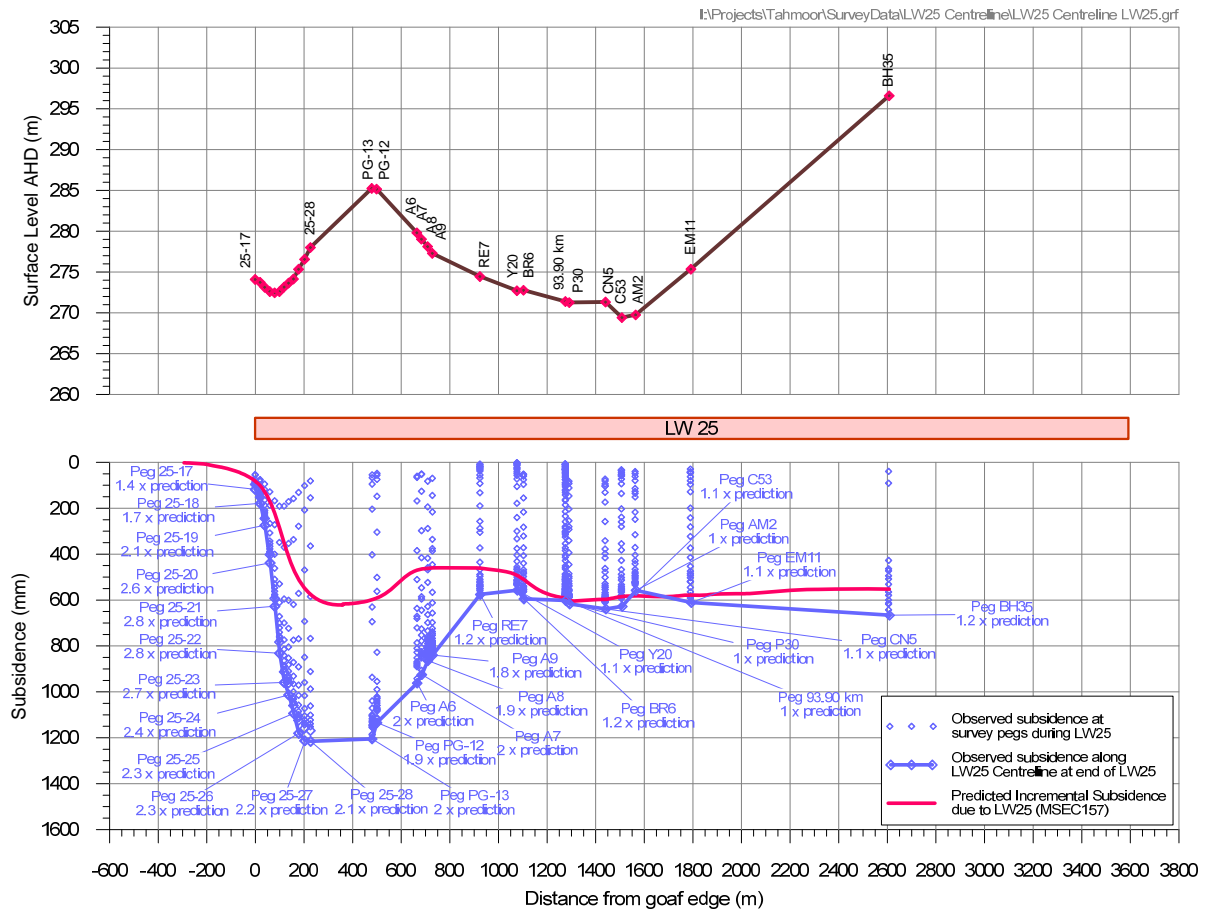
Fig. 2.2 Observed Subsidence along Centreline of Longwall 25

It can be seen from Fig. 2.2 that observed subsidence was approximately twice the predicted maximum value, with maximum subsidence of 1216 mm at Peg 25-28.

Observed subsidence is similar to but slightly more than predicted at Peg RE7 and is similar to prediction at Peg Y20 and at all pegs located further along the panel. Survey pegs A6, A7, A8 and A9 are located within a transition zone where subsidence has gradually reduced from areas of maximum increased subsidence to areas of normal subsidence.

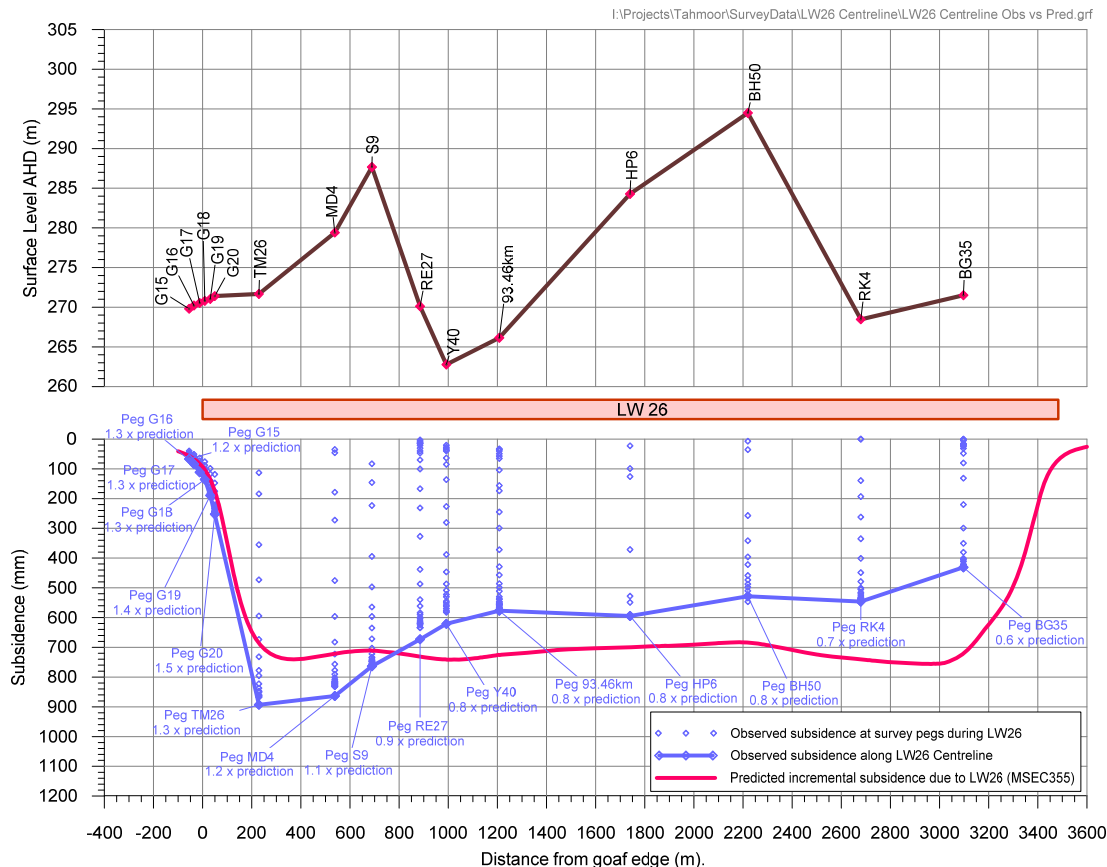
Fig. 2.3 Observed Subsidence along Centreline of Longwall 26

It can be seen from Fig. 2.3 that observed subsidence was approximately 1.3 times the predicted maximum value, with maximum subsidence of 893 mm at Peg TM26.

Observed subsidence reduced along the panel until Peg Y40 on York Street, where it was less than prediction. Survey pegs S9 and RE27 are located within a transition zone where subsidence has gradually reduced from areas of maximum increased subsidence between Pegs TM26 and MD4 to areas of normal subsidence at Peg Y40 and beyond.

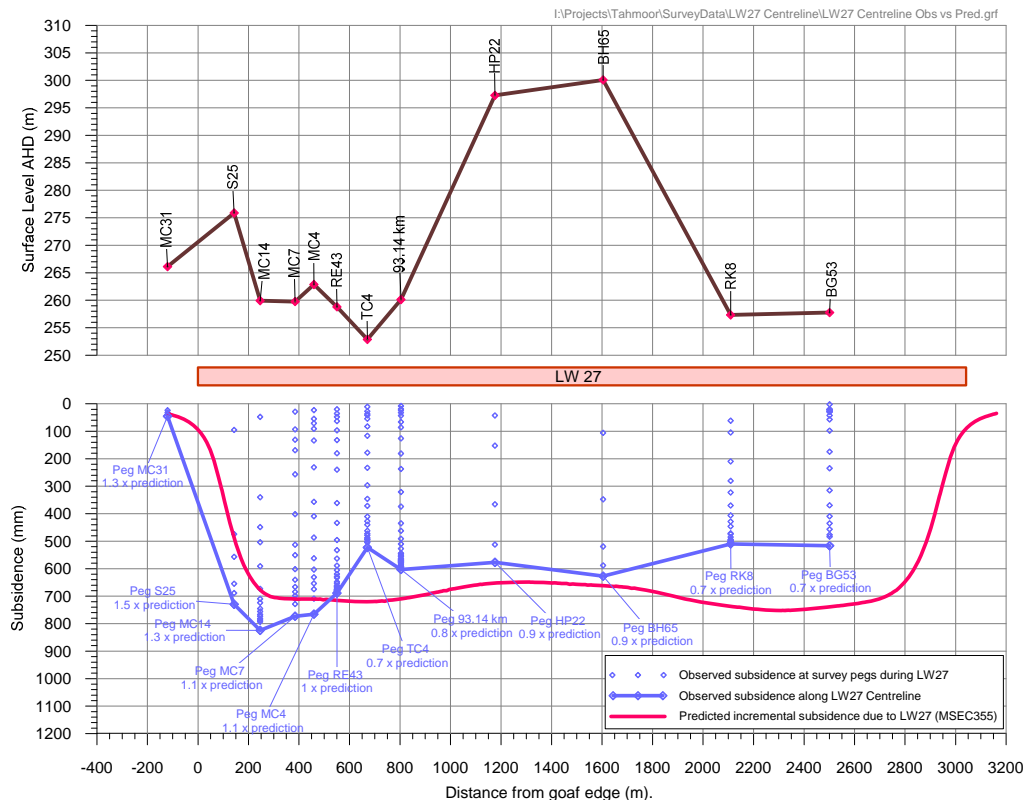
Fig. 2.4 Observed Subsidence along Centreline of Longwall 27

It can be seen from Fig. 2.4 that observed subsidence is approximately 1.3 times the predicted maximum value, with current maximum subsidence of 825 mm at Peg MC14.

Observed subsidence reduced along the panel from Peg MC14 until Peg TC4, which is located between Remembrance Drive and Myrtle Creek. Observed subsidence along the centreline returned to normal levels as mining progressed beyond Peg TC4.

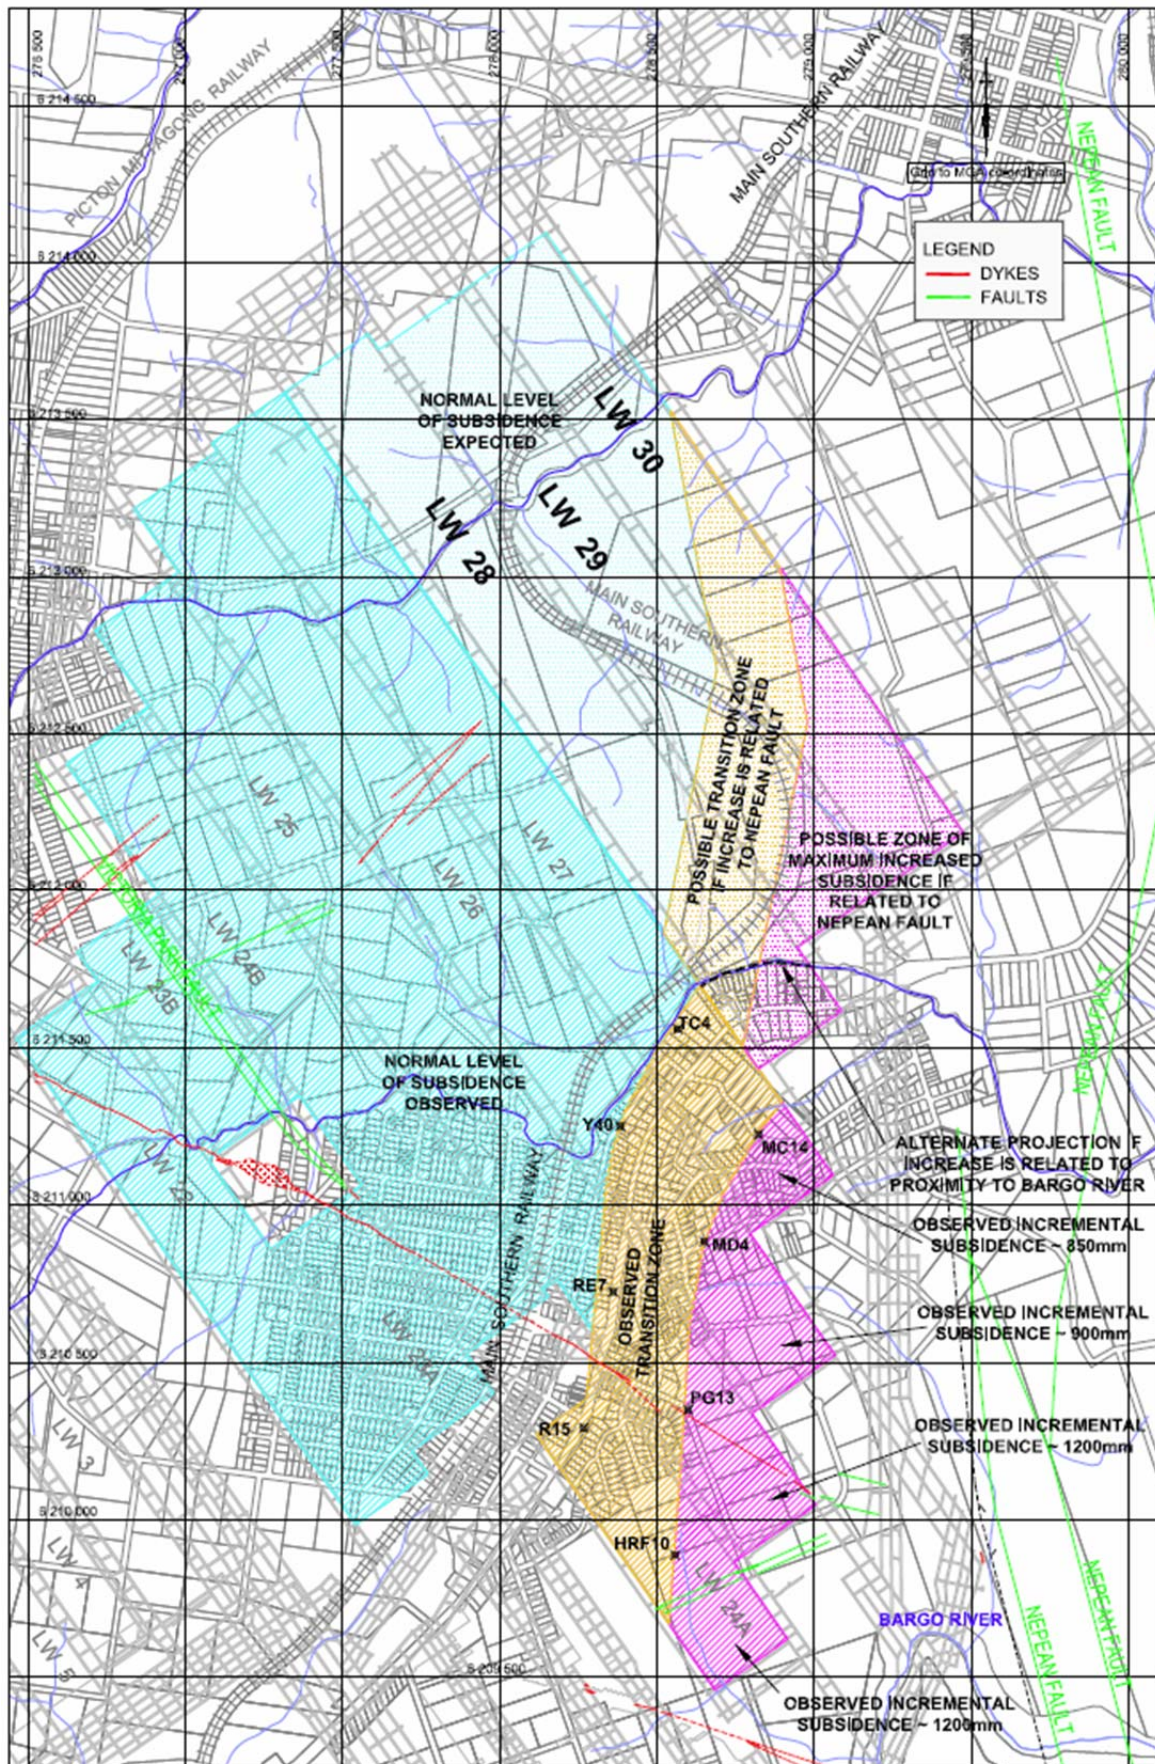
Fig. 2.5 Figure showing zones of increased subsidence over Longwalls 22 to 27

Fig. 2.5 shows that as the alignment of the Nepean Fault moved further away from the Bargo River gorge and above Longwalls 26 and 27, the magnitude of increased subsidence reduced, indicating that the cause of the movements is clearly linked to the proximity of the Bargo River. This observation confirms the findings of Gale and Sheppard (2011) that the increased subsidence is linked to localised weathering of joint and bedding planes above a depressed water table adjacent to the incised gorge of the Bargo River and the presence of the major fault.

As observed maximum subsidence above Longwalls 26 (900 mm) and 27 (850 mm) has reduced compared to observed maximum subsidence above Longwalls 24A and 25 (1200 mm), it is expected that the magnitude of maximum subsidence above the commencing end of Longwall 29 will be less than previously observed and may return close to normal levels of subsidence elsewhere at Tahmoor.

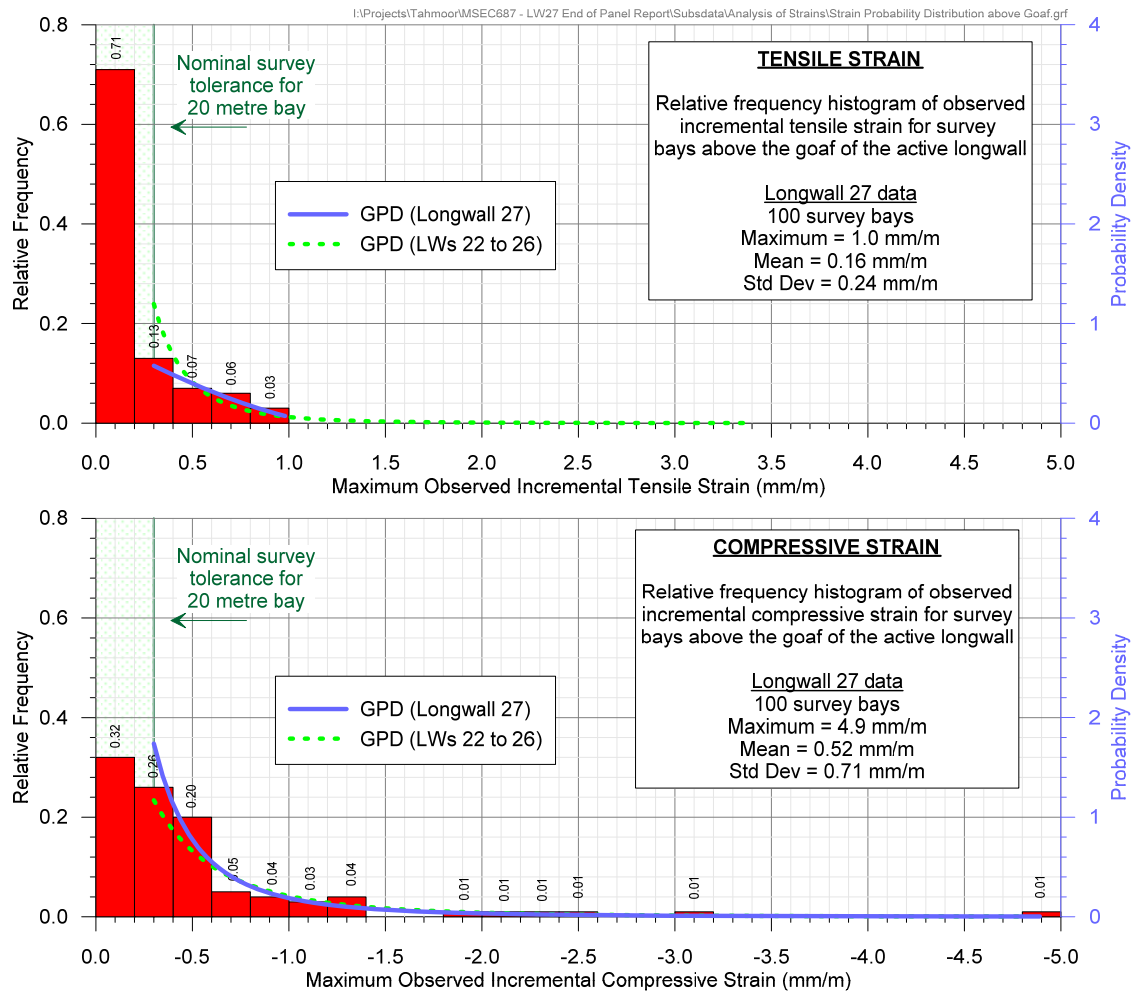
Fig. 2.6 Observed Incremental Strain for Survey Bays above Goaf resulting from the Extraction of Longwall 27

The probability distribution functions for previous monitoring during the mining of Longwalls 22 to 26 are also shown in this figure, as the dashed green lines. It can be seen from these comparisons, that the overall distribution of tensile and compressive strain resulting from the extraction of Longwall 27 was similar in magnitude when compared with those observed during the mining of Longwalls 22 to 26.

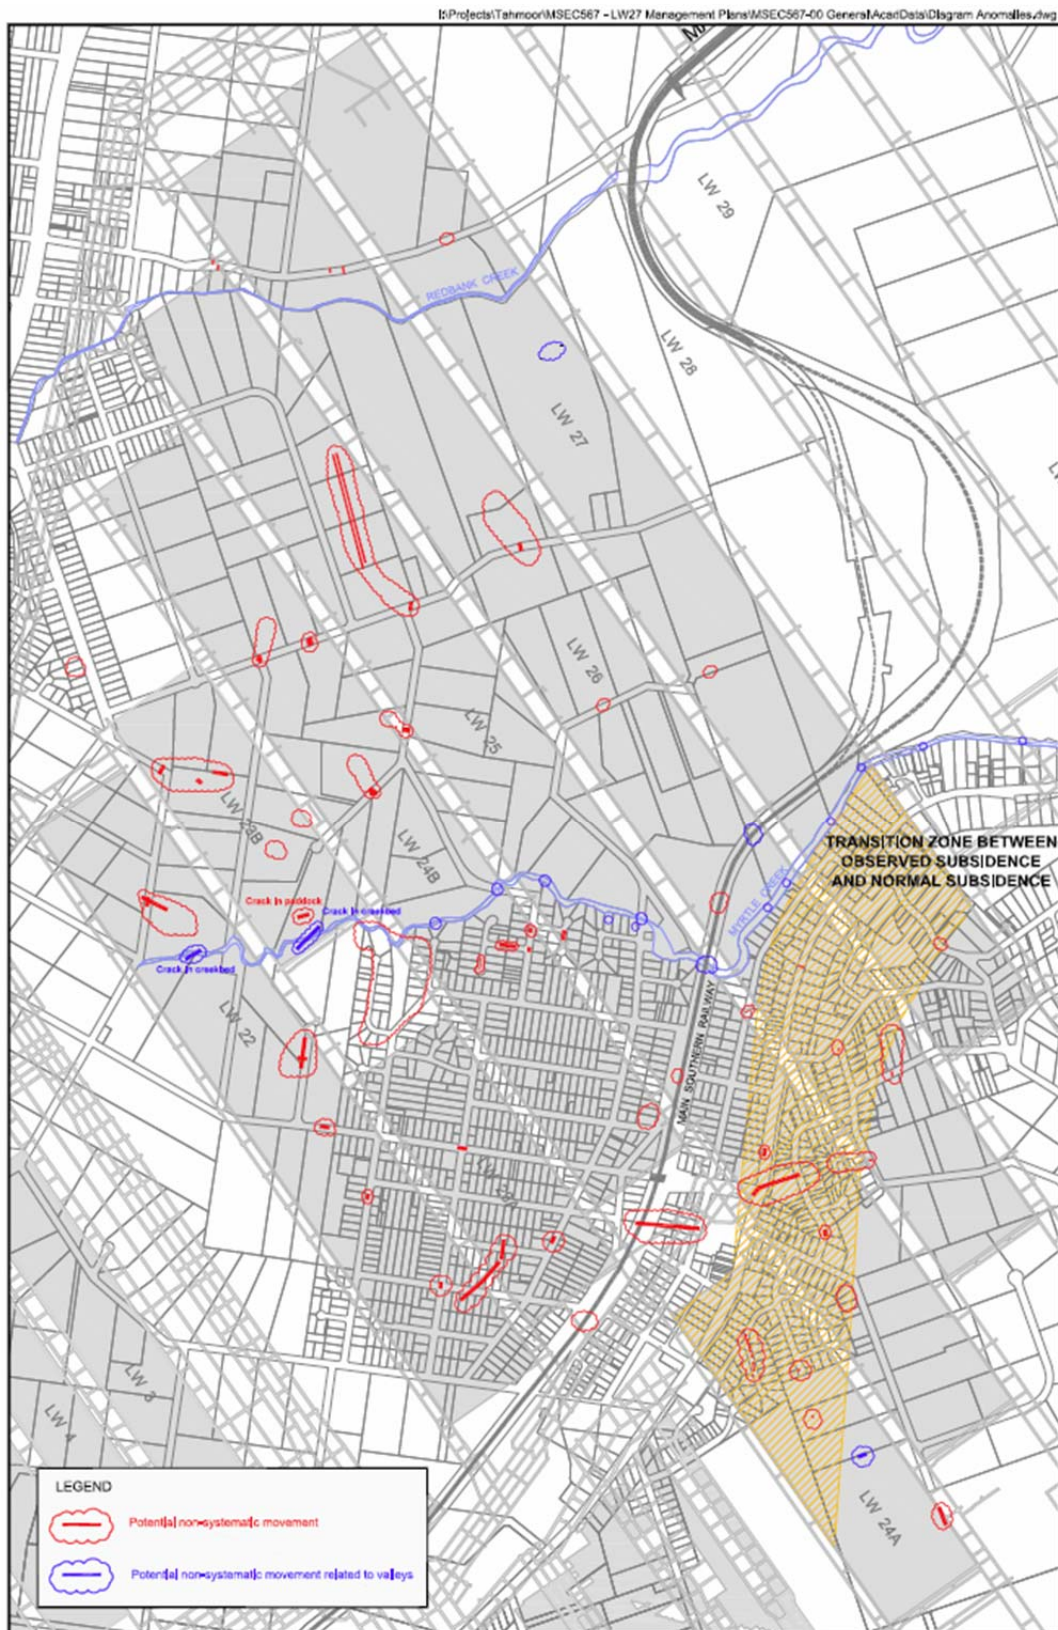
Fig. 2.7 Map of Locations of Potential Non-Systematic Movements

A plan showing the locations of observed non-systematic movements at Tahmoor is shown in Fig. 2.7. The locations were selected based on ground monitoring results or observed impacts that appear to have been caused by non-systematic movement. A total of approximately 50 locations (not including valleys) have been identified over the extracted Longwalls 22 to 27, of which 3 new locations were observed during the mining of Longwall 27.

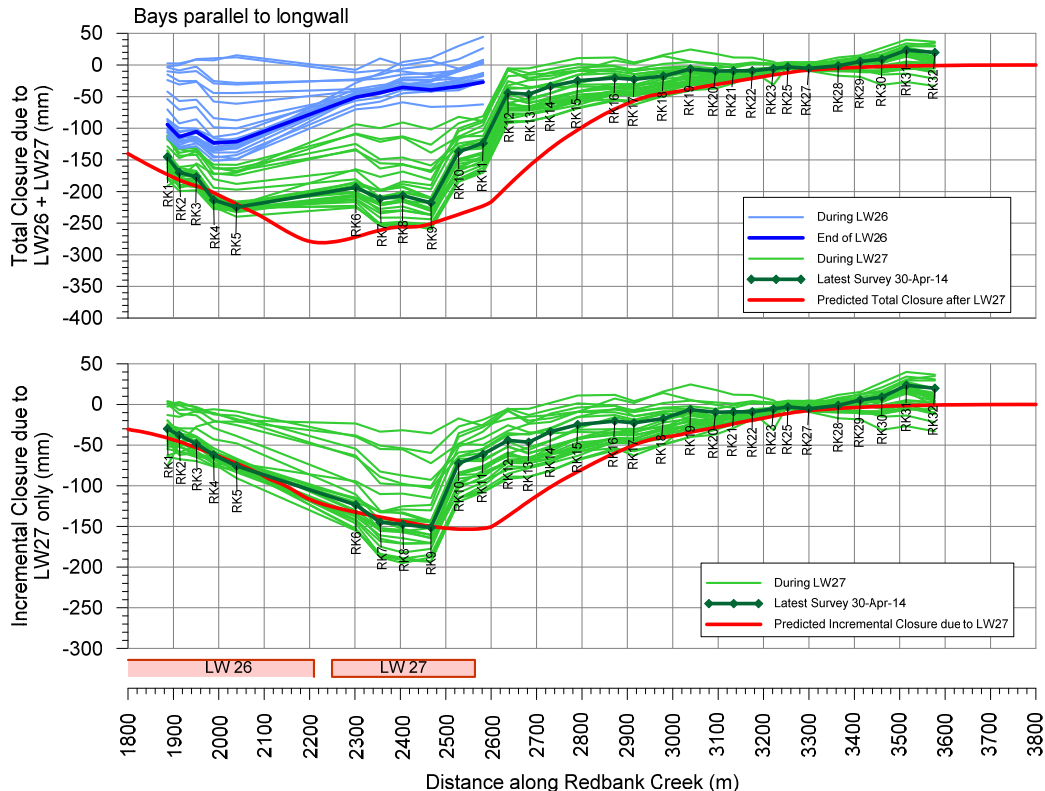
Fig. 2.14 Comparison between observed and predicted valley closure along Redbank Creek

Observed total closure is also less than the predicted total closure of 500 mm due to the mining of Longwalls 22 to 30.

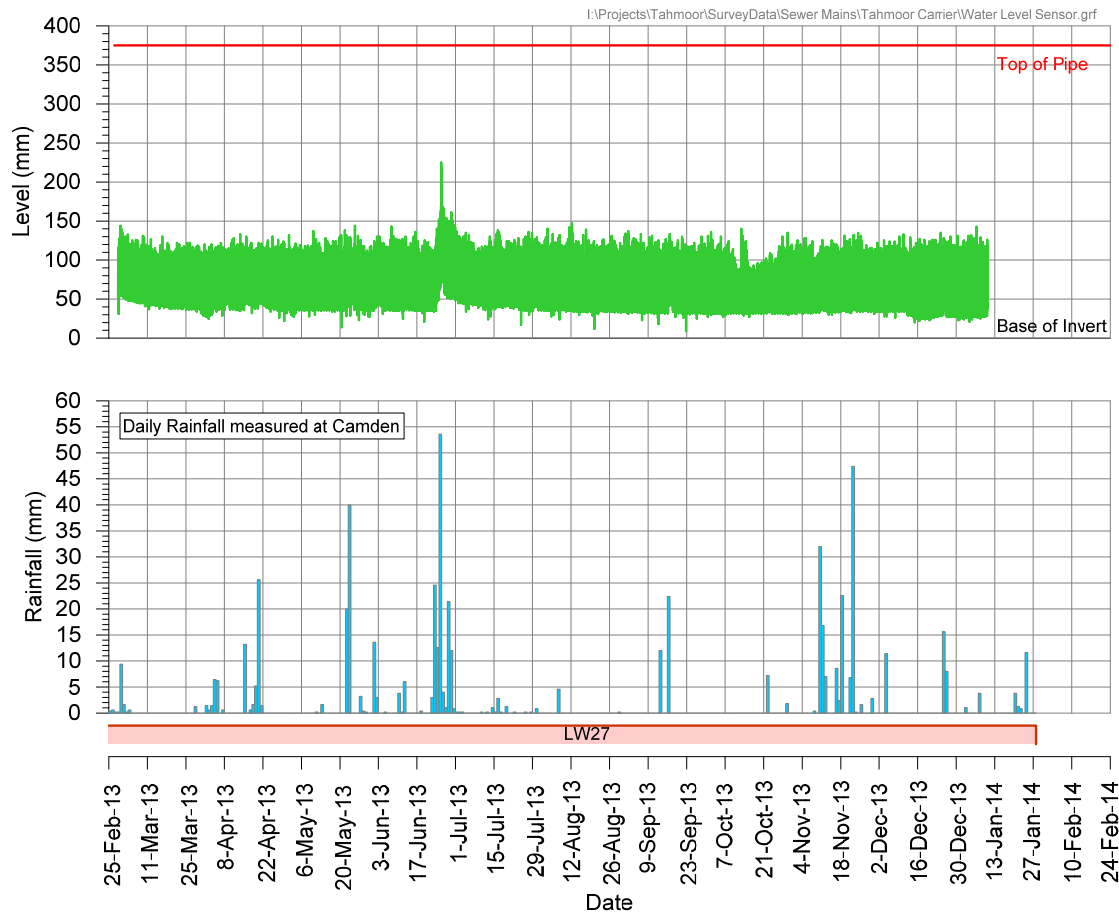
Fig. 2.17 Observed changes in water level in Tahmoor Carrier pipe

A water level sensor was installed in the upstream pit prior to the influence of Longwall 27 and no noticeable changes have been observed, as shown in Fig. 2.17.

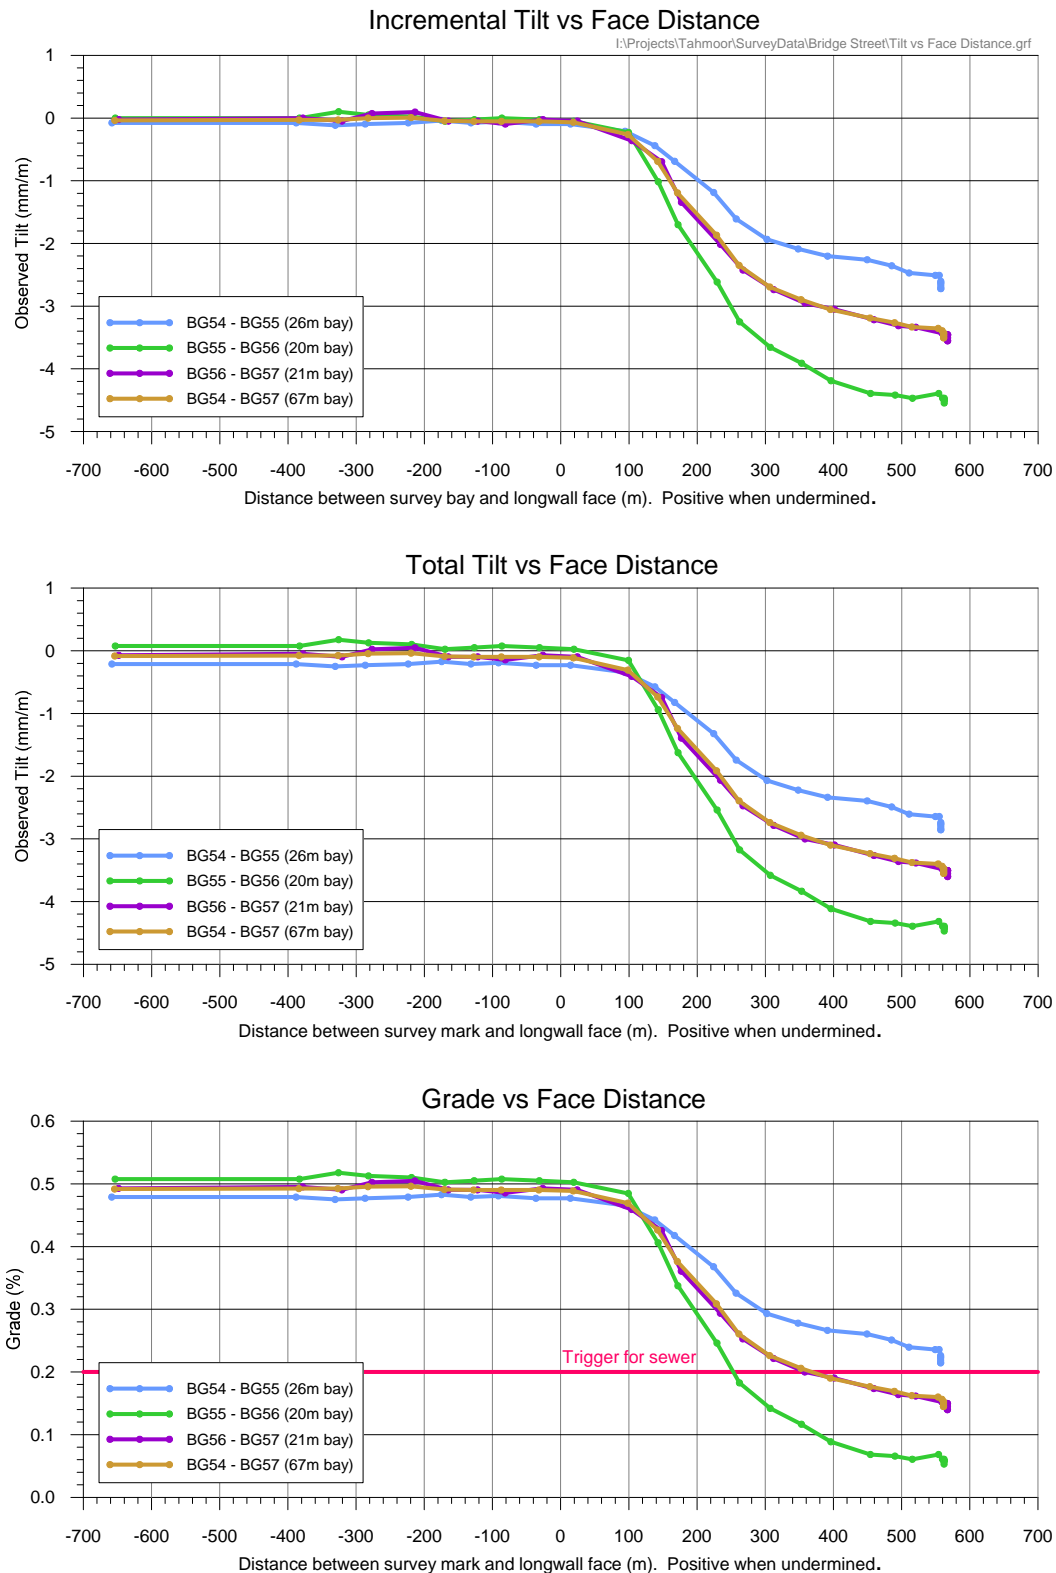
Fig. 2.18 Development of tilt on Bridge Street between pegs BG54 and BG57

Ground surveys have found that the grade for one 20 metre section (Peg BG55 to BG56) has reduced to 0.06%, below the early warning trigger level of 0.2%. When the survey results between Pegs BG54 and BG57 are used to estimate change over the 67 metre section, the average grade is approximately 0.15% from pit to pit.

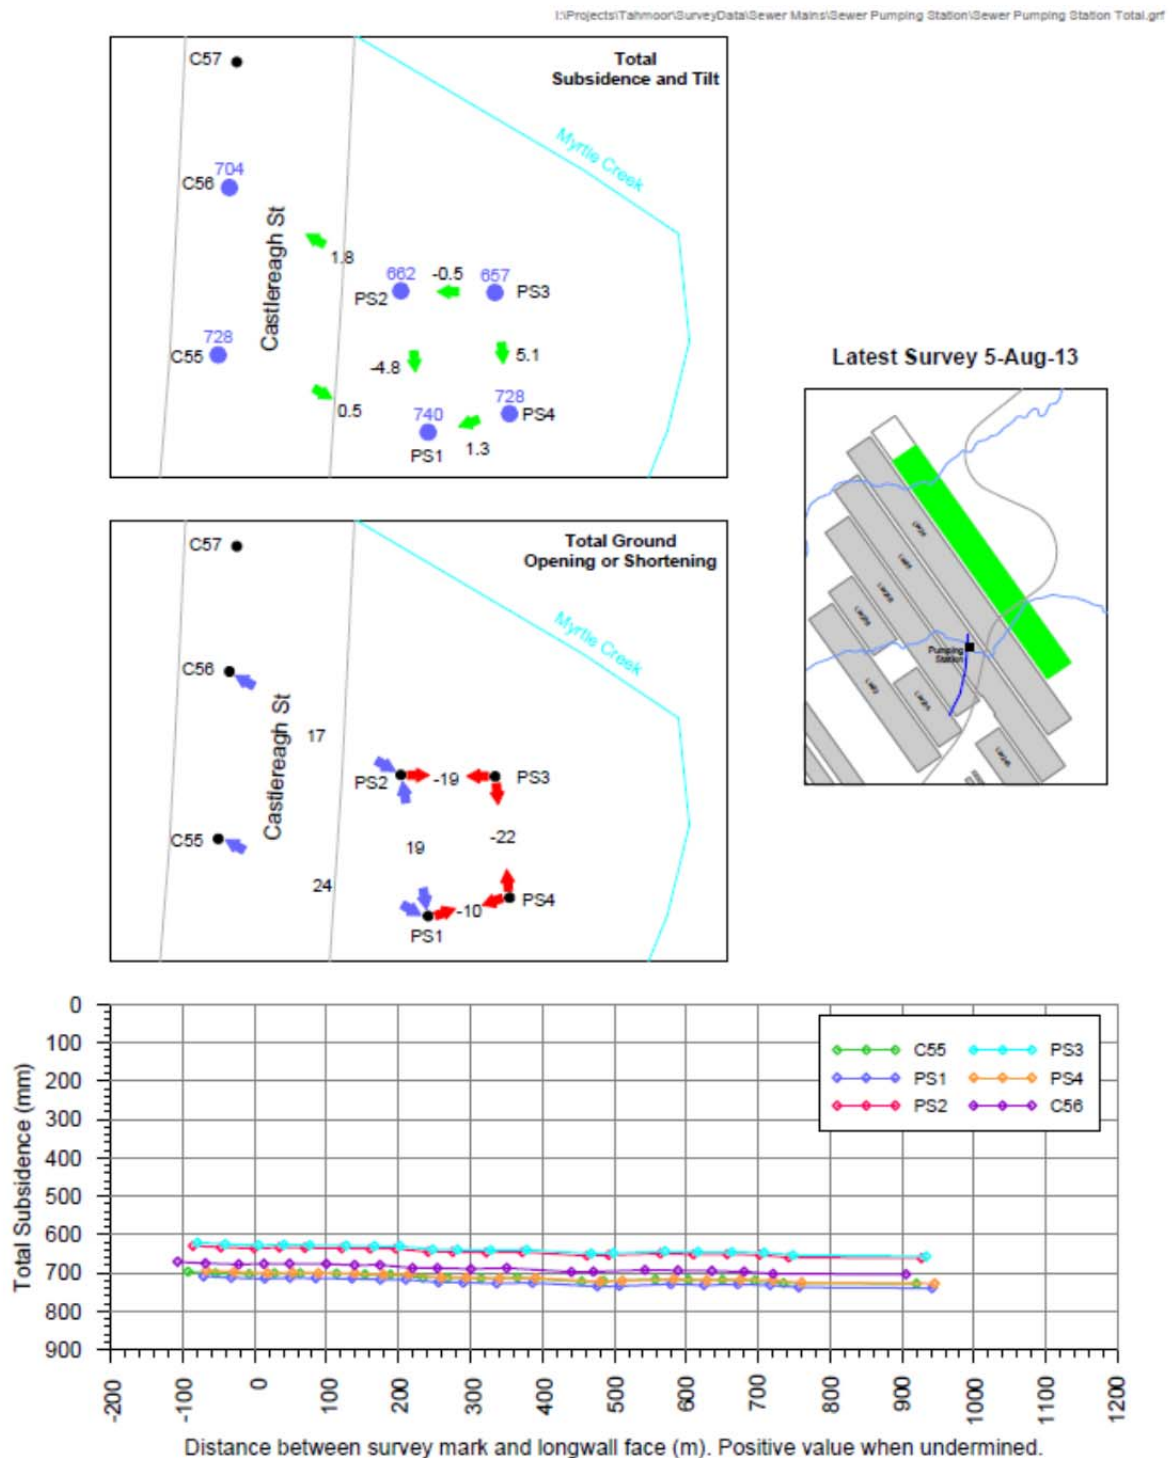
Fig. 2.19 Sewer Pumping Station Monitoring during Longwall 27

The majority of ground strains around the pumping station were relatively small. Maximum compressive strain of 1.7 mm/m was observed between Pegs PS1 and PS4 in April 2013.

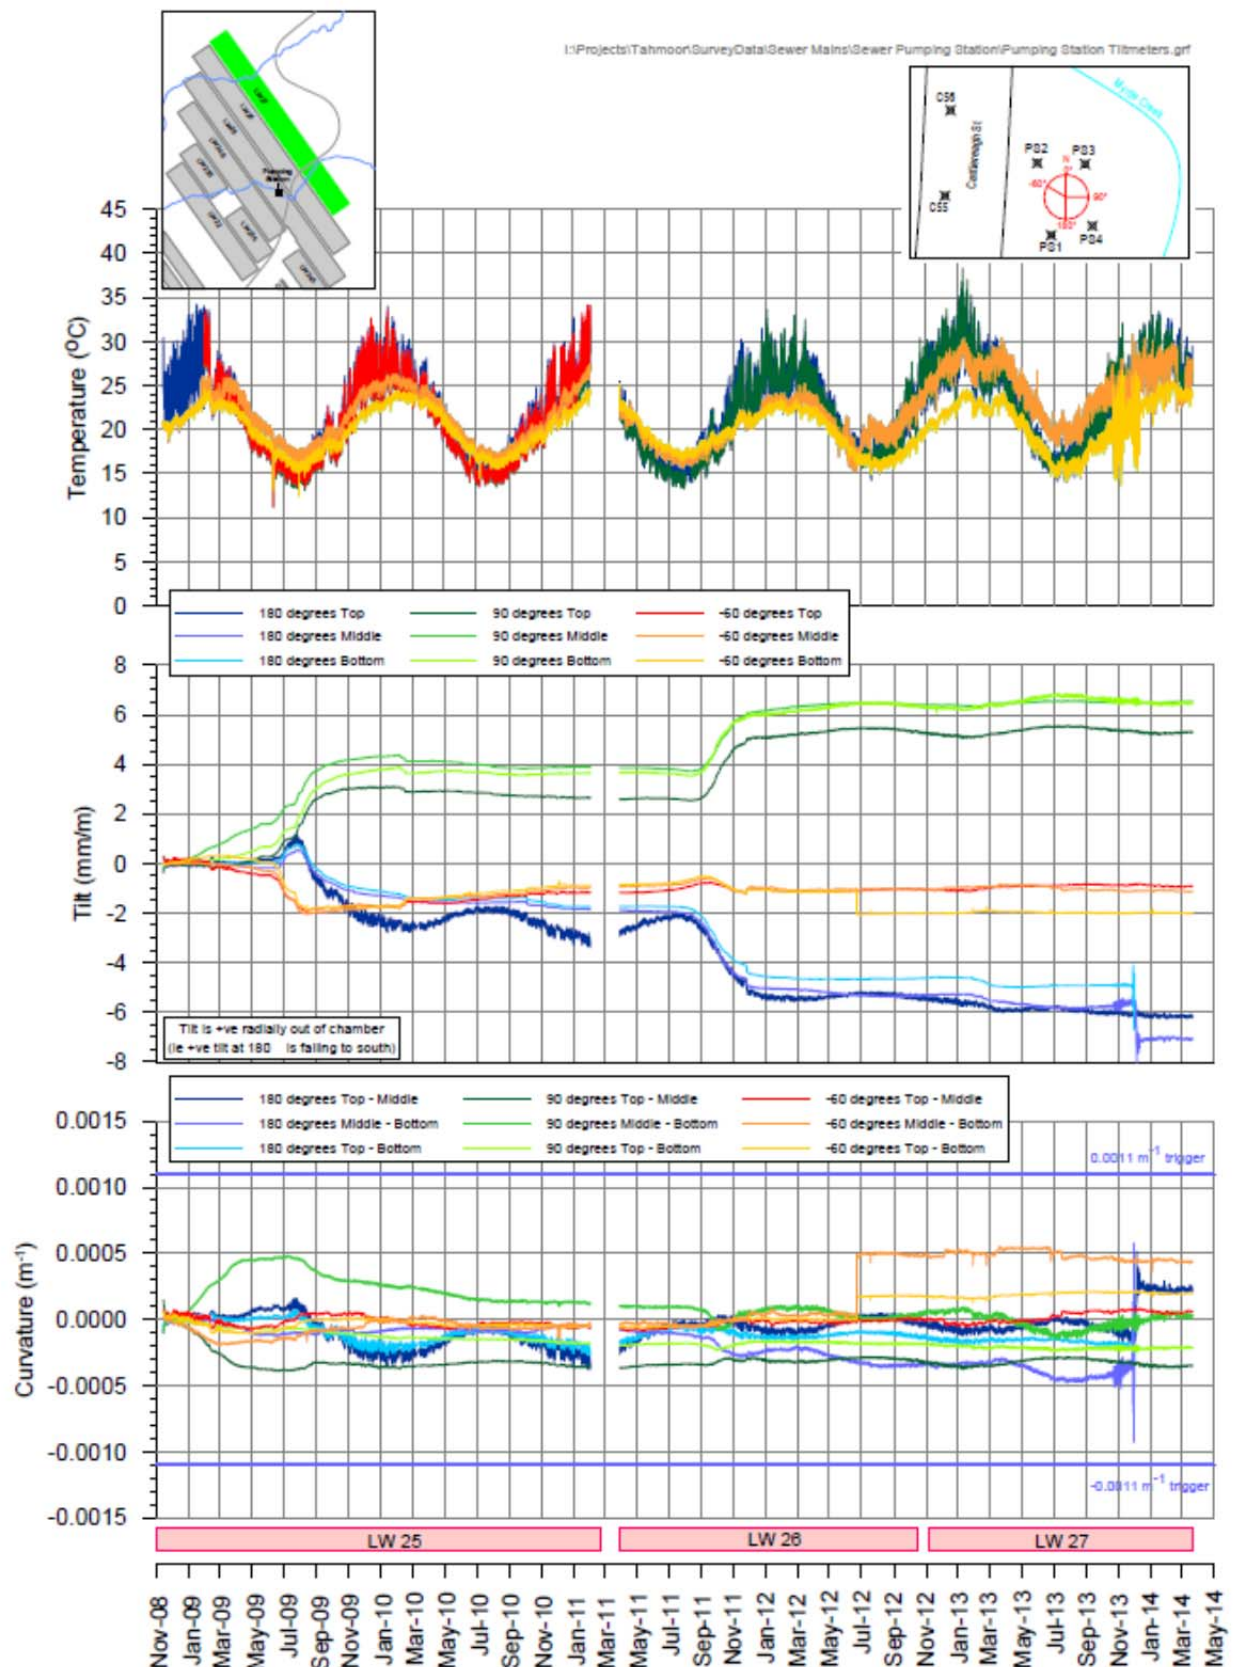
Fig. 2.20 Sewer Pumping Station Tiltmeters during Longwalls 25, 26 and 27

Automated continuous tiltmeters monitored changes in tilt in 3 vertical lines, placed at the top, base and mid-point on the internal face of the chamber wall. As shown in Fig. 2.20, observed curvatures are well within trigger levels as defined under the Management Plan. It can be seen that after more than 5 years of operation, some sensors have recorded erratic readings at the 180 degrees position in December 2013. These sensors will not be replaced. The timing of the disturbance coincides with physical works that were undertaken in the chamber.

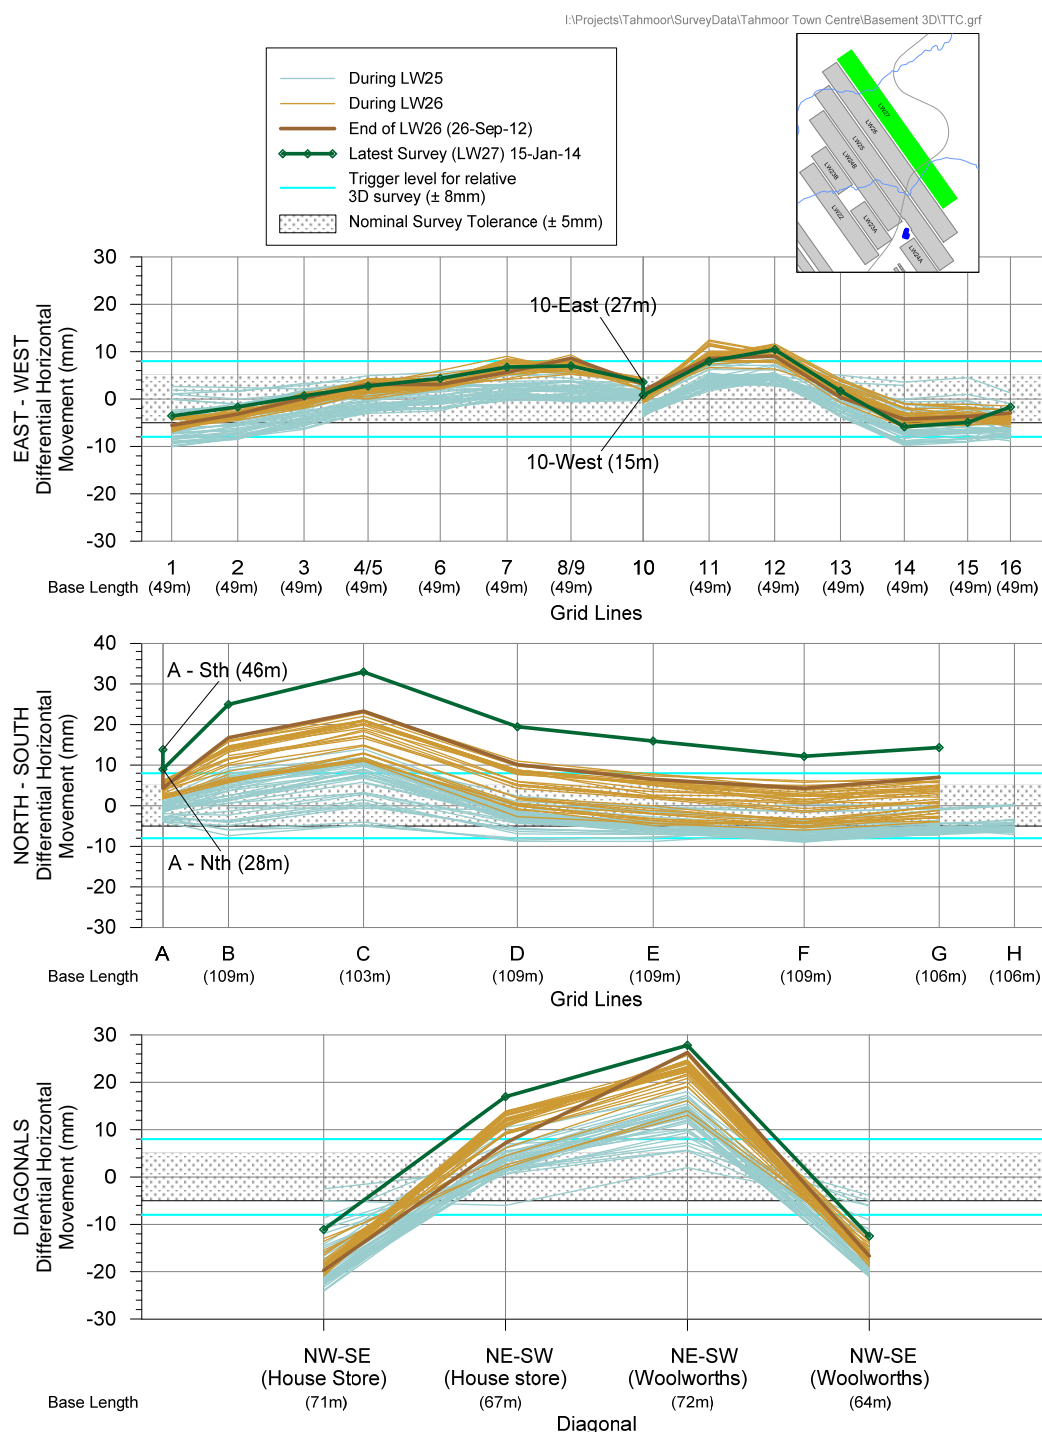
Fig. 2.22 Basement Width and Length Surveys during Longwall 27

The distances across the width and length of the TTC basement were measured once during Longwall 27. The results indicate small movements in the North-South direction, and slightly greater closure movement across the diagonal NW/SE direction.

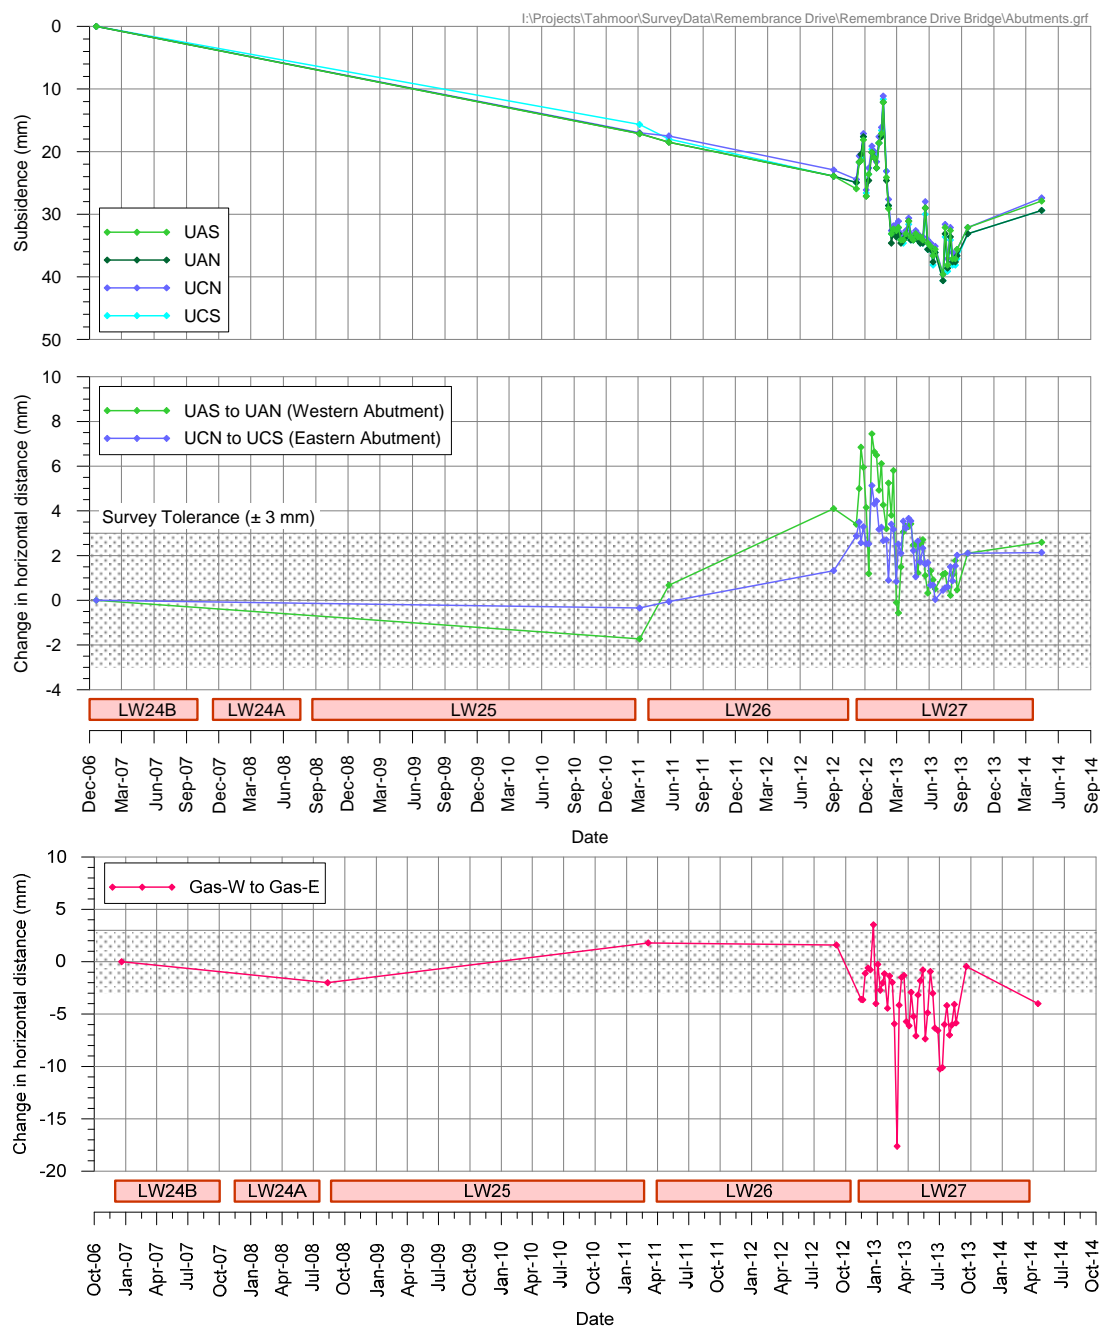
Fig. 2.23 Observed subsidence and changes in horizontal distances across the abutment and gas pipe supports at Remembrance Drive (Myrtle Creek) Road Bridge

An irregular spike was once observed across a survey bay that is only 3 metres long. The measured 8 mm change in horizontal distance equated to an apparent ground strain of more than 2 mm/m. Subsequent surveys confirmed that the previous measurement was erroneous. No corresponding spike in compression was observed across the bridge abutments.

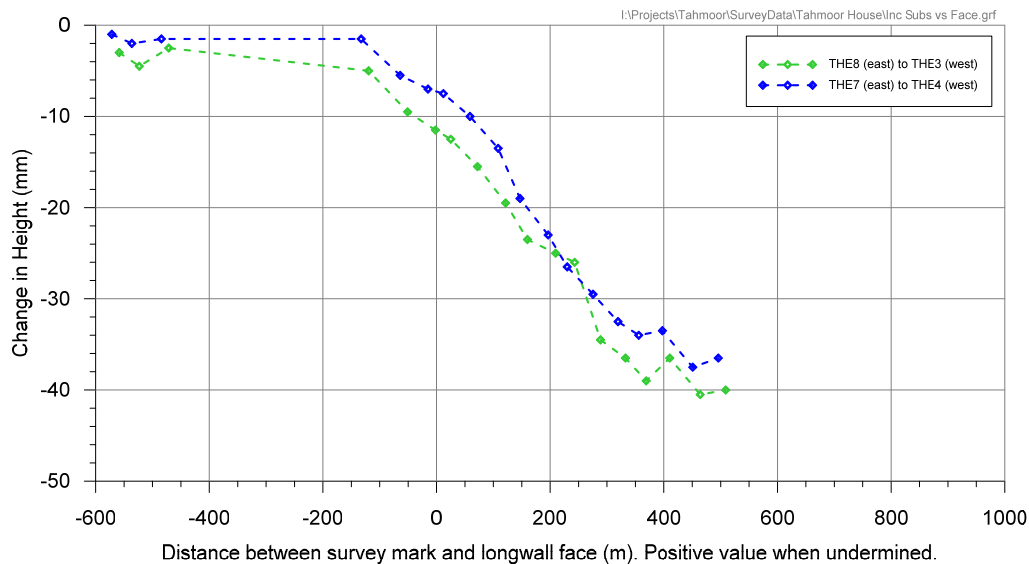
Fig. 2.24 Development of subsidence for ground pegs around Tahmoor House versus distance to longwall face

Vertical subsidence around the property has remained relatively uniform. Slightly more subsidence (approximately 40 mm) is observed at the western side of the house compared to the eastern side, as seen in Fig. 2.24.
