SIMEC Mining:

Tahmoor Coking Coal Operations - Longwall 31

End of Panel Subsidence Monitoring Report for Longwall 31

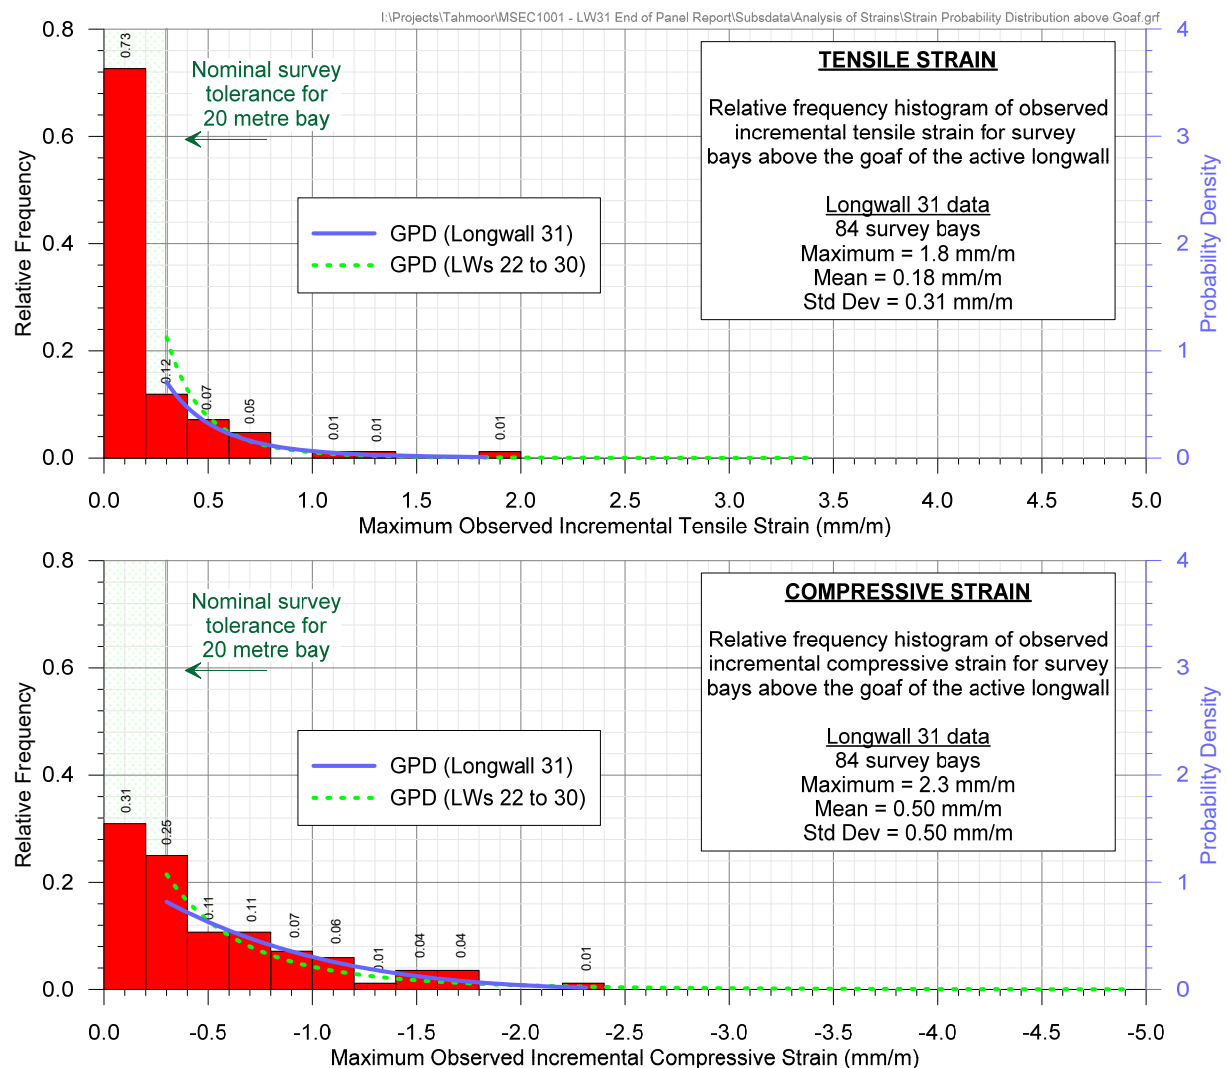
Fig. 2.1 Observed Incremental Strain for Survey Bays above Goaf resulting from the Extraction of Longwall 31

The probability distribution functions for previous monitoring during the mining of Longwalls 22 to 30 are also shown in this figure, as dashed green lines. It can be seen from these comparisons, that the overall distribution of tensile and compressive strain resulting from the extraction of Longwall 31 was similar to that observed during the mining of Longwalls 22 to 30.

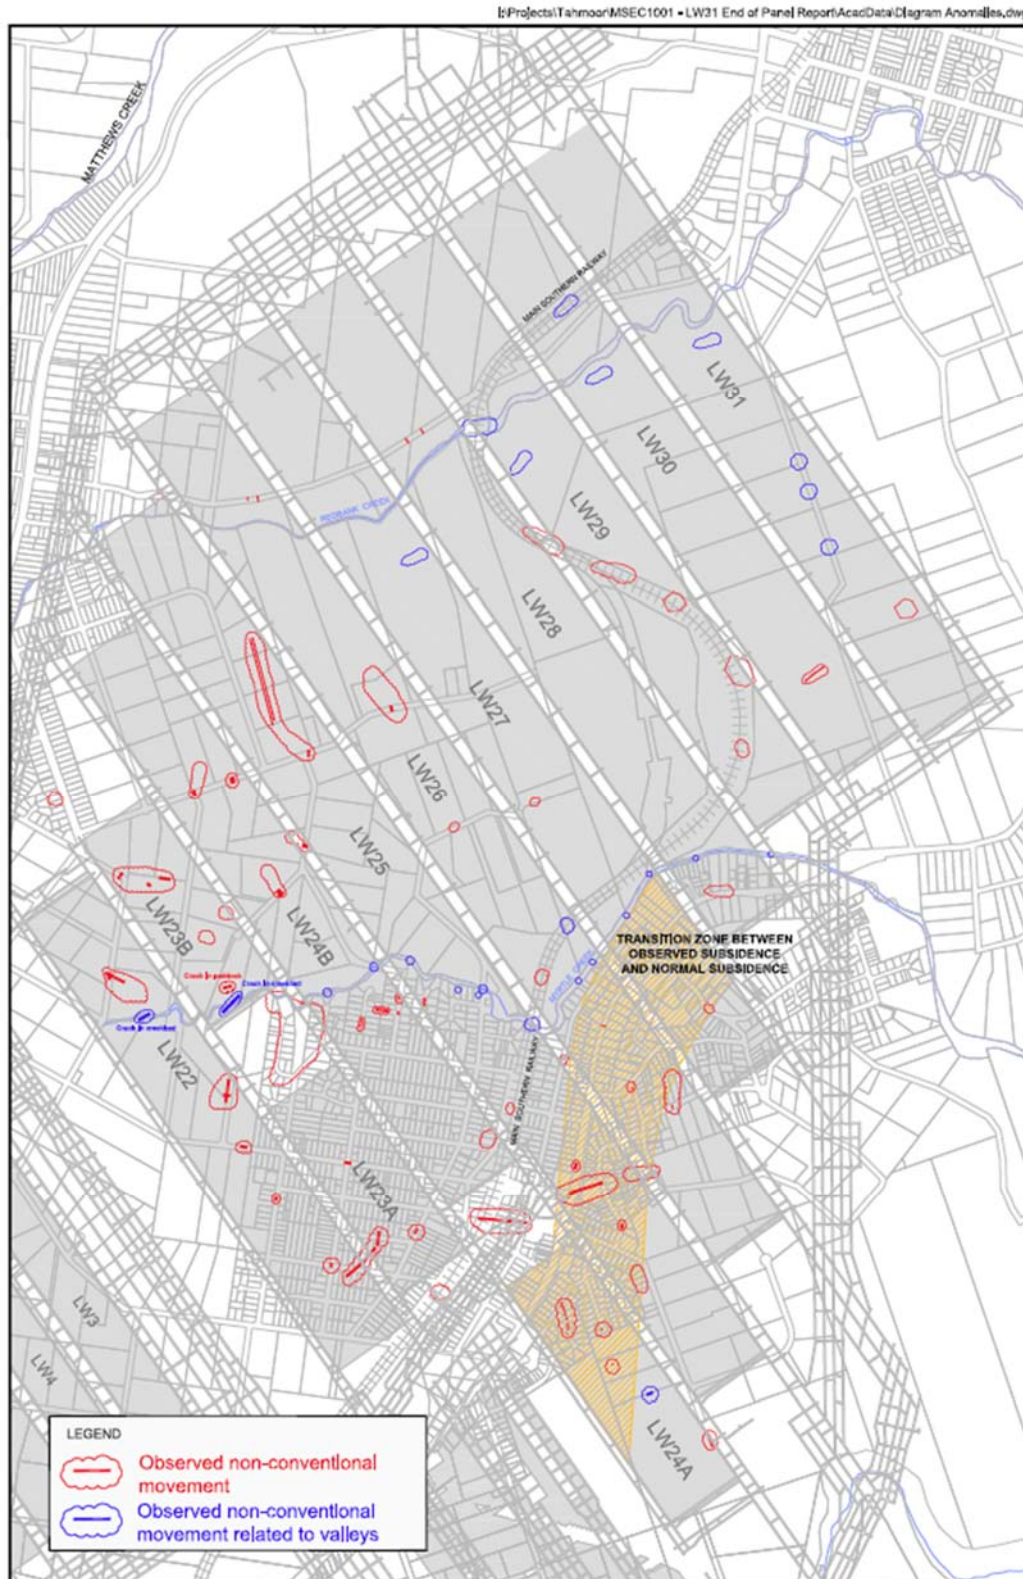
Fig. 2.2 Map of Locations of Potential Non-Systematic Movements

A plan showing the locations of observed non-systematic movements at Tahmoor is shown in Fig. 2.2. The locations were selected based on ground monitoring results or observed impacts that appear to have been caused by non-systematic movement. A total of approximately 55 locations (not including valleys) have been identified over the extracted Longwalls 22 to 31, of which 1 new location was observed during the mining of Longwall 31.

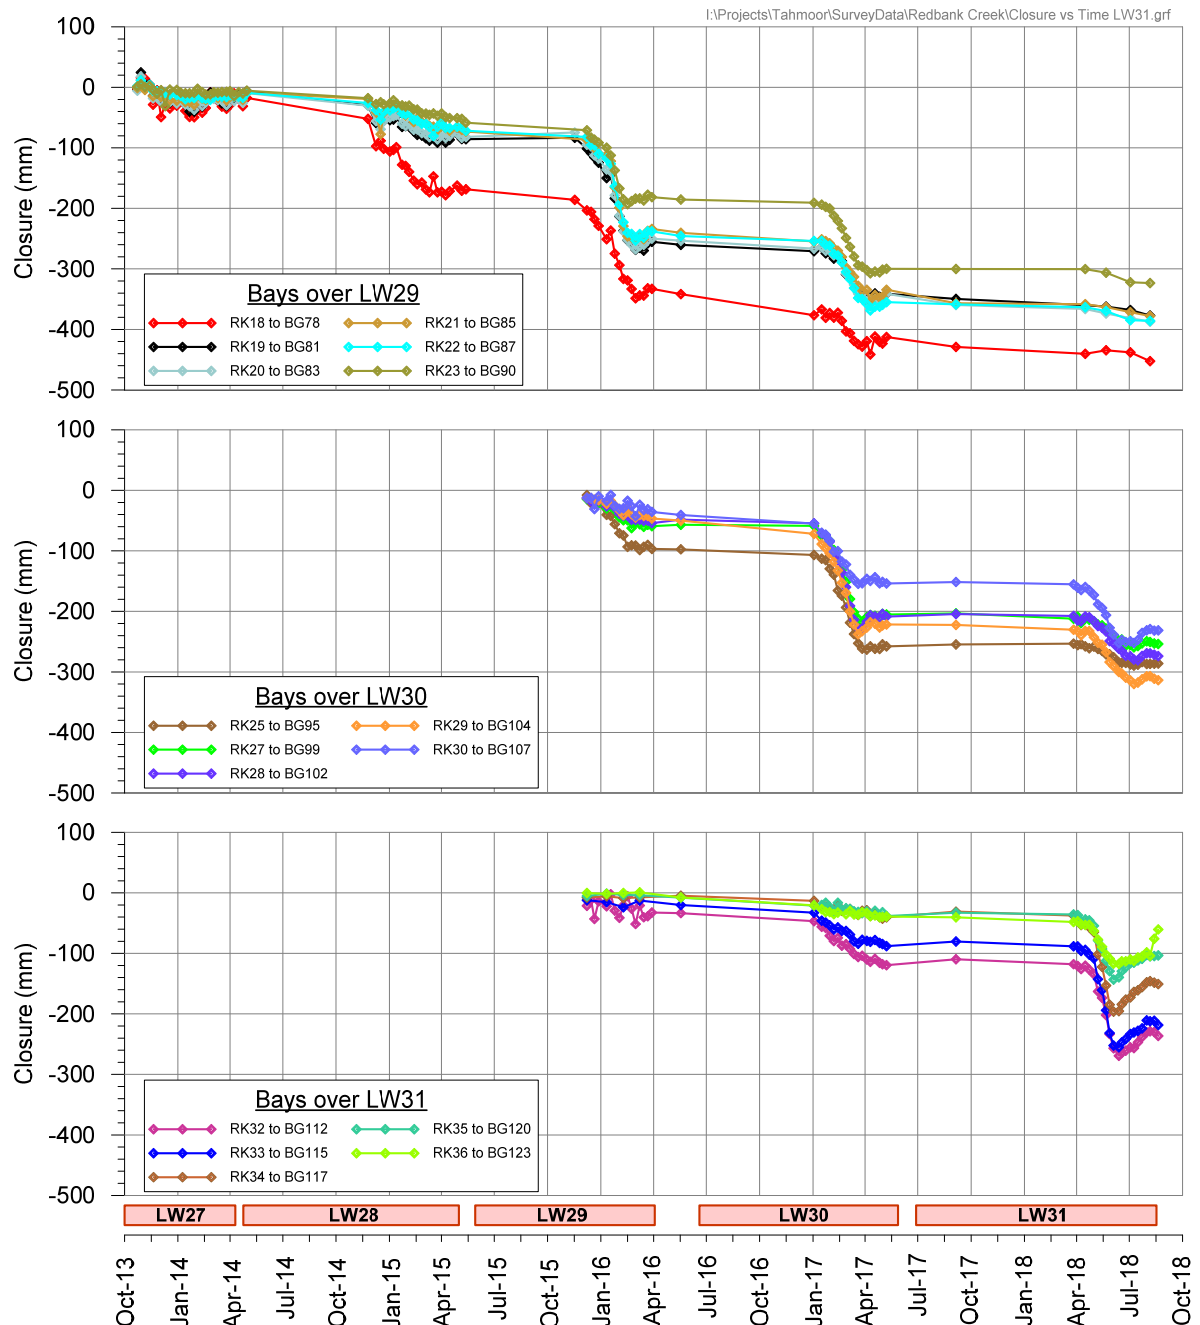
Fig. 2.4 Observed development of closure across Redbank Creek over time

- It can be seen from Fig. 2.4 that valley closure was slightly greater for a temporary period of time, when the transient effects of the subsidence travelling wave passed through the valley.
- Maximum observed closure above Longwall 31 was similar to maximum observed closure above Longwall 30 and less than maximum observed closure above Longwall 29. This was predicted as the valley is deeper and more incised above Longwall 29.

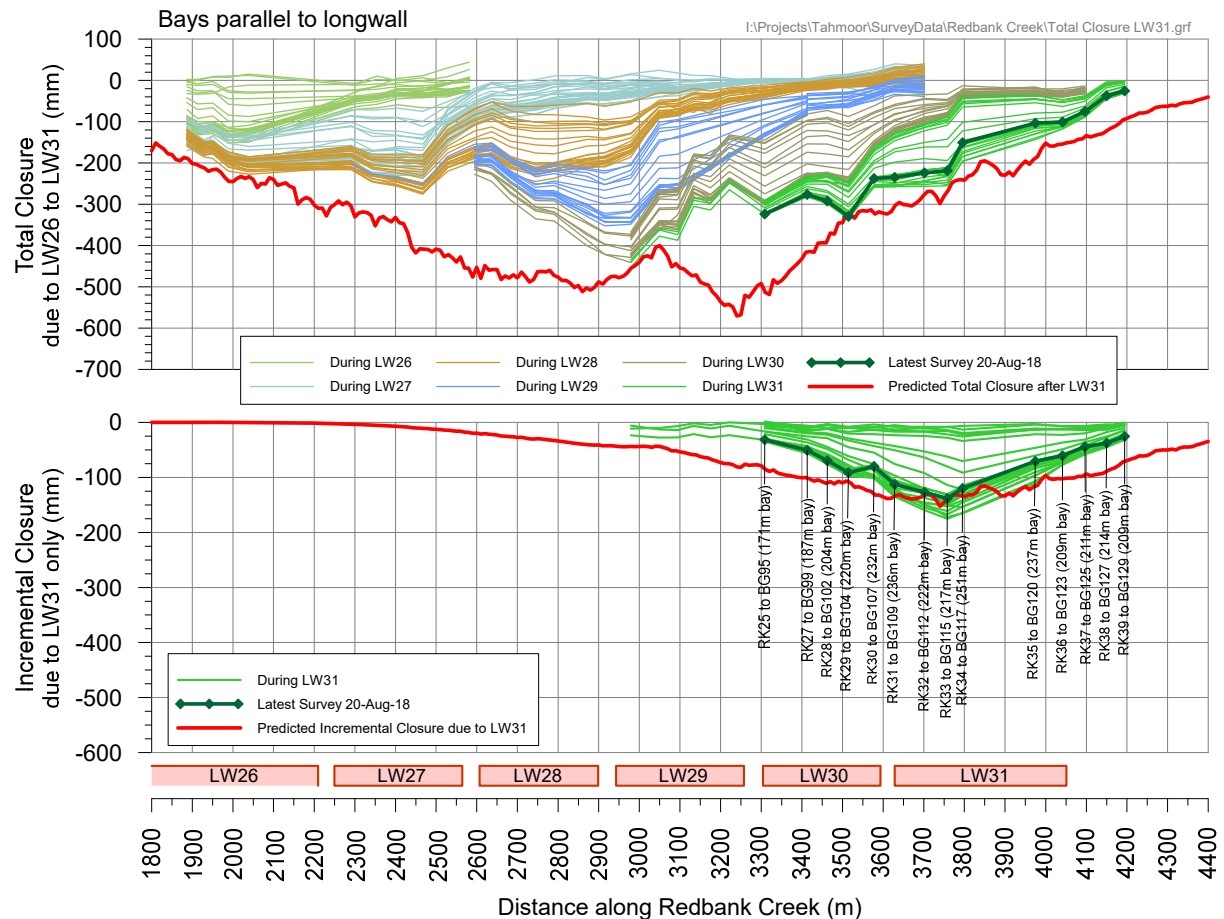
Fig. 2.6 Comparison between observed and predicted valley closure along Redbank Creek

- There has been a reasonable correlation between predicted and observed closure at the completion of Longwall 31.
- Observed total closure from the mining of Longwalls 26 to 31 is less than predicted.

Maximum predicted valley closure due to extraction of Longwall 31 was 152 mm. As shown in the bottom graph of Fig. 2.6, observed maximum incremental valley closure at the completion of Longwall 31 was 138 mm.

It can also be seen, from the top graph of Fig. 2.6 that observed total closure from the mining of Longwalls 26 to 31 is less than predicted along the length of Redbank Creek. Maximum observed total closure is 452 mm, which is less than the predicted total closure of 575 mm due to the mining of Longwalls 22 to 31, as reported in Report No. MSEC647.

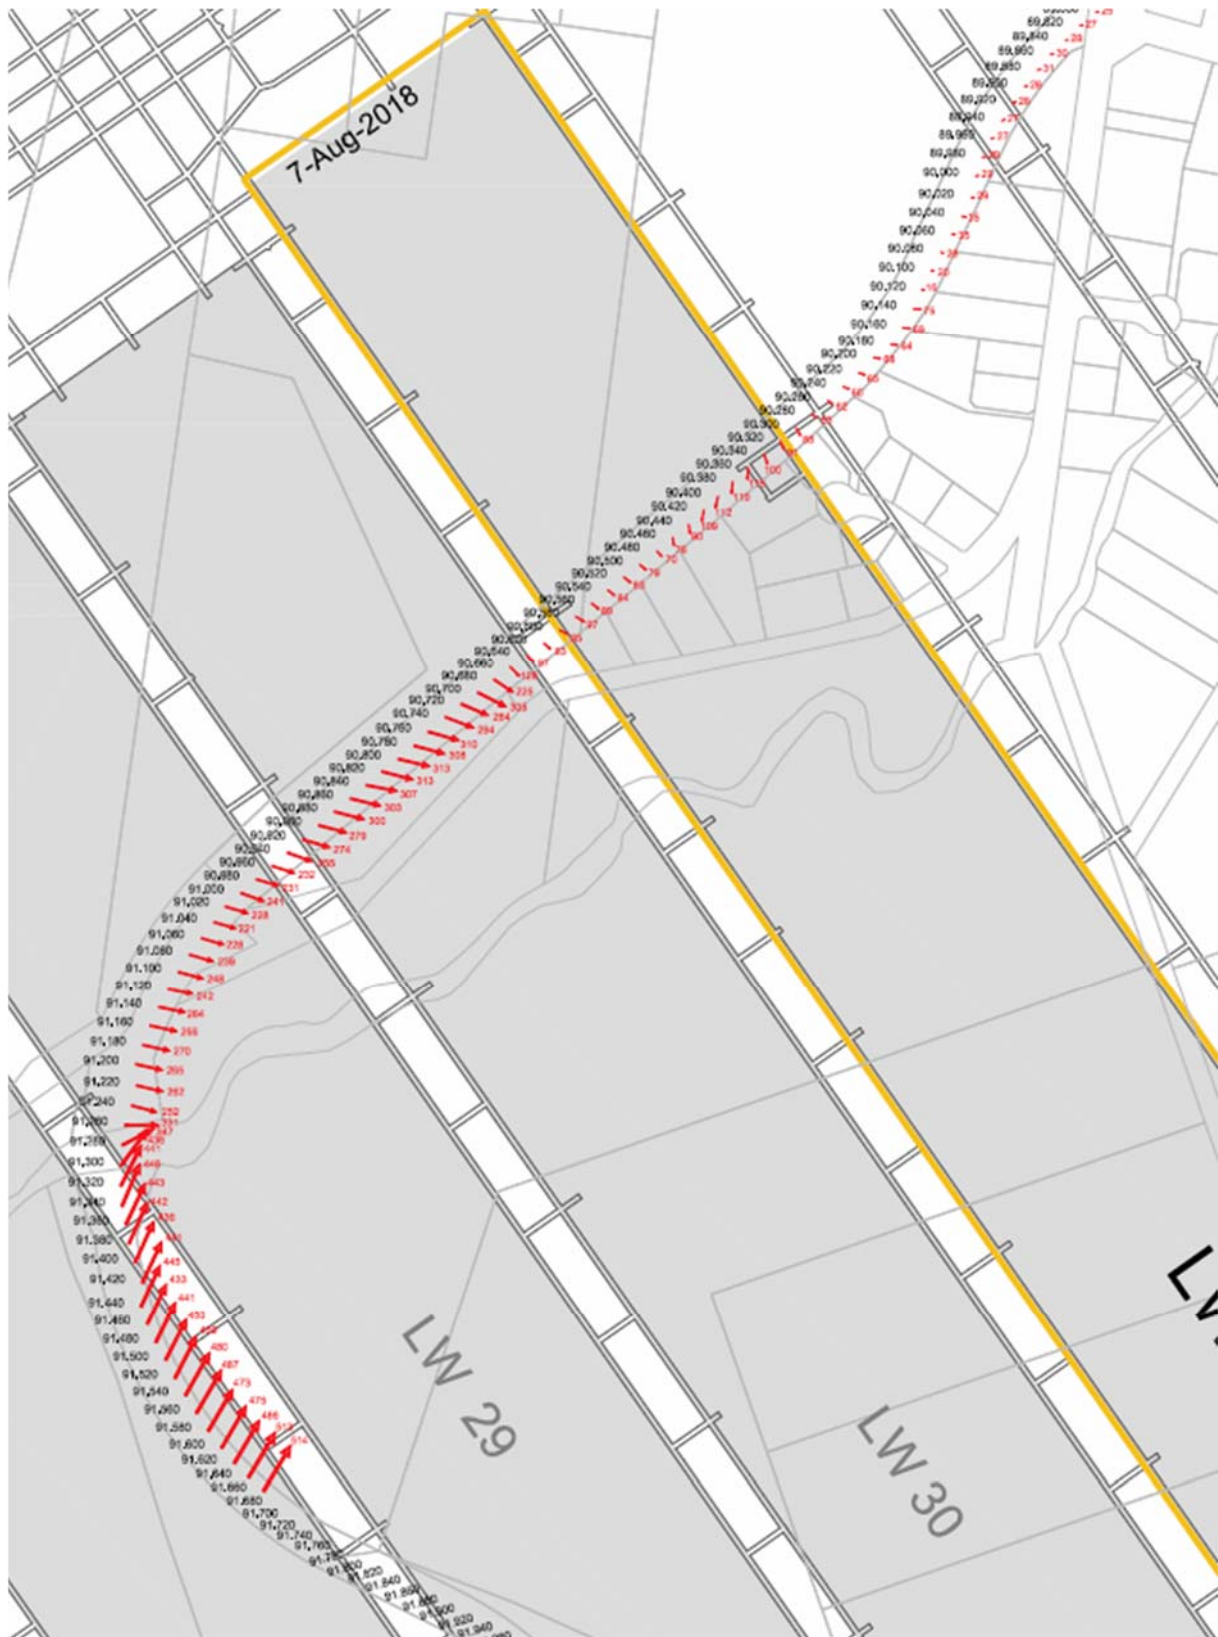
Fig. 2.7 Observed total horizontal movement along Main Southern Railway during the mining of Longwalls 27 to 31

Observed absolute horizontal movements along the Main Southern Railway are shown in Fig. 2.7. It can be seen that the rockmass on the southern of Country side of the Culvert has moved in a different direction to the northern or Sydney side of the Culvert.

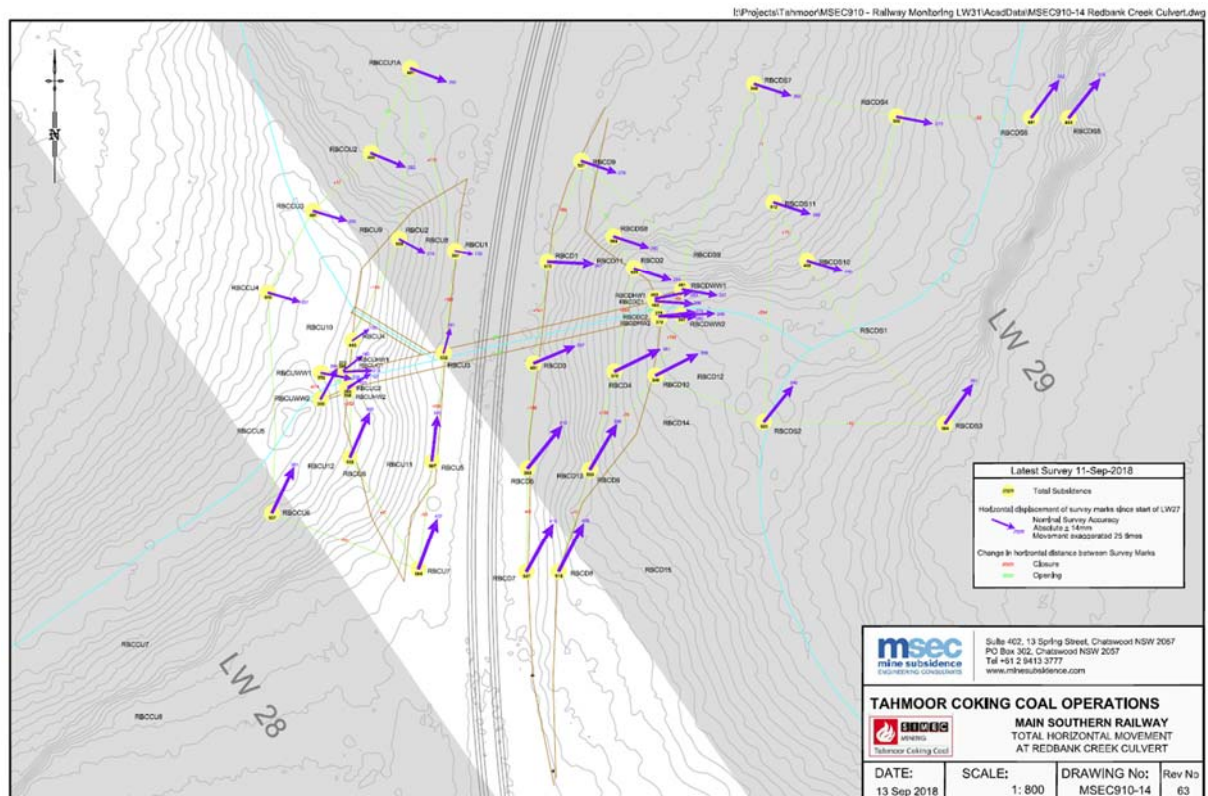
Fig. 2.8 Observed total horizontal movement at Redbank Creek Culvert and embankment during the mining of Longwalls 27 to 31

Observed total subsidence and horizontal movement of survey marks in the immediate of the culvert and embankment are shown in Fig. 2.8. The results show that boundaries of the rockmass in the south-western quadrant intersect with the country side of the culvert. The corner of the rockmass is approximately aligned with midpoint of the culvert, which correlates well with observed detailed closure measurements inside the culvert itself.

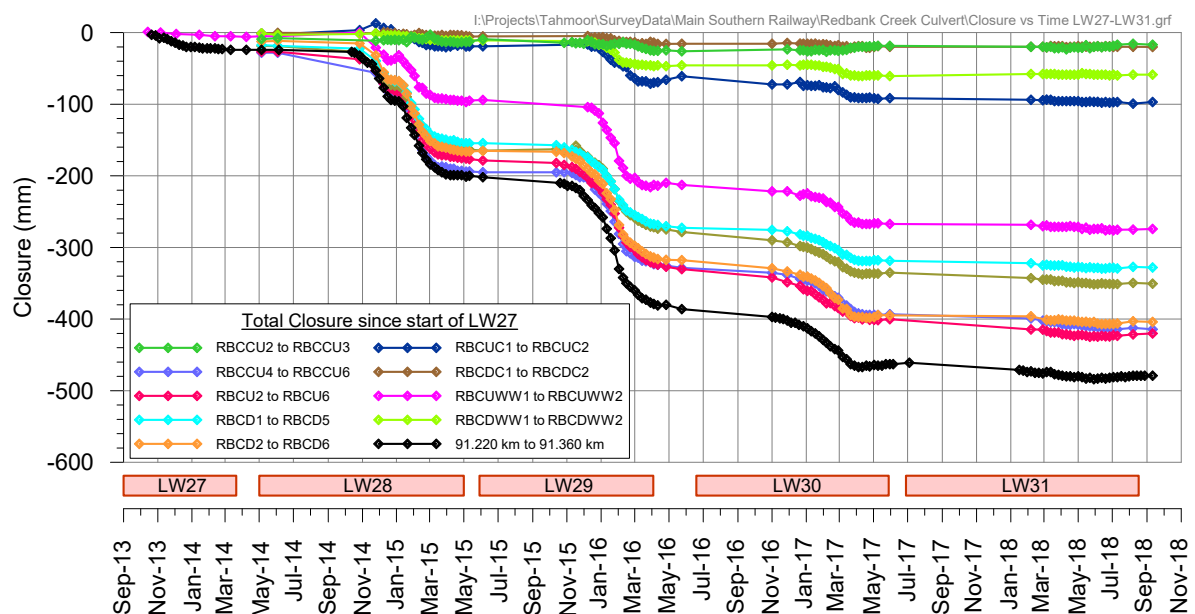
Fig. 2.9 Observed Total Valley Closure over time across Redbank Creek Culvert at Main Southern Railway during the mining of Longwall 31 (includes closure from Longwalls 27 to 30)

The observed gradual development with time of differential horizontal movements between selected pegs at the culvert and embankment are shown in Fig. 2.9. Maximum observed closure was measured between the long bay survey pegs on the track at 91.220 km and 91.360 km, though a similar result was observed between Pegs RBCCU4 and RBCCU6, RBCU4 and RBCU6, and between RBCD2 and RBCD6, which are located in the base of the embankment across the upstream inlet. This suggests that closure across the valley of Redbank Creek and its tributary, were focussed at the culvert. This was confirmed at greater detail from additional detailed surveys in the culvert, which are discussed later.

Whilst the ends of the wingwall on the upstream end have closed by 274 mm, the culvert barrel at the inlet has opened by 20 mm. Measured closure at the ends of the wingwall on the downstream end is 59 mm, and the culvert barrel at the inlet has opened 21 mm.

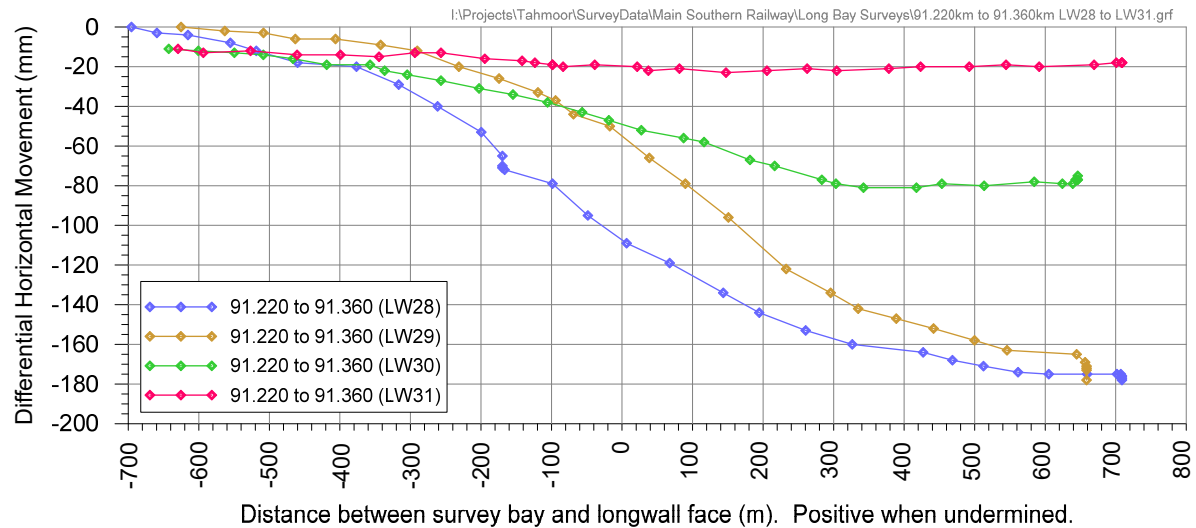
Fig. 2.10 Observed incremental valley closure as measured by long bay survey, relative to face distance, across Redbank Creek Culvert at Main Southern Railway during the mining of Longwalls 28 to 31

It can be seen from Fig. 2.10 that only minor valley closure movements occurred during Longwall 31. When compared to the development of valley closure during the mining of Longwalls 28 and 30, it can be seen that valley closure was substantially less than observed during previous longwalls. By the end, the increment of valley closure due to the extraction of Longwall 31 was a quarter of the increment observed due to the extraction of Longwall 30.

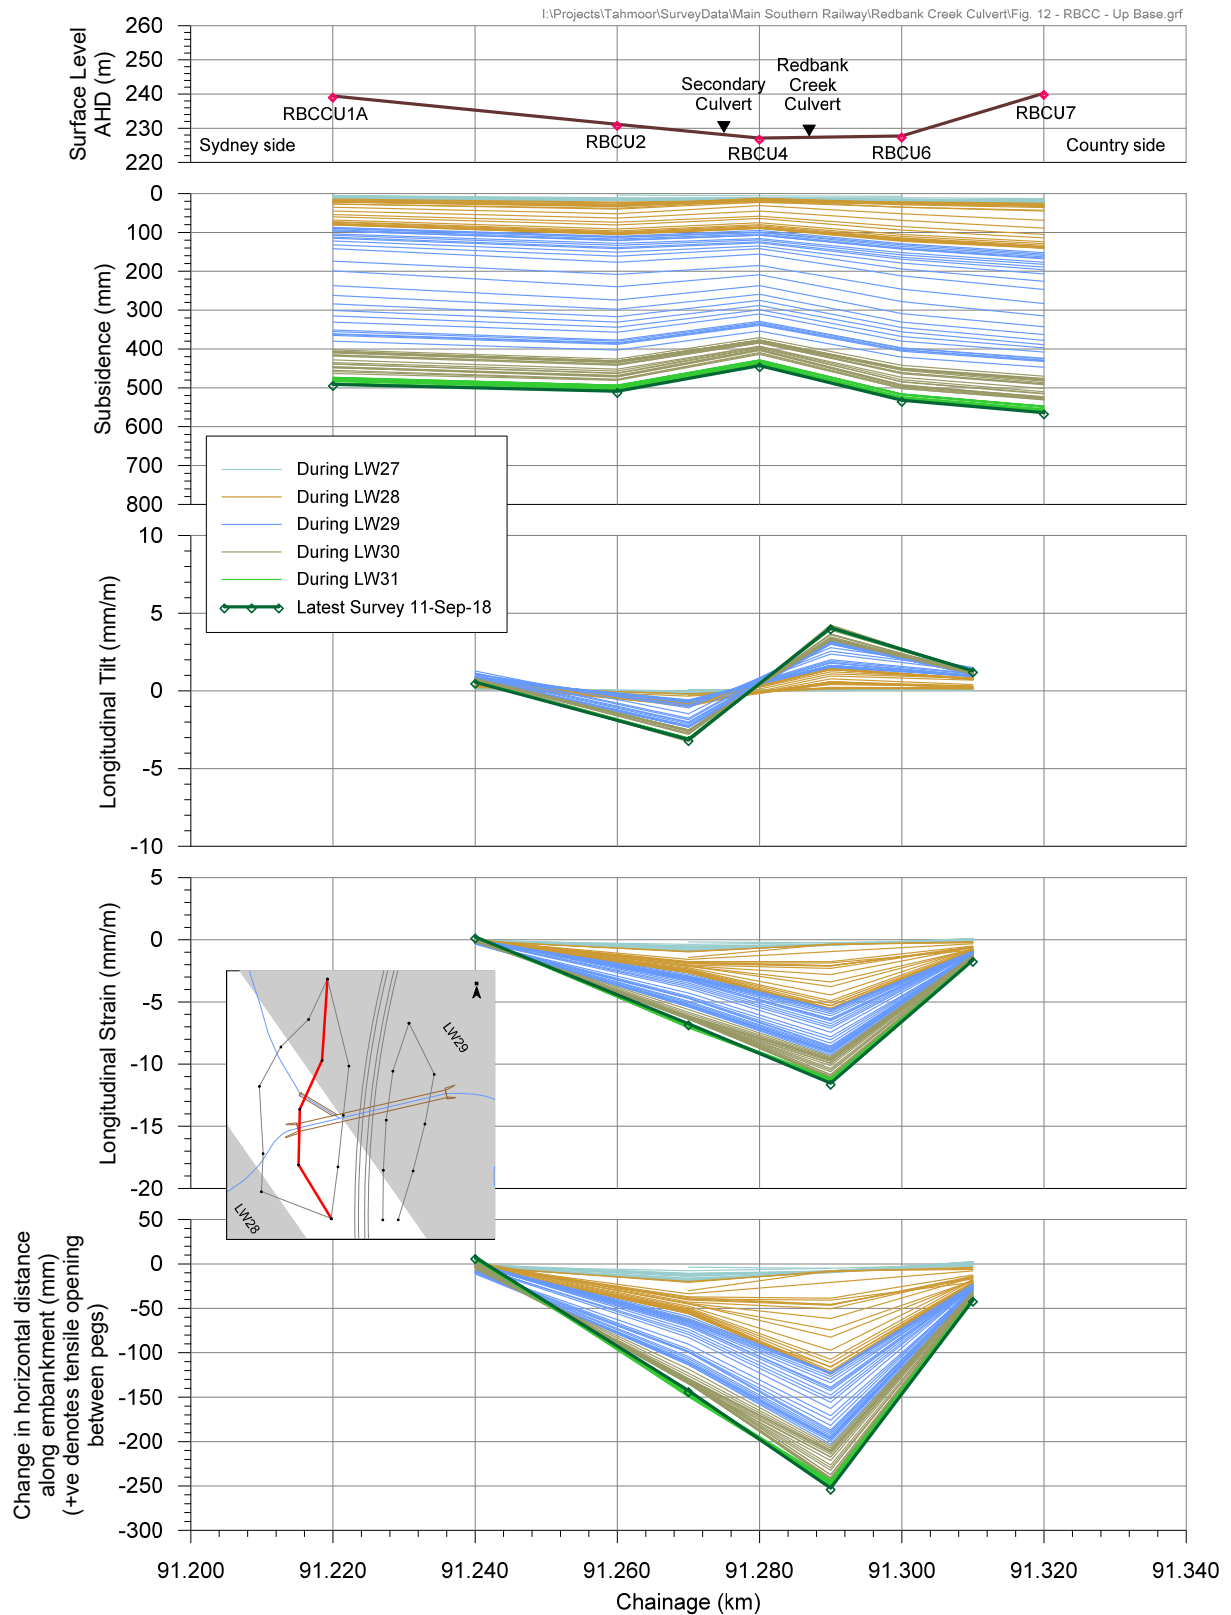
Fig. 2.11 Observed total subsidence, tilt and strain across the upstream base of Redbank Creek Culvert due to the mining of Longwalls 27 to 31

Observed subsidence along the base of the embankment on the upstream side is shown in Fig. 2.11. The results show valley closure focussing between Pegs RBCCU4 and RBCCU6, with upsidence observed at Peg RBCCU4. It can also be seen that very little change in ground strain was observed during the mining of Longwall 31.

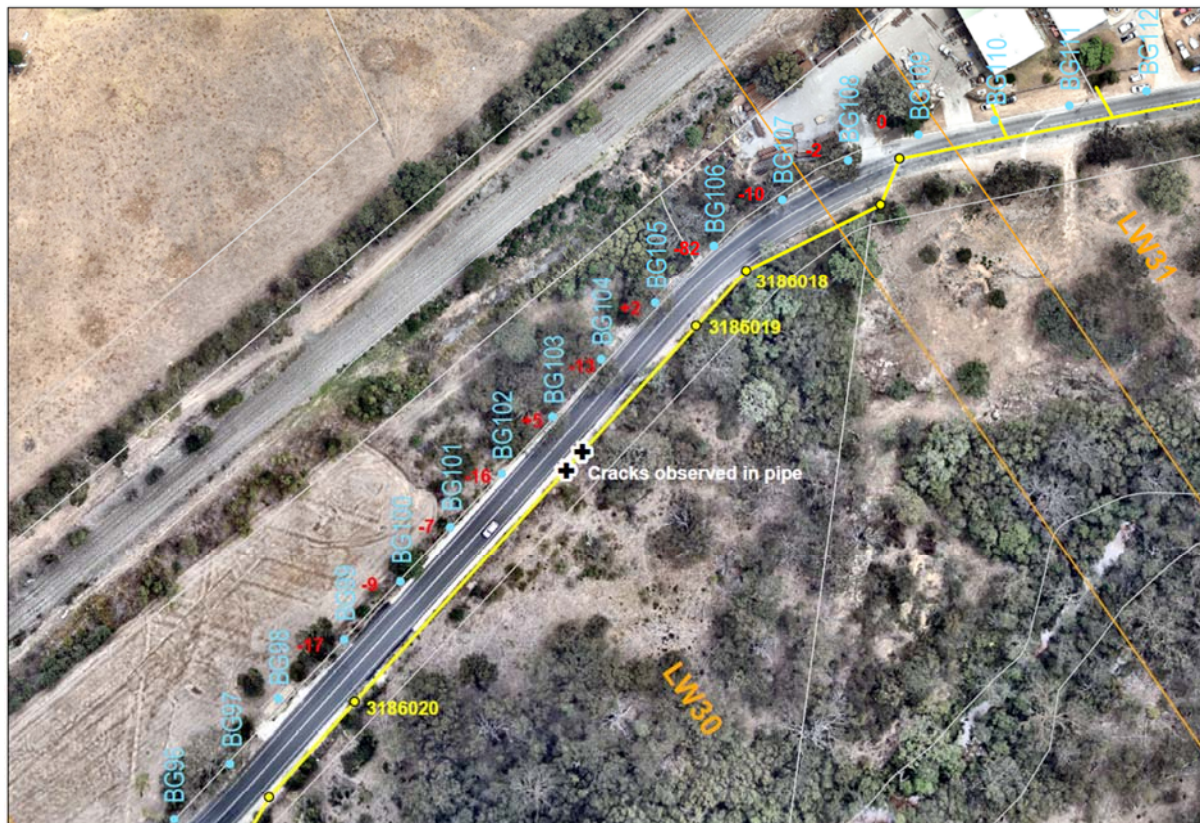
Fig. 4.2 Locations of cracks observed by CCTV inspection in Thirlmere Carrier Pipe on 25 July 2018

Whilst no impacts were observed between Pegs BG105 and BG106, cracks were found approximately 50 metres to the west between Pegs BG102 and BG103. The locations of the impact sites are shown in Fig. 4.2.

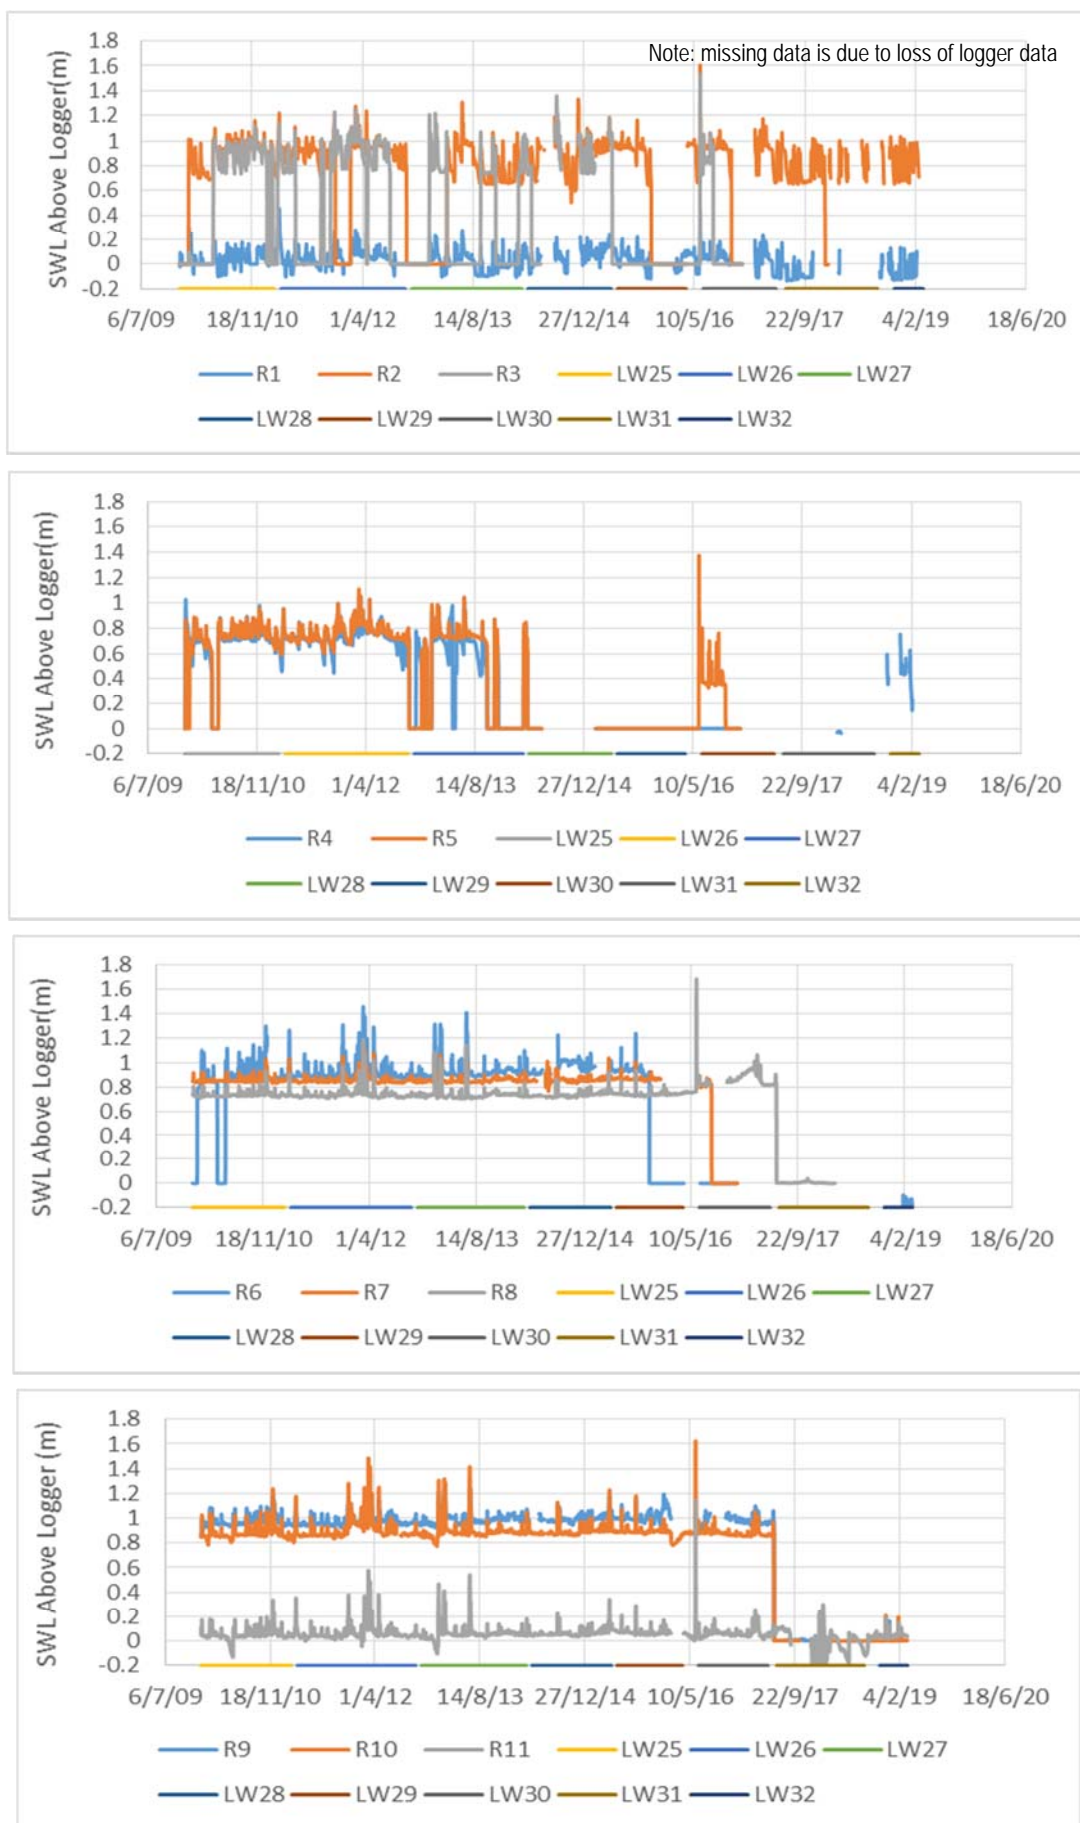
Figure 2 Redbank Creek Pool Depth

The majority of pools over and downstream of Longwalls 25 to 32 show evidence of subsidence related pool holding capacity effects, whilst R11 does not, as shown in **Figure 2**.

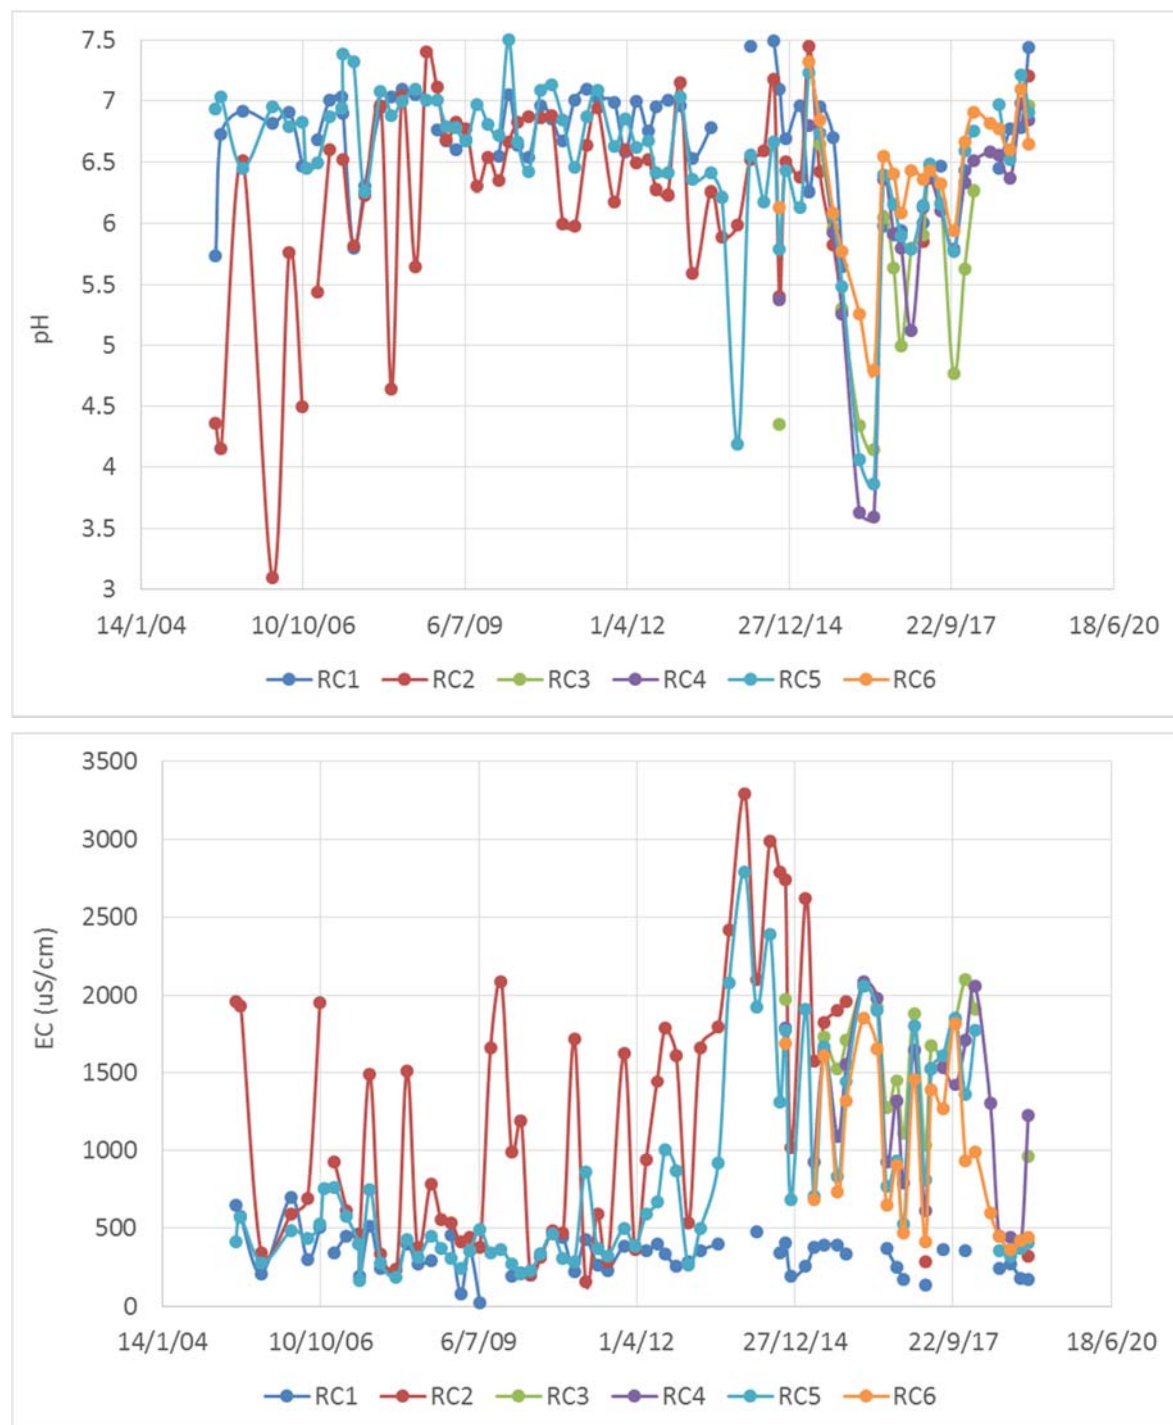
Figure 3 Redbank Creek Field Water Quality

During extraction of Longwall 31, pH in Redbank Creek distinctly acidified at all monitored sites, whilst salinity did not show a specific trend, except for higher salinity during low flow periods.

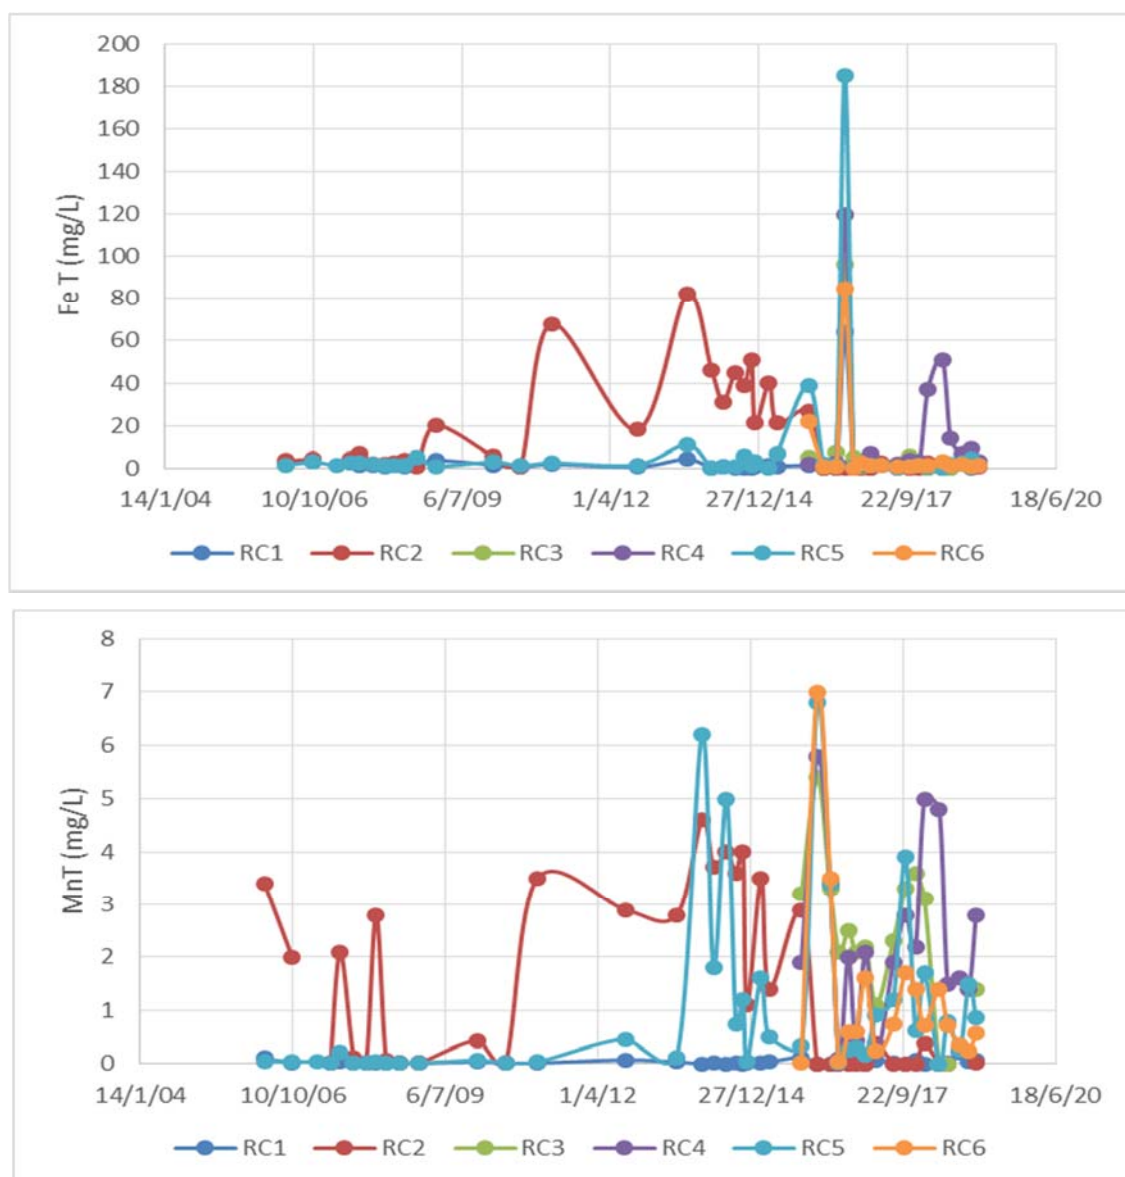
Figure 4 Redbank Creek Iron and Manganese

Manganese also rose during extraction of Longwall 30 at Sites RC3 to RC6 (at which time RC1 and RC2 were dry).

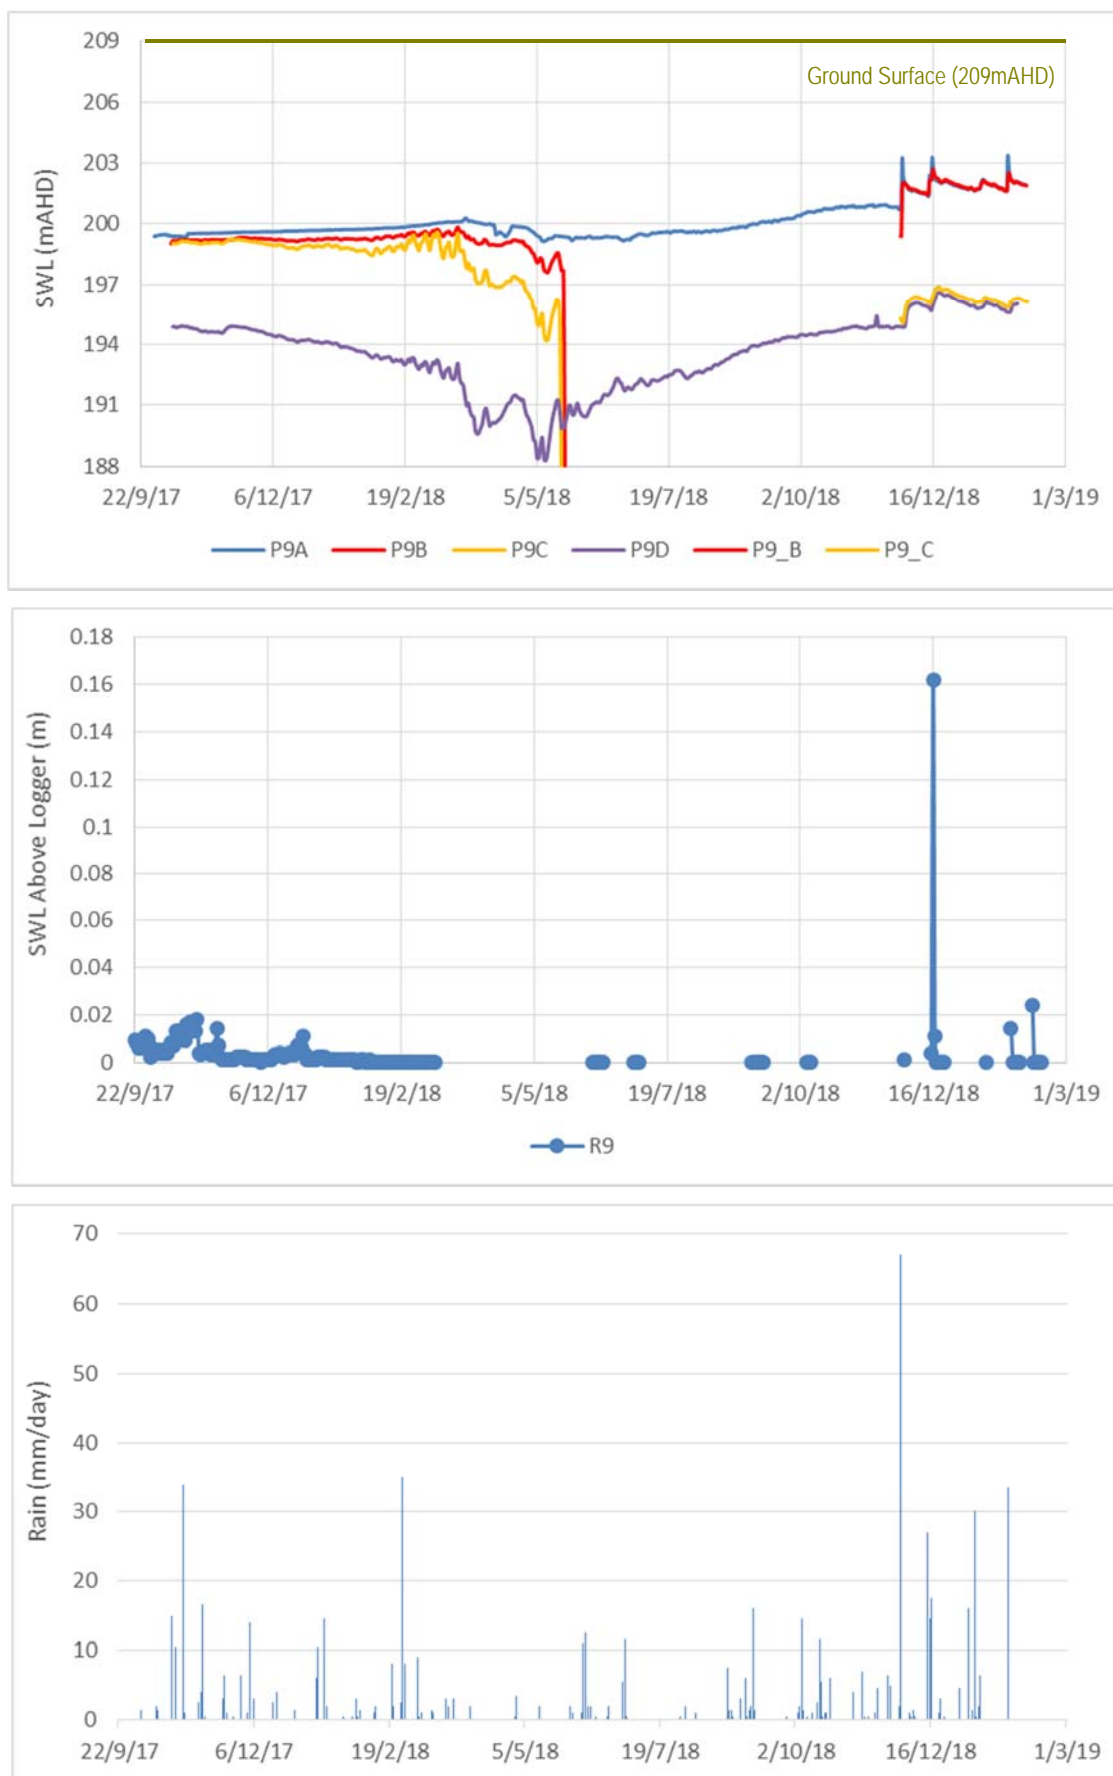
Figure 9 P9 Series Groundwater Levels, Pool R9 Water Level and Rainfall

It has also been observed that the pre-undermining separation of the four individual hydrographs has modified so that the upper two intakes are at an equivalent elevation, whilst the two deeper intakes are also at an equivalent, deeper elevation. The separation between the two post undermining systems occurs at around 10.5m below surface.
