SIMEC Mining:  
**Tahmoor Coal - Longwall 32**

End of Panel Subsidence Monitoring Report for Longwall 32

This report has been prepared by Mine Subsidence Engineering Consultants (MSEC) for Tahmoor Coal to comply with conditions of the SMP Approval for Tahmoor Longwall 32 dated 14 September 2018.

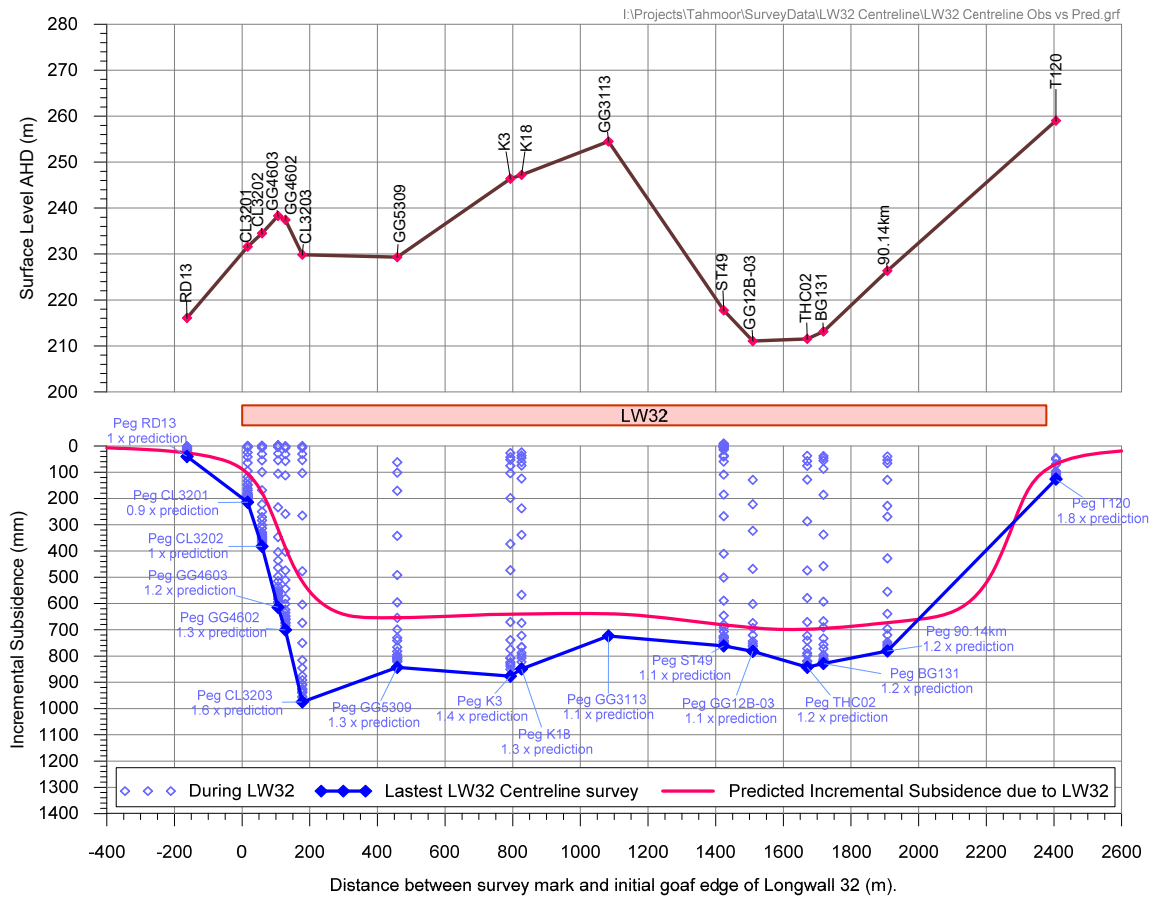
**Fig. 2.1 Observed incremental subsidence along centreline of Longwall 32**

The monitoring results during the mining of Longwall 32 showed, however, that increased subsidence has developed above the commencing end of Longwall 32 at levels similar to those observed above Longwall 26, as shown in Fig. 2.1. The magnitude of subsidence reduces along the panel as the longwall face progressed to the north, though subsidence was generally at the higher end of the previously observed range.

The observation above the commencing end of Longwall 32 has shown that increased subsidence has developed where mining has occurred close to the mapped first order fault echelon structures. In this case, Peg CL3203 is located approximately 700 metres to the west of the mapped first order fault and the commencing end of the panel is located at the head of a fault ramp, in between two fault echelons. As observed during the mining of Longwalls 24A to 26, the magnitude of subsidence was reduced over the unmined, solid coal side of Longwall 32. Many survey pegs were installed across the mapped first order fault structure and associated second order geological structures to the side of Longwall 32. No increased differential subsidence movements were observed to the side of Longwall 32.

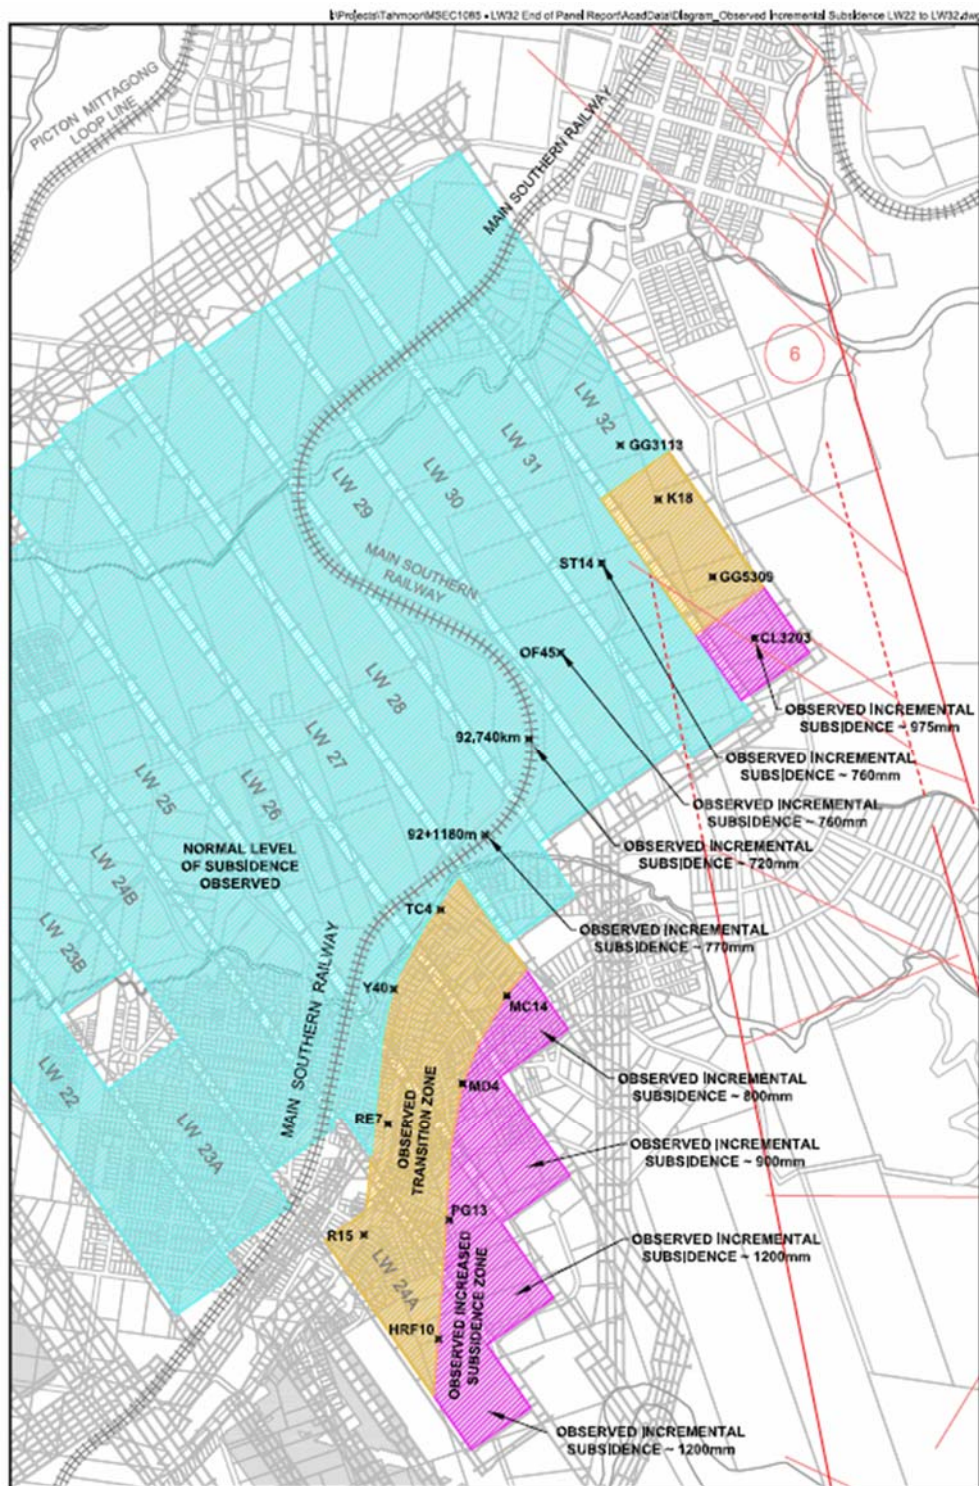
Fig. 2.2 Zones of increased subsidence over Longwalls 22 to 32

Prior to the mining of Longwall 32, it was considered possible that subsidence might return to higher than normal levels during the mining of Longwall 32, as it would mine adjacent to another fault echelon structure as shown in Fig. 2.2. It was noted, however, the observations above previously extracted Longwalls 30 and 31 indicated that subsidence has been developing close to normal levels.

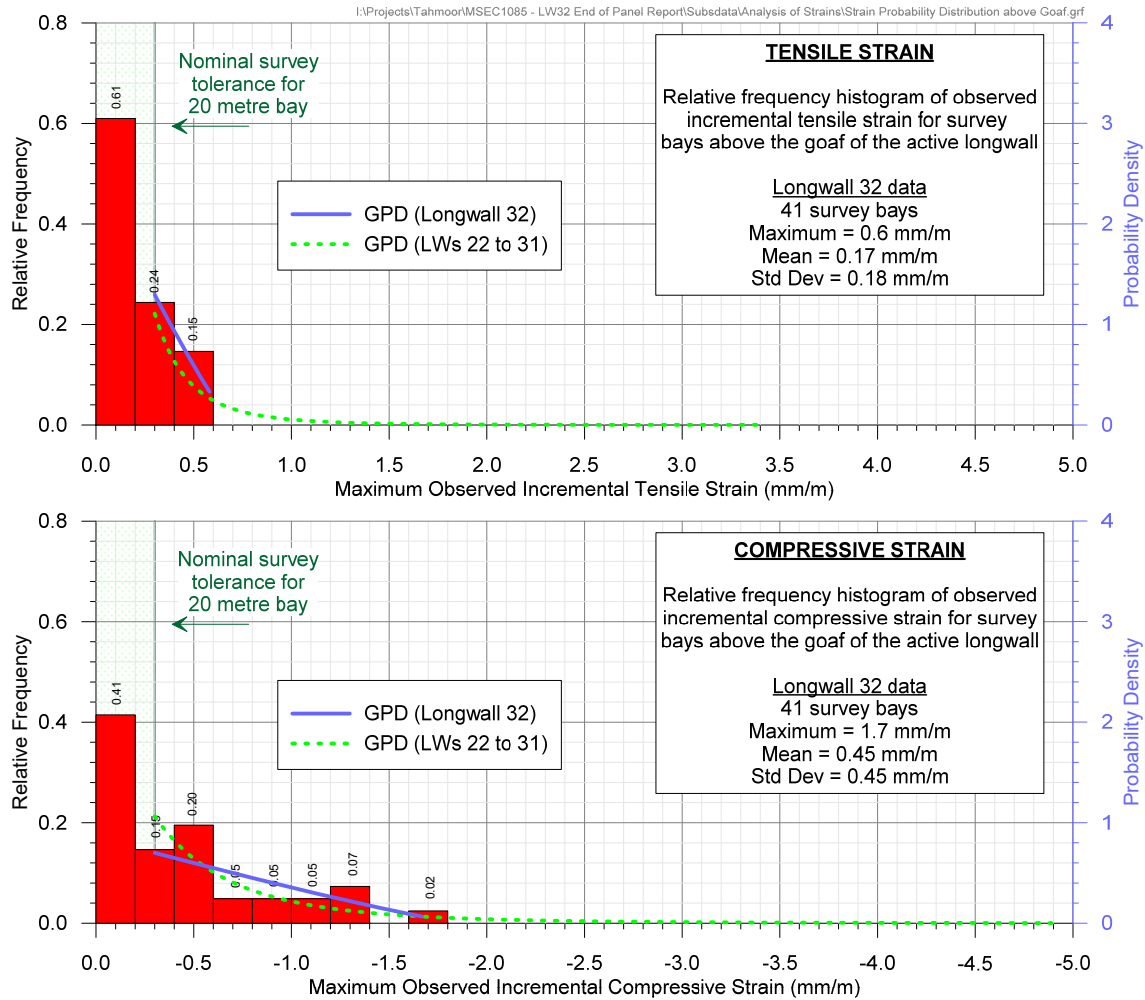
**Fig. 2.3 Observed incremental strain for survey bays above goaf resulting from the extraction of Longwall 32**

A *Generalised Pareto Distribution (GPD)* has been fitted to the raw strain data for Longwall 32, as shown in blue. The probability distribution functions for previous monitoring during the mining of Longwalls 22 to 31 are also shown in this figure, as dashed green lines. It can be seen from these comparisons, that the overall distribution of tensile and compressive strain resulting from the extraction of Longwall 32 was similar to that observed during the mining of Longwalls 22 to 31.

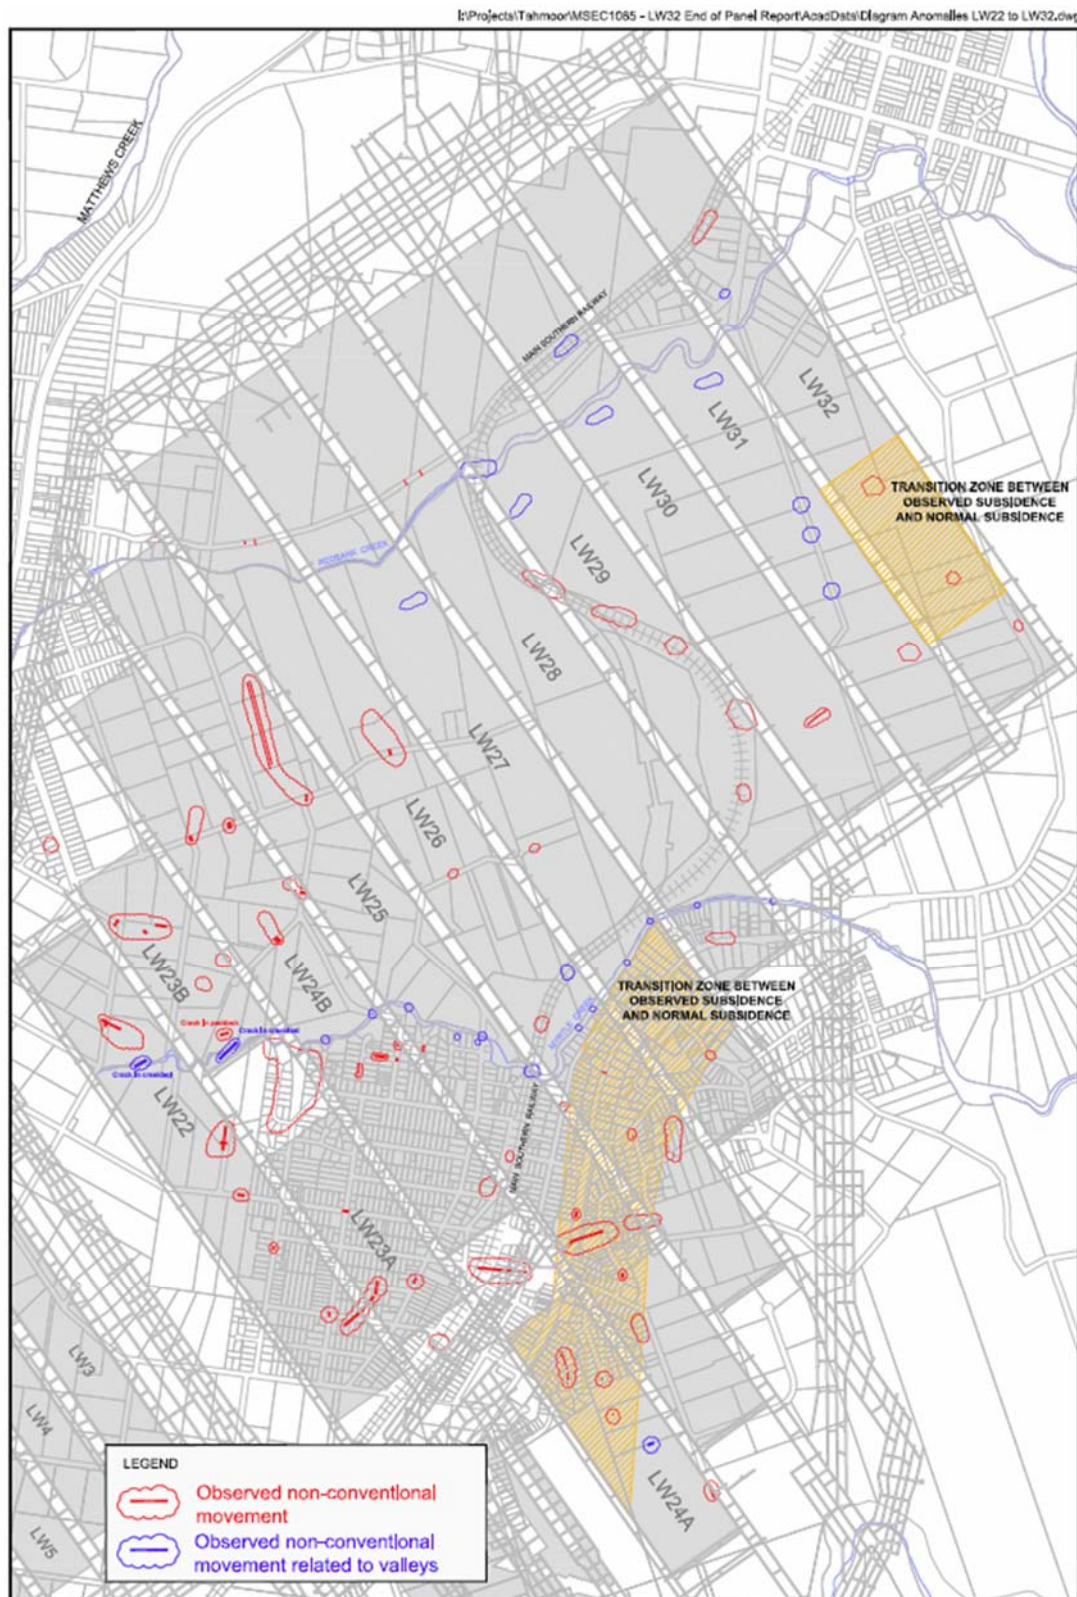
**Fig. 2.4 Map of locations of potential non-systematic movements**

A plan showing the locations of observed non-systematic movements at Tahmoor is shown in Fig. 2.4. The locations were selected based on ground monitoring results or observed impacts that appear to have been caused by non-systematic movement. A total of approximately 59 locations (not including valleys) have been identified over the extracted Longwalls 22 to 32, of which 4 new locations were observed during the mining of Longwall 32.

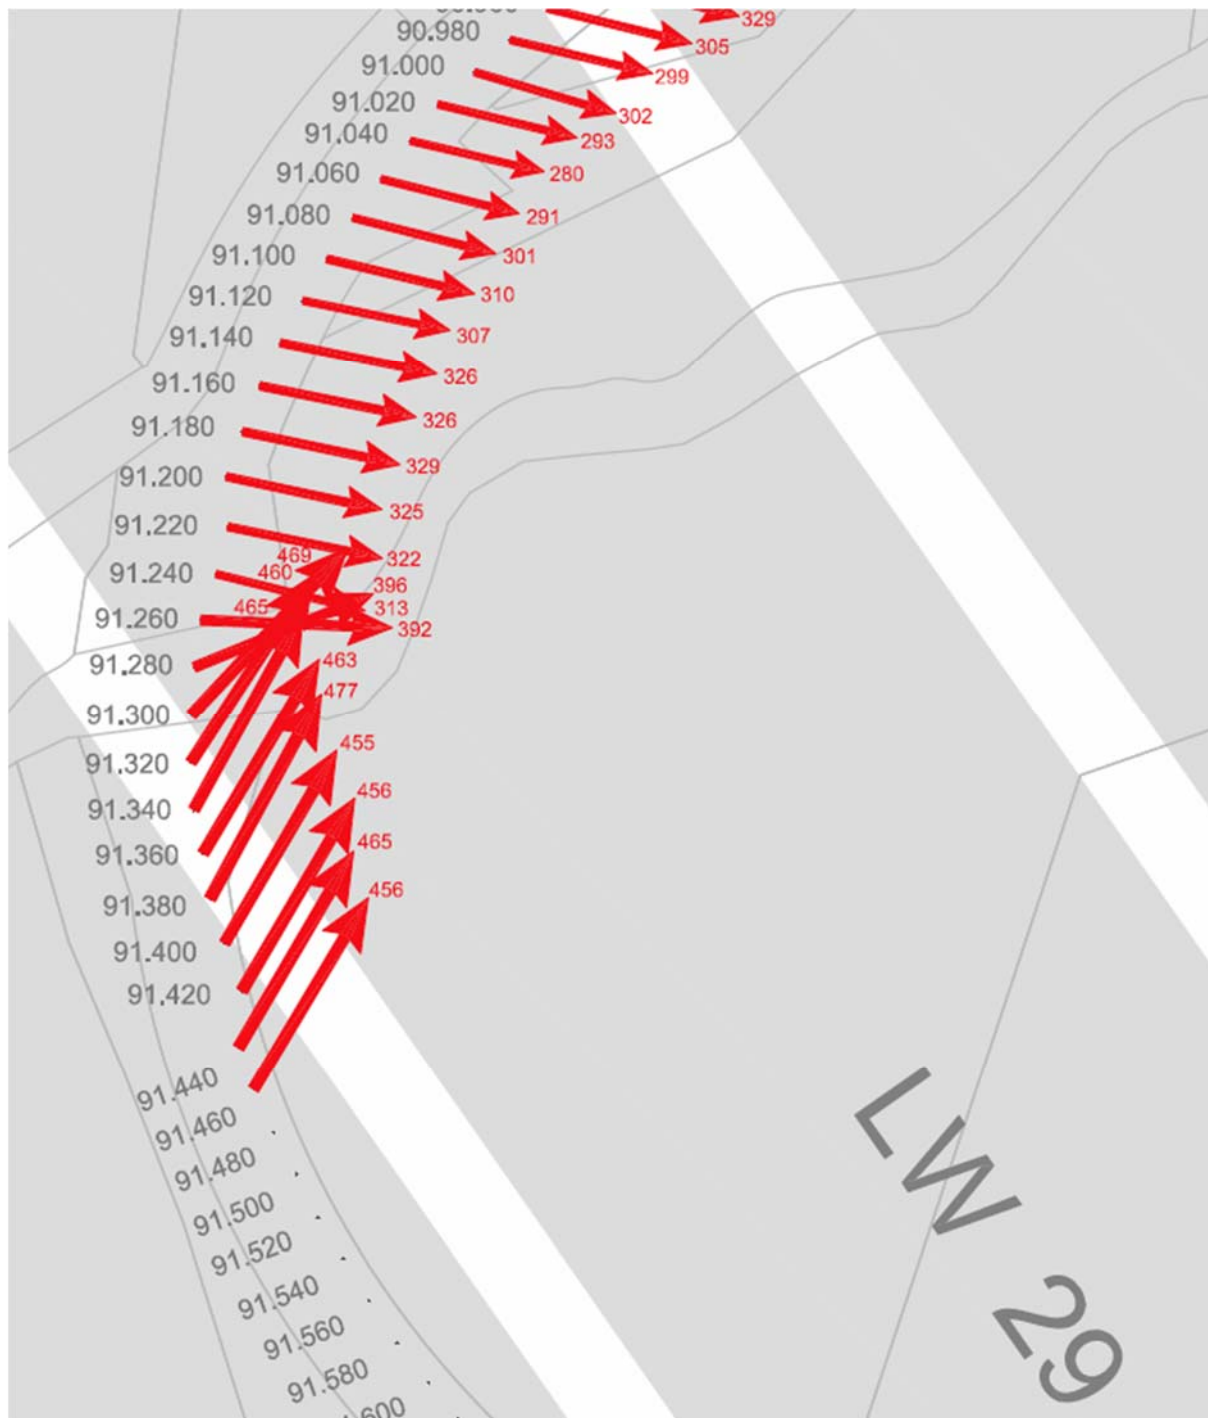
**Fig. 2.6** Observed total horizontal movement along Main Southern Railway during the mining of Longwalls 27 to 32

Observed absolute horizontal movements along the Main Southern Railway are shown in Fig. 2.6. It can be seen that the rockmass on the southern of Country side of the Culvert has moved in a different direction to the northern or Sydney side of the Culvert.

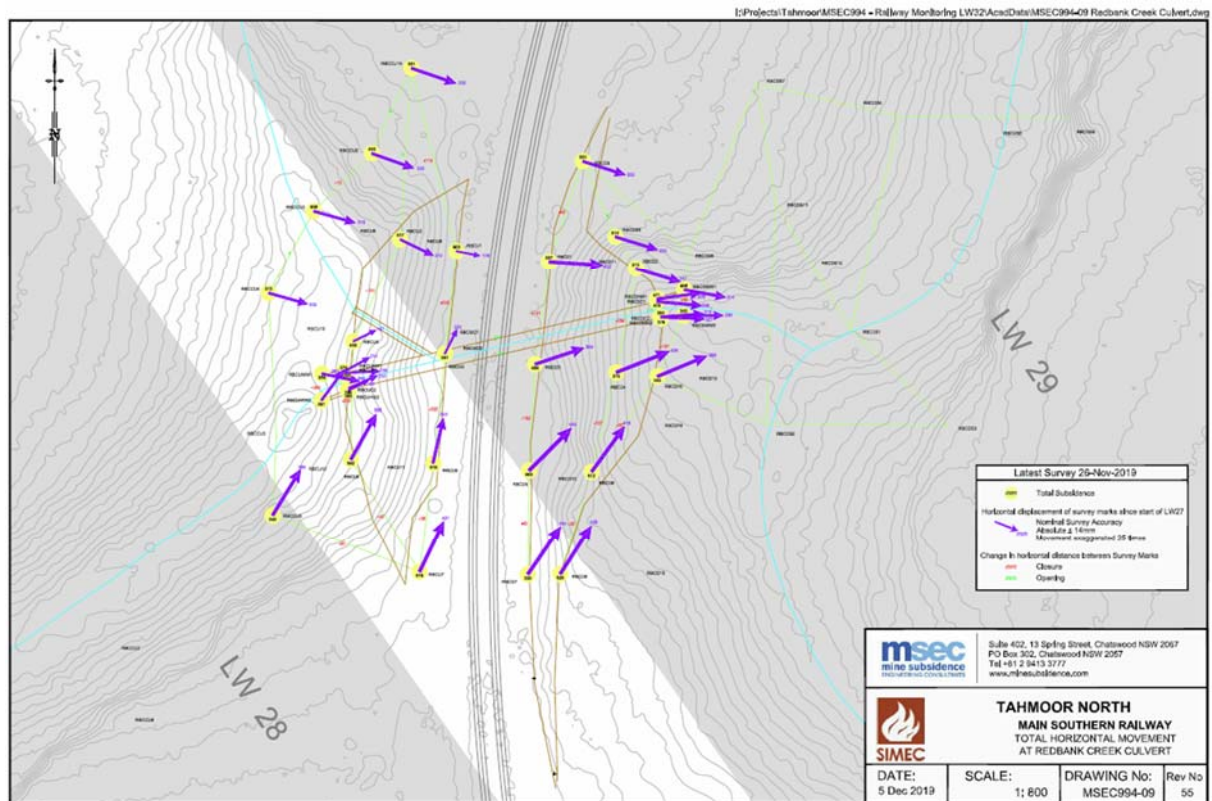
**Fig. 2.7** Observed total horizontal movement at Redbank Creek Culvert and embankment during the mining of Longwalls 27 to 32

Observed total subsidence and horizontal movement of survey marks in the immediate of the culvert and embankment are shown in Fig. 2.7. The results show that boundaries of the rockmass in the south-western quadrant intersect with the country side of the culvert. The corner of the rockmass is approximately aligned with midpoint of the culvert, which correlates well with observed detailed closure measurements inside the culvert itself.

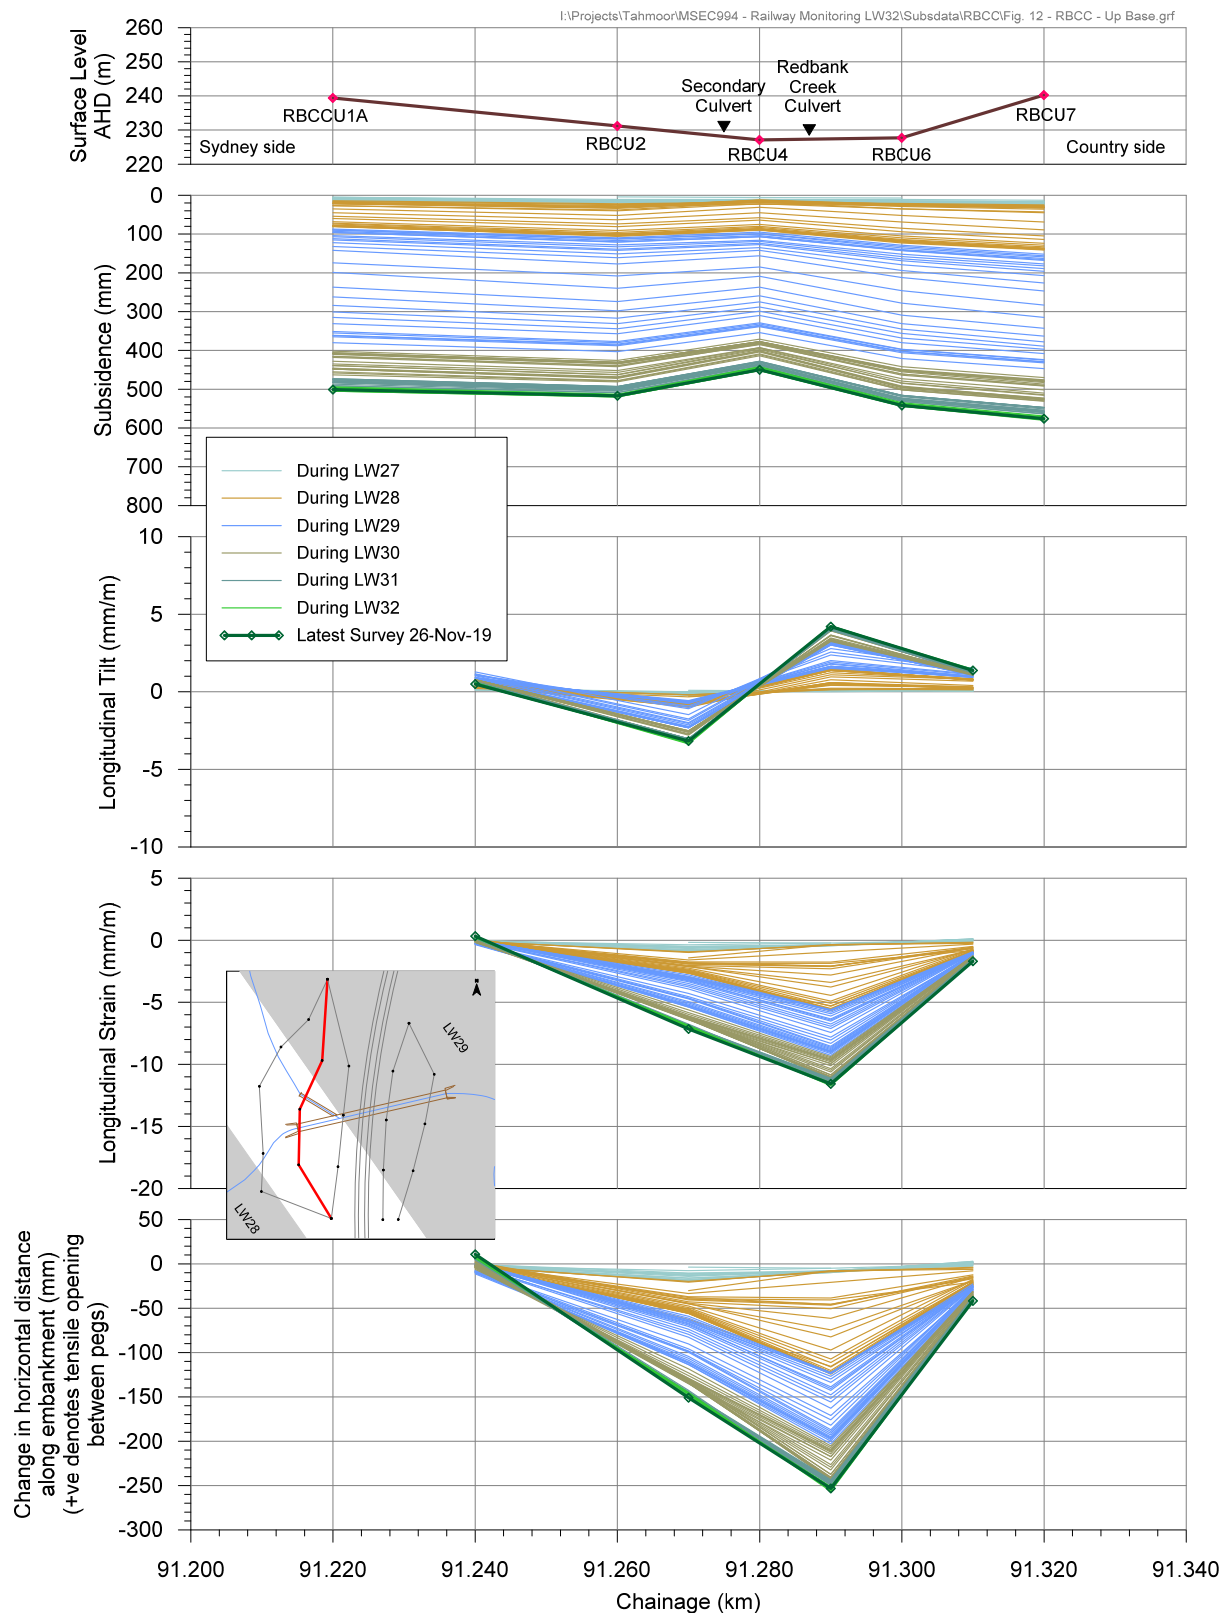
**Fig. 2.10 Observed total subsidence, tilt and strain across the upstream base of Redbank Creek Culvert due to the mining of Longwalls 27 to 32**

Observed subsidence along the base of the embankment on the upstream side is shown in Fig. 2.10. The results show valley closure focussing between Pegs RBCCU4 and RBCCU6, with upsidence observed at Peg RBCCU4. It can also be seen that no measurable change in ground strain was observed during the mining of Longwall 32.

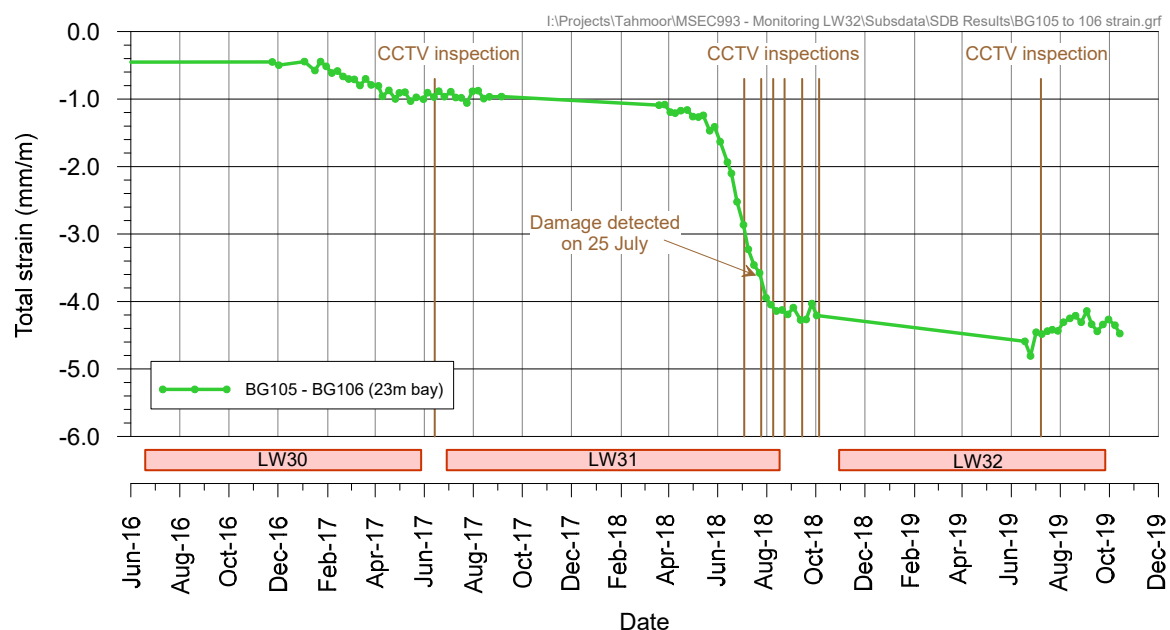
Fig. 2.11 Observed total strain between Pegs BG105 and B106 on Bridge Street

As shown in Fig. 2.11, a small increase in compressive strain was measured between Pegs BG105 and BG106 since the completion of Longwall 31, with minor changes observed. Sydney Water has commenced plans to repair the damaged section of pipe.

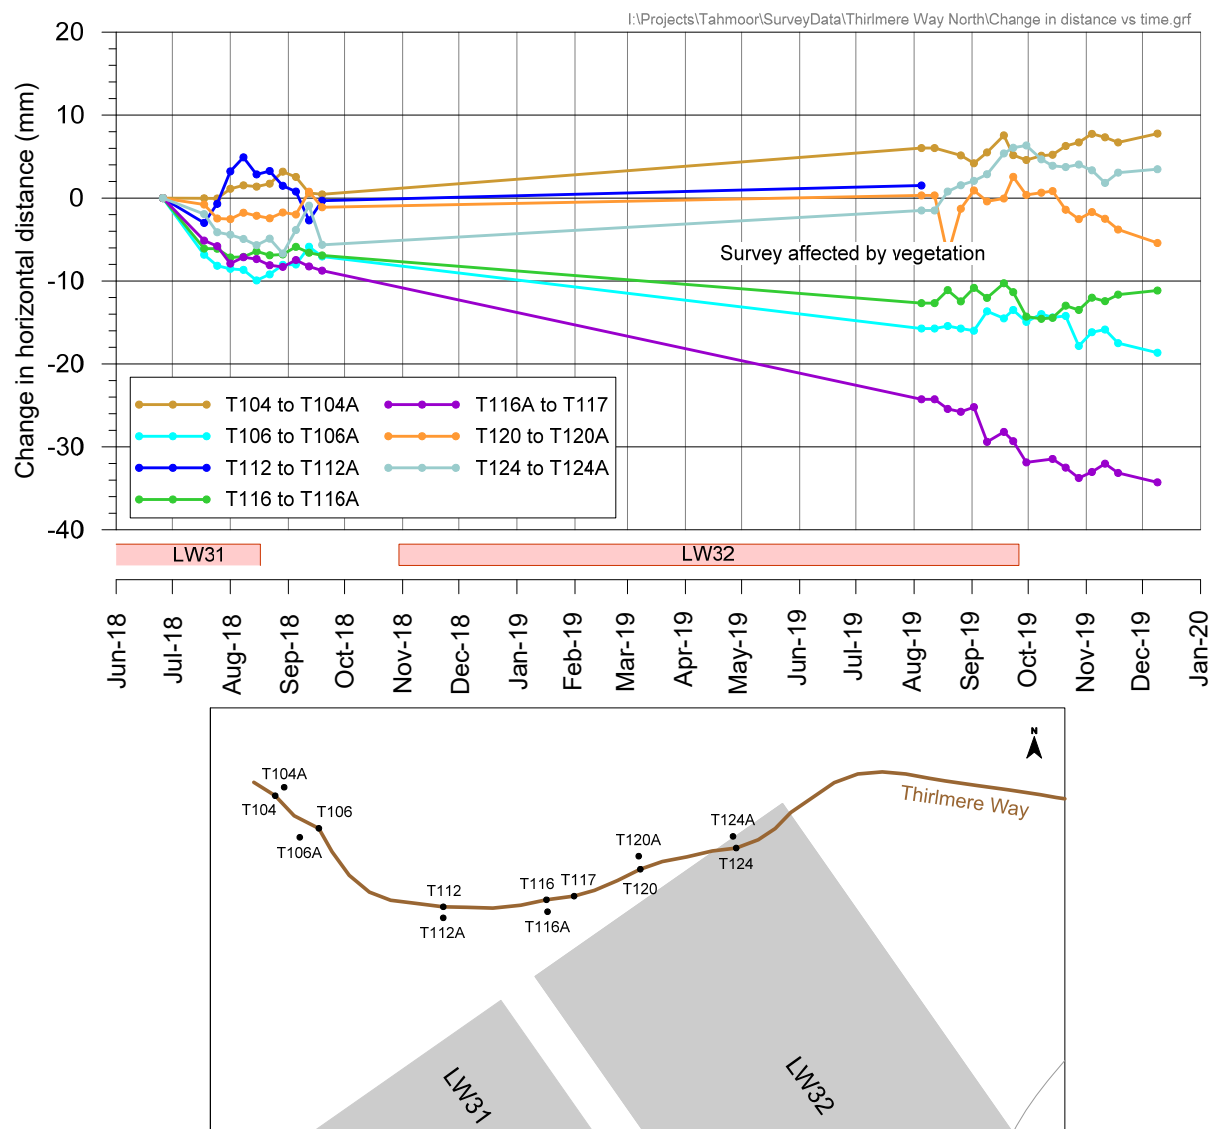
**Fig. 2.12 Changes in horizontal distance across Thirlmere Way over time**

Measured changes in distance across Thirlmere Way over time are shown in Fig. 2.12. Ongoing small changes are also observed between Pegs T116A and T117, which are oriented along Thirlmere Way on the southern side of the road. No impacts are observed to the pavement or around the pegs. The crash barrier cable on the northern side of the road opposite Peg T118 is slack. An inspection by geotechnical engineer GHD Geotechnics found that one of the support posts had been struck by a vehicle. No issues were identified that were indicative of instability.

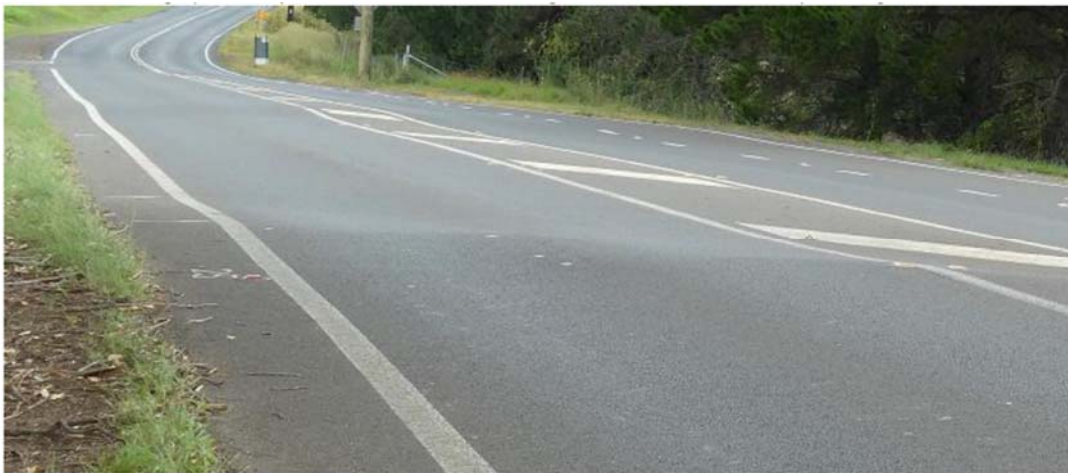
Bump on Remembrance Drive

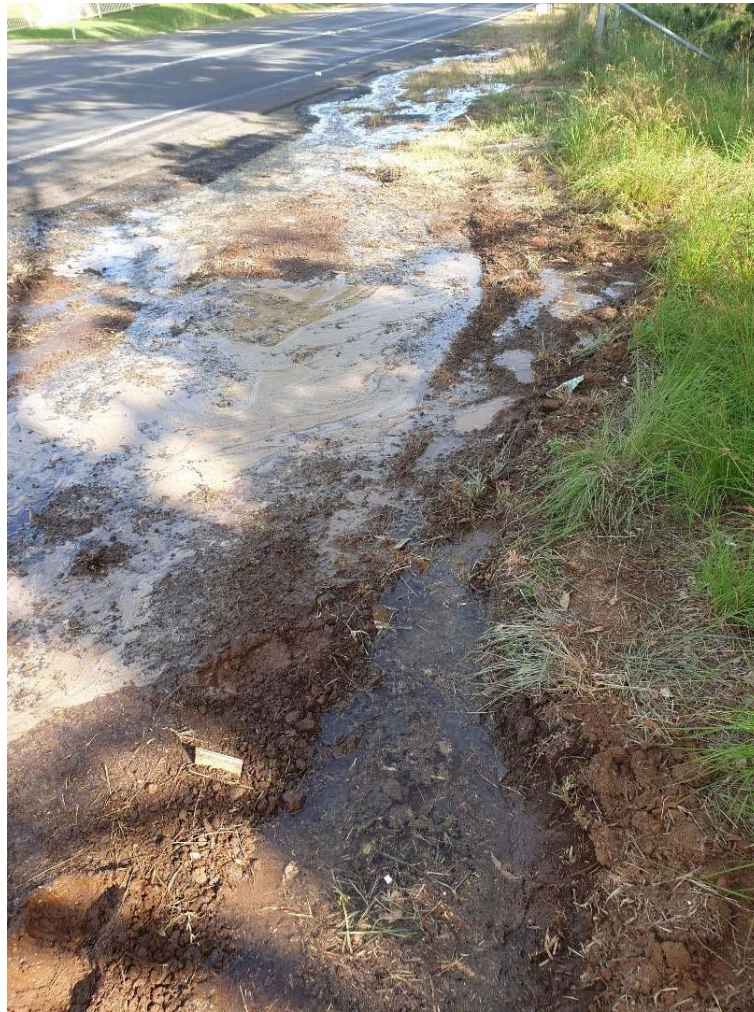
Sydney Water was consulted on 19 December 2018 regarding the development of compressive ground strain between Pegs RD26 and RD27, where the bump had formed in the road pavement. Twice weekly focussed inspections were being conducted at this location. The water main was found leaking on the morning of 8 February 2019. The main was able to support water pressure and the Picton reservoir was 93% full at the time. The water main was repaired on the evening of 8 February. A photograph of the leak is shown in Fig. 4.2.

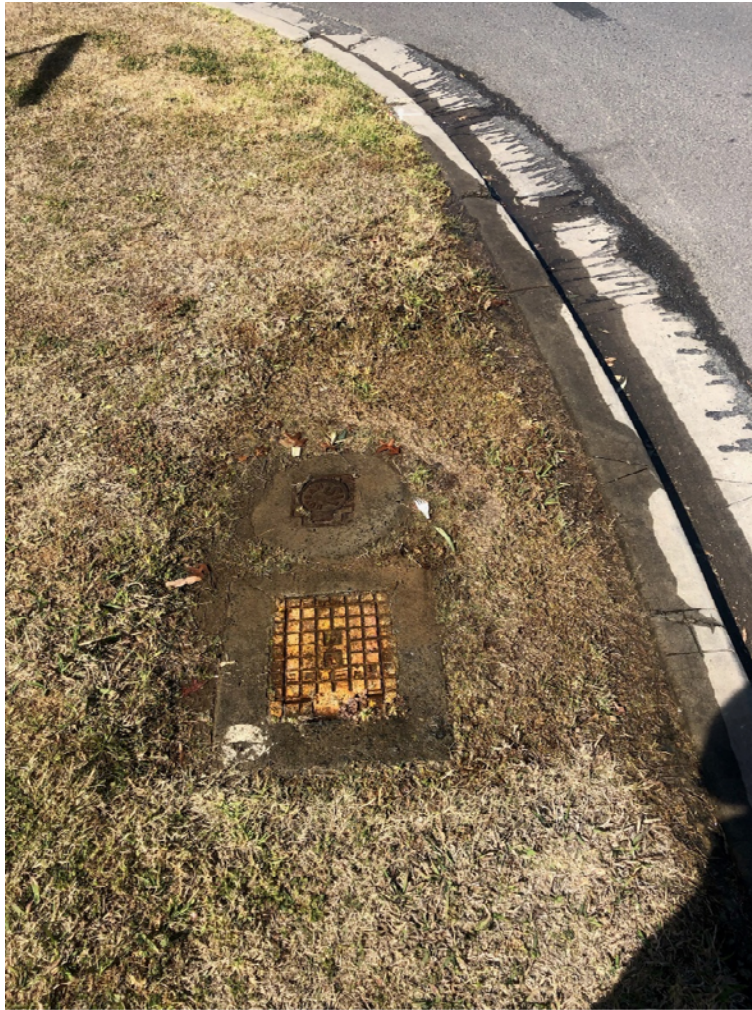
A minor water leak was observed on 21 August 2019 at the corner of Bridge Street and Redbank Place. The leak occurred at a stop valve and hydrant and was repaired on 22 August. A photograph of the leak is shown in Fig. 4.3.
