**Tahmoor Coal Pty Ltd**

# **SIX MONTHLY SUBSIDENCE IMPACT REPORT**

**Western Domain Longwalls West 1 – West 4**

**Report 5 – June 2022**

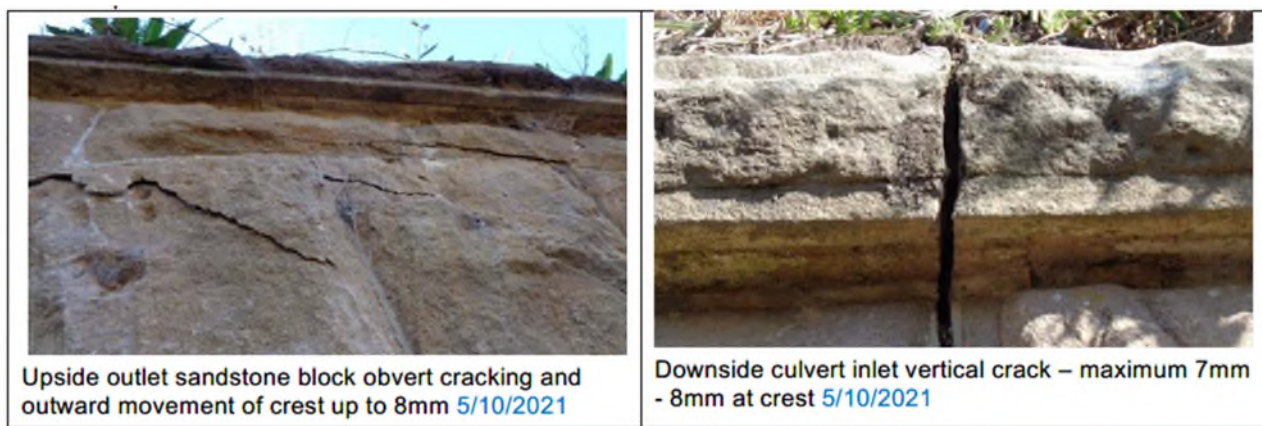
- Historical Heritage TARP – Level 3 Trigger for impacts to sandstone culvert at 88.400 km and 88.980 km. These impacts included cracking and minor spalling. This Level 3 TARP trigger is a continuation of the TARP notification to DPE on 21 September 2021. Tahmoor Coal will undertake remediation after the full effects of LW W3-W4 have been completed;

Figure 2-1 Cracking at culvert 88.44 km

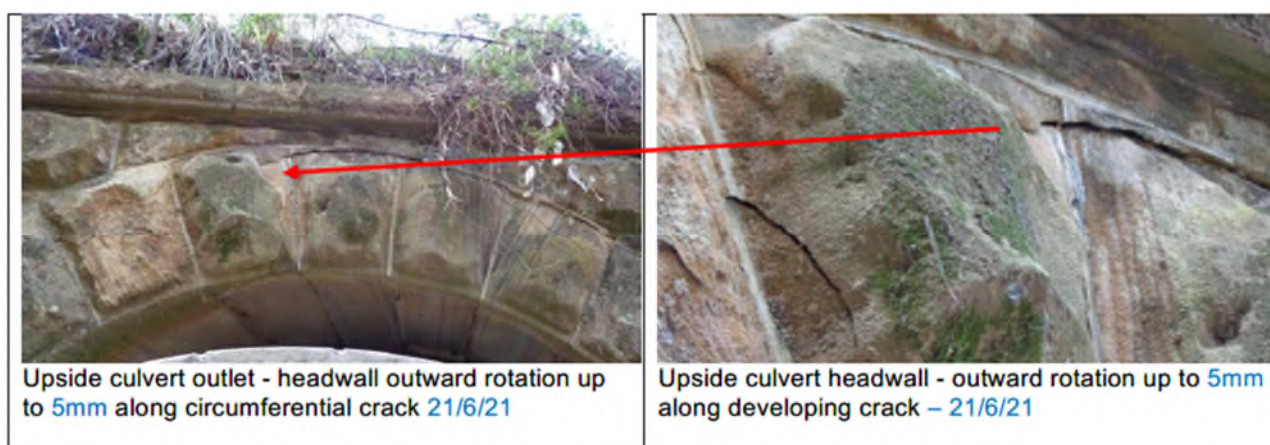
Figure 2-2 Cracking at culvert 88.980 km

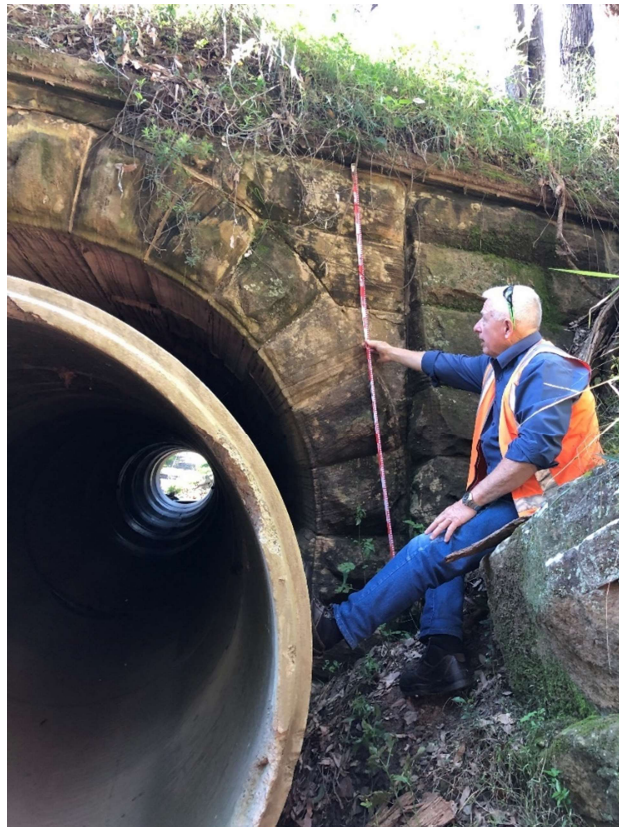
Western portal. Cracking around arch stones that was first noted during extraction of LW W2 has not worsened during LW W3.

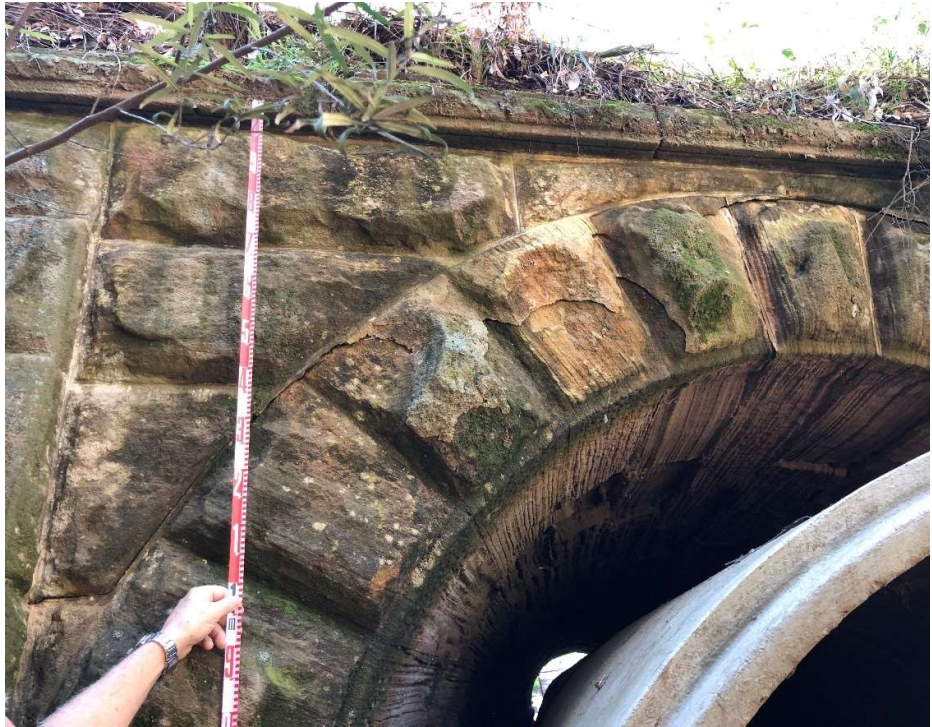
Western portal. Cracking along the mortar and spalling of the arch stones has not worsened significantly during extraction of LW W3.

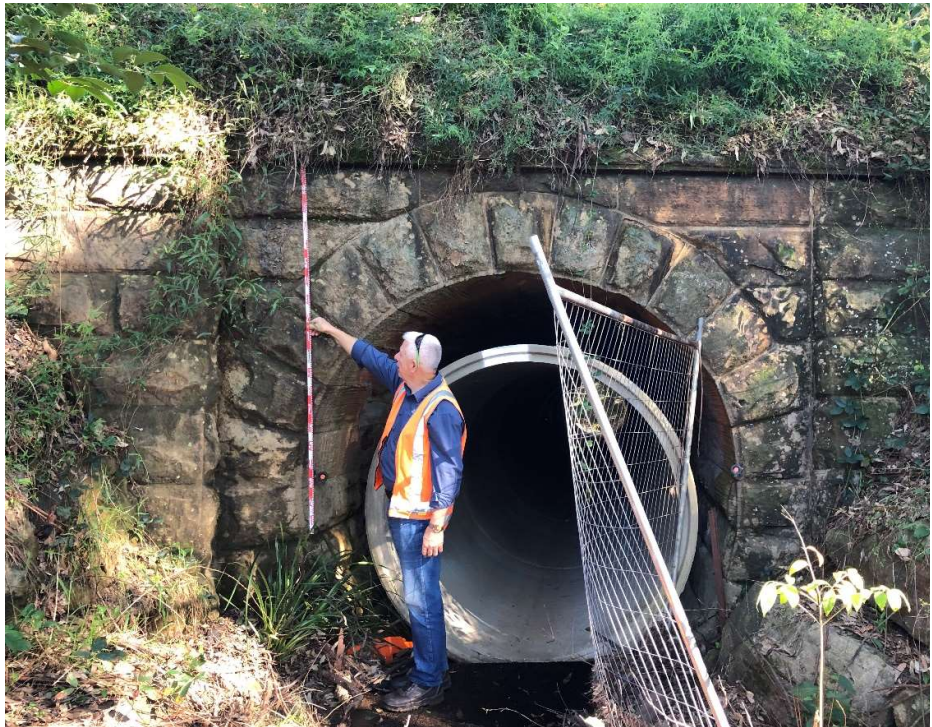
Eastern portal, generally in good condition.

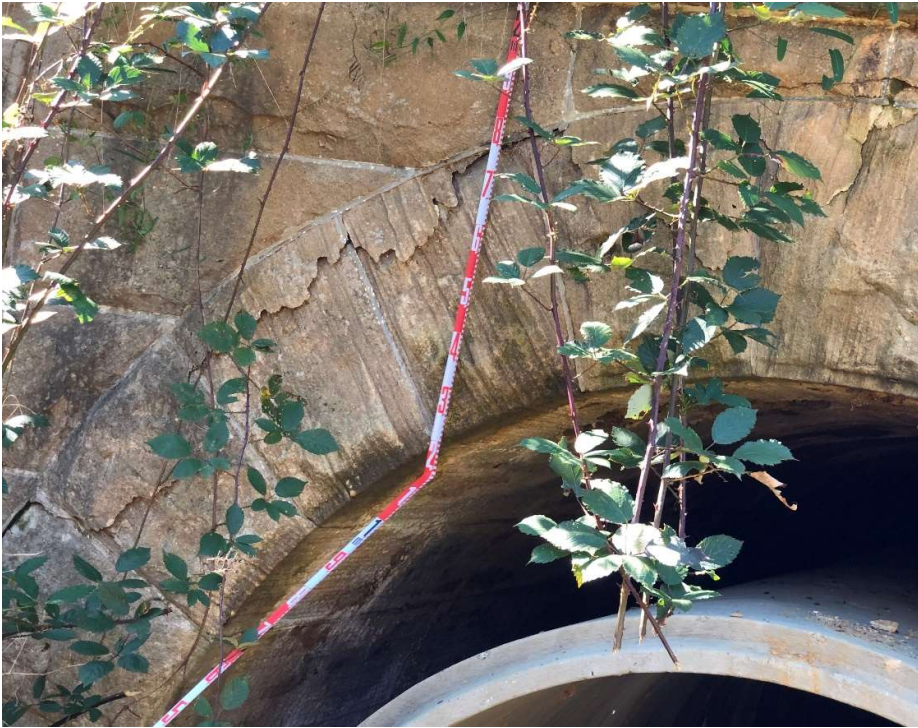
<p>Western portal. Spalling above the arch that developed during extraction of LW W2 has not worsened significantly during LW W3.</p>

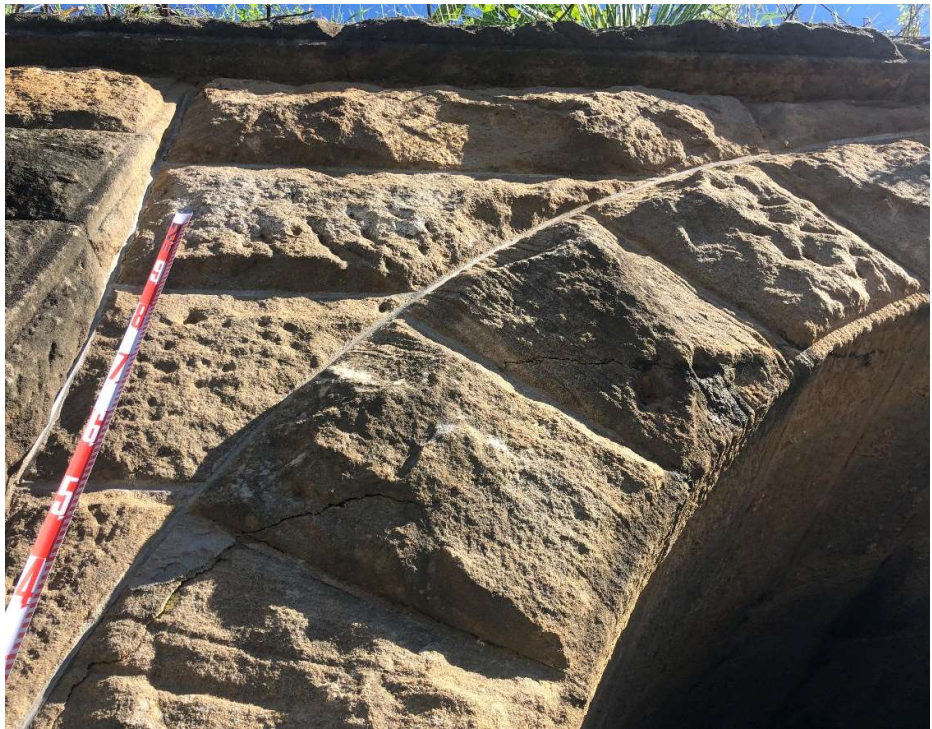
Eastern portal. No worsening of cracking during extraction of LW W3.

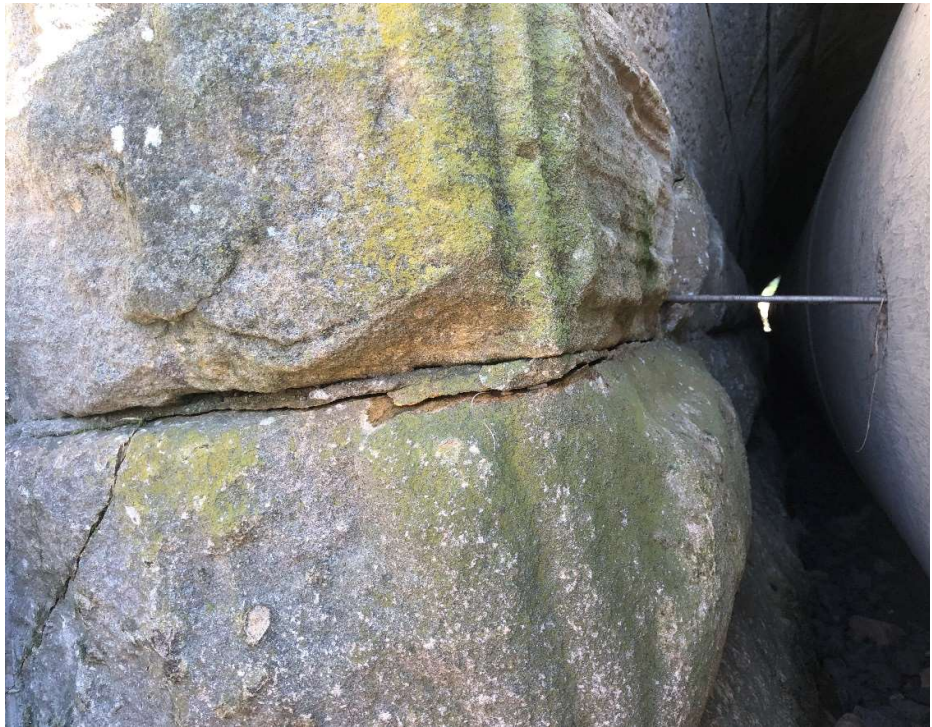
Eastern portal. Screw securing concrete sleeve to the arch of the culvert has resulted in some cracking along the mortar and through the sandstone.

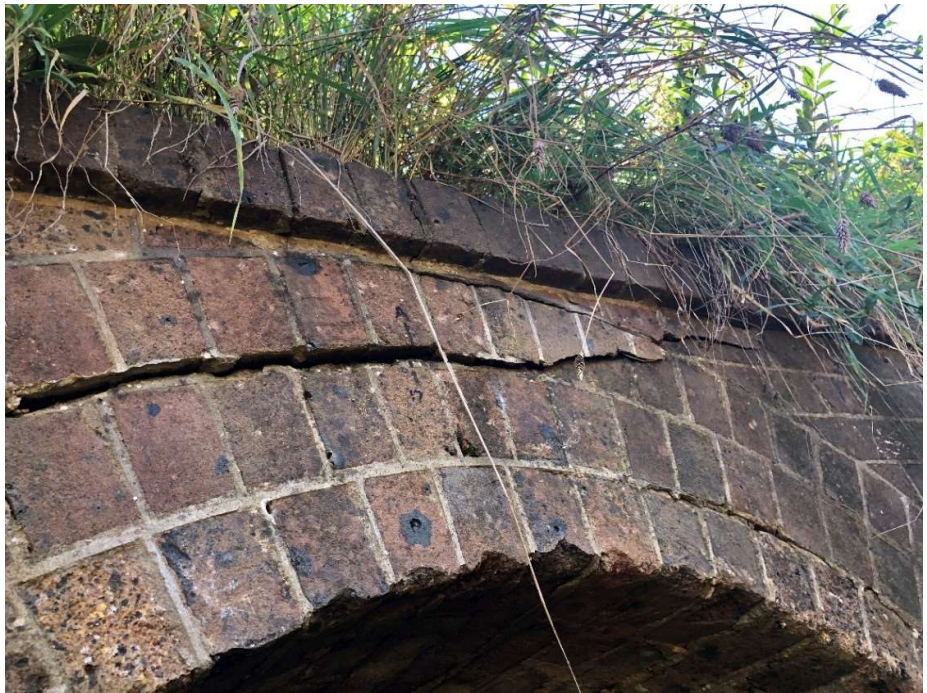
Detail, pre-existing cracking and displacement of bricks around the eastern portal arch that does not appear to have worsened significantly during longwall mining in the Western Domain.

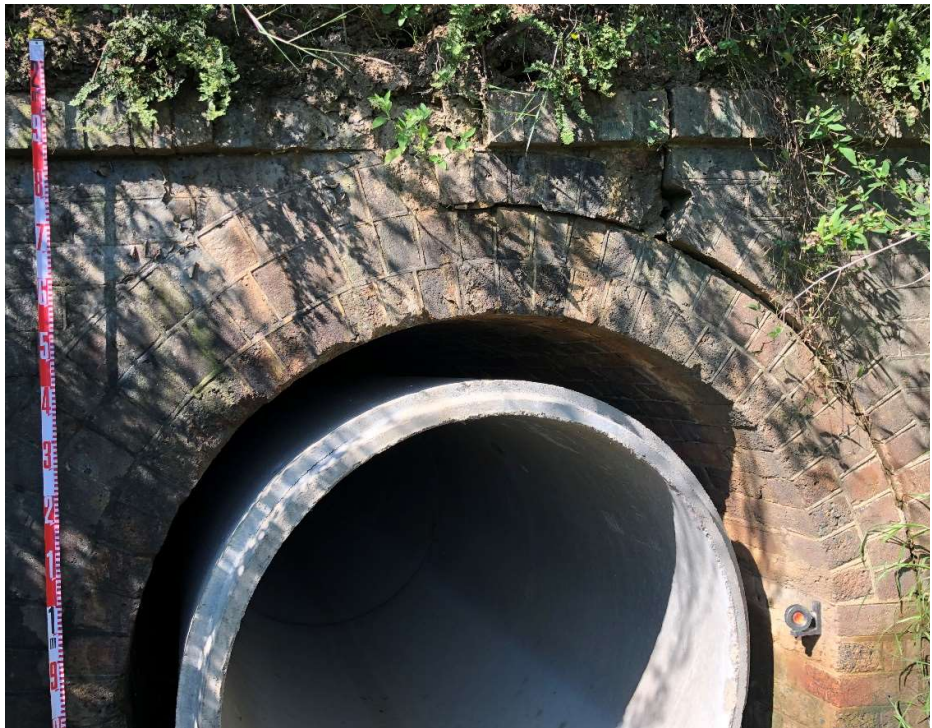
Cracking and displacement of bricks around the western portal arch. Does not appear to have worsened during longwall mining in the Western Domain.

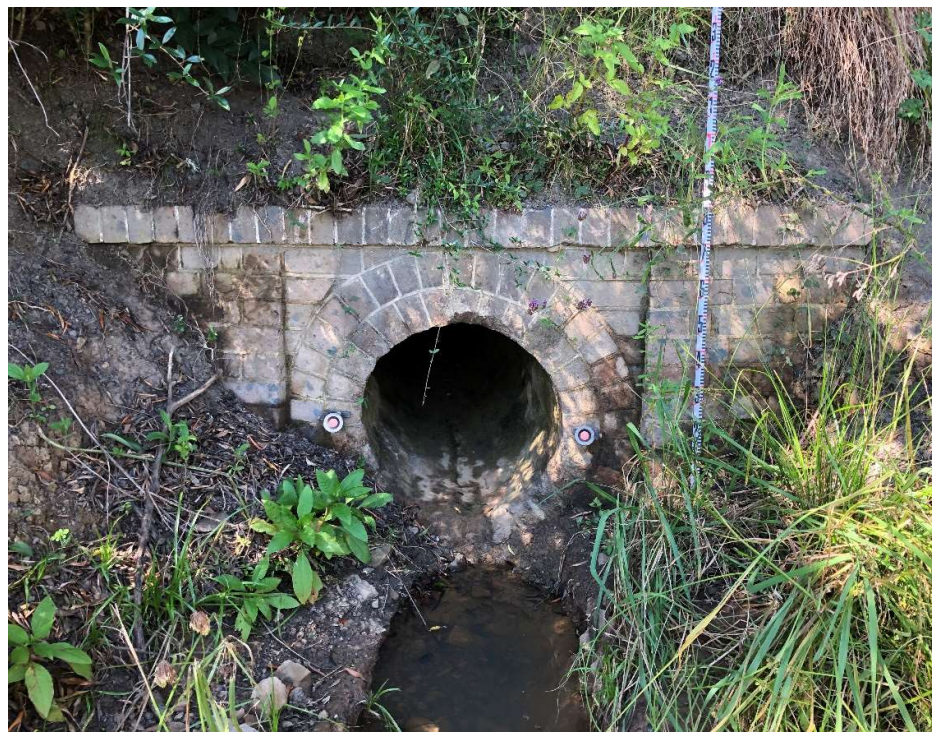
Western portal. In sound condition

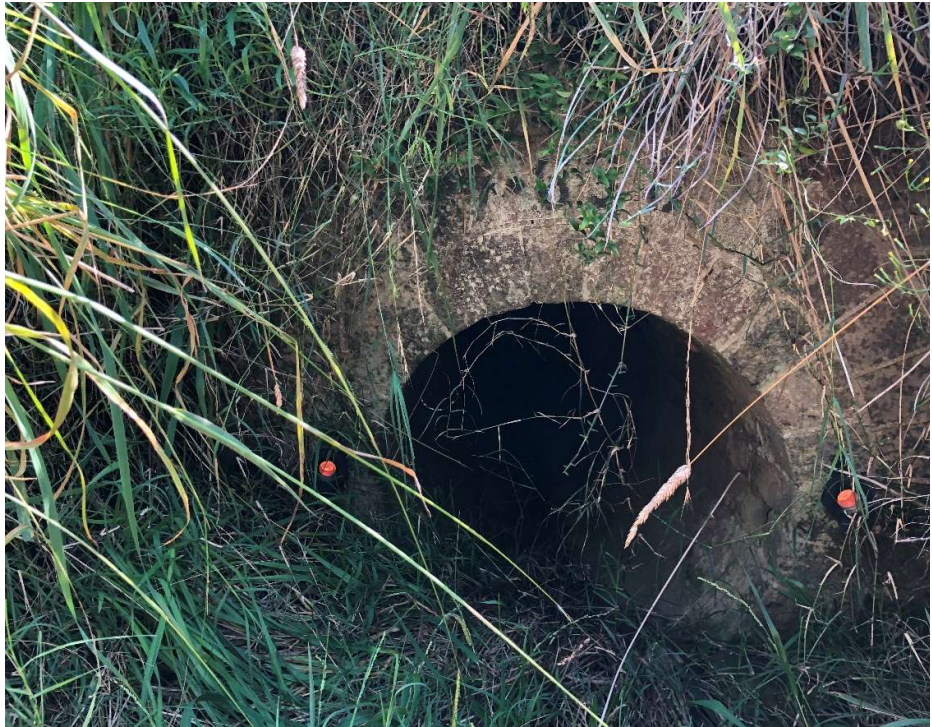
Eastern portal. Overgrown but appears to be in sound condition.

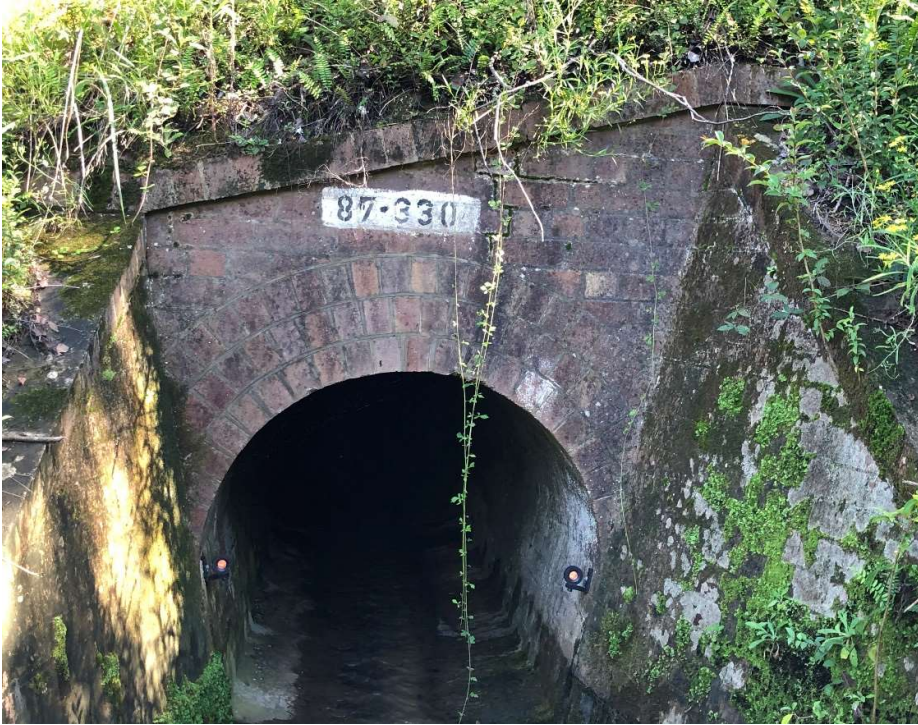
<p>Eastern (downside) portal. In sound condition</p>

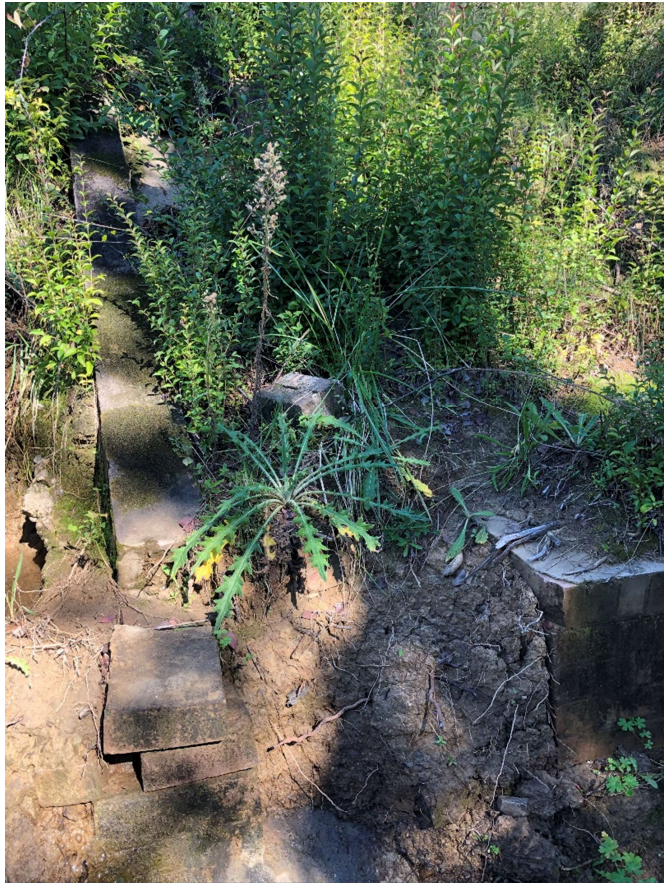
Displaced bricks at the base of the brick chute to the south of the eastern portal.

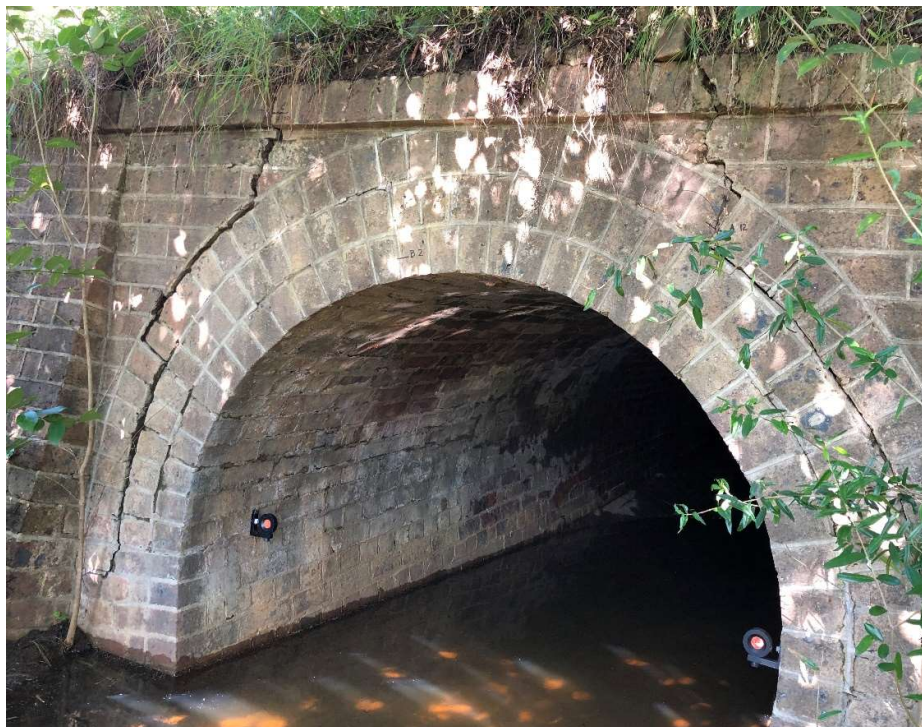
Northern portal. Difficult to access due to water and weeds. Pre-existing cracking around the arch, mostly through mortar.

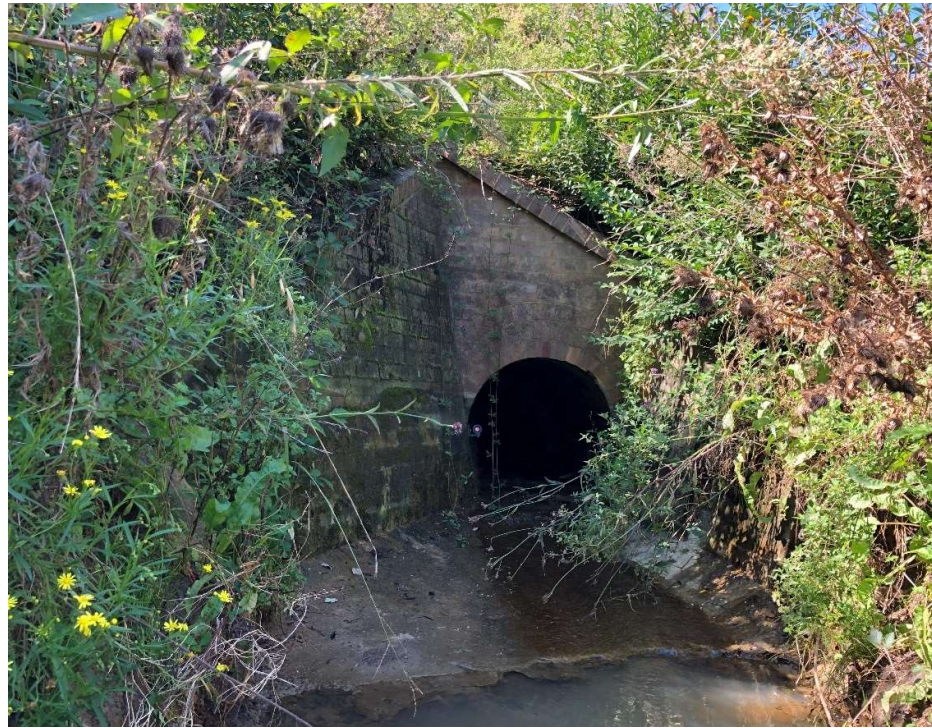
Western portal. In sound condition.

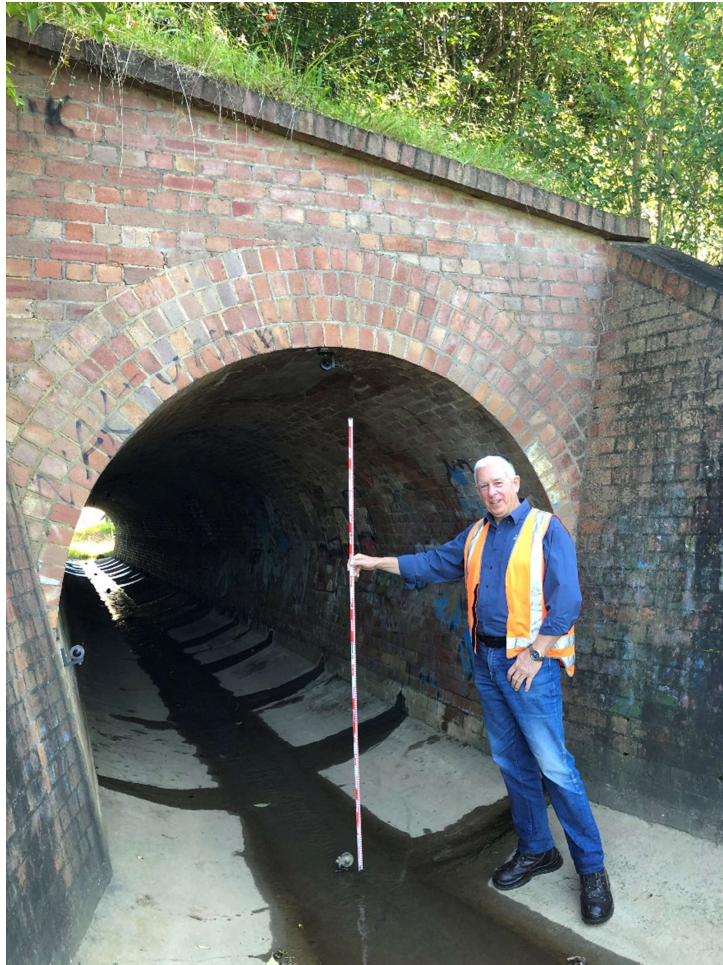
Eastern portal. Culvert is in good condition.

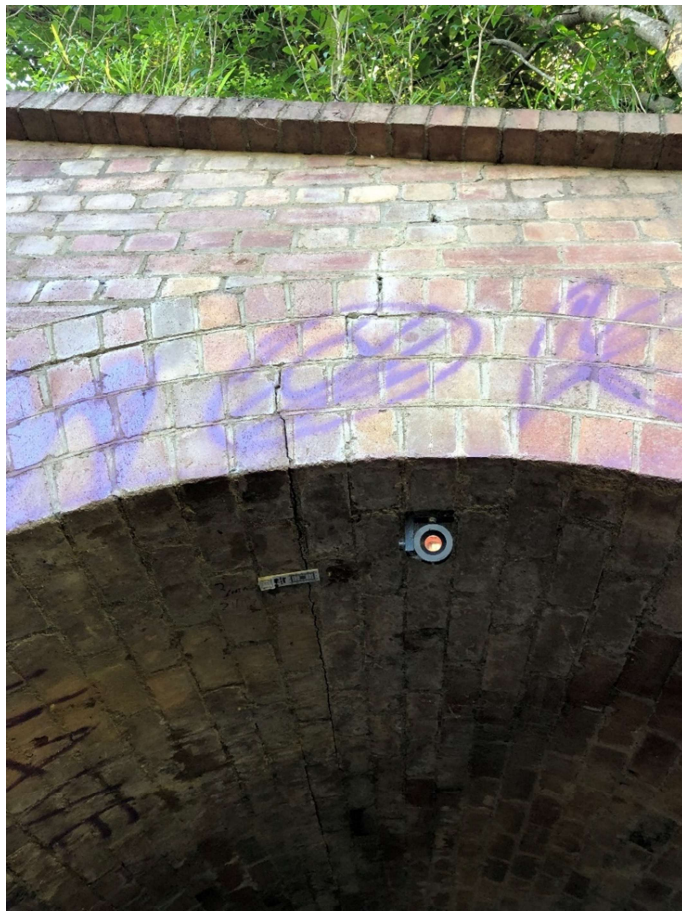
Western portal. Cracking through the mortar above the arch continues along the roof of the culvert.
