## 27 Remembrance Drive, Tahmoor

Structural Inspection Report: R0194-Rev1

Re: 27 Remembrance Drive, Tahmoor

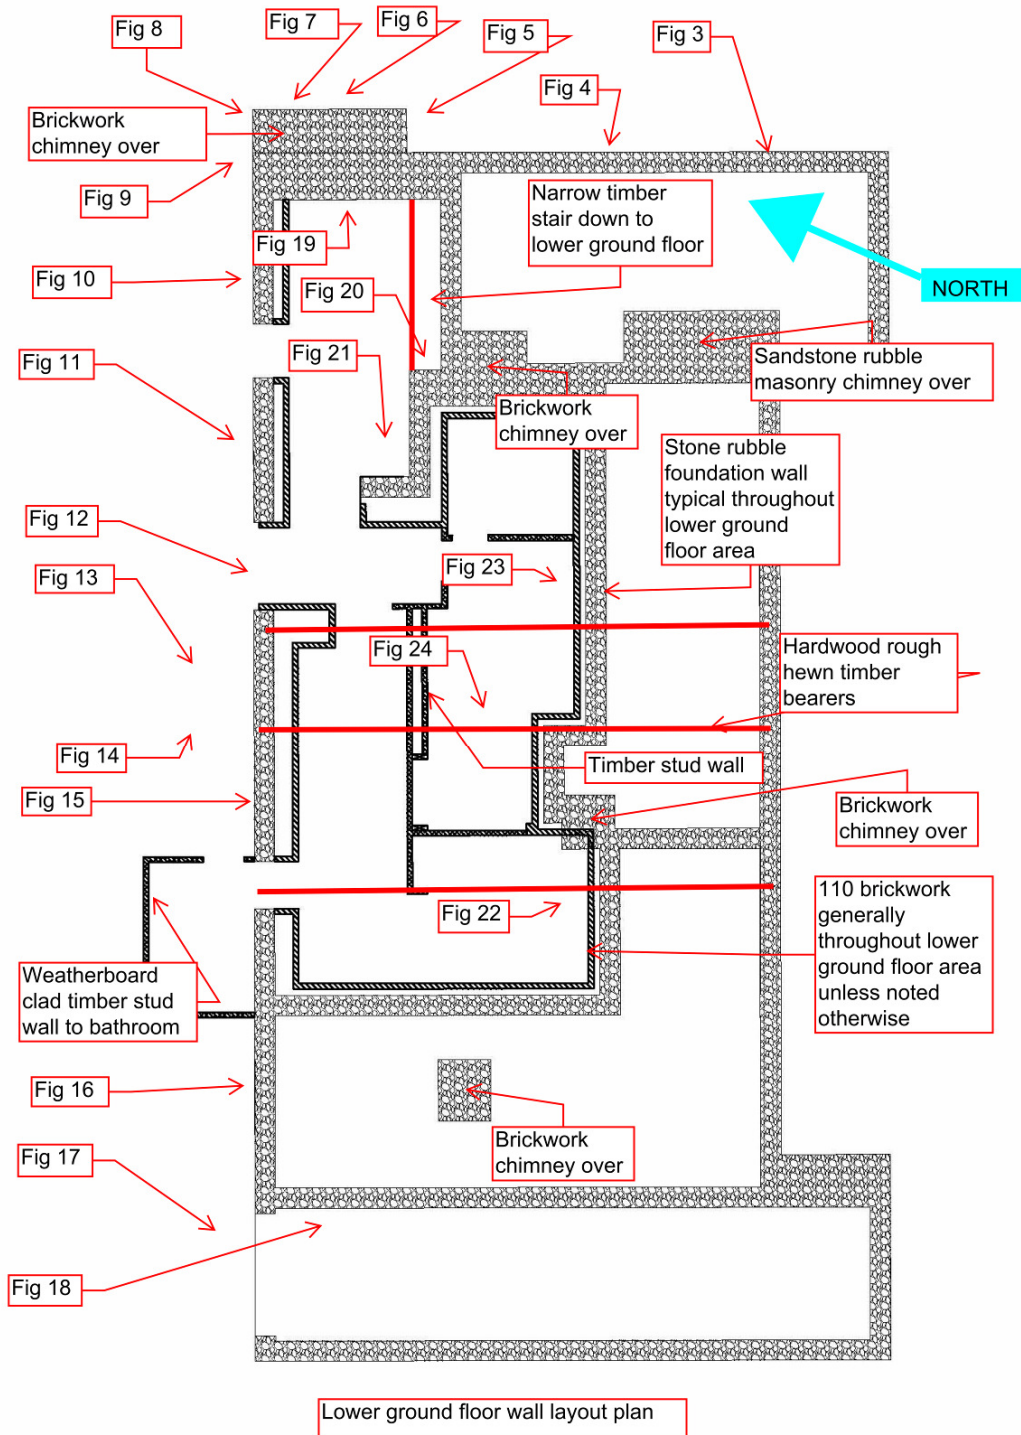
Figure 2

The sandstone rubble foundation wall along the northern elevation of the dwelling (refer to figure 2 in Appendix A) appears to have been constructed as an infill between stack bonded sandstone block piers, refer to figures 3, 4 5 & 6 in Appendix A. Each stone comprising the stack-bonded piers appears to be bedded upon a cement mortar. The infill walls appear to have been constructed by setting the larger stones and then dry-fitting stone spalls more or less carefully into the interstices after which mortar was dashed into the remaining spaces in an attempt to work the mortar into the crevices. The walls appear to contain headers every metre or so along the wall that serve to bind the stones together and prevent the foundation wall from splitting under imposed vertical load.

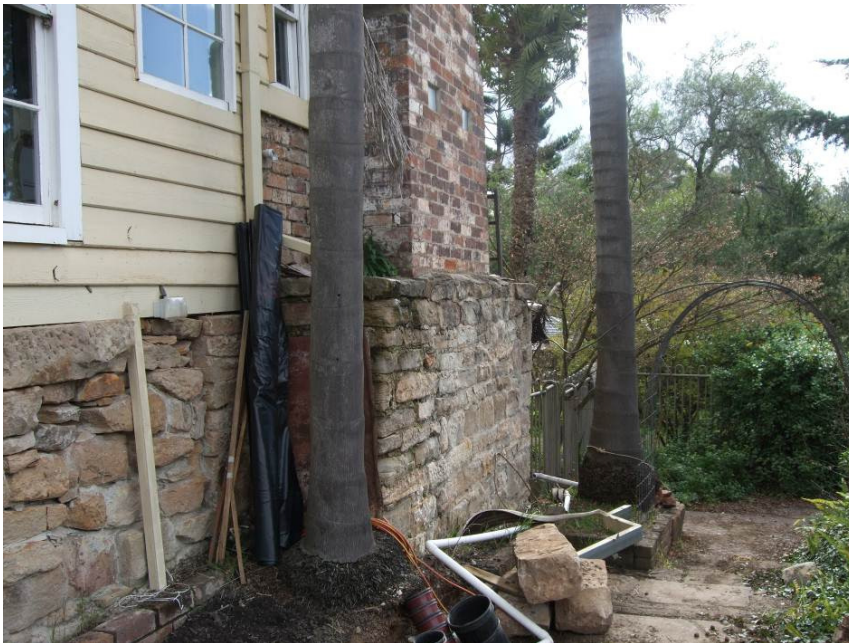
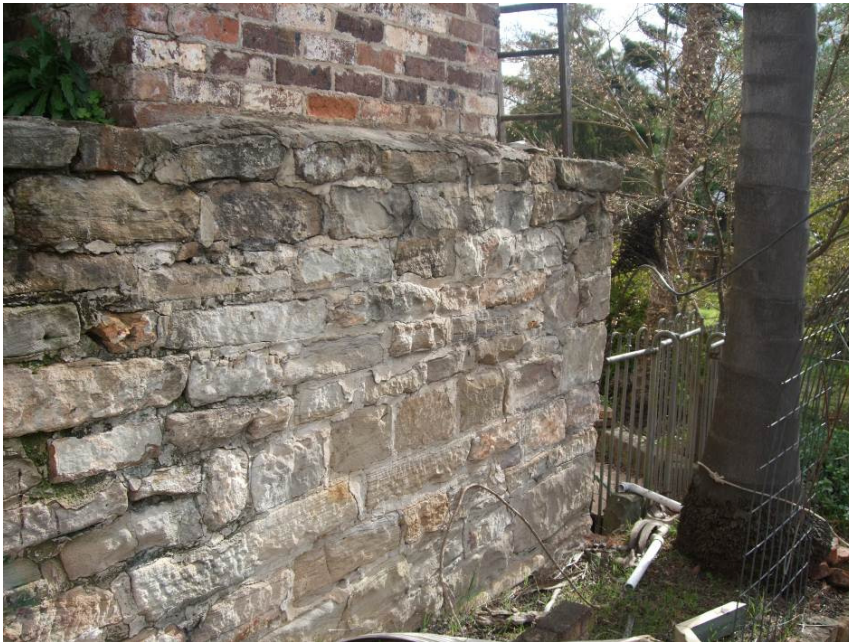
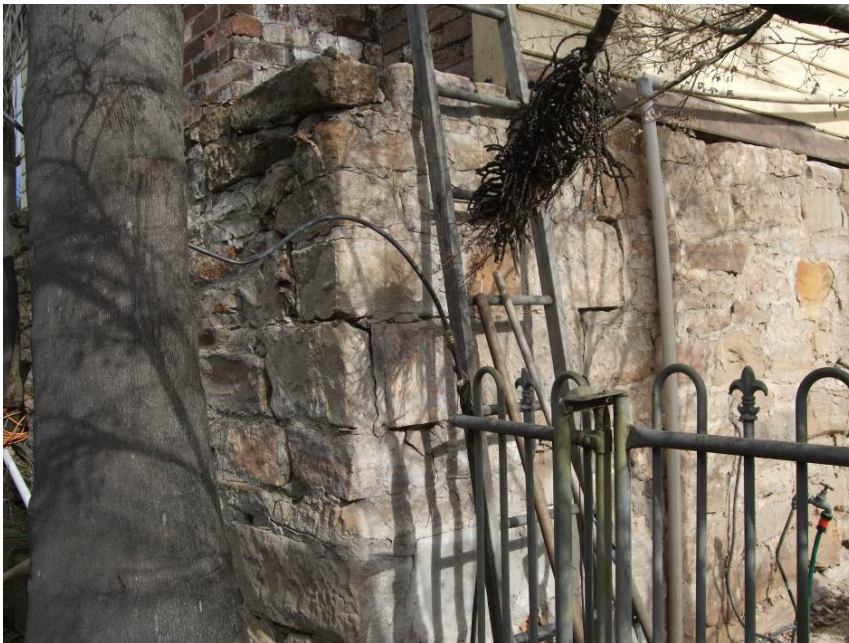
The foundation wall to the kitchen chimney was constructed as a sandstone rubble wall where the external face of the walls was carried up with a good; refer to figures 6, 7 & 8 in Appendix A. There is some historical evidence inferring that the mortar used in the construction of much of the sandstone rubble walls was a cement stabilised clay mortar with the clay being locally sourced (no material testing was conducted). The mortar erosion evident figure 14 in Appendix A and figure 50 in Appendix D supports the argument that the mortar was most likely a cement stabilised clay mortar.

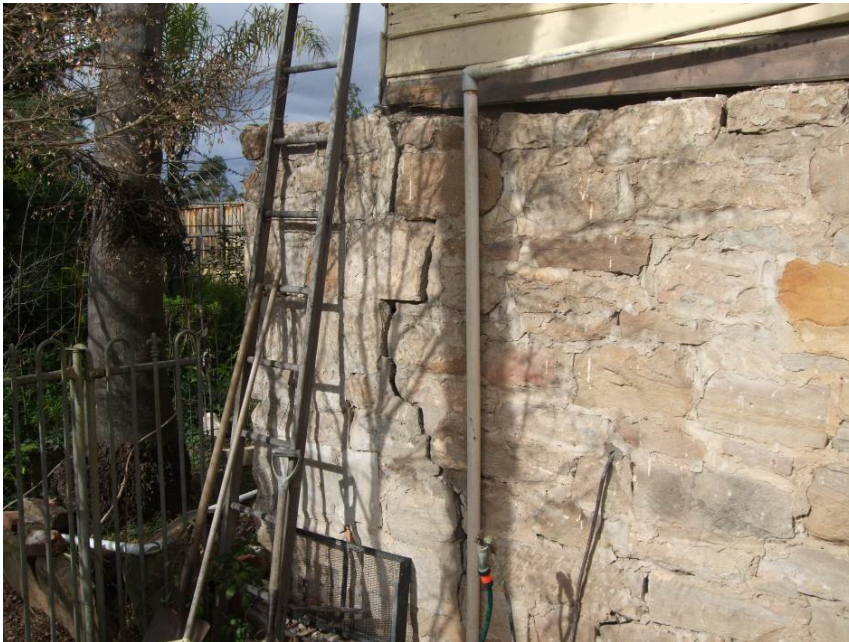
Figure 9 the northwestern corner of the foundation wall outside the laundry prior to repair

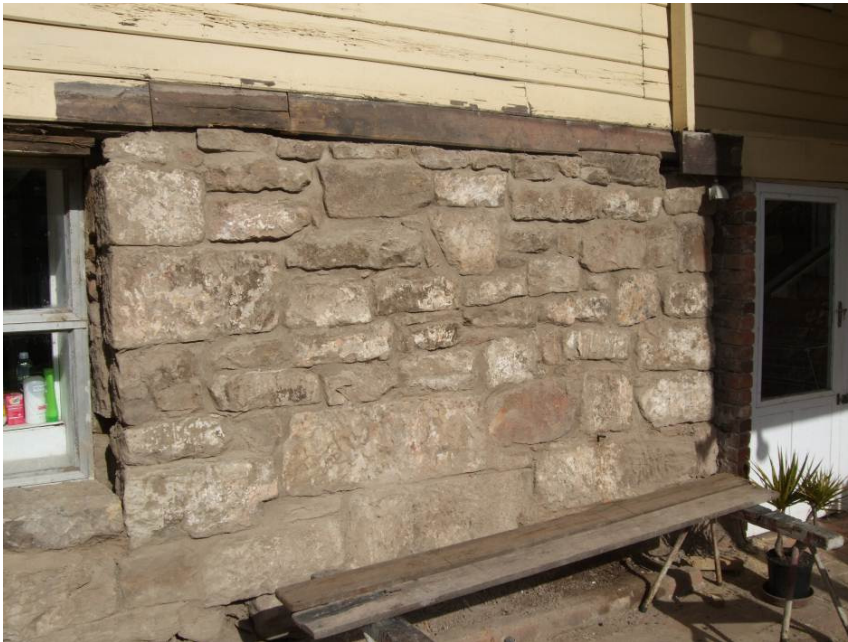
Figure 11 Repaired foundation wall outside laundry at the northwestern corner of the dwelling contrast with the damage evident in figure 50 in Appendix D after the brick veneer wall was demolished

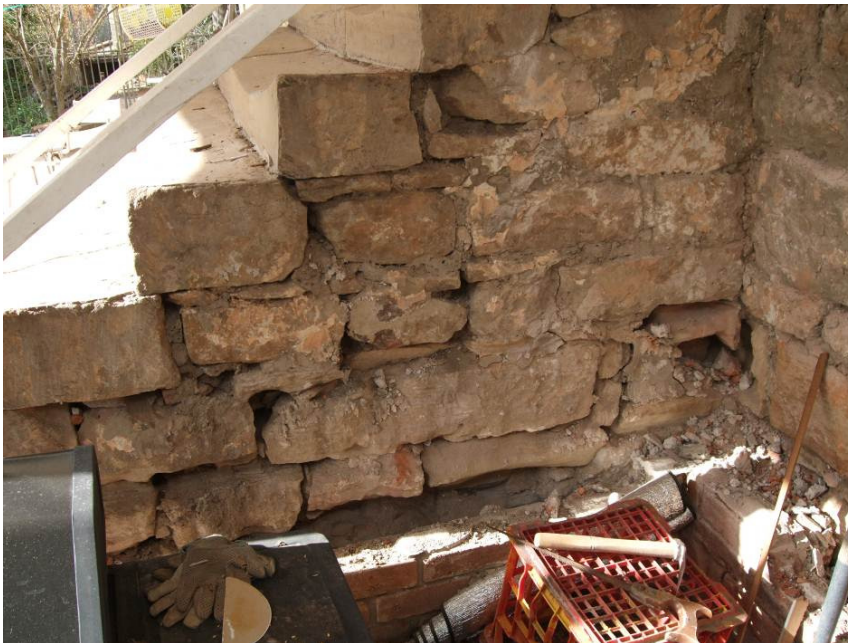
Figure 14

The western foundation wall and the walls supporting the external stair have been substantially repaired since the veneer brick wall was demolished during 2009. The owner advised that the repairs were carried out using a cement stabilised clay mortar “consistent with the mortar used elsewhere in the original building”. There was significant mortar damage at a number of locations with the most severe damage shown in figure 50 in Appendix D resulting from rainfall erosion. Rising damp softened the mortar above ground level in the sidewalls to the external stair; refer to figure 14 in Appendix A.

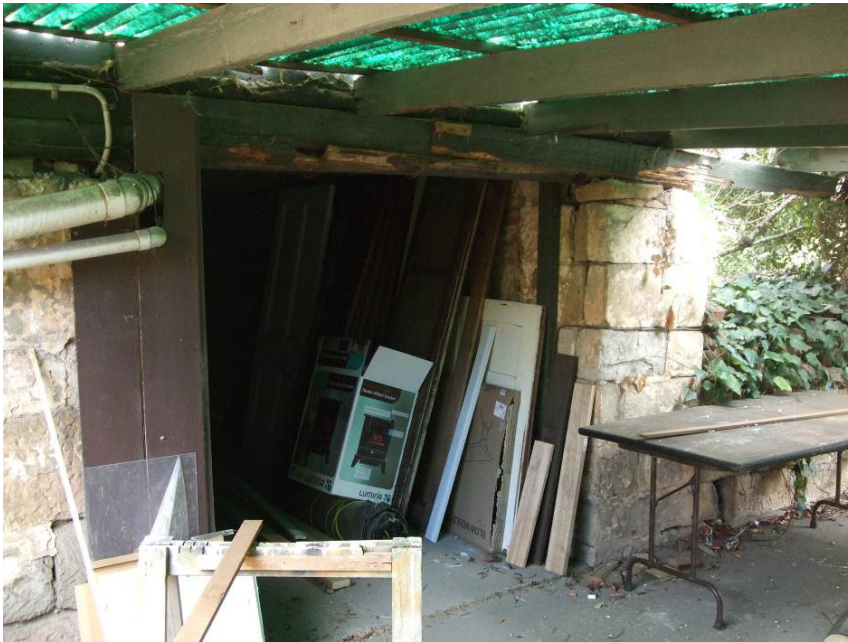
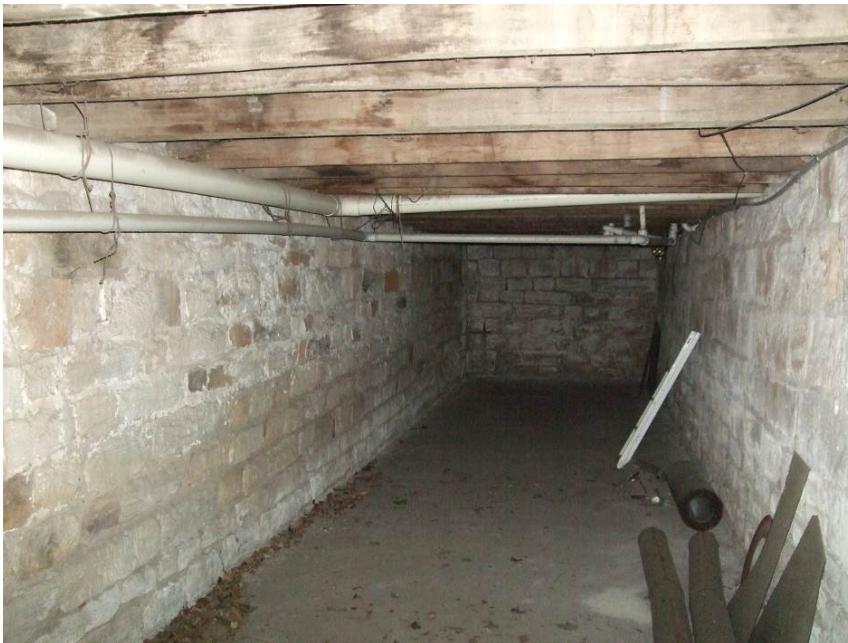
The foundation walls constructed during the 1835 extension using a harder and more durable lime-cement mortar. The exposed masonry is of much fairer face than the original walls, refer to figures 17 and 18 in Appendix A and contrast with figures 9 through 16 in Appendix A. The mortar was largely uncracked with minimal deterioration and the masonry was in serviceable condition.

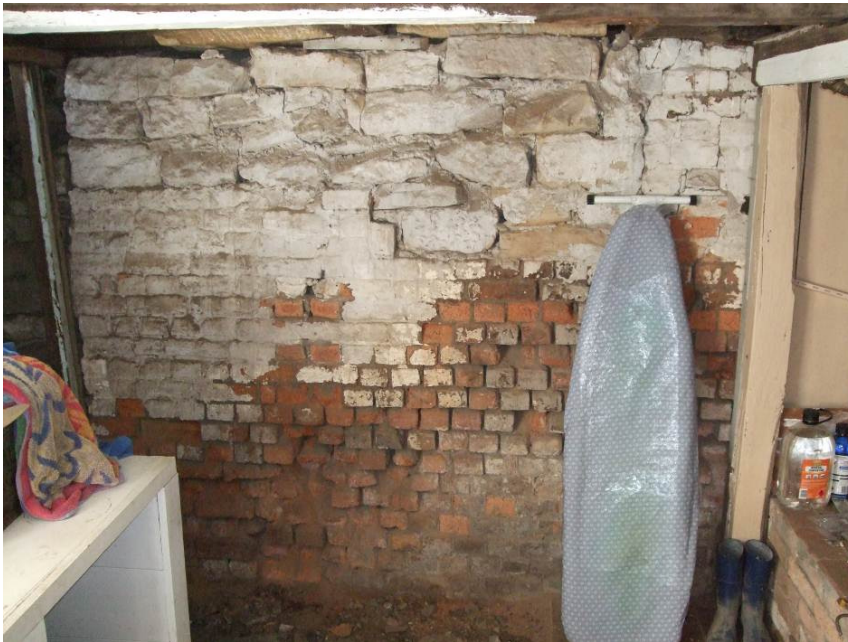
Figure 19

The condition and construction of the internal foundation walls varied somewhat depending upon what materials that was available at the time of construction. The lower levels of the internal wall beneath the kitchen chimney was constructed as brick masonry but transitioned to sandstone rubble masonry between lower ground and ground floor level, refer to figure 19 in Appendix A.

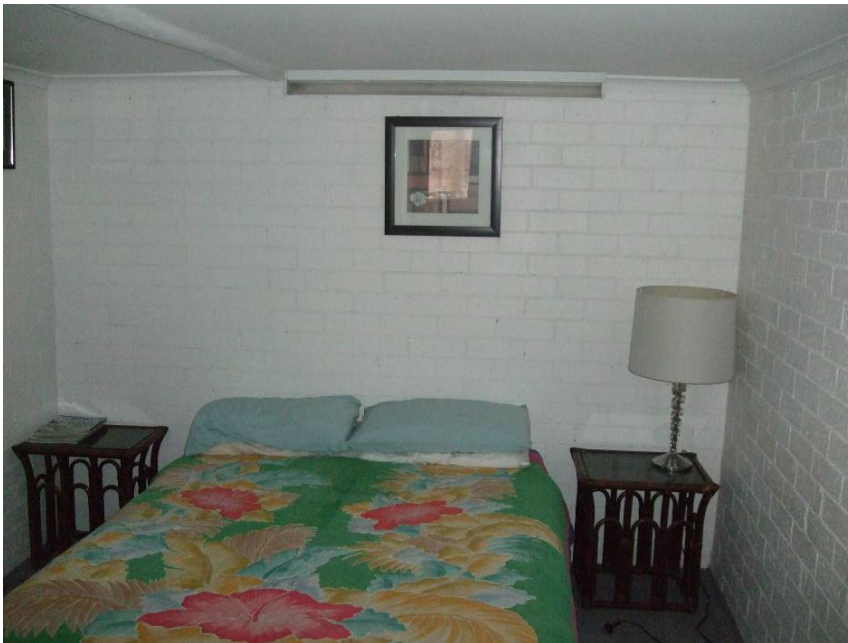
The original suspended timber framed ground floor consisted of hardwood timber joists at 450mm centres supported by roughhewn hardwood bearers, that appeared to be oversized for the spans and applied loads. The bearers were originally supported upon the sandstone rubble walls and are now supported by the more recent internal brick partition walls that conceal the original sandstone rubble masonry, refer to figures 22, 23 & 24.

**Figure 22** Underside of roughhewn hardwood beam, which is supported by the new brickwork

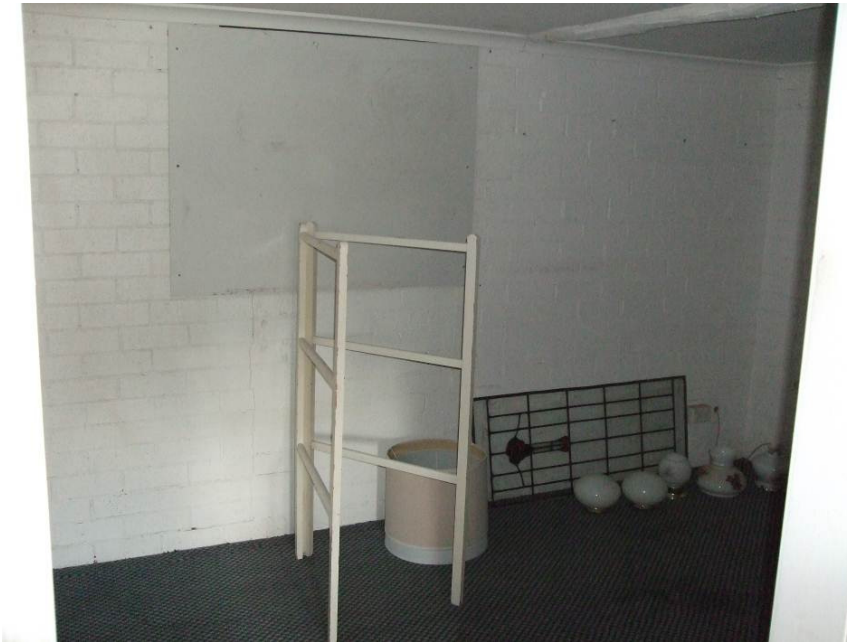
Figure 23 Underside of roughhewn hardwood beam, which is supported by the new brickwork

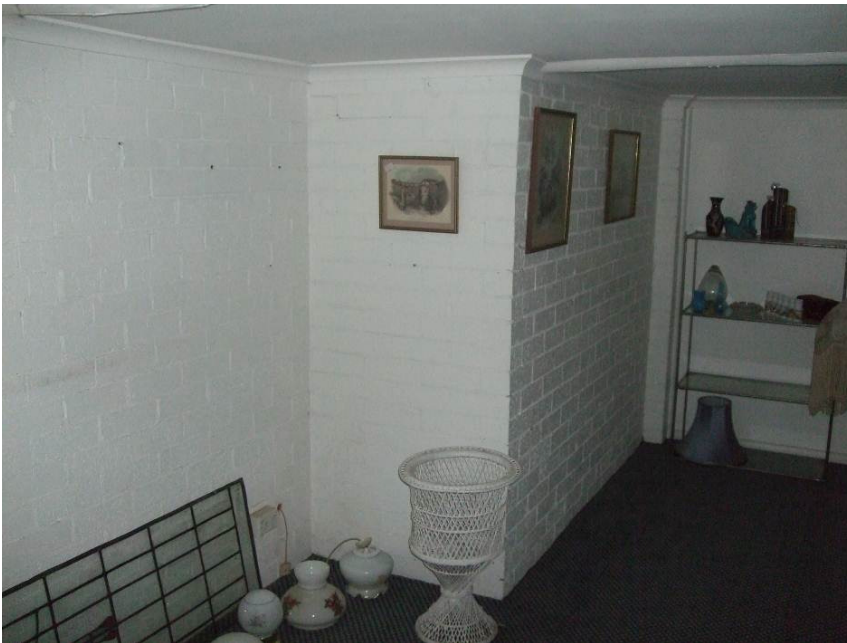
Figure 24 Underside of roughhewn hardwood beam, which is supported by the new brickwork

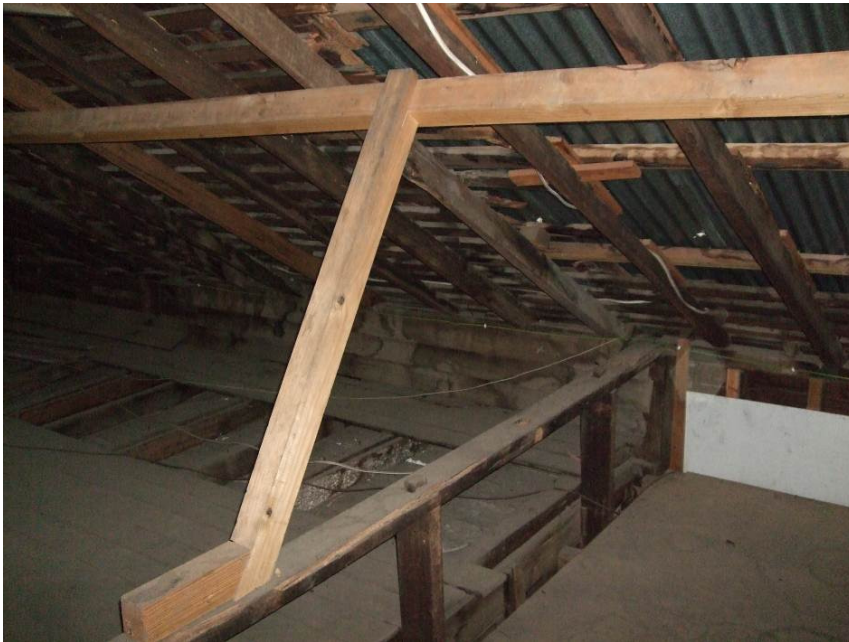
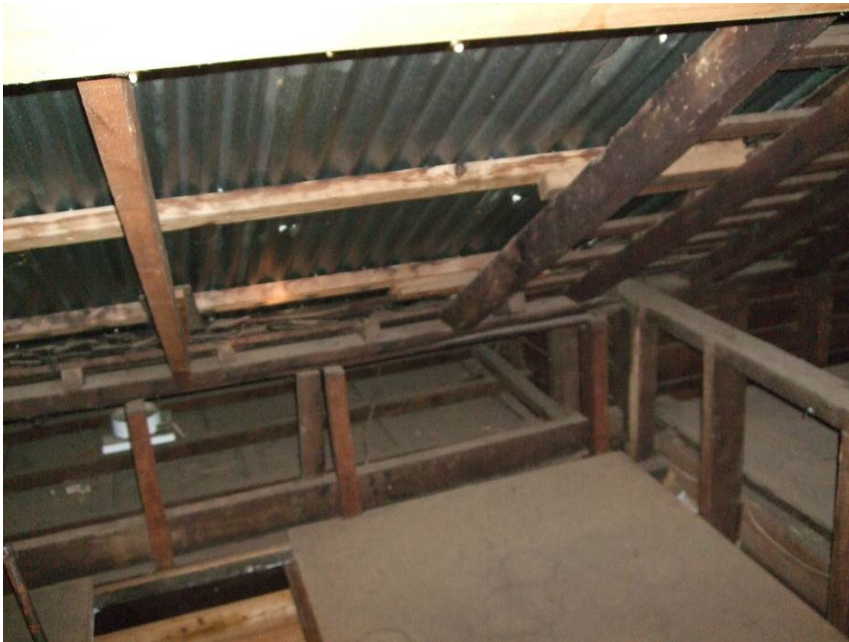
The original roof battens and shingles appeared to have been removed at the southern end of the dwelling, refer to figures 30 and 44 that show 50x75 timber battens packed out from the common rafters and the exposed underside of the corrugated steel roof sheeting. Other localised areas of shingles and battens were removed as shown in figures 33, 37, 41 & 42.

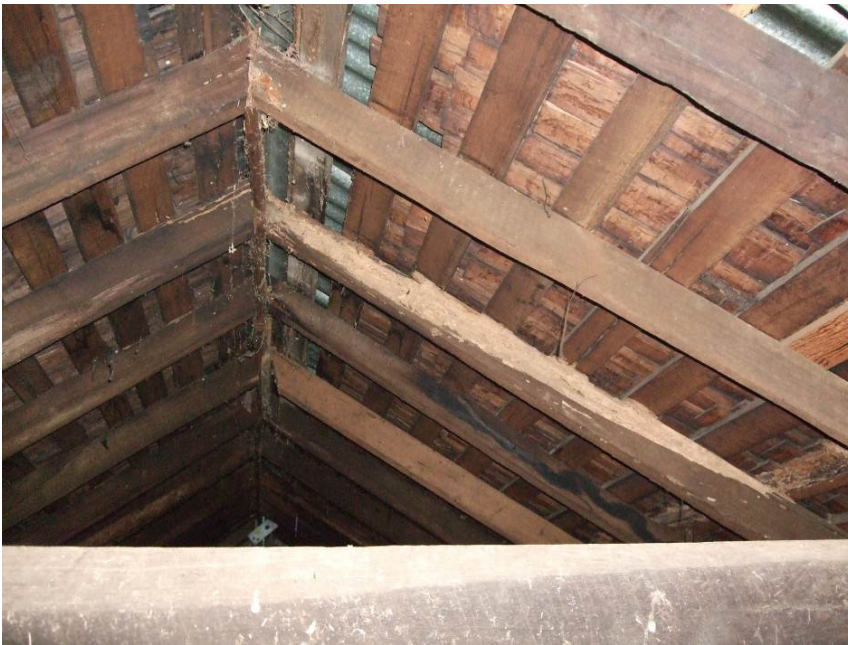
Figure 33

Termite damage was evident at a number of locations within the roof structure. The timber rafter shown in figure 33 and the nearby roof batten shown in figure 34 in Appendix C were severely damaged by termites. The damage appeared to be localised and more widespread termite damage was not apparent in the adjoining members. The rafter shown in figure 36 has lost support near the external support wall where the rafter has displaced downwards. The aforementioned rafters should be replaced by the owner to maintain structure serviceability.

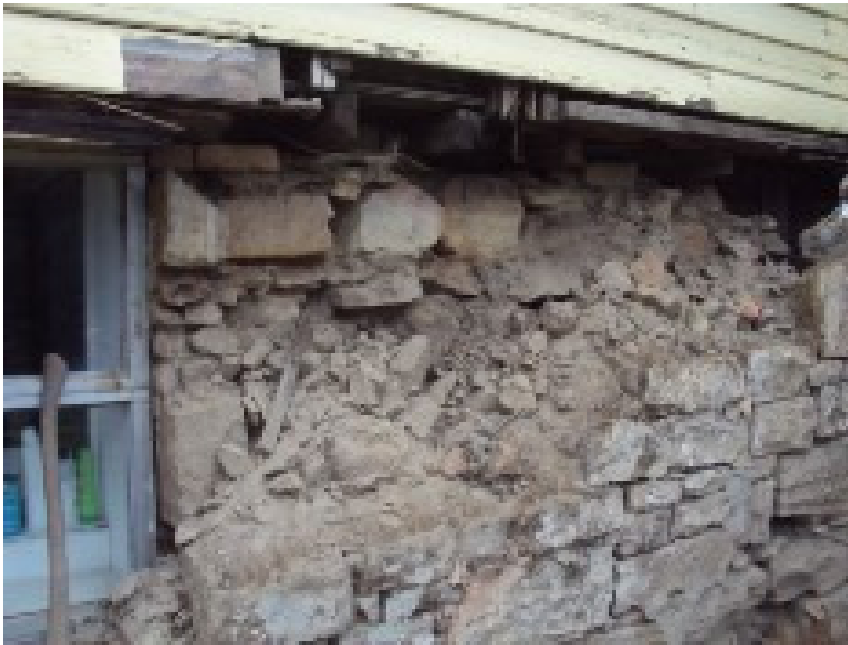
**Figure 50** Mortar erosion exposed when the external brickwork was removed near the northwest corner of the dwelling during recent renovation.
