Tahmoor Coal Pty Ltd

2019 ANNUAL REVIEW AND AEMR

March 2020

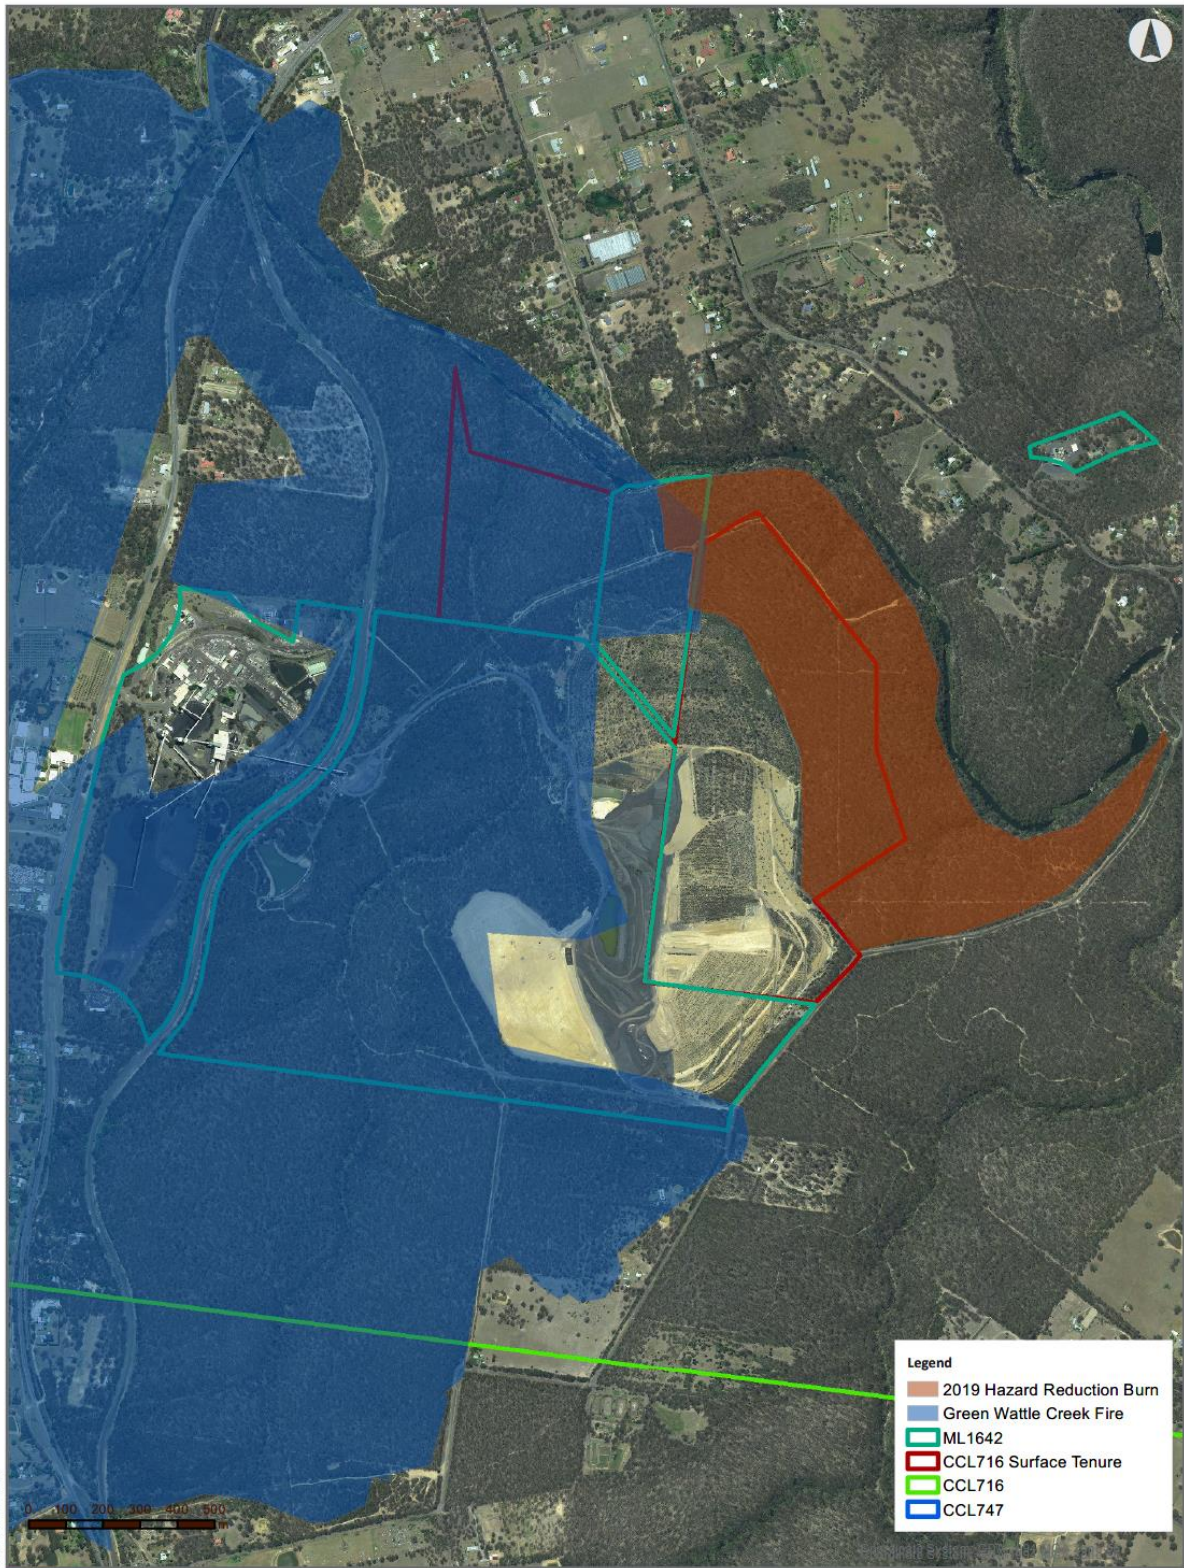
On the 17 December 2019 the Green Wattle Creek Bushfire reached Tahmoor Mine Pit Top and REA. The bushfire caused a significant amount of damage to water pumping systems, vegetation within the area and equipment within the laydown areas. The area burnt around the Mine is displayed in **Figure 5**.

Tahmoor Coal will be reviewing the Bushfire Management Plan to update with a new hazard reduction burn schedule as a response to the Green Wattle Creek fire.

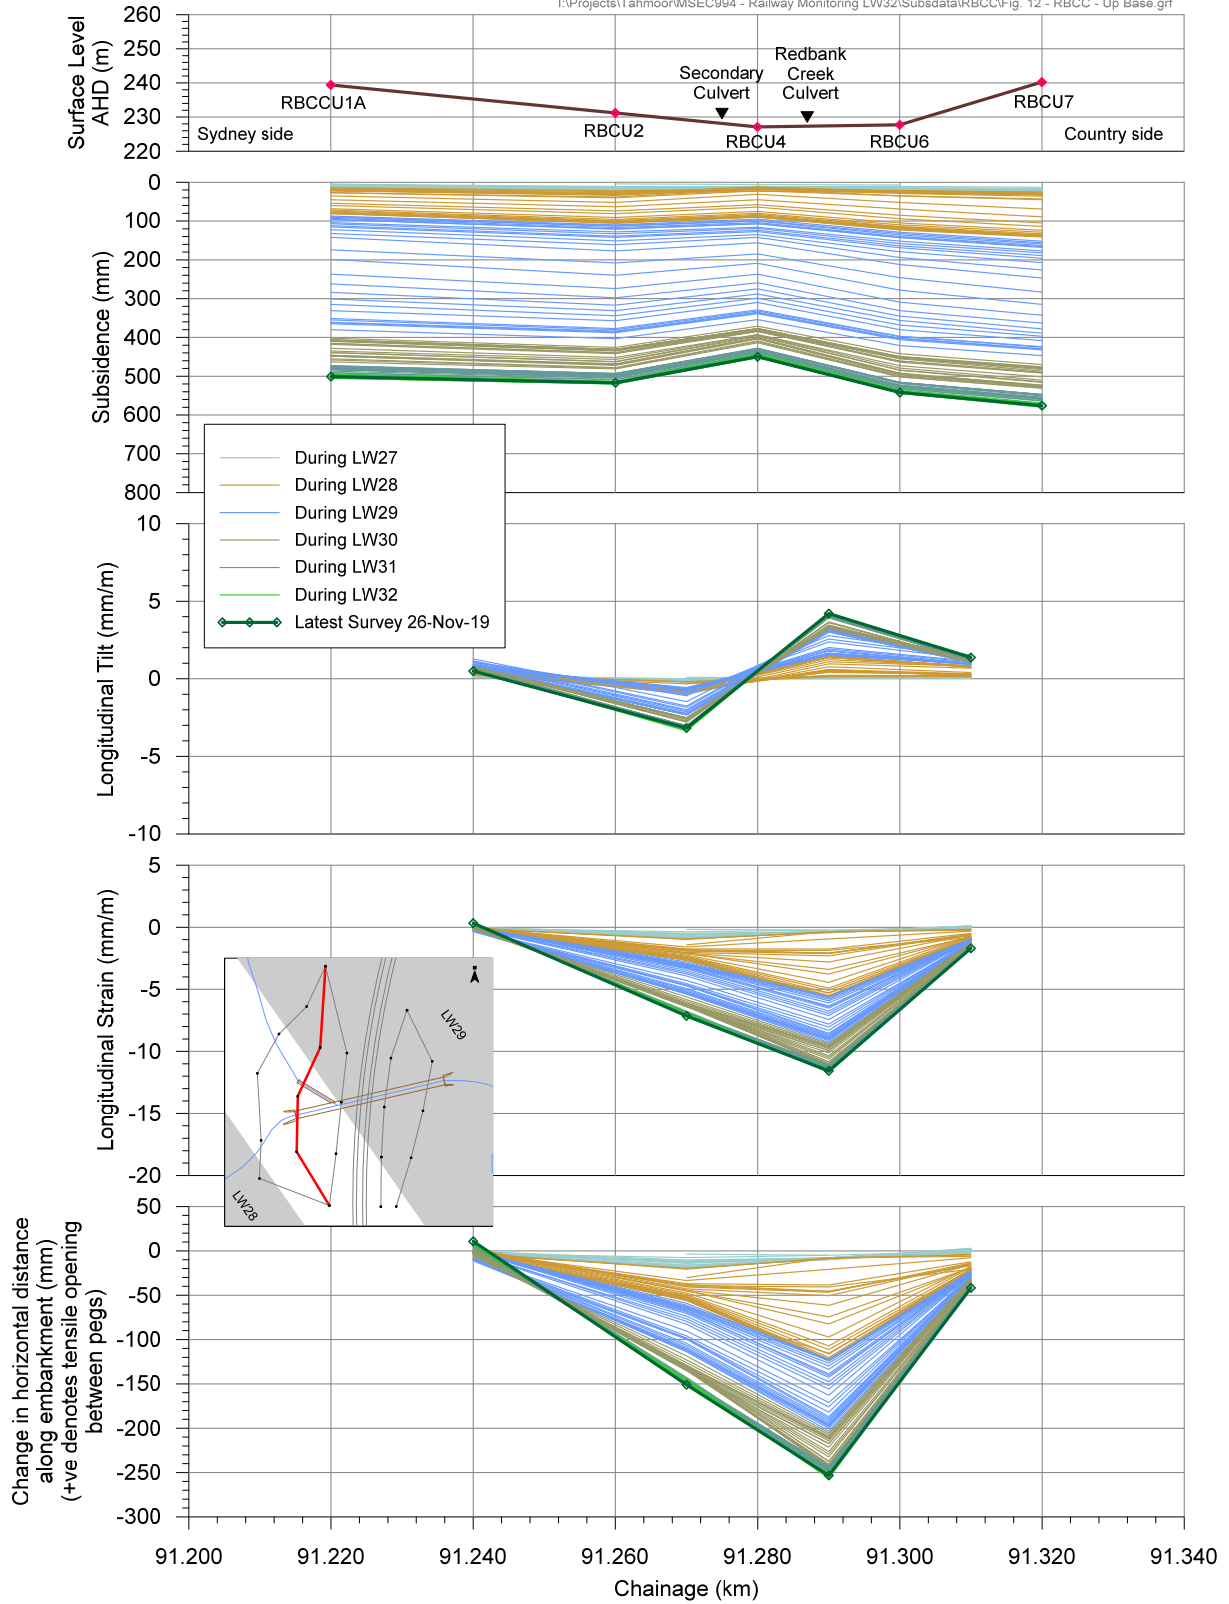
Fig. 2.10 Observed total subsidence, tilt and strain across the upstream base of Redbank Creek Culvert due to the mining of Longwalls 27 to 32

Observed subsidence along the base of the embankment on the upstream side is shown in Fig. 2.10. The results show valley closure focussing between Pegs RBCCU4 and RBCCU6, with upsidence observed at Peg RBCCU4. It can also be seen that no measurable change in ground strain was observed during the mining of Longwall 32.

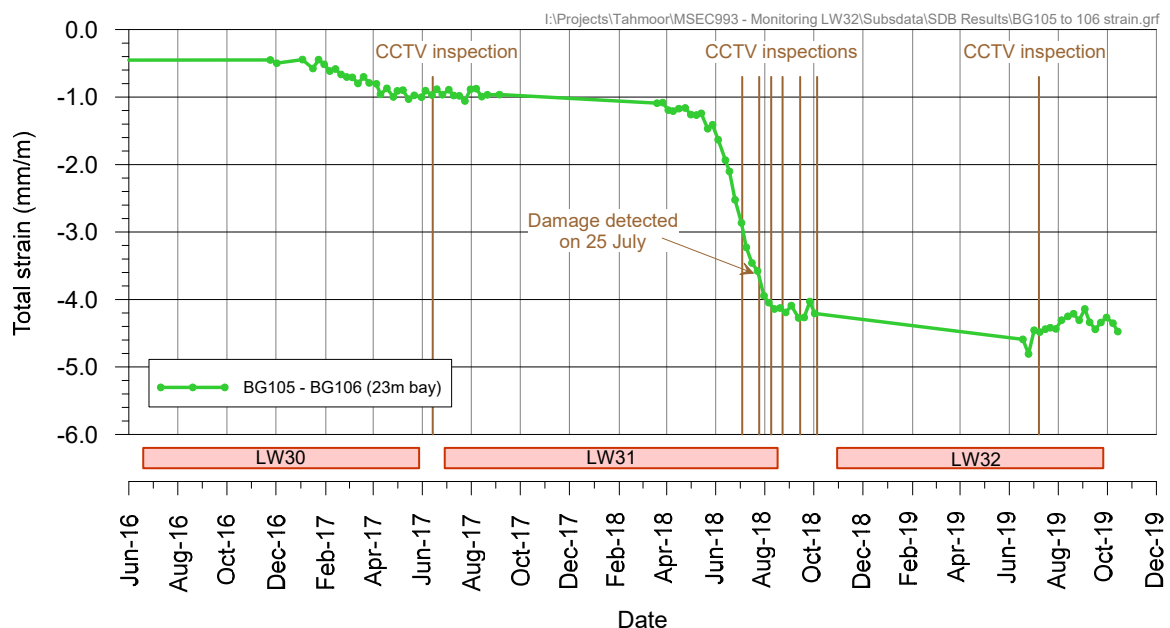
Fig. 2.11 Observed total strain between Pegs BG105 and B106 on Bridge Street

As shown in Fig. 2.11, a small increase in compressive strain was measured between Pegs BG105 and BG106 since the completion of Longwall 31, with minor changes observed. Sydney Water has commenced plans to repair the damaged section of pipe.

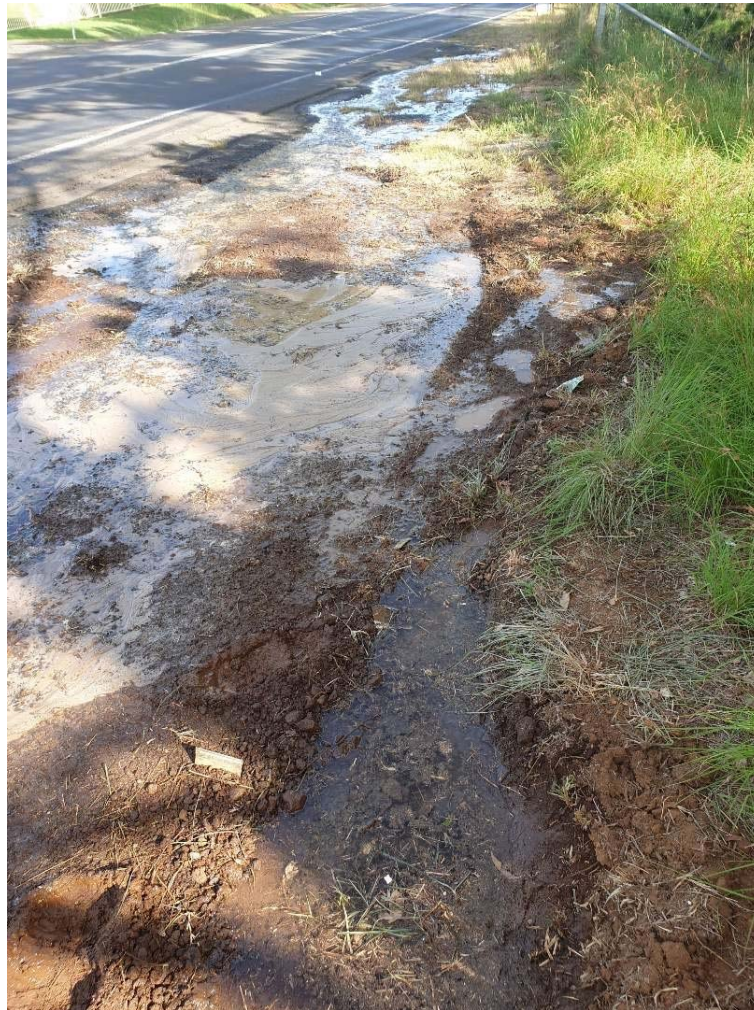
Sydney Water was consulted on 19 December 2018 regarding the development of compressive ground strain between Pegs RD26 and RD27, where the bump had formed in the road pavement. Twice weekly focussed inspections were being conducted at this location. The water main was found leaking on the morning of 8 February 2019. The main was able to support water pressure and the Picton reservoir was 93% full at the time. The water main was repaired on the evening of 8 February. A photograph of the leak is shown in Fig. 4.2.

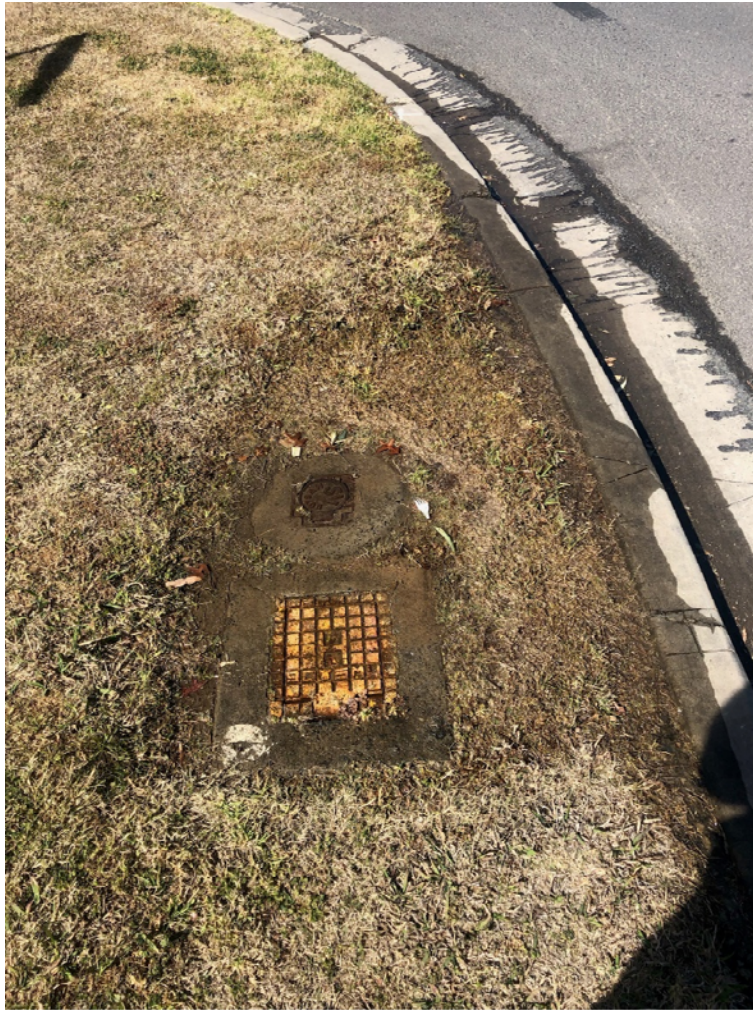
A minor water leak was observed on 21 August 2019 at the corner of Bridge Street and Redbank Place. The leak occurred at a stop valve and hydrant and was repaired on 22 August. A photograph of the leak is shown in Fig. 4.3.

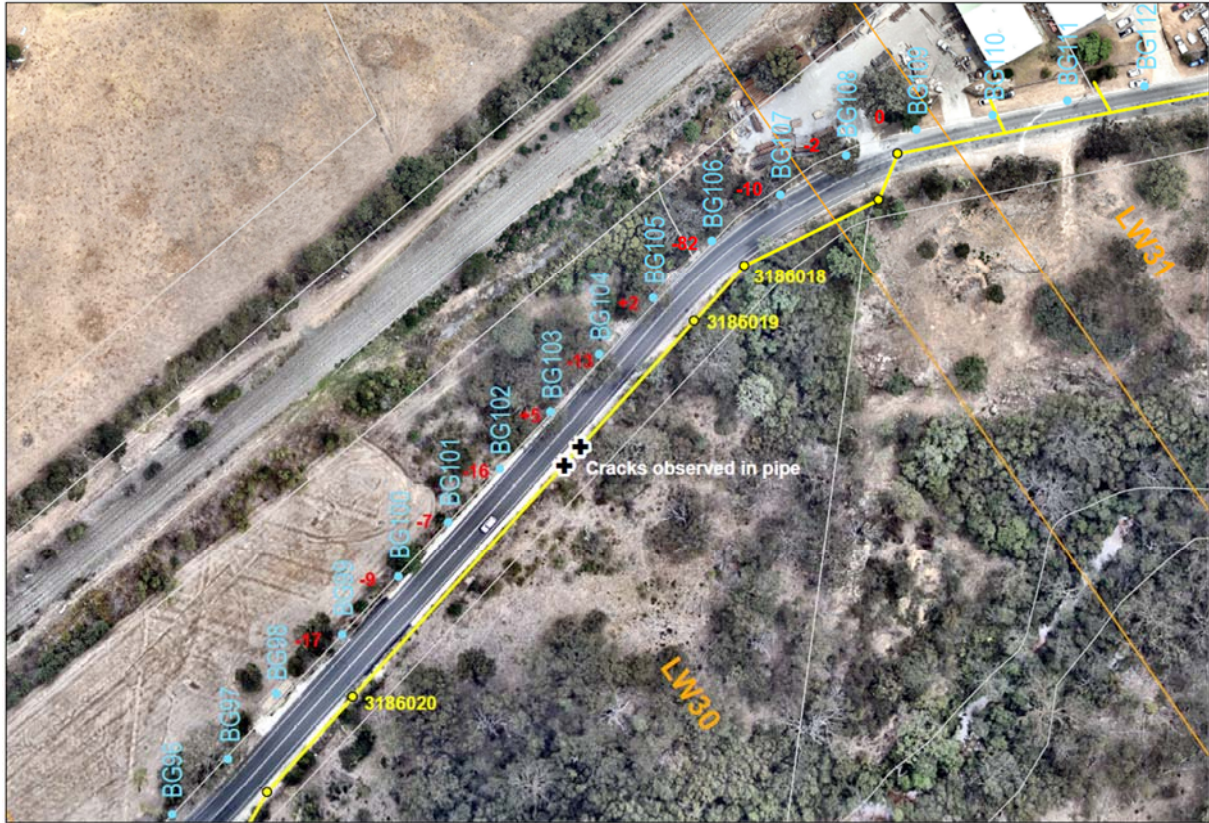
Fig. 4.4 Locations of cracks observed by CCTV inspection in Thirlmere Carrier Pipe on 25 July 2018

Whilst no impacts were observed between Pegs BG105 and BG106, cracks were found approximately 50 metres to the west between Pegs BG102 and BG103. The locations of the impact sites are shown in Fig. 4.4.
