Tahmoor Coal Pty Ltd

SIX MONTHLY SUBSIDENCE IMPACT

**Tahmoor North, Western Domain
Longwalls West 1 and West 2**

Report 1 - May 2020

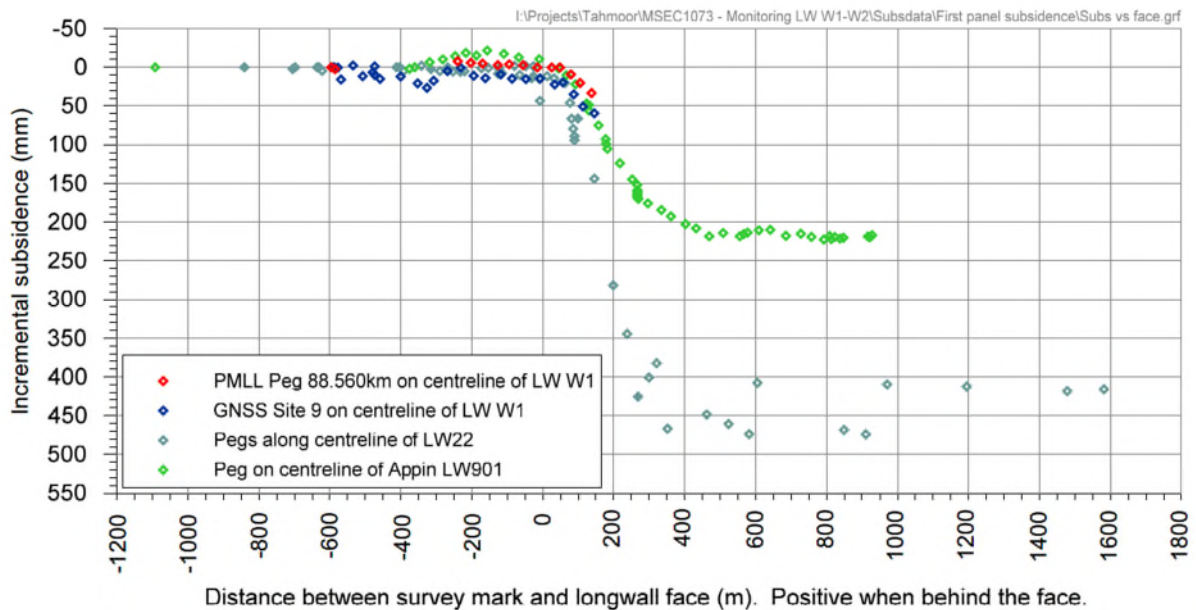
Figure 4-2 Development of subsidence along centreline of LW W1 compared to previously extracted single panels (source: MSEC, Subsidence Monitoring Report 5, **Appendix A**).

The development of subsidence at Peg 88.560 km and GNSS Peg 9 (both located on the centreline of LW W1) are illustrated in **Figure 4-2**. This figure shows that subsidence currently observed along the centreline of LW W1 are similar to that observed during the extraction of Appin LW901, which was a similar single panel extraction.

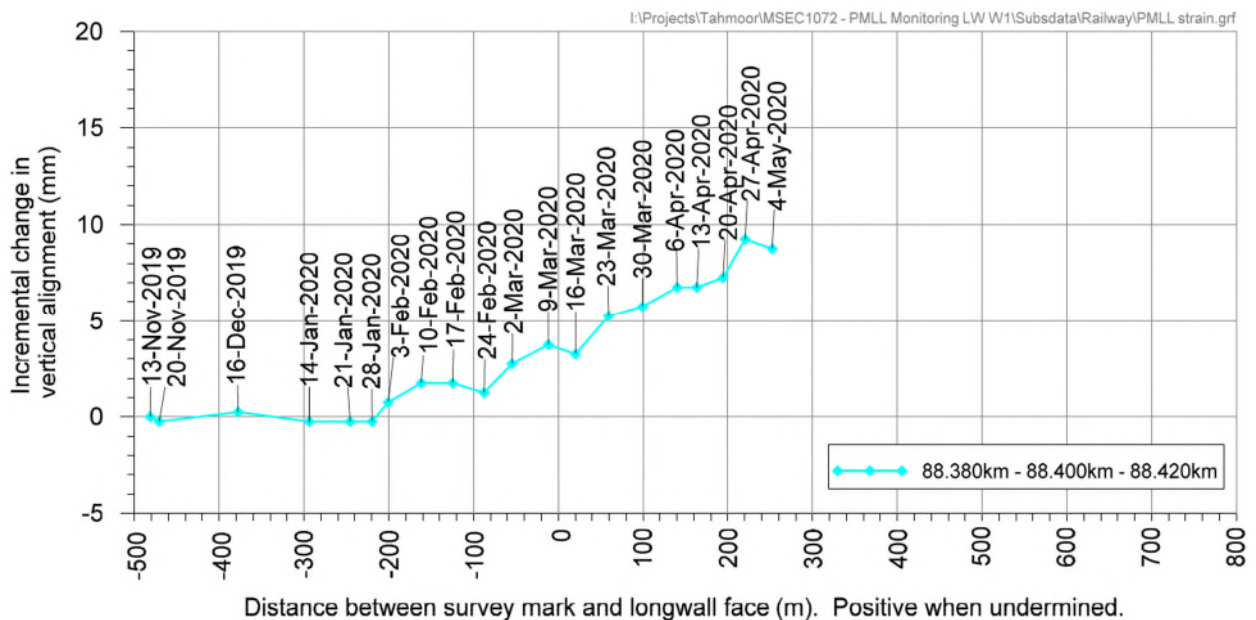
Figure 4-3 Observed development of ground strains and changes in vertical alignment at selected locations along PMLL (source: MSEC, Subsidence Monitoring Report 5, **Appendix A**).

Whilst observed ground strains are generally small, a small bump in the subsidence profile (upsidence) has gradually developed at 88.400 km, accompanied by increased compressive ground strain between 88.400 km and 88.420 km. Rates of change have been noted to reduce with further surveys. These observations are illustrated in **Figure 4-3**.

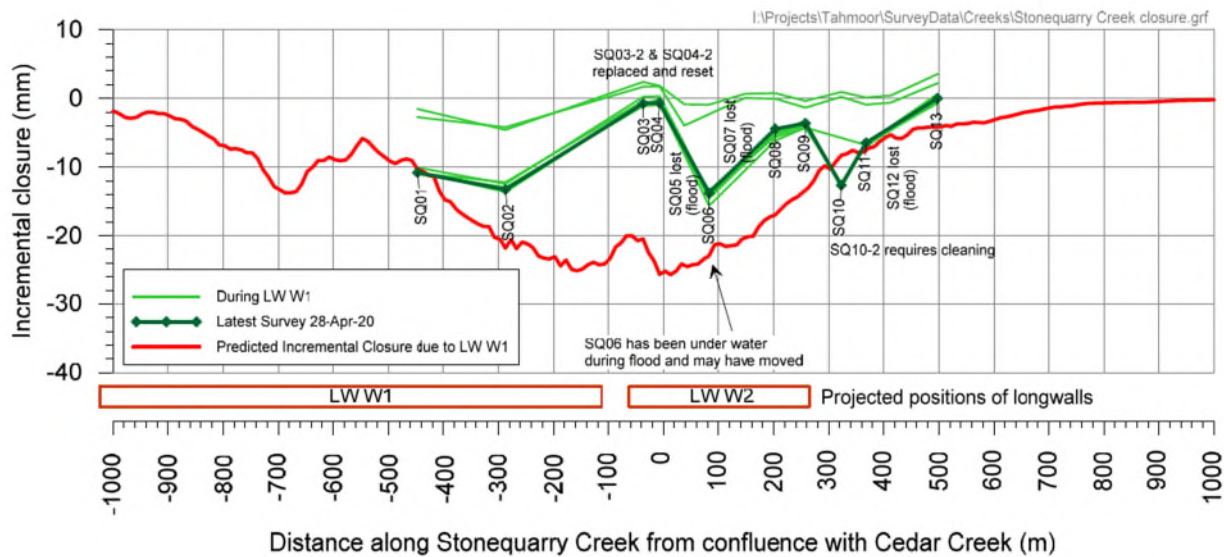
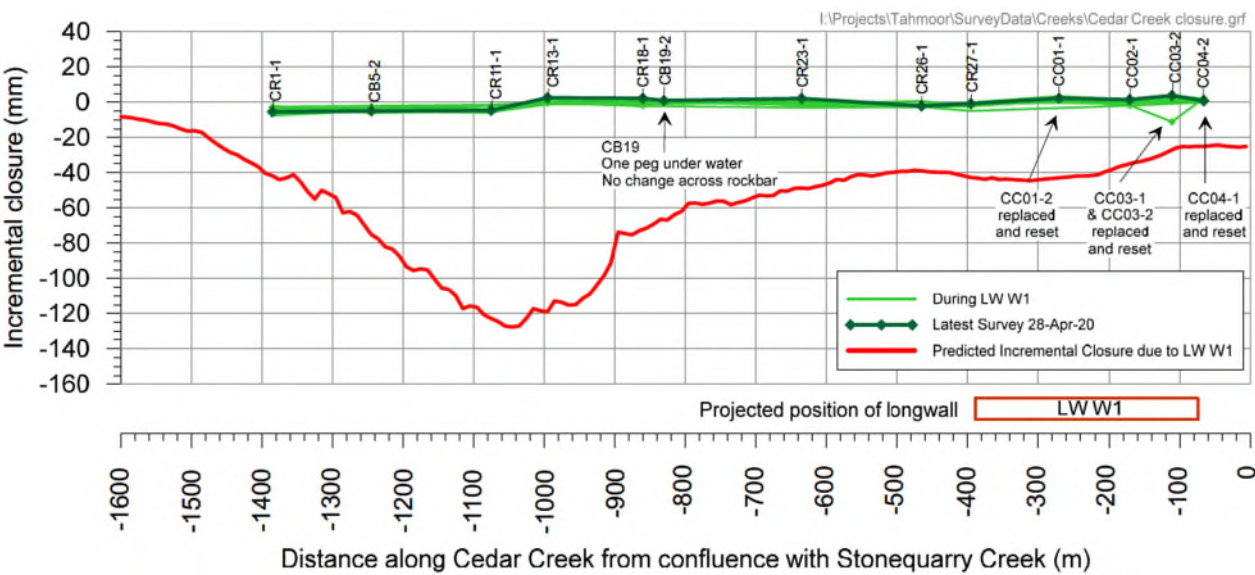
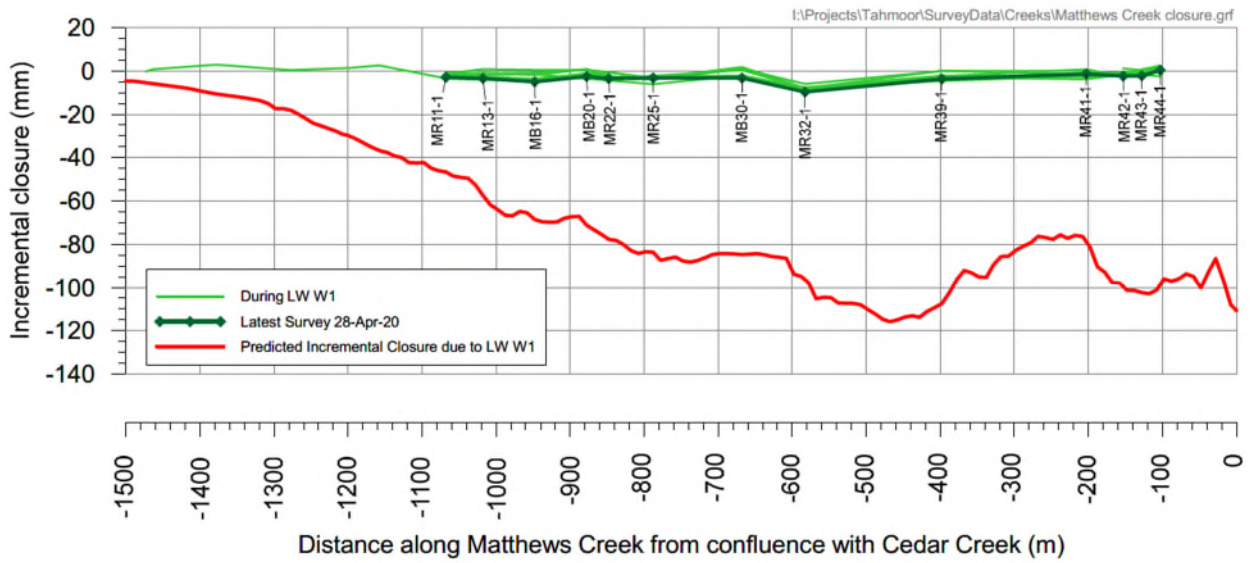
Figure 4-4 Comparison between observed and predicted valley closure along Stonequarry Creek, Cedar Creek and Matthews Creek (source: MSEC, Subsidence Monitoring Report 5, Appendix A).

Survey results have indicated that very little change in closure (if any) has been observed since the pegs were reinstated in Stonequarry Creek and Cedar Creek, and only minor changes were also observed in Matthews Creek (refer to **Figure 4-4**). Monitoring frequency has therefore been returned to monthly for all three creeks.

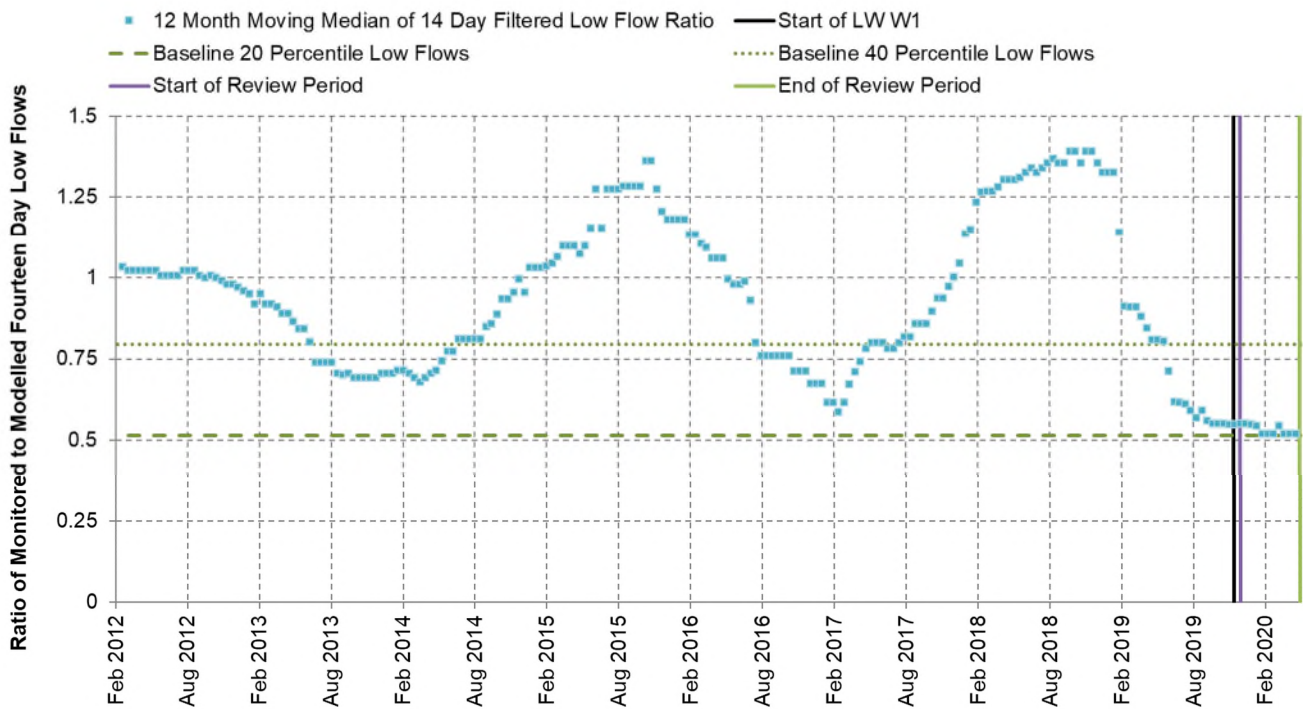
Figure 4-6 One Year Sliding Median for the Ratios of the 14 Day Sums of Monitored and Modelled Flow Rates at Stonequarry Creek at Picton (GS212053) (source: HEC, Surface Water Technical Report, **Appendix B**)

The results show that the moving 12-month median of the 14 day filtered low flow ratio fell below the 40th percentile during the baseline period and was close to the 20th percentile at the commencement of mining of LW W1. In January 2020, following the substantial decline in streamflow which occurred in late December 2019, the ratio of monitored to modelled flows fell slightly but remained just above the 20th percentile low flow ratio for the duration of the review period.

The decline in streamflow and the associated decline in the ratio of monitored to modelled flows is likely due to the substantial decline in rainfall during this period. Consequently, although the ratio of the monitored to modelled flows fell close to the 20th percentile low flow ratio, this is considered a result of the prevailing low rainfall conditions rather than as a result of mining of LW W1.

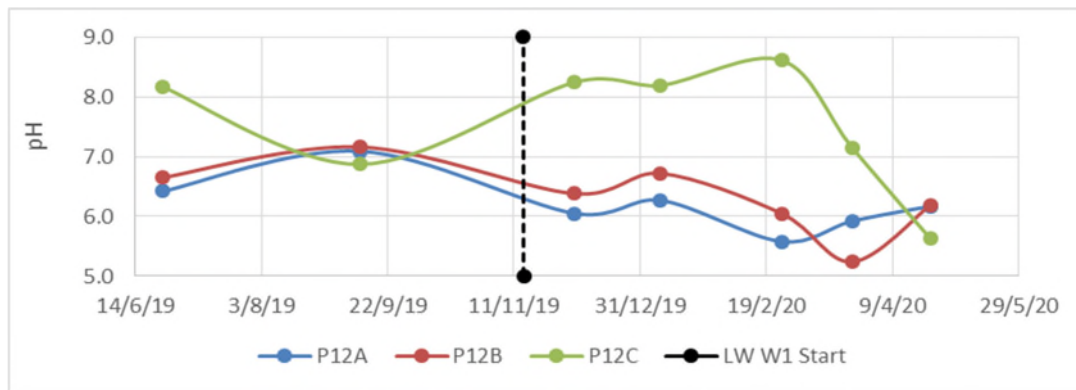
Figure 4-8 Groundwater quality for reporting period – pH at P12 (source: GeoTerra, Groundwater Monitoring Report 4, **Appendix D**)

- There has not been a greater than 3-month change in pH outside the pH baseline variability; and
- The effect is potentially a re-equilibration response following significant rainfall in January and February 2020.

It was also noted that a similar trend was observed at piezometer P16C, however was absent in other deeper piezometers within the Western Domain monitoring area.

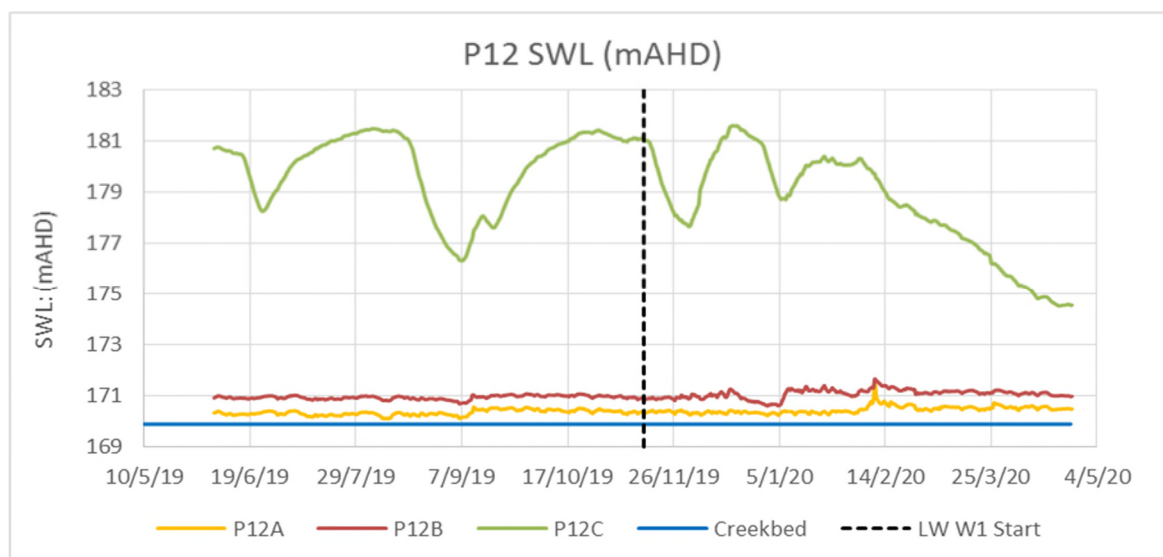
Figure 4-10 Groundwater bore levels during the reporting period – P12 (source: GeoTerra, Groundwater Monitoring Report 4, **Appendix D**)

- The water level reduction was not persistent over a period of up to 3 months; and
- A groundwater level rise in response to a significant rainfall recharge event was observed.

The reduction in water level at P12C was attributed to climatic factors.

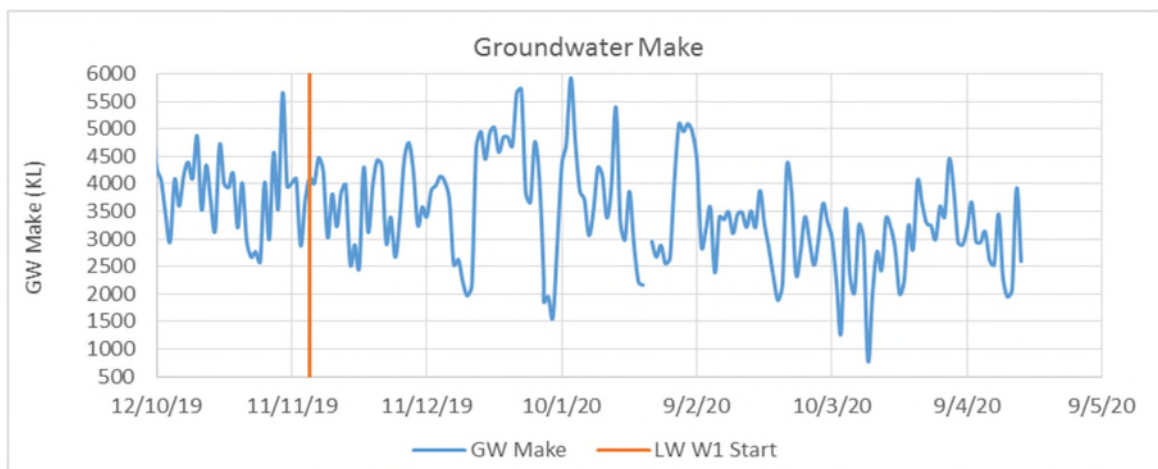
Figure 4-11 Tahmoor Mine daily water make since LW W1 extraction commencement (source: GeoTerra, Groundwater Monitoring Report 4, **Appendix D**)

Water make into the Tahmoor Mine underground workings (as plotted in **Figure 4-11**) does not indicate that there has been any observable increase in mine water make since extraction of LW W1 commenced.
