Tahmoor Coal Pty Ltd

SIX MONTHLY SUBSIDENCE IMPACT

Tahmoor North, Western Domain
Longwalls West 1 and West 2

Report 2 - November 2020

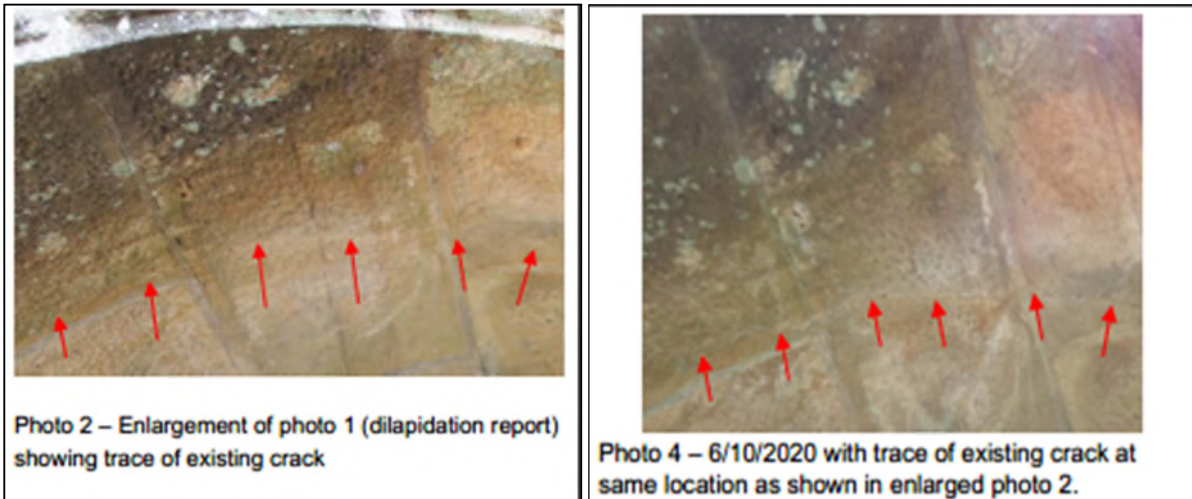
Figure 2-1 Pre-mining and current photos of the crack at culvert 89.629 km (source: PMLL Detailed Monitoring Report 47, **Appendix E**).

In the Picton-Mittagong Loop Line Monitoring Report 46 (refer to Appendix F), it was noted that visual inspections of the sandstone culvert at 89.629 km in late August to early September 2020 had noted that a small transverse crack up to 1 mm in width had become evident across the downside culvert overt about 0.4 – 0.5 m inside the headwall (refer **Figure 2-1**).

It was highlighted in the report that the crack was minor and was not adversely affecting the structural integrity of the culvert. No further developments of this crack had been noted in subsequent weekly reports during this reporting period.

However, this observation triggered a Level 2 TARP trigger for historical heritage in September 2020 to October 2020.

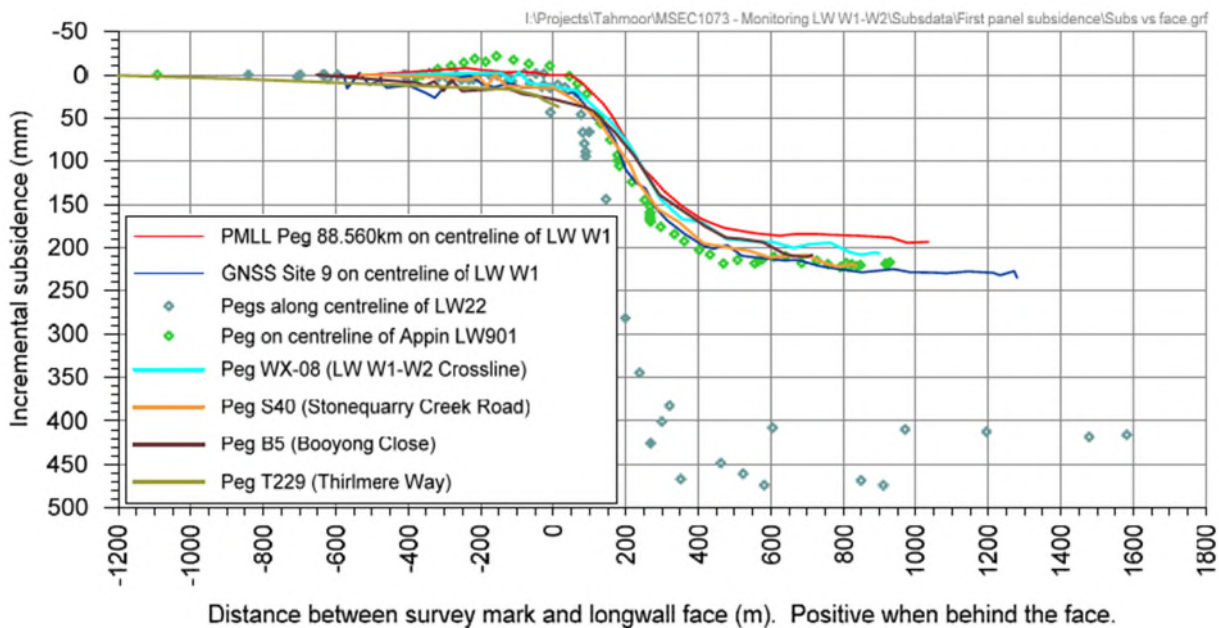
Figure 4-2 Development of subsidence along centreline of LW W1 compared to previously extracted single panels (source: MSEC, Subsidence Monitoring Report 29, **Appendix A**).

The development of subsidence at pegs and GNSS units located on the LW W1 centreline that have been mined directly beneath by LW W1 are illustrated in **Figure 4-2**. This figure shows that subsidence currently observed along the centreline of LW W1 are similar to that observed during the extraction of Appin LW901, which was a similar single panel extraction.

Observed subsidence movements have been less than predicted. Subsidence is currently developing along the LW W1-W2 Cross Line, Stonequarry Creek Road, Booyong Close, Attunga Close and Carramar Close. The results show that the monitoring lines are following similar trends as observed along the PMLL during the previous Six Monthly Subsidence Impact Report.

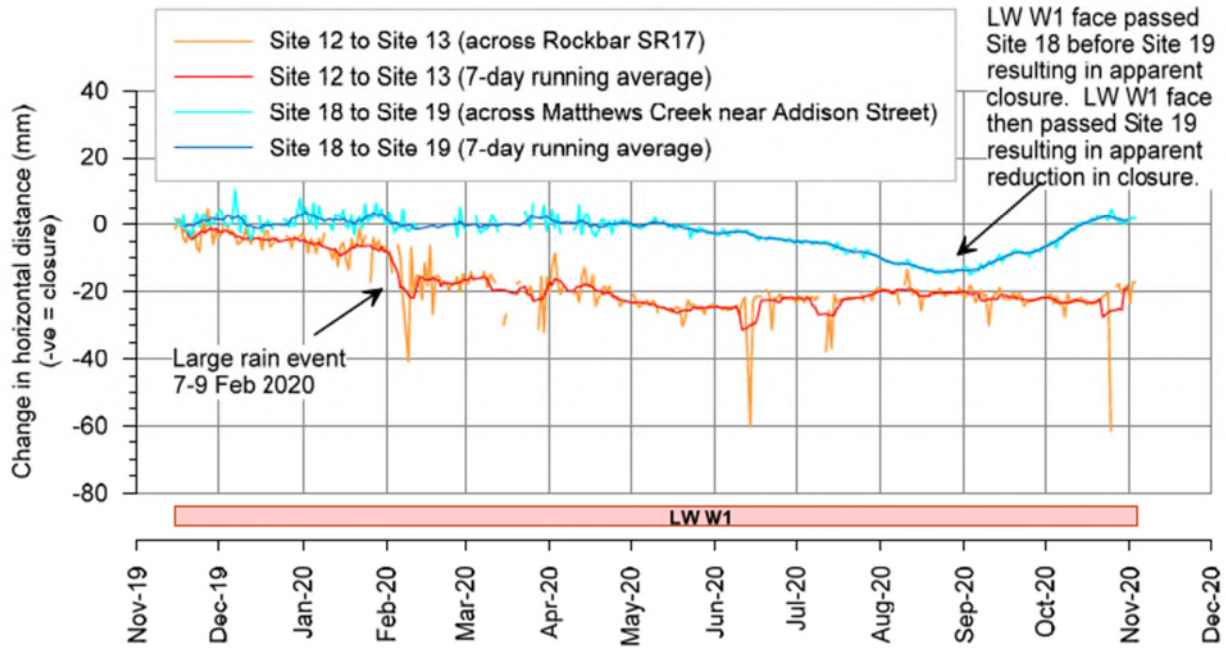
Figure 4-3 Observed changes in horizontal distances between GNSS units (source: MSEC, Subsidence Monitoring Report 29, **Appendix A**).

Site 12 and Site 13 are located across Stonequarry Creek at Rockbar SR17. Site 12 appeared to have been affected by the heavy rainfall event between 7 and 9 February 2020, resulting in swelling of clay soils around the unit and movement of the sensor. If the movements during the week after the wet weather event on 7 and 9 February 2020 are removed from the results, the resultant movements at Site 12 would be similar in magnitude to the movements measured at Site 13. No measurable changes have been observed since this event (refer **Figure 4-3**).

The LW W1 face passed Site 18 in early August 2020 and passed Site 19 in late August 2020, resulting in Site 18 moving towards LW W1 earlier than Site 19. This resulted in an apparent closure between the two sites between June and late August 2020, and an apparent reduction in closure between September to mid-October 2020 (refer **Figure 4-3**).

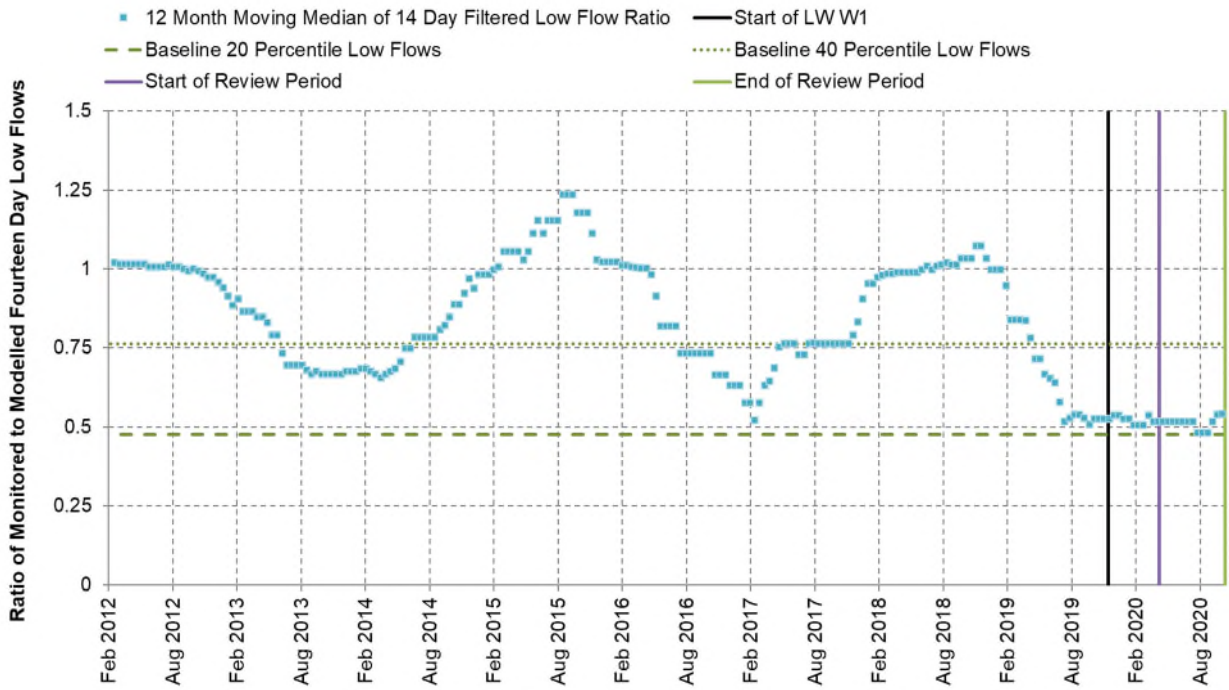
Figure 4-4 One Year Sliding Median for the Ratios of the 14 Day Sums of Monitored and Modelled Flow Rates at Stonequarry Creek at Picton (GS212053) (source: HEC, Surface Water Review Summary Report, **Appendix B**).

The results show that the moving 12-month median of the 14-day filtered low flow ratio of monitored to modelled flow was below the 40th percentile and close to the 20th percentile during the reporting period. Similar flow conditions occurred at the reference sites at Bargo River (Site 300061) and Hornes Creek (Site 300062). As such, a Level 2 TARP significance in relation to catchment streamflow applies for the current review period.

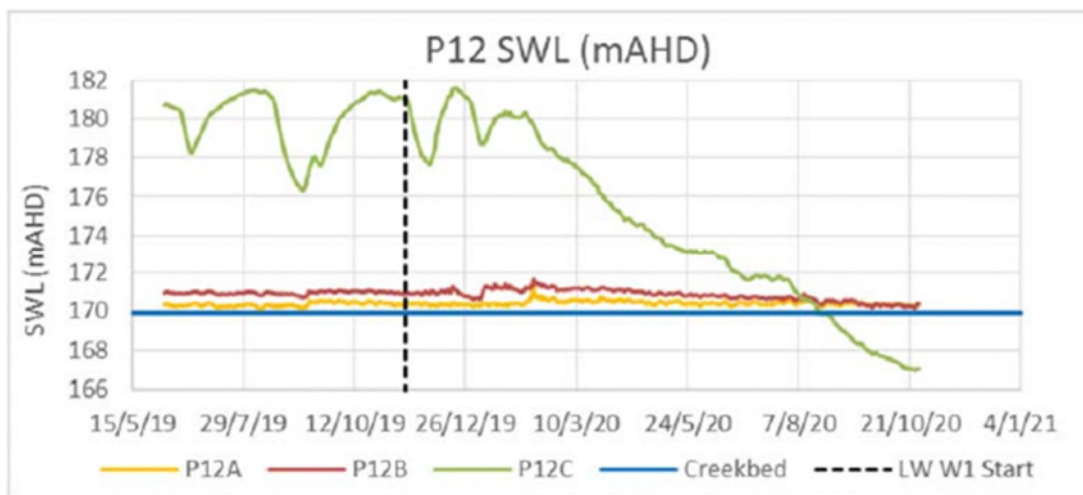
Figure 4-10 Groundwater bore levels during the reporting period – P12 (source: GeoTerra, Groundwater Monitoring Report 10, **Appendix D**)

These trends have been attributed to mining induced regional depressurisation of deeper groundwater aquifers. At this stage, groundwater depressurisation in the deeper aquifers is not influencing the shallow aquifers or the surface water system.

As a consent condition for the commencement of LW W2 extraction, DPIE have requested that the monitoring frequency of OSP groundwater level at P12C is increased from monthly to fortnightly for the duration of LW W2 extraction. This requirement has been included in the Water Management Plan and the monitoring program.

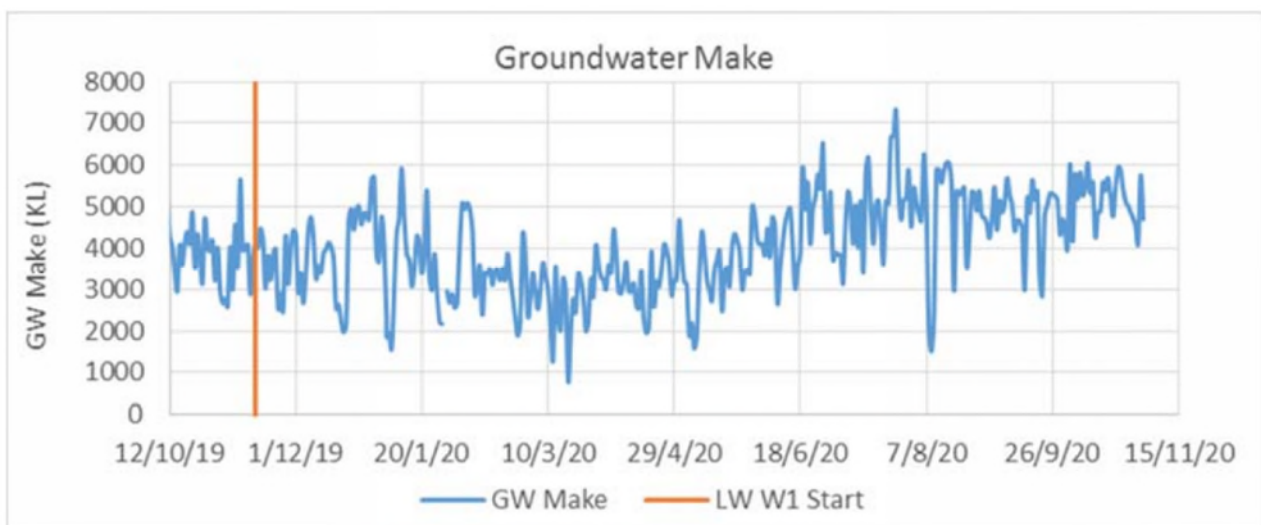
Figure 4-13 Tahmoor Mine daily water make since LW W1 extraction commencement (source: GeoTerra, Groundwater Monitoring Report 10, **Appendix D**)

Water make into the Tahmoor Mine underground workings (as plotted in **Figure 4-13**) indicates a rise in groundwater inflow to the mine from around late June 2020. This increased groundwater pump out for the mine would most likely be due to an increased groundwater make associated with extraction of LW W1 within the previously unmined Western Domain mining area, with the newly goafed, subsided, fractured and delaminated overburden depressurising and dewatering the area for the first time.

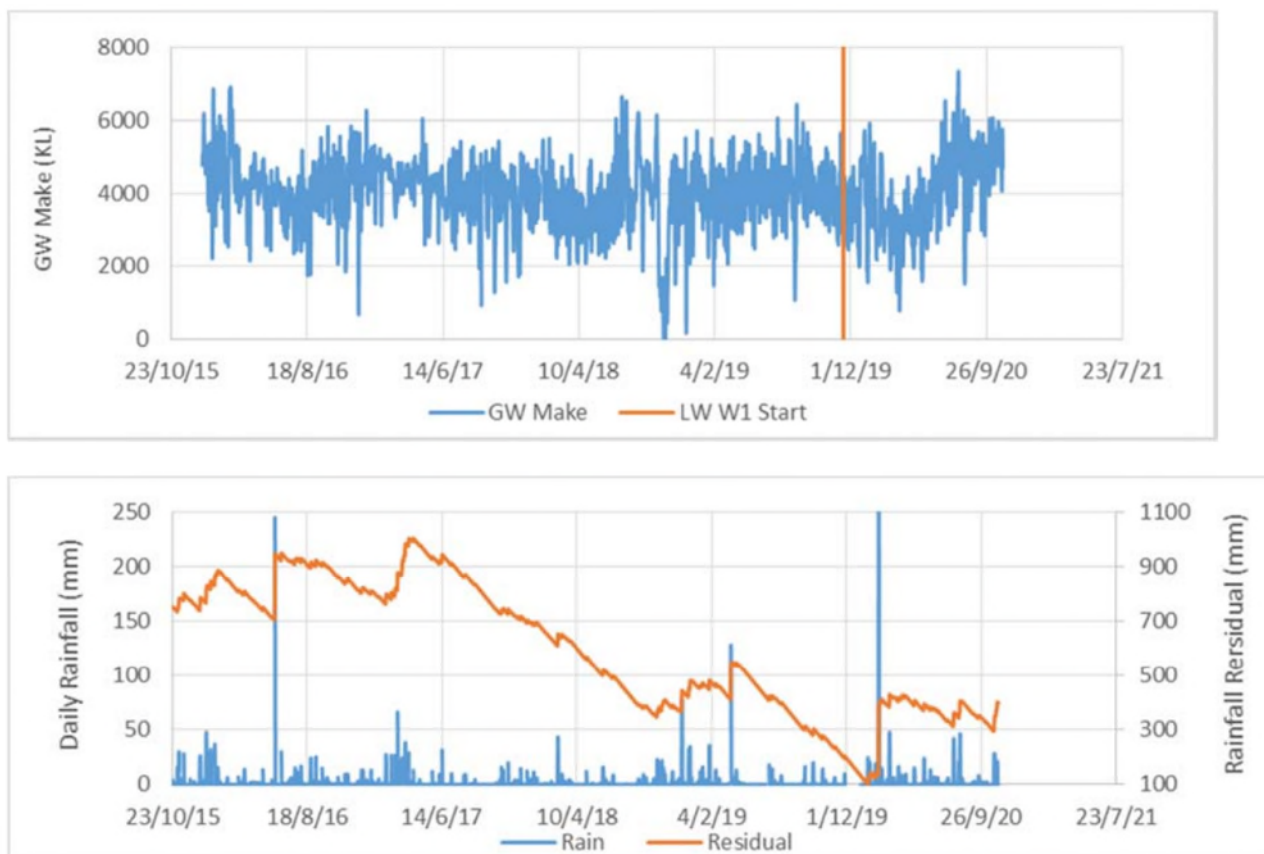
Figure 4-14 Tahmoor Mine Groundwater Inflow and Rainfall Residual comparison (source: GeoTerra, Groundwater Monitoring Report 10, **Appendix D**)

In addition, **Figure 4-14** illustrates that there does not appear to be a definitive correlation between rainfall and the increased pump out from the mine.
