Tahmoor Coal Pty Ltd

SIX MONTHLY SUBSIDENCE IMPACT

**Tahmoor North, Western Domain
Longwalls West 1 and West 2**

13 October 2020 – 21 April 2021

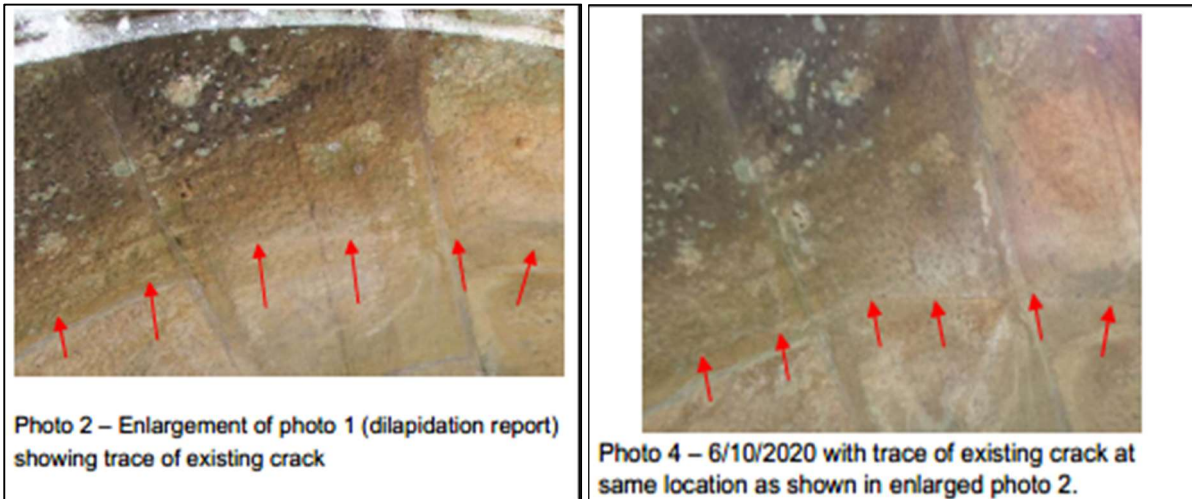
- Historical Heritage TARP – Level 2 Trigger for Sandstone Culvert impacts at 89.629km as a result of a small traverse crack up to 2mm. This cracking is related to the minor

opening of an existing crack (previously reported and not adversely affecting the structural integrity of the culvert);

The impact to the sandstone culvert at 89.629 km was discussed in detail during the previous Six-Monthly Subsidence Impact Report. A small traverse crack up to 1 mm in width was observed in late August to early September 2020 (refer **Figure 2-1**), and was noted to be a minor pre-existing crack that was likely formed due to lateral loading from the retaining wall and steep batter slope. It is possible that the recent minor subsidence effect may have resulted in slight opening of the crack.

The crack was noted to have slightly opened up to 2 mm during subsidence effects on 17 November 2020 (refer to PMLL Detailed Monitoring Report 53; **Appendix E**). No further changes were noted for the remainder of the reporting period.

Figure 2-1 Pre-mining and current photos of the crack at culvert 89.629 km (source: PMLL Detailed Monitoring Report 47, **Appendix E**).

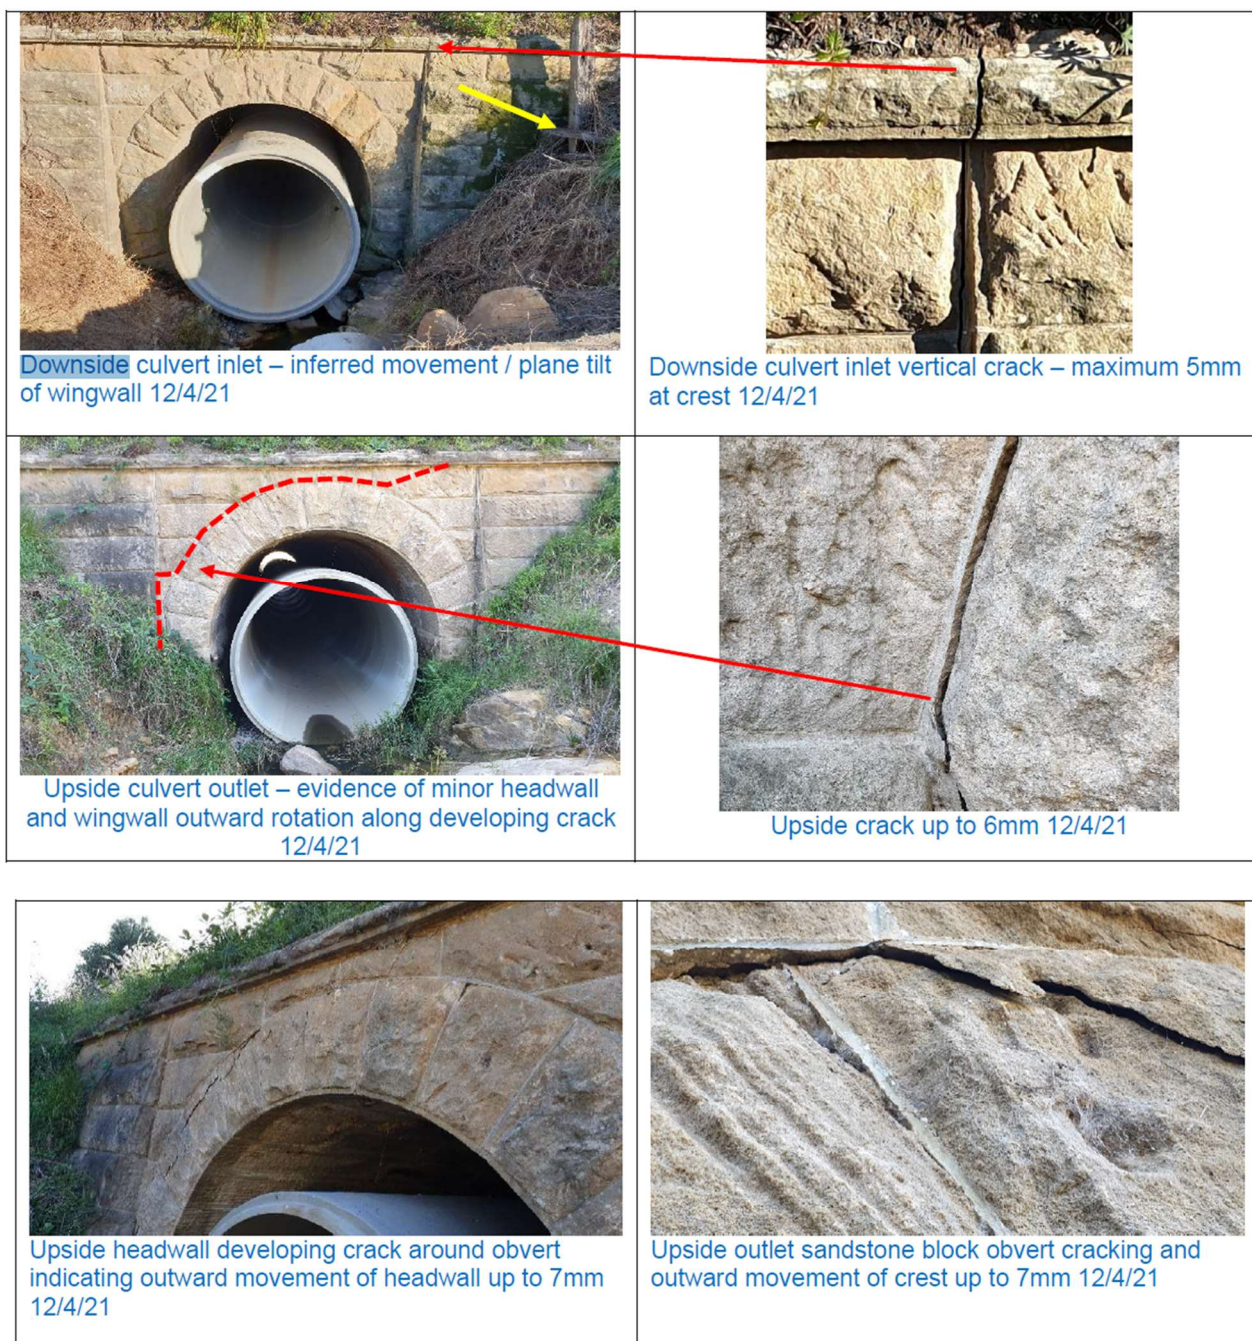
- Historical Heritage TARP – Level 2 Trigger for Sandstone Culvert Impacts at 88.44 km – crack up to 7 mm at the crest, crack on the upside headwall up to 6 mm, and minor spalling on the obvert headwall showing evidence of outward movement up to 7 mm of the headwall and wingwall relative to the culvert (not adversely affecting the structural integrity of the culvert);

A vertical 1 mm wide crack was first noted on 1 February 2021 along a mortar joint at the downside inlet headwall of the sandstone culvert at 88.44 km (PMLL Detailed Monitoring Report 9; **Appendix E**). This cracking increased to up to 2 mm on 1 March 2021, 3 mm on 15 March 2021, and 7 mm at the crest on 12 April 2021 (PMLL Detailed Monitoring Report 19; **Appendix E**; refer **Figure 2-2**). No further movement was noted during the reporting period.

During an inspection of the sandstone culvert at 88.44 km on 14 February 2021, hairline cracking on the upside headwall were first observed, together with minor spalling of sandstone blocks (PMLL Detailed Monitoring Report 11; **Appendix E**). Crack width was noted to increase to 2 mm on 1 March 2021, and on 12 April 2021 the crack was noted to be up to 6 mm with minor spalling on the obvert headwall showing evidence of outward movement up to 7 mm of the headwall and wingwall relative to the culvert (PMLL Detailed Monitoring Report 19; **Appendix E**; refer **Figure 2-2**). No further movement was noted during the reporting period.

Figure 2-2 Cracking at culvert 88.44 km (source: PMLL Detailed Monitoring Report 19, **Appendix E**).

LWW2 has passed beneath the Picton to Mittagong Loop line at 88.13km on 12/01/2021. At the culvert at 88.400 km, a 7 mm wide crack in the vertical mortar joint at the Down side headwall and a 6 mm wide crack in a mortar joint at the Up side headwall have been observed. Minor spalling of sandstone was also noted and a minor outward movement up to 7 mm of the headwall and wingwall relative to culvert. Compressive strains continue to develop at 88.400 km to the side of the culvert, within the embankment fill.

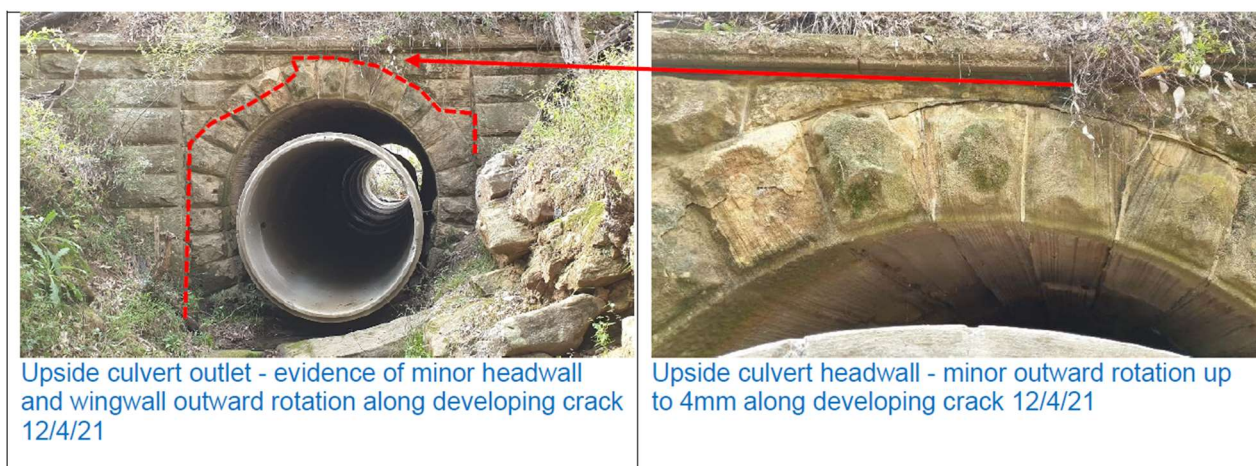
- Historical Heritage TARP – Level 2 Trigger for Sandstone Culvert Impacts at 88.980 km – minor separation and circumferential cracking. These cracks are noted to be minor and are not adversely affecting the structural integrity of the culvert;

Impacts to the sandstone block culvert headwall of the culvert at 88.980 km was first noted on 25 February 2021 (PMLL Detailed Monitoring Report 12; **Appendix E**). This impact included minor separation and circumferential cracking of the sandstone block arch obvert, minor hairline crack along mortar, and minor spalling of sandstone block facing.

- Minor separation and circumferential cracking of the sandstone block arch obvert predominantly along mortar bed indicative of outward rotation of the headwall up to 4mm with some associated spalling of sandstone block facing.
- Vertical crack along mortar up to 4mm at city side junction between wingwall and headwall with outward rotation of the wingwall up to 4mm.

These changes were noted in the PMLL Detailed Monitoring Report 19 (**Appendix E**) and are illustrated in **Figure 2-3**. No further movement was noted during the reporting period.

Figure 2-3 Cracking at culvert 88.980 km (source: PMLL Detailed Monitoring Report 19, **Appendix E**).

These cracks are noted to be minor and are not adversely affecting the structural integrity of the culverts. However, these observations triggered a Level 2 TARP trigger for historical heritage in October 2020, November 2020, February 2021, March 2021 and April 2021.

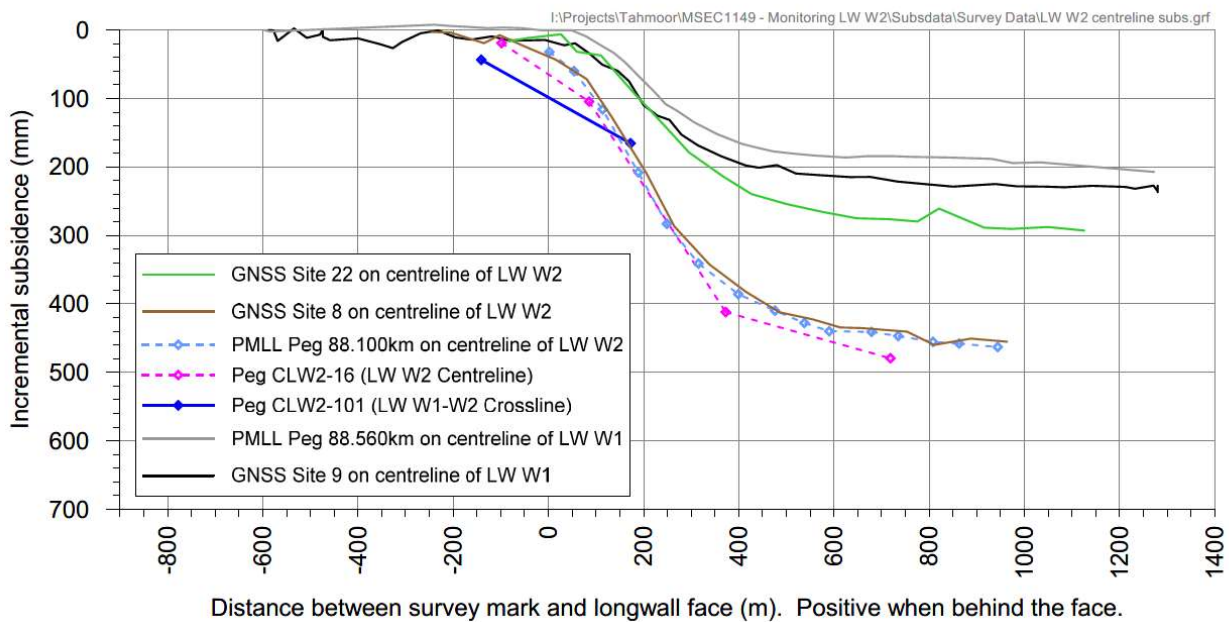
During the reporting period, observed subsidence along the centreline of LW W2 is greater than LW W1 but current trends indicate that observed subsidence will be less than predicted subsidence and no trends of definitive valley closure have been evident.

The development of subsidence at pegs and GNSS units located on the LW W2 centreline that have been mined directly beneath by LW W2 are illustrated in **Figure 4-2**. This figure shows that subsidence currently observed along the centreline of LW W2 is greater than LWW1 but current trends indicate that observed subsidence will be less than predicted subsidence.

Figure 4-2 Development of subsidence along centreline of LW W2 compared to previously extracted single panels (source: MSEC, Subsidence Monitoring Report 15, Appendix A).

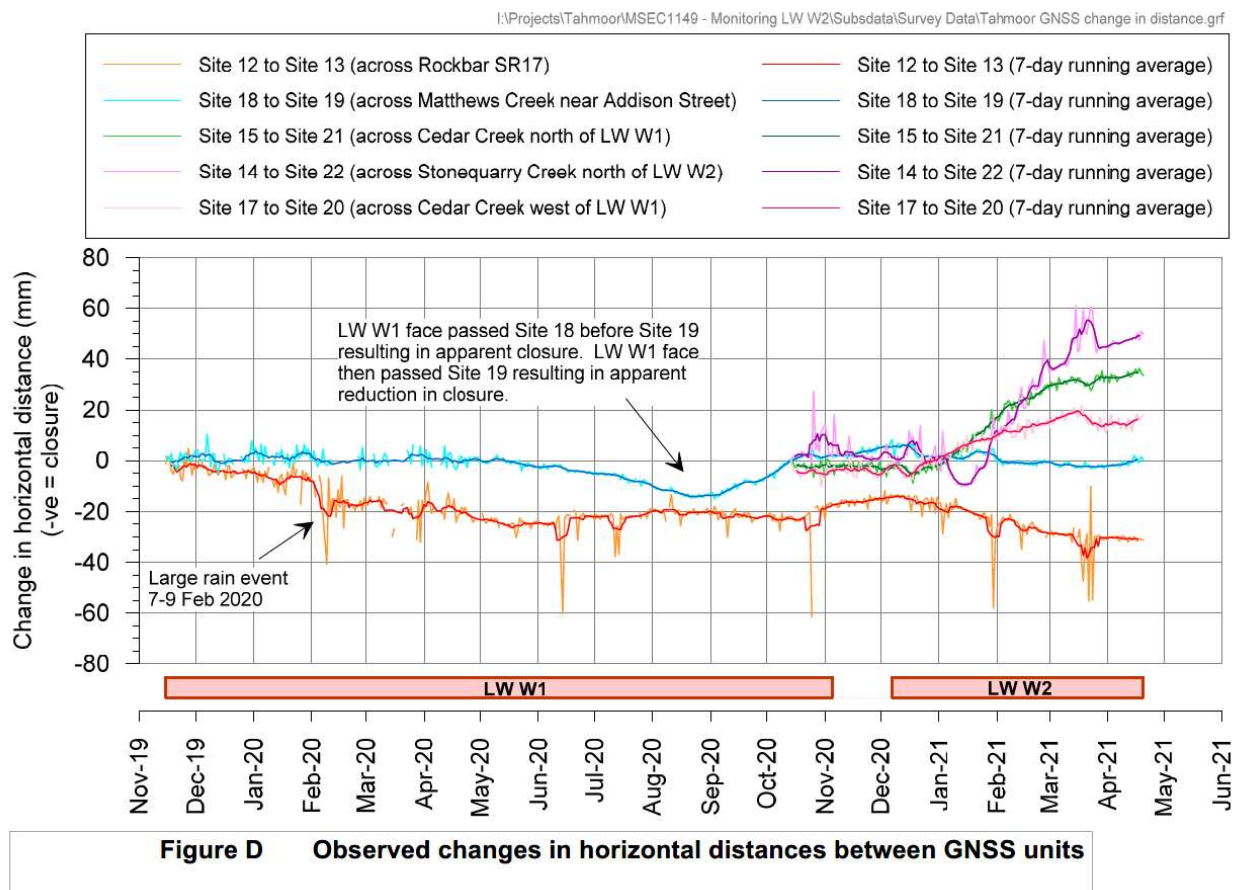
Site 13 moved south more than Site 12, resulting in closure of approximately 15 mm since the commencement of LW W2. Very little change is, however, measured across the rockbar itself and rates of change have reduced. Site 12 was observed to rise in height in response to the heavy rainfall event in late March and has stopped rising (refer **Figure 4-3**).

The LW W1 face passed Site 18 in early August 2020 and passed Site 19 in late August 2020, resulting in Site 18 moving towards LW W1 earlier than Site 19. This resulted in an apparent closure between the two sites between June and late August 2020, and an apparent reduction in closure between September to mid-October 2020 (refer **Figure 4-3**).

Figure 4-3 Observed changes in horizontal distances between GNSS units (source: MSEC, Subsidence Monitoring Report 15, Appendix A).
