Tahmoor Coal Pty Ltd

SIX MONTHLY SUBSIDENCE IMPACT REPORT

Western Domain Longwalls West 1 – West 4

Report 6 – December 2022

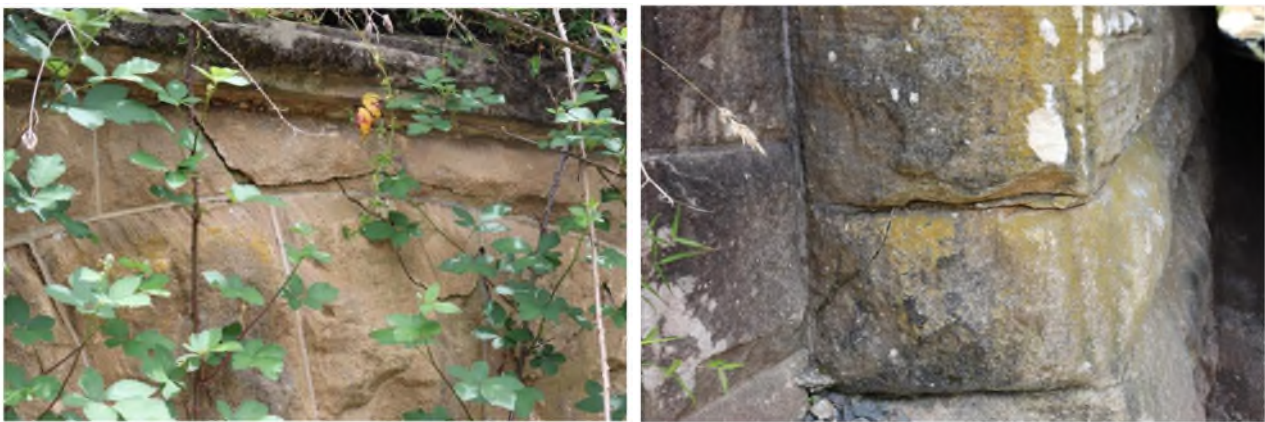
Cracking on the portal ends of the sandstone culverts at 88.980 km and 88.400 km and the barrel of the culvert at 88.400 km results in a Level 3 TARP trigger due to confirmed mining-related impacts.

Figure 2-1 Cracking on the portal ends at culvert 88.400 km. This cracking has not worsened during the mining of LW W4.

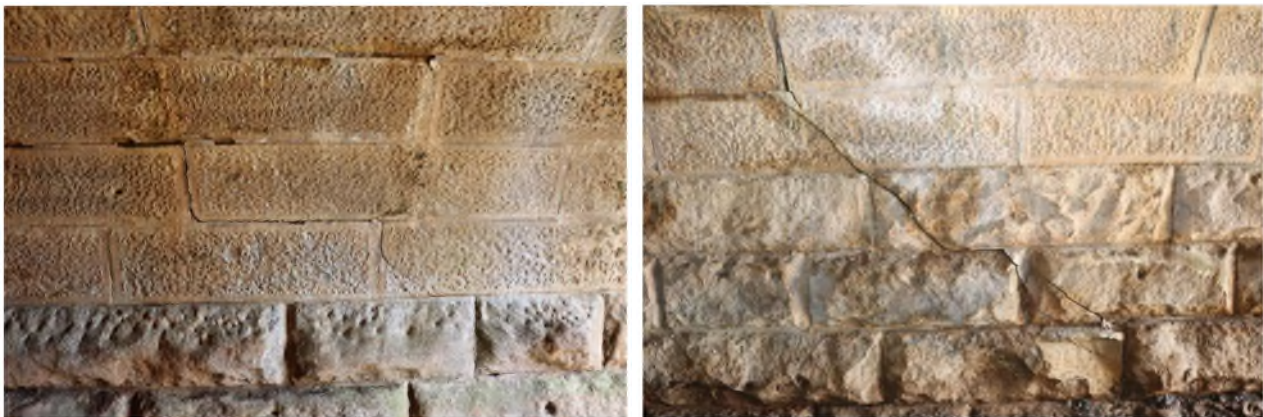
Figure 2-2 Cracking in the barrel of culvert 88.400 km. This cracking has formed during the mining of the Western Domain.

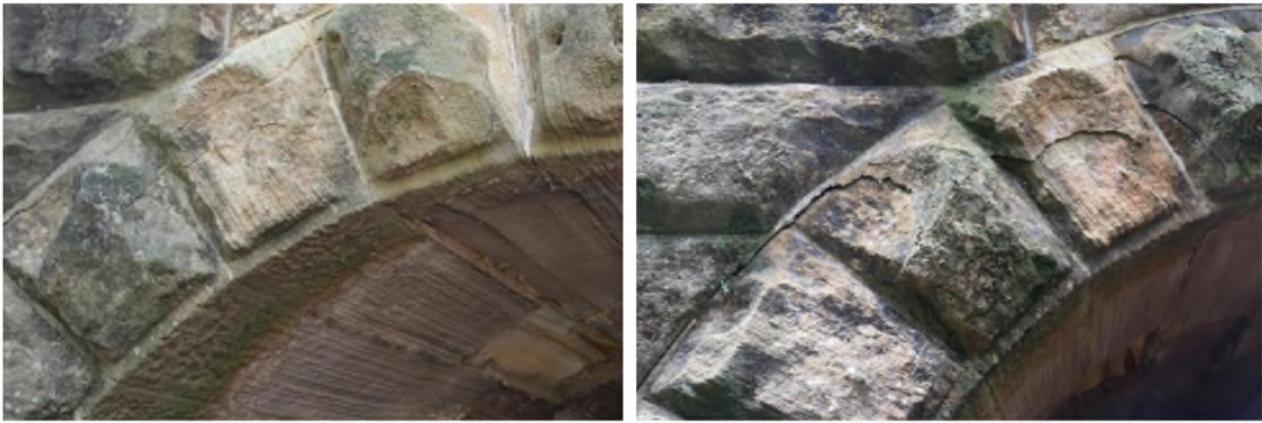
Figure 2-3 Cracking at culvert 88.980 km. Pre-mining (left) and post-mining (right) inspection photographs. Cracking along the mortar and spalling of the arch stones has not worsened significantly during extraction of LW W4.

During the current reporting period, it was confirmed that no new impacts to the portal ends of the culverts have been observed during the monitoring throughout the extraction of LW W4, and the end of panel heritage inspection confirmed that no additional cracking, worsening of existing cracks or spalling had occurred (**Appendix E**).

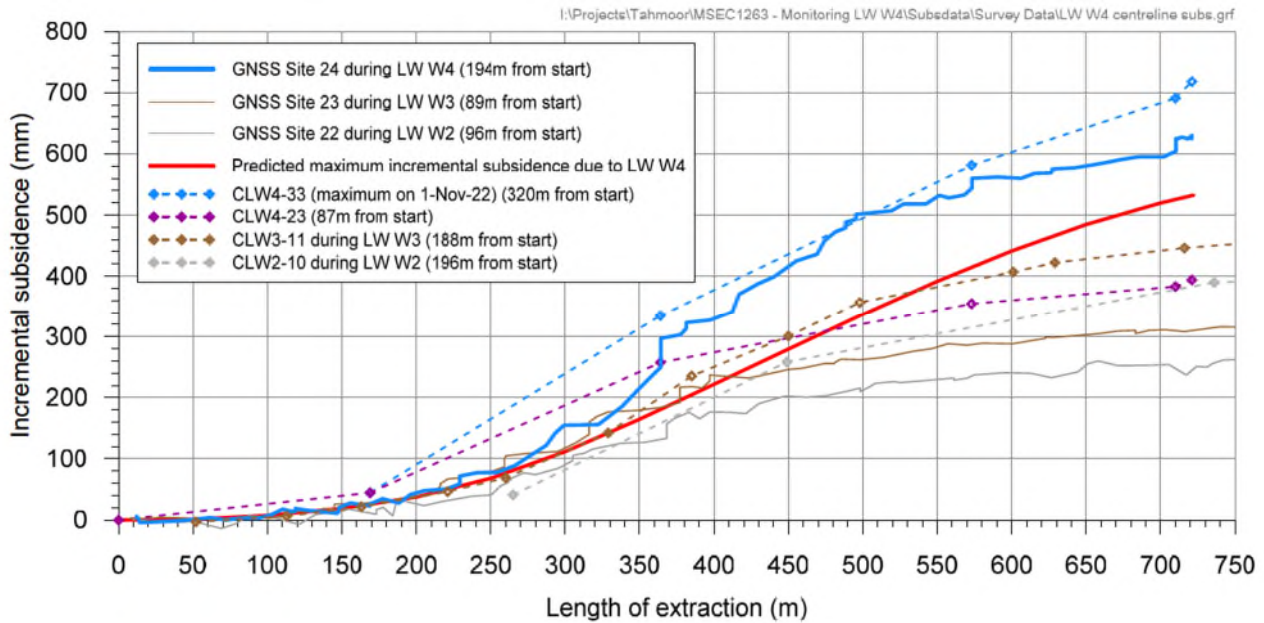
Figure 4-2 Development of subsidence along centreline of LW W4 (source: MSEC, Subsidence Monitoring Report 20, Appendix A)

The development of subsidence at pegs and GNSS units located on the LW W4 centreline that have been mined directly beneath by LW W4 are illustrated in **Figure 4-2**. Observed subsidence exceeded predicted subsidence above the northern portion of LW W4, however returned to within predictions above the southern portion of LW W4. The subsidence observations above the northern portion of LW W4 is similar to previously observed increased subsidence above LWs 24A to 28 and LW 32, which were influenced by the Nepean Fault. The Nepean Fault is also located close to LW W4, and the potential for increased subsidence was raised in the subsidence prediction report for LW W3-W4 Extraction Plan.

GNSS unit 24 has experienced greater subsidence than predicted and greater subsidence than was previously experienced at equivalent locations during the mining of LW W2 and LW W3.
