Report on
Geotechnical Assessment
Longwalls S1A to S6A, Bargo

Prepared for
Tahmoor Coal Pty Ltd

Project 210597.00
December 2022

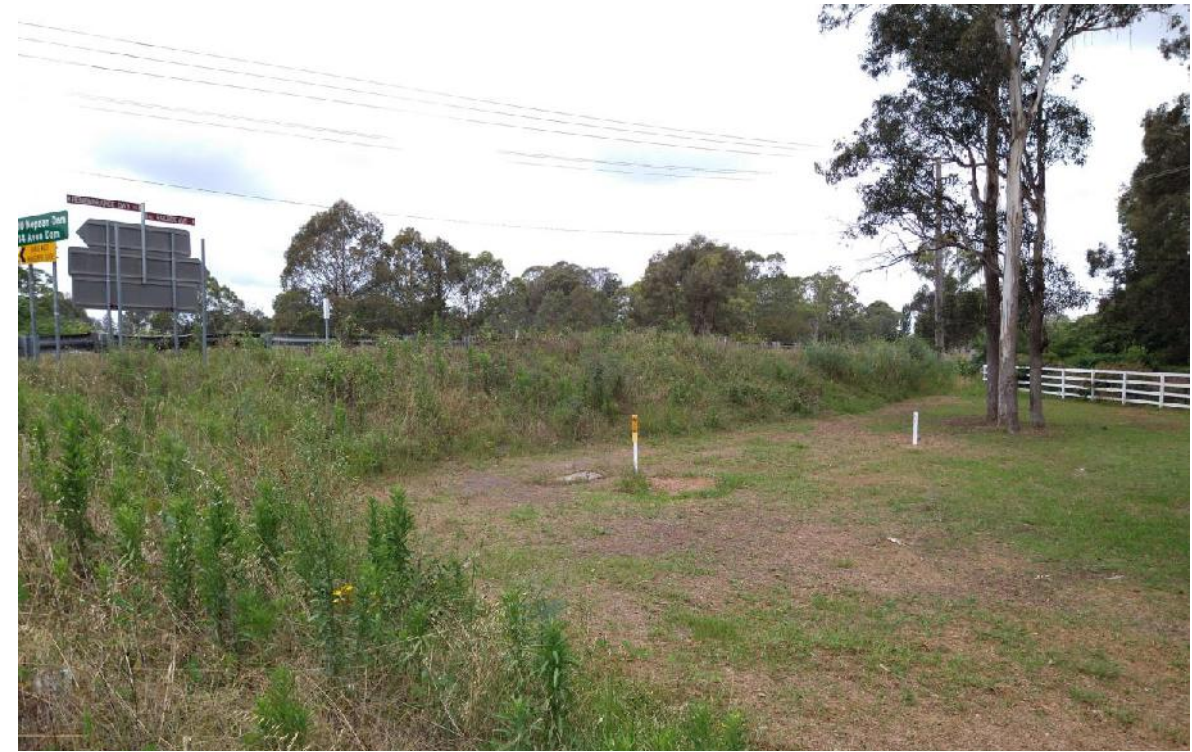
Photo 2: View looking south east across the south western corner of the RE1 road embankment.

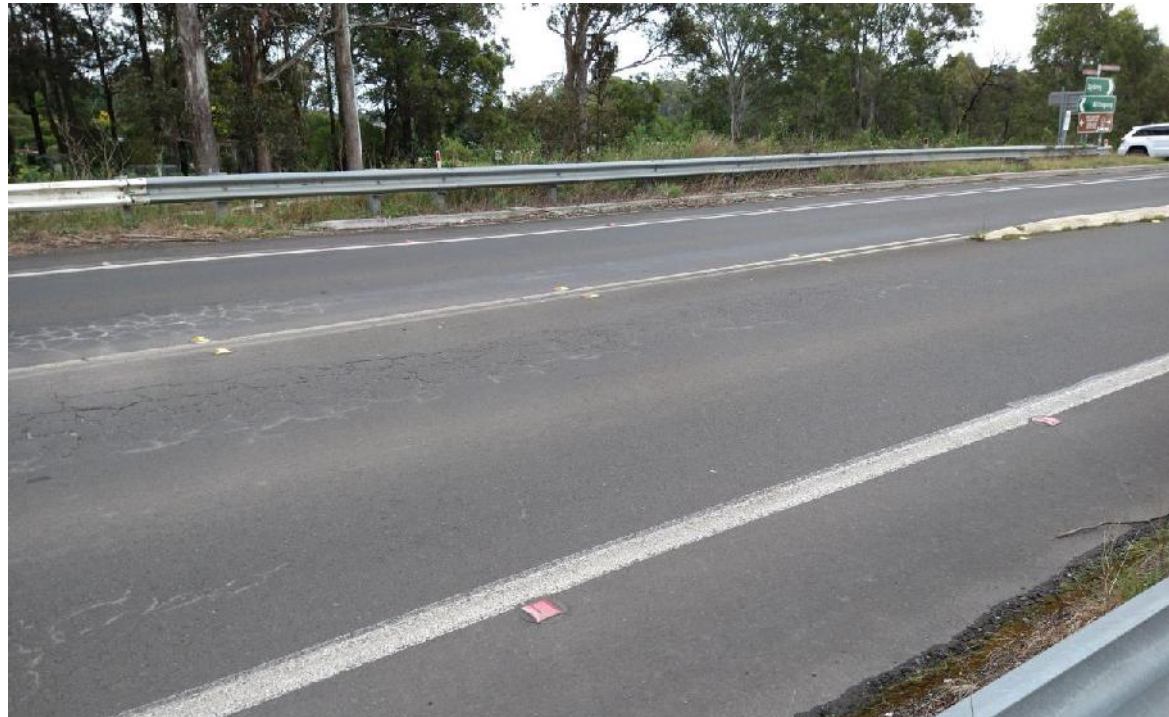
Photo 3: View looking north west at rutting and crocodile cracking in the Remembrance Drive wearing course to the south of the intersection with Wellers Road (RE1).

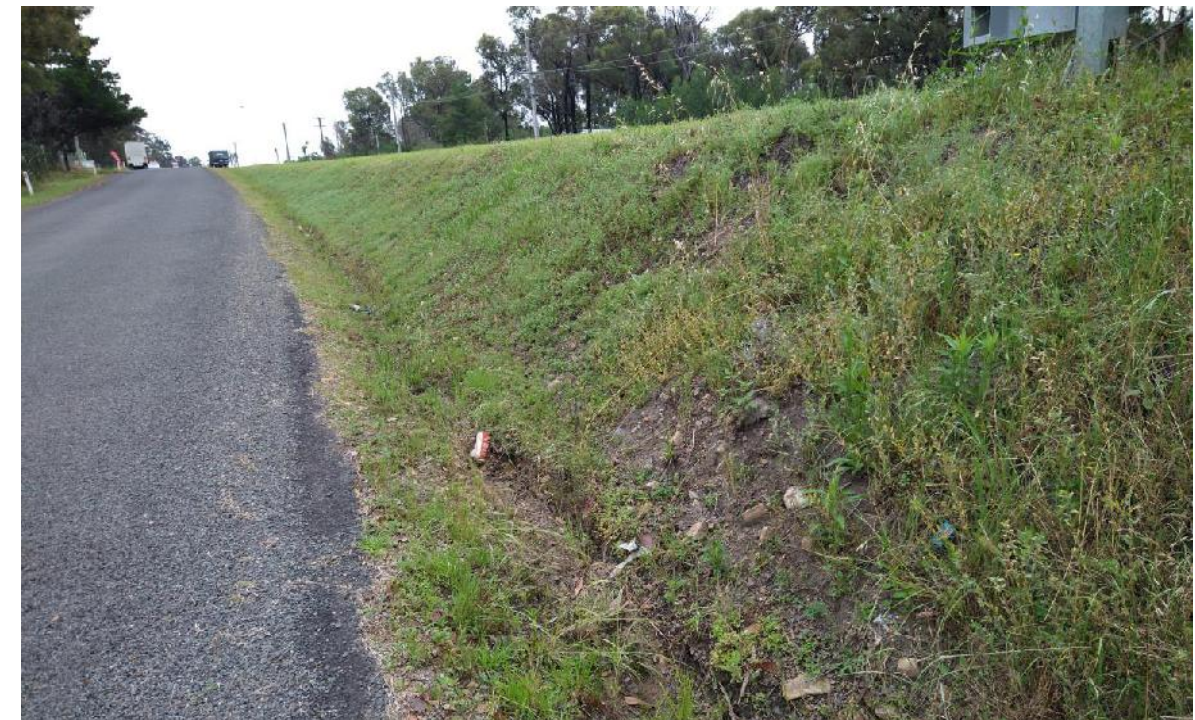
Photo 11: View looking south along the upstream face of RE4 opposite No. 3100 Remembrance Drive. Note: the drain cut into the toe of the embankment.

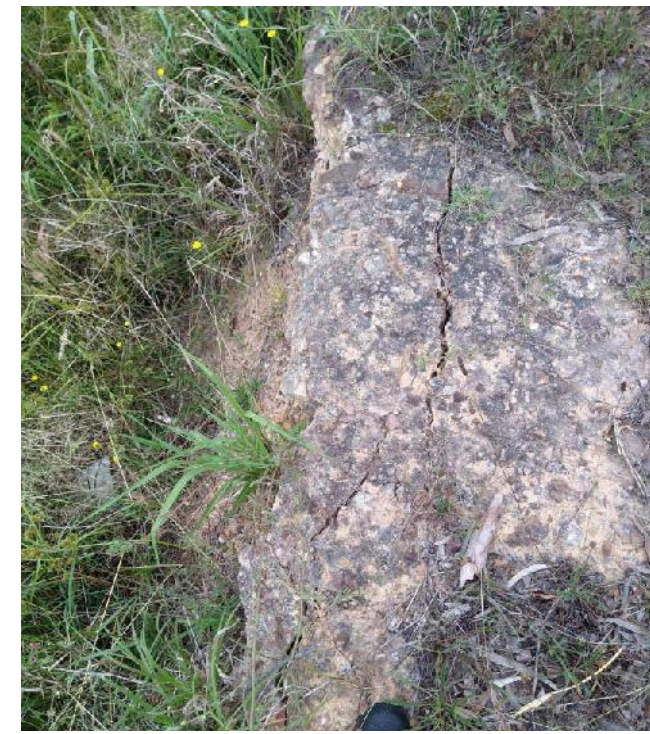
Photo 16: View looking at tension cracks setback behind the crest of opposite No. 3122 Remembrance Drive.

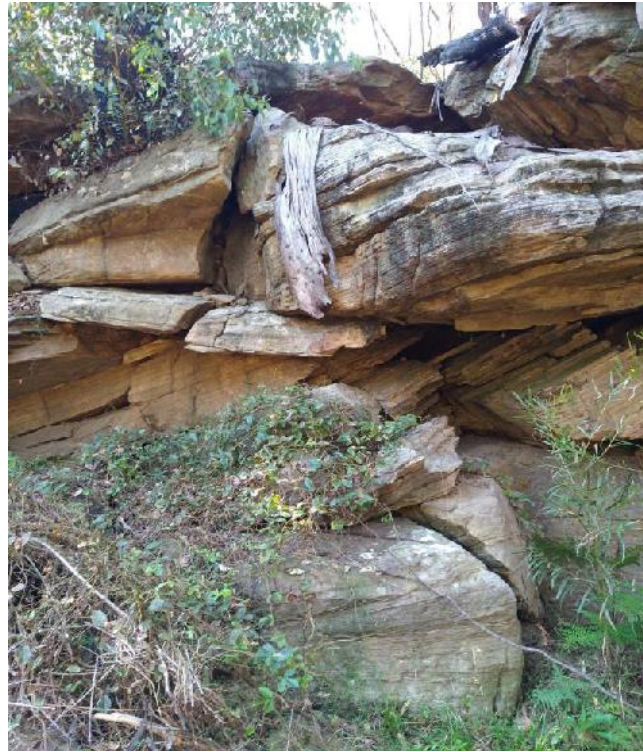
Photo 17: View looking open jointing and dislodged joint blocks near the 'Big Pool' (WC1) in Wirrimbirra Creek.

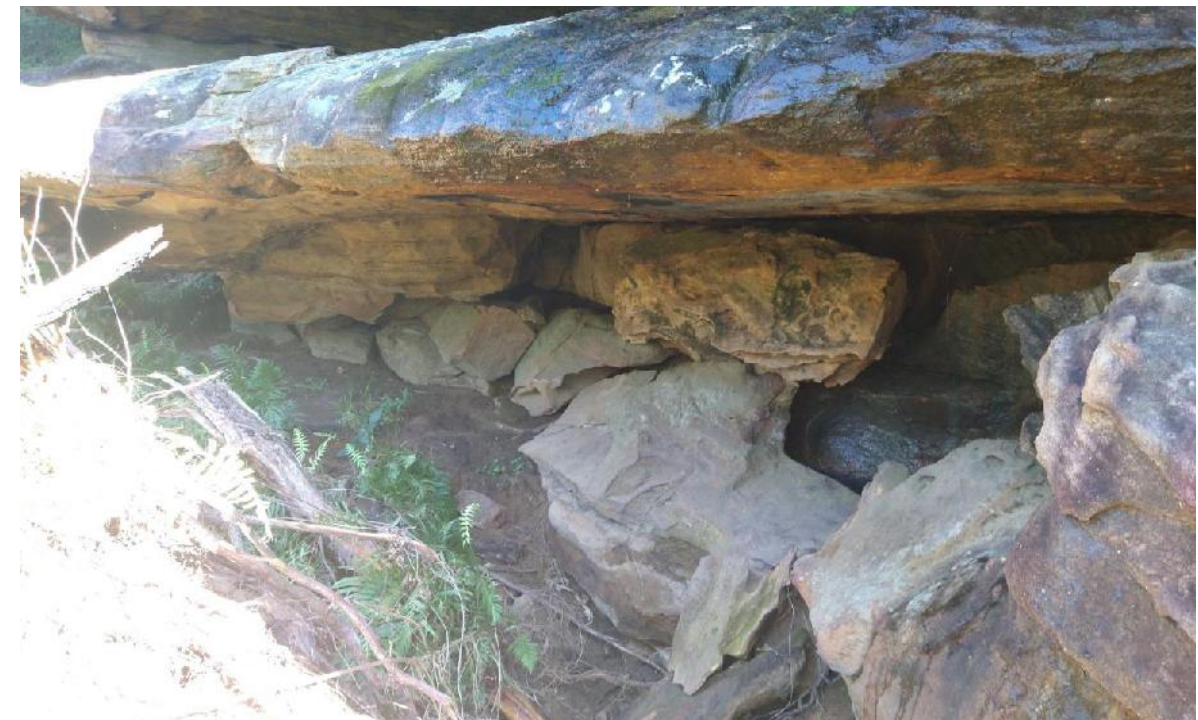
Photo 20: View looking at collapsed joint blocks below a section of overhang near Dekenden Pool (WC2).

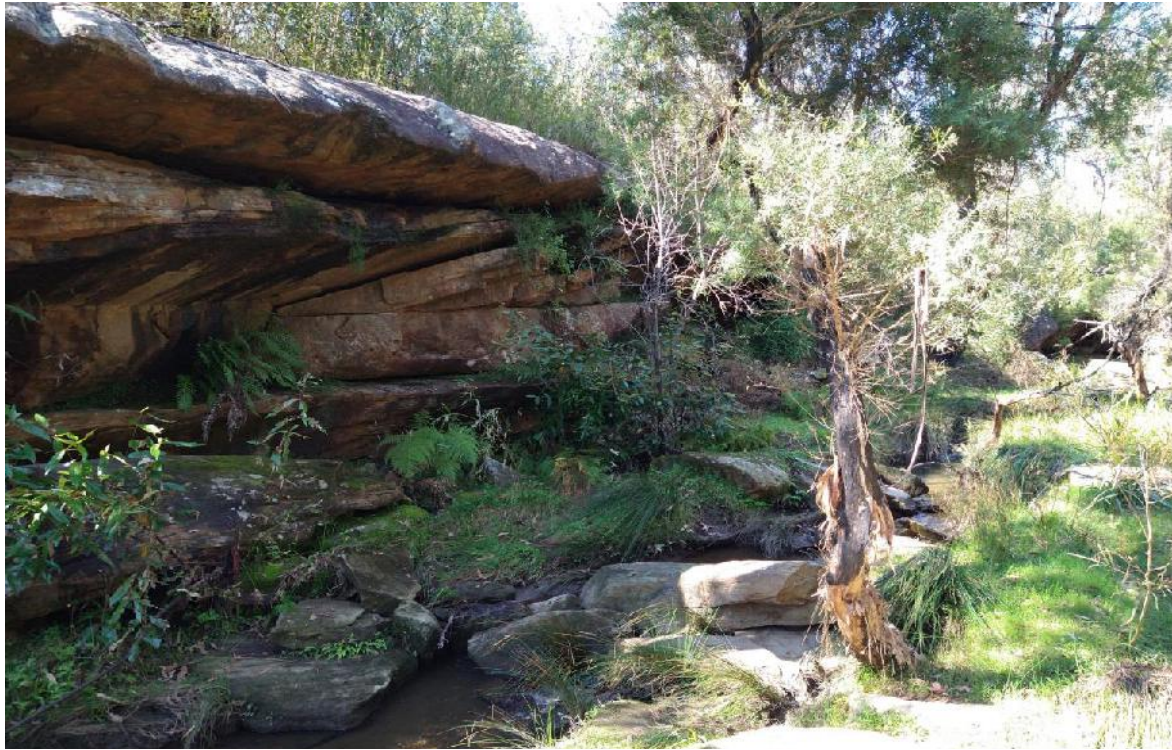
Photo 21: View looking at overhanging rocky outcrops near 'Petroph Pass' (WC3) in Wirrimbirra Creek.

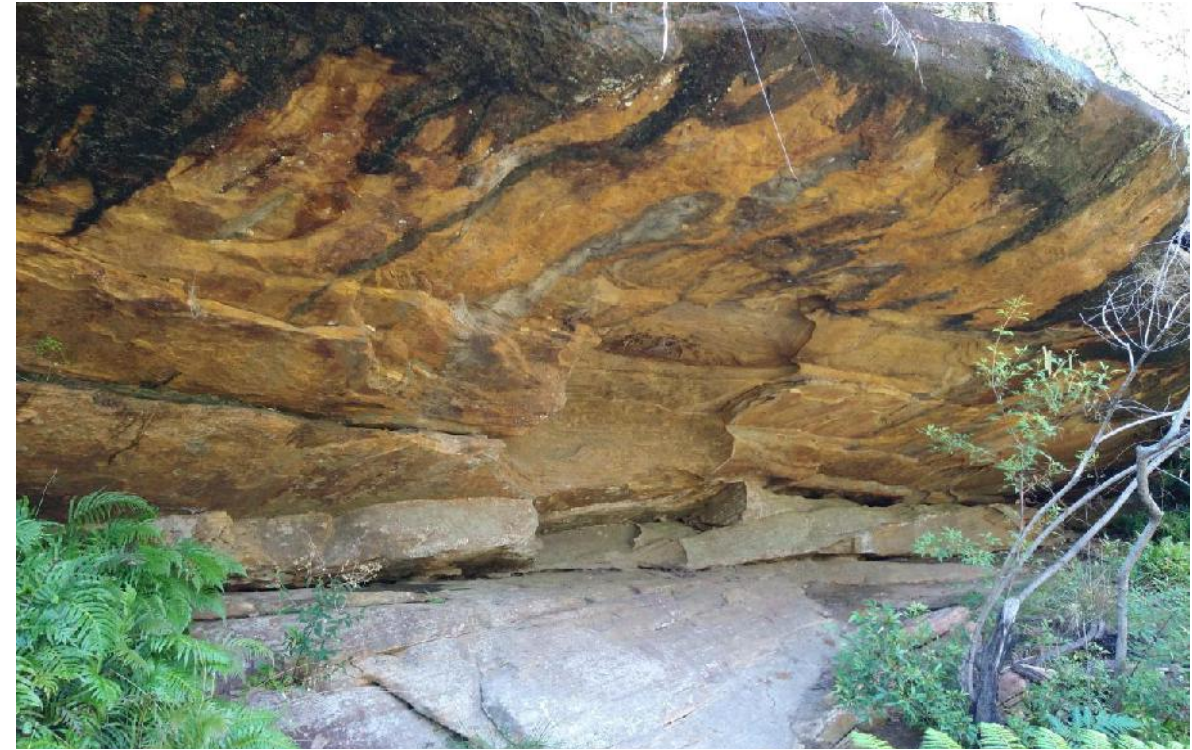
Photo 22: View looking at a wide section of overhang near 'Petroph Pass' (WC3) in Wirrimbirra Creek.

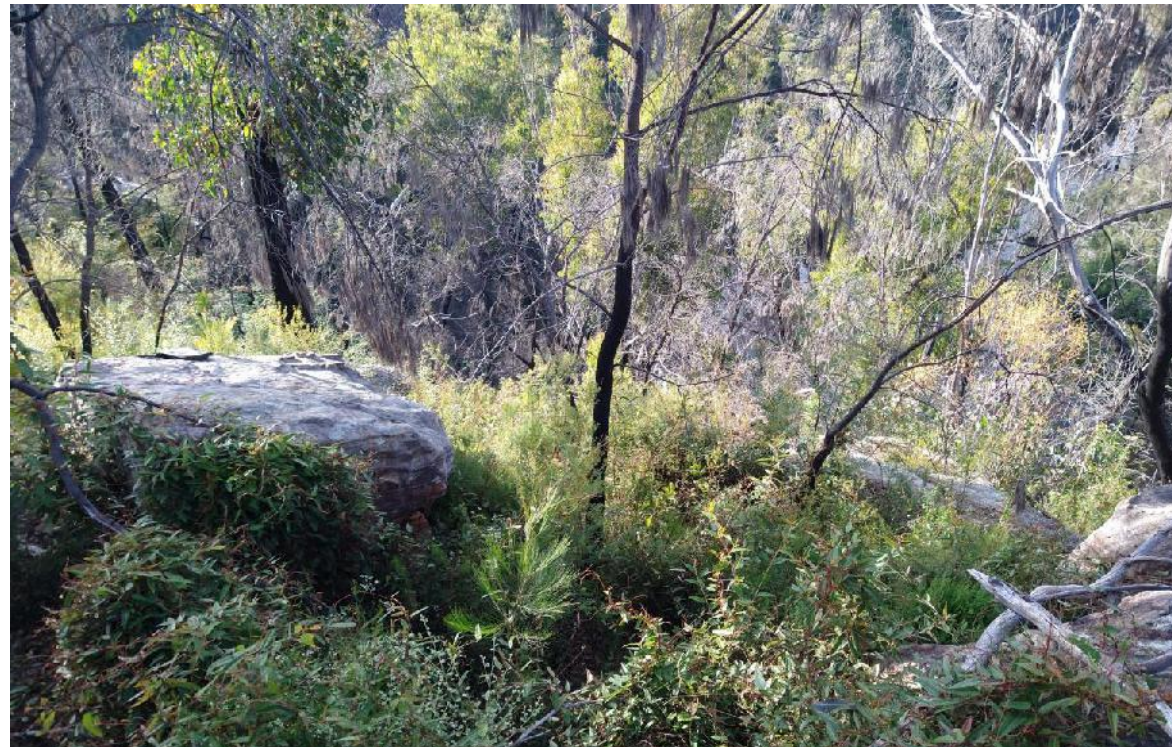
Photo 23: View looking south downslope at WC4. Note: the sandstone blocks and slabs of sandstone resting on the surface.

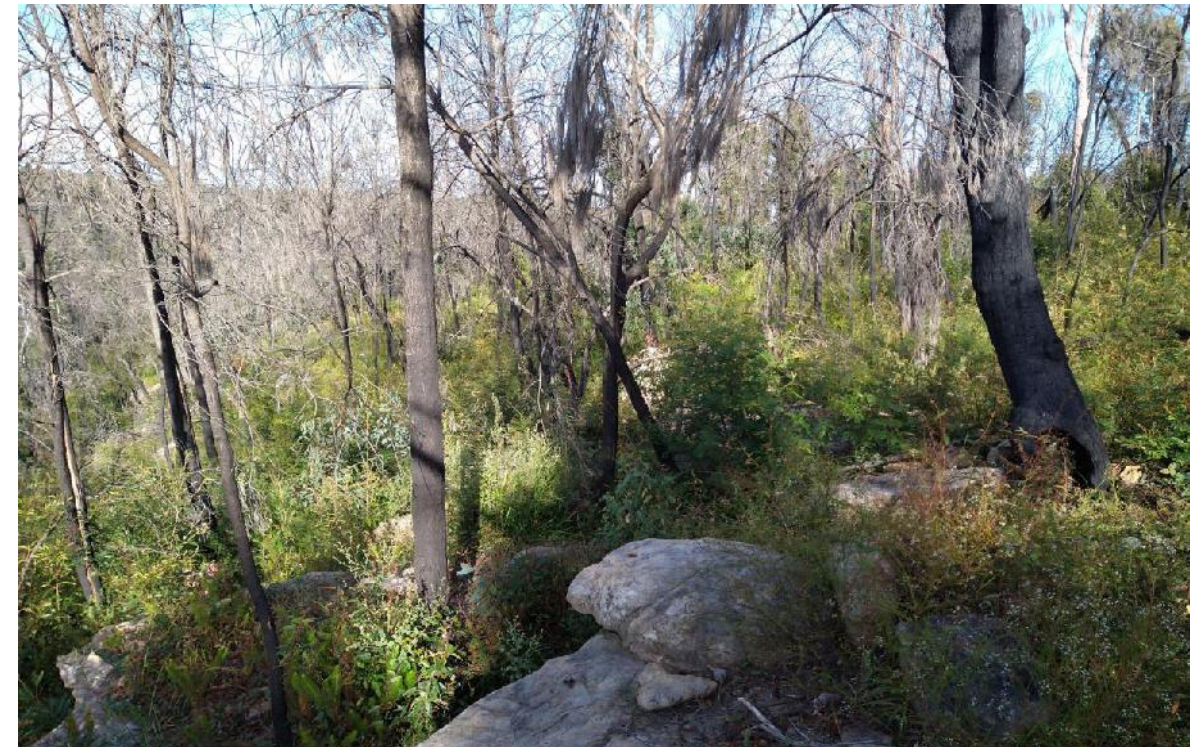
Photo 24: View looking west across the upper slope above the Bargo River at WC4. Note: the sandstone blocks and slabs of sandstone resting on the surface and burnt/dead trees.

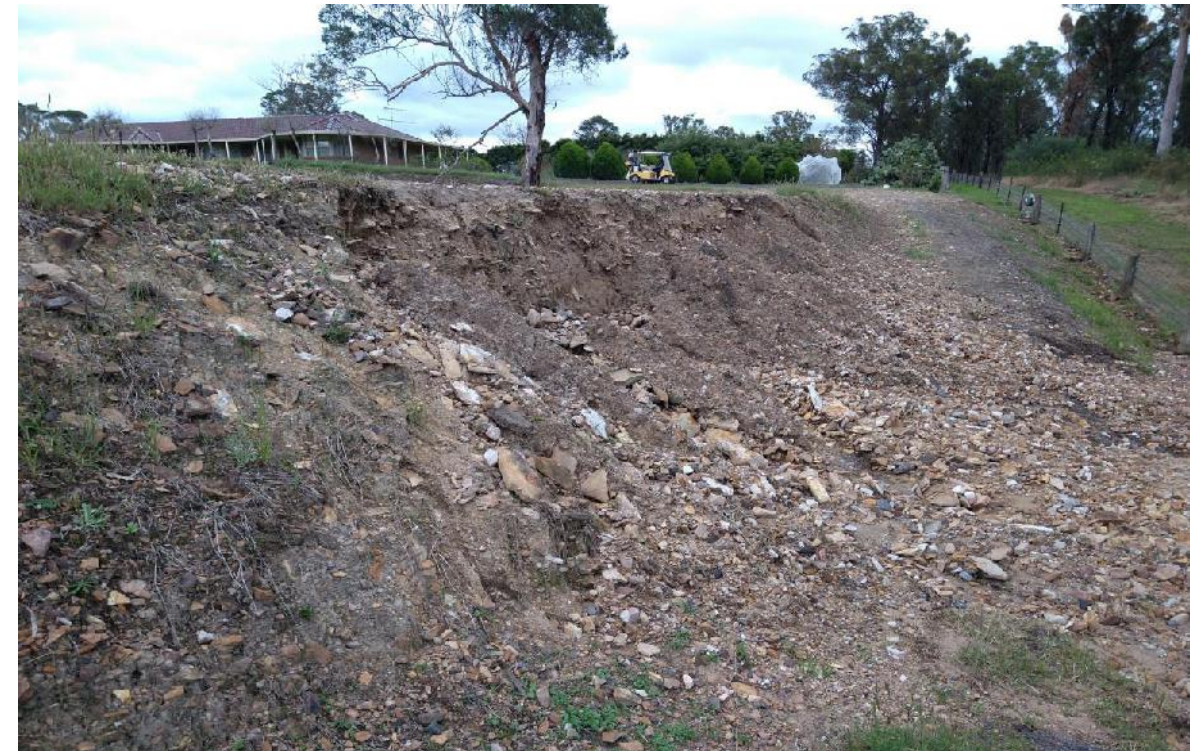
-	4 Olive Lane	12/04/2022	<ul style="list-style-type: none"> – The dam spillway comprises an approximately 250 mm diameter pipe. – The owner advised that the farm dam had overtopped during heavy rainfall in early March 2022 that resulted in scour of the downstream dam embankment. The downstream embankment was repaired in March. Further erosion occurred during a second overtopping event in early April 2022 (refer Photos 25 and 26).
FD1	115 Charlies Point Rd	10/02/2022	– The dam has no spillway. The dam (refer Photo 27) is partially incised into the site slope (ie not within a watercourse). Overflow goes around the south eastern and south western sides of the wall.
FD2 & FD3	Wollondilly Anglican College (WAC), No. 3000 Remembrance Drive, No.'s 1 and 5 Olive Lane)	17/01/2022	<ul style="list-style-type: none"> – A WAC grounds keeper advised FD2 is a bore-fed dam. FD2 (refer Photo 28 and 29) is partially incised into the site slopes. – FD3 (refer Photo 30) comprise small ponds partially incised in the site slopes above the gully. A WAC grounds keeper advised that it is not a spring-fed dam, rather it collects flows from the nearby shed roof.

Photo 26: View looking west along the downstream toe of the farm dam at 4 Olive Lane (outside the SA). Note: the erosion and scour following overtopping during a heavy rainfall event in early April 2022.

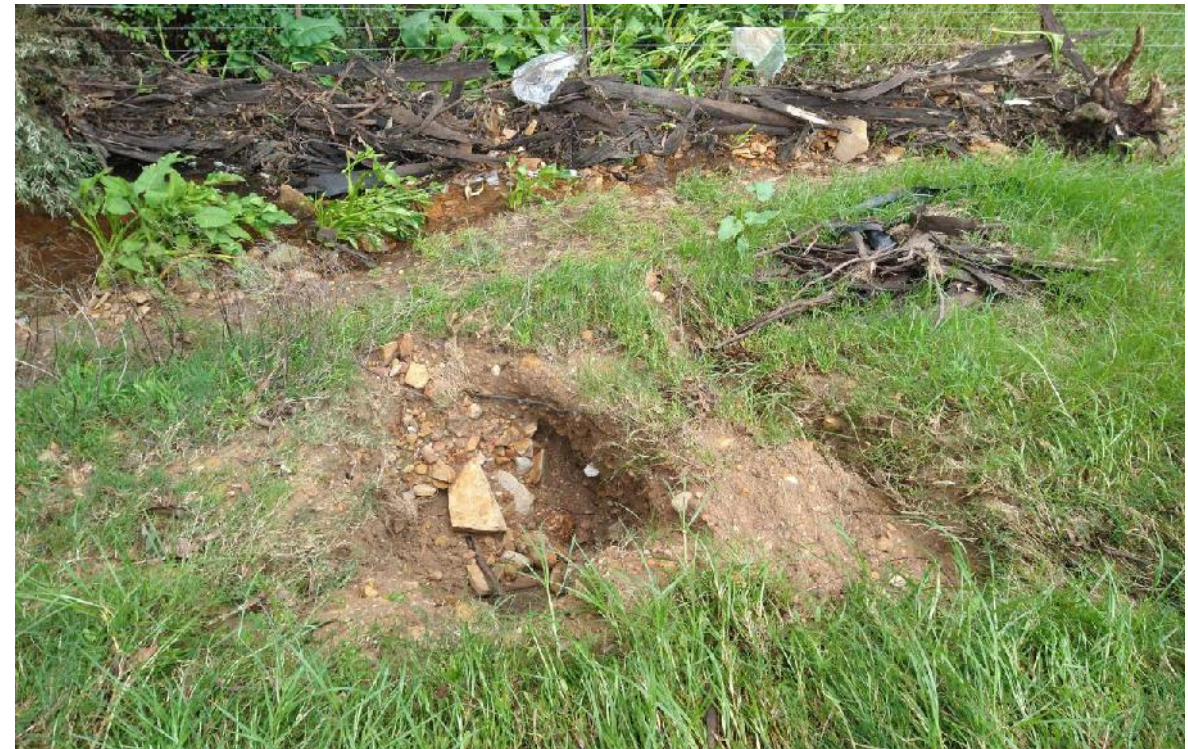
Photo 38: View looking at erosion and scour in the downstream face of FD27. Note the spillway channel at the toe of the embankment in the upper photo.

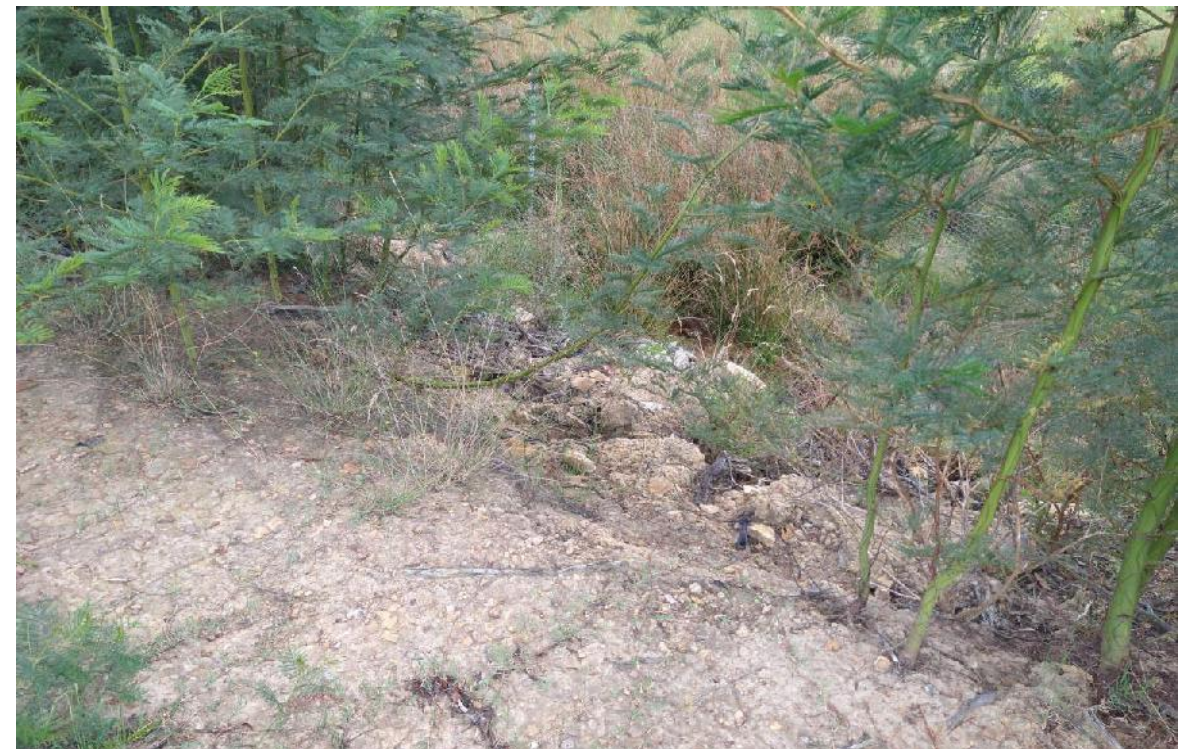
Photo 40: View looking at erosion in the downstream embankment face of FD31. Note: the saplings growing in the downstream face.
