Tahmoor Coal Pty Ltd

SIX MONTHLY SUBSIDENCE IMPACT REPORT

Western Domain Longwalls West 1 – West 4

Report 7 – March 2023

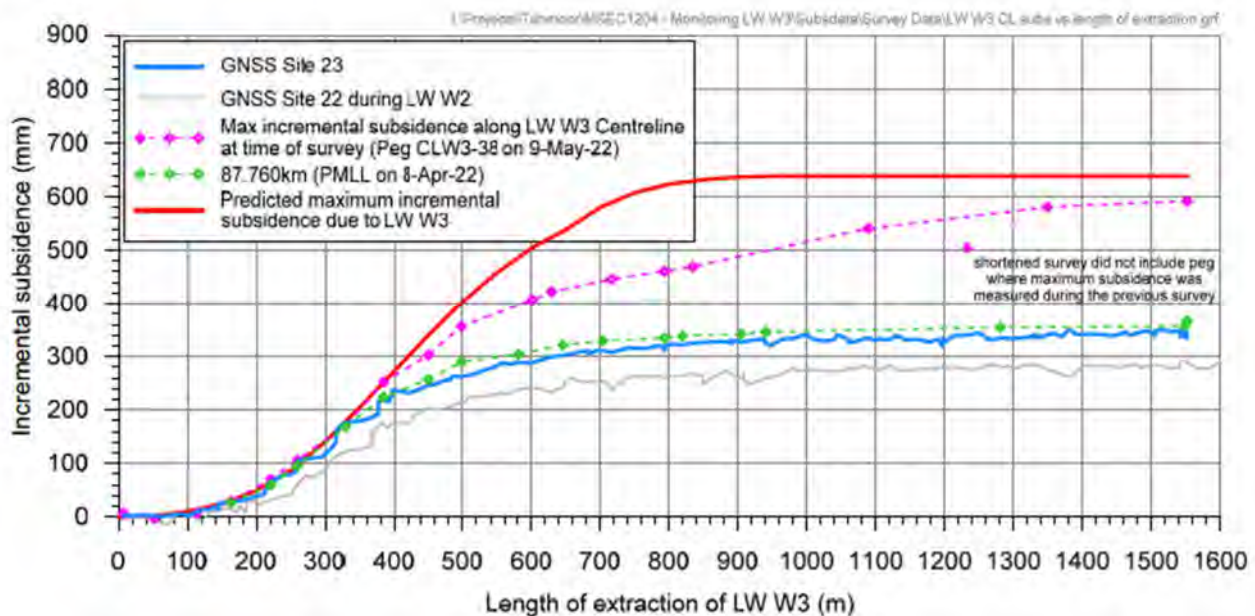
Figure 2-1 Development of subsidence along centreline of LW W3 (source: MSEC, Subsidence Monitoring Report 27, Appendix A)

The development of subsidence at pegs and GNSS units located on the LW W3 centreline that have been mined directly beneath by LW W3 are illustrated in **Figure 2-1**. This figure shows that subsidence observed along the centreline of LW W3, as well as that observed at GNSS Site 23 and 87.760 km on the Picton Mittagang Loop Line, was less than predicted.

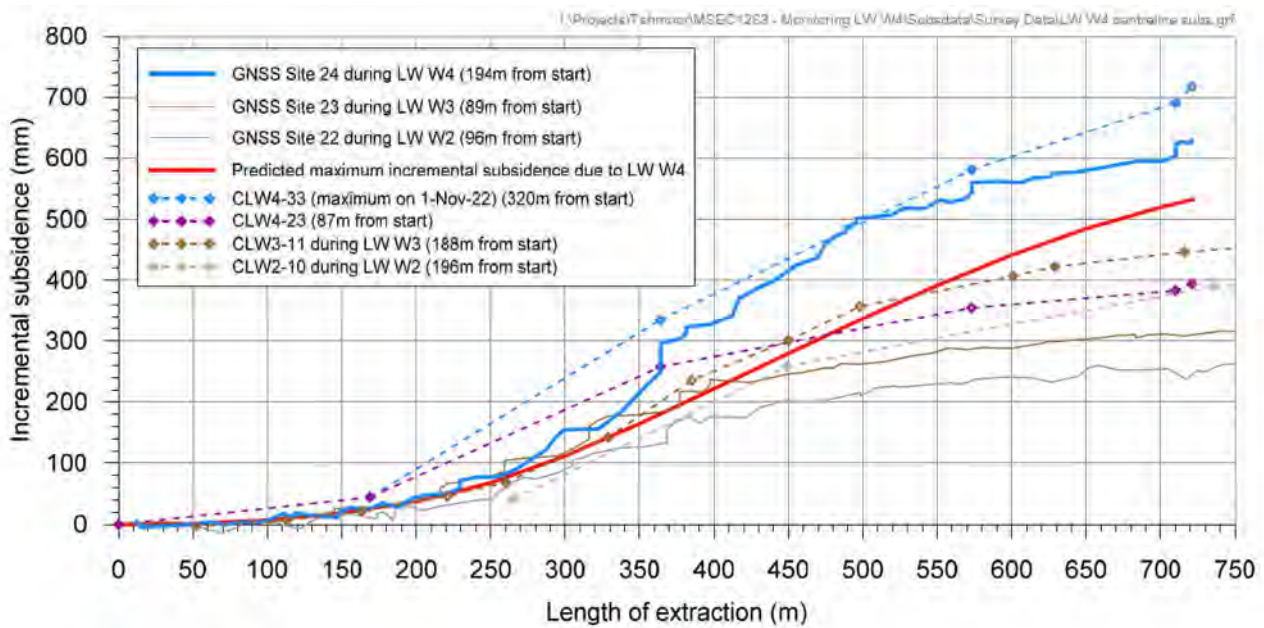
Figure 2-2 Development of subsidence along centreline of LW W4 (source: MSEC, Subsidence Monitoring Report 20, Appendix A)

The development of subsidence at pegs and GNSS units located on the LW W4 centreline that have been mined directly beneath by LW W4 are illustrated in **Figure 2-2**. Observed subsidence exceeded predicted subsidence above the northern portion of LW W4, however returned to within predictions above the southern portion of LW W4. The subsidence observations above the northern portion of LW W4 is similar to previously observed increased subsidence above LWs 24A to 28 and LW 32, which were influenced by the Nepean Fault. The Nepean Fault is also located close to LW W4, and the potential for increased subsidence was raised in the subsidence prediction report for LW W3-W4 Extraction Plan.

GNSS unit 24 has experienced greater subsidence than predicted and greater subsidence than was previously experienced at equivalent locations during the mining of LW W2 and LW W3.

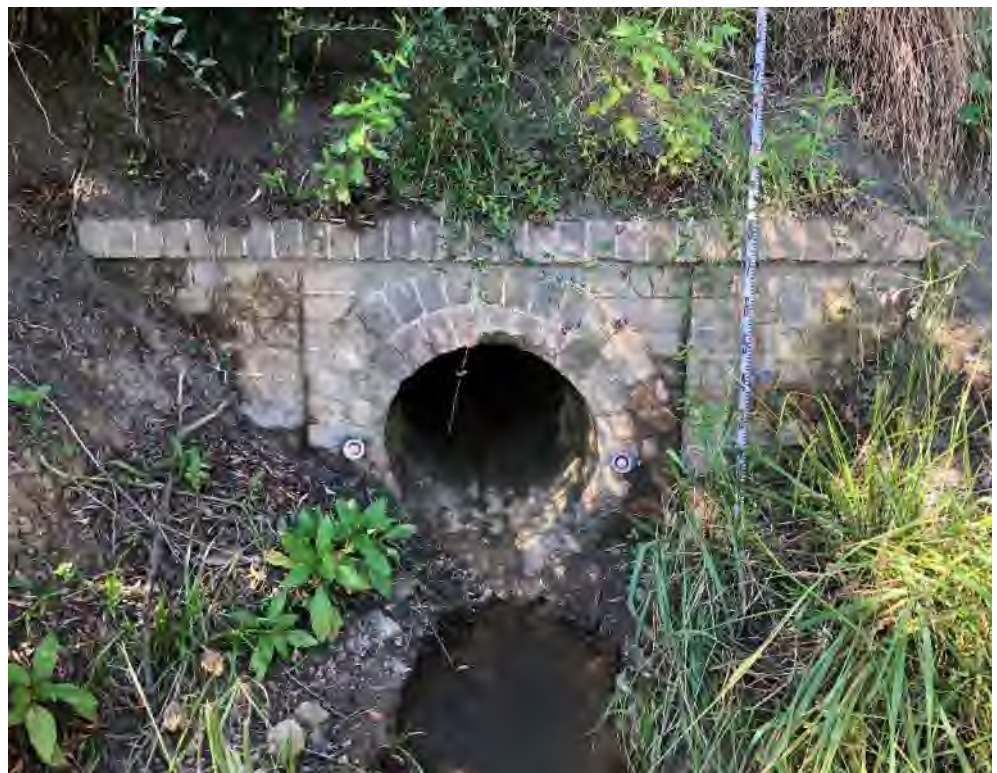
Photo 87.630-1 Western portal. In sound condition

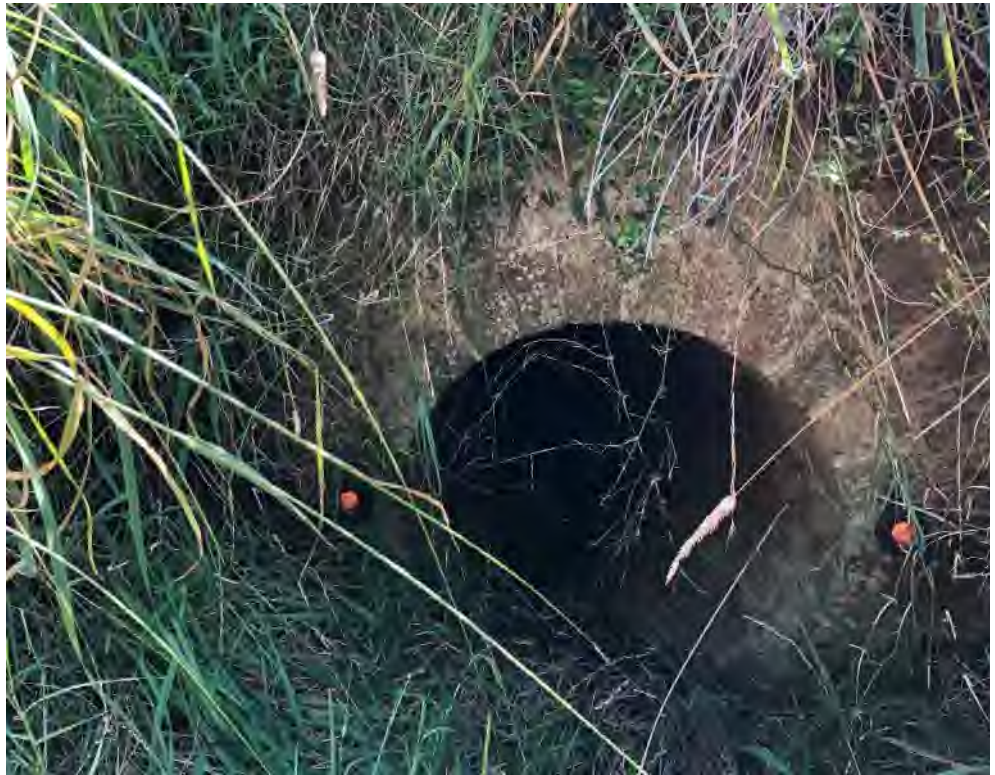
Photo 87.630-2 Eastern portal. Overgrown but appears to be in sound condition.

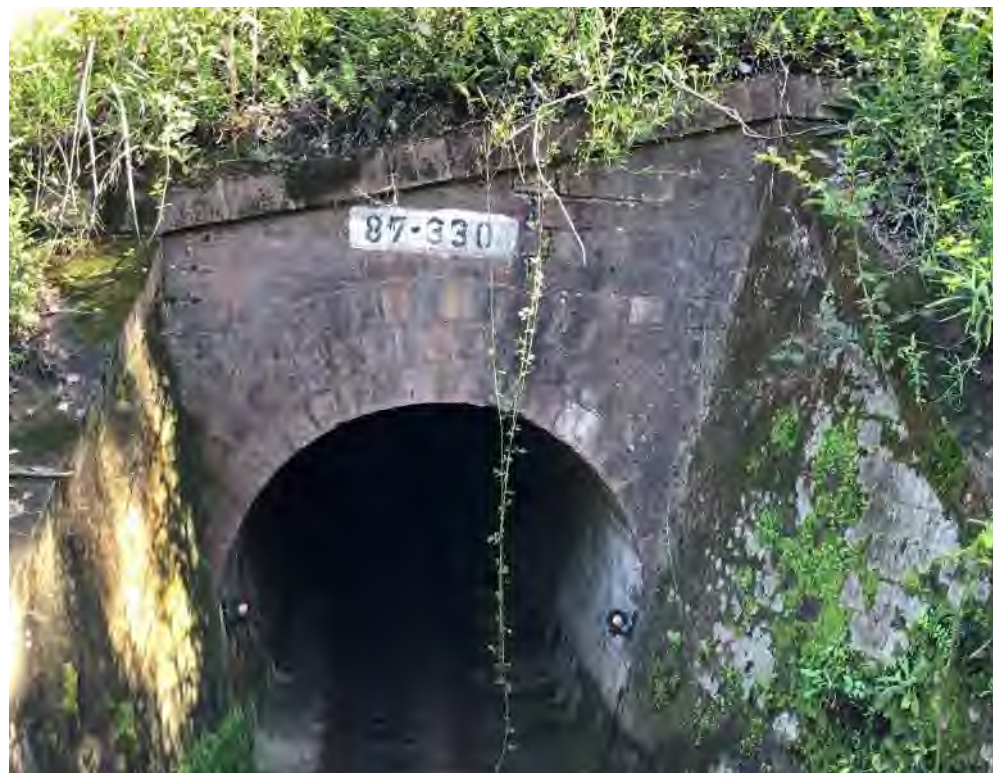
Photo 87.330-1 Eastern (downside) portal. In sound condition

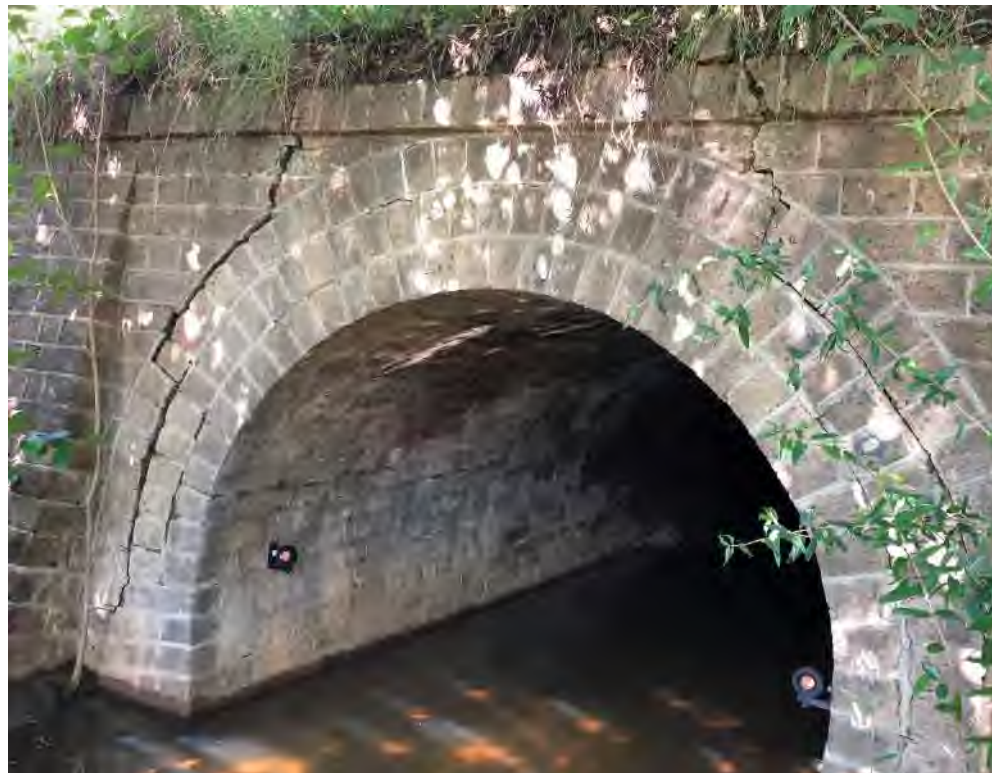
Photo 87.300-1 Northern portal. Difficult to access due to water and weeds. Pre-existing cracking around the arch, mostly through mortar.

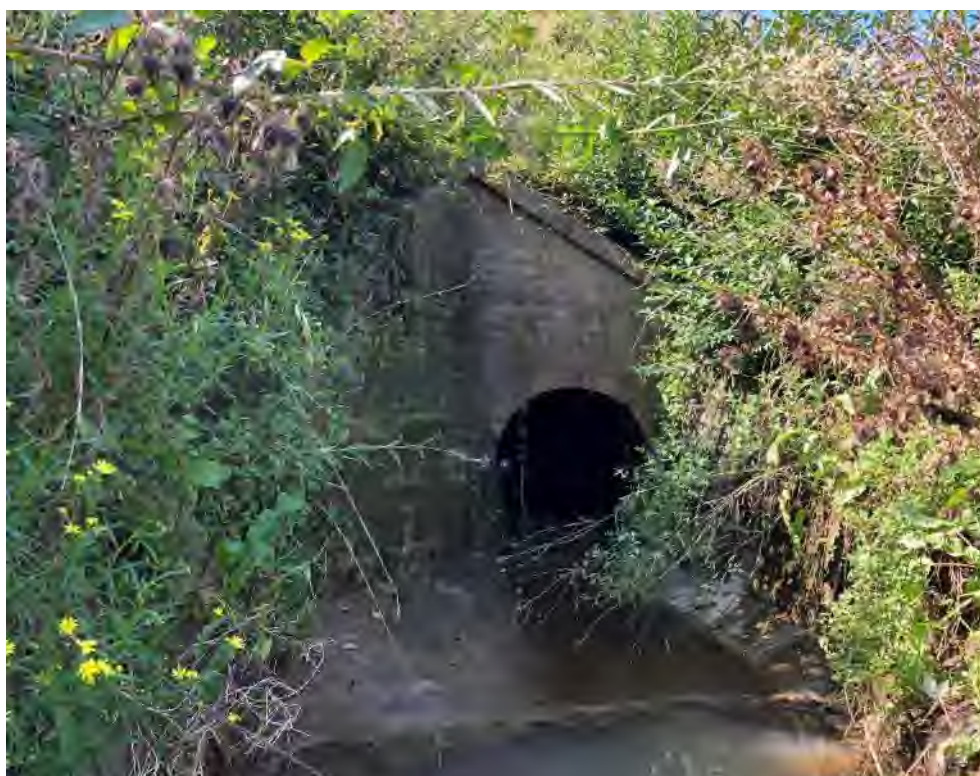
Photo 87.331-1 Western portal. In sound condition.

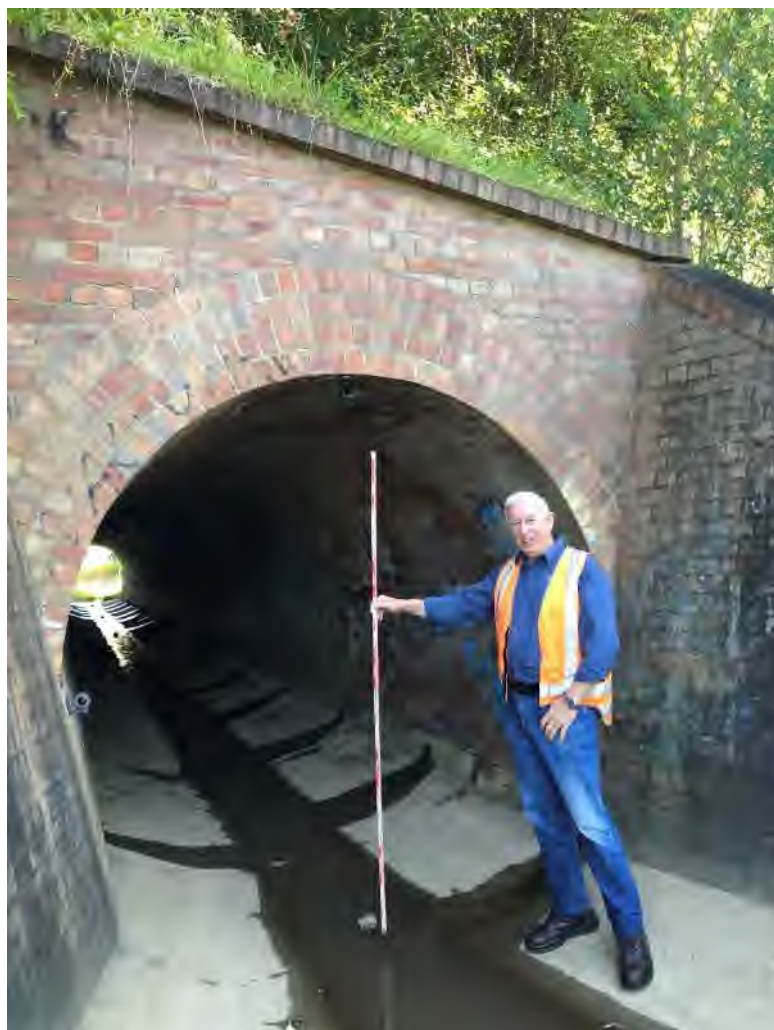
Photo 89.216-1 Eastern portal. Culvert is in good condition.
