Tahmoor Coal Pty Ltd

SIX MONTHLY SUBSIDENCE IMPACT REPORT

Western Domain Longwalls West 1 – West 4

Report 8 – September 2023

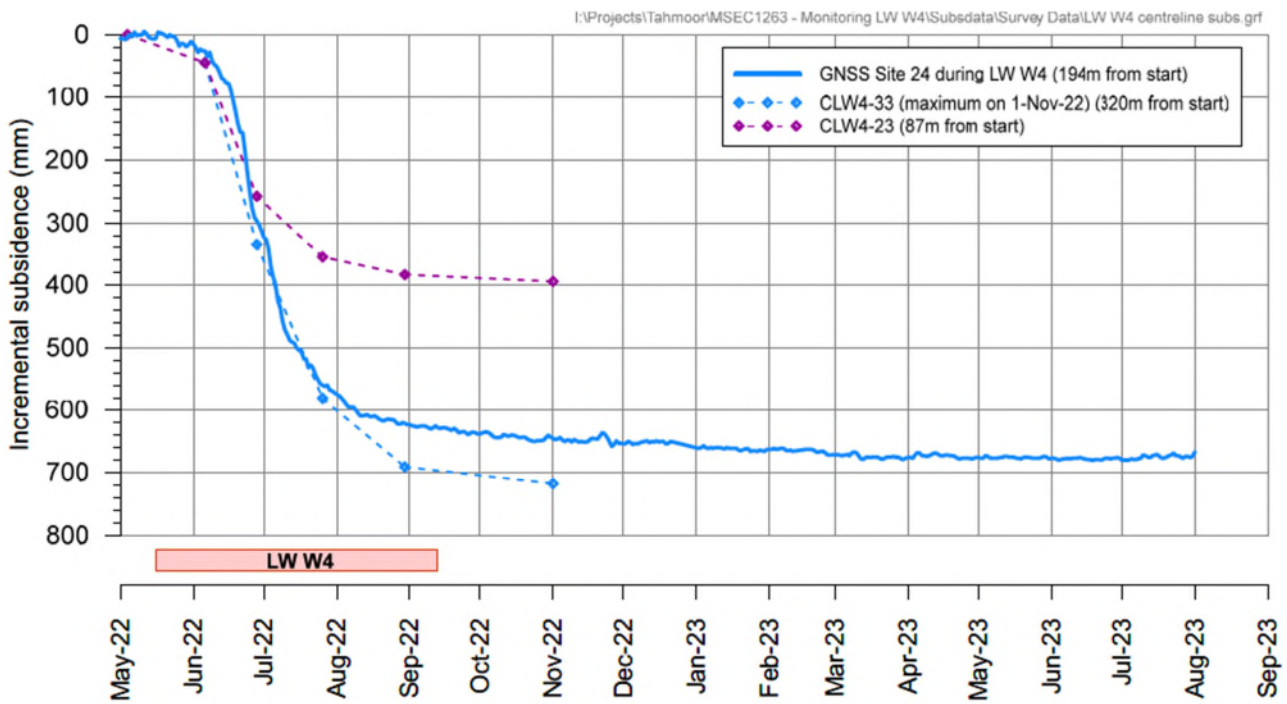
Figure 2-1 Development of subsidence along centreline of LW W4 (source: MSEC, Subsidence Monitoring Report 21, Appendix A).

GNSS Site 24 is located directly above the centreline of LW W4, approximately 200 metres from the commencing end. The unit has recorded approximately 660 mm subsidence and has also moved to the east and south. Rates of change have reduced to very low levels. GNSS Site 24 recorded an additional 16 mm of vertical subsidence in the reporting period, which is likely to be attributed to normal ground movement from climatic variations.

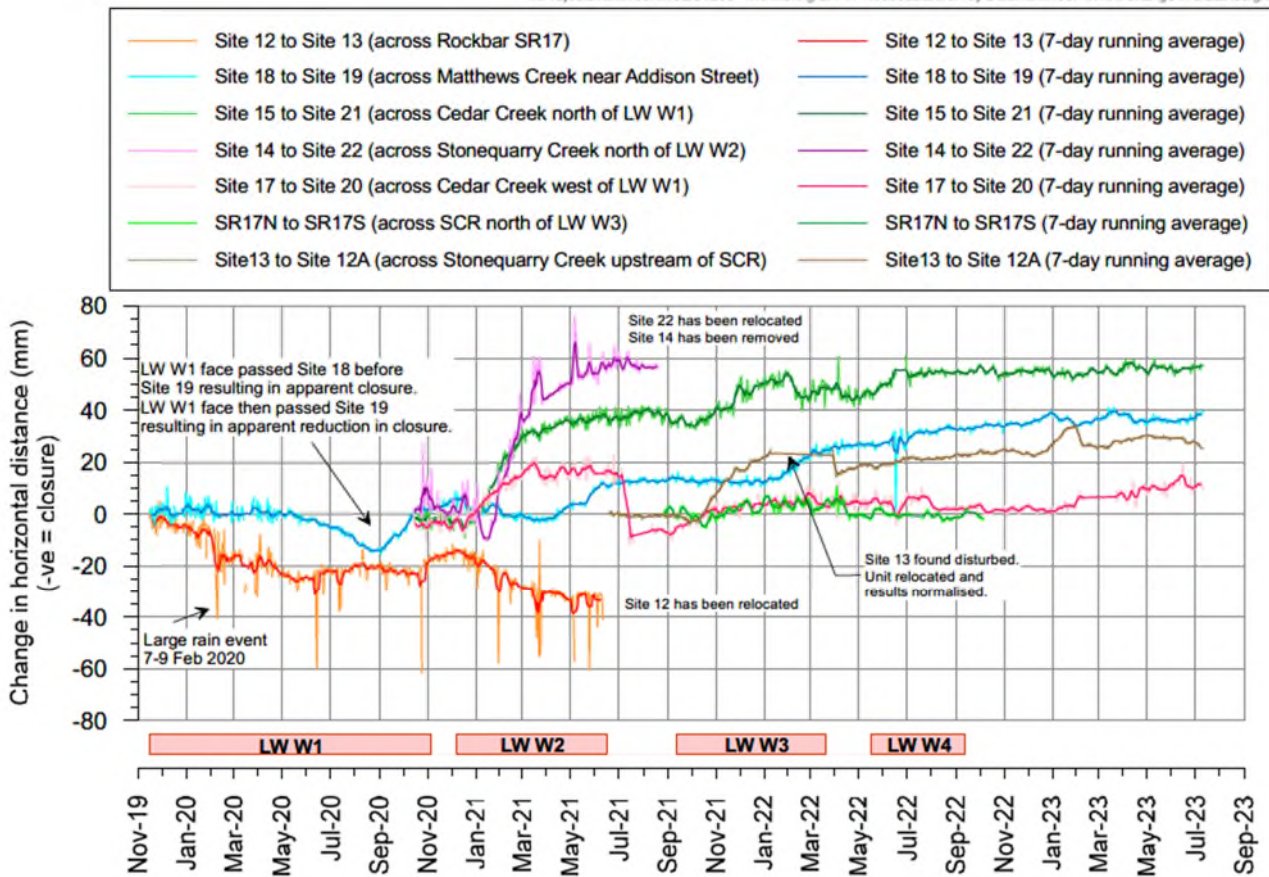
Figure 2-2 Observed changes in horizontal distances between GNSS units during LW W1-W4 extraction (source: MSEC, Subsidence Monitoring Report 21, Appendix A).

Changes in horizontal distances between GNSS units stationed near each other and on opposite sides of a waterway as a result of the extraction of LW W1-W4 are shown in **Figure 2-2**. During LW W4 extraction, only minor changes have been observed between the GNSS units.

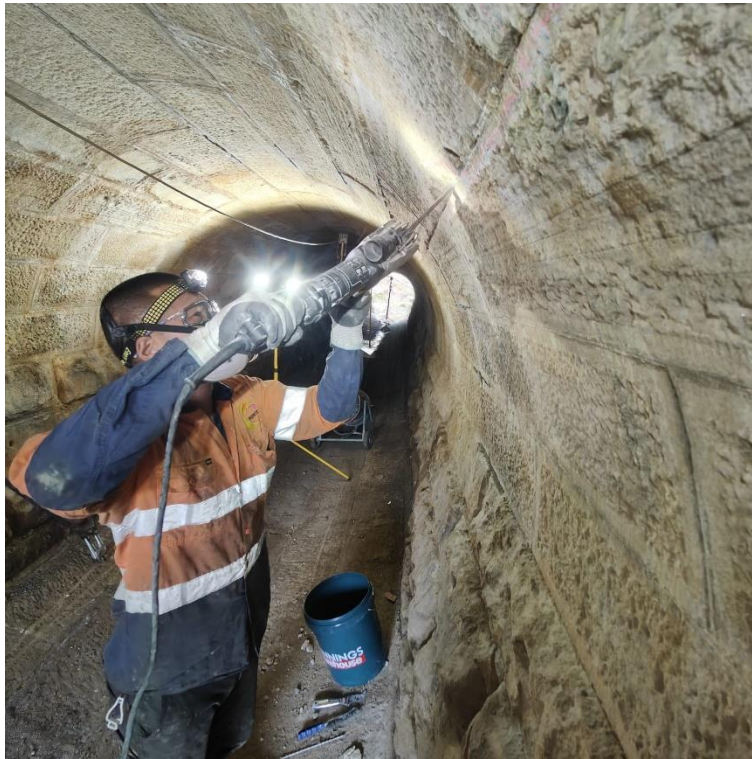
3. Route cracked mortar beds

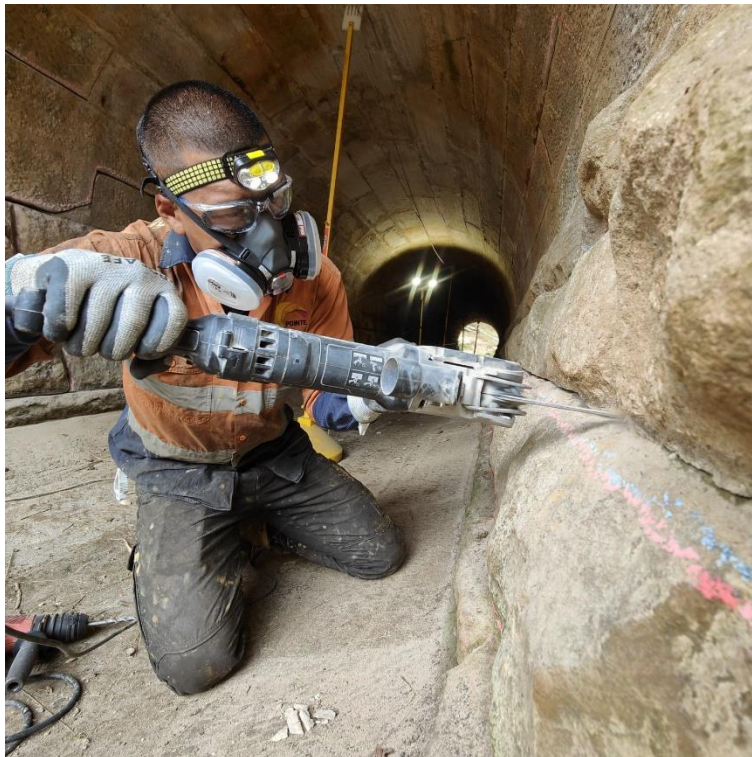
4. Route cracked mortar beds

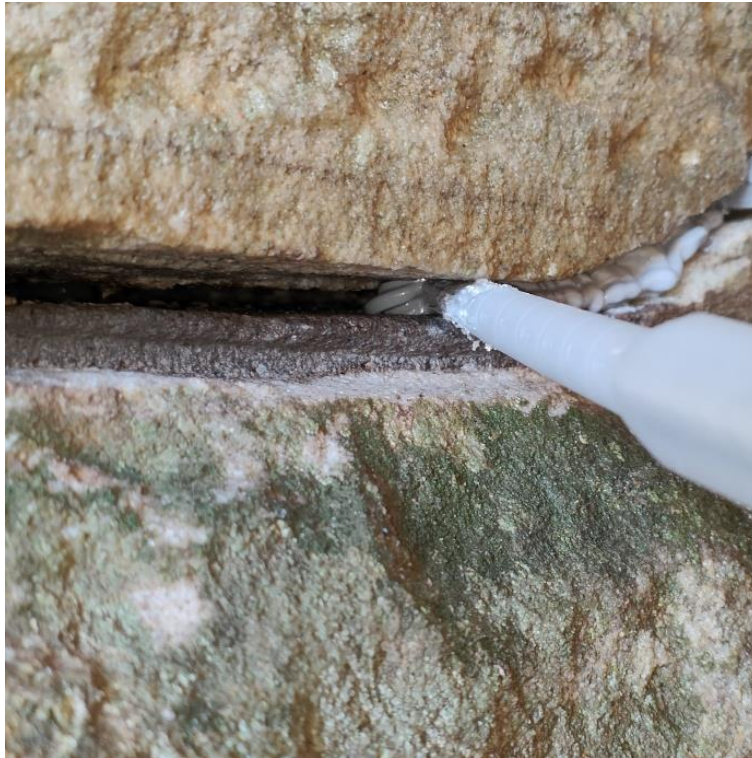
7. Sealing crack prior to injection

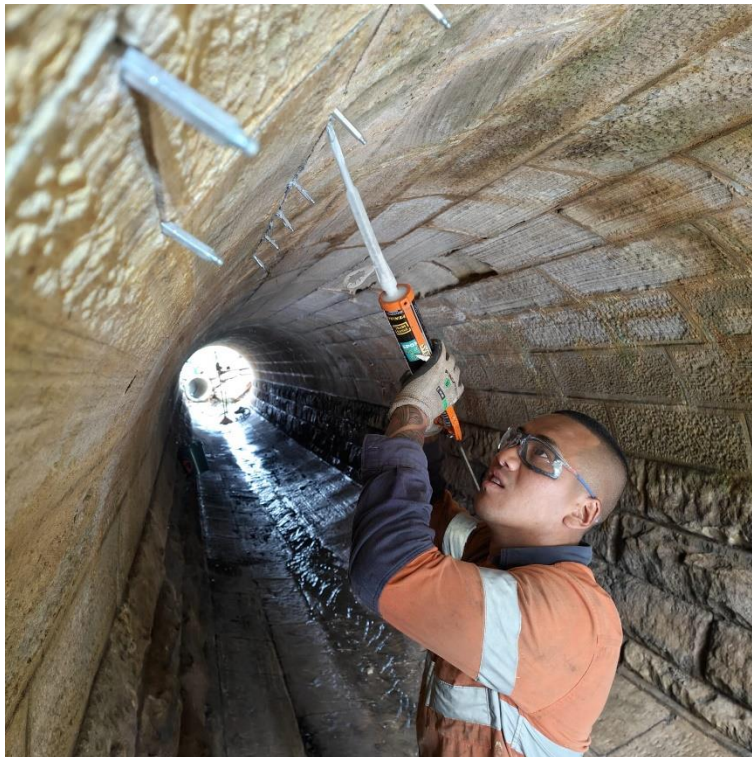
8. Sealing crack prior to injection

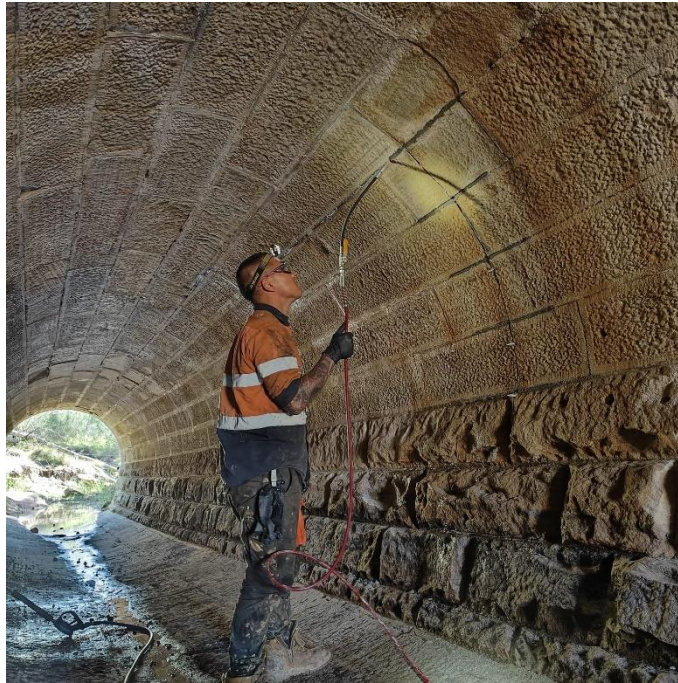
9. Epoxy crack injection

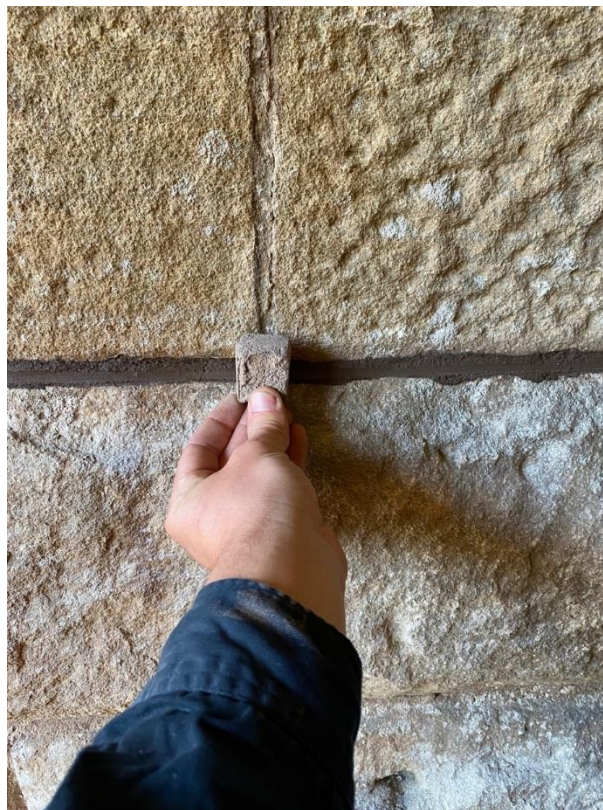
10. After re pointing, prior to drying

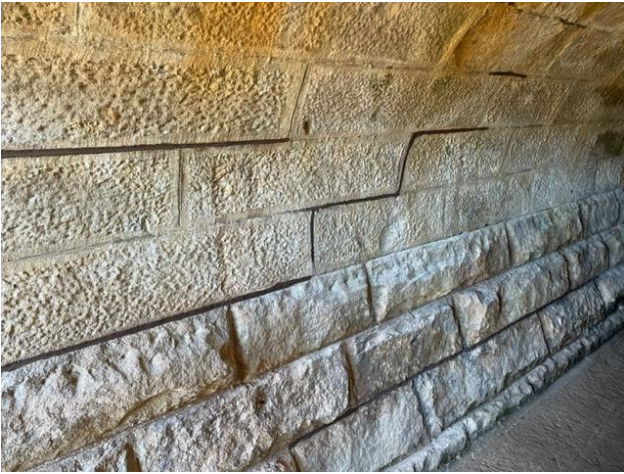
Figure 2 – Mortar repairs/replacement

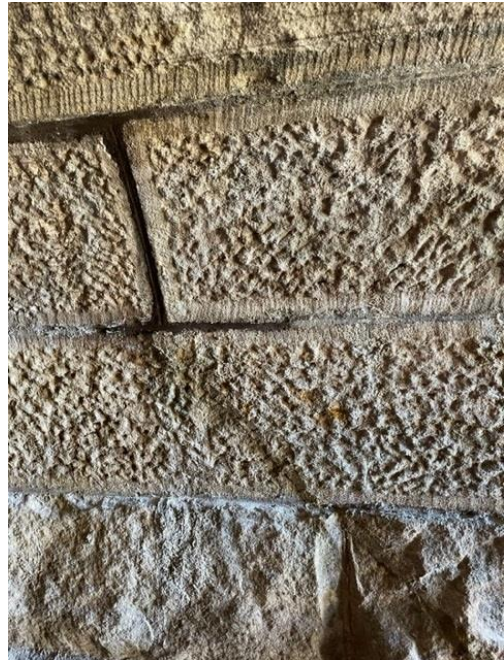
Figure 3: Crack and mortar repairs

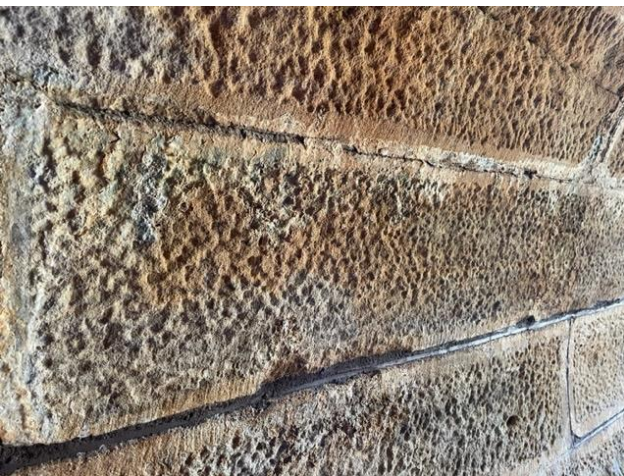
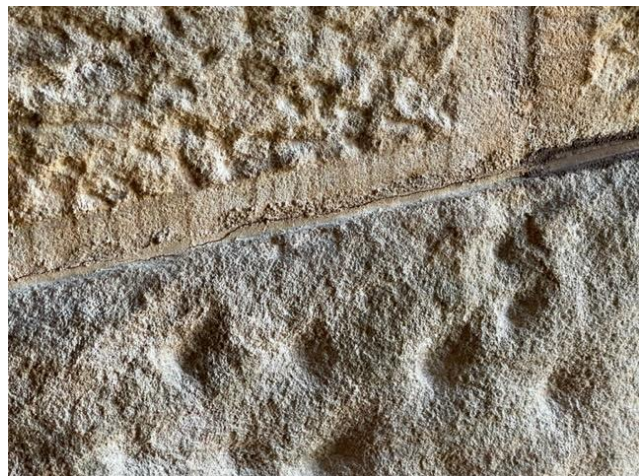
Figures 4 & 5 - Repointing
