Tahmoor Coal Pty Ltd

SIX MONTHLY SUBSIDENCE IMPACT REPORT

Tahmoor South Domain Longwalls South 1A – South 6A

1 January 2023 – 30 June 2023

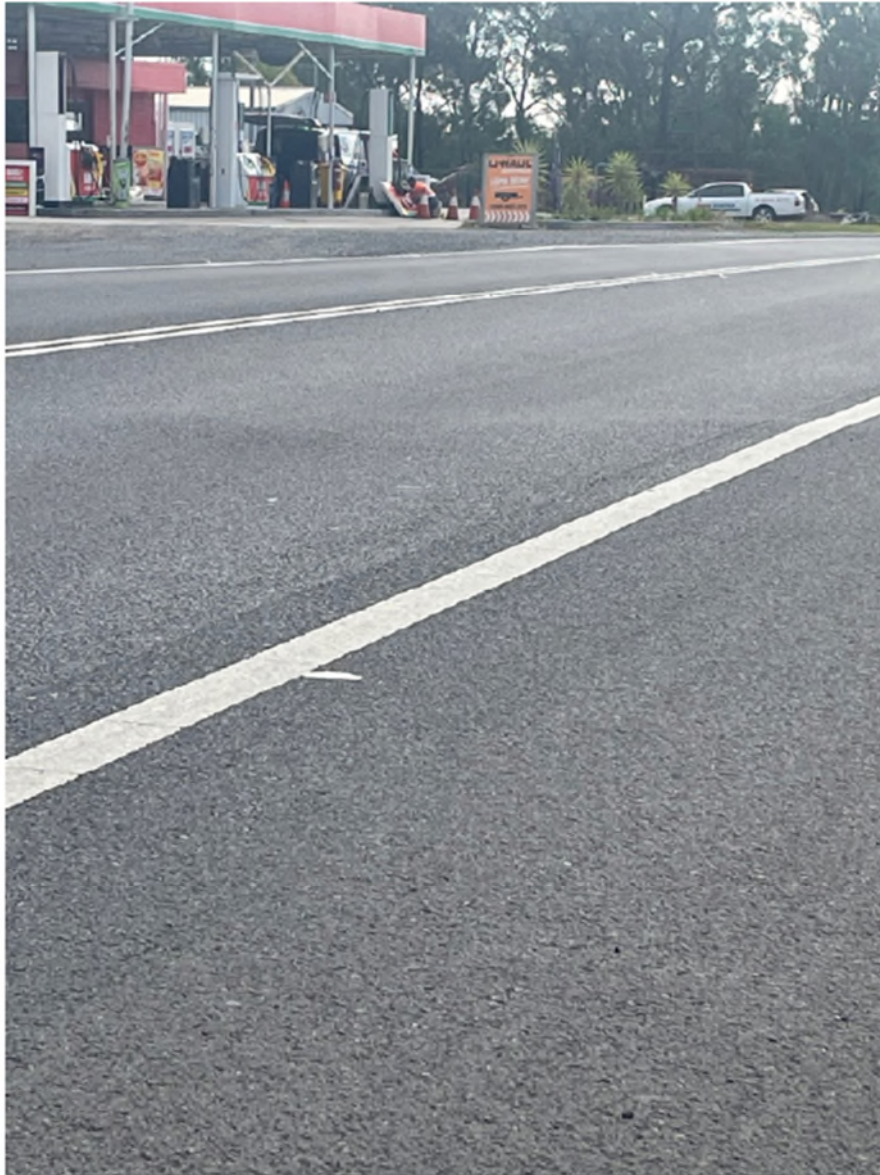
A focused visual inspection was conducted on 31 May, which identified a small compression bump in the southbound lane of Remembrance Drive between Pegs R47 and R48. A photograph of the bump on 31 May is shown in **Figure 2-19**. The bump intersects with a number of utility services, including Jemena’s gas main, Sydney Water’s potable water main and sewer main, and optical fibre and copper telecommunication cables.

Figure 2-19 Small bump observed in southbound lane of Remembrance Drive near Peg R46 on 31 May 2023 (Source: MSEC1304 Report 38, Appendix A)

The management of this change is discussed further in **Section 3.2.5**.

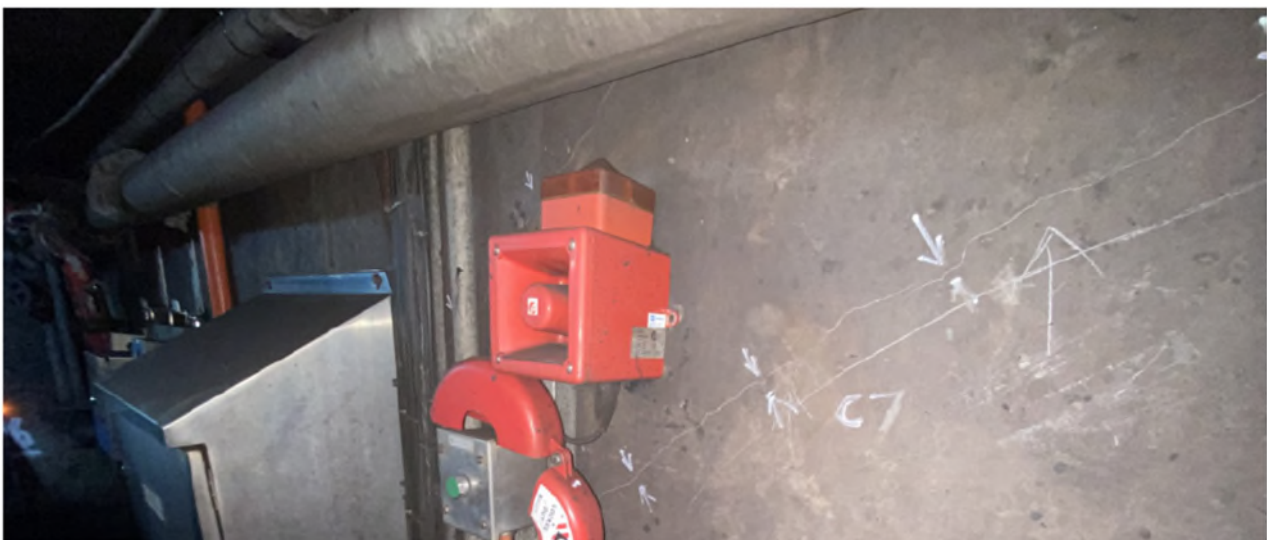
A schematic of the cracks at 6C Tunnel and a photo example of one crack is provided in **Figure 2-20**.

Figure 2-20 Schematic of cracks located in 6C Tunnel and example of crack (crack C7 taken 27 June 2023) (Source: Photo report: Tahmoor Mine Conveyors 27/9/2023, Appendix G)

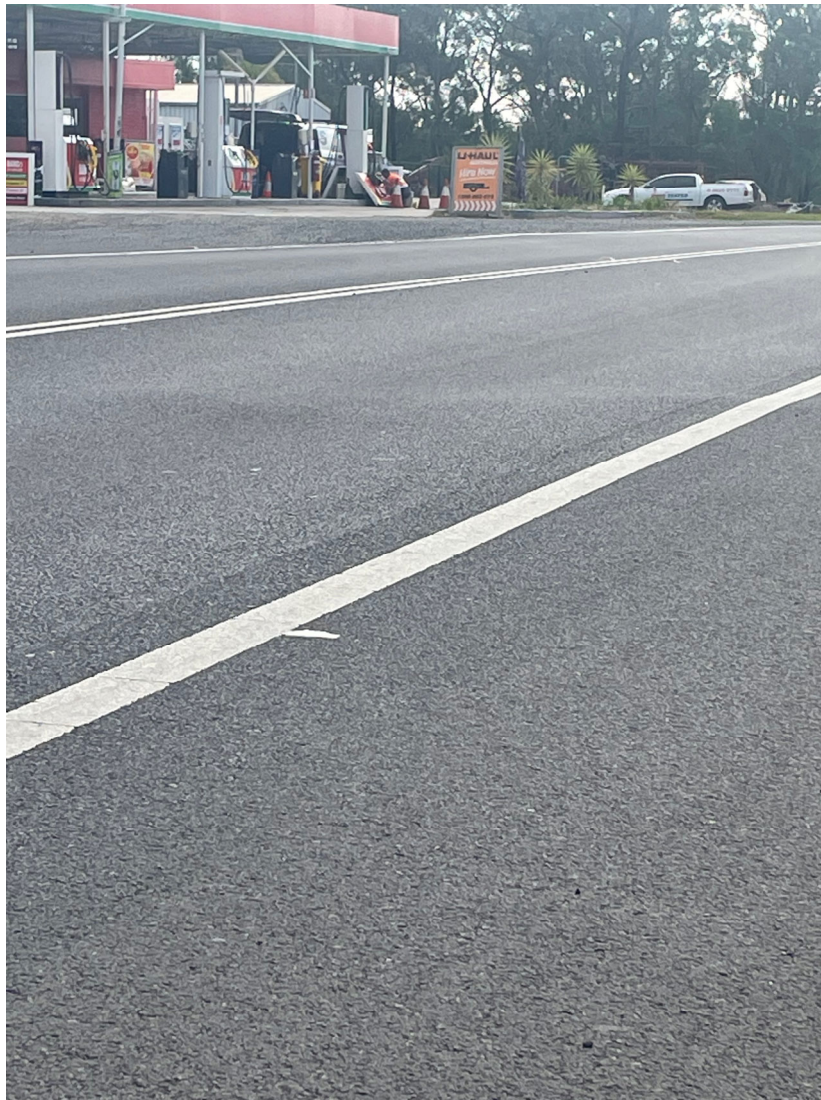
A focussed visual inspection was conducted on 31 May, which identified a small compression bump in the southbound lane of Remembrance Drive between Pegs R47 and R48. A photograph of the bump on 31 May is shown in Figure D. A map showing the location and orientation of the bump relative to nearby building structures and utility services is shown in Figure E. It can be seen that the bump is located to the side of LW S1A and above future LW S2A. It is oriented at an angle to the pavement and does not intersect with the Bargo Petroleum petrol station or any other structures. The bump intersects with a number of utility services, including Jemena's gas main, Sydney Water's potable water main and sewer main, and optical fibre and copper telecommunication cables.

Figure D Small bump observed in southbound lane of Remembrance Drive near Peg R46 on 31 May 2023

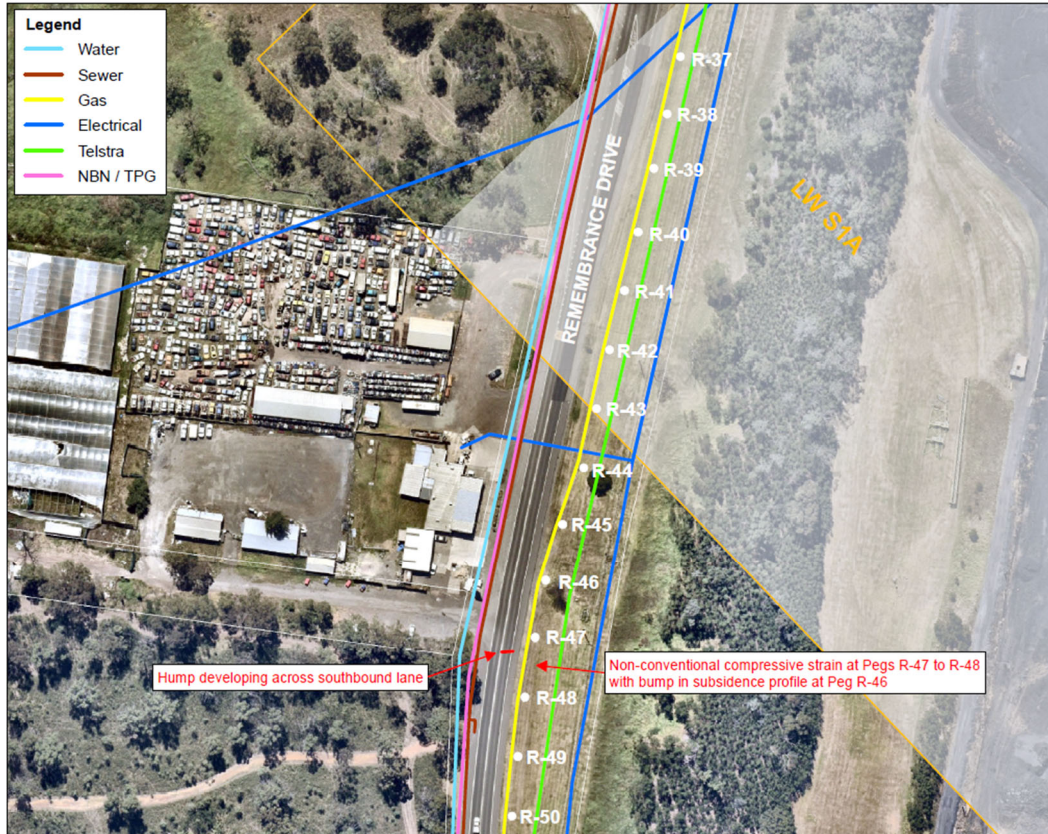
Figure E Location of small bump observed in southbound lane of Remembrance Drive near Peg R46 on 2 June 2023

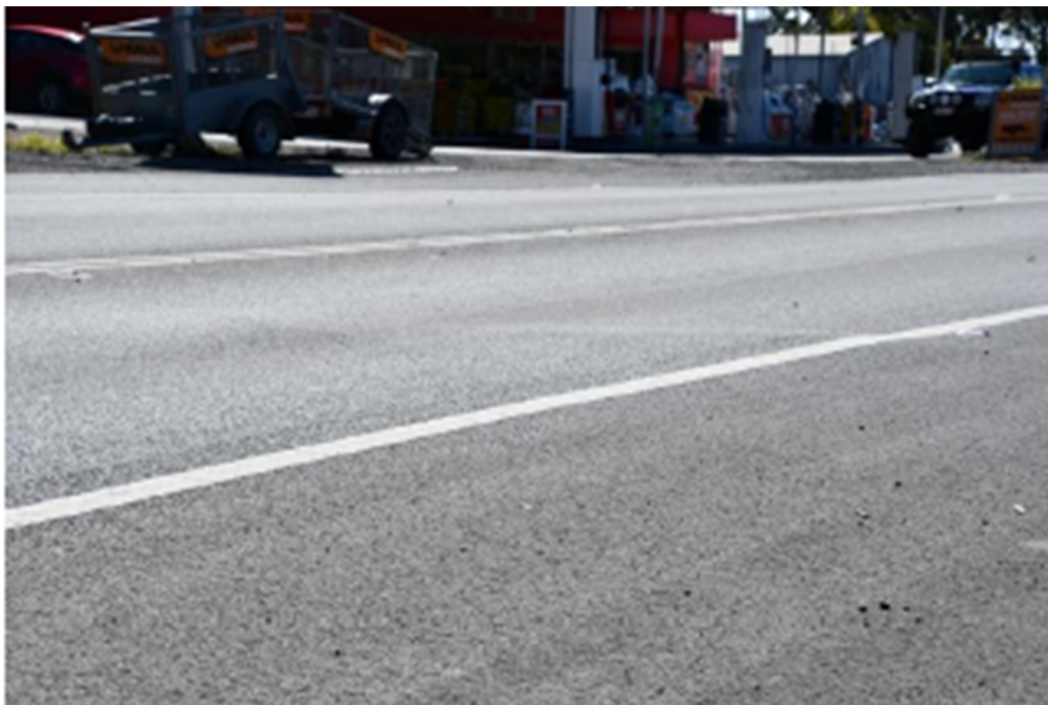
Visual inspections were conducted on 18 August and a photograph of the bump is shown in Figure F. No significant changes were observed since the inspection on 30 June. A faint bump is visible on the edge line of the northbound lane south of Peg R46.

Figure F Small bump observed in southbound lane of Remembrance Drive near Peg R46 on 18 August 2023 (no significant changes observed since 30 June)

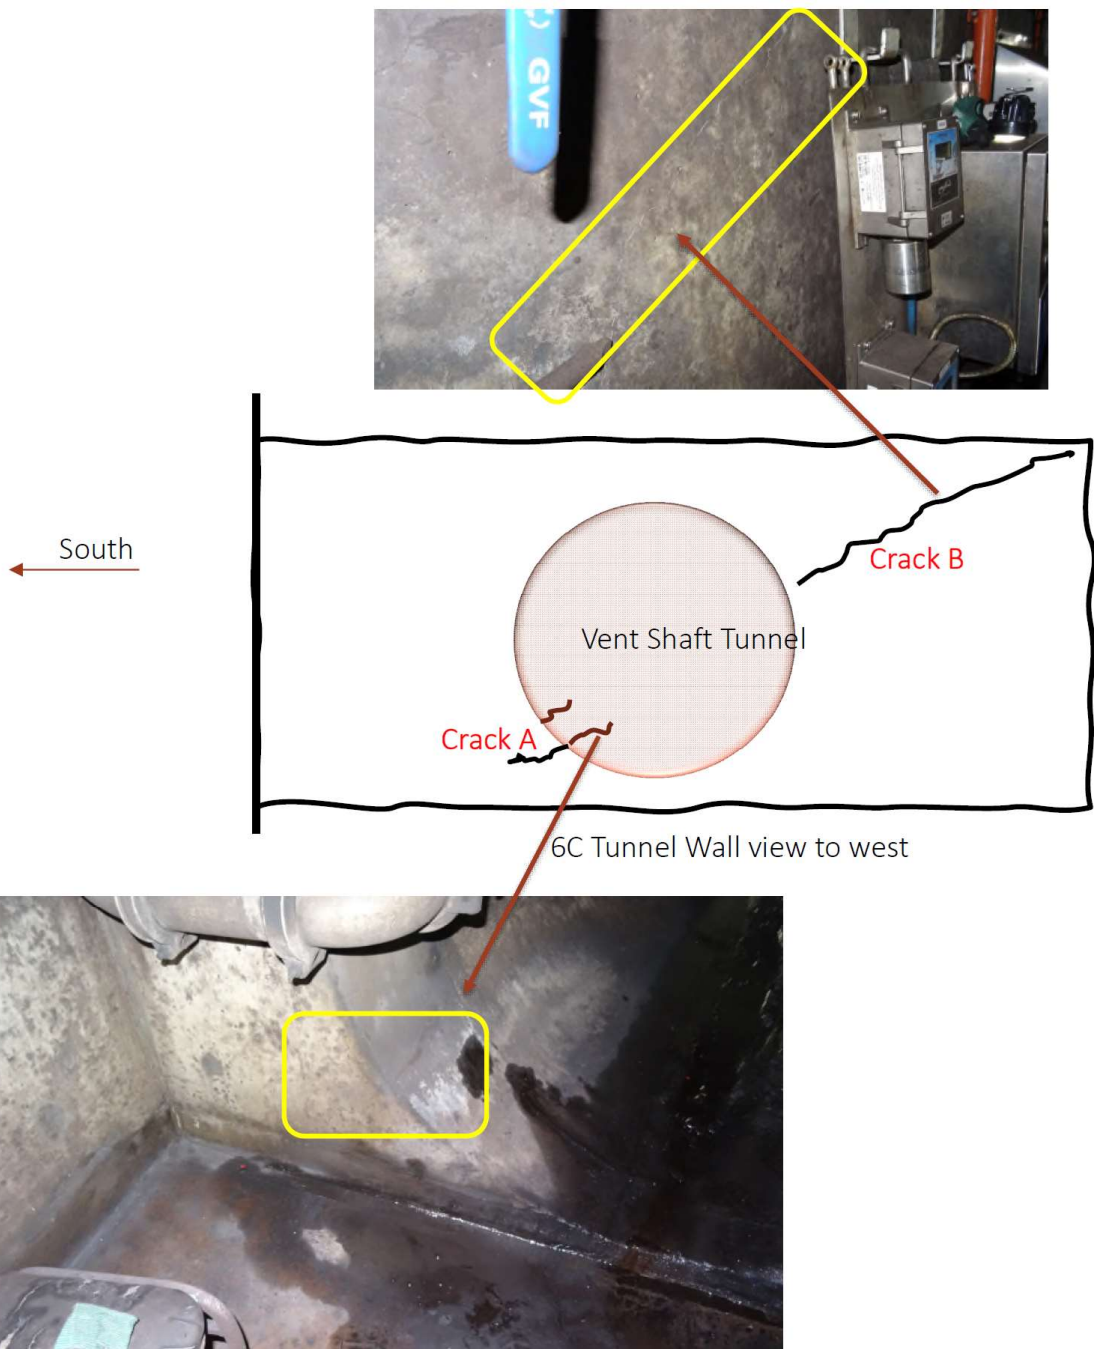
Plate 4.1 Location of cracks A(C1) and B (C2) within Tunnel 6C (David Talbert 29 May 2023).

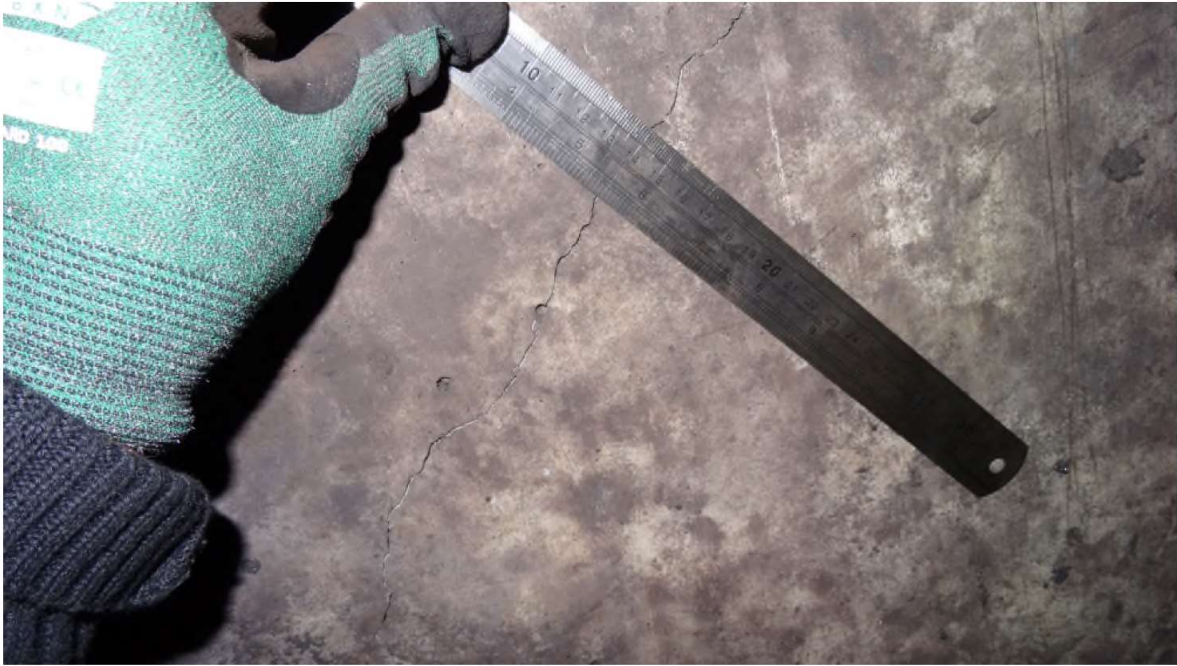
Plate 4.2 Crack B (C2), width <1 mm (David Talbert 29 May 2023).

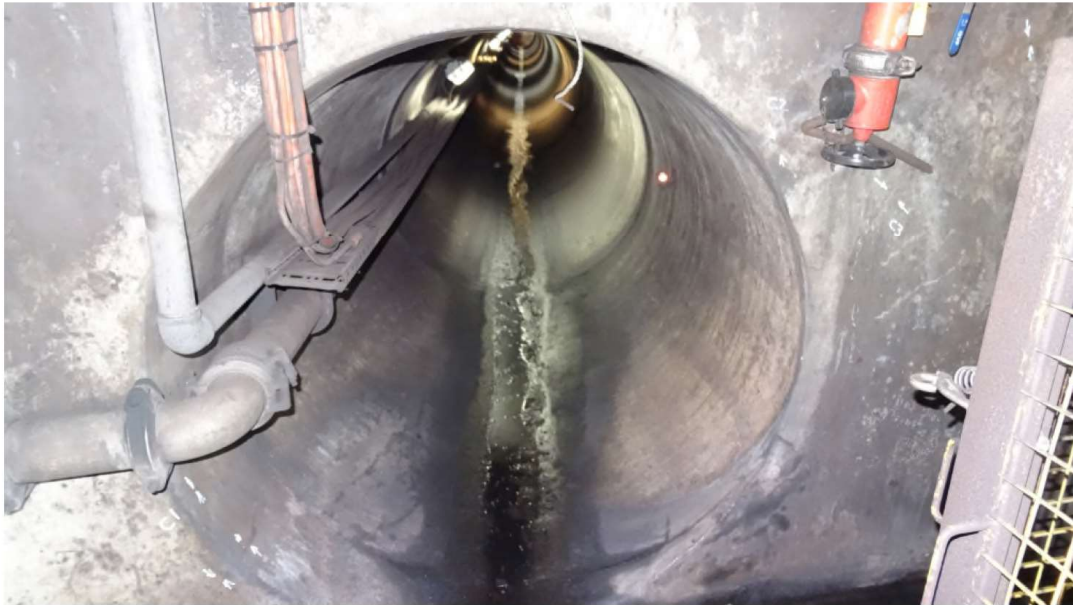
Plate 4.3 Context for the location of cracks C1, C2 and C3 (David Talbert, 6 June 2023).

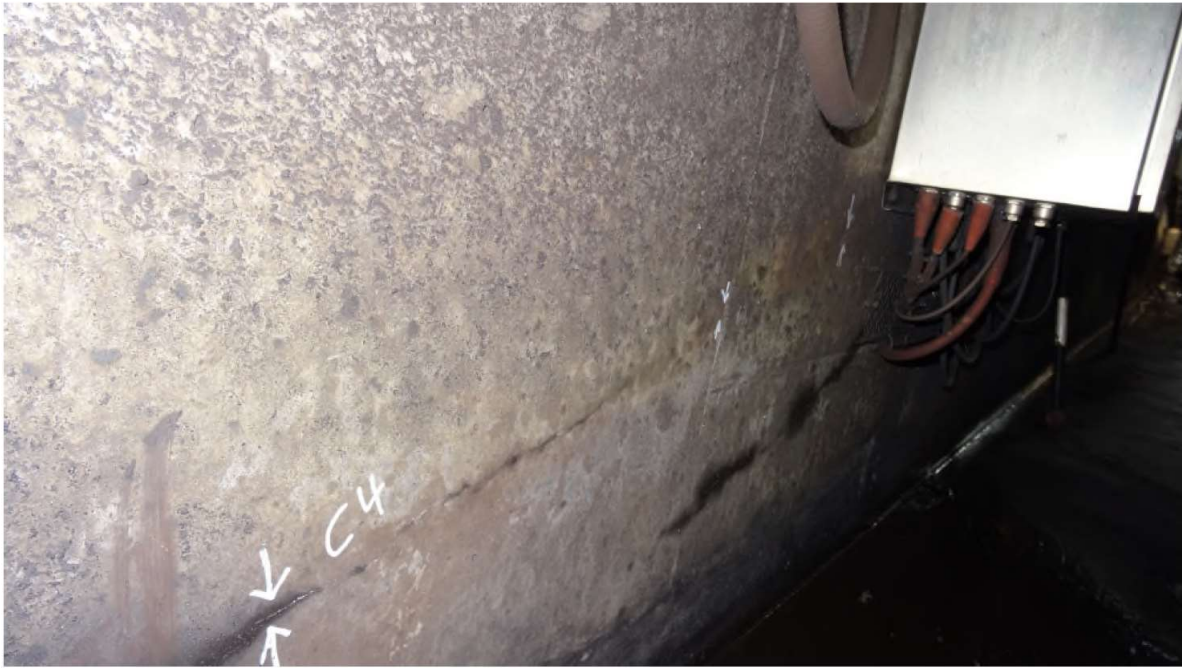
Plate 4.4 Crack C4 (David Talbert, 6 June 2023).

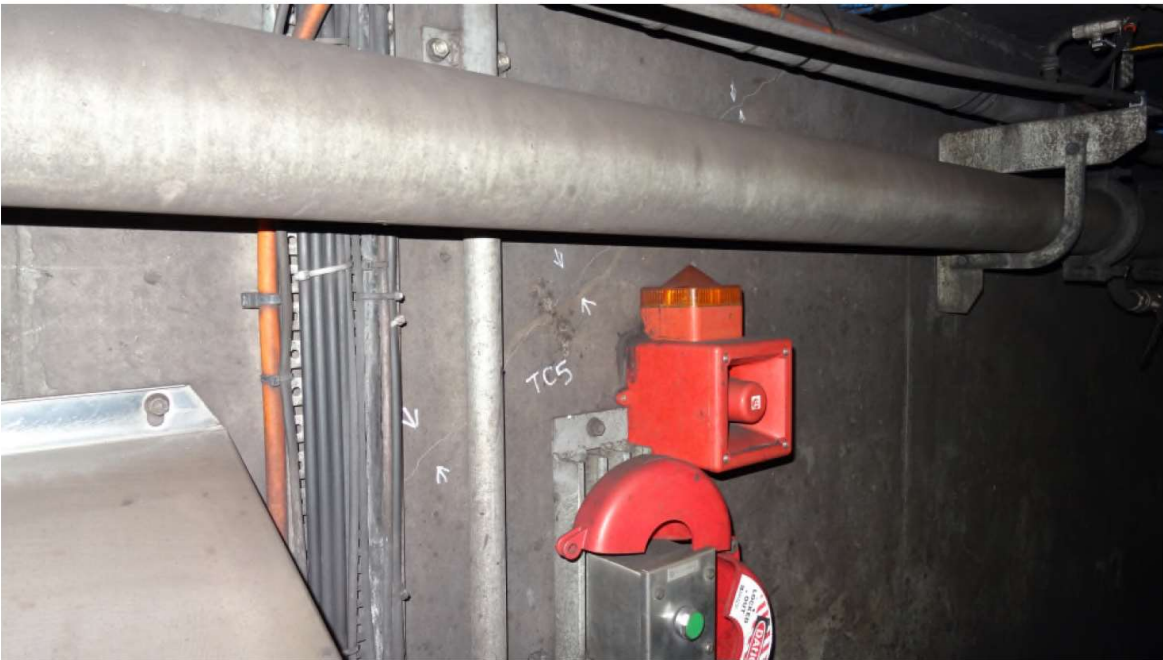
Plate 4.5 Crack C5 (David Talbert, 6 June 2023).

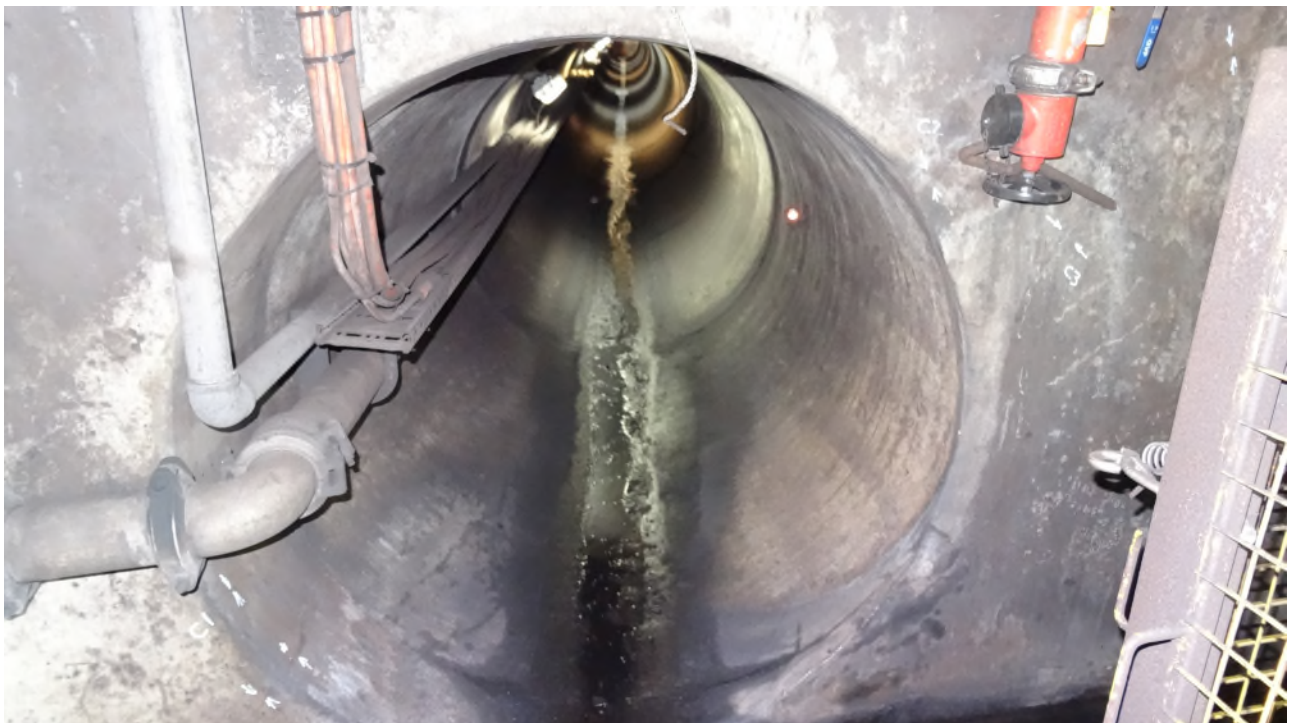
Cracking is now evident is at least six (6) locations as shown below. Crack width has increased with crack C3 now approaching 1mm. All other cracks are at less than 1mm at this stage. Refer photos below.

Photo 1: General location of cracks C1, C2 and C3.

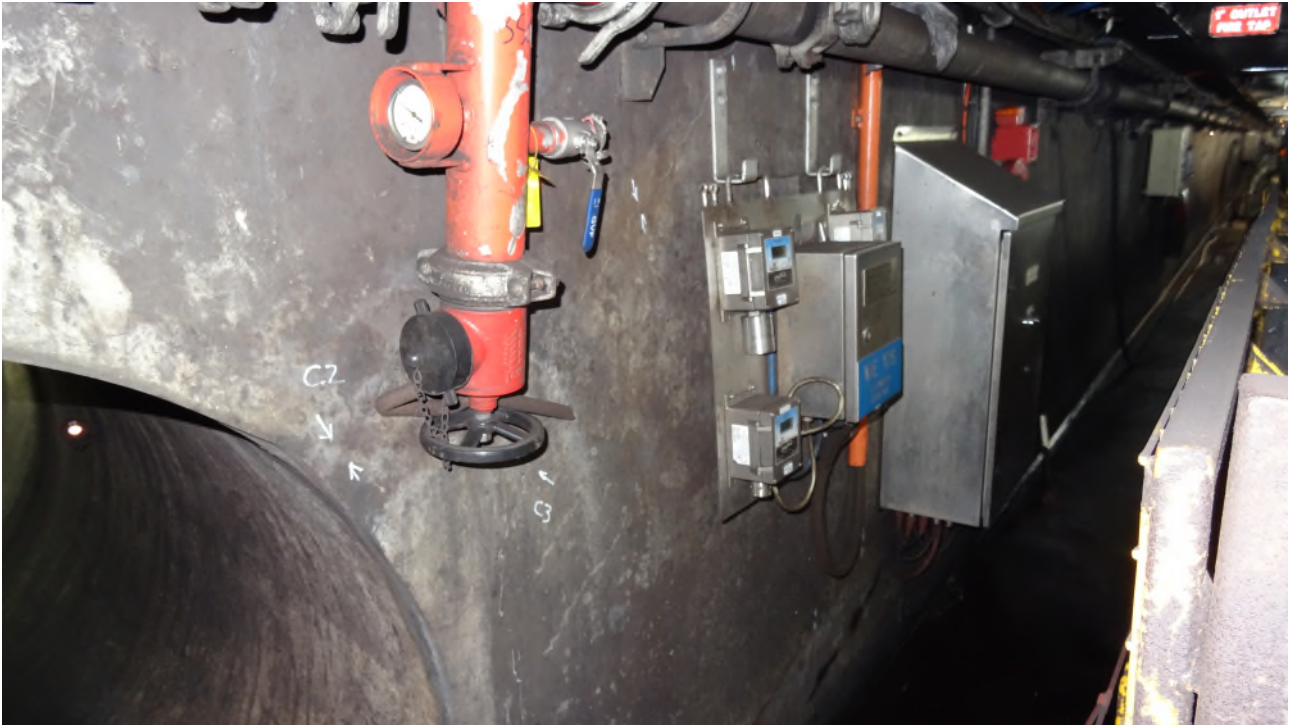
Photo 2: General location of cracks C2 and C3.

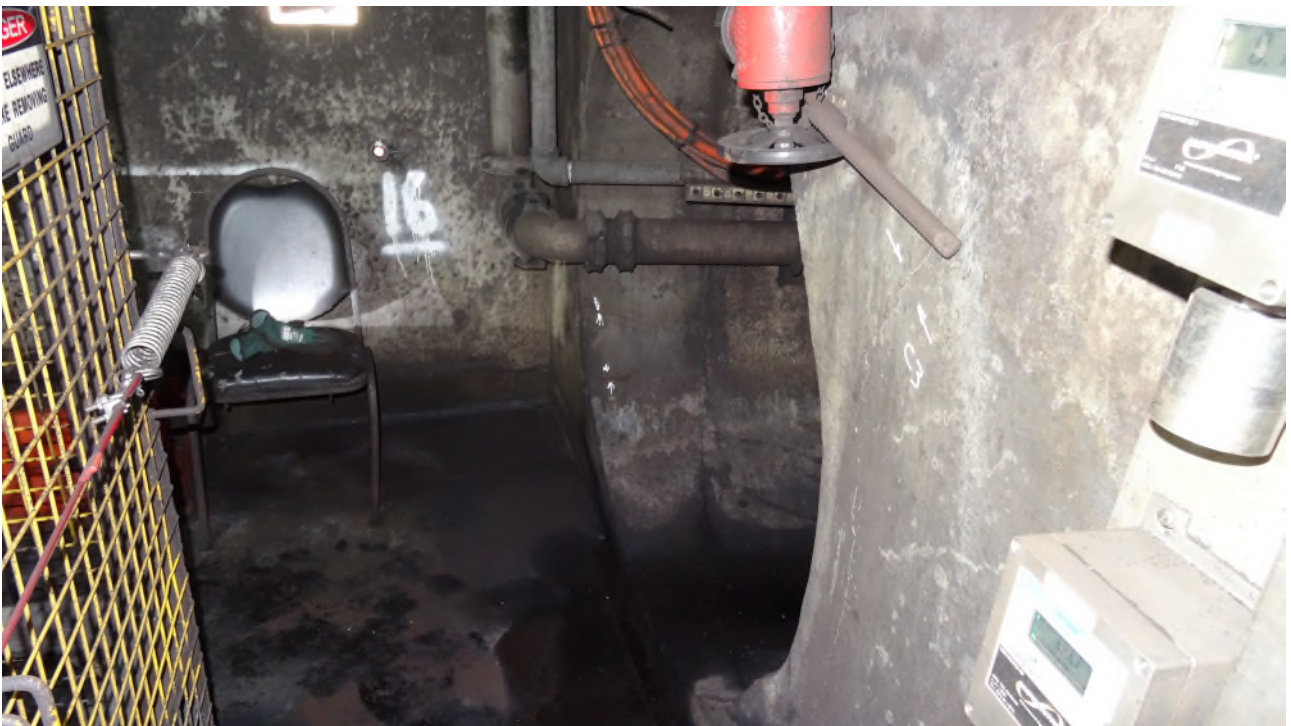
Photo 3: General location of cracks C1 and C3.

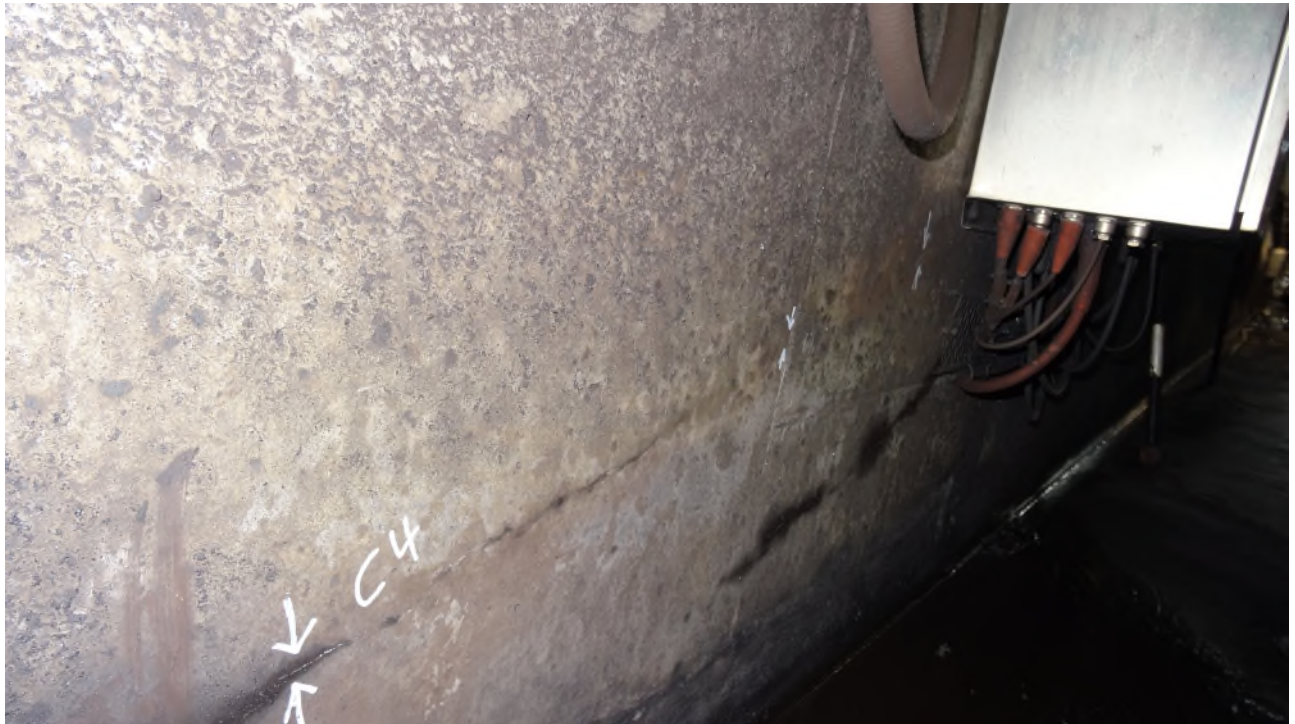
Photo 4: General location of cracks C4.

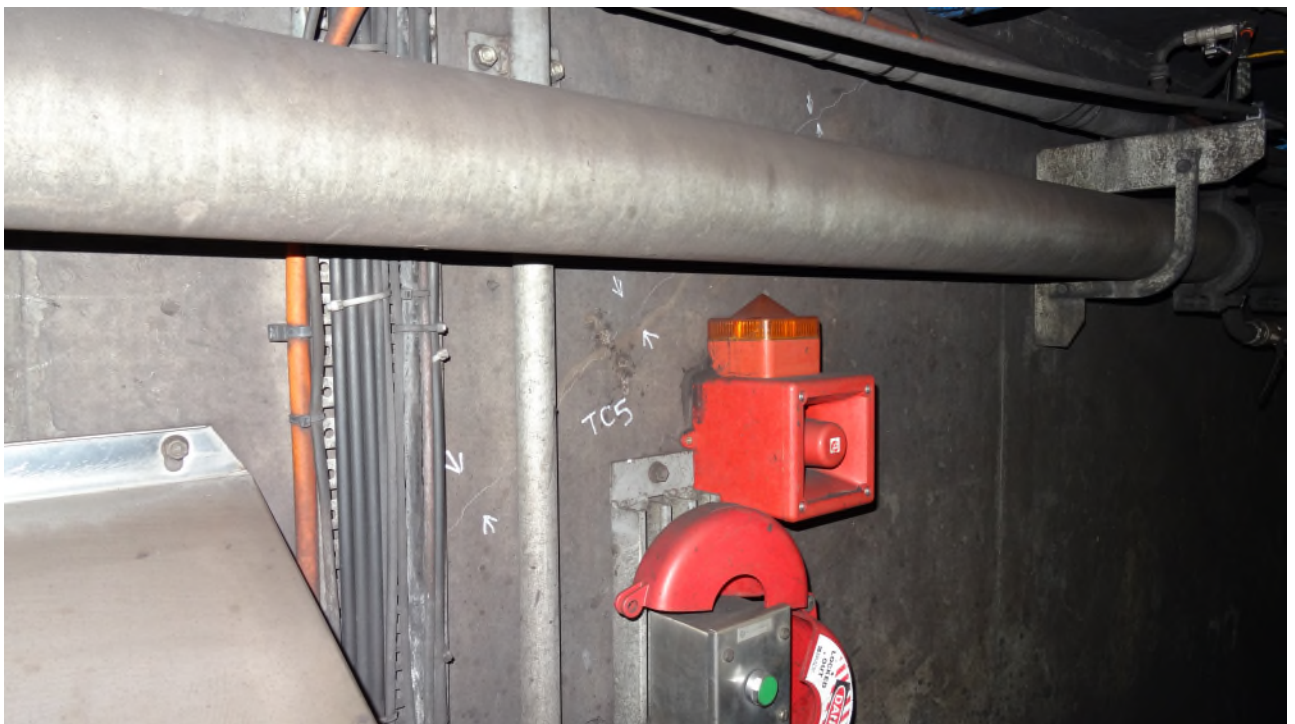
Photo 5: General location of crack C5 (Toms crack).

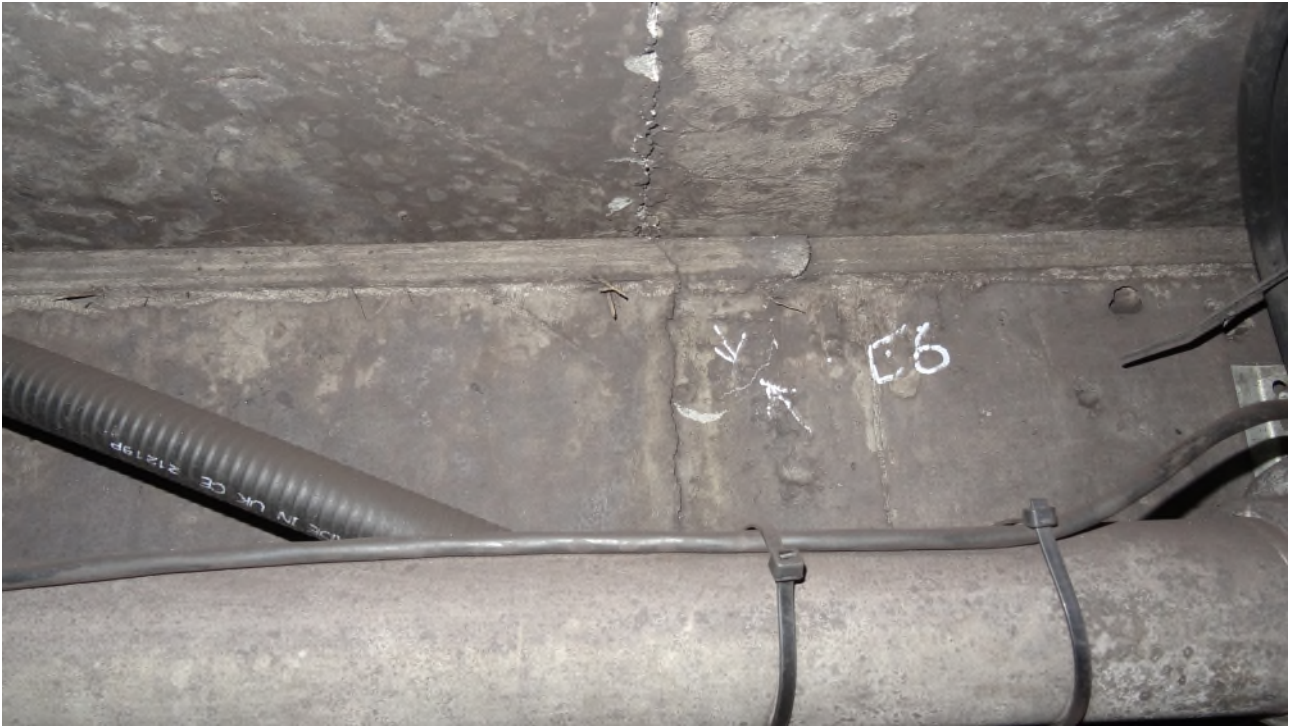
Photo 6: General location of crack C6.

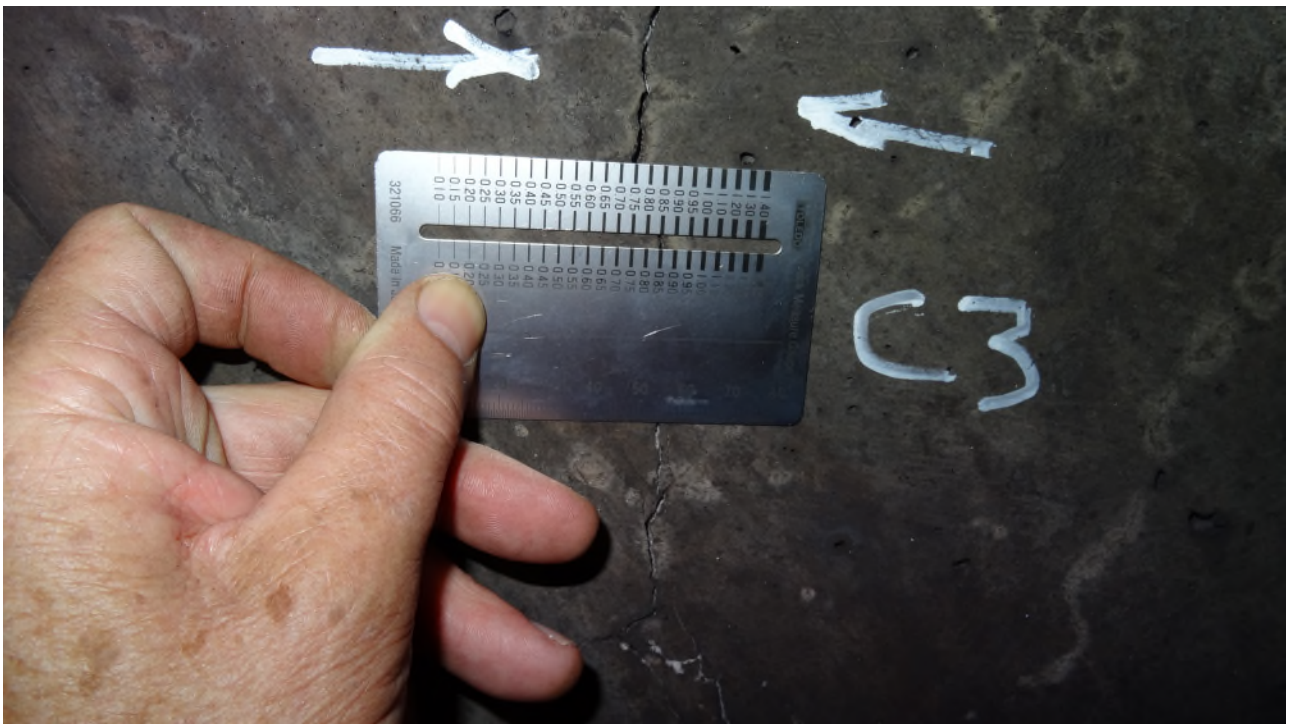
Photo 7: Width of crack C3.

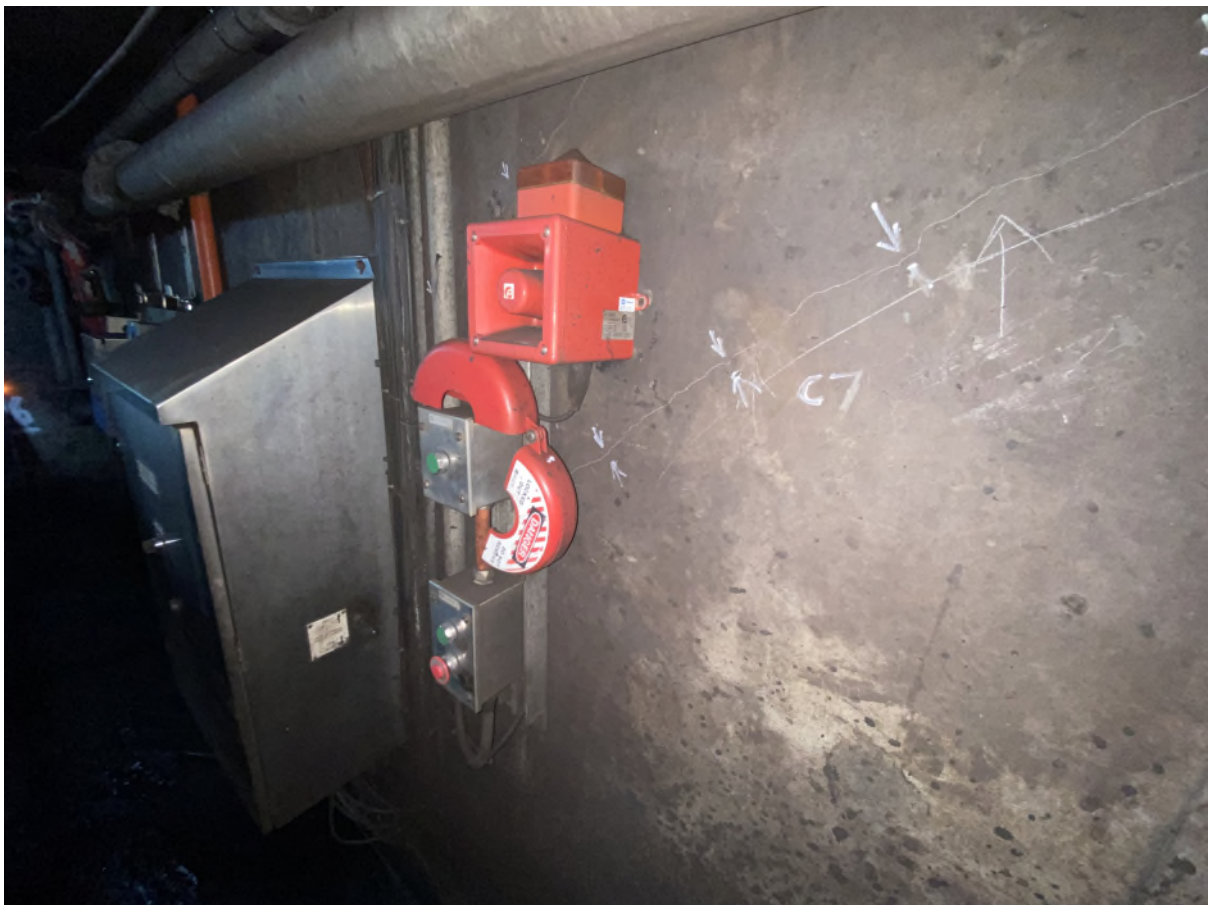
New crack detected (C7) as shown in figure and photo, currently less than 1mm in width. No noticeable change in existing cracking.

Photo 3: Location of new crack (C7).

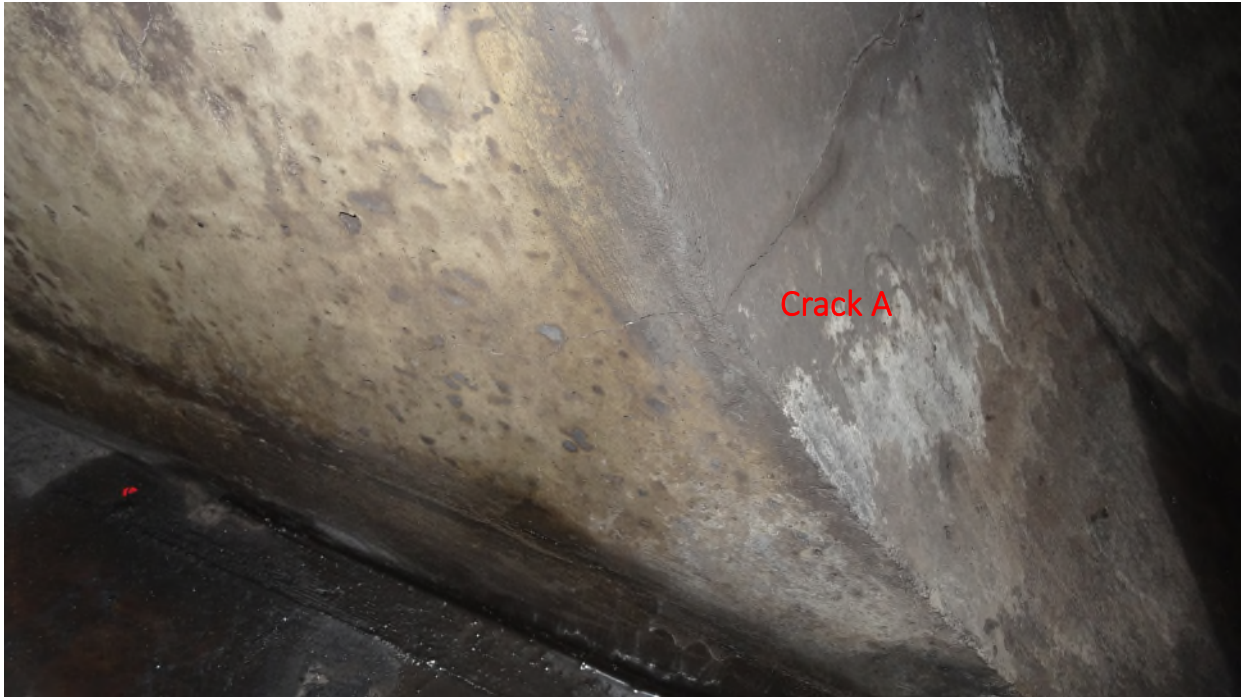
Photo 1: Crack A located approximately 7 O'clock along western face extending into the vent shaft tunnel.

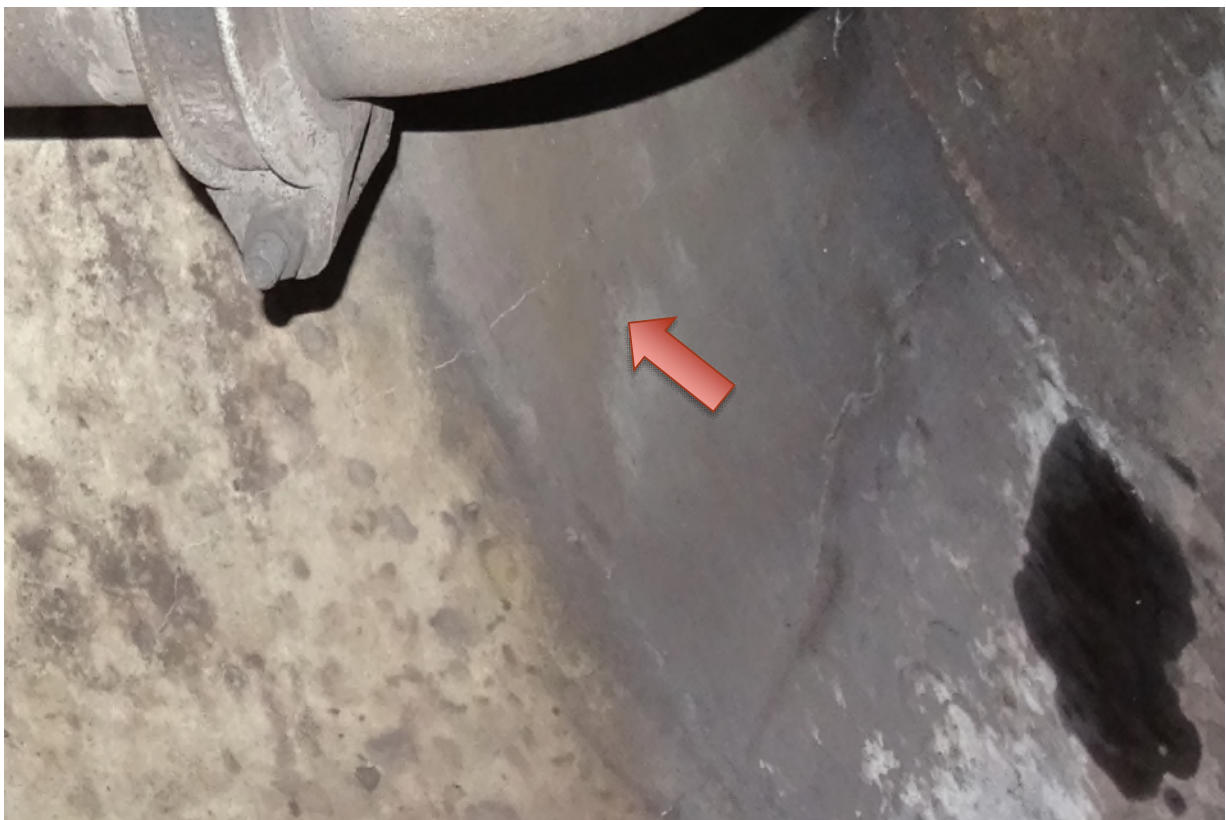
Photo 2: evidence of finer cracking above larger crack.

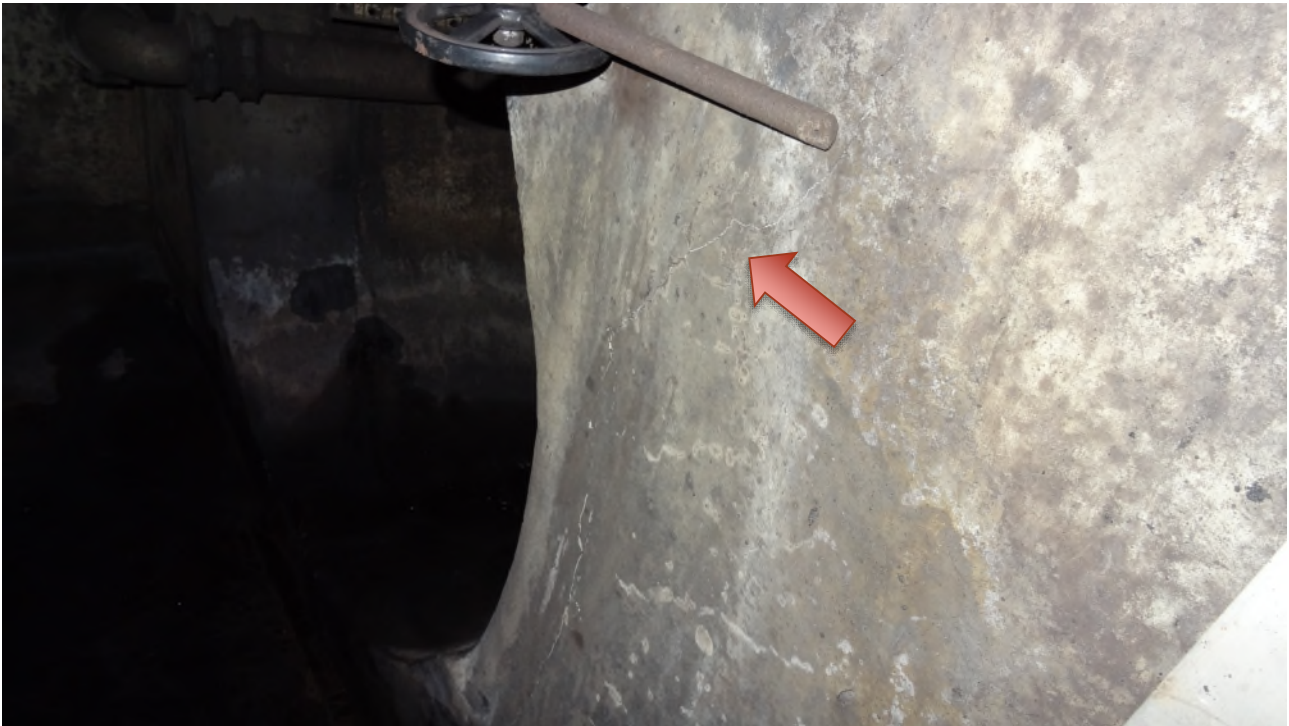
Photo 3: Crack B at edge of vent shaft tunnel extending toward roof.

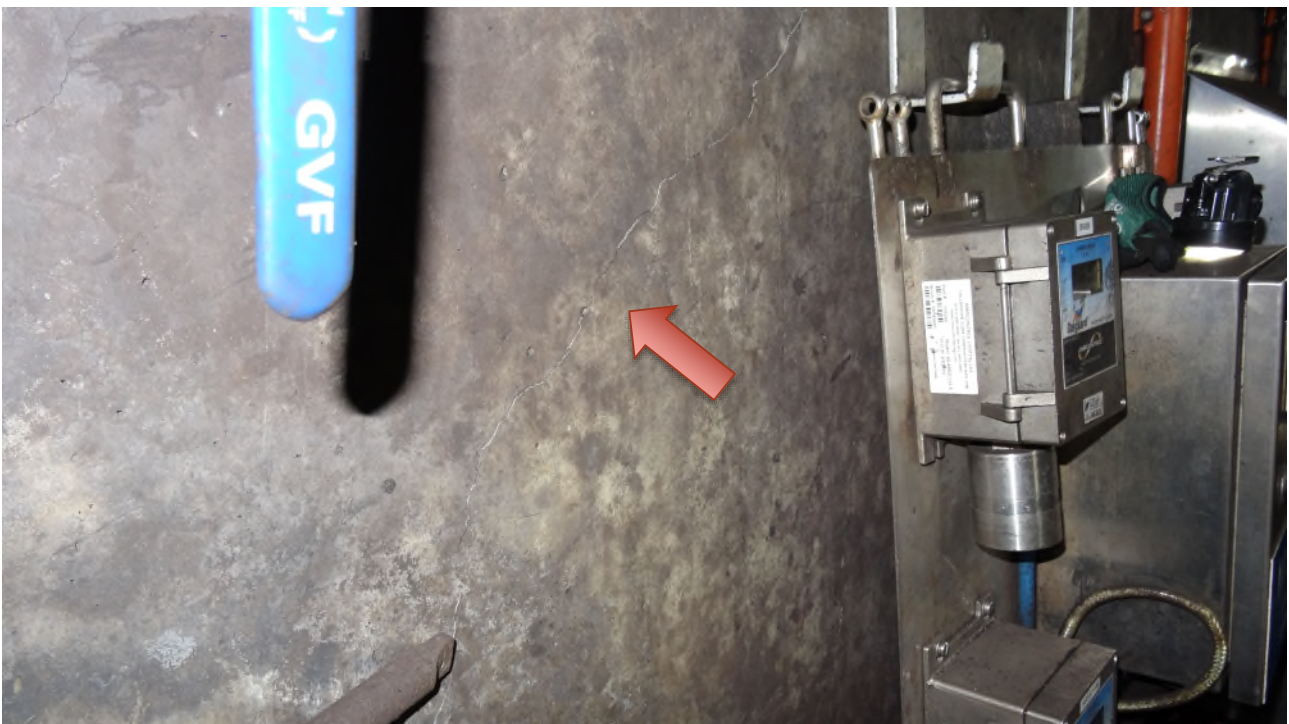
Photo 4: Crack B extending toward 6C tunnel roof.

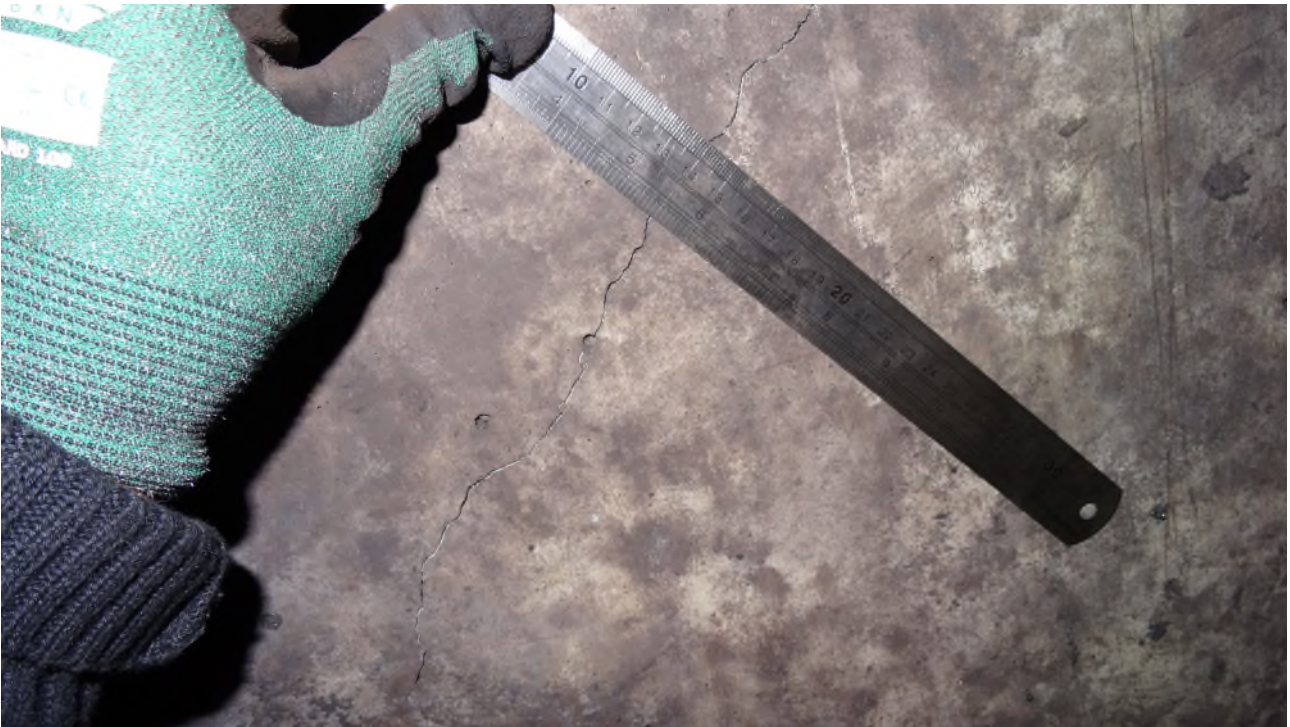
Photo 5: Crack B showing crack width $< 1\text{mm}$.
