## **Tahmoor South Longwalls S2A to S6A**

Subsidence Management Plan for potential impacts to MKD Machinery,  
3165 Remembrance Drive, Bargo

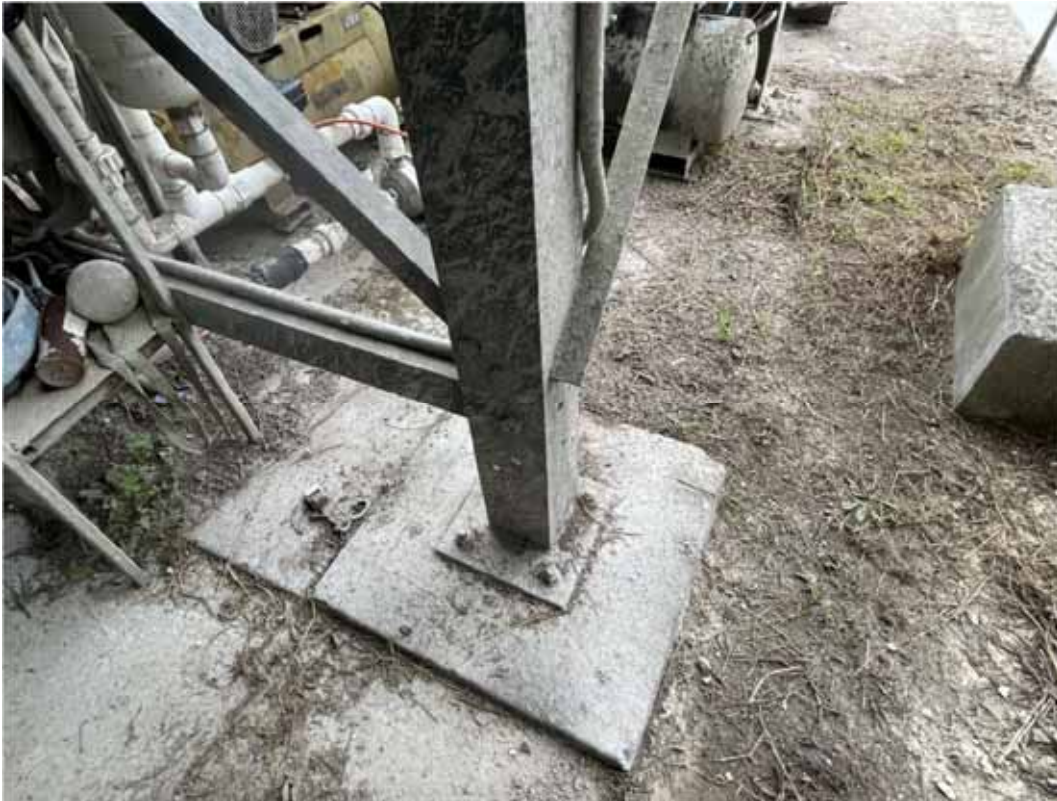
**Fig. 3.6 Silo hopper tower bolted connections for baseplates of tower legs**

The circular silo hopper comprises a cross-braced structural steel tower supporting a cylindrical hopper. The cross-bracing has been installed symmetrically to all four faces of the tower. The baseplates of the tower legs are bolted onto reinforced concrete piers that are embedded at least one metre into bedrock. A photograph of the tower base is shown in Fig. 3.6.

JMA (2023c) advises that an angle tie is currently missing at the base of the topper on the northern side. Subject to approval by the landowner, Tahmoor Coal will install the missing angle tie prior to the influence of LW S3A, as recommended by the structural engineer (JMA, 2023c).

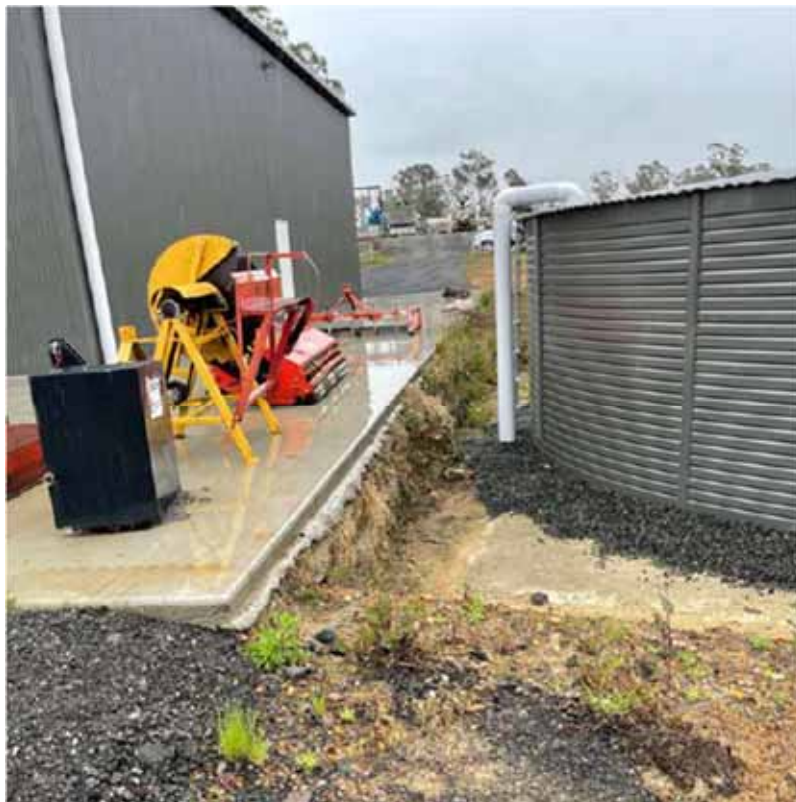
A new steel portal framed shed at the rear of the property has been constructed on a jointed reinforced concrete raft slab. A large metal rainwater tank has been constructed adjacent to the shed. The ground was excavated to form level ground for the rainwater tank, which has resulted in a near-vertical face supporting the external concrete pavement, as shown in Fig. 3.7. JMA (2023a) advises that the excavated vertical face is prone to erosion, which affects the stability of the fill material that supports the slab.

The new shed could experience impacts due to mine subsidence such as cracking to the ground slab and apron slab. The steel columns are surface mounted to the slab and the connections at the baseplates could be adjusted in the unlikely event that the structure experiences severe non-conventional movements.

Tahmoor Coal has extensive experience of mining beneath sheds and tanks and will implement similar subsidence management and monitoring measures for this property. This includes installation of ground survey marks around the house, visual inspections and consultation with the landowner during mining during periods of active subsidence, and repairs if required to ensure the safety and serviceability of the structures.

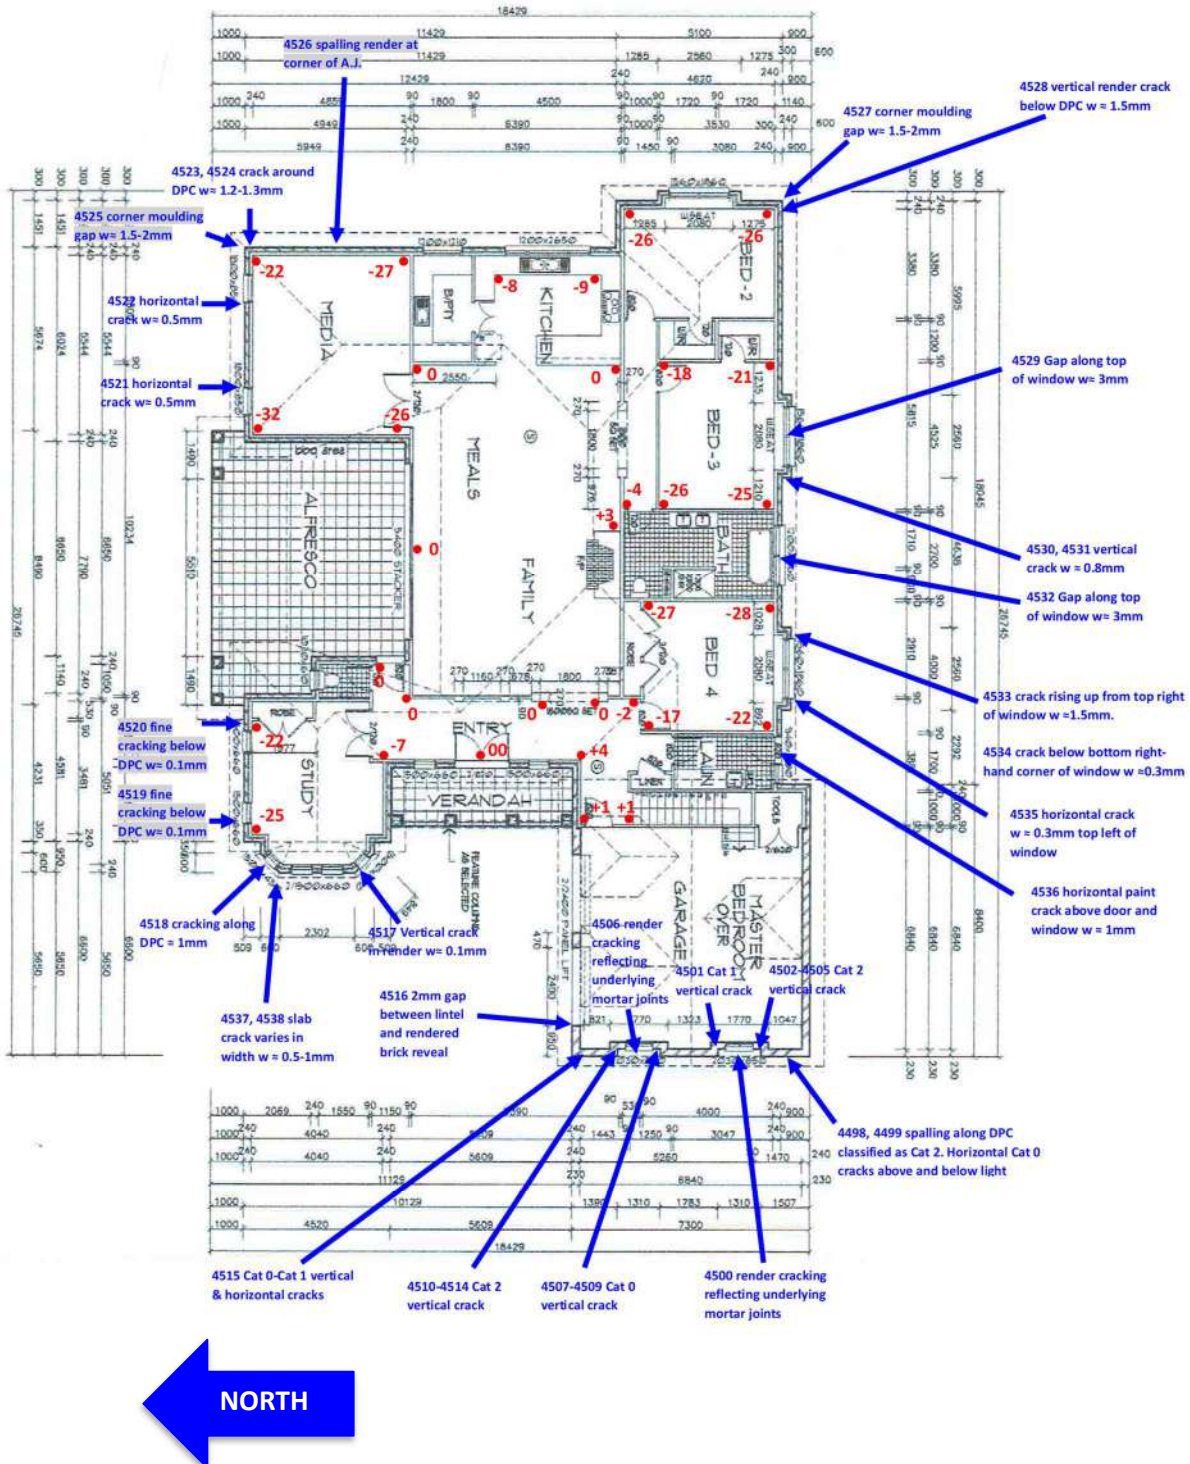
Figure 1 Floor layout plan of main dwelling with site notes and measured internal finished floor levels relative to an assumed datum inside the front entry door. Damage observed around the dwelling noted on plan.

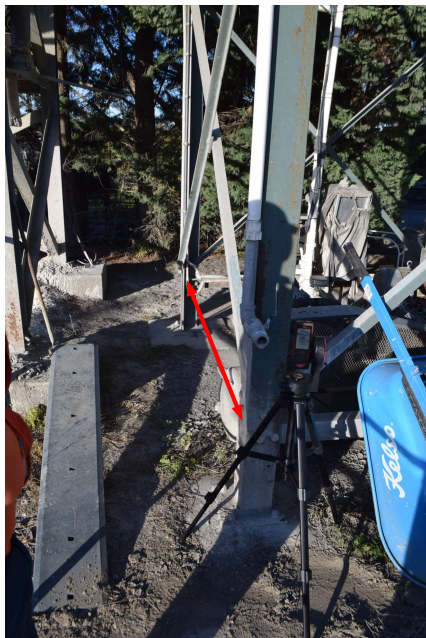
Increasing the eccentricity of the structure mass relative to the base is expected to cause an increase in the magnitude of horizontal forces acting on the structure, increasing the magnitude of tension forces in the bracing members, compression in the horizontal angle members and the anterior columns (in the direction of tilt) and a reduction in compression for the posterior columns. The design review indicates that the tower columns, horizontal angles, and cross bracing angles should meet the requirements of AS4100 Steel structures for the predicted tilt assuming that the horizontal angle that is currently missing from the north elevation (just above ground level) is-reinstalled, see **Figure 3**.

*Figure 3 Location of missing angle tie indicated by red double-headed arrow.*

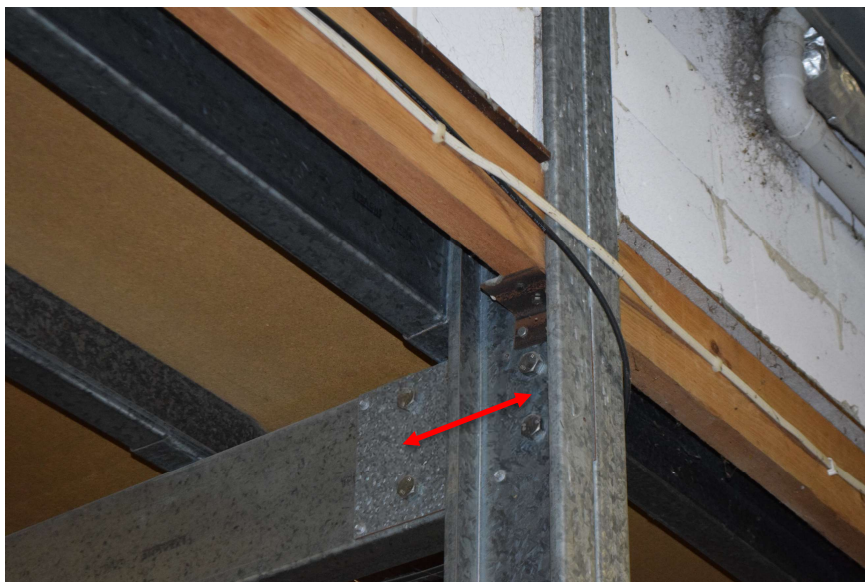
*Figure 5 Back-to-back steel columns continue up to support the high-bay roof and are effectively restrained by the Hebel blockwork in the minor-axis direction, major-axis load eccentricity indicated by red arrow.*

It is recommended, therefore, that supplementary support should be installed adjacent to the columns that have been identified in **Figure 4**, which are isolated and do not have an alternate load path through adjacent Hebel block walls if an overstress occurred. The props are designated Type A & Type B and could comprise 75x5 SHS posts located adjacent to or sandwiched against and screwed or bolted to the existing columns, with a 10mm baseplate to bear on the ground slab (and 2M12 HD bolts) and a 10mm cap plate to support the timber bearer with 2 M12 coach bolts, see **Figures 6 & 7** for the types of columns where supplementary support is recommended.

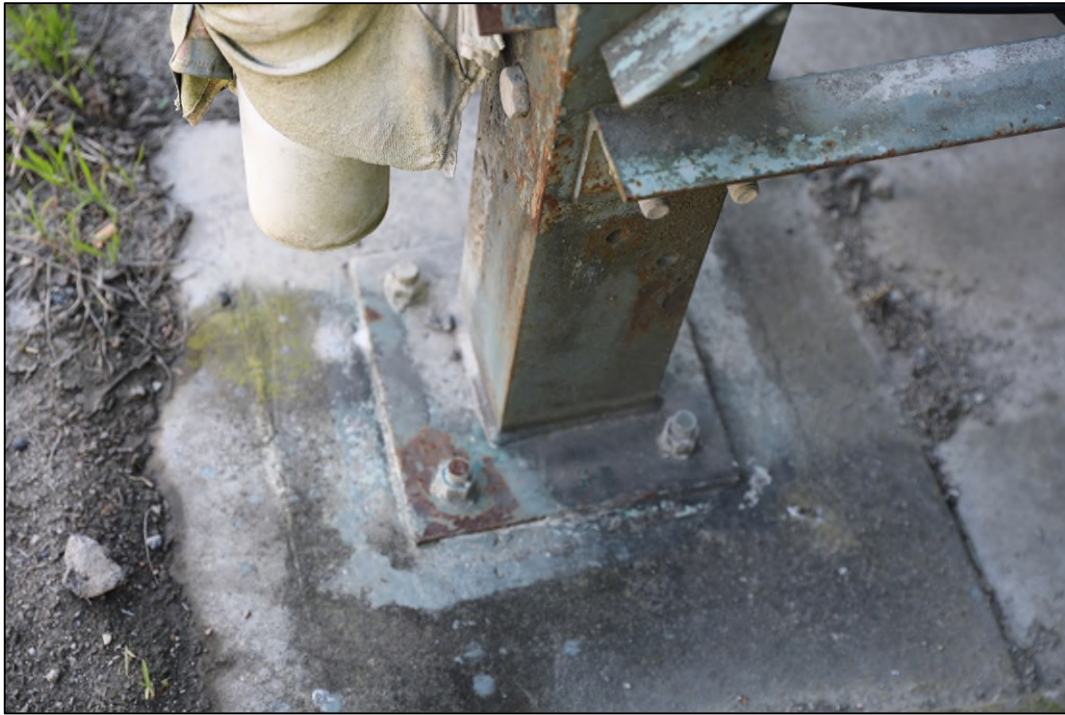
The silo was securely fixed to the foundation.

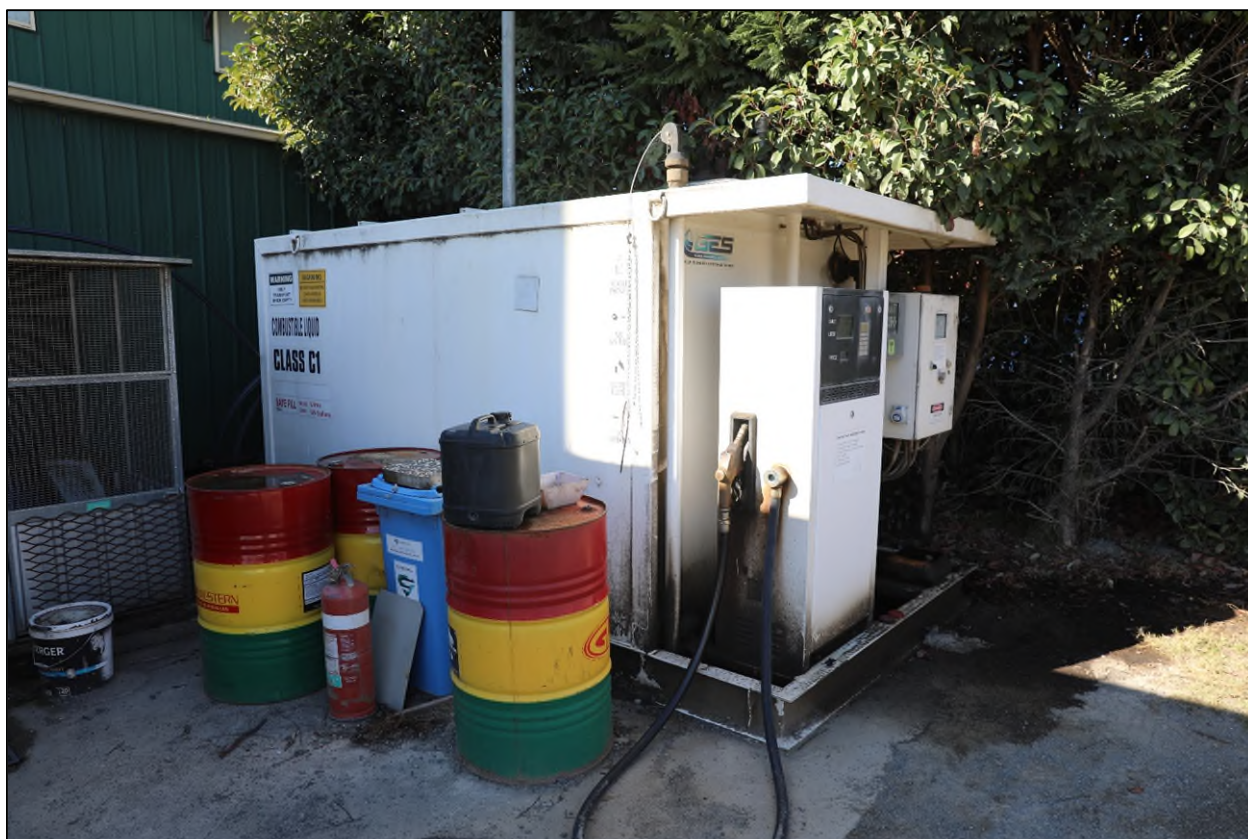
General arrangements include a large open area for trucks and loaders to move around the site. Any equipment is free standing and securely fastened. The front barrier wall is made of large concrete blocks, which are flexible but stable.
