Tahmoor Coal Pty Ltd

SIX MONTHLY SUBSIDENCE IMPACT REPORT

Tahmoor South Domain Longwalls South 1A – South 6A

1 July 2023 – 31 December 2023

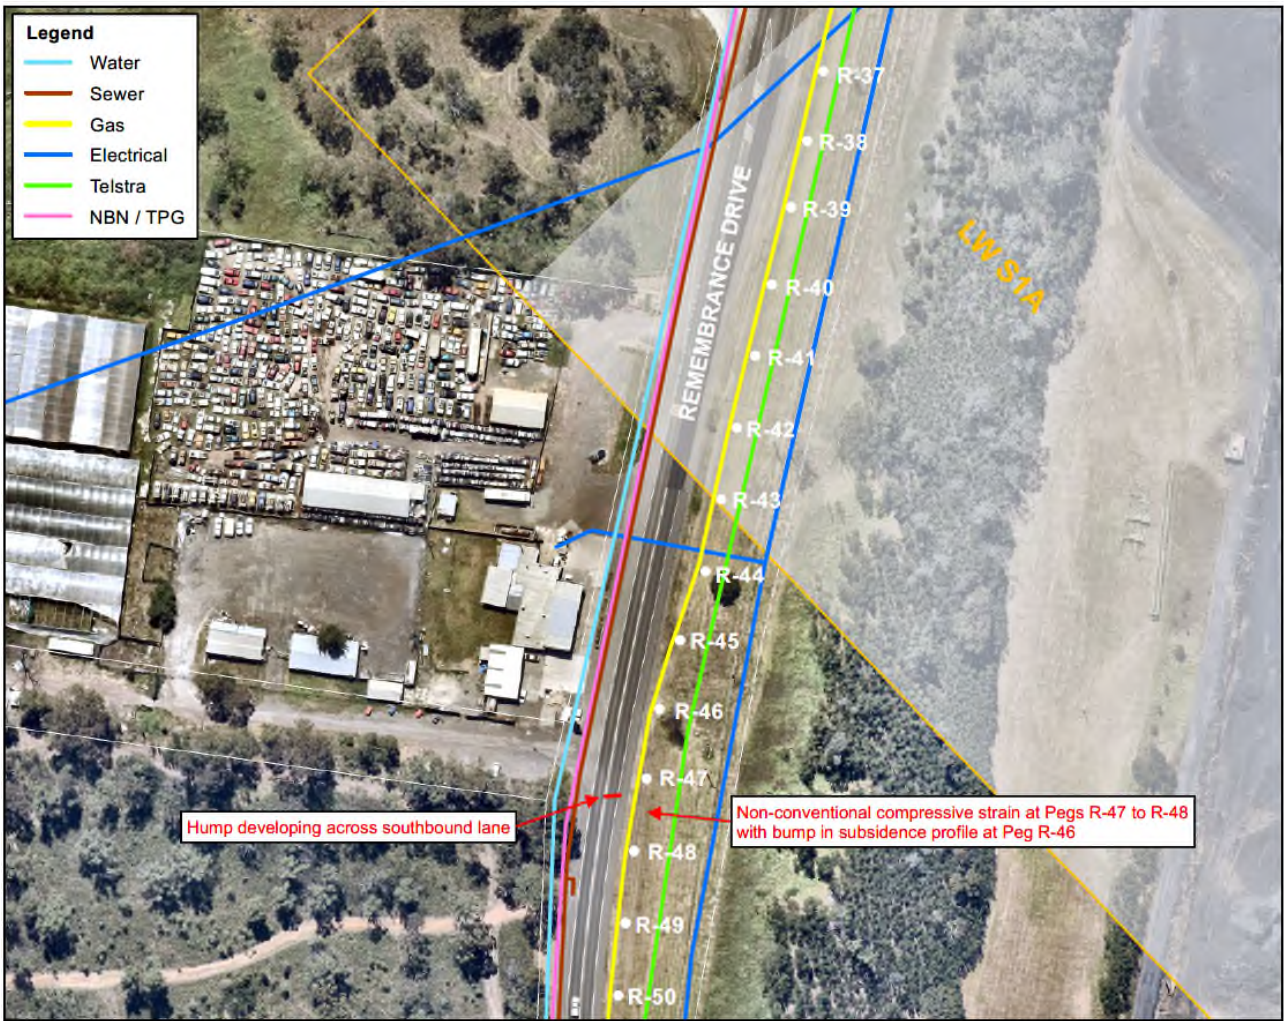
An increase in compressive strain was observed in December 2023, with very minor changes in vertical misalignment.

Figure 3-18 Location of non-conventional compressive strain, bump and hump in southbound lane of Remembrance Drive near Peg R46 (Source: MSEC1368 Report 19a, Appendix A)

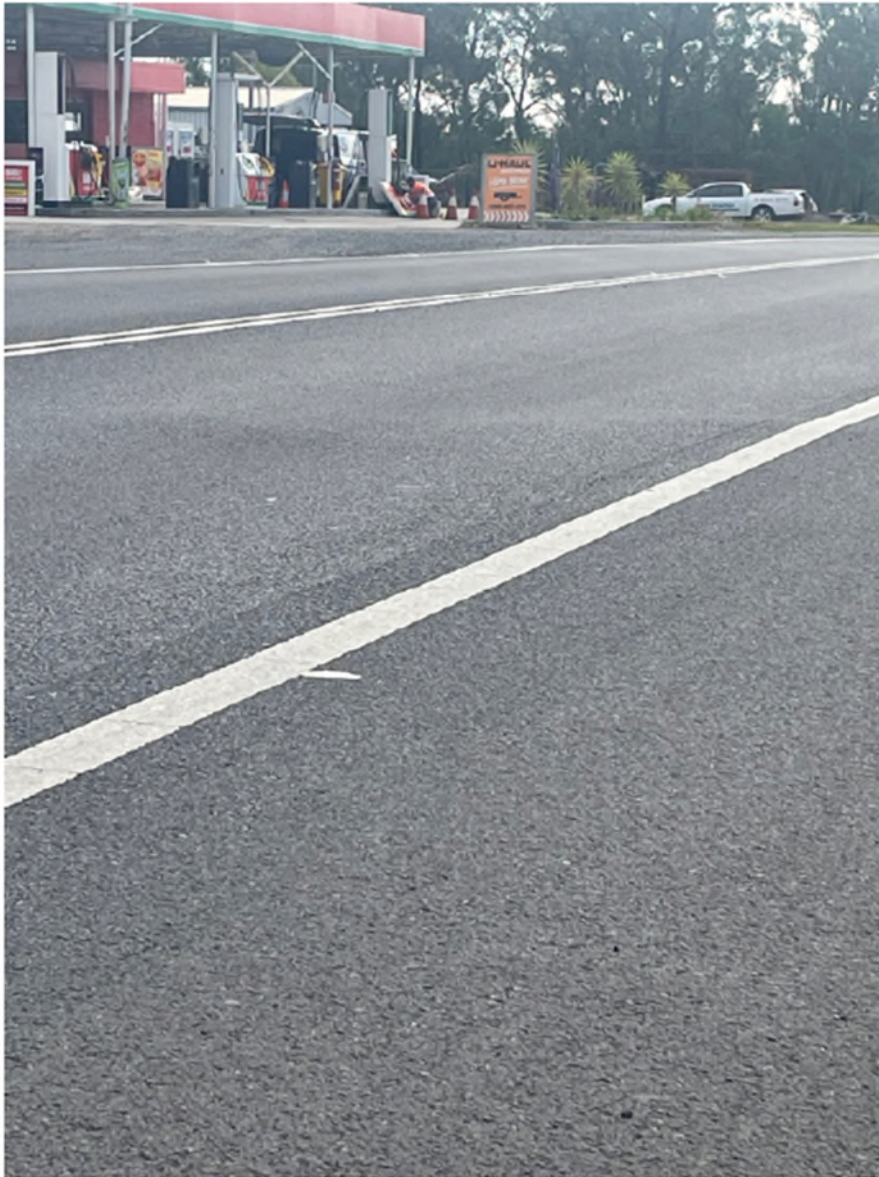
Figure 3-19 Small bump observed in southbound lane of Remembrance Drive near Peg R46 on 31 May 2023 (Source: MSEC1368 Report 19a, Appendix A)

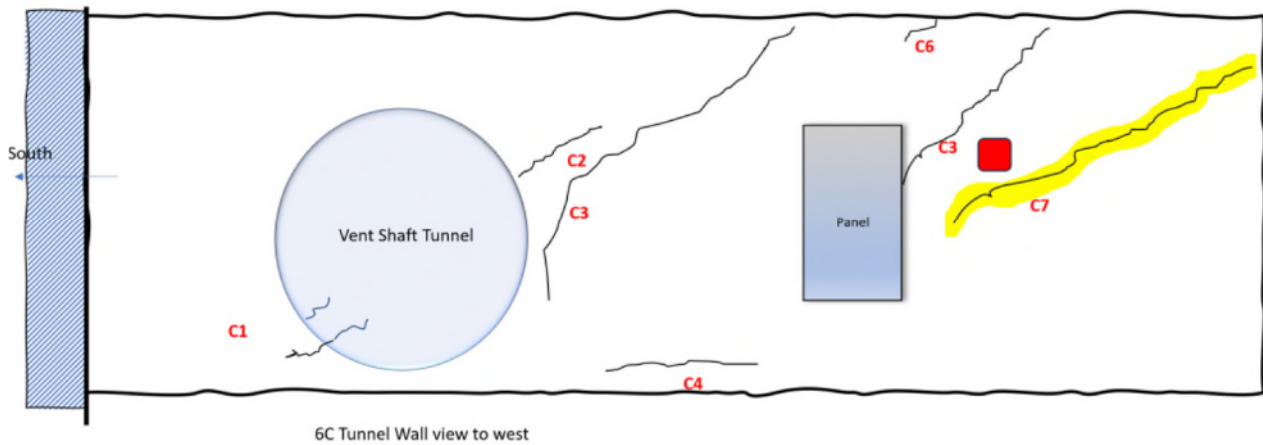
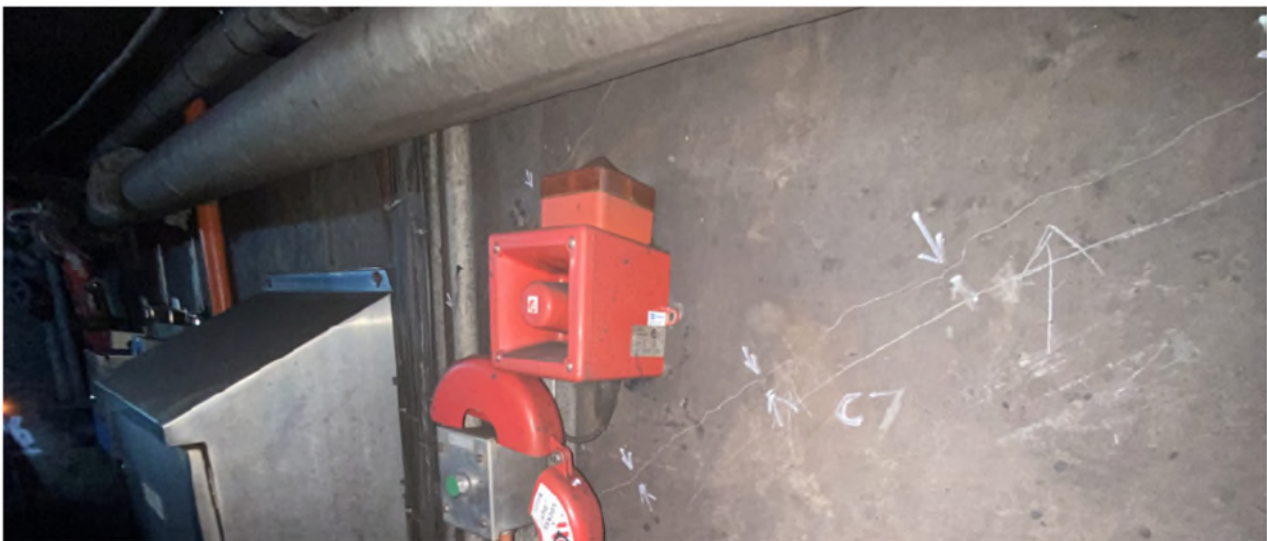
The mine site remained safe and serviceable during LW S1A and LW S2A extraction. A structural engineer inspected the cracks in the 6C Tunnel on 30 May 2023 and reported no immediate concerns.

Figure 3-20 Schematic of cracks located in 6C Tunnel and example of crack (crack C7 taken 27 June 2023) (Source: Photo report: Tahmoor Mine Conveyors 27/9/2023, Appendix F)

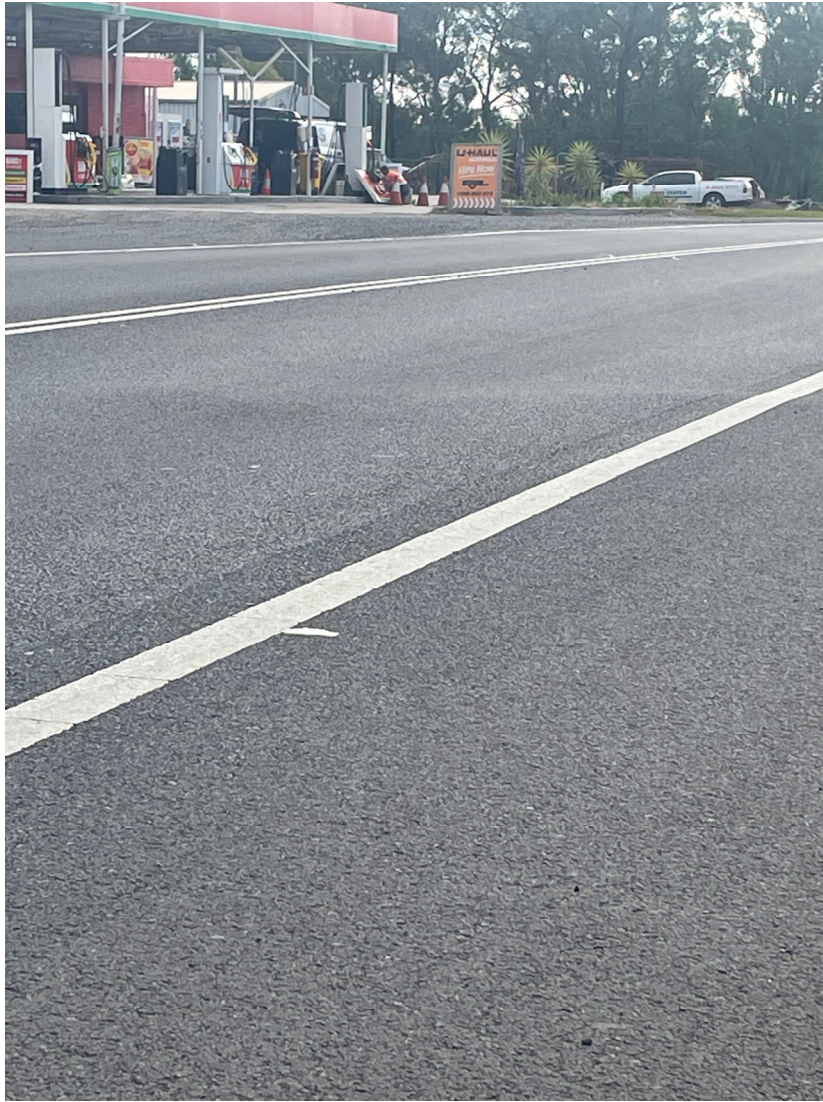
A focussed visual inspection was conducted on 31 May, which identified a small compression bump in the southbound lane of Remembrance Drive between Pegs R47 and R48. A photograph of the bump on 31 May is shown in Figure D. A map showing the location and orientation of the bump relative to nearby building structures and utility services is shown in Figure E. It can be seen that the bump is located to the side of LW S1A and above future LW S2A. It is oriented at an angle to the pavement and does not intersect with the Bargo Petroleum petrol station or any other structures. The bump intersects with a number of utility services, including Jemena’s gas main, Sydney Water’s potable water main and sewer main, and optical fibre and copper telecommunication cables.

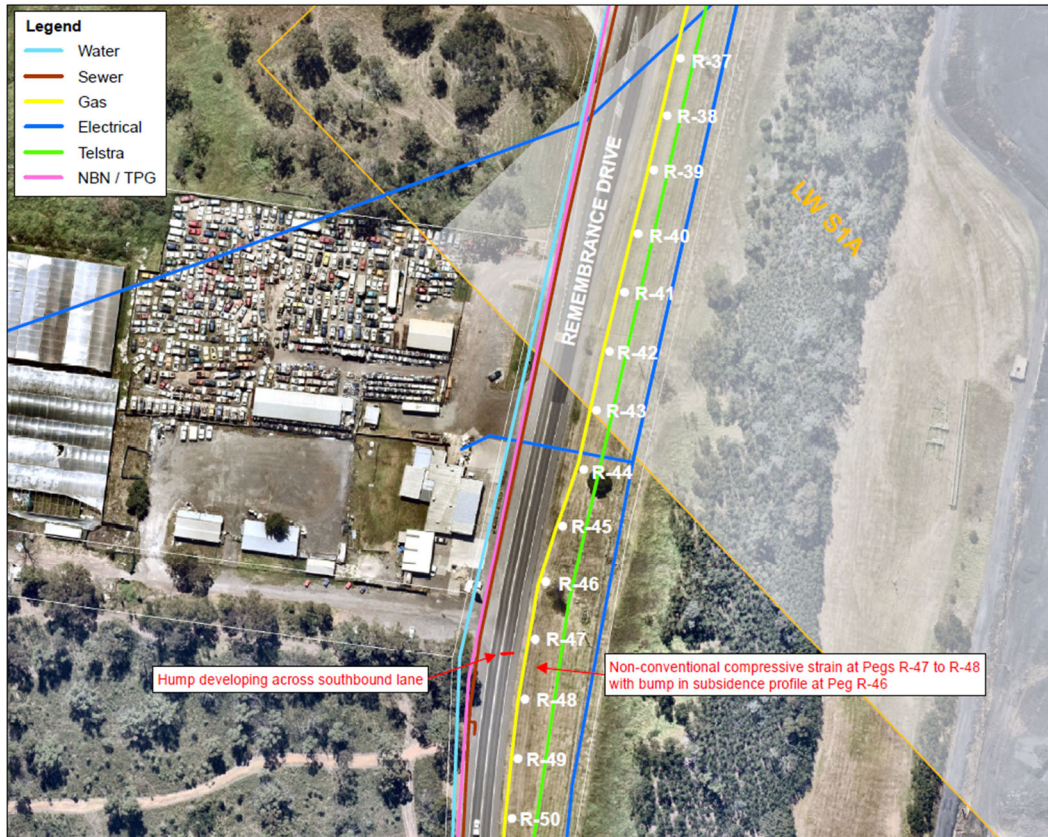
Figure E Location of small bump observed in southbound lane of Remembrance Drive near Peg R46 on 2 June 2023

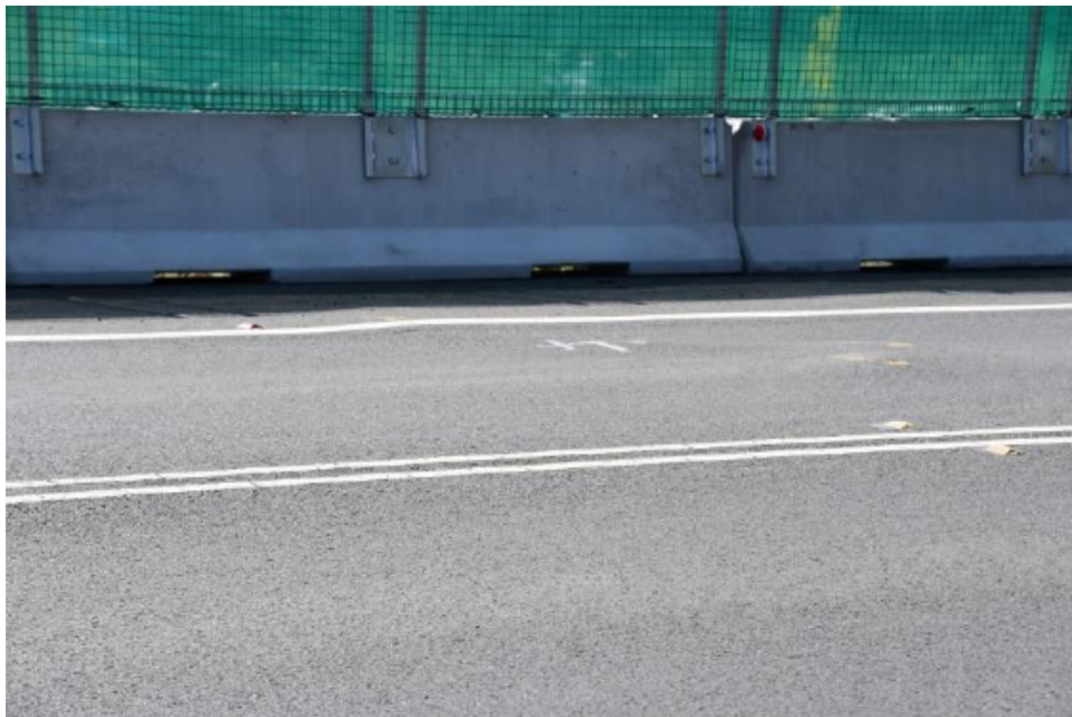
Visual inspections were conducted on [3 January](#) and a photograph of the bump is shown in Figure F. No significant changes have been observed since the inspection on 18 August. A faint bump is visible on the edge line of the northbound lane south of Peg R46.

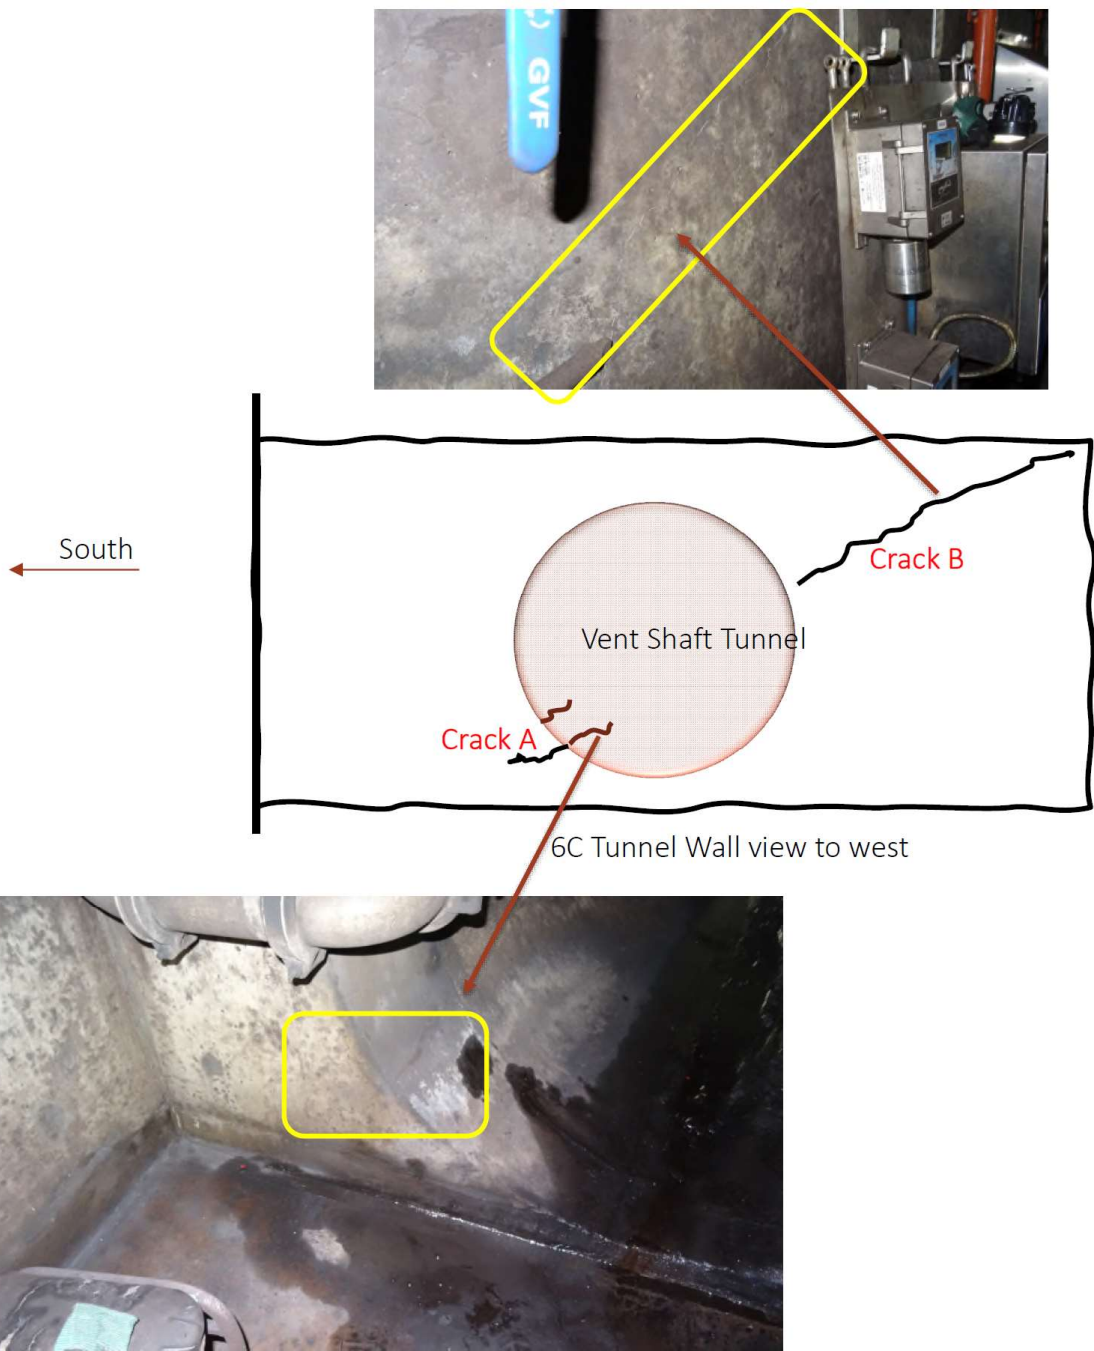
Plate 4.1 Location of cracks A(C1) and B (C2) within Tunnel 6C (David Talbert 29 May 2023).

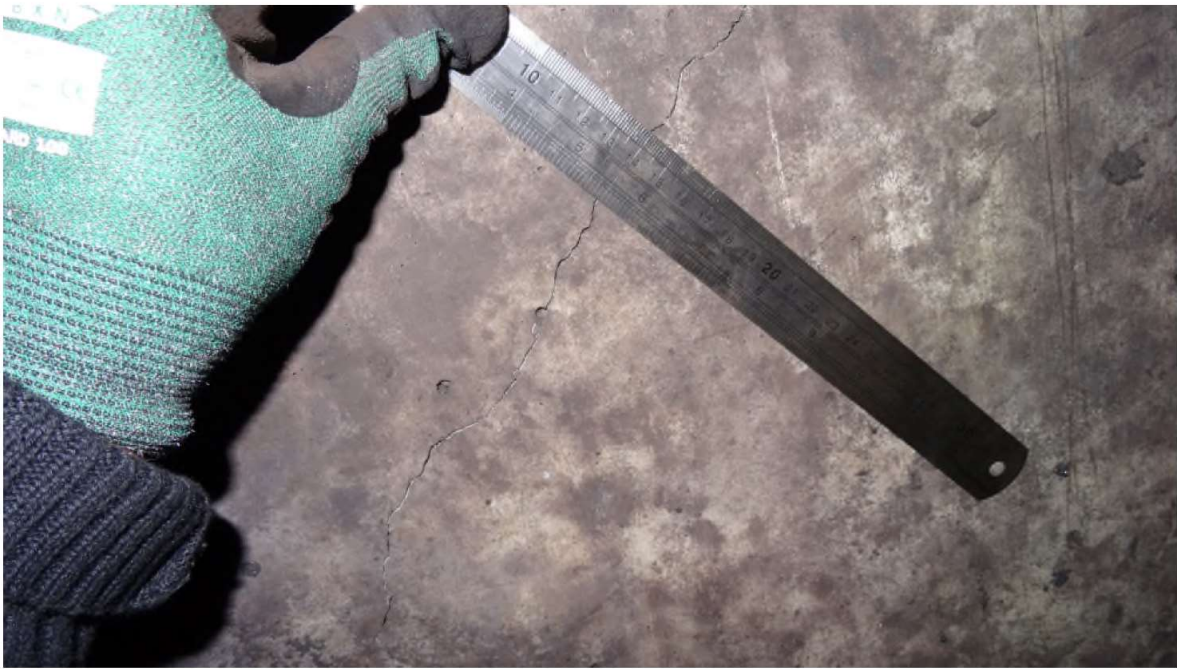
Plate 4.2 Crack B (C2), width <math><1\text{ mm}</math> (David Talbert 29 May 2023).

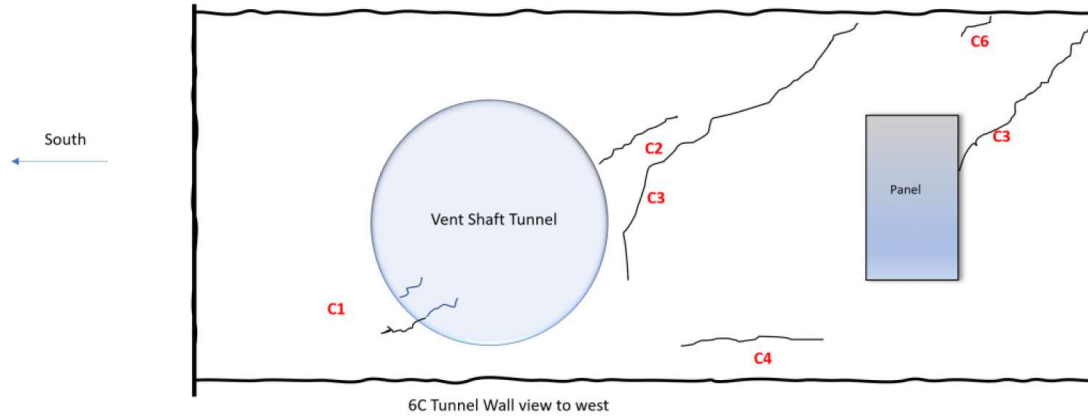
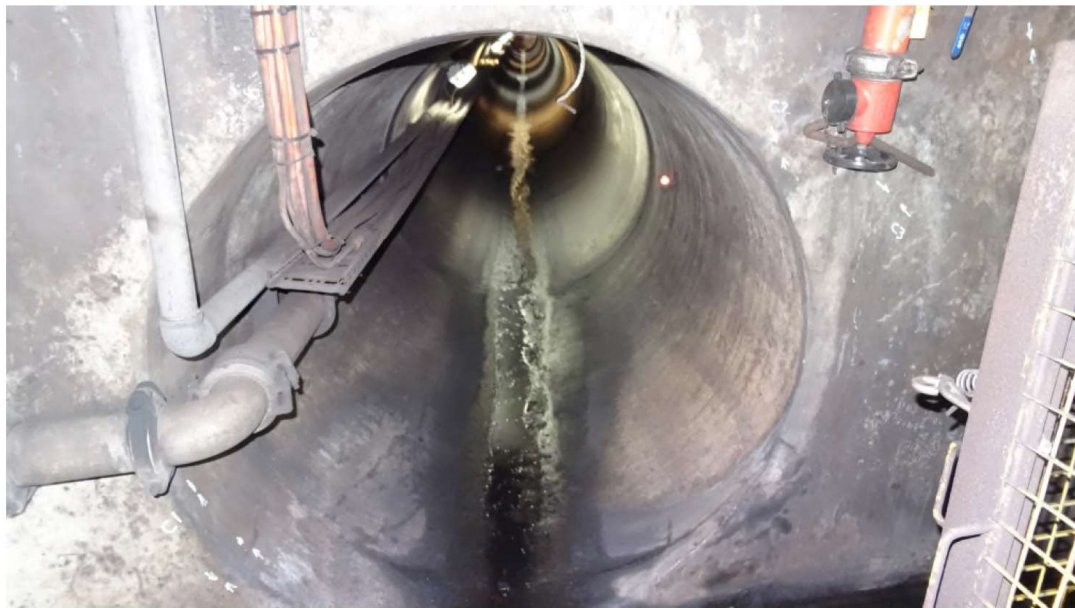
Plate 4.3 Context for the location of cracks C1, C2 and C3 (David Talbert, 6 June 2023).

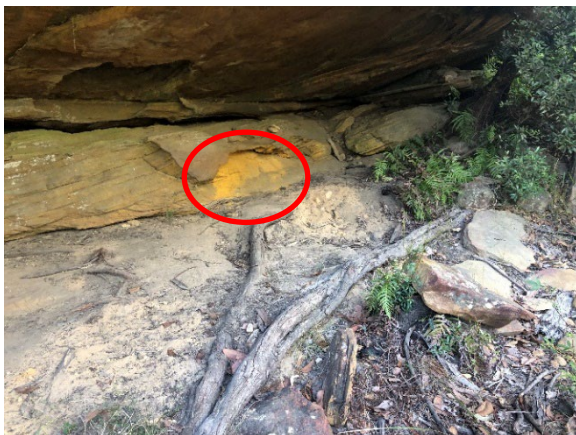
Plate 5 Some abrasion (the bright yellow) on the back wall at the south of the rockshelter, and which may reflect recent damage as a result of animal use or climatic changes.
