Report on  
Geotechnical Assessment  
Longwalls S1A to S6A, Bargo

Prepared for  
Tahmoor Coal Pty Ltd

Project 210597.00  
June 2024

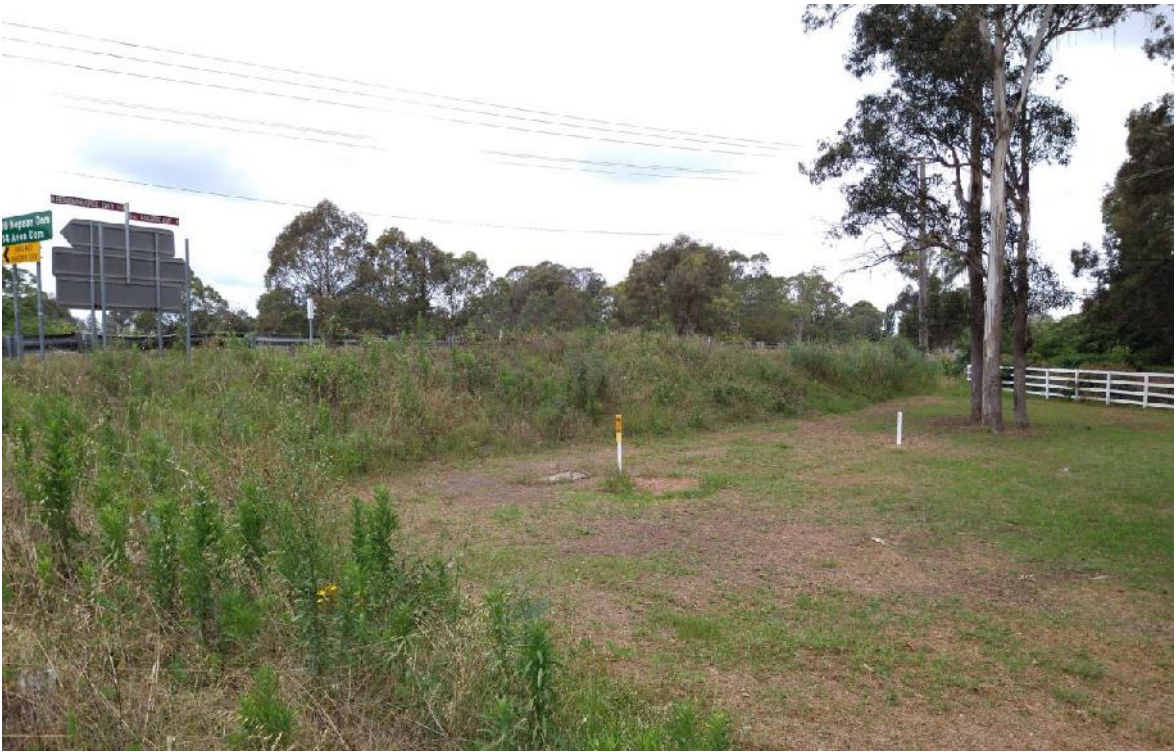
Feature ID/s	Address/Site	Date Inspected	Site Observations
RE1	Remembrance Drive intersection with Wellers Road	23/12/2021	<ul style="list-style-type: none"> <li>– The soil exposed in the embankment comprises clay and gravel fill (refer Photo 1) including shale, carbonaceous siltstone and sandstone.</li> <li>– There is rutting, crocodile cracking, shoving and bleeding in the Remembrance Drive wearing course and a number of patches in both lanes (refer Photo 3). Table drains are located on both sides of the Remembrance Drive roadway to the north of the intersection with Wellers Road.</li> <li>– The surface of the road embankment batter on the eastern side of Remembrance Drive, approximately 130 m to the north of the intersection has an irregular surface.</li> <li>– No signs of deep-seated movement in the pavement.</li> <li>– A high-pressure gas pipeline is located along the eastern side of the embankment.</li> </ul>

Photo 2: View looking south east across the south western corner of the RE1 road embankment.

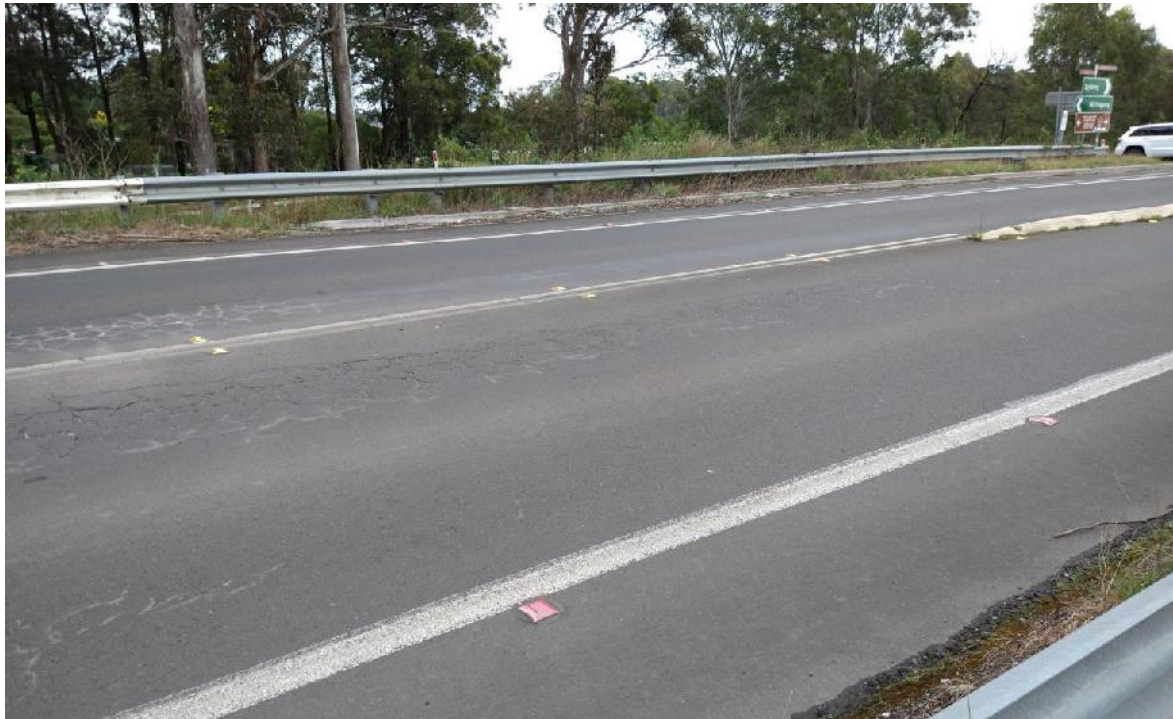
Photo 3: View looking north west at rutting and crocodile cracking in the Remembrance Drive wearing course to the south of the intersection with Wellers Road (RE1).

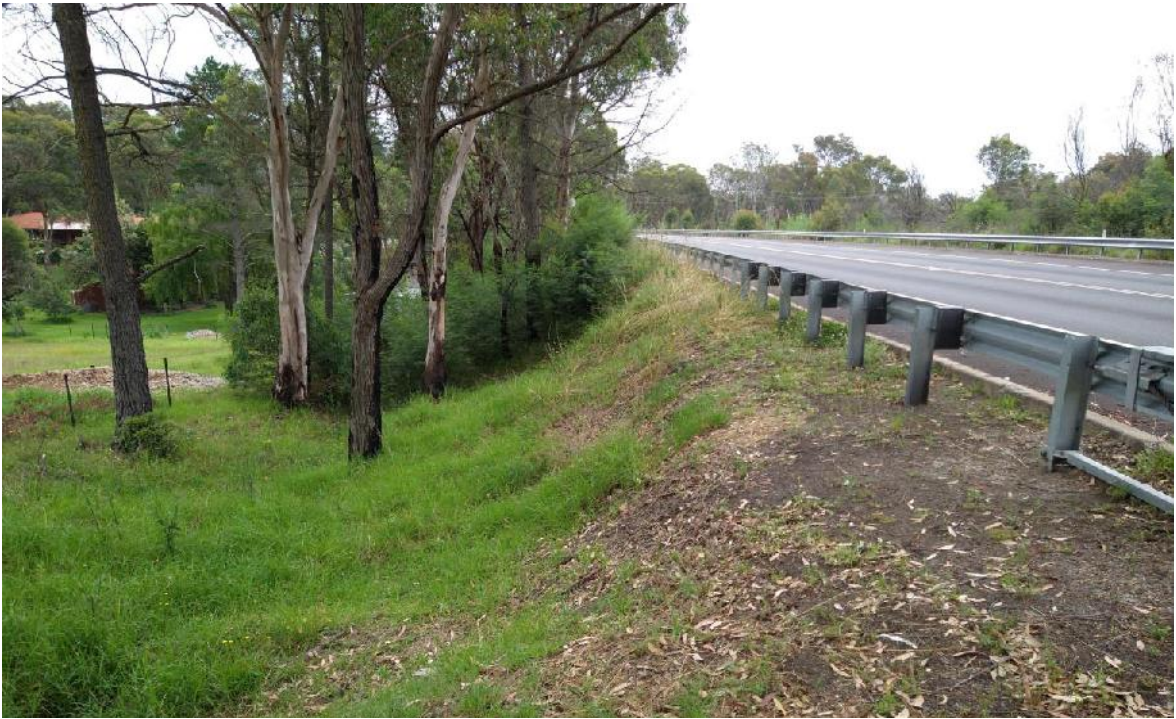
RE2	Remembrance Drive south of Yarran Road	23/12/2021	<ul style="list-style-type: none"> <li>– Average batter slopes measured to be 33° to 35°. Mature trees are growing in the embankment (refer Photos 4 and 5).</li> <li>– Cracking in the kerb, offsets of up to 20 mm and gaps of up to 70 mm of the north-bound lane, approximately 170 m south of Yarran Road.</li> <li>– No signs of deep-seated movement in the pavement.</li> <li>– A high-pressure gas pipeline is located along the eastern side of the embankment.</li> </ul>
RE3	Remembrance Drive north of Yarran Road	23/12/2021	<ul style="list-style-type: none"> <li>– The upstream face is generally grassed (refer Photos 6 – 8) while the downstream face was obscured with long grass and shrubs.</li> <li>– No signs of deep-seated movement in the pavement.</li> <li>– A high-pressure gas pipeline is located along the eastern side of the embankment.</li> </ul>

Photo 4: View looking north along the upstream face for RE2.

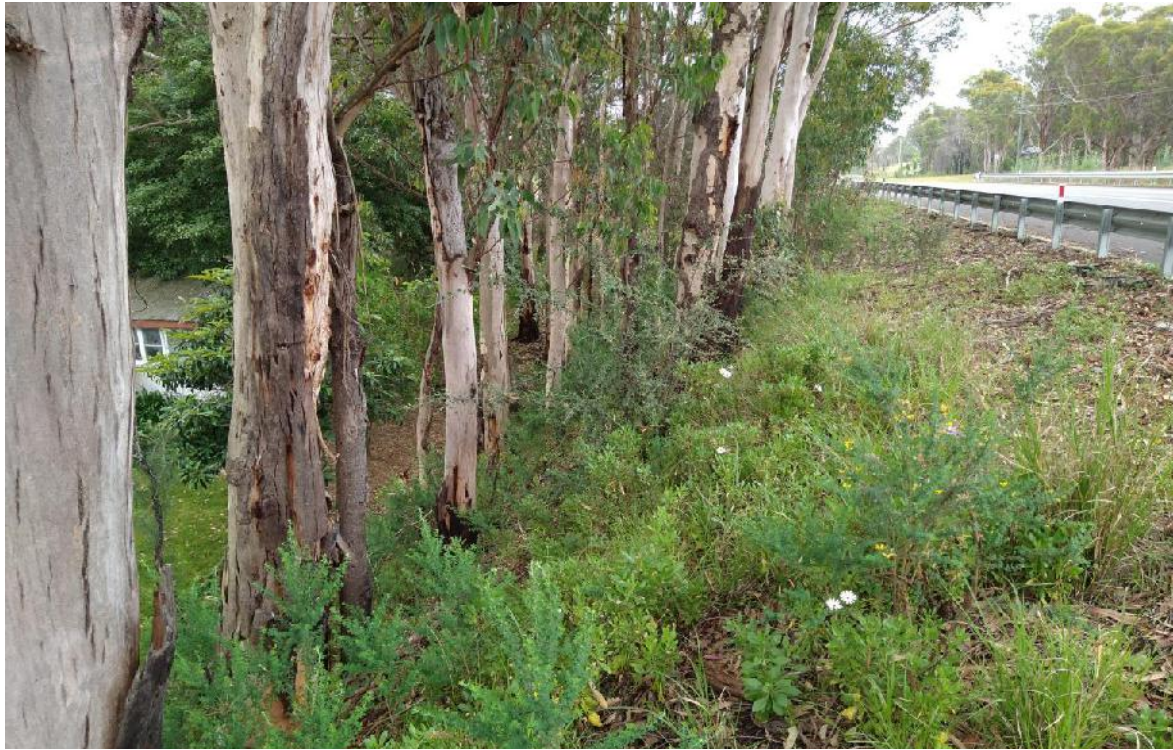
Photo 5: View looking north along the upstream face for RE2. Note: the dwelling at the toe of the embankment, which is downstream from FD51.

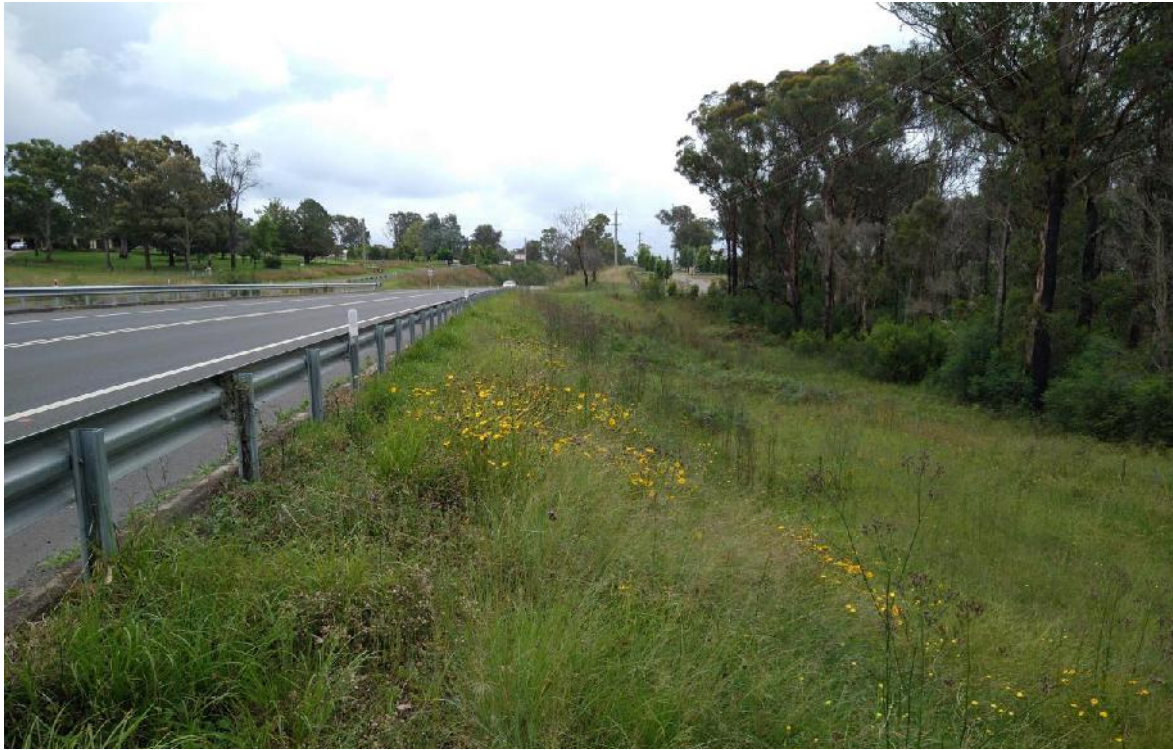
Photo 6: View looking north along the downstream face for RE3.

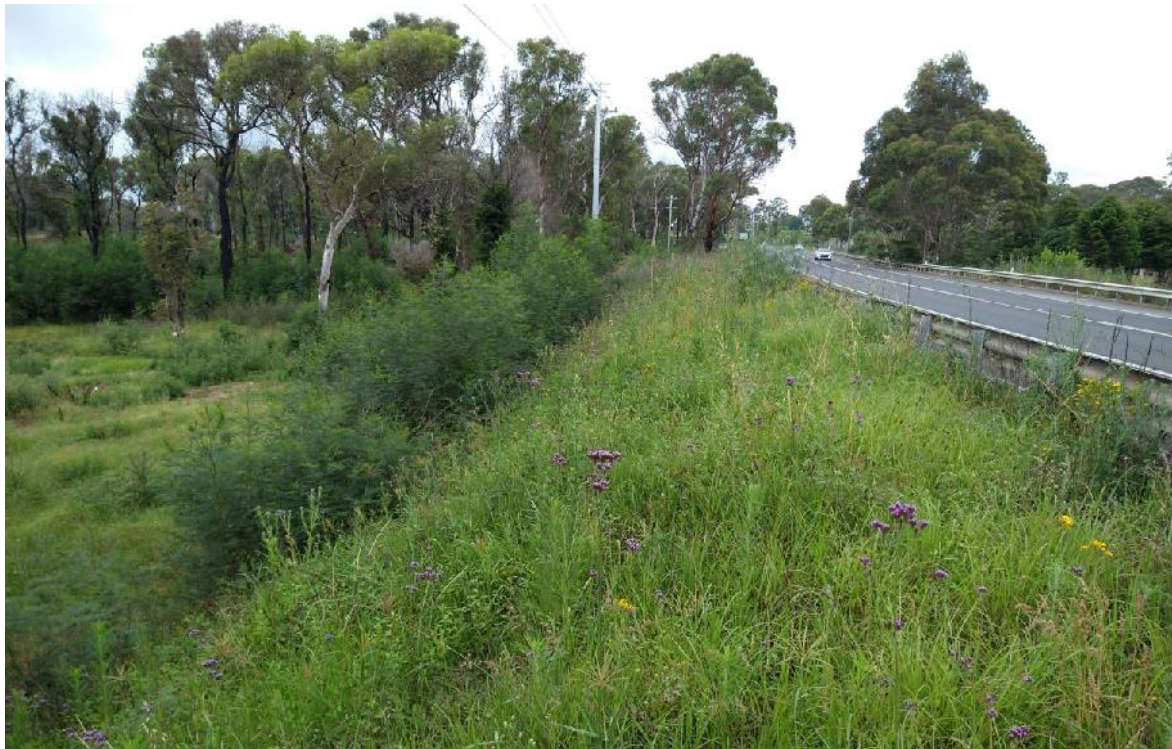
Photo 9: View looking south along the crest of the downstream face for RE4.

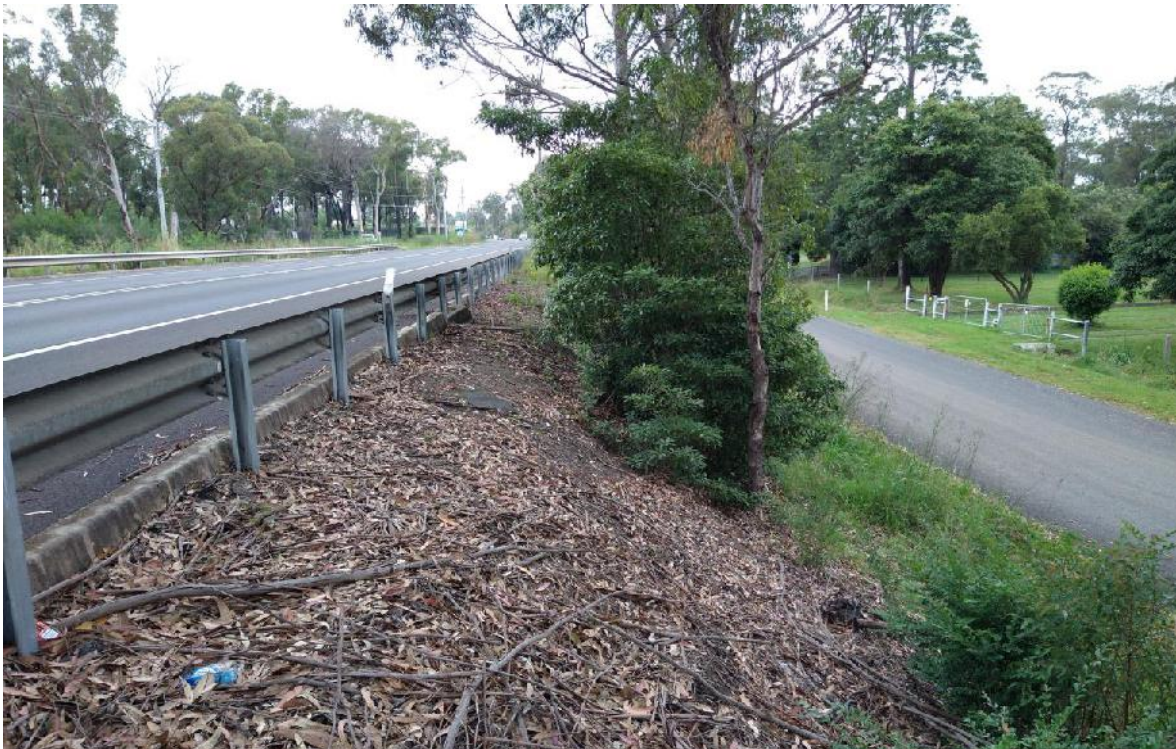
Photo 10: View looking along the crest of the upstream face for RE4.

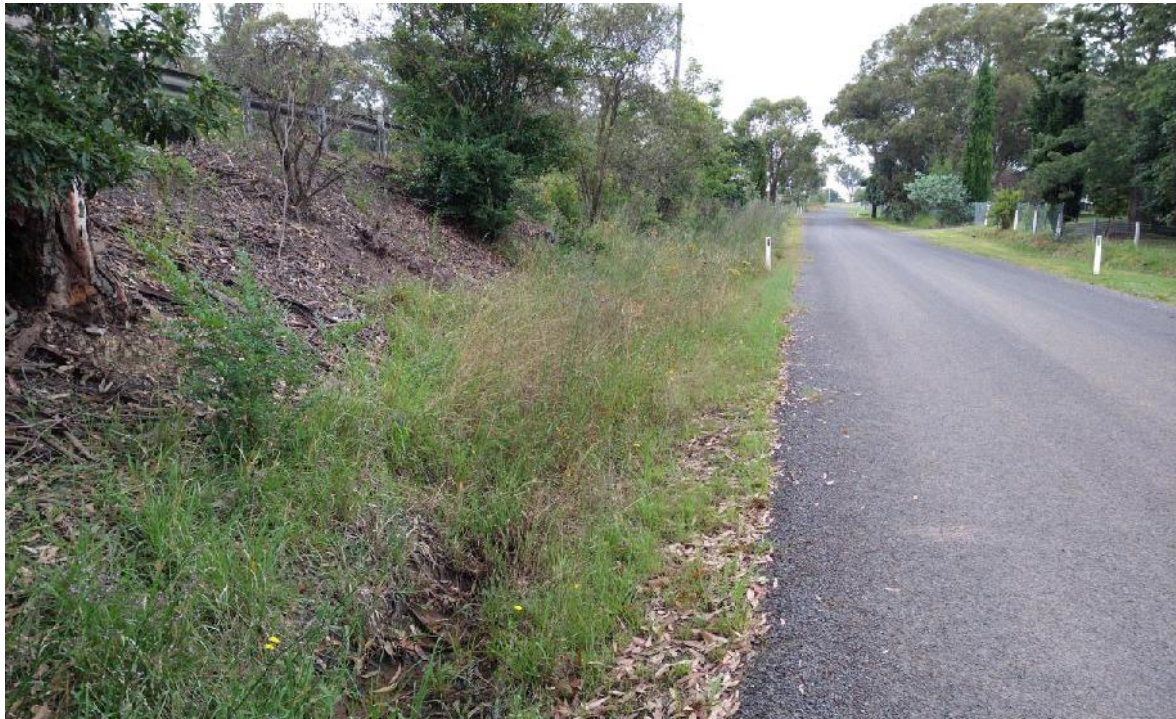
Photo 11: View looking south along the upstream face of RE4 opposite No. 3100 Remembrance Drive. Note: the drain cut into the toe of the embankment.

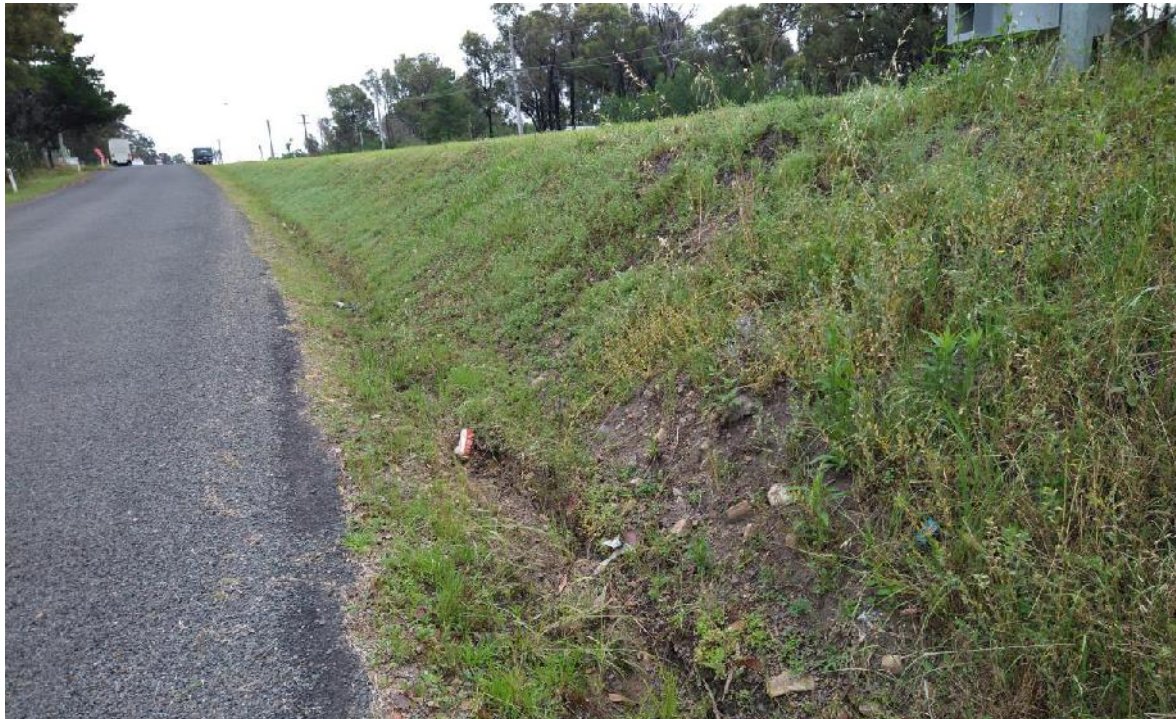
Photo 12: View looking north along the upstream face of RE4 opposite No. 3088 Remembrance Drive.

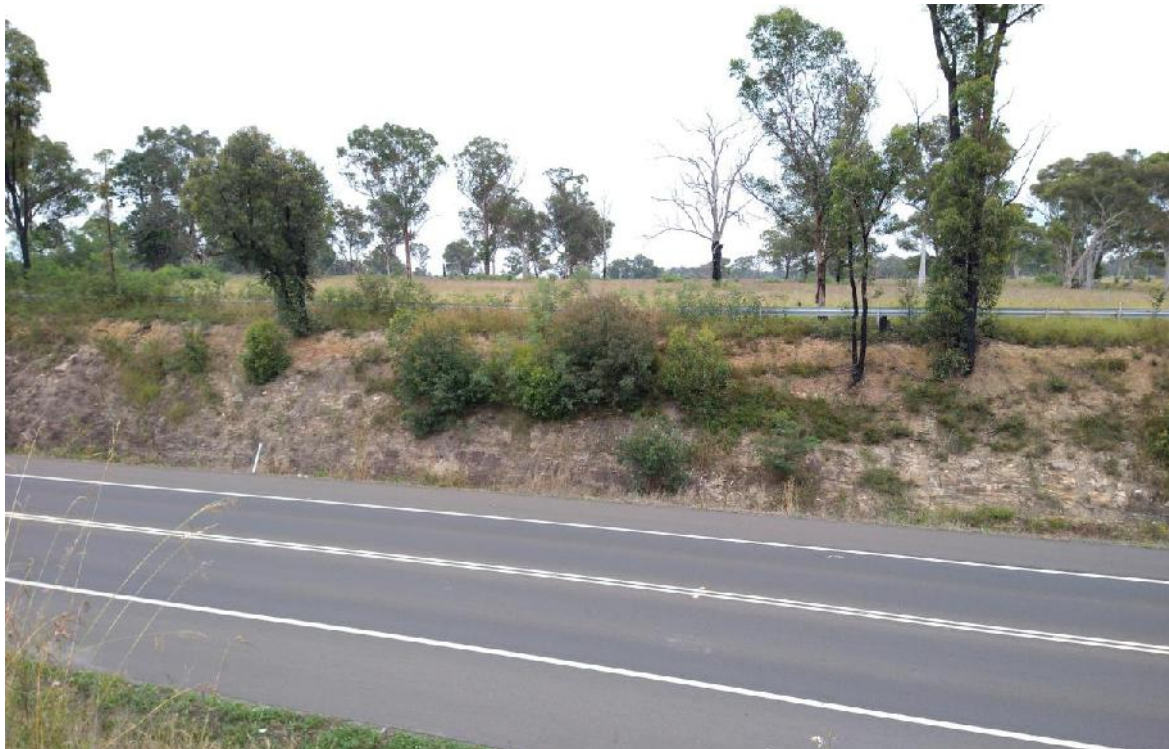
Photo 13: View looking southwest towards the road cutting adjacent to No. 3140 Remembrance Drive. Note: the soil and weathered rock in the upper cut and medium to thickly bedded rock in the middle and lower.

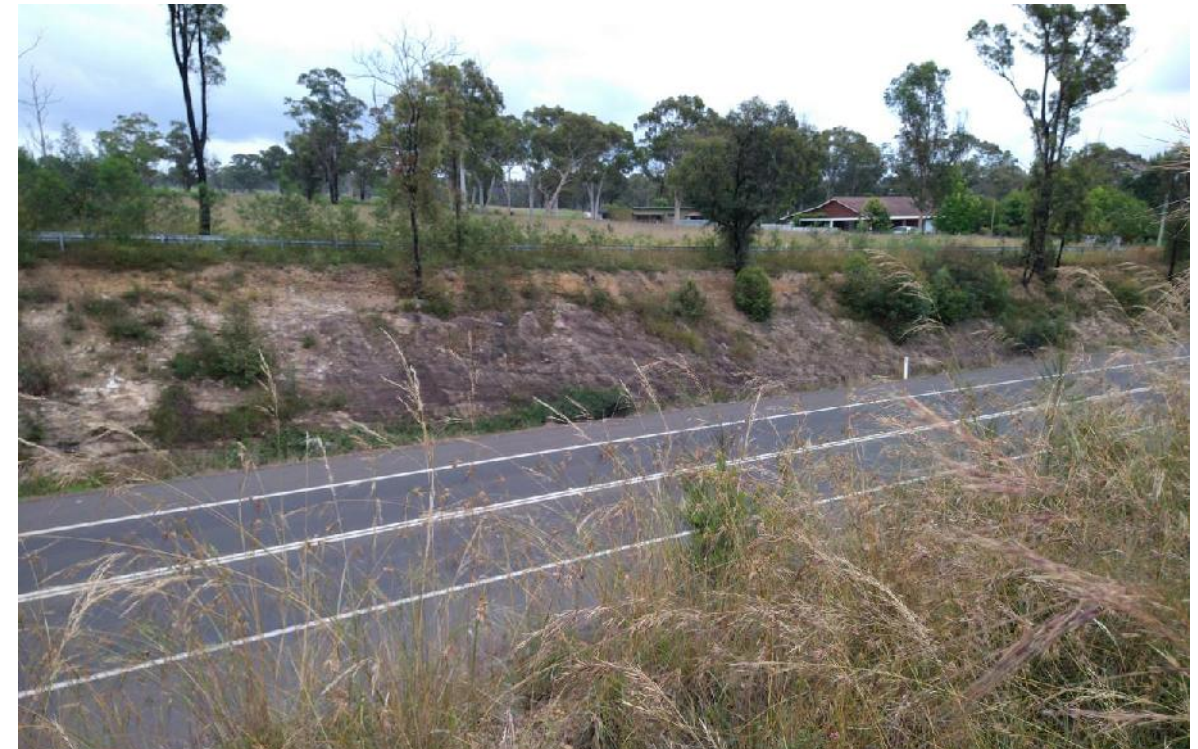
Photo 14: View looking north west towards the road cutting adjacent to No. 3116 Remembrance Drive. Note: the soil and weathered rock in the upper cut and medium to thickly bedded rock in the middle and lower.

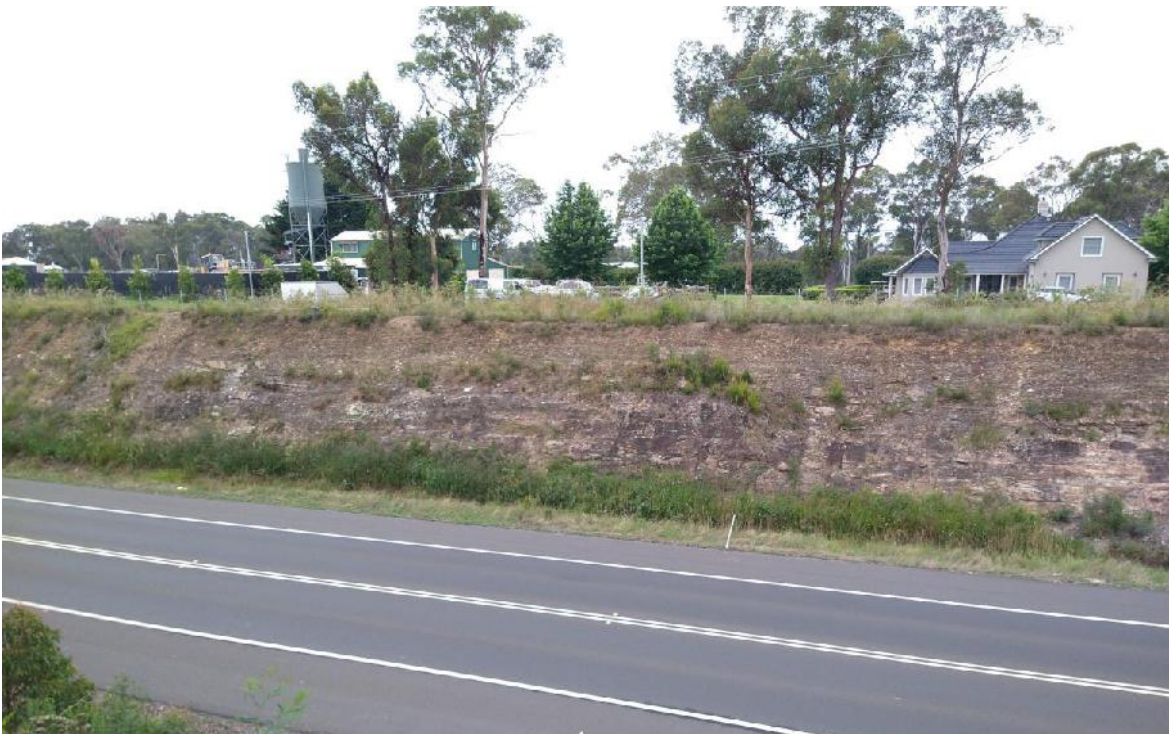
Photo 15: View looking east towards the cutting adjacent to No. 3165 Remembrance Drive. Note: the weathered rock in the upper cut and medium to thickly bedded rock in the middle and lower cut.

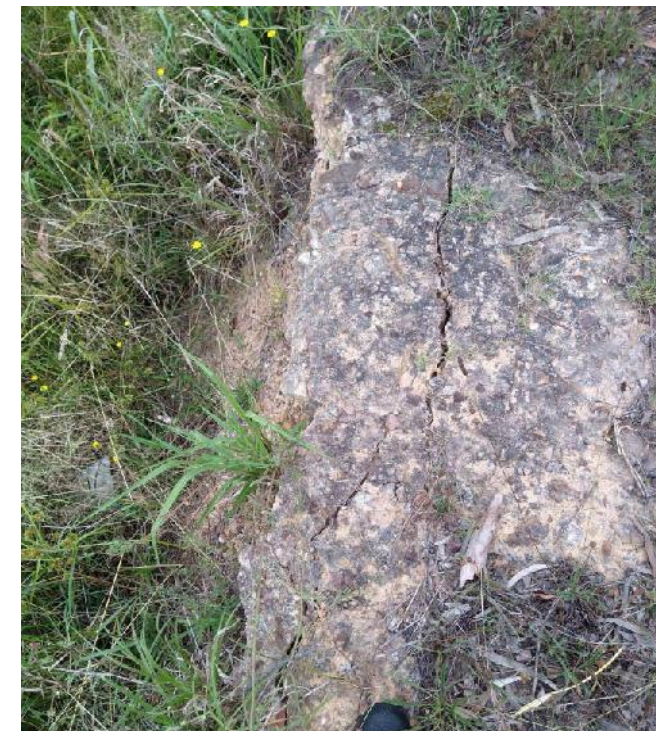
Photo 16: View looking at tension cracks setback behind the crest of opposite No. 3122 Remembrance Drive.

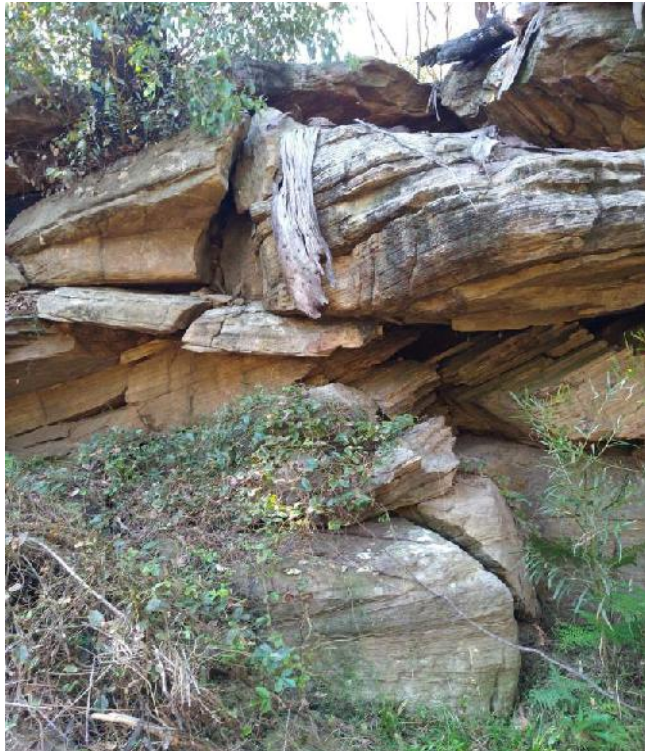
WC1 – WC3	Wirrimbirra Creek	12/04/22	<ul style="list-style-type: none"> <li>– The gully associated with the creek line is characterised with steep slopes and rocky outcrops of sandstone (refer Photos 17 – 22). The rocky outcrops include preferential weathering and erosion of cross-bedded sandstone resulting in overhangs. Collapsed joint blocks (refer Photos 17, 18 and 20) were observed at a number of locations beneath overhangs.</li> <li>– At the time of the inspection, the grass in the floor of the gully had been 'pushed flat' from high flow levels during recent heavy rainfall.</li> </ul>

Photo 17: View looking open jointing and dislodged joint blocks near the 'Big Pool' (WC1) in Wirrimbirra Creek.

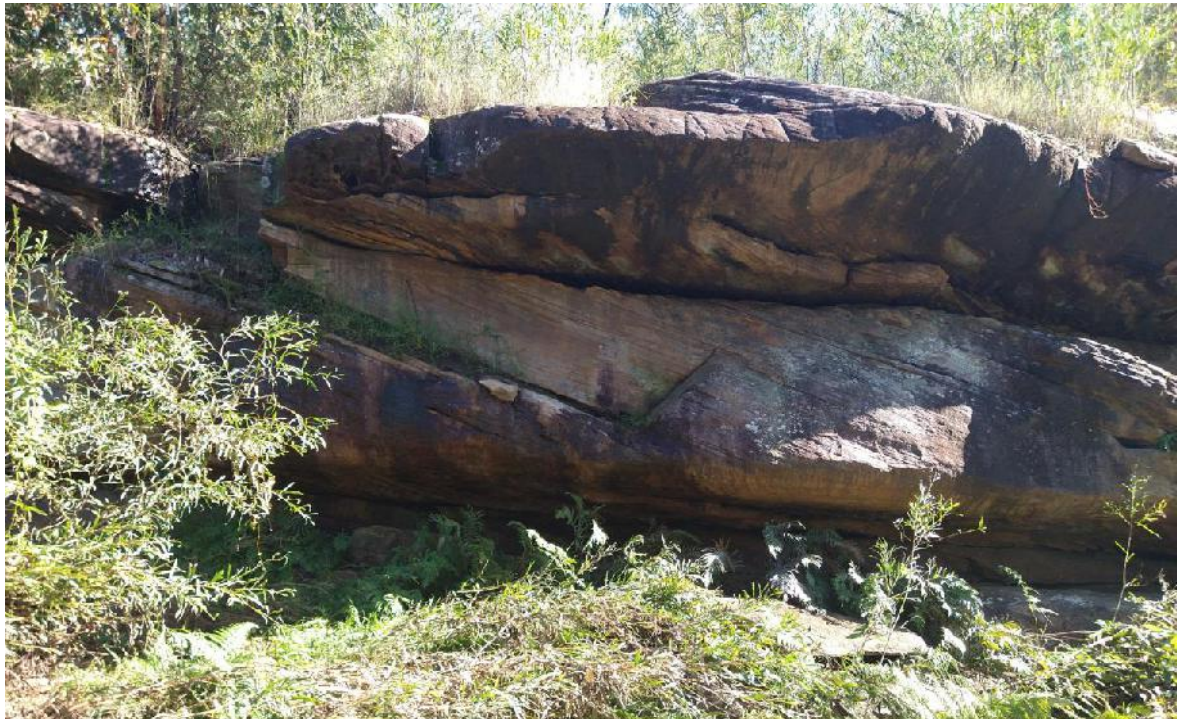
Photo 19: View looking west at rocky outcrop about Dekenden Pool (WC2) in Wirrimbirra Creek.

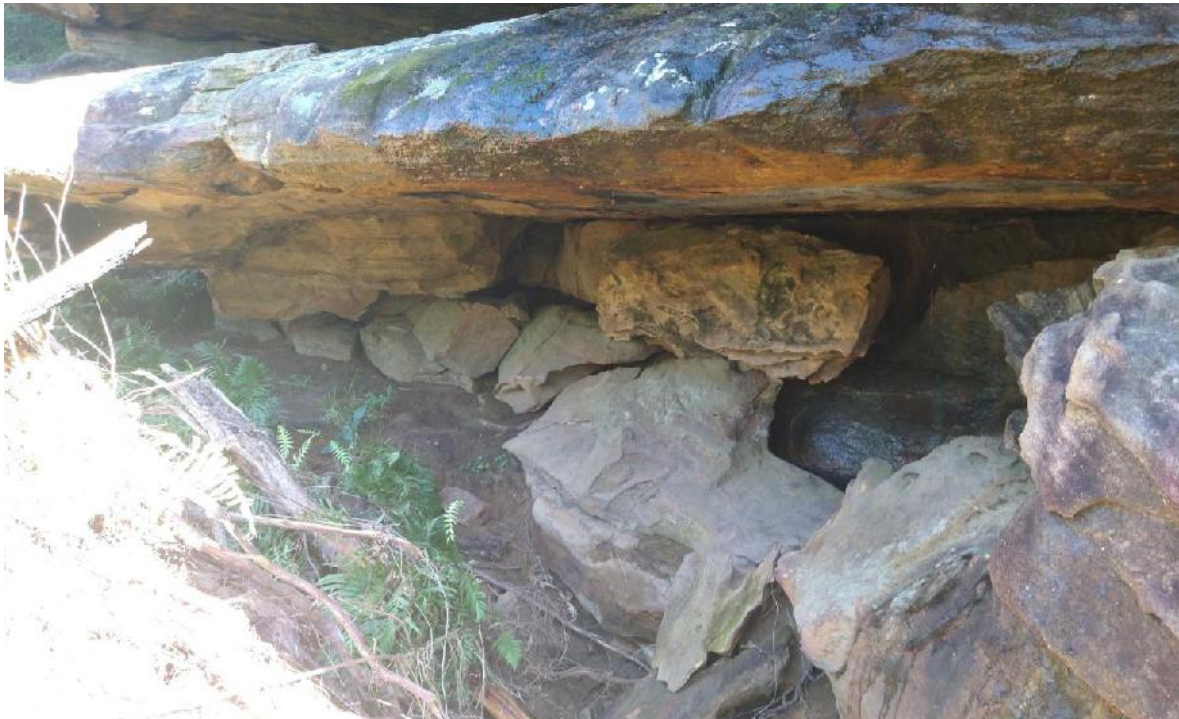
Photo 20: View looking at collapsed joint blocks below a section of overhang near Dekenden Pool (WC2).

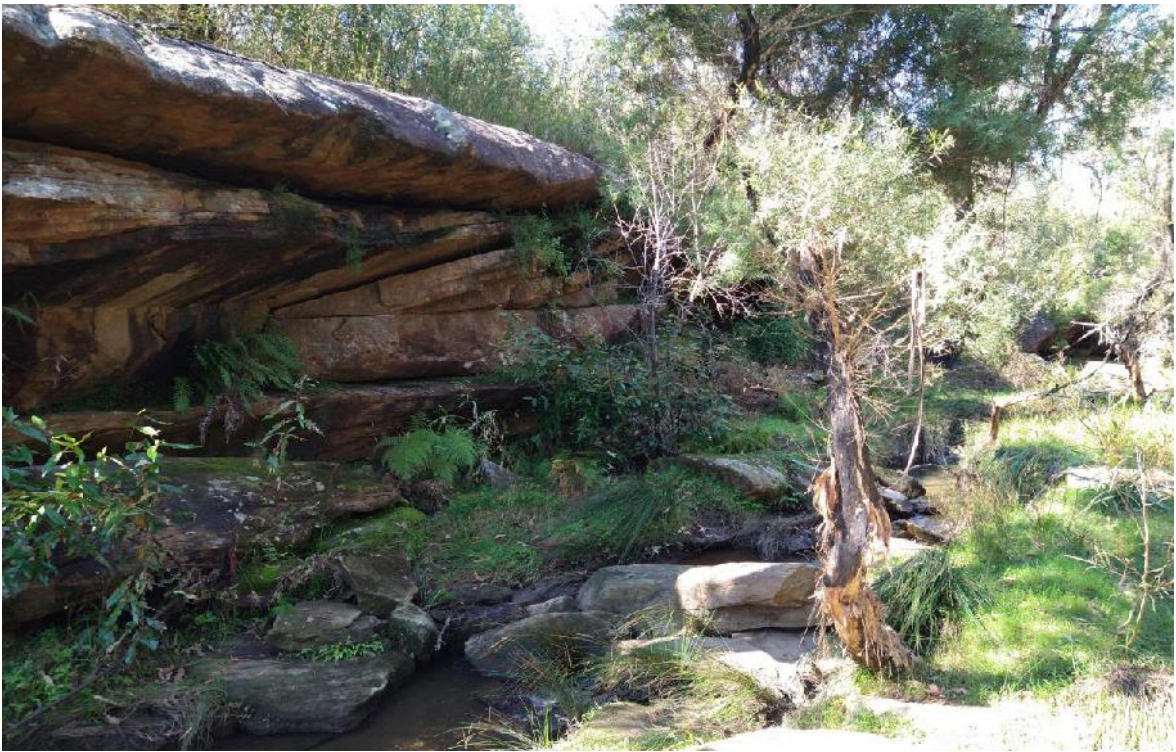
Photo 21: View looking at overhanging rocky outcrops near 'Petroph Pass' (WC3) in Wirrimbirra Creek.

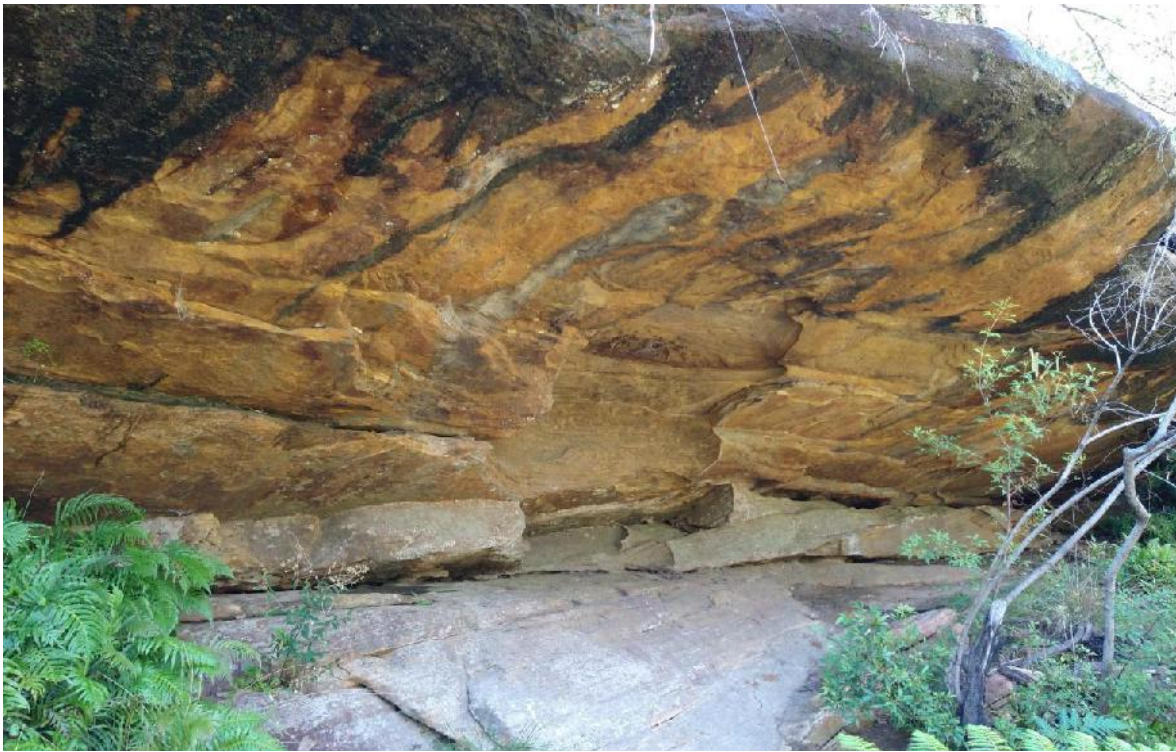
Photo 22: View looking at a wide section of overhang near 'Petroph Pass' (WC3) in Wirrimbirra Creek.

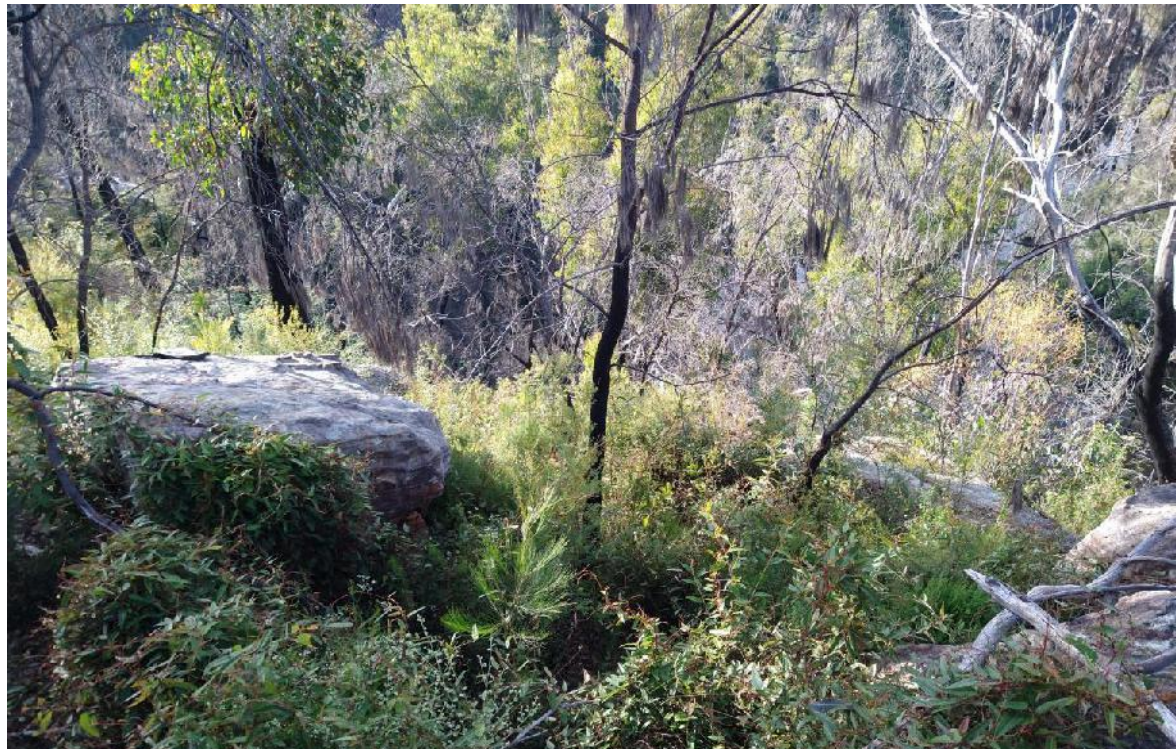
Photo 23: View looking south downslope at WC4. Note: the sandstone blocks and slabs of sandstone resting on the surface.

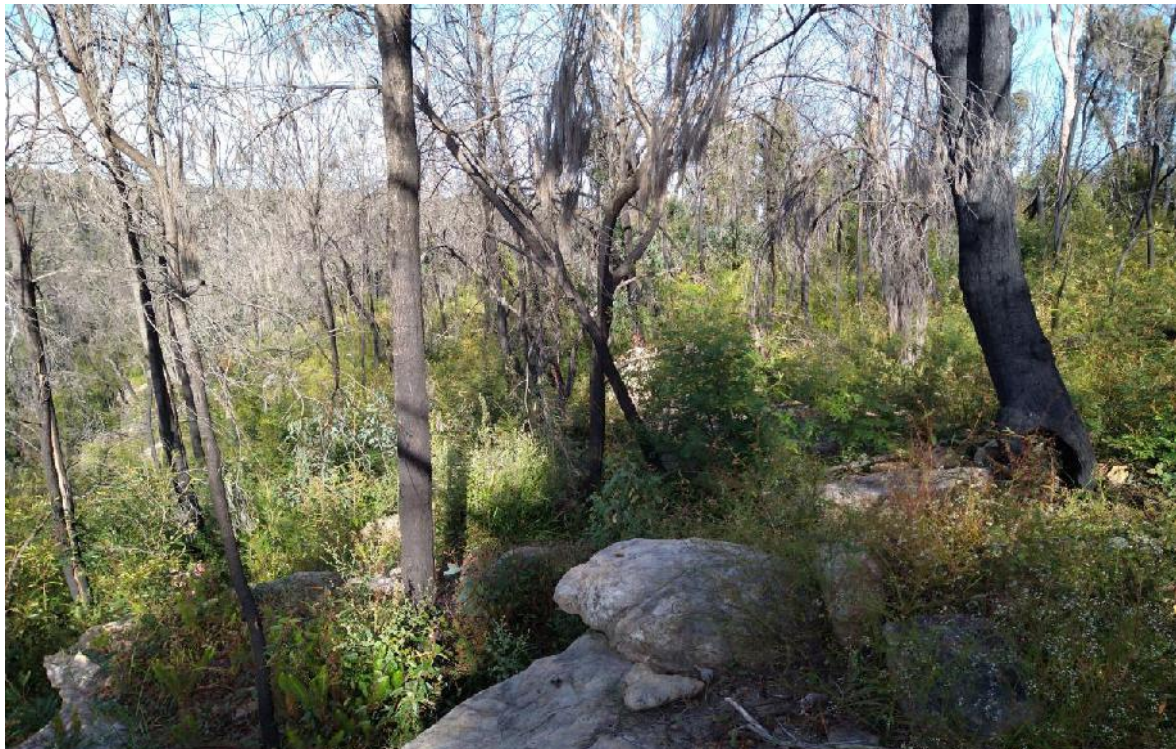
Photo 24: View looking west across the upper slope above the Bargo River at WC4. Note: the sandstone blocks and slabs of sandstone resting on the surface and burnt/dead trees.

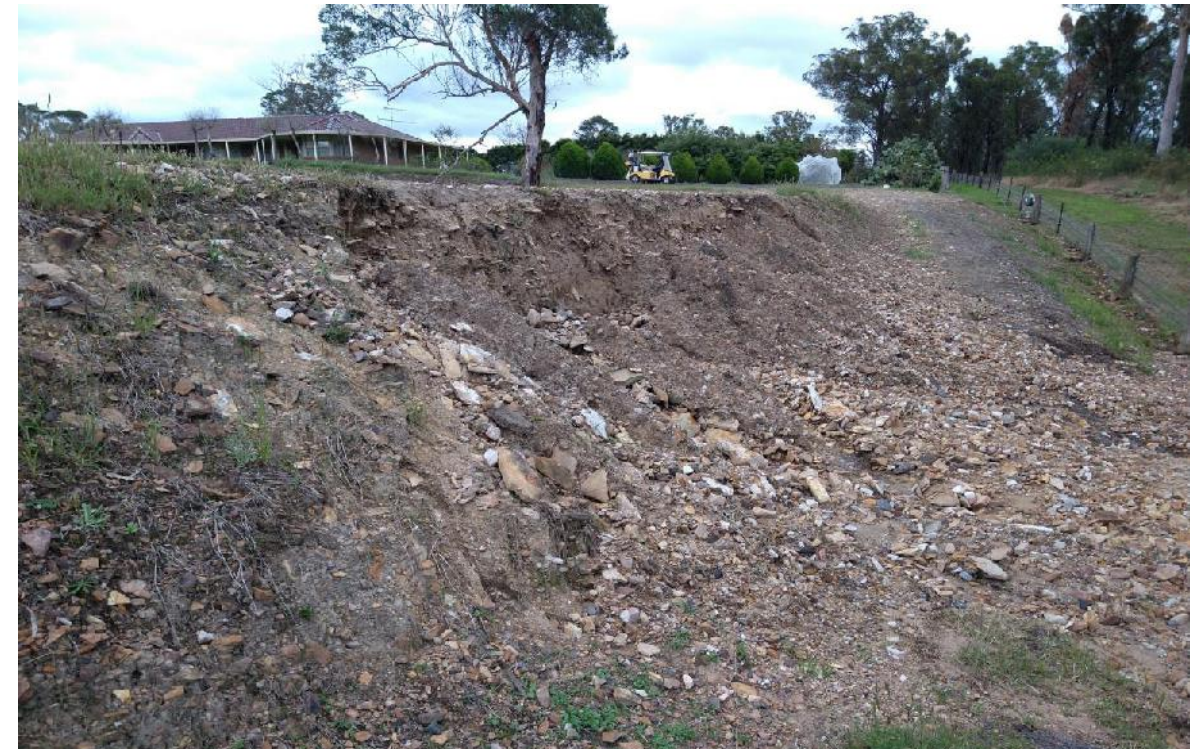
-	4 Olive Lane	12/04/2022	<ul style="list-style-type: none"> <li>The dam spillway comprises an approximately 250 mm diameter pipe.</li> <li>The owner advised that the farm dam had overtopped during heavy rainfall in early March 2022 that resulted in scour of the downstream dam embankment. The downstream embankment was repaired in March. Further erosion occurred during a second overtopping event in early April 2022 (refer Photos 25 and 26).</li> </ul>
FD1	115 Charlies Point Rd	10/02/2022	<ul style="list-style-type: none"> <li>The dam has no spillway. The dam (refer Photo 27) is partially incised into the site slope (ie not within a watercourse). Overflow goes around the south eastern and south western sides of the wall.</li> </ul>
FD2 & FD3	Wollondilly Anglican College (WAC), No. 3000 Remembrance Drive, No.'s 1 and 5 Olive Lane)	17/01/2022	<ul style="list-style-type: none"> <li>A WAC grounds keeper advised FD2 is a bore-fed dam. FD2 (refer Photo 28 and 29) is partially incised into the site slopes.</li> <li>FD3 (refer Photo 30) comprise small ponds partially incised in the site slopes above the gully. A WAC grounds keeper advised that it is not a spring-fed dam, rather it collects flows from the nearby shed roof.</li> </ul>

Photo 26: View looking west along the downstream toe of the farm dam at 4 Olive Lane (outside the SA). Note: the erosion and scour following overtopping during a heavy rainfall event in early April 2022.

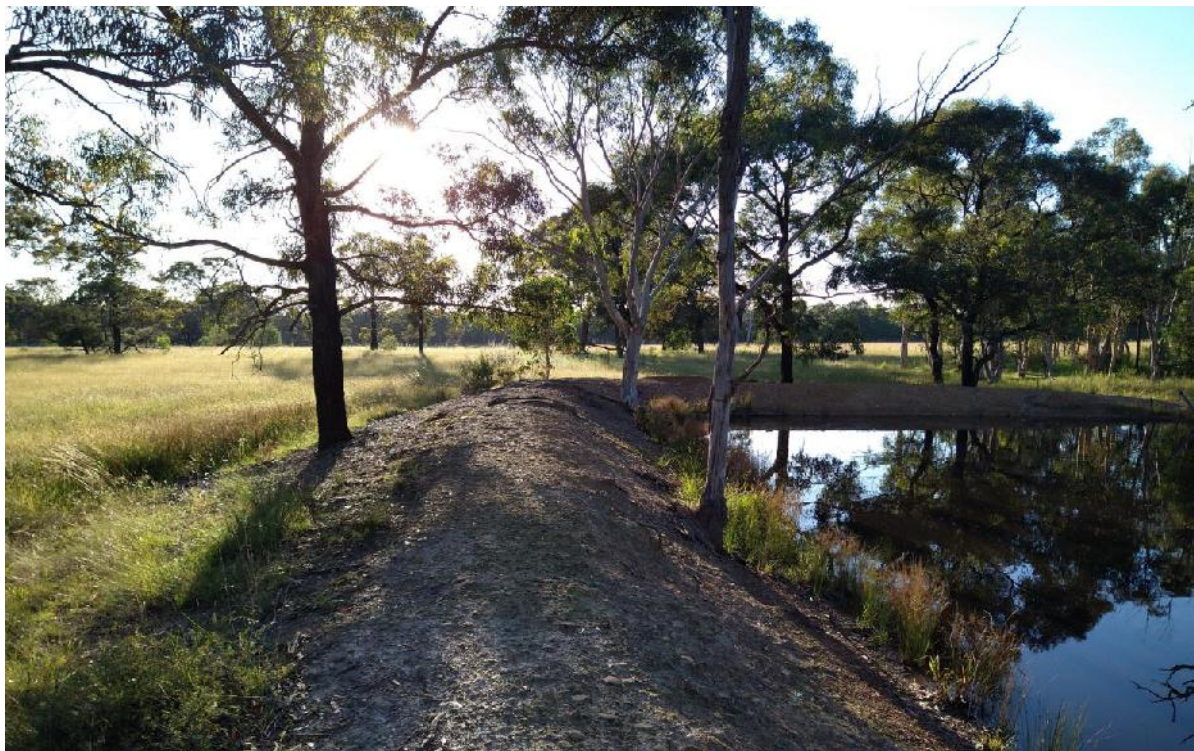
Photo 27: View looking east along the crest for FD1.

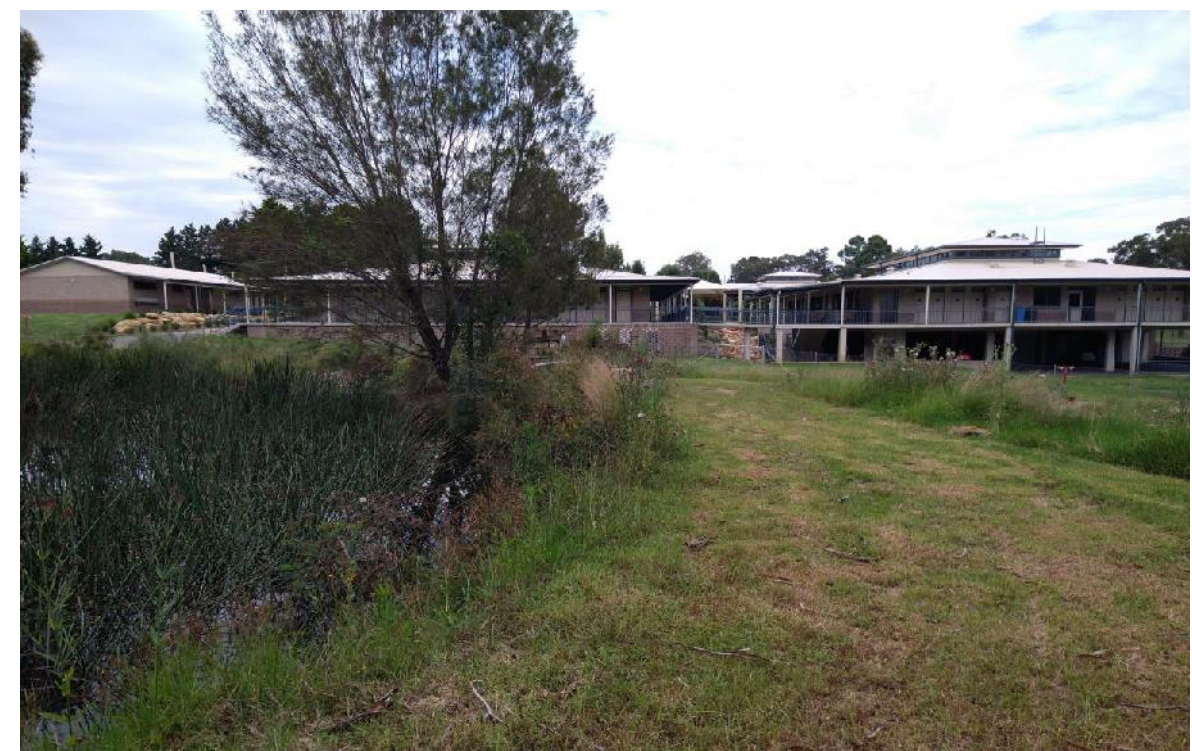
Photo 28: View looking south east across the crest of FD2.

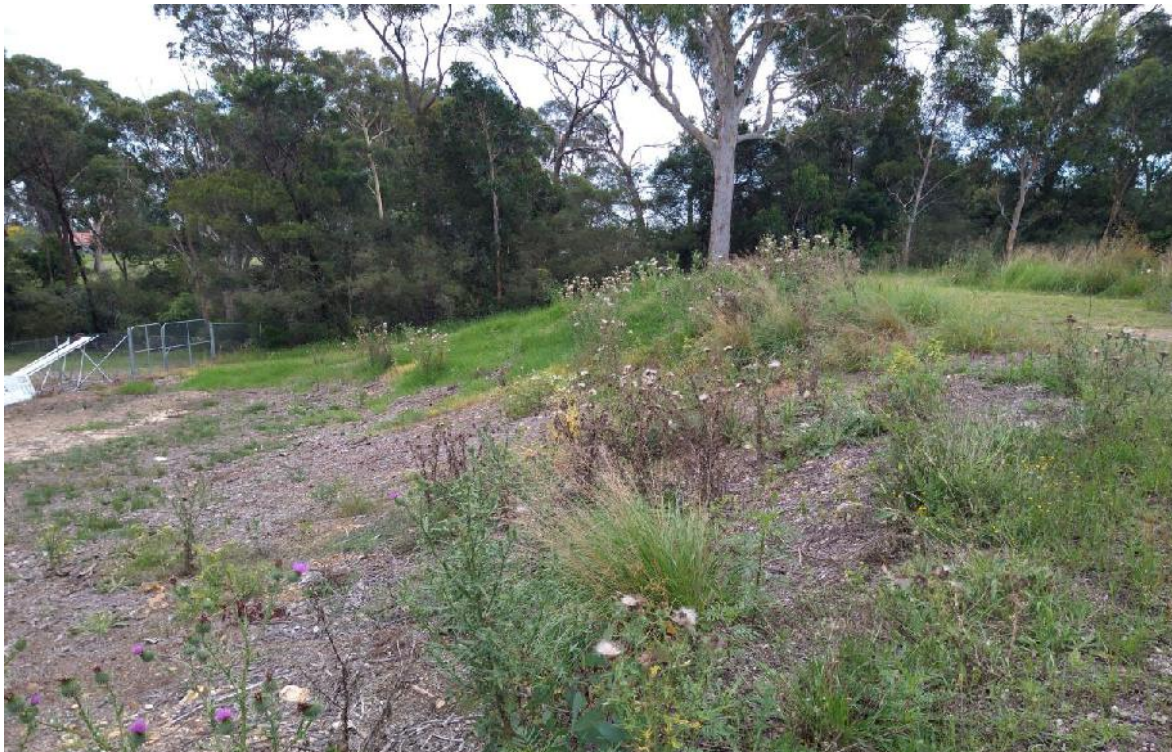
Photo 29: View looking north along the downstream embankment face of FD2.

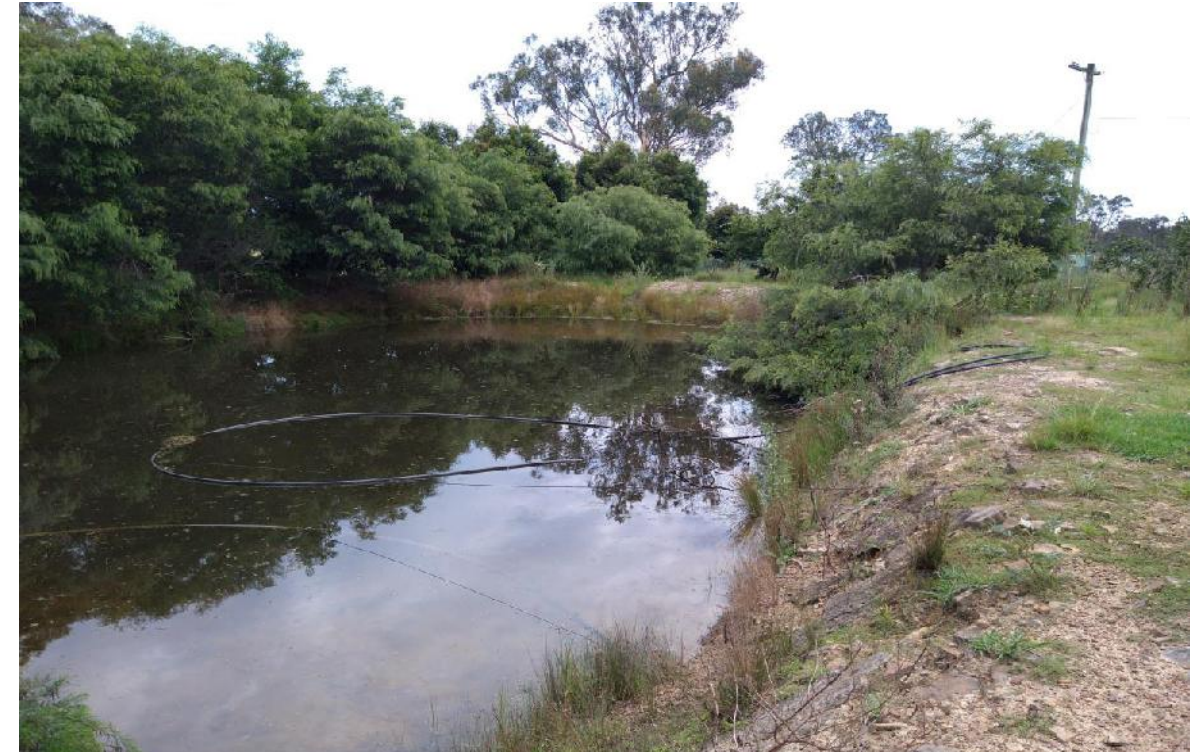
Photo 30: View looking north across FD3.
