Report on  
Geotechnical Assessment  
Longwalls S1A to S6A, Bargo

Prepared for  
Tahmoor Coal Pty Ltd

Project 210597.00  
June 2024

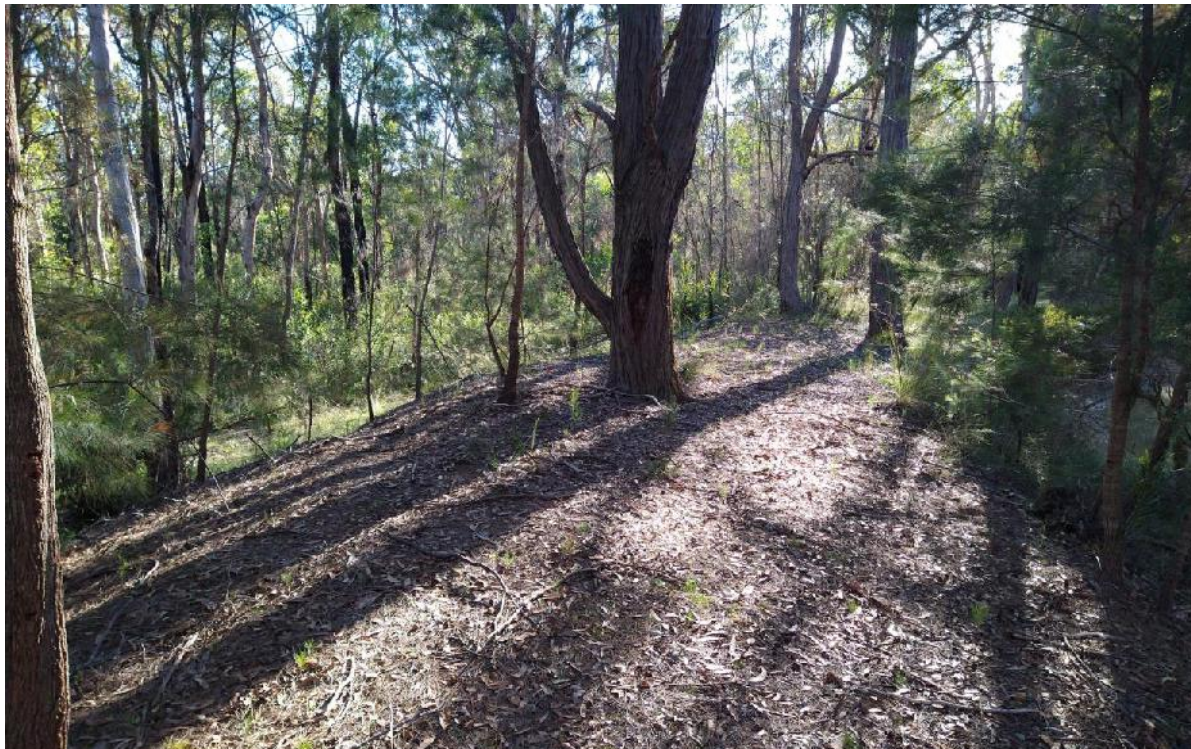
Photo 31: View looking south along the crest of FD5.

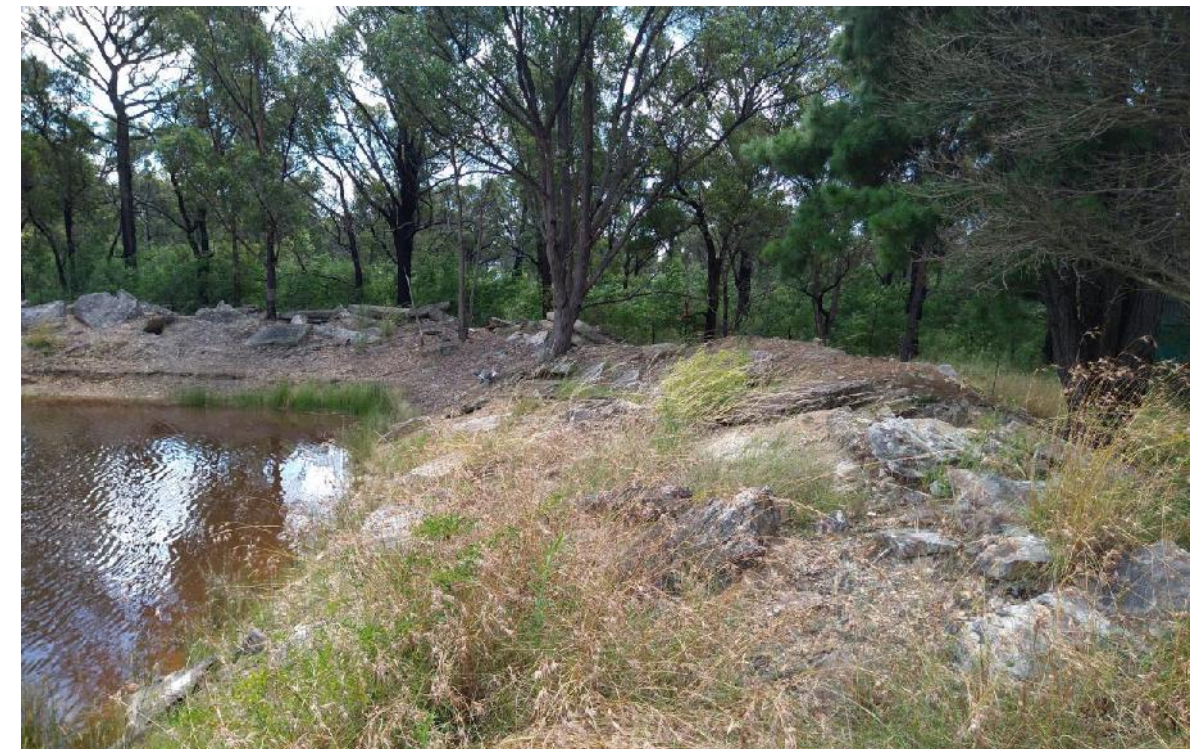
Photo 32: View looking north along the crest and upstream embankment face for FD8. Note: the large sandstone boulders placed over the crest.

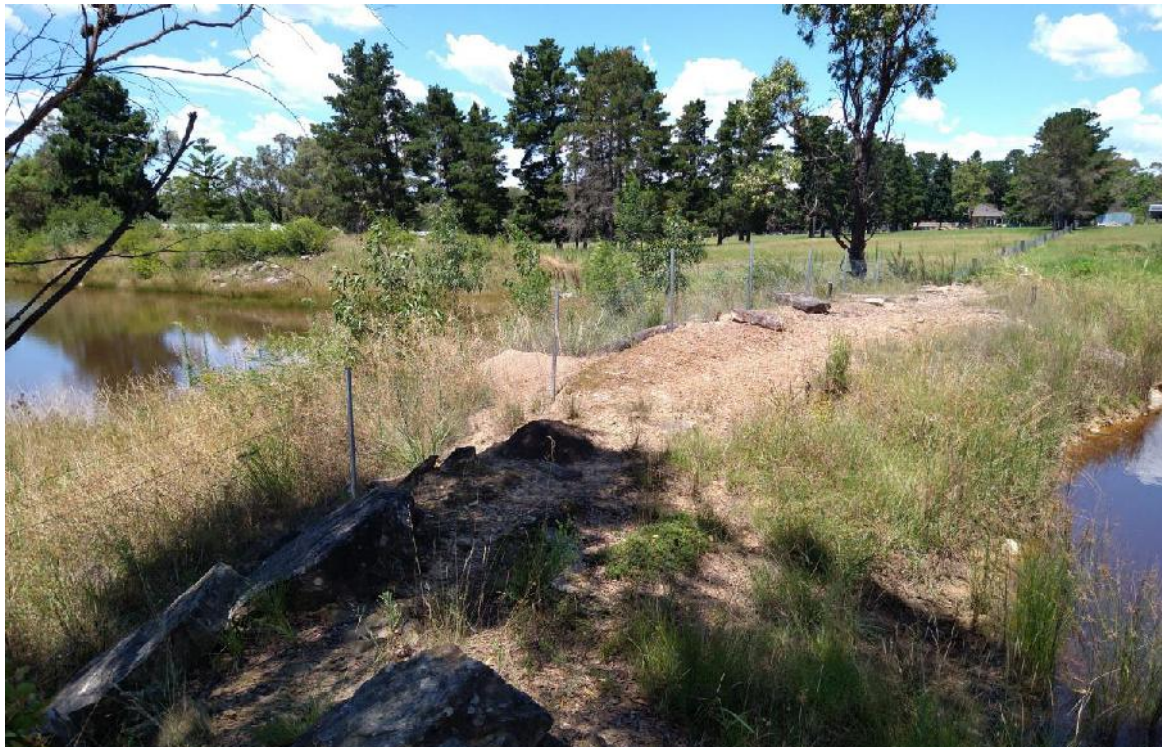
Photo 33: View looking south along the crest for FD9. Note: the sandstone cobbles and boulders placed embedded in the crest.

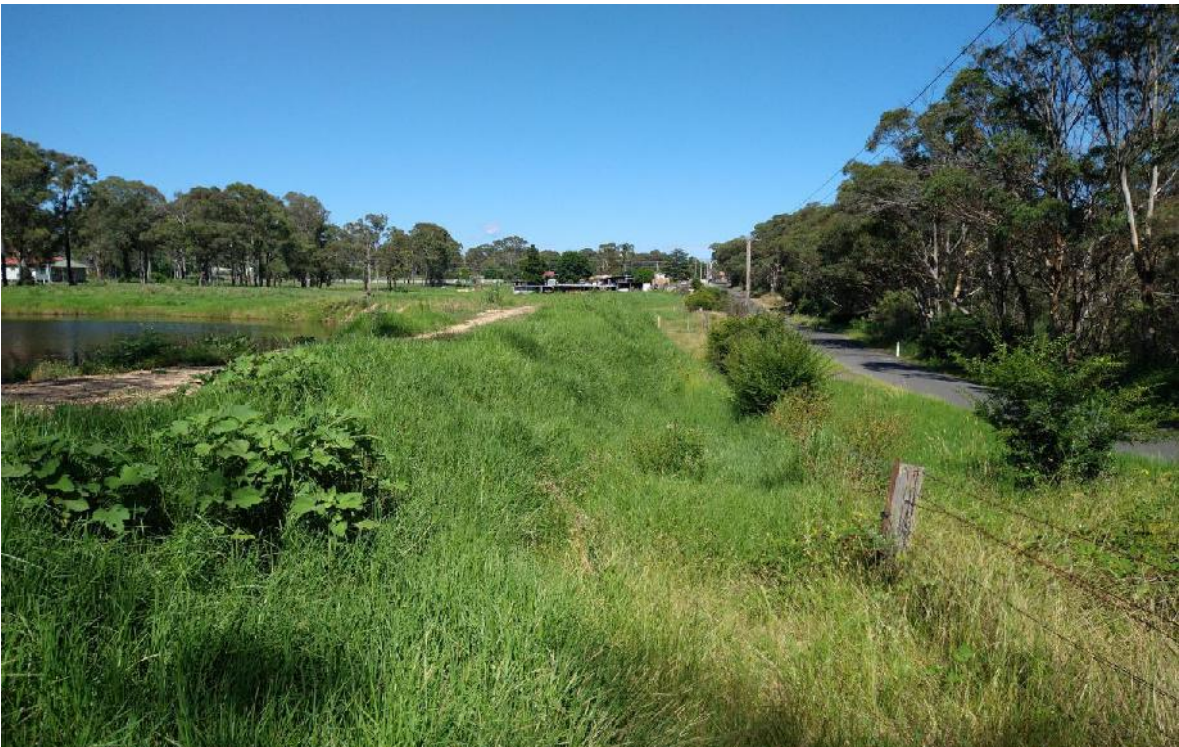
Photo 34: View looking west across the downstream embankment of FD15.

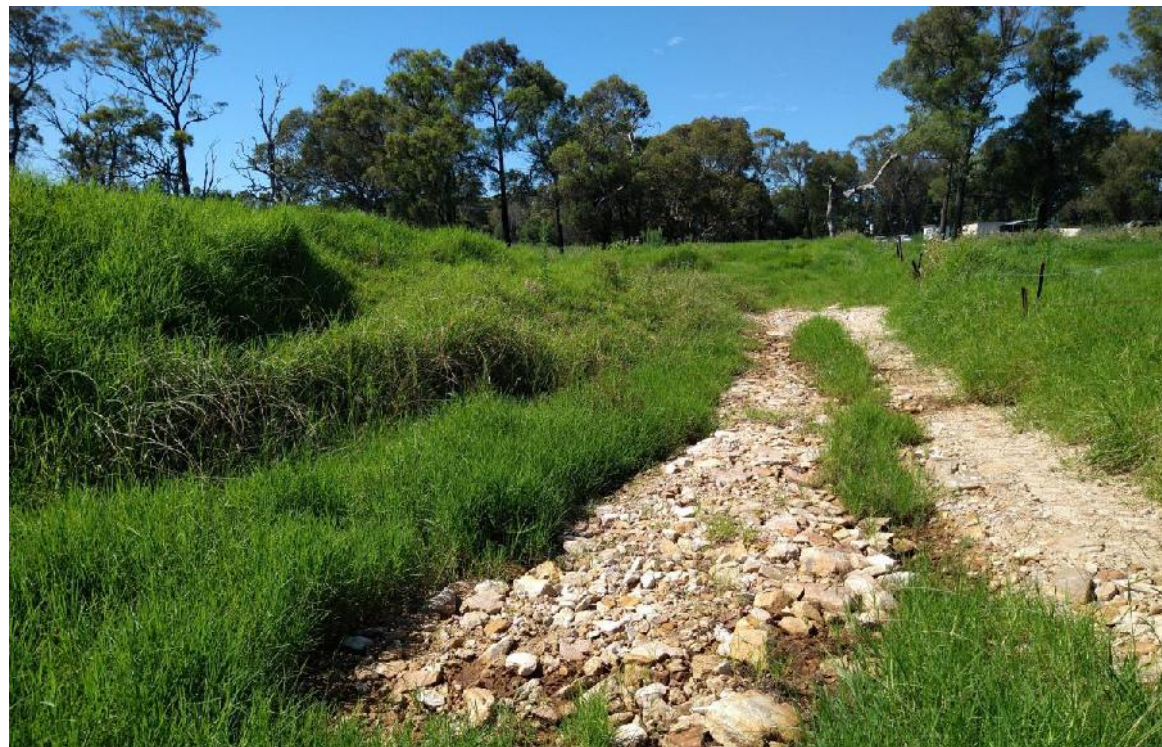
Photo 35: View looking along the spillway for FD15. Note: the embankment along the western side of the pond in the left of the photo.

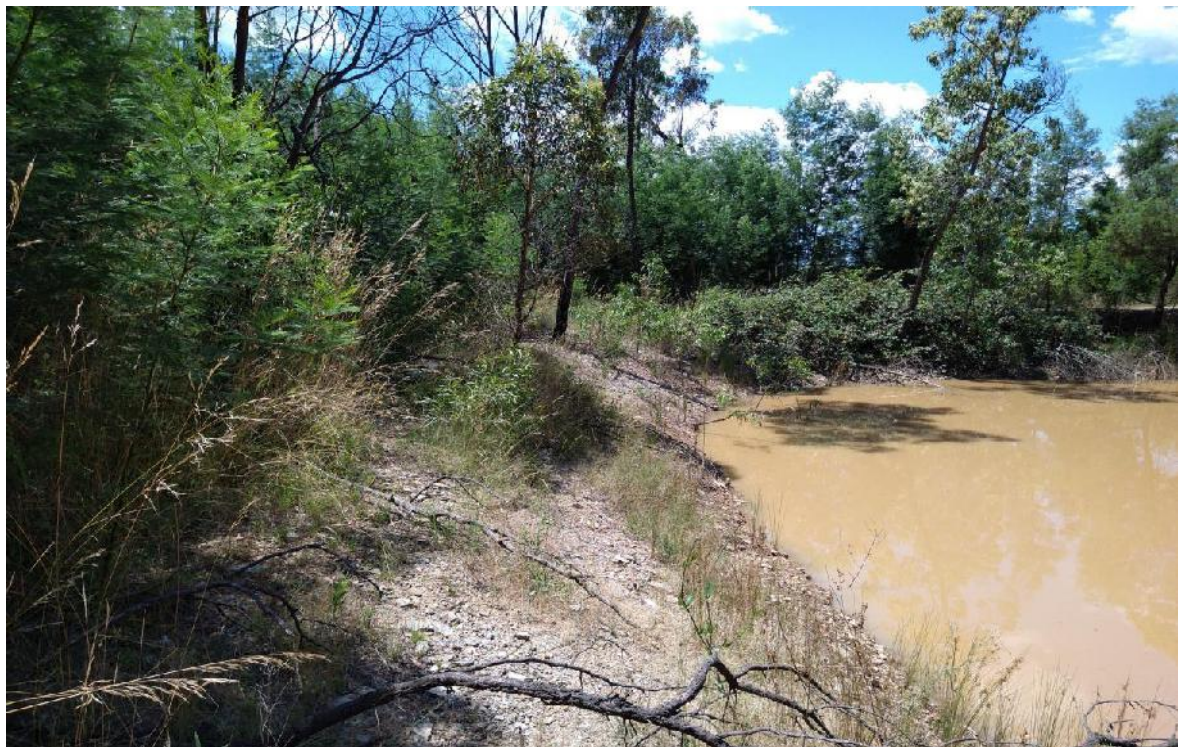
Photo 36: View looking east across the upstream embankment face of FD22.

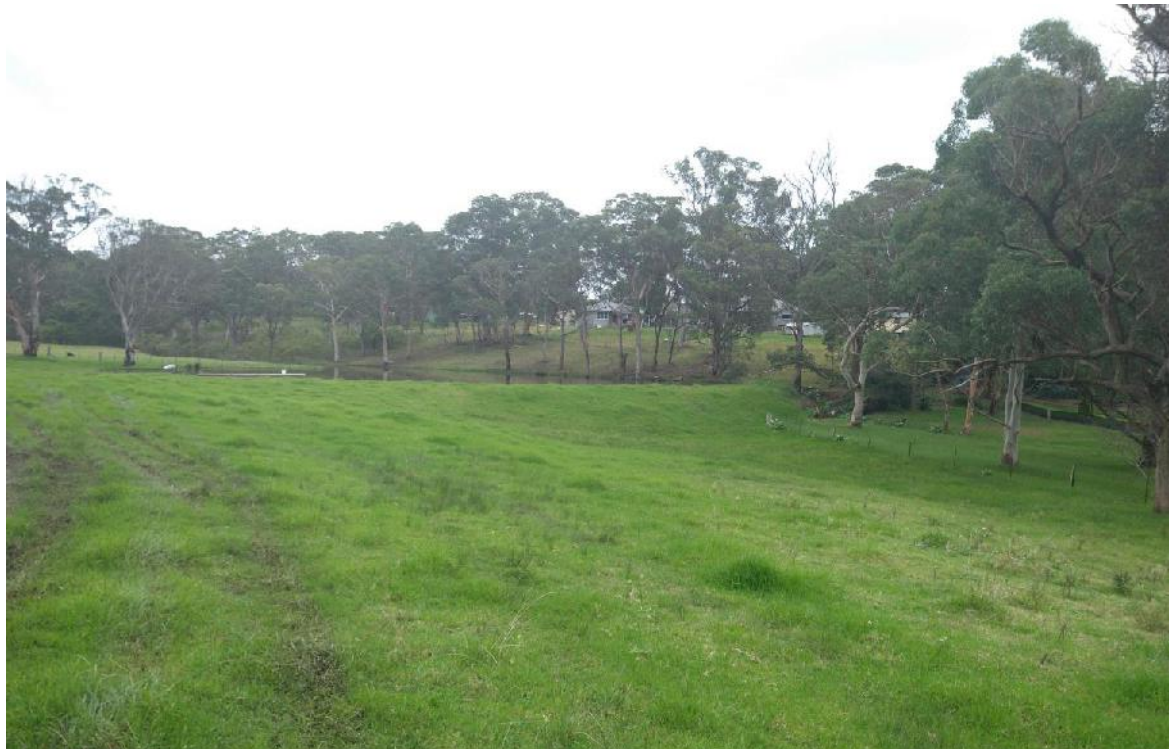
Photo 37: View looking north west towards the embankment for FD27.

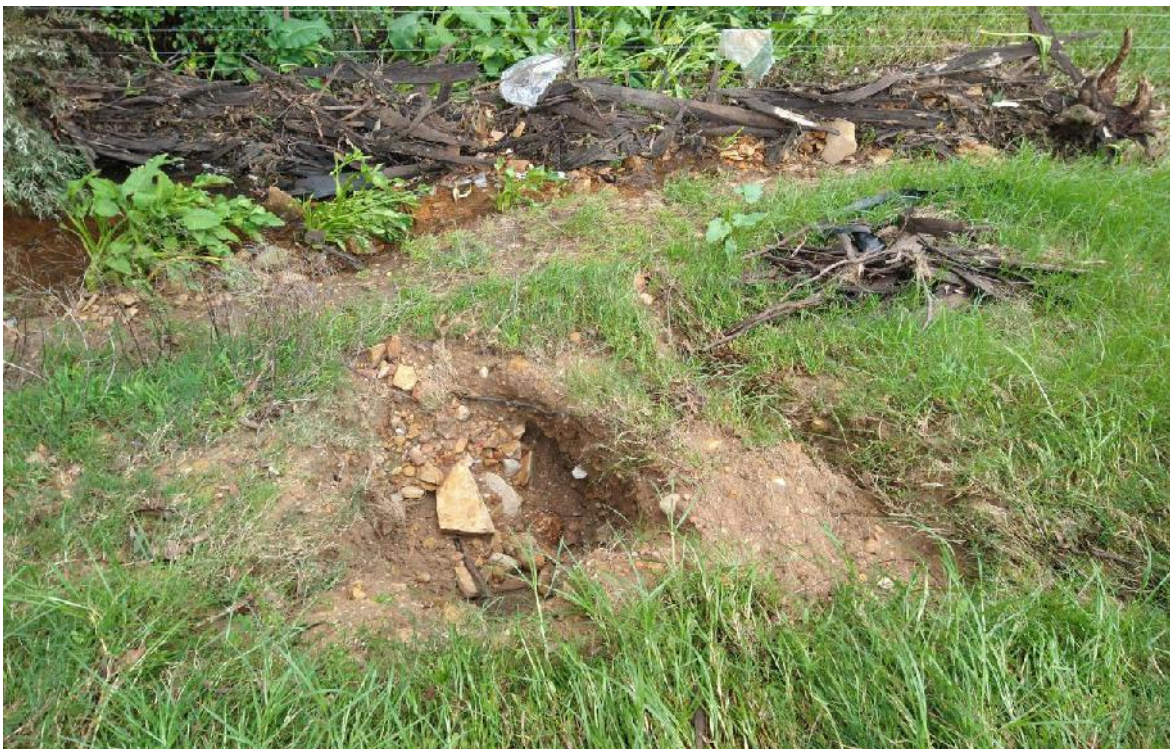
Photo 38: View looking at erosion and scour in the downstream face of FD27. Note the spillway channel at the toe of the embankment in the upper photo.

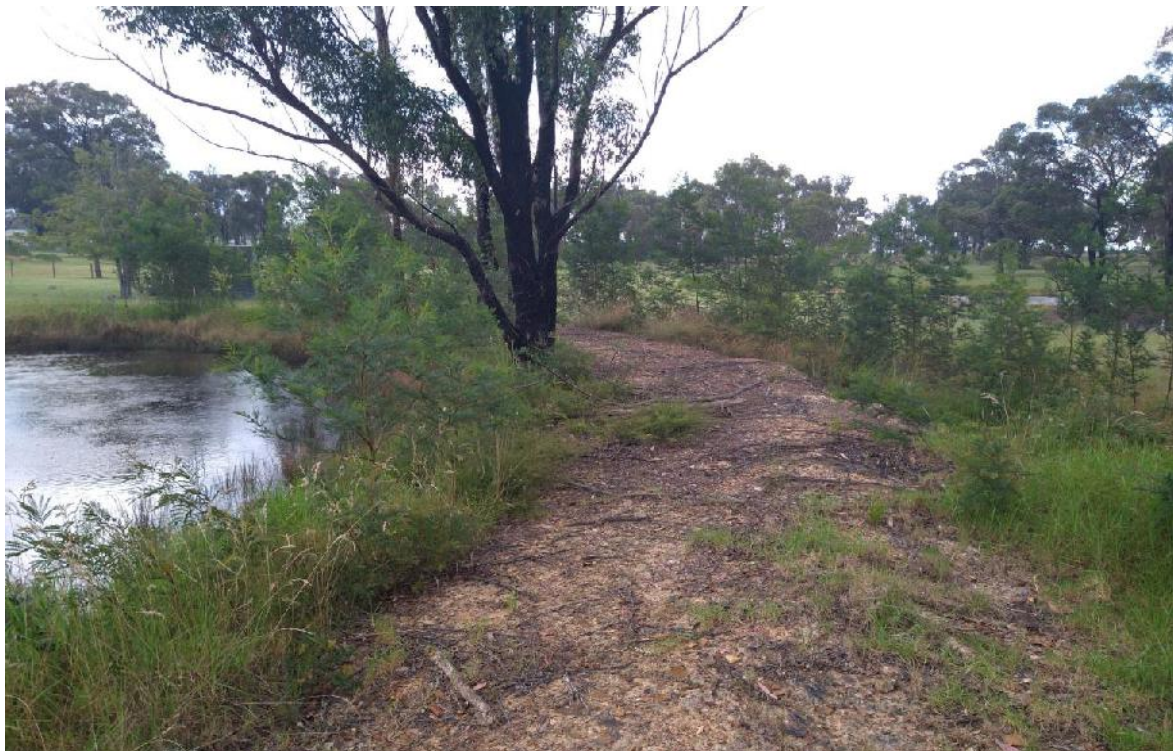
Photo 39: View looking north along the crest of FD31.

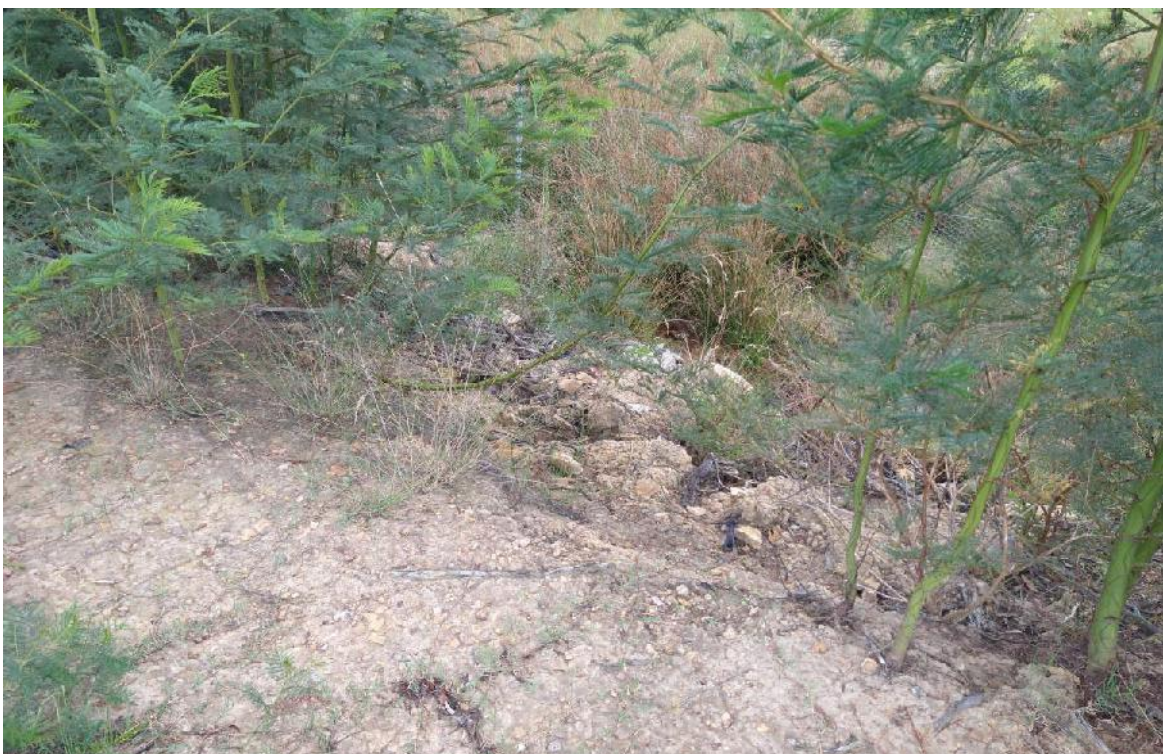
Photo 40: View looking at erosion in the downstream embankment face of FD31. Note: the saplings growing in the downstream face.

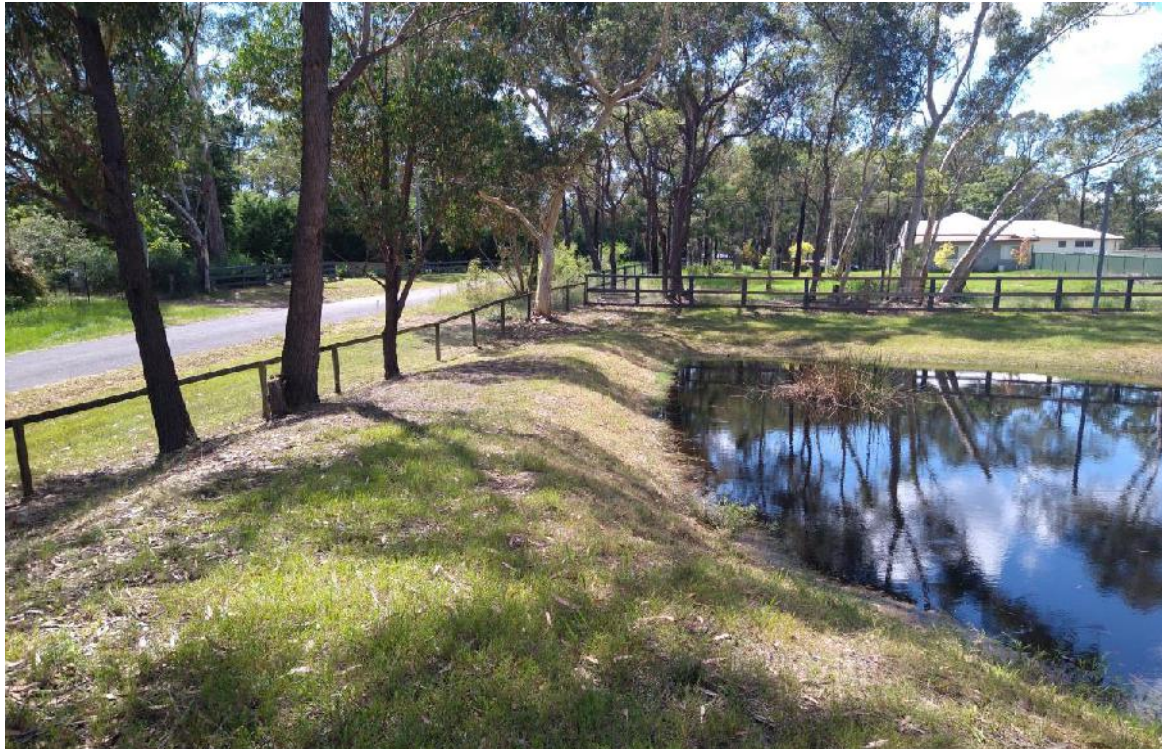
Photo 39: View looking east across the crest of FD39.

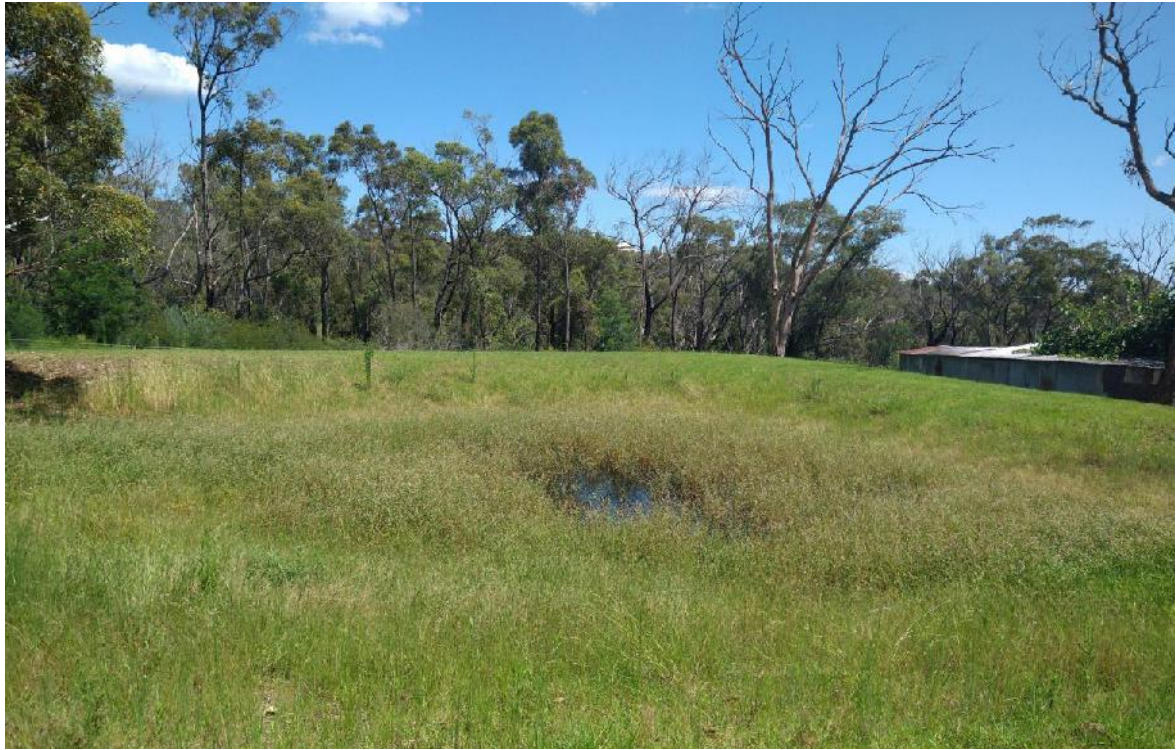
Photo 42: View looking northwest across FD40.

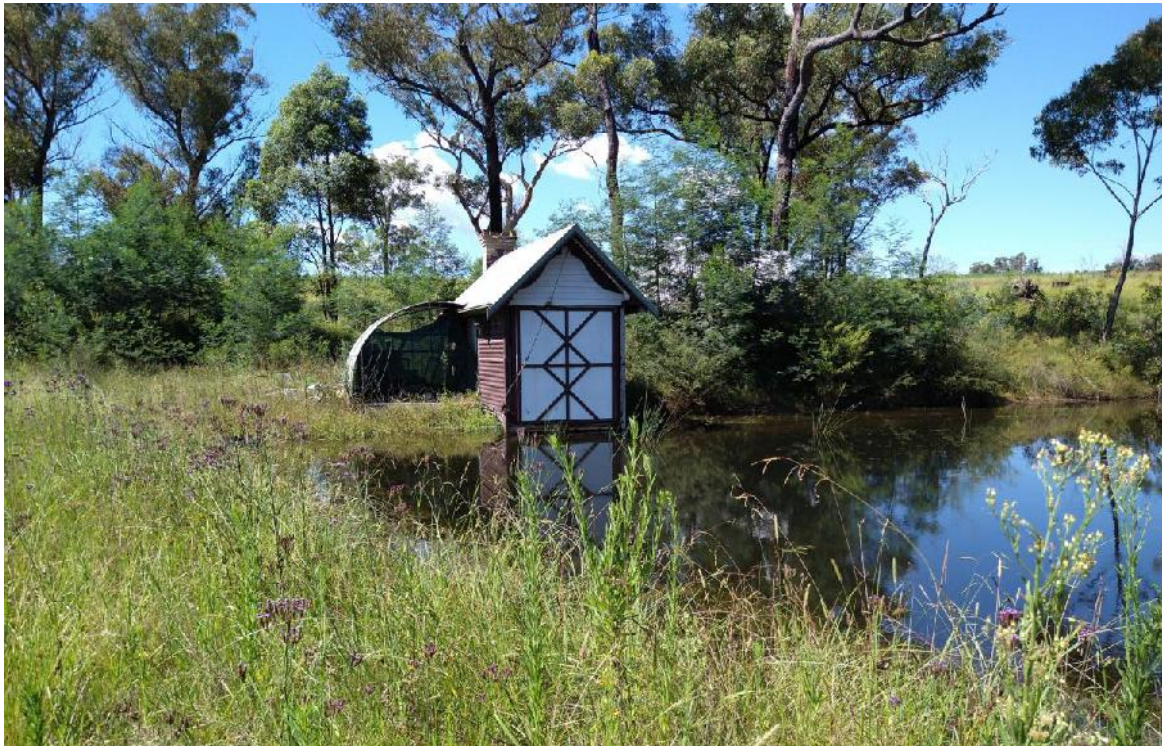
Photo 43: View looking south east across FD41. Note: the crest in the left of the photo.

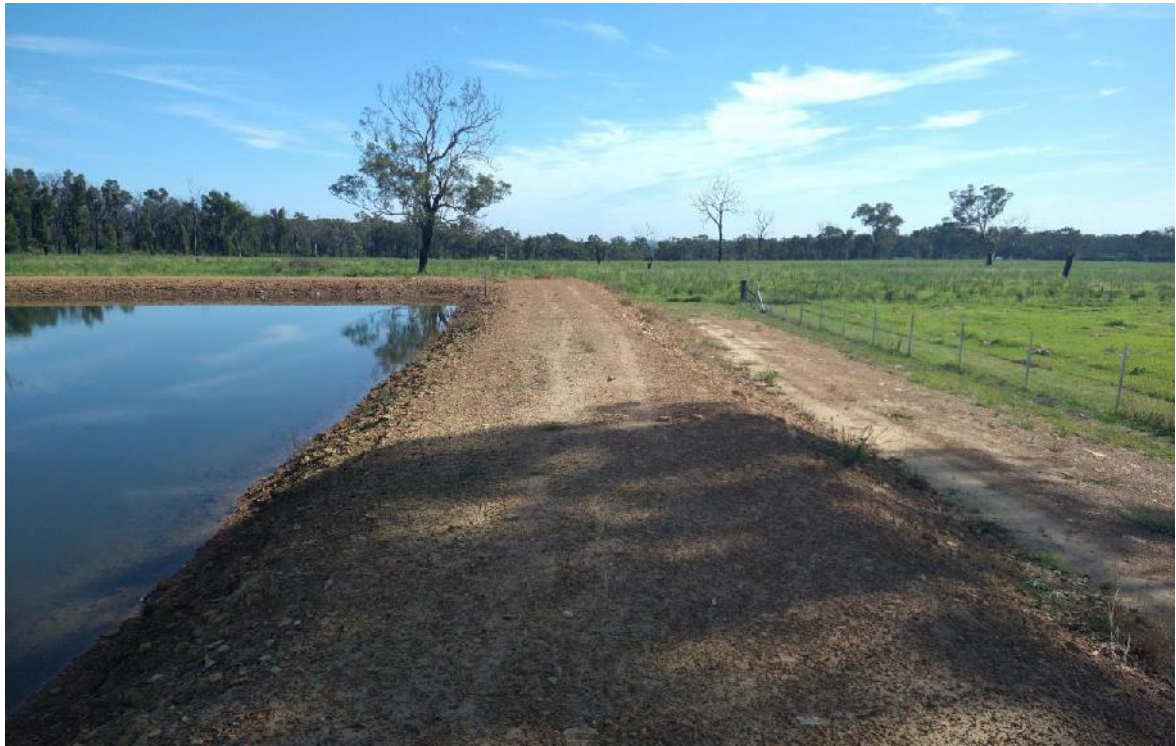
Photo 44: View looking along the eastern wall of FD45.
