Tahmoor Coal Pty Ltd SIX MONTHLY SUBSIDENCE IMPACT REPORT

Tahmoor South Domain Longwalls South 1A – South 6A

1 January 2024 - 30 June 2024

Report 4 – October 2024

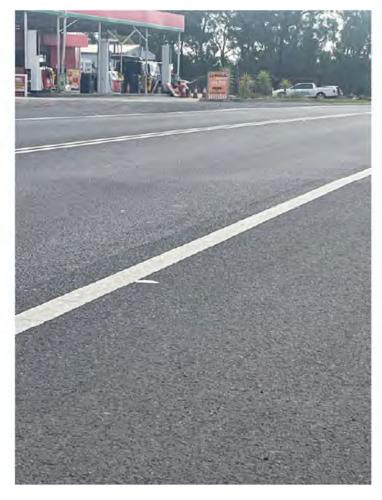
Figure 3-21 Small bump observed in southbound land of Remembrance Drive near Peg R46 on 31 May 2023 (Source: MSEC1368 Report 37, Appendix A)

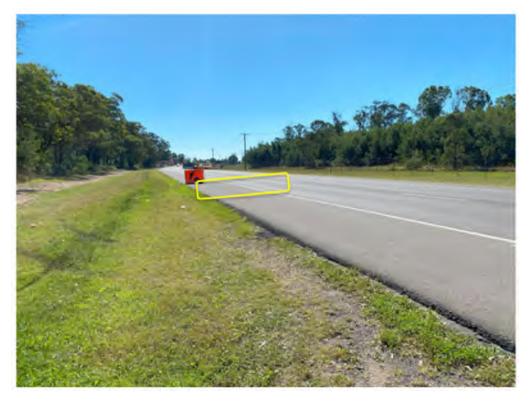
Figure 3-22 Very minor bump observed in northbound land of Remembrance Drive near Peg R61 on 22 April 2024 (Source: MSEC1368 Report 37, Appendix A)

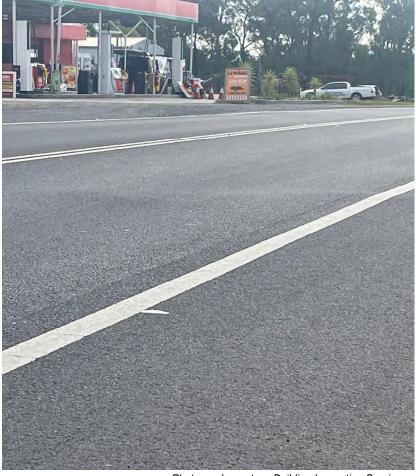
Figure E Small bump observed in southbound lane of Remembrance Drive near Peg R46 on 31 May 2023

In light of the survey results and observations of minor impacts on the pavement, Tahmoor Coal notified potentially affected stakeholders. The gas main pipeline was decoupled from the ground on 11 March. Tahmoor Coal remains on standby with respect to repairing the road pavement and reducing stresses on the direct buried Telstra cable, if required.

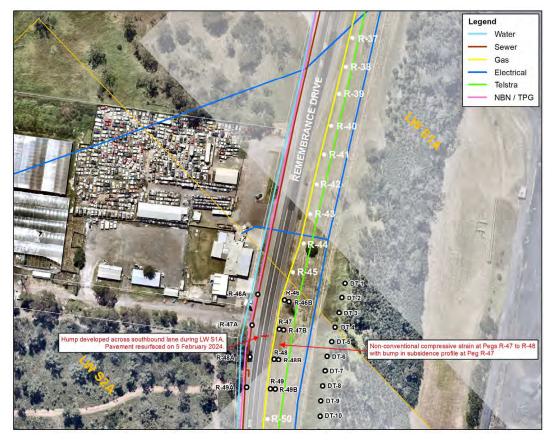
Figure F Location of small bump observed in southbound lane of Remembrance Drive near Peg R46 on 2 June 2023

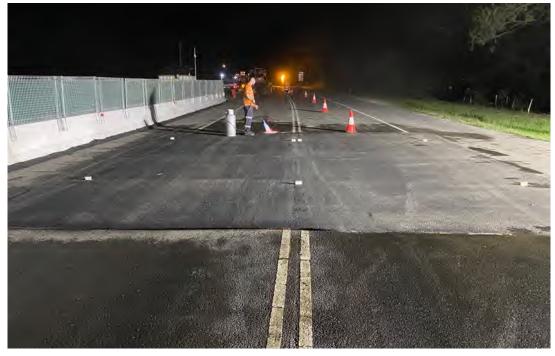
Figure G Resurfacing of bump near Peg R47 on 5 February 2024

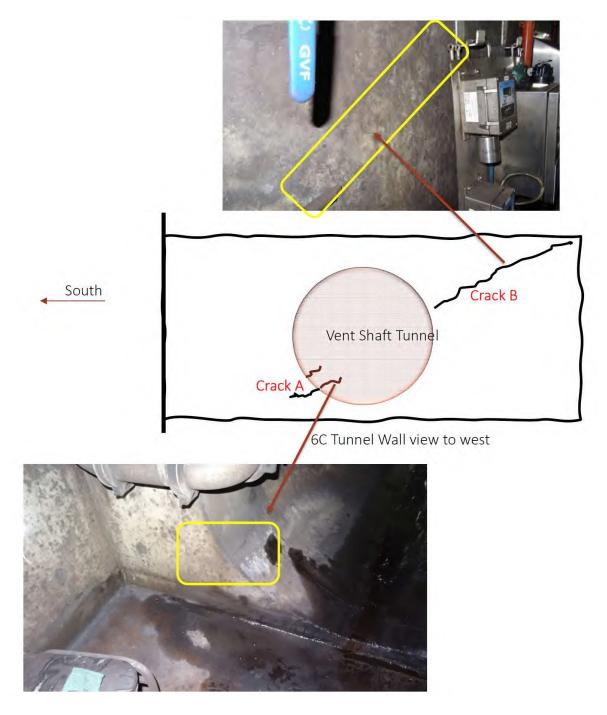
Plate 4.1 Location of cracks A(C1) and B (C2) within Tunnel 6C (David Talbert 29 May 2023).

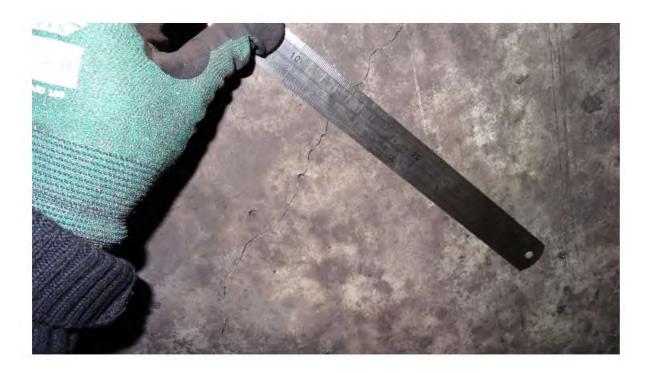
Plate 4.2 Crack B (C2), width <1 mm (David Talbert 29 May 2023).

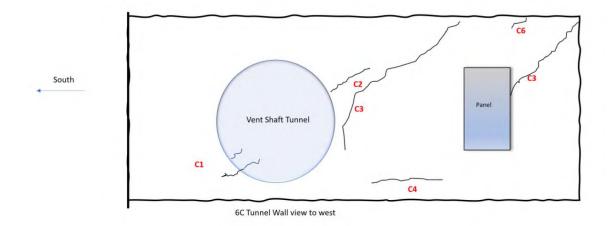
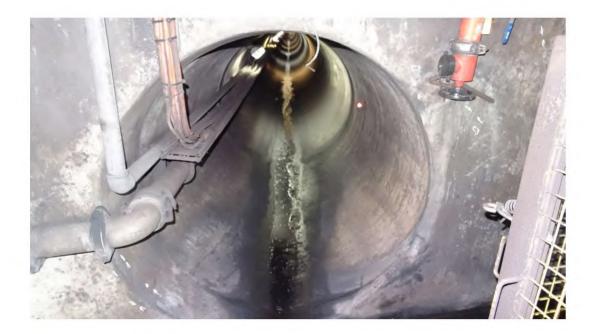
Plate 4.3 Context for the location of cracks C1, C2 and C3 (David Talbert, 6 June 2023).

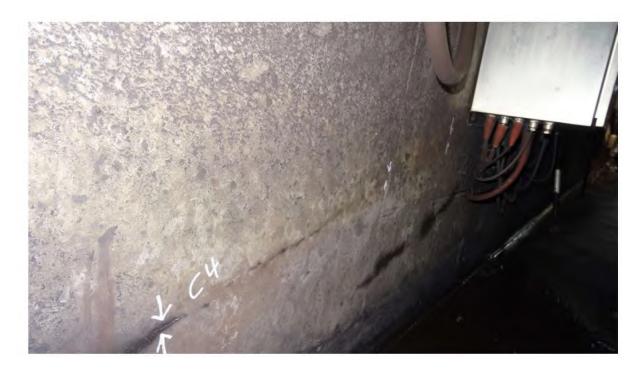
Plate 4.4 Crack C4 (David Talbert, 6 June 2023).

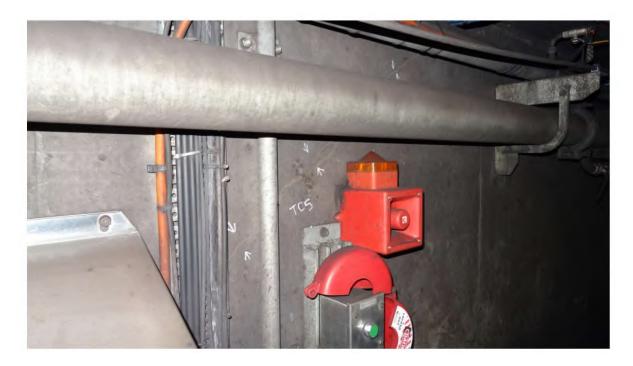
Plate 4.5 Crack C5 (David Talbert, 6 June 2023).

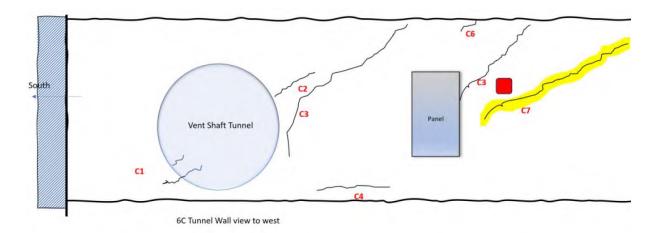
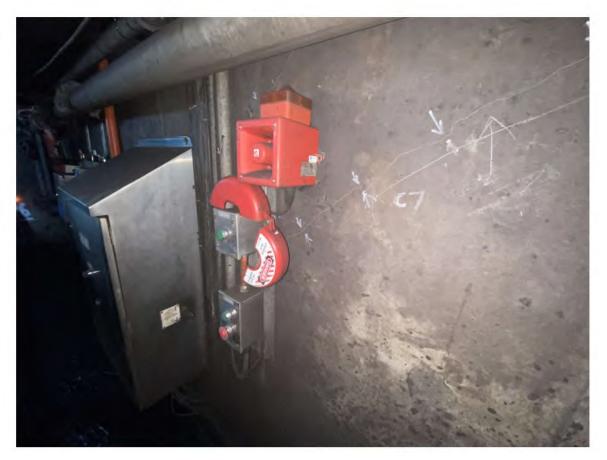
Plate 4.6 Location of C7 (David Talbert, 27 June 2023)
