# 2024 Annual Rehabilitation Walkover

Refuse Emplacement Area

| Project Name | Tahmoor Coal Pty Ltd Rehabilitation Monitoring 2024 |

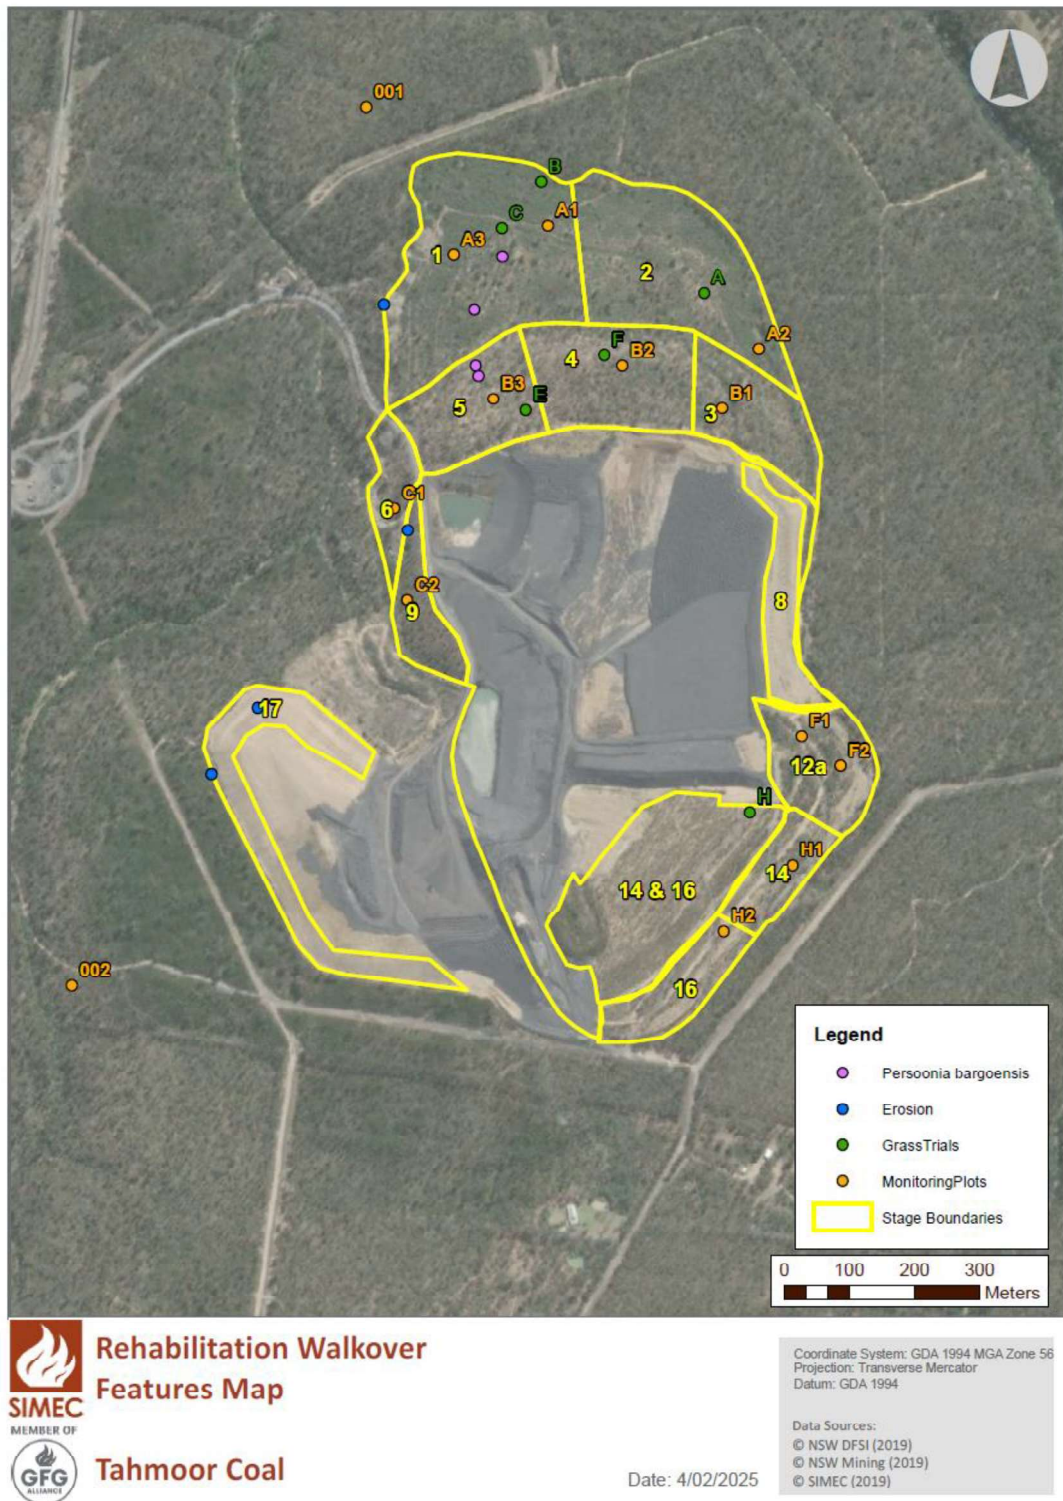
Figure 2 Rehabilitation Walkover Features Identified

Erosion control structures, which were implemented in 2019, remain in good condition and no major erosion was recorded along the slopes of the REA. An area in Stage 1, where seepage affected vegetation growth, was rehabilitated with the ripping of the soil surface and mulching in 2018. This area continues to be in a good condition with no seepage evident in 2024. Nearby the seepage area, minor erosion has been recorded, this is shown on the boundary of Stage 1 in **Figure 2** below. Erosion has also been identified in Stage 9 on an access road from the Haul Road and in two (2) areas in Stage 17 (see **Figure 2**).

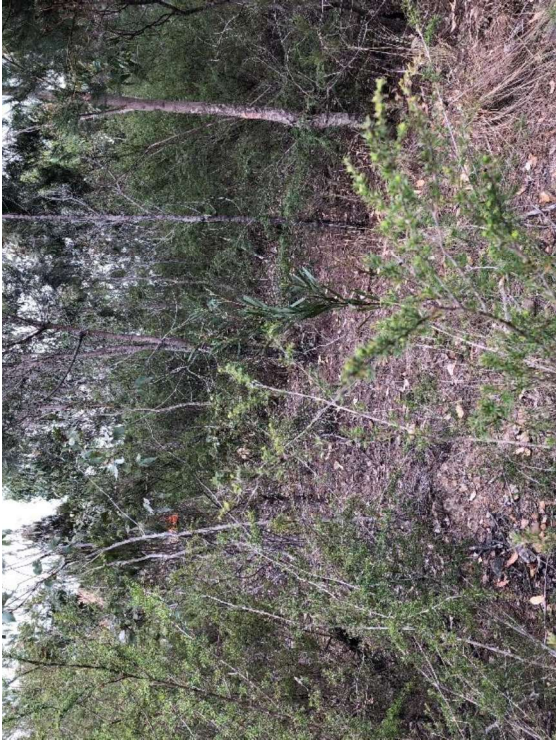
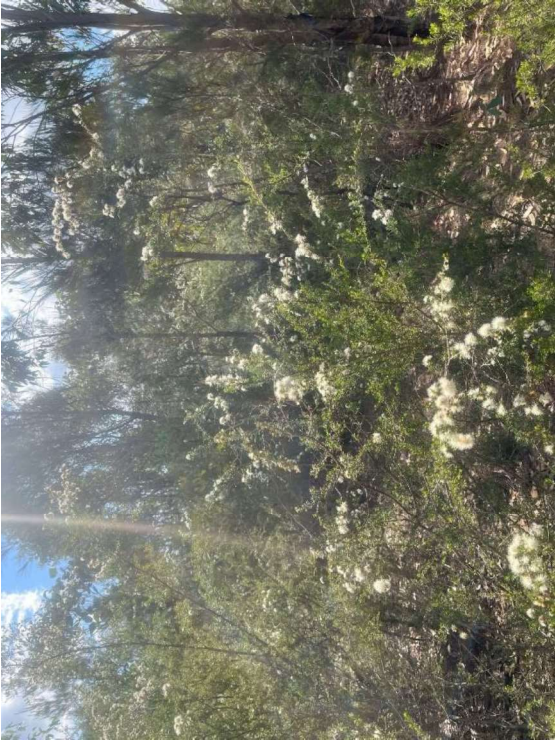
Figure 13: Stage 12A plot F1 in 2023 and 2024

| REA Permanent Monitoring Site Field Sheet 2024 | | Stage: Stage 12a | | |
|---|---|---|---|---|
| <b>Comments:</b> Midstorey is dense. Canopy has increased. Exotic cover has also increased. Four trees tagged in 2024. <i>Pseudonaja textilis</i> (Eastern brown snake) observed in plot. | | | | |

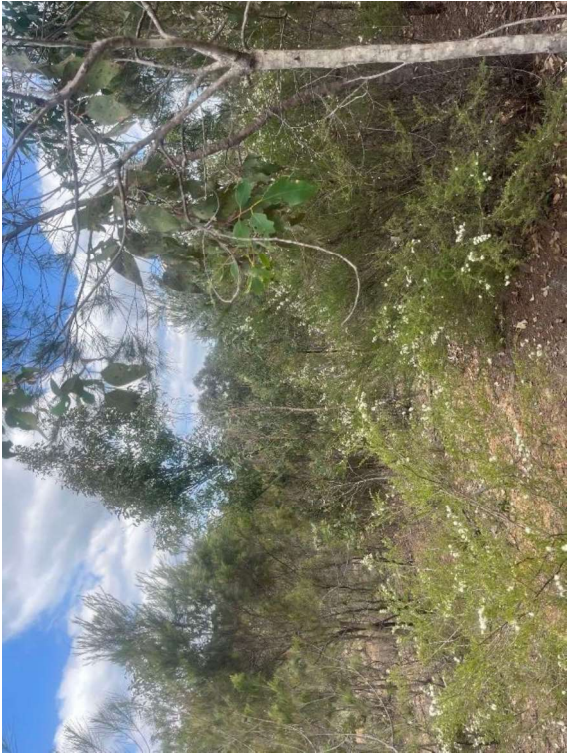
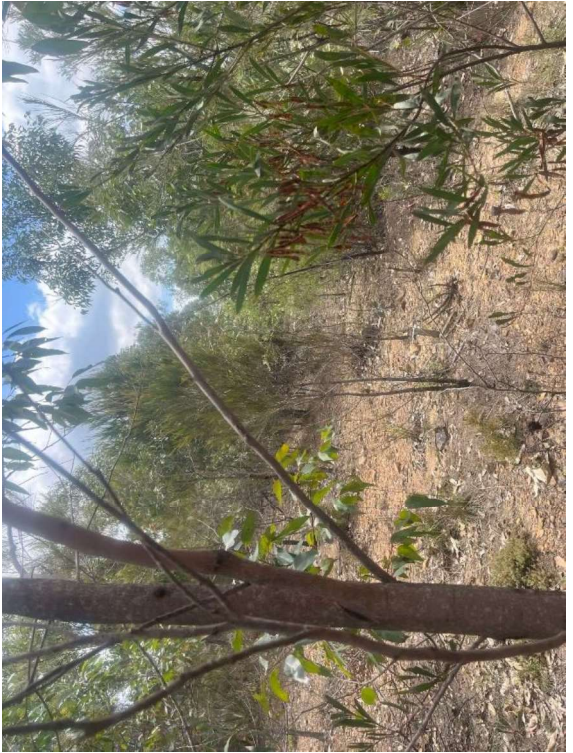
Figure 14: Stage 12A plot F2 in 2023 and 2024

| REA Permanent Monitoring Site Field Sheet 2024 | | Stage: Stage 12a | | |
|---|---|---|---|---|
| <b>Comments:</b> Several missing tree tags and incorrectly tagged trees. <i>Eucalyptus punctata</i> in very good health. Eleven trees tagged in 2024. | | | | |

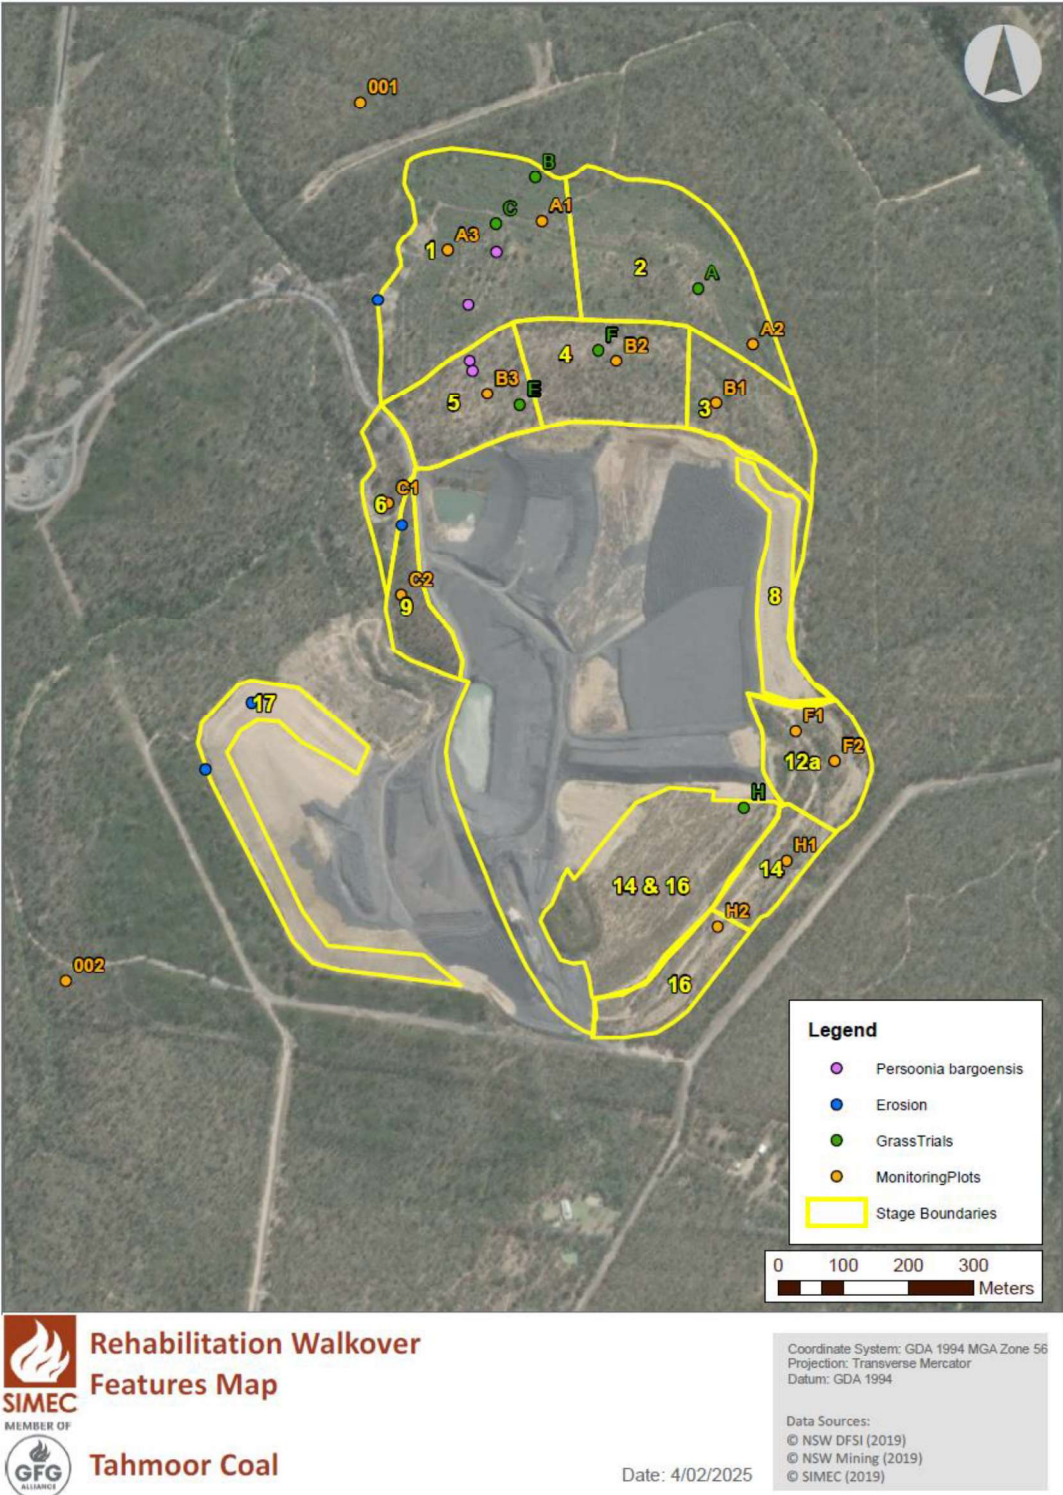
Figure 2 Rehabilitation Walkover Features Identified

There was little change observed in erosion points throughout the REA with drainage lines in good condition. It is recommended that areas previously identified with minor erosion are monitored throughout the year. Some remediation had been undertaken during 2024 on erosion points in Stages 12a and developing Stage 8 with the addition of coir logs.

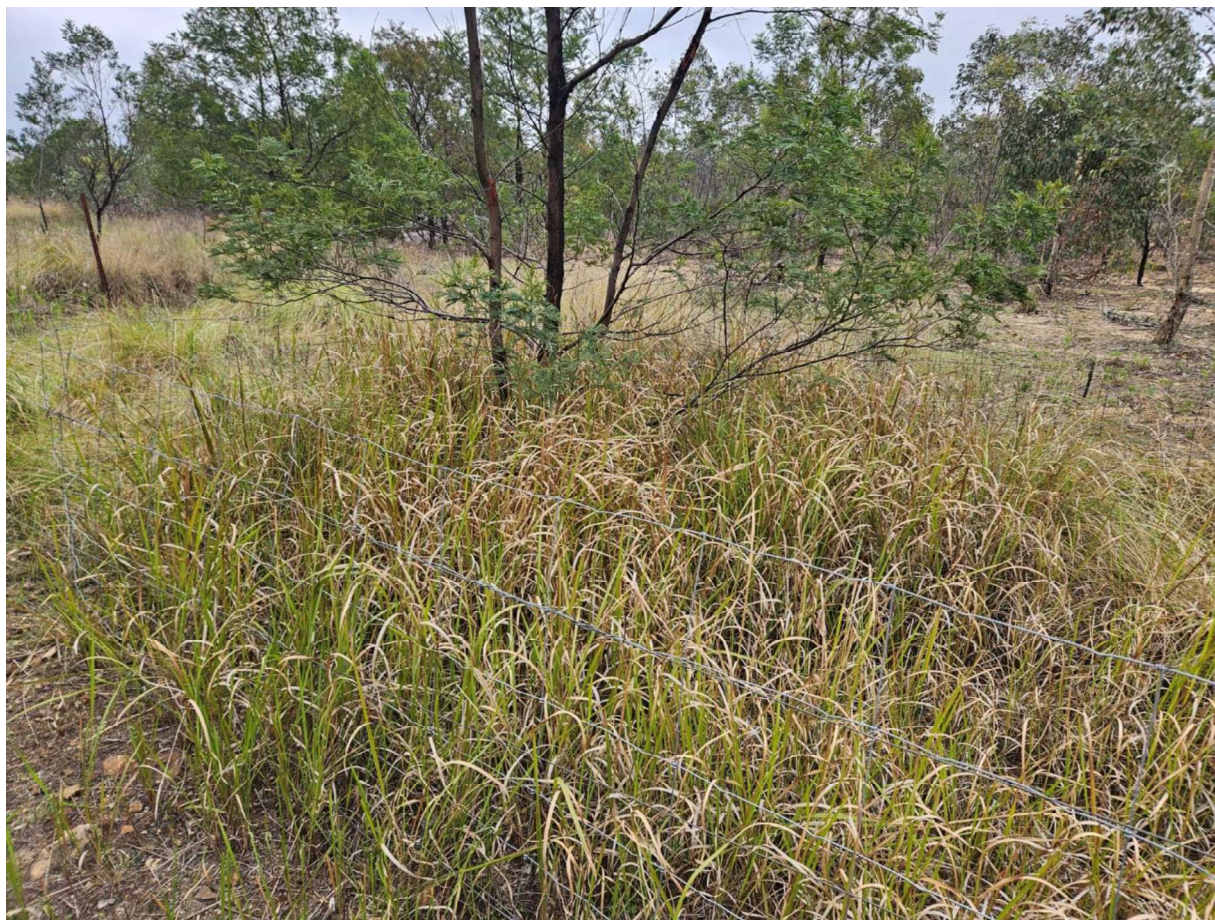
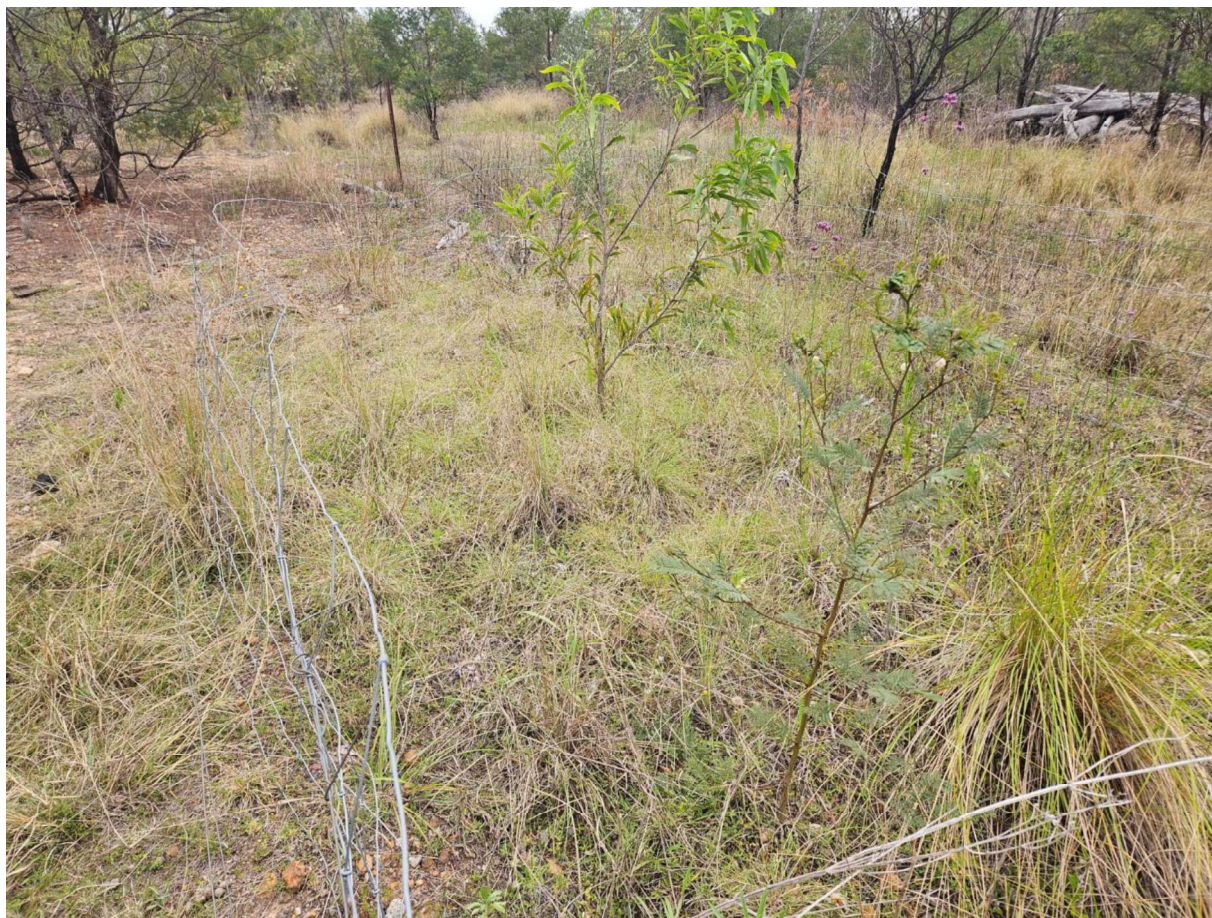
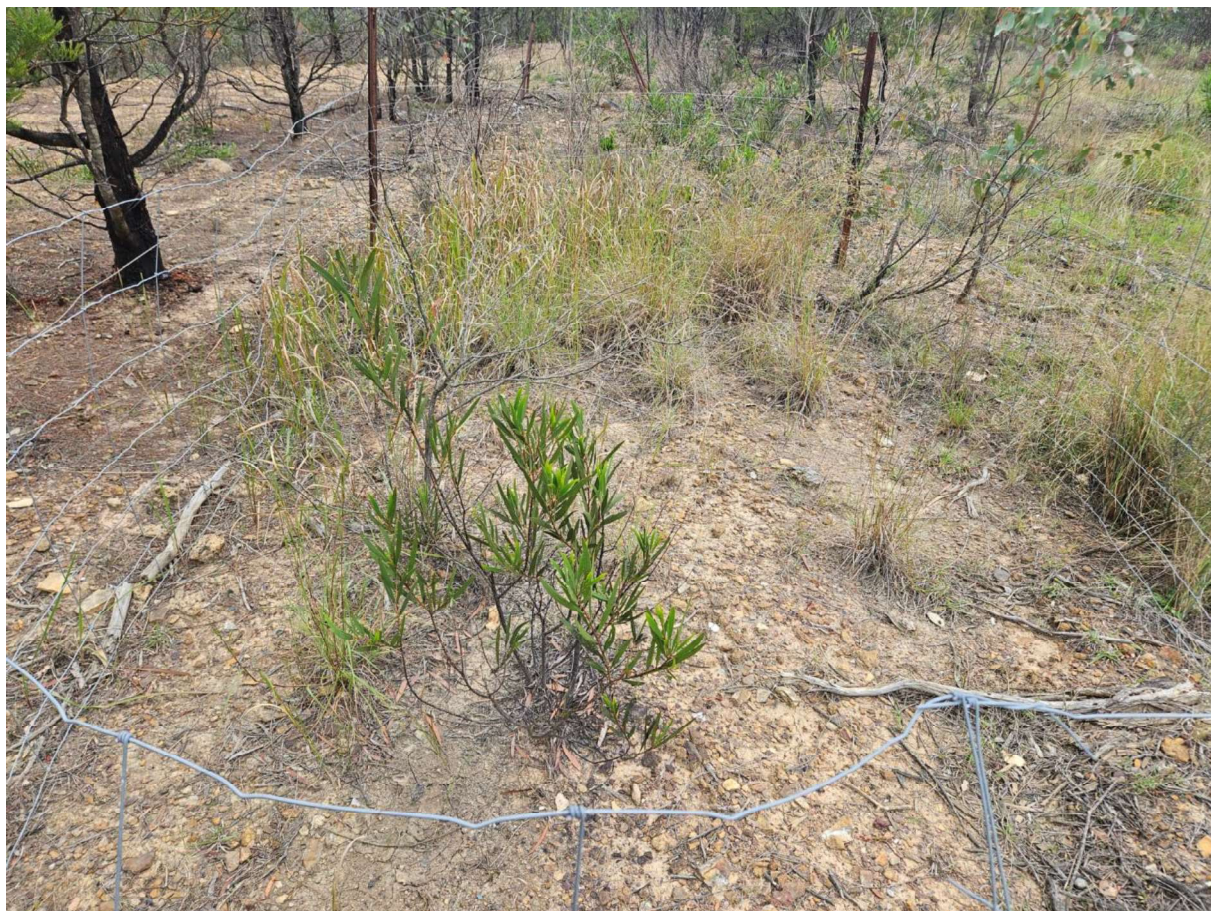
During 2024, weed coverage has decreased in Trial H and still remains the highest in grass cover when compared with all the other Trials. Trial E and F had the least grass coverage however good diversity in emerging seedling species. Trials A, B and C had good grass coverage with less species diversity. Low weed presence was noted for all trails during 2024 inspections.
