Geotechnical Assessment - Longwall S7A

Tahmoor Coal

PSM5522-013R Rev 01 01 October 2025

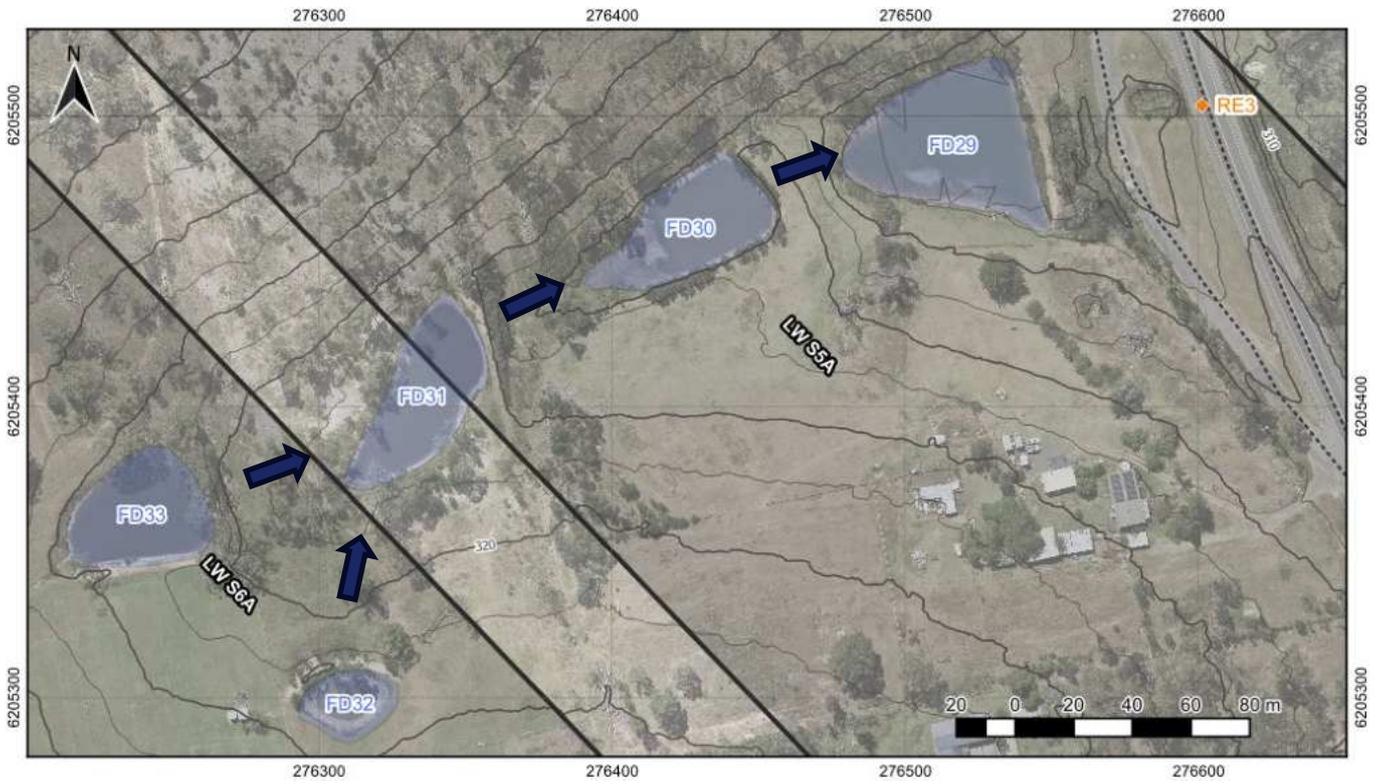
Inset 8: Potential risk for cascading failure between FD29 to FD33.

Most of the farm dams have been placed along valleys and are thus susceptible to cascading failure, as shown in the following insets. It should also be noted that FD42 and FD28 are directly upstream of FD41 and FD27 respectively. FD28 is a very small dam and is likely to have limited if any impact on the stability of FD27, however FD42 is likely to be larger than FD41 and has a higher change of leading to its failure in case of dam break.

The DP (2024b) does not appear to consider the implications of cascading failure for dams FD32-FD33, FD44-FD45 and FD42. Consequently, we propose have the Consequence Category of dams located upstream of other dams to be matched to the Consequence Category of lower dams were necessary to reflect the consequences of a cascading failure. Based on the DP (2024b) dam break assessment for a sunny day failure all dams would be subject to a “Very Low” consequence category including the effects of cascading failure.
