# **Tahmoor Colliery - Longwall 29**

End of Panel Subsidence Monitoring Report for Tahmoor Longwall 29

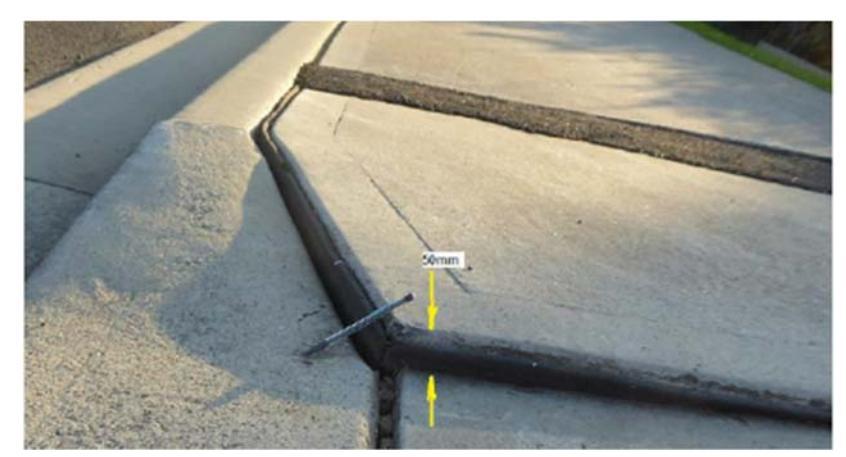
**Remembrance Drive**

Approximately 25.5 kilometres of asphaltic pavement lie directly above the extracted longwalls and a total of 49 impact sites have been observed. The observed rate of impact equates to an average of one impact for every 520 metres of pavement. The impacts were minor and did not present a public safety risk. A collection of photographs of impacts is provided in Fig. 4.1.

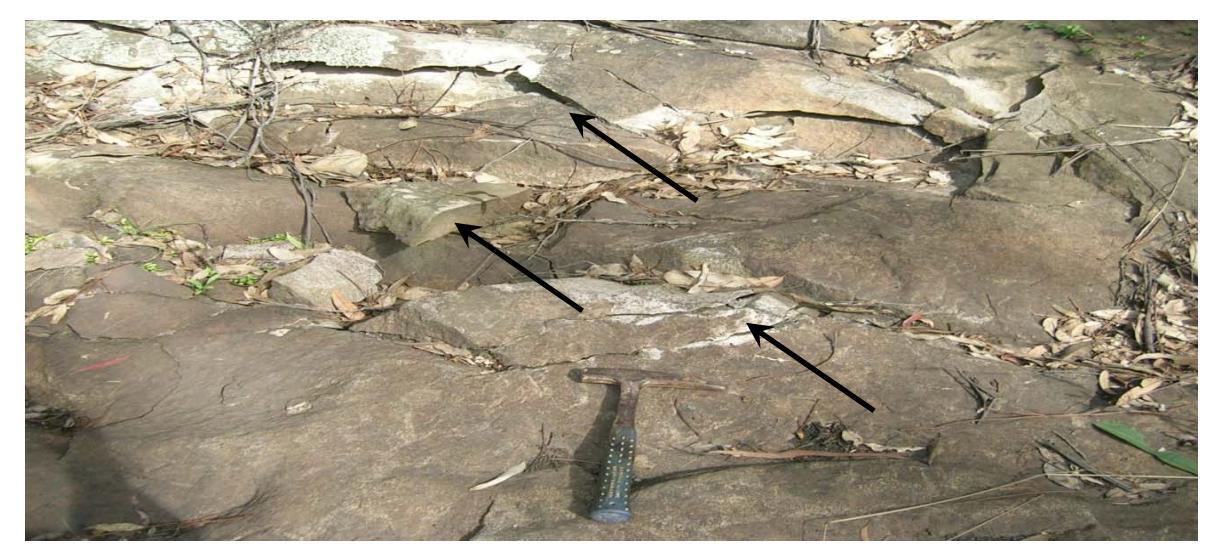
The bedrock crack in the creek bed over Panel 22 is within a small sandstone rock bar outcrop, with no observable adverse effect on stream flow, and therefore, no rehabilitation of the Panel 22 cracking was proposed.

Figure 1 Cracking over Longwall 22

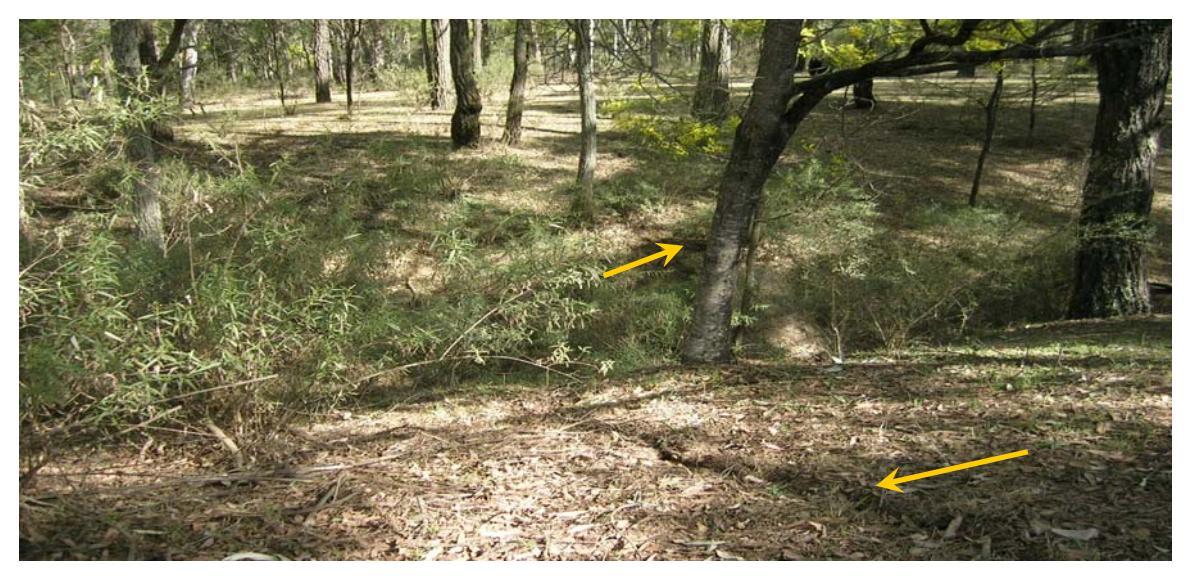
Even though soil cracking was noted in the creek over Longwall 23B, it did not instigate bed or bank instability and was not rehabilitated. No surface flow diversion, reduction in water quality or change to ponding or pool storage capacity was observed in the creek.

Figure 2 Cracking over Longwall 23B

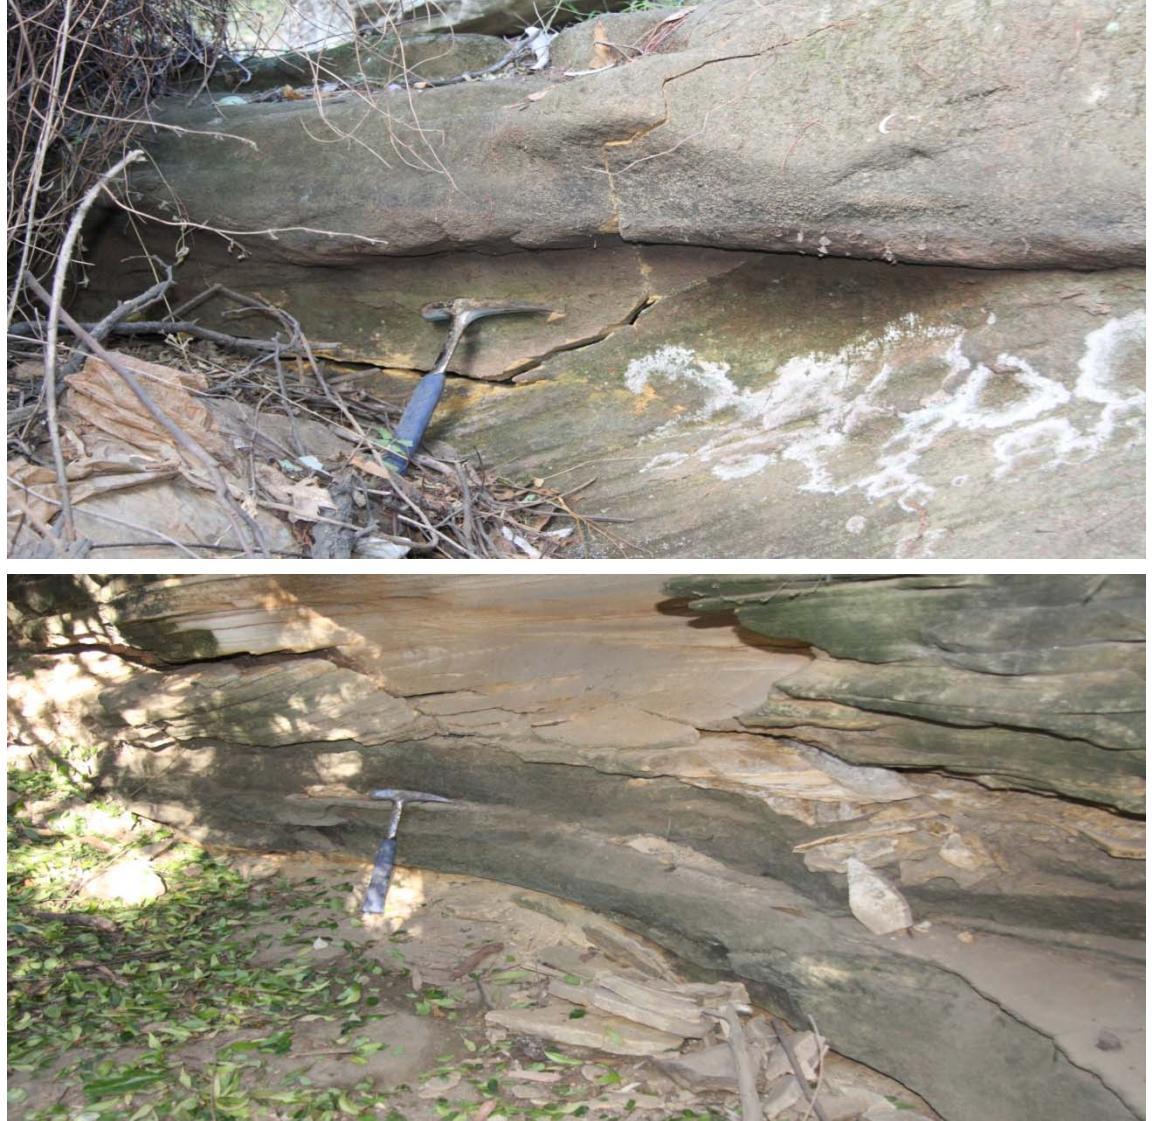
Figure 3 Cracking over Longwall 25

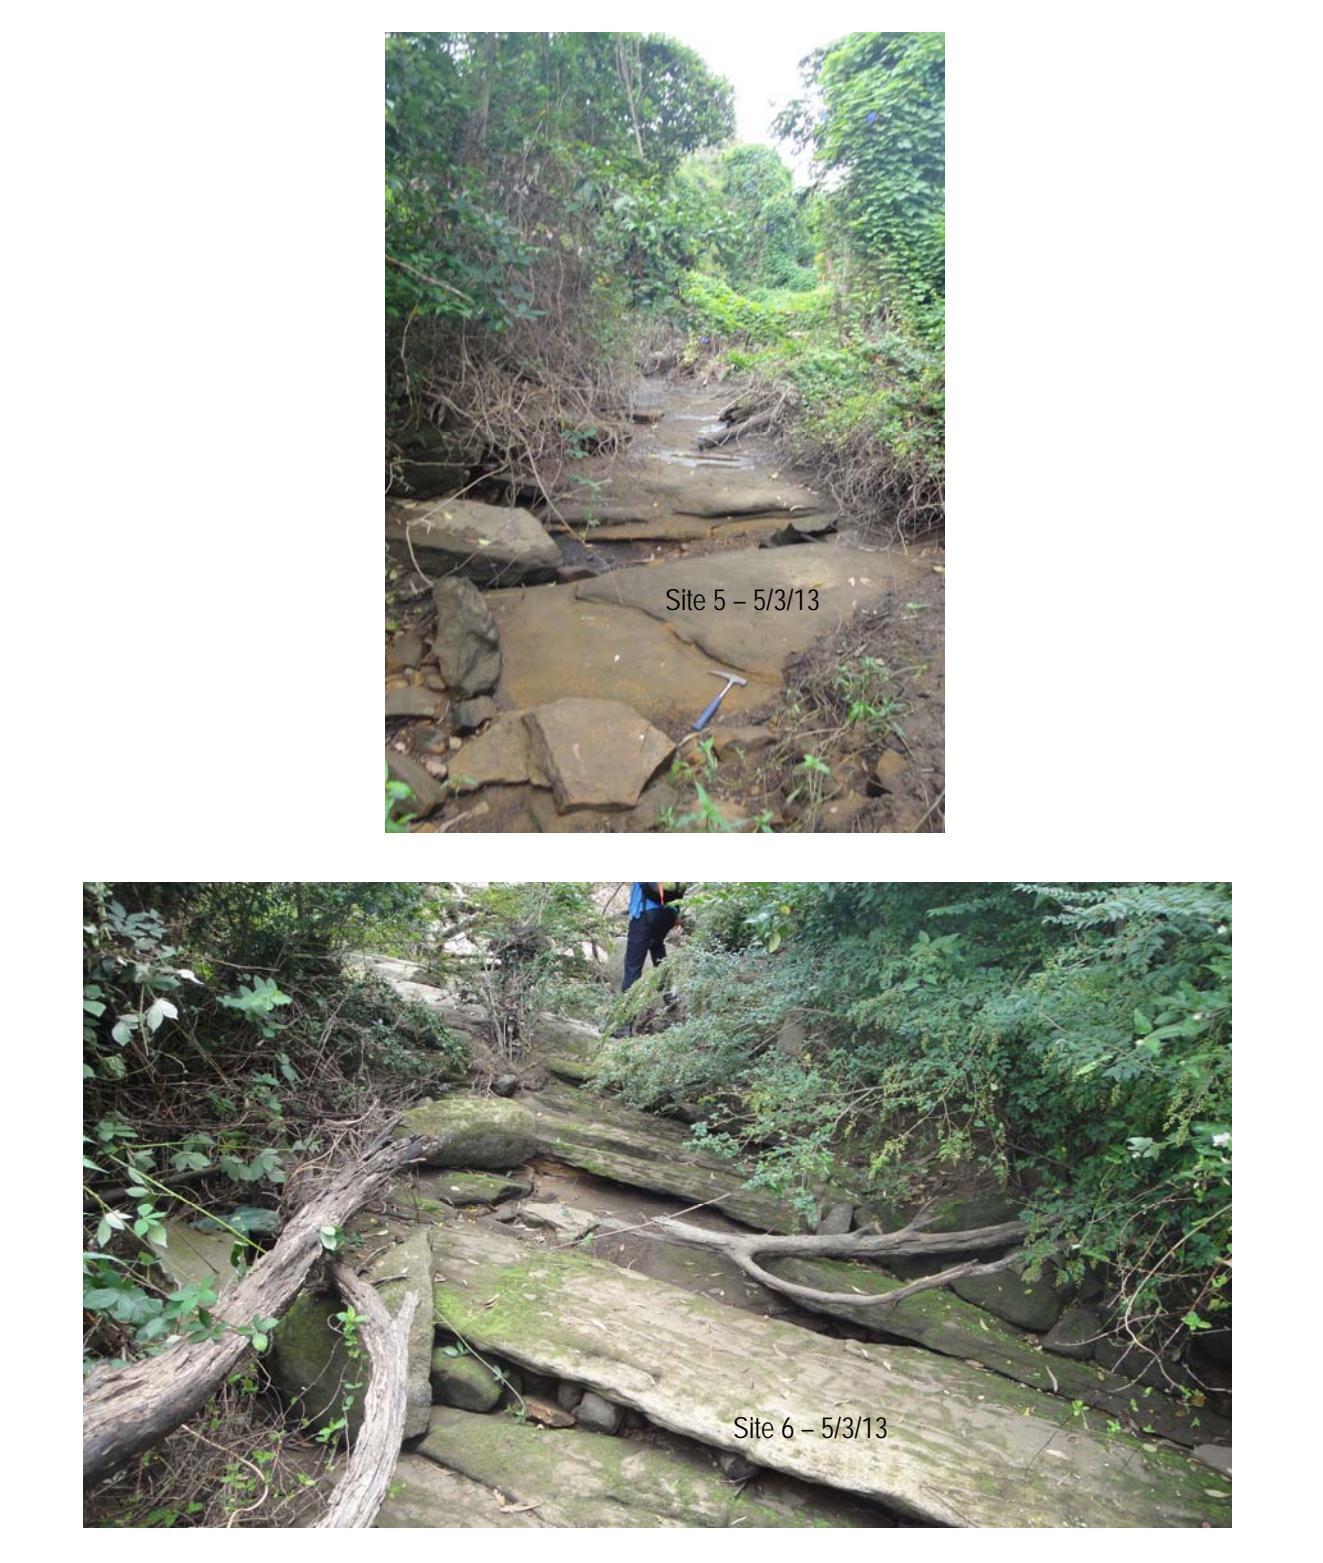
Figure 4 Site 5 and 6 Subsidence Effects after Longwall 26 Extraction

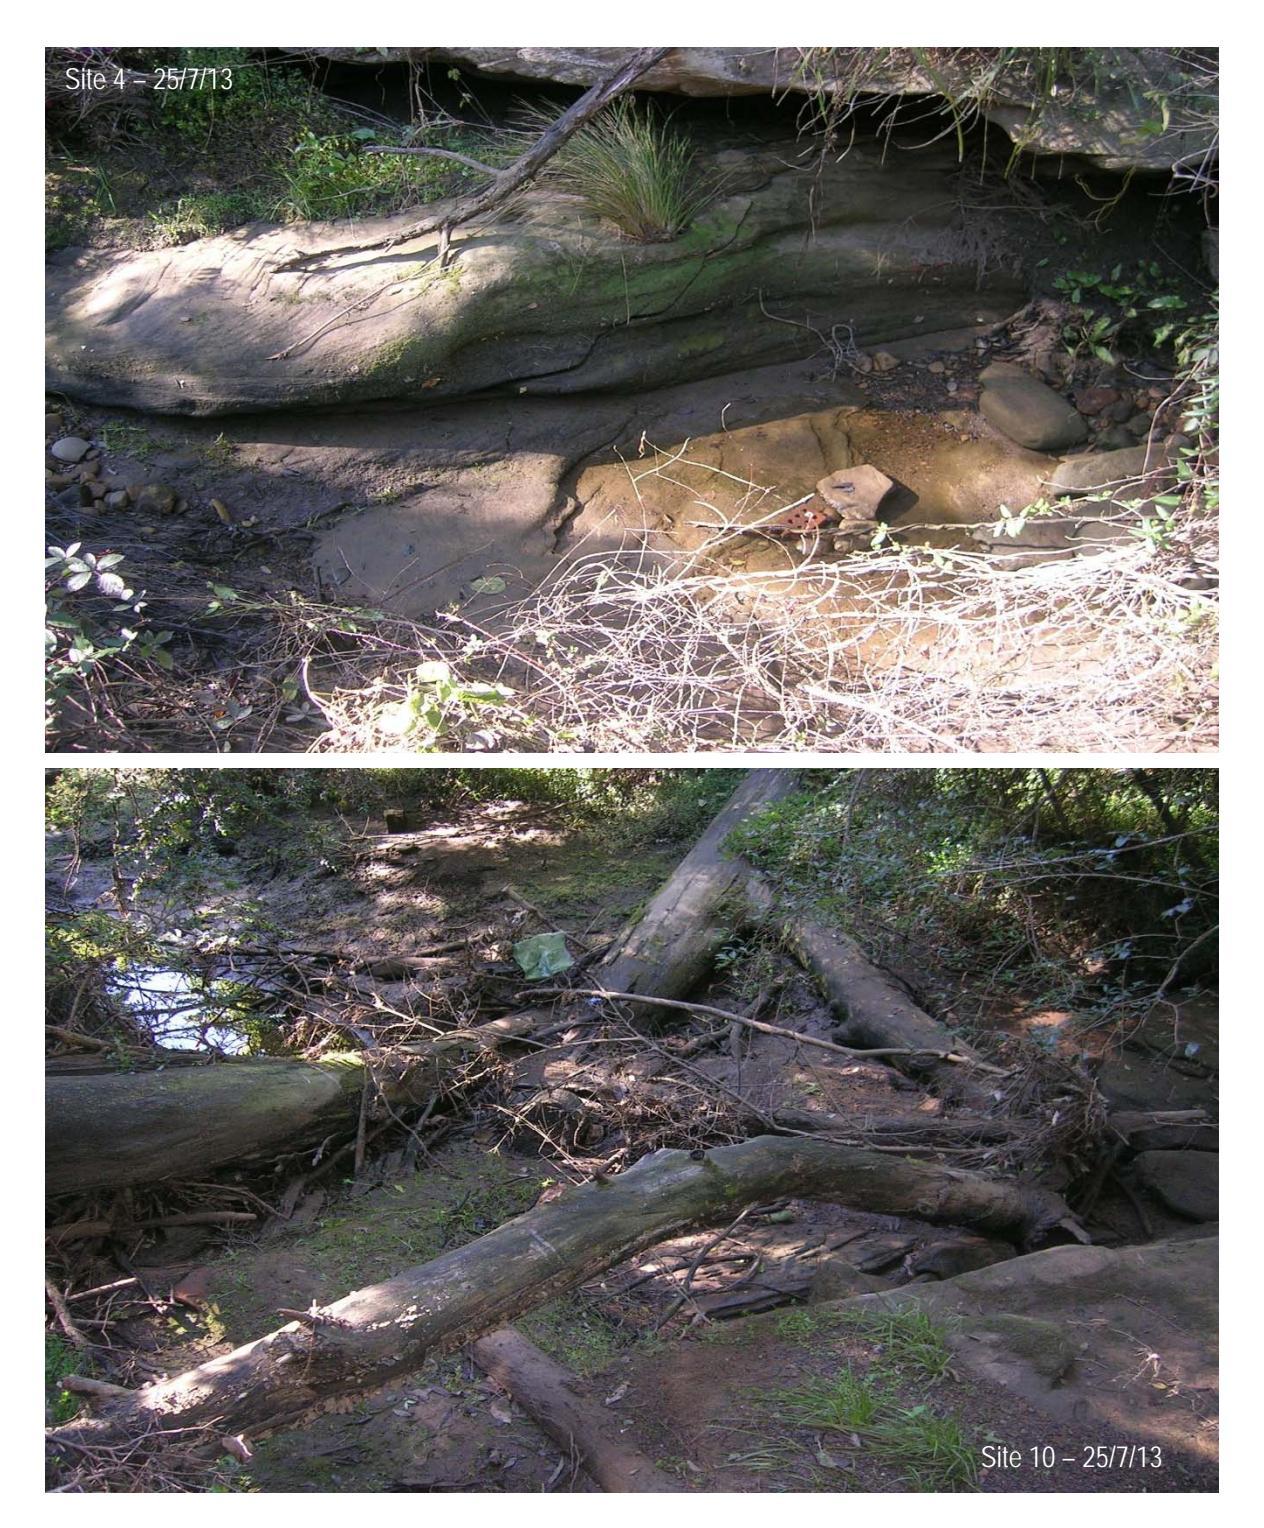
Figure 9 Site 4 and 10 Subsidence Effects after Longwall 27 Extraction

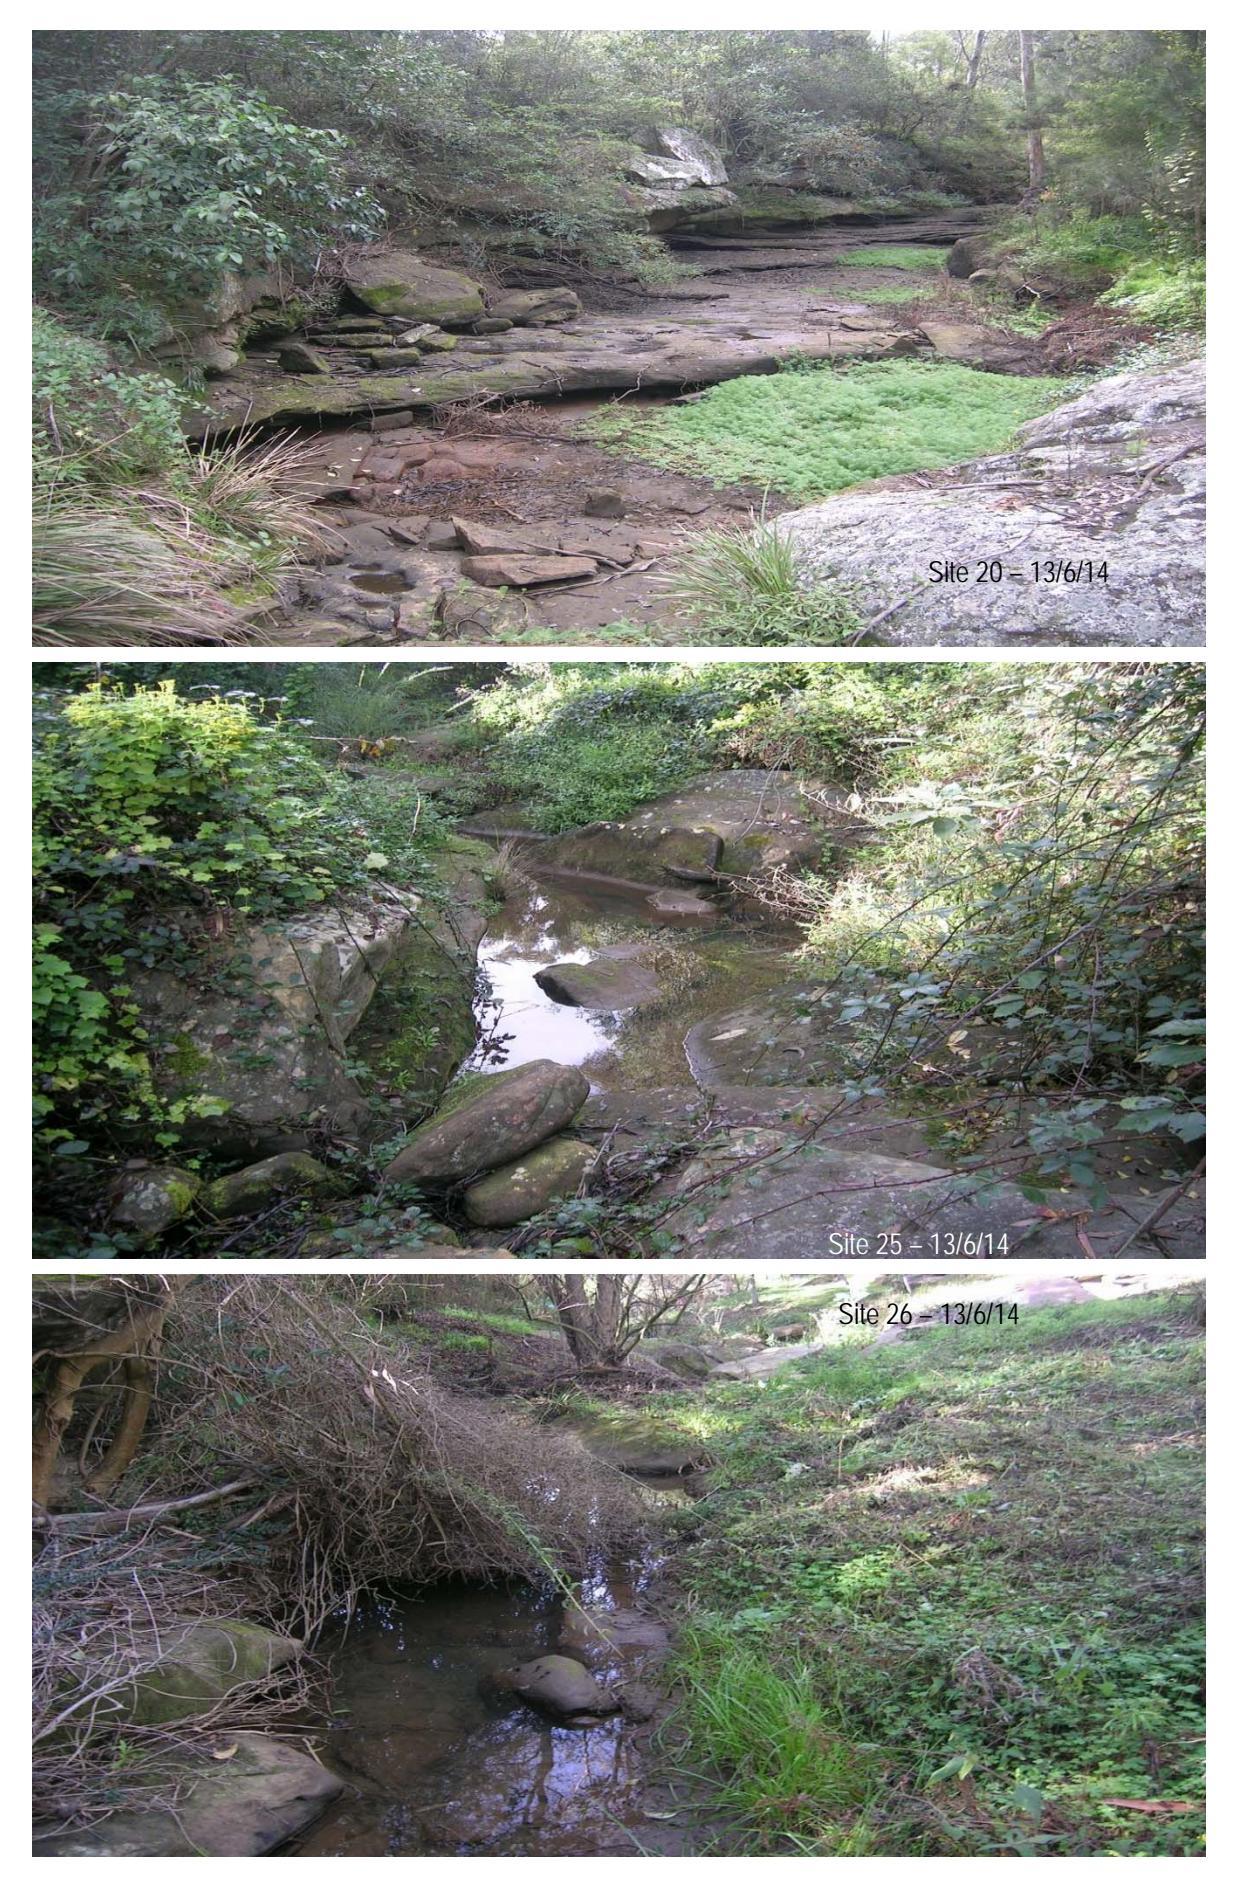
Figure 13 Site 20, 25 and 26 Subsidence Effects after Longwall 28 Extraction

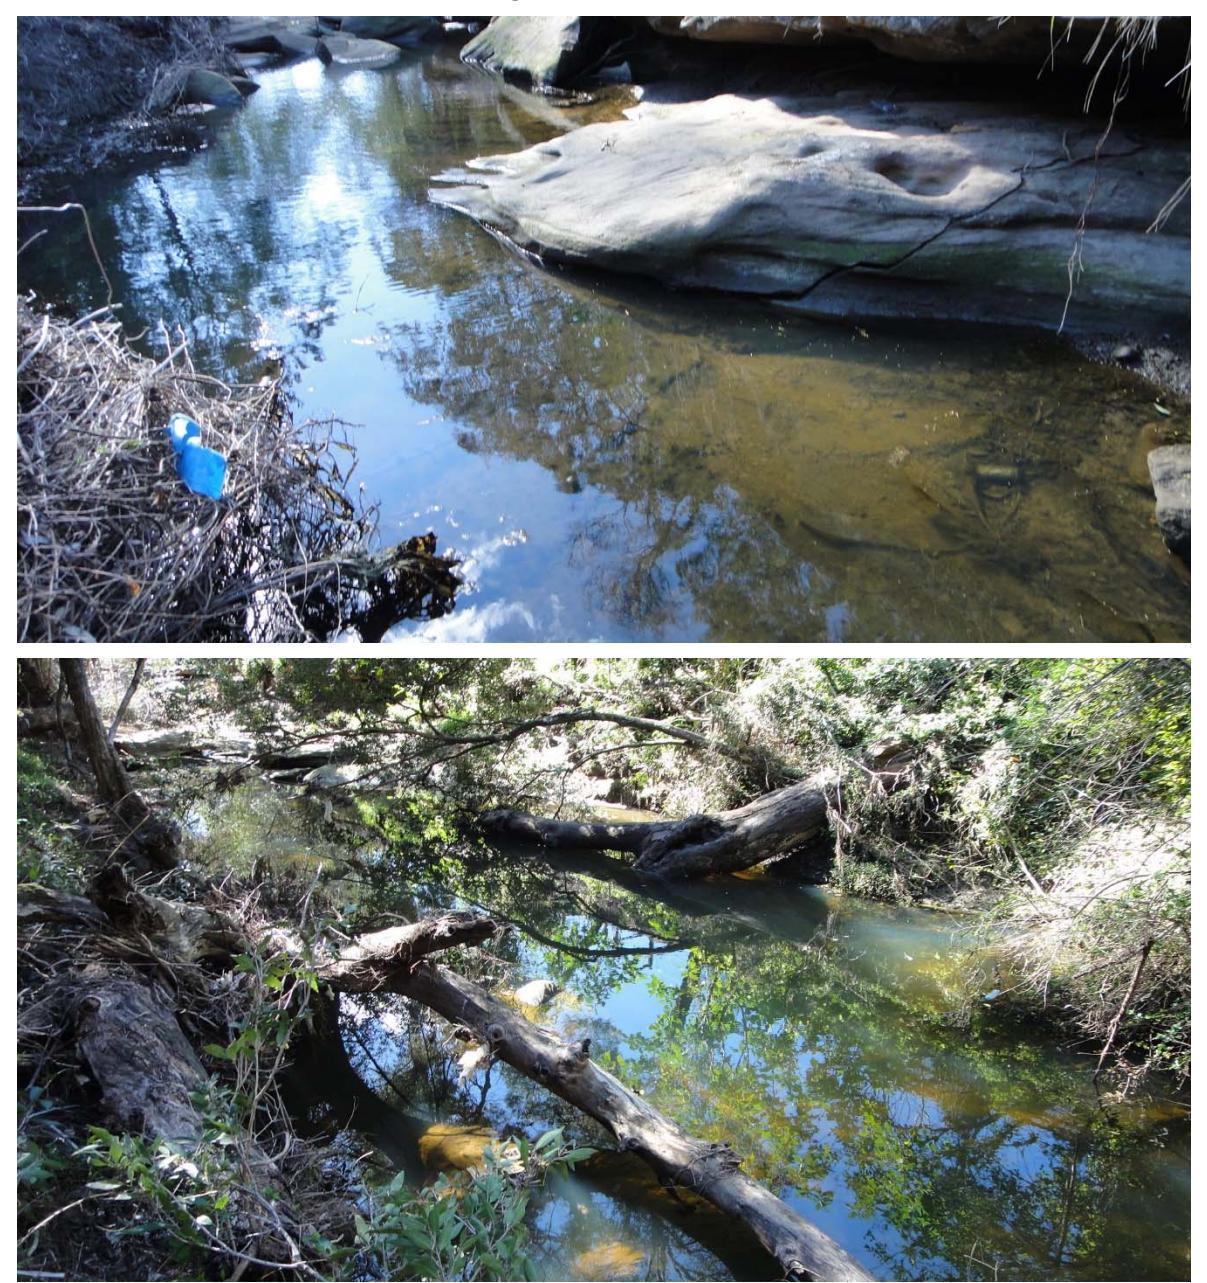
However, downstream of the culvert and over the tailgate and maingate sections of Longwall 26, a number of pools had shown significant recovery as shown in **Figure 21**, even though there remains a significant reach of exposed sandstone shelf in the middle of Longwall 26 that has not recovered as shown in **Figure 22**.

Figure 21 Recovering Pools at Site 4 and 10 over Longwall 26

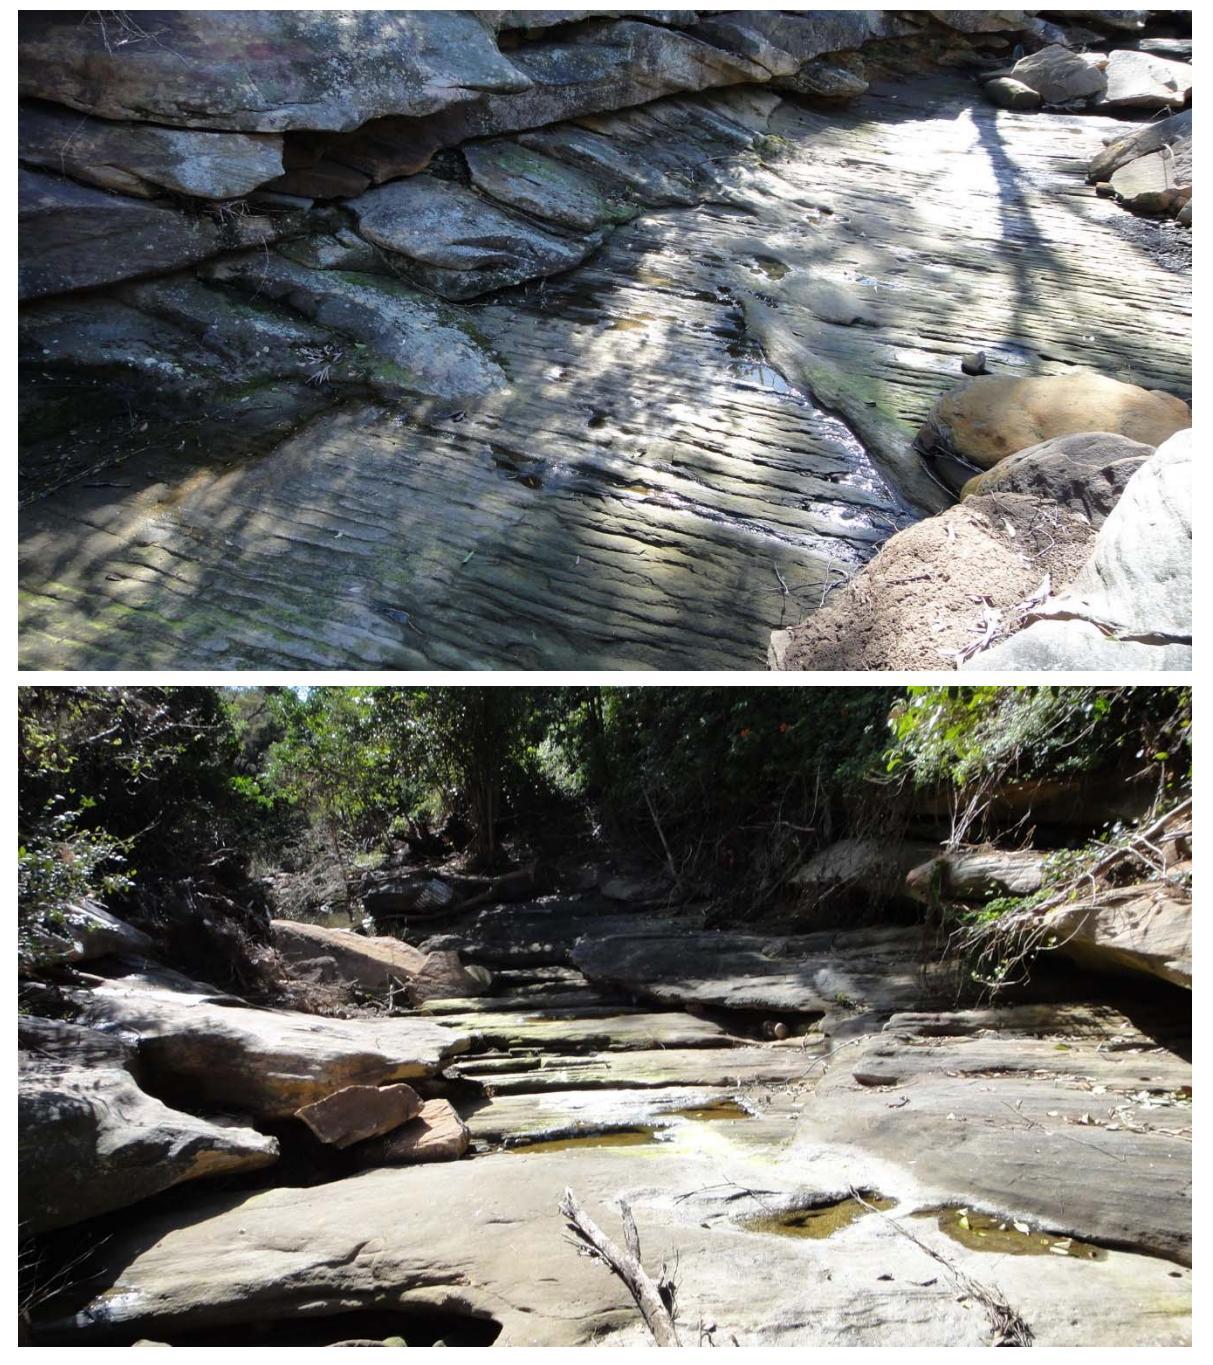
# Figure 22 Sandstone Shelf at Site 7 and 8 over Longwall 26 with No Sign of Recovery

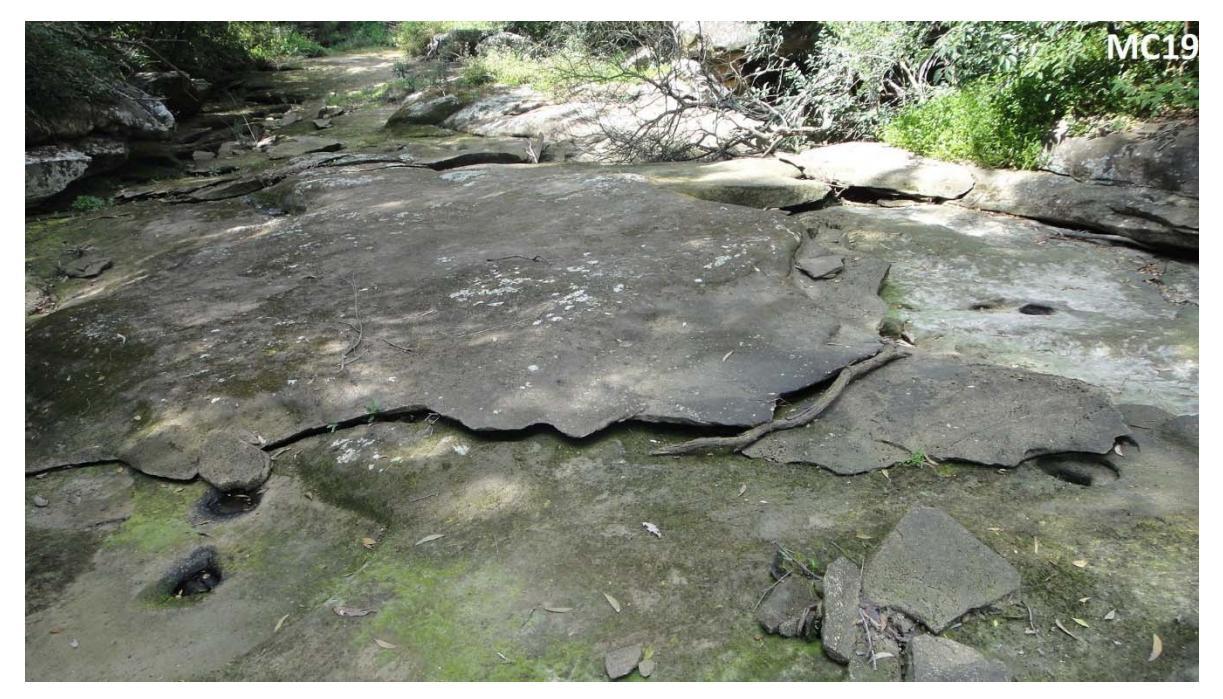
As the stream becomes wider, deeper and more incised, with exposed sandstone being more dominant, more cracking / delamination effects, along with long term drying up of pools or rock shelves were observed, which in some cases, such as at Site 19 (15/9/2015), was significantly affected, as shown in **Figure 23**.

Figure 23 Site 19 Subsidence Effects (15/09/15)

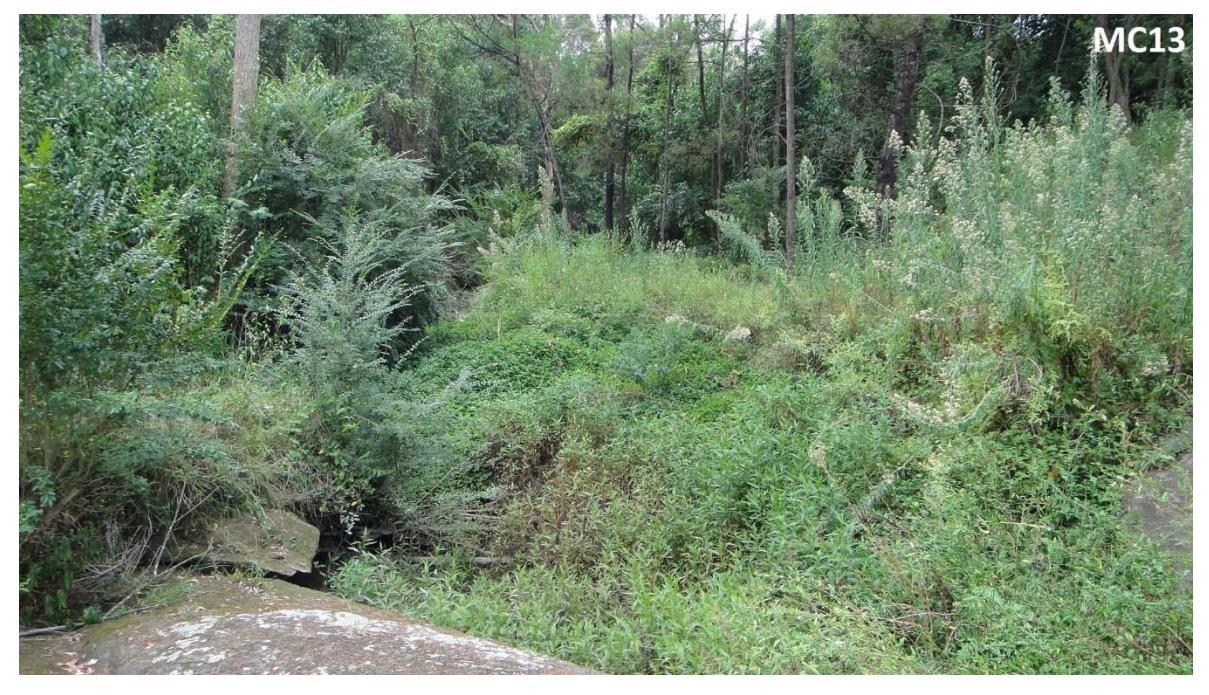
The subsidence affected pools were dry for a sufficiently long period that grasses, weeds and small shrubs grew in the old pool sites as shown below for Site 13 (03/03/2016).

Figure 24 Site 13 Subsidence Effects (03/03/16)

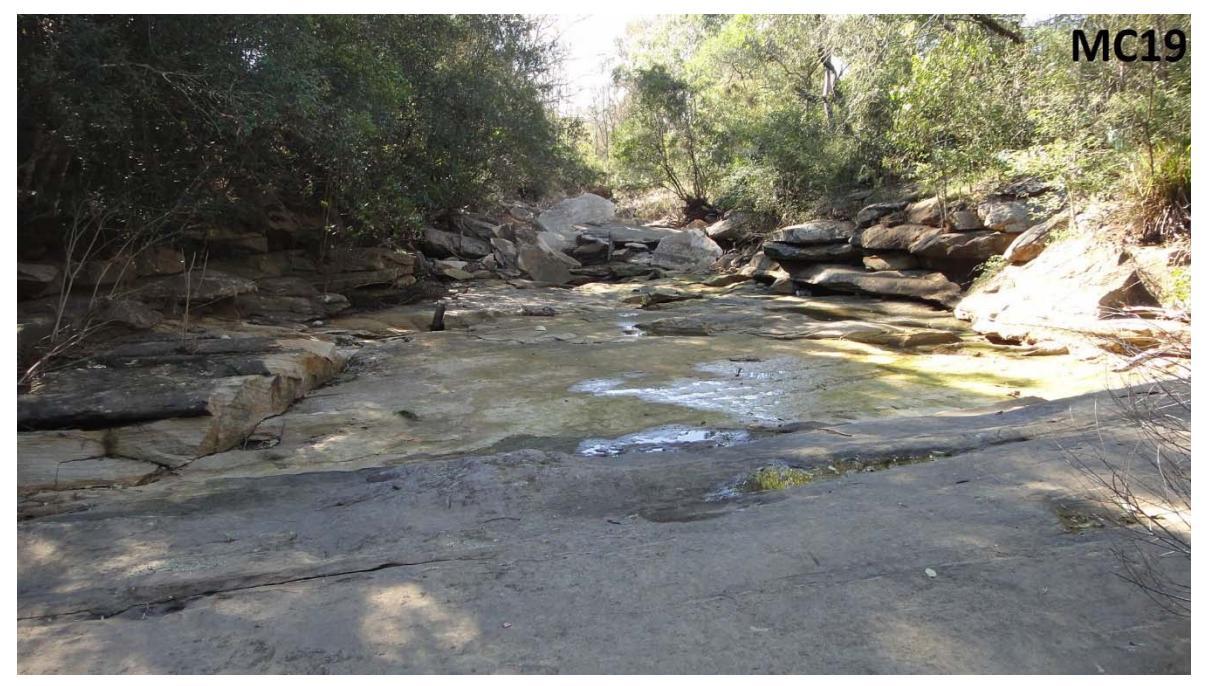
During the storm of June 2016, where significant flooding occurred in the local area, the creek had sufficient force to flip over, break up and wash away the delaminated reach, such as at Site 19 (29/07/2016) with the broken blocks piled up further downstream.

Figure 25 Site 19 after June 2016 East Coast Low Storm
