Tahmoor Colliery - Longwalls 28 to 30

Management Plan for Potential Impacts to Sydney Water Sewer Infrastructure

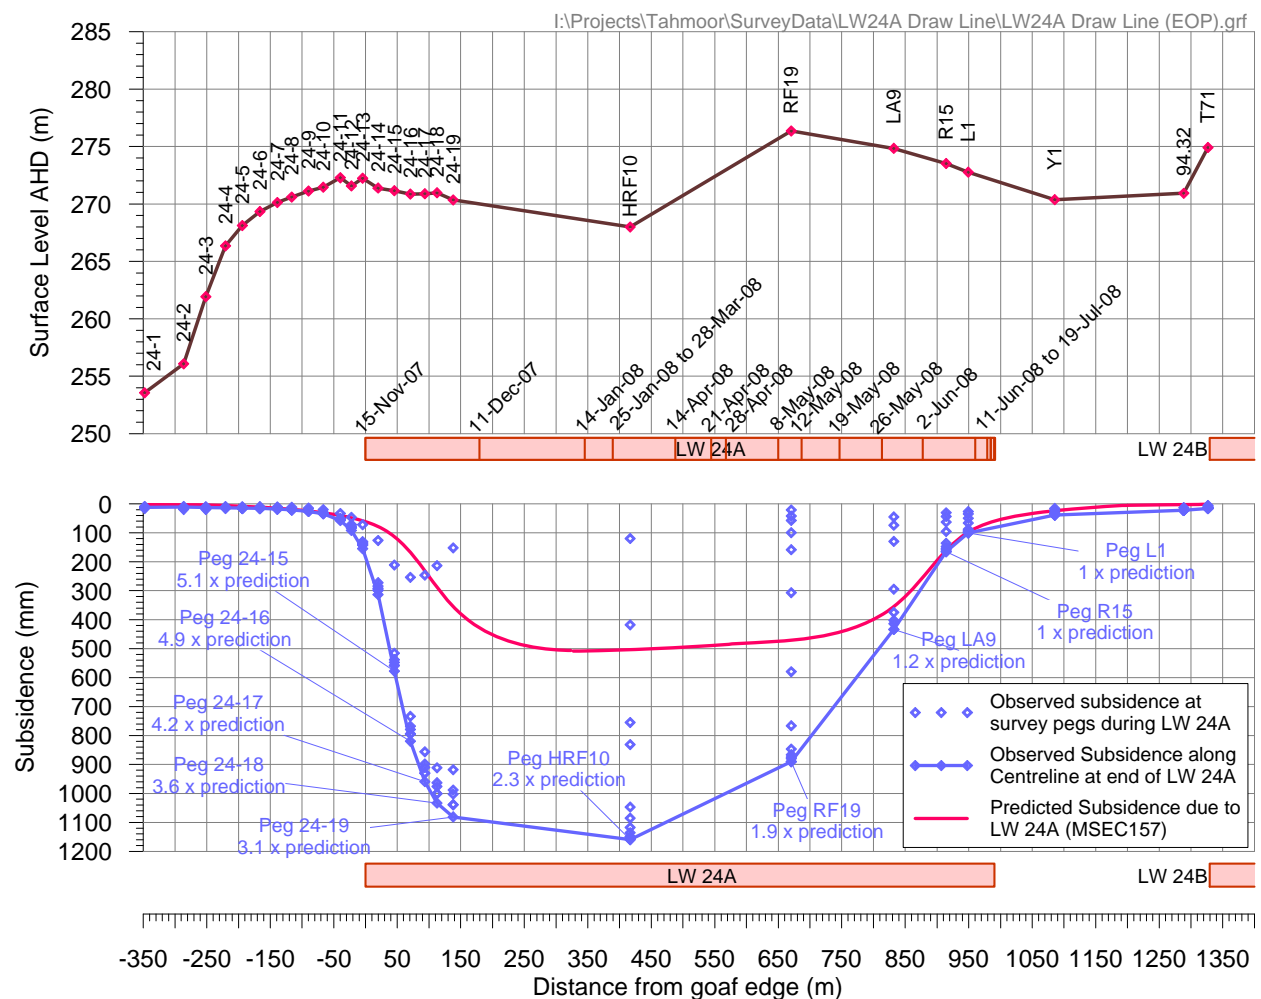
Fig. 2.1 Observed Subsidence along Centreline of Longwall 24A

It can be seen from Fig. 2.1 that observed subsidence was more than twice the predicted maximum value, reaching to a maximum of 1169 mm at Peg HRF10. It is possible that actual maximum subsidence developed somewhere between Pegs HRF10 and RF19, though this was not measured. Observed subsidence was similar to prediction near Peg R15 on Remembrance Drive. Survey pegs RF19 and LA9 are located within a transition zone where subsidence gradually reduced from areas of maximum increased subsidence to areas of normal subsidence.

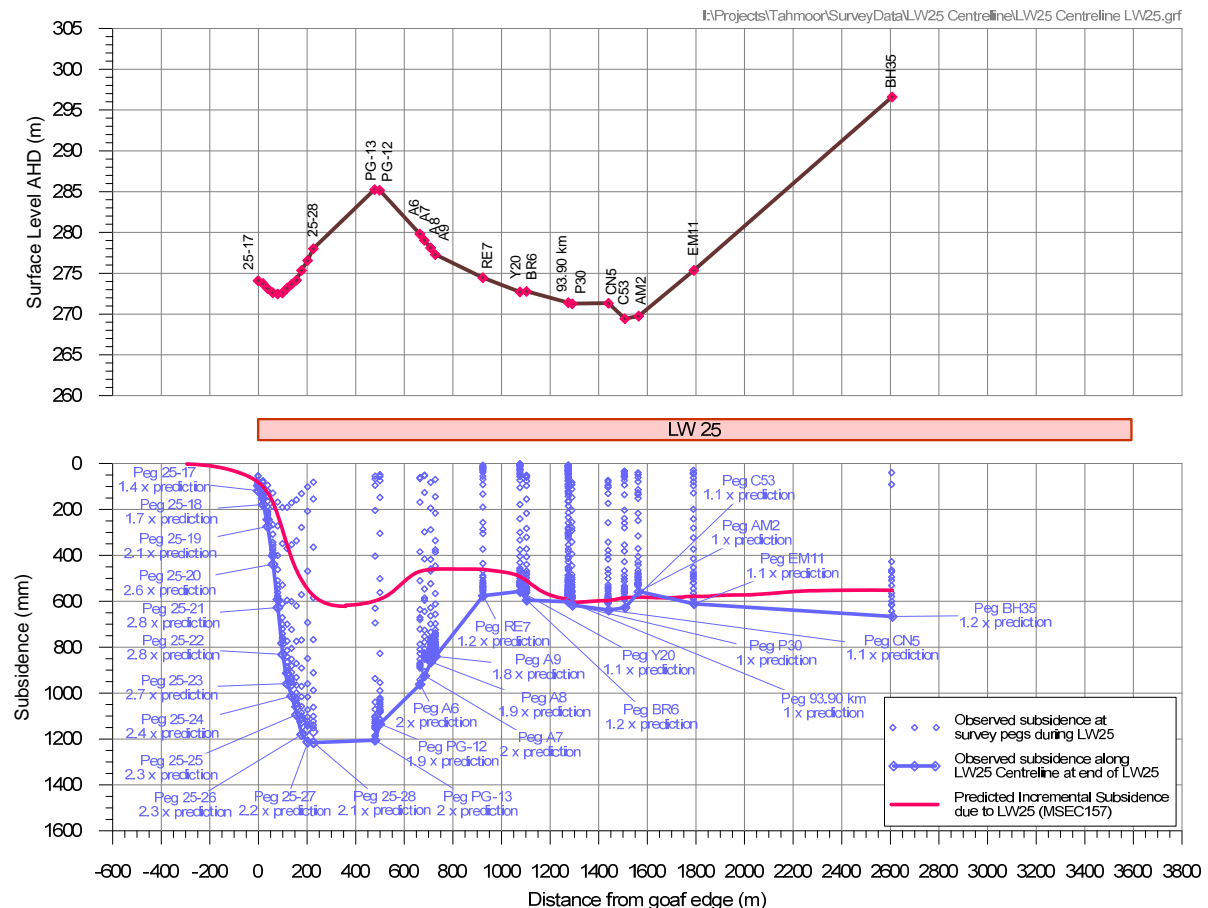
Fig. 2.2 Observed Subsidence along Centreline of Longwall 25

It can be seen from Fig. 2.2 that observed subsidence was approximately twice the predicted maximum value, with maximum subsidence of 1216 mm at Peg 25-28.

Observed subsidence is similar to but slightly more than predicted at Peg RE7 and is similar to prediction at Peg Y20 and at all pegs located further along the panel. Survey pegs A6, A7, A8 and A9 are located within a transition zone where subsidence has gradually reduced from areas of maximum increased subsidence to areas of normal subsidence.

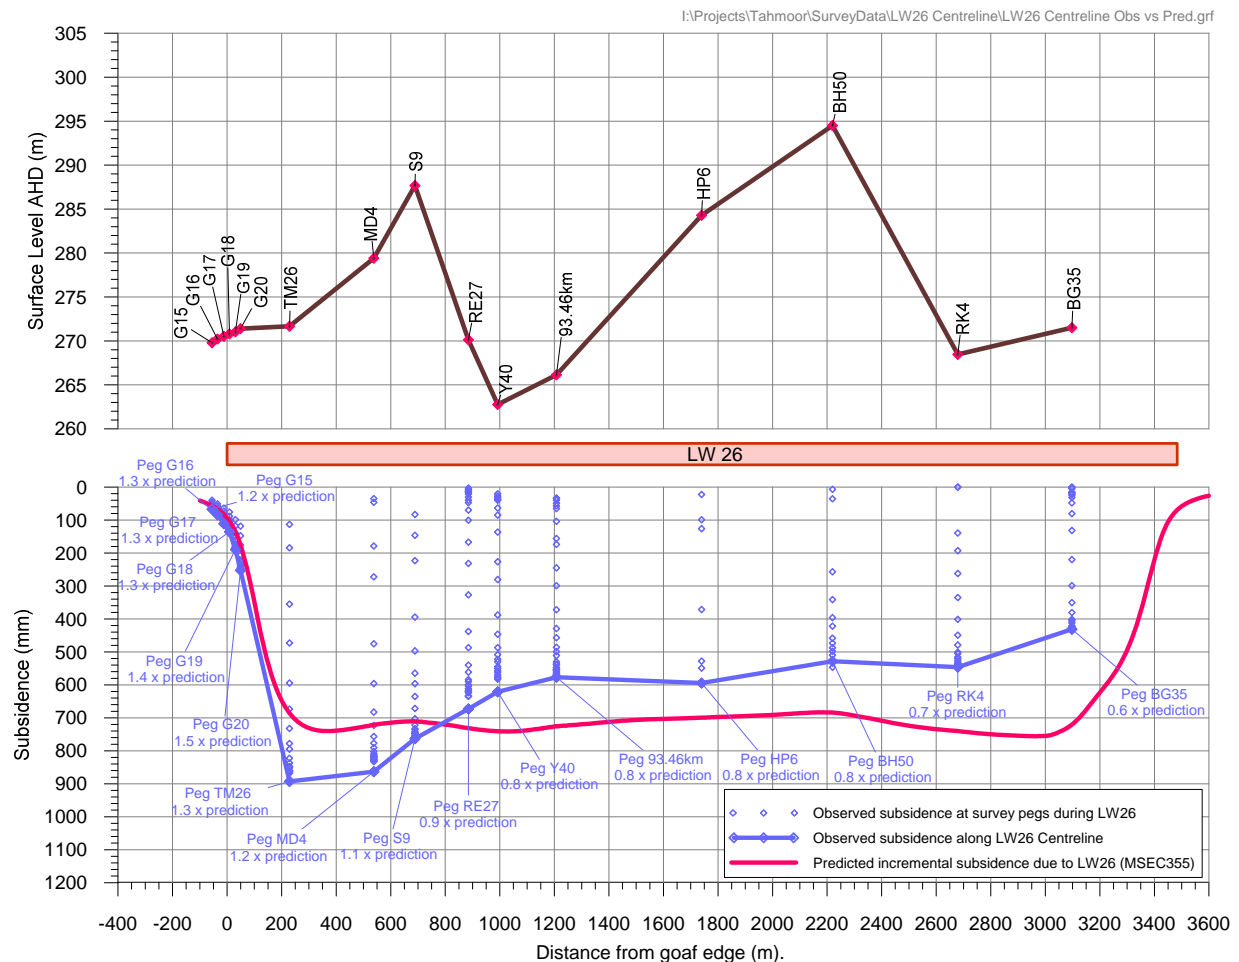
Fig. 2.3 Observed Subsidence along Centreline of Longwall 26

It can be seen from Fig. 2.3 that observed subsidence was approximately 1.3 times the predicted maximum value, with maximum subsidence of 893 mm at Peg TM26.

Observed subsidence reduced along the panel until Peg Y40 on York Street, where it was less than prediction. Survey pegs S9 and RE27 are located within a transition zone where subsidence has gradually reduced from areas of maximum increased subsidence between Pegs TM26 and MD4 to areas of normal subsidence at Peg Y40 and beyond.

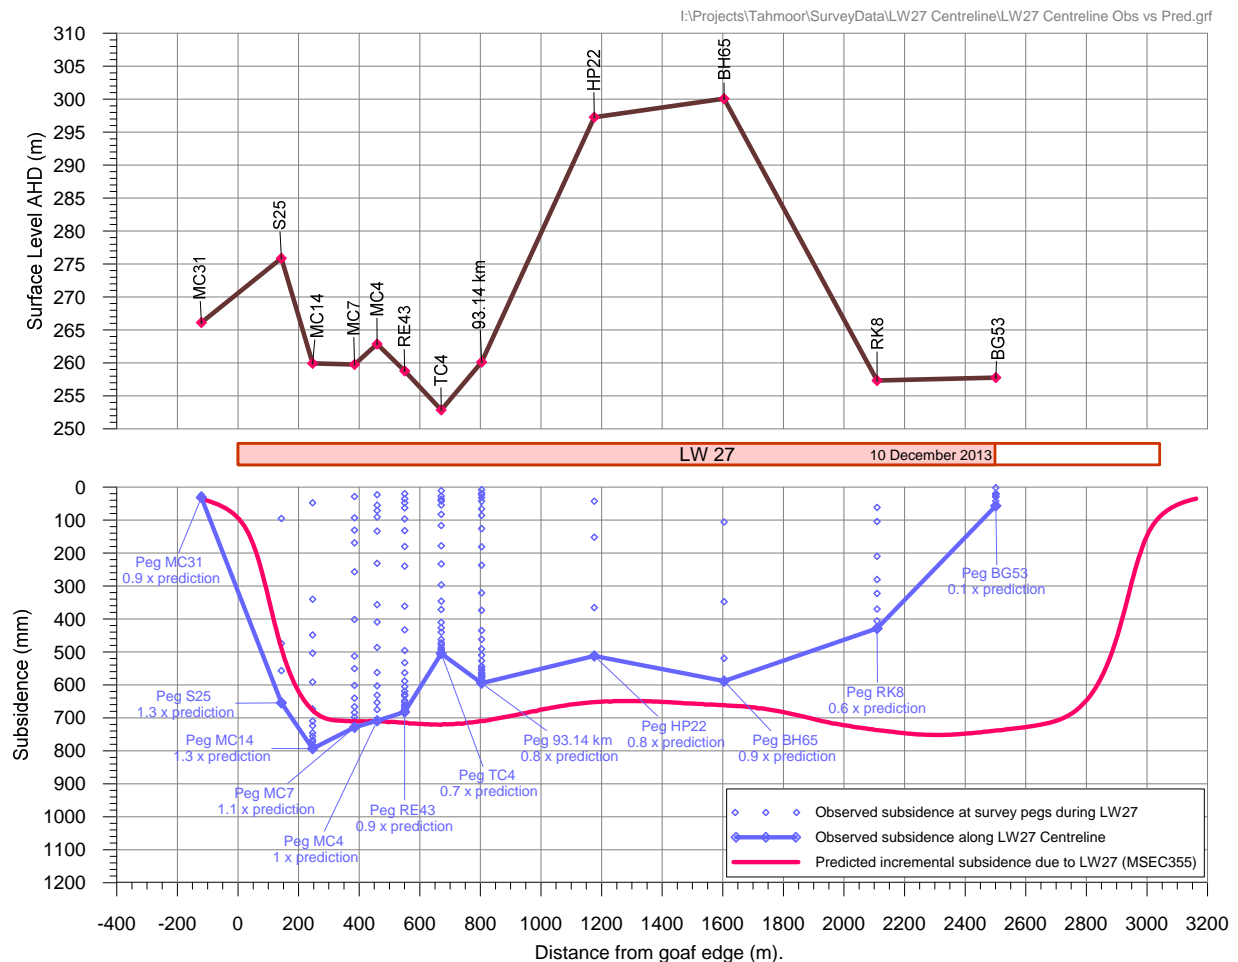
Fig. 2.4 Observed Subsidence along Centreline of Longwall 27

It can be seen from Fig. 2.4 that observed subsidence is approximately 1.3 times the predicted maximum value, with current maximum subsidence of 793 mm at Peg MC14.

Observed subsidence reduced along the panel from Peg MC14 until Peg TC4, which is located between Remembrance Drive and Myrtle Creek. Observed subsidence along the centreline returned to normal levels as mining progressed beyond Peg TC4.

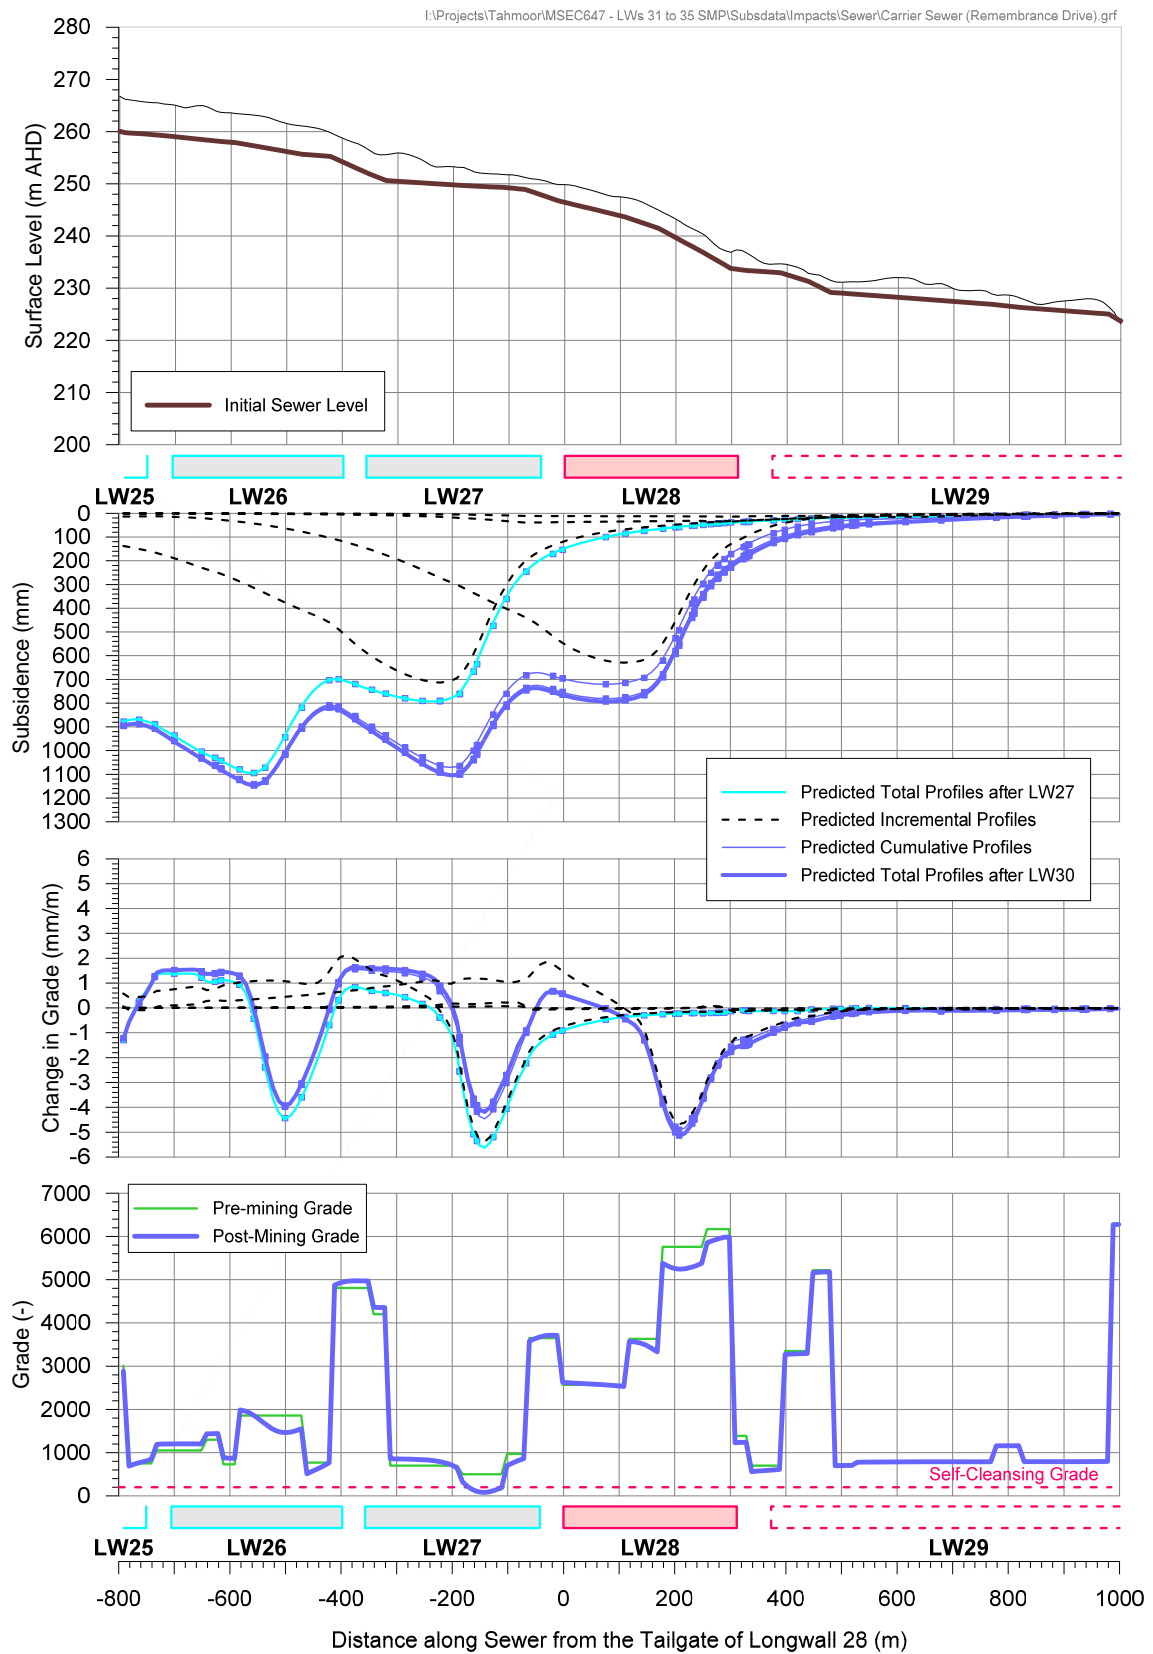
Fig. 2.11 Predicted Subsidence and Changes in Grade along Tahmoor Carrier

The mining of Longwalls 28 to 30 will result in an increase in grade for this section of pipe. It can be seen from Fig. 2.11 that grades for pipes above Longwall 28 are well above self-cleansing prior to mining and predicted to remain so after mining.

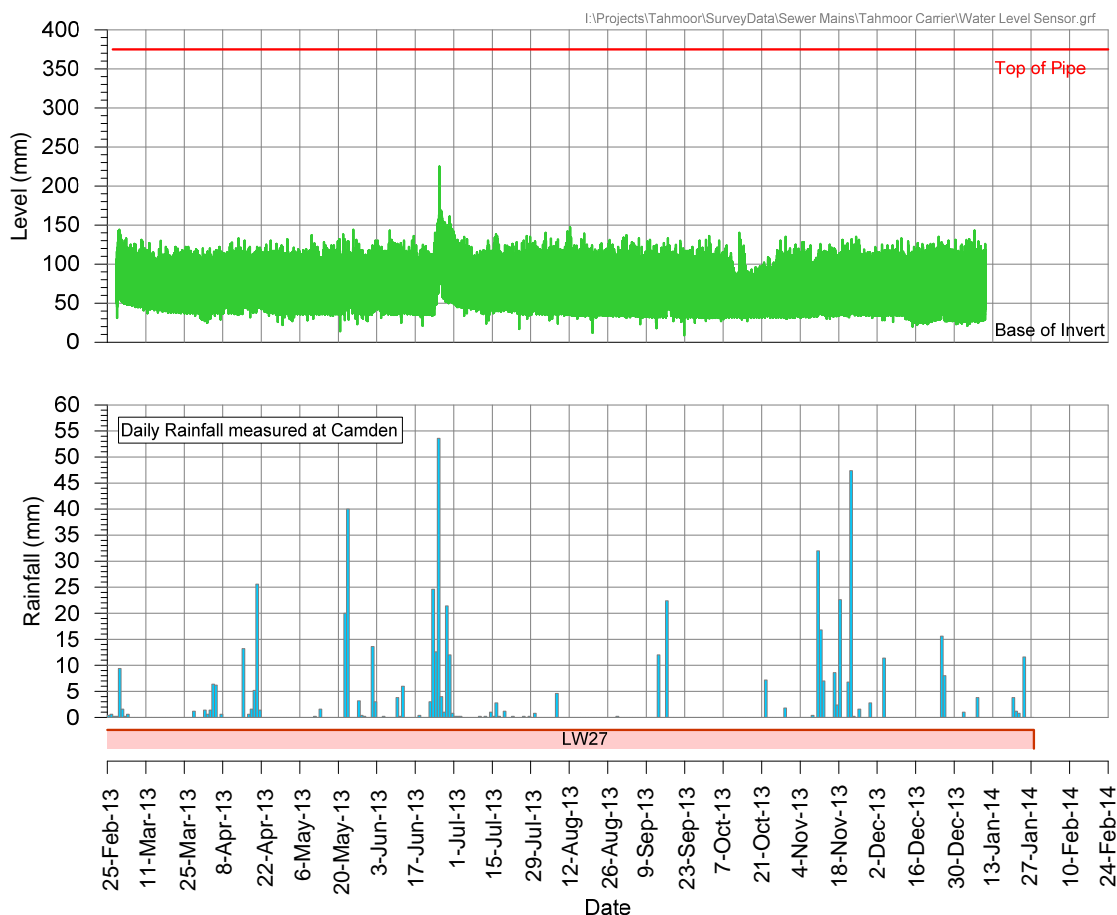
Fig. 2.14 Water level sensor observations during Longwall 27

the sensor were taken every five minutes and transmitted to a monitoring website. As seen in Fig. 2.14, the water level has remained well below the top of the pipe.

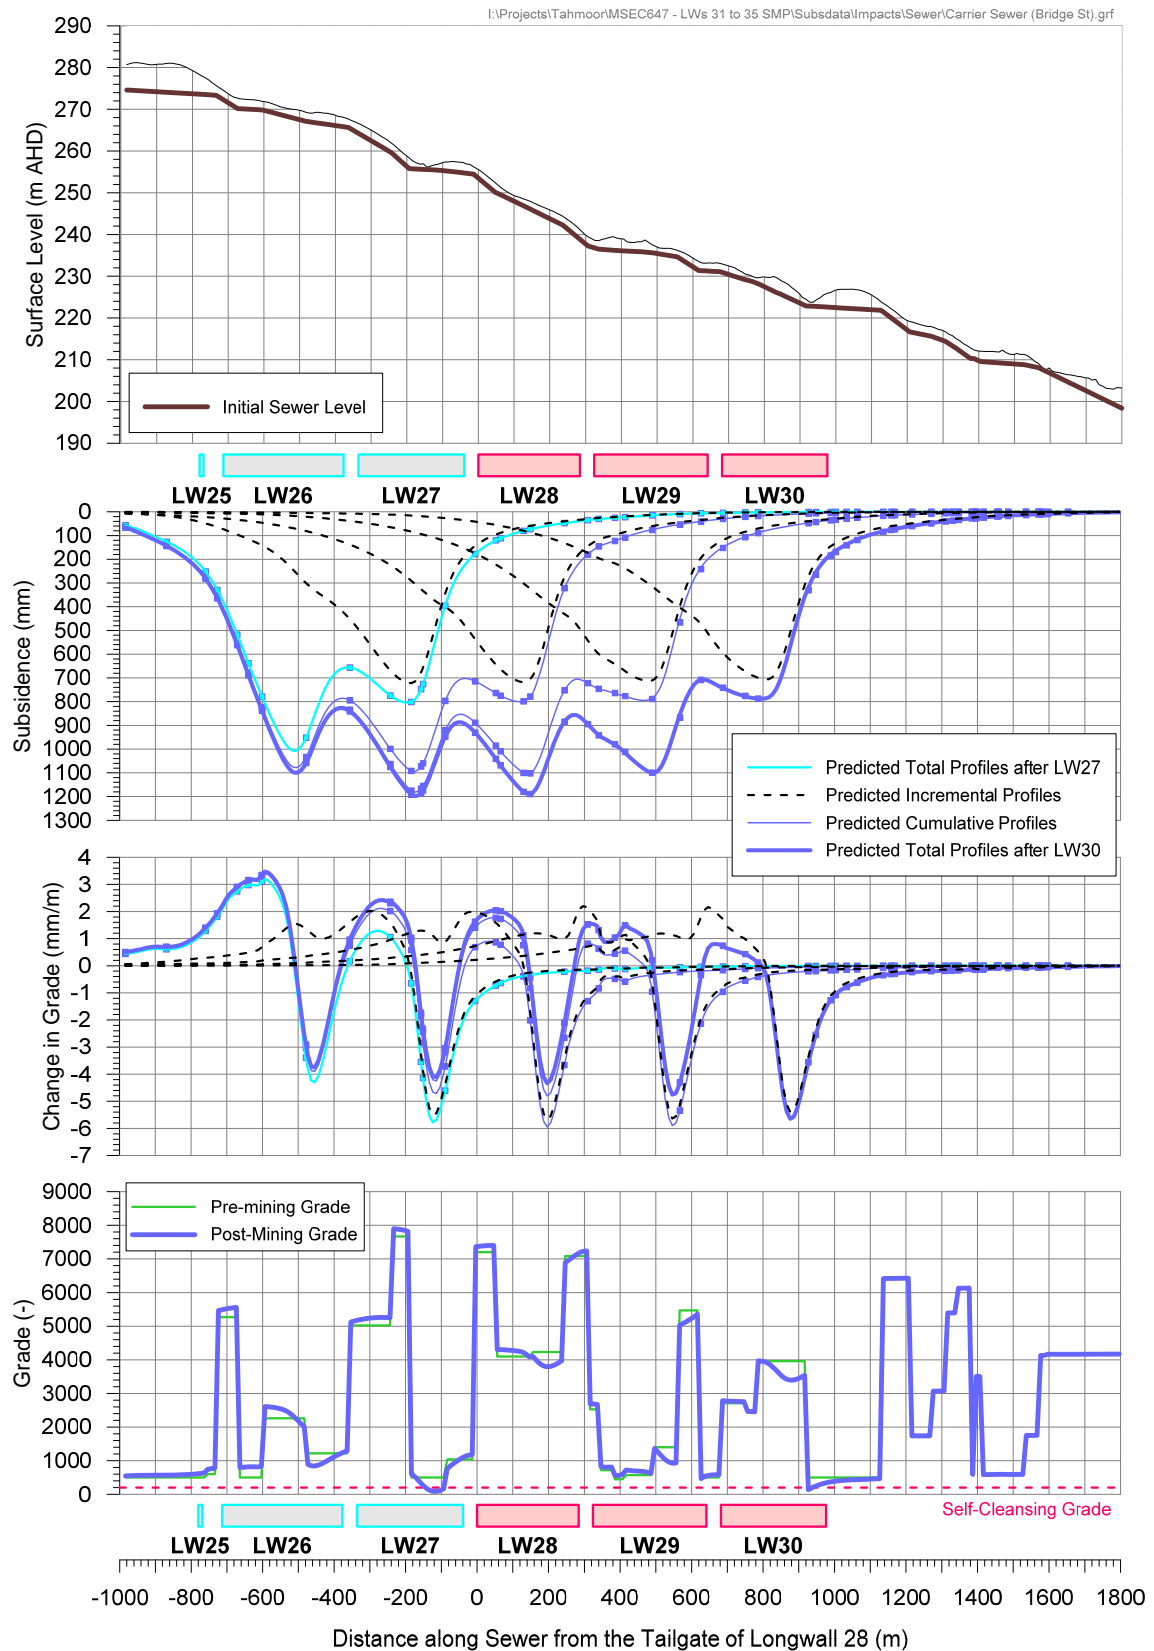
Fig. 2.15 Predicted Subsidence and Changes in Grade along Thirlmere Carrier

As at 29 January 2014, ground surveys have found that the grade for one 20 metre section (Peg BG55 to BG56) has reduced to 0.14%, below the early warning trigger level of 0.2%. When the survey results between Pegs BG54 and BG57 are used to estimate change over the 67 metre section, the average grade is approximately 0.23% from pit to pit.

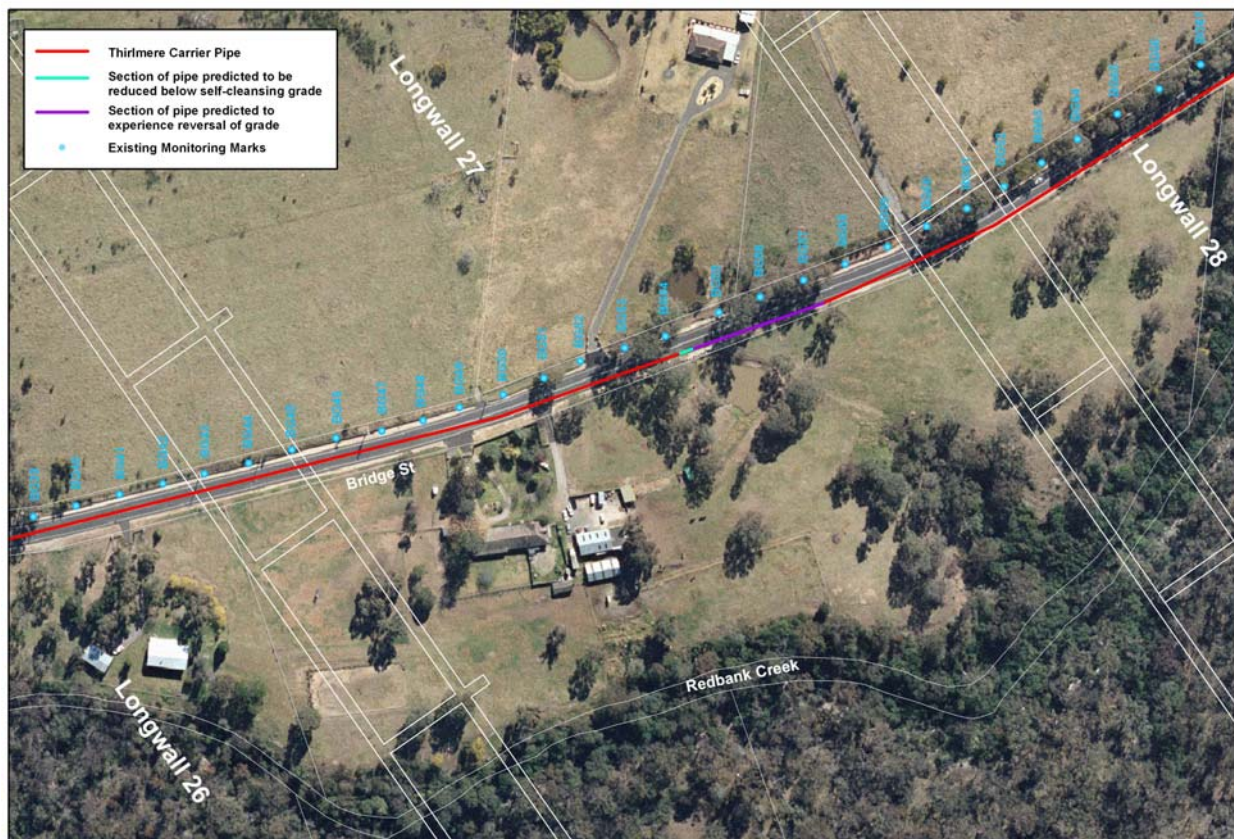
Fig. 2.16 Location of Thirlmere Carrier Pipe on Bridge Street where a reversal of grade may occur during the mining of Longwall 27

In the case of Longwall 27, a 67 metre long section of 375 mm diameter pipe was laid with a pre-mining grade of 0.5% (5.0 mm/m), which is close to the minimum grade for self-cleansing of 0.2% (2 mm/m). The pipe section is located beneath the southern shoulder of Bridge Street directly above Longwall 27. As shown in Fig. 2.15, the pipe was predicted to experience a maximum reduction in grade of 5.9 mm/m, which would result in a very slight reversal in grade of approximately 0.9 mm/m (0.09%). It is estimated that approximately 50 metres of this pipe is predicted to experience a very slight reversal of grade during the mining of

Longwall 27. The section is located approximately between Pegs BG54 and BG57 on Bridge Street, as shown by the purple line in Fig. 2.16.

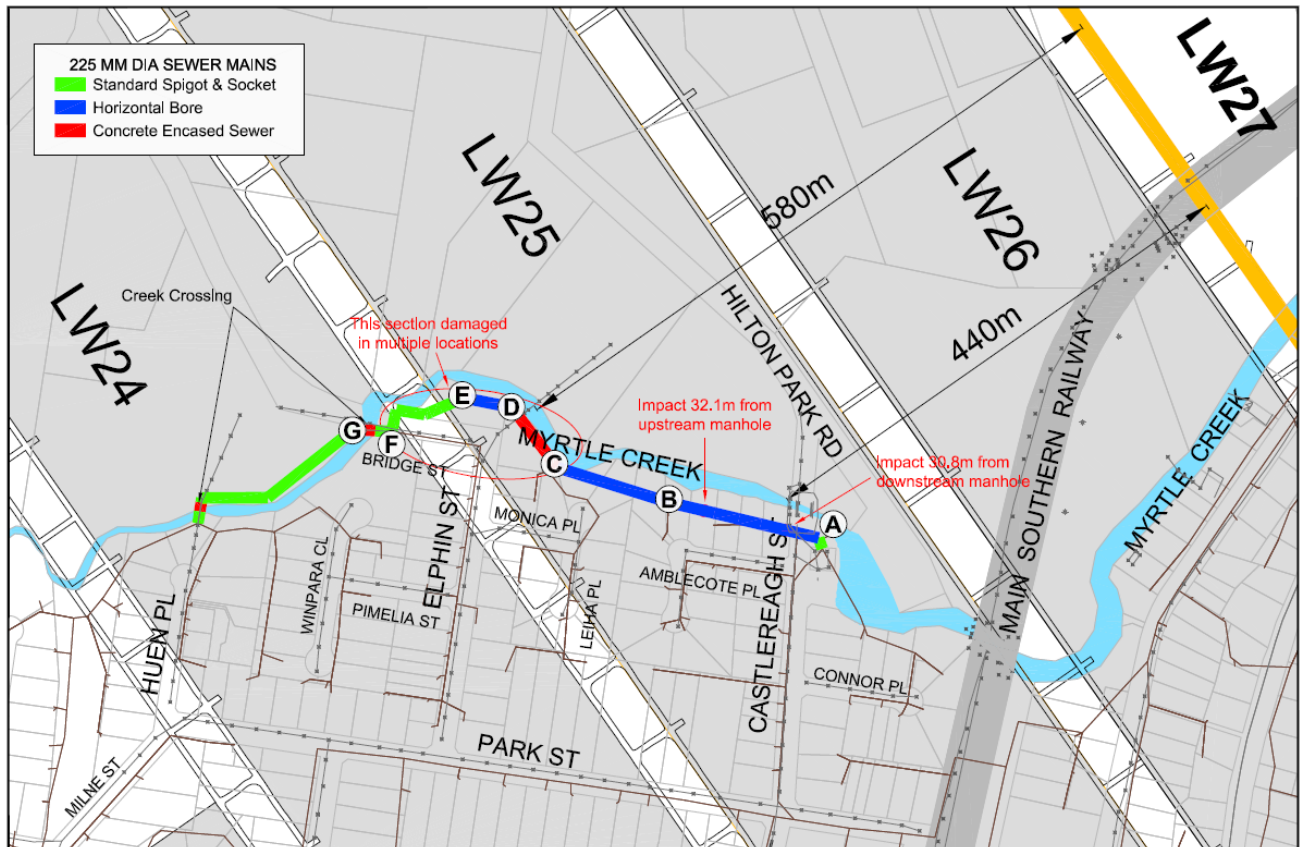
Fig. 2.19 Diagram showing the locations of subsidence impacted sewer pipes near Myrtle Creek

A map of this section of sewer is shown in Fig. 2.19.

The design of the replacement bores has taken into account expected additional subsidence movements. The rectification work includes the following:

Replacement of horizontal bore from Sites A to C

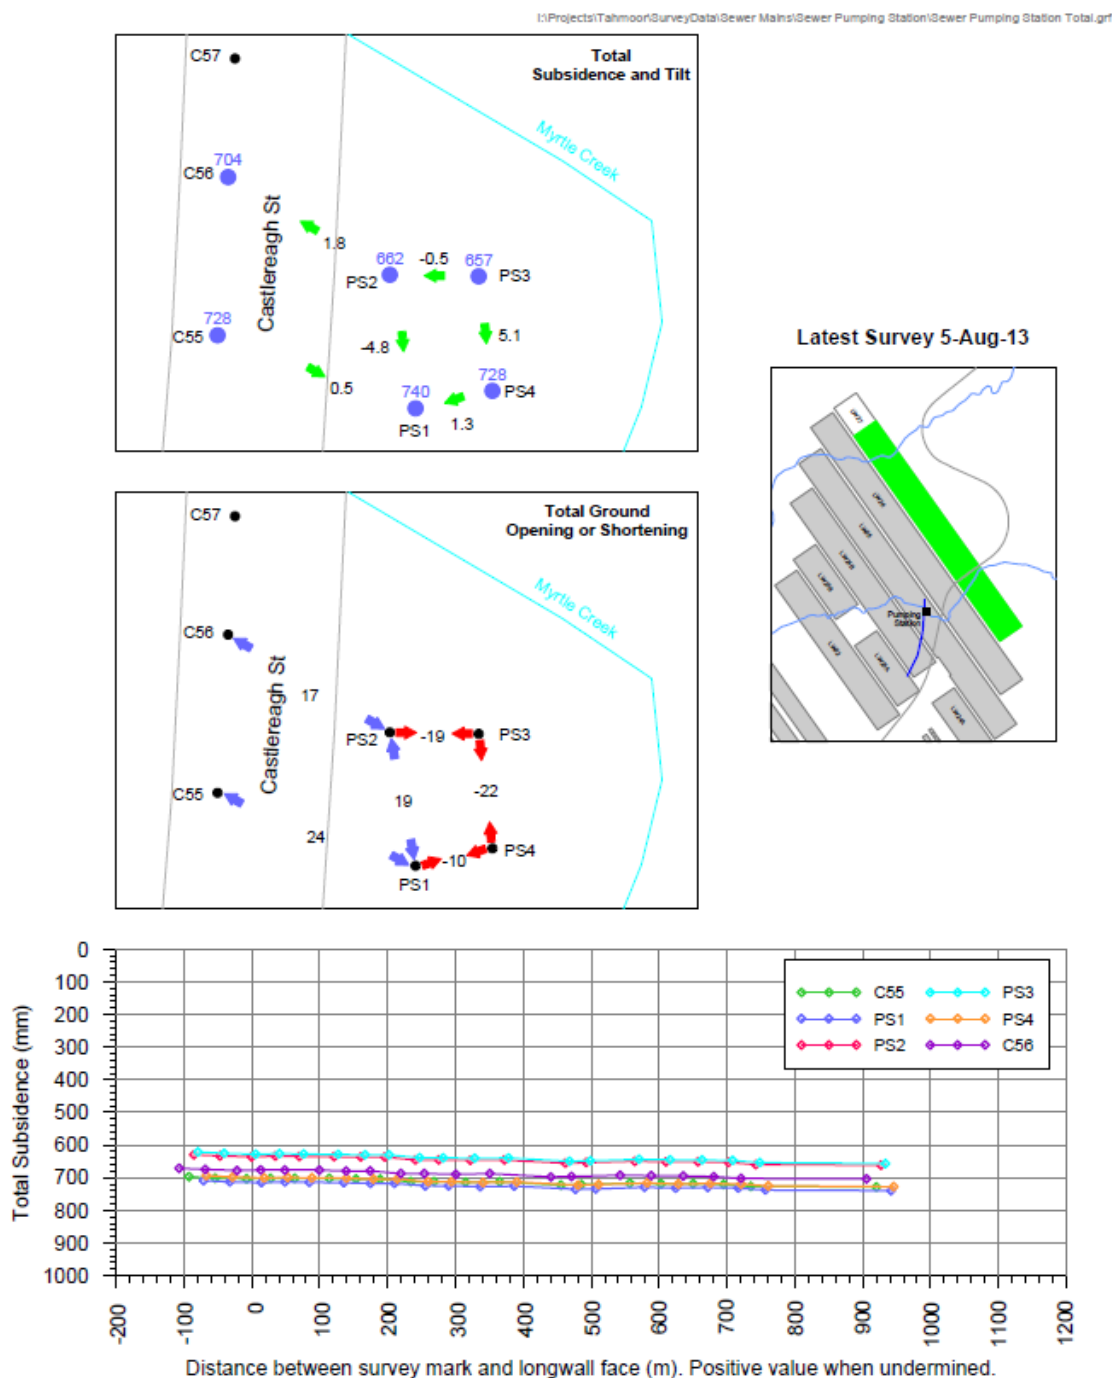
Fig. 2.22 Observed Total Subsidence, Tilt and Strain of Survey Pegs around SP1045 during the mining of Longwall 27

Ground monitoring around the pumping station during the mining of Longwalls 25, 26 and 27 showed that the pumping station subsided approximately 740 mm, as shown in Fig. 2.22. Observed tilts were within expectations. The majority of ground strains around the pumping station were relatively small, with the exception of strain between Pegs PS2 and PS3 on the northern or downslope side. Compressive strain between the pegs reached a maximum of 3.4 mm/m in December 2009 during Longwall 25, but had reduced to 1.7 mm/m in August 2013 during Longwall 27.

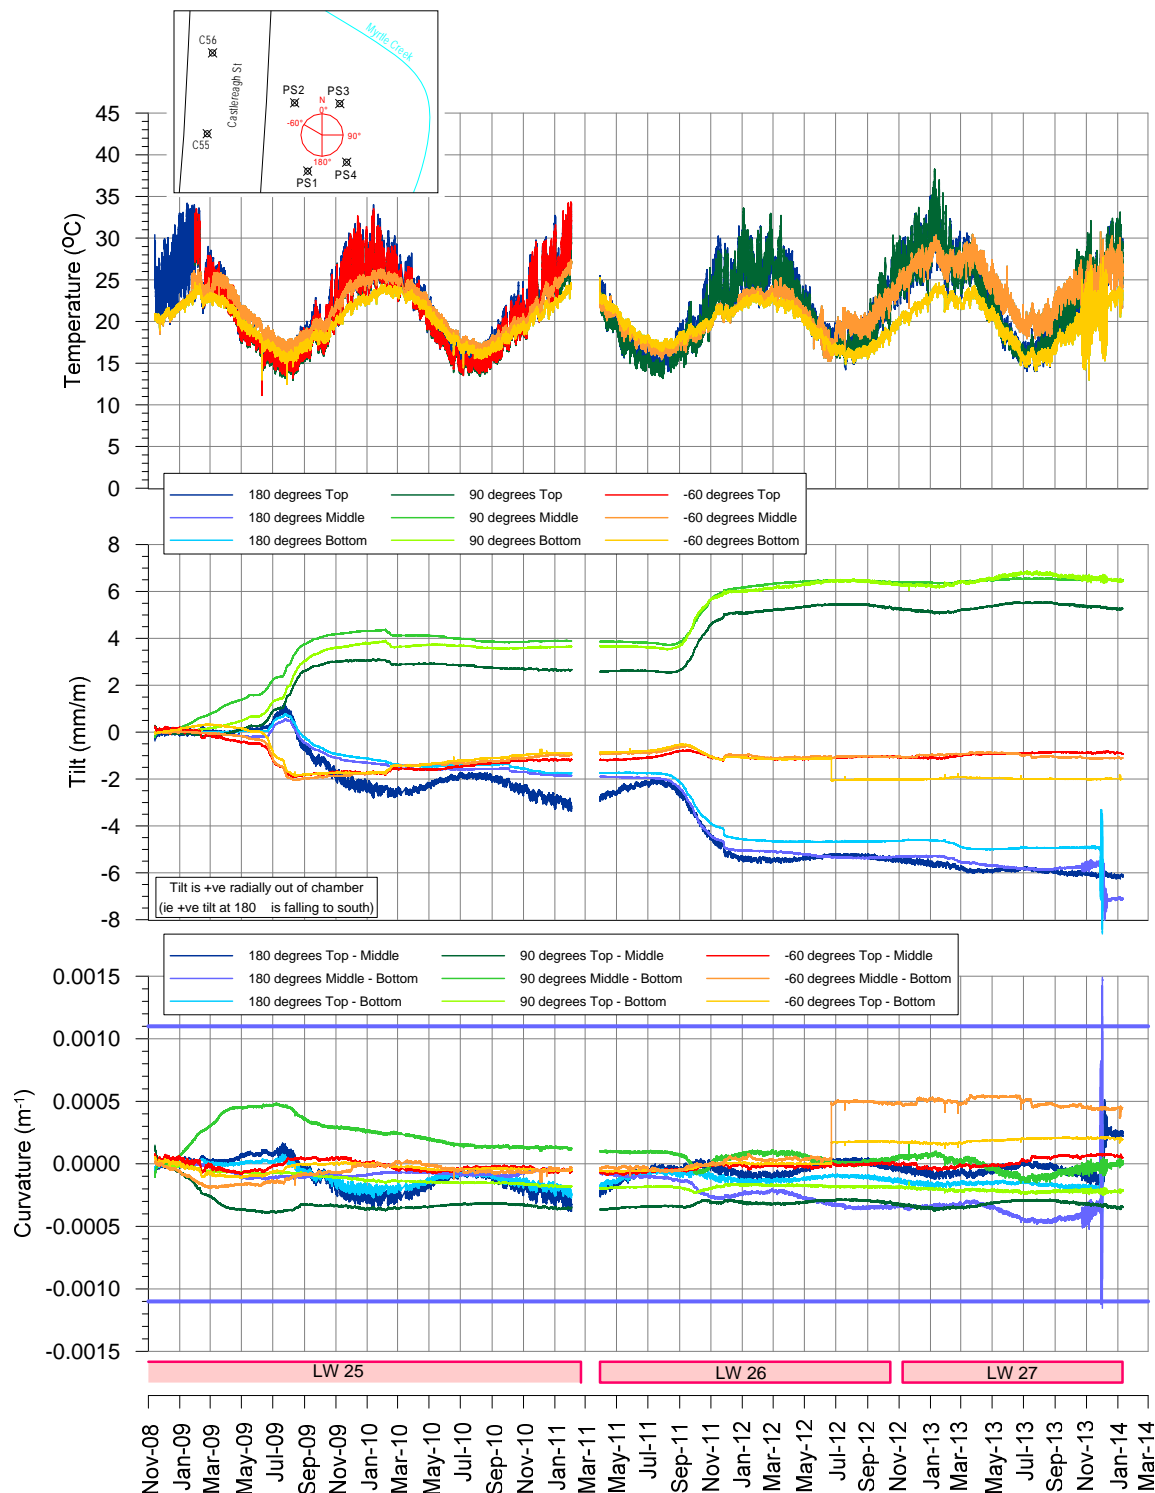
Fig. 2.23 Observed Tilts and Curvature of Walls of SP1045 measured by tiltmeters

Automated continuous tiltmeters monitored changes in tilt in 3 vertical lines, placed at the top, base and mid-point on the internal face of the chamber wall. As shown in Fig. 2.23, observed curvatures are well within trigger levels as defined under the Management Plan. Very little change was observed during the mining of Longwall 27. It can be seen that after more than 5 years of operation, some sensors have recorded erratic readings at the 180 degrees position in December 2013. These sensors will not be replaced.

Very little changes were observed during the mining of Longwall 27 and the pumping station is located approximately 700 metres from the side of Longwall 28. It is predicted to experience very little additional vertical subsidence during the mining of Longwalls 28 to 30.
