## XSTRATA COAL: **Tahmoor Colliery - Longwall 27**

Management Plan for Potential Impacts to Wollondilly Shire Council Infrastructure

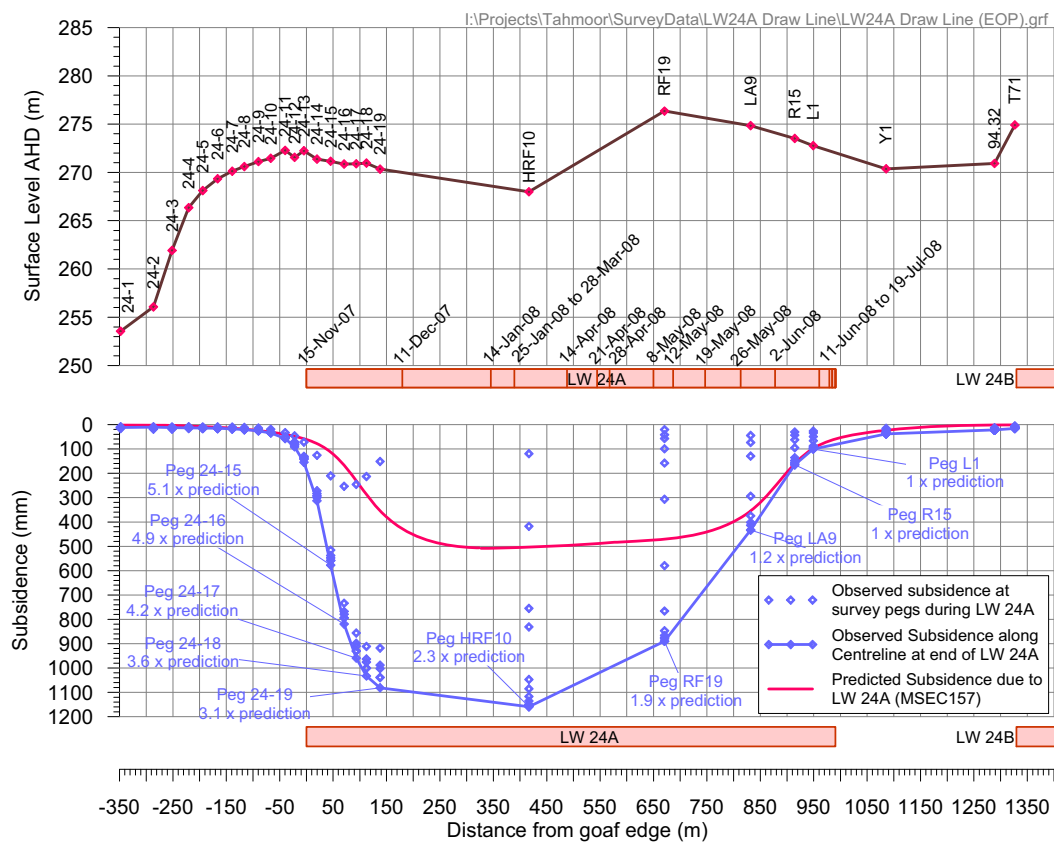
**Fig. 2.1 Observed Subsidence along Centreline of Longwall 24A**

It can be seen from Fig. 2.1 that observed subsidence was more than twice the predicted maximum value, reaching to a maximum of 1169 mm at Peg HRF10. It is possible that actual maximum subsidence developed somewhere between Pegs HRF10 and RF19, though this was not measured. Observed subsidence was similar to prediction near Peg R15 on Remembrance Drive. Survey pegs RF19 and LA9 are located within a transition zone where subsidence gradually reduced from areas of maximum increased subsidence to areas of normal subsidence.

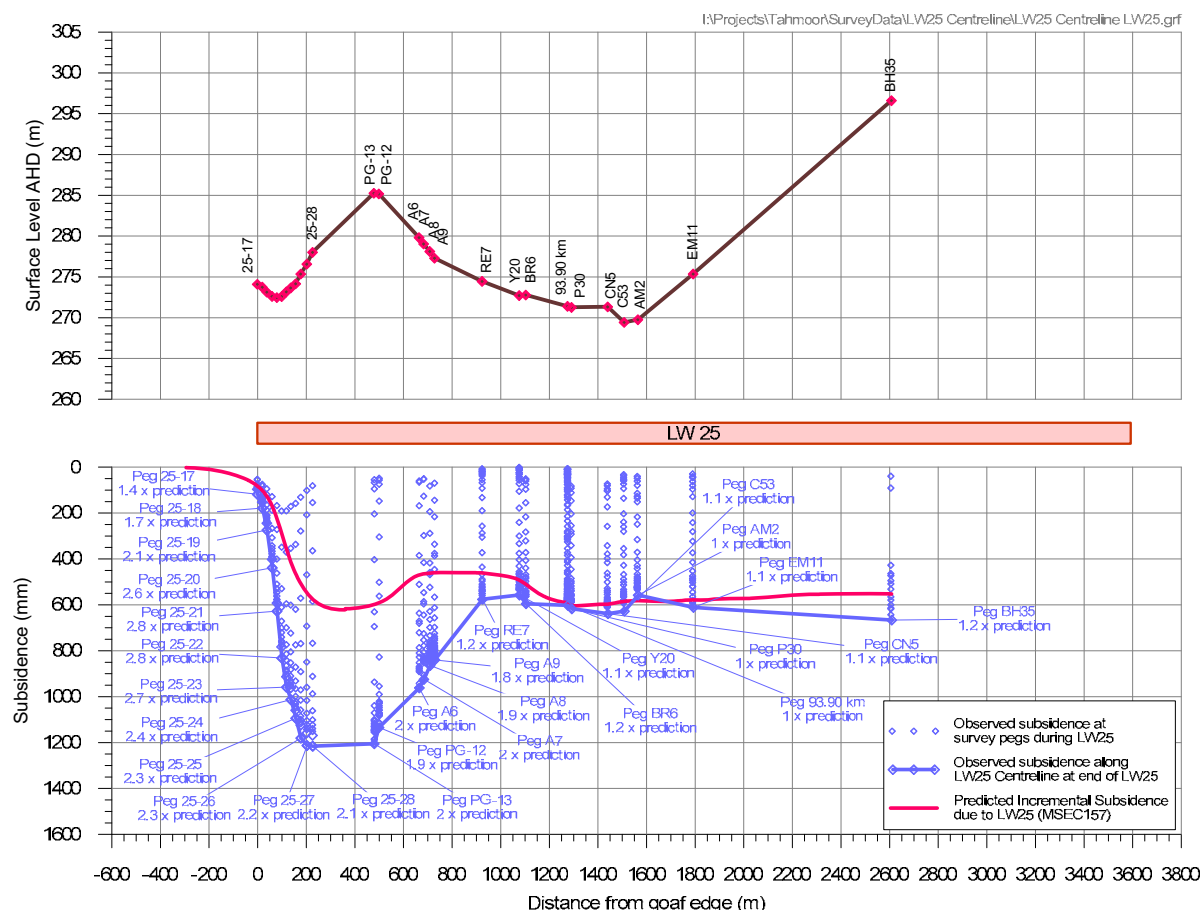
**Fig. 2.2 Observed Subsidence along Centreline of Longwall 25**

It can be seen from Fig. 2.2 that observed subsidence was approximately twice the predicted maximum value, with maximum subsidence of 1216 mm at Peg 25-28.

Observed subsidence is similar to but slightly more than predicted at Peg RE7 and is similar to prediction at Peg Y20 and at all pegs located further along the panel. Survey pegs A6, A7, A8 and A9 are located within a transition zone where subsidence has gradually reduced from areas of maximum increased subsidence to areas of normal subsidence.

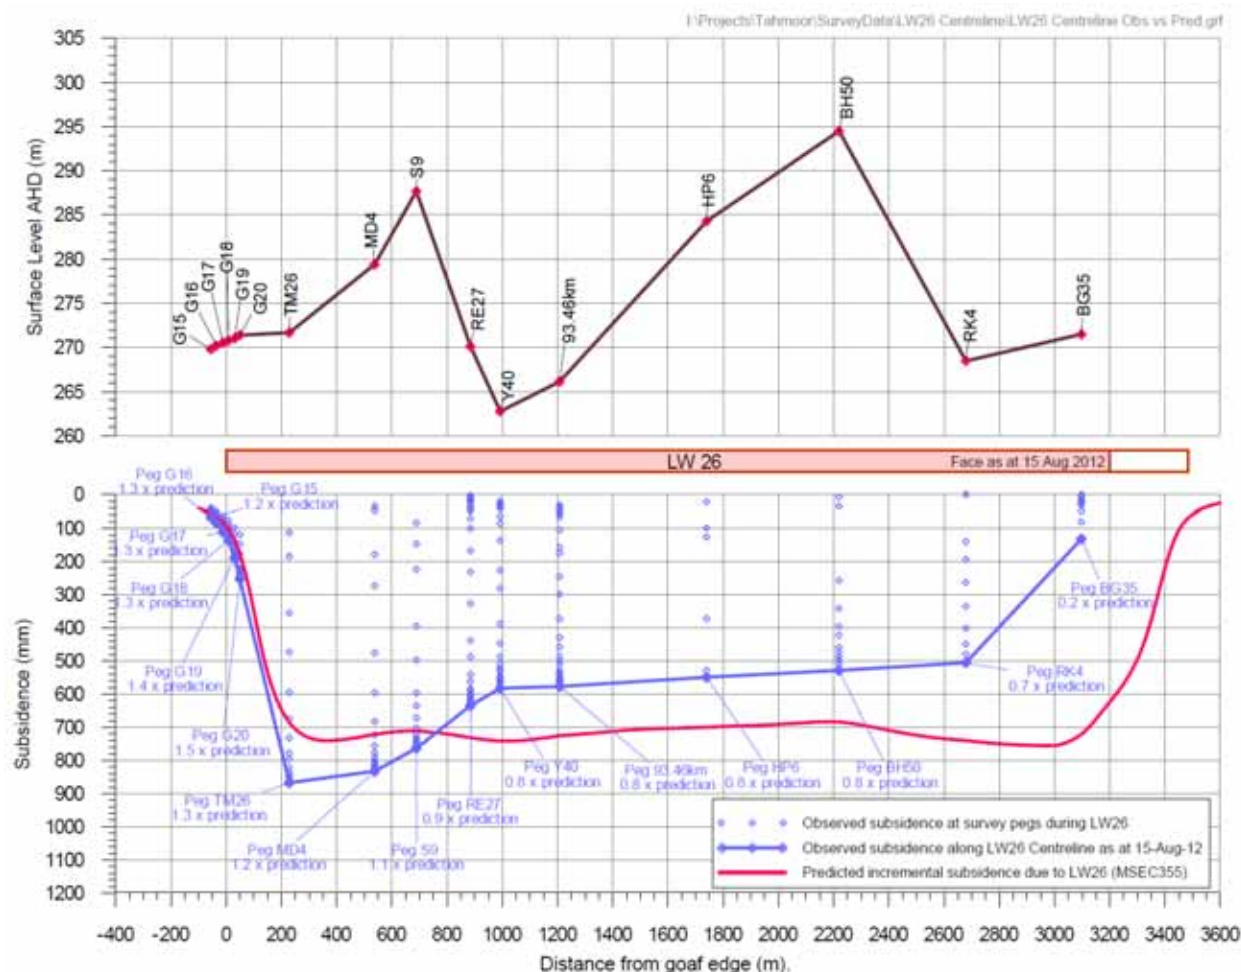
**Fig. 2.3 Observed Subsidence along Centreline of Longwall 26 as at August 2012**

It can be seen from Fig. 2.3 that observed subsidence was approximately 1.3 times the predicted maximum value, with maximum subsidence of 867 mm at Peg TM26.

Observed subsidence reduced along the panel until Peg Y40 on York Street, where it was less than prediction. Survey pegs S9, and RE27 are located within a transition zone where subsidence has gradually reduced from areas of maximum increased subsidence between Pegs TM26 and MD4 to areas of normal subsidence at Peg Y40 and beyond.

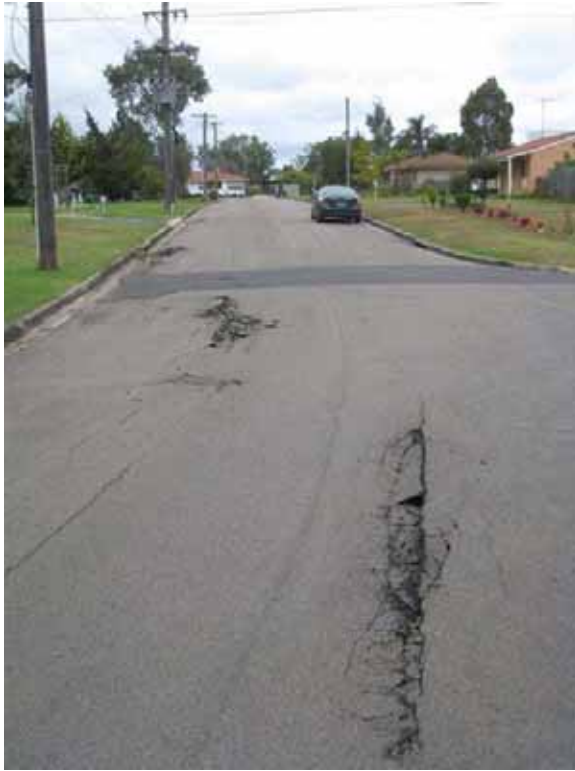
One of these impact sites, located on Lintina Street above Longwall 24A, was substantially greater than the other 11 impact sites. A selection of photographs is provided in Fig. 4.1. The impacts on Lintina Street were repaired twice by the Mine Subsidence Board as the longwall progressed.

Lintina Street (most severe to date)

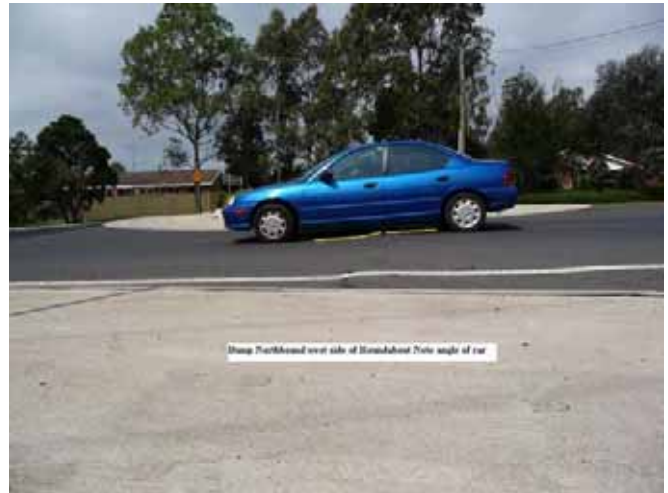
Impacts were also observed during the mining of Longwall 25. A hump was observed on Abelia Street during the mining of Longwall 25 and this has been repaired by the Mine Subsidence Board. A hump was also observed on Remembrance Drive at the roundabout intersection with Thirlmere Way, as shown in Fig. 4.1.

Remembrance Drive (hump at roundabout)

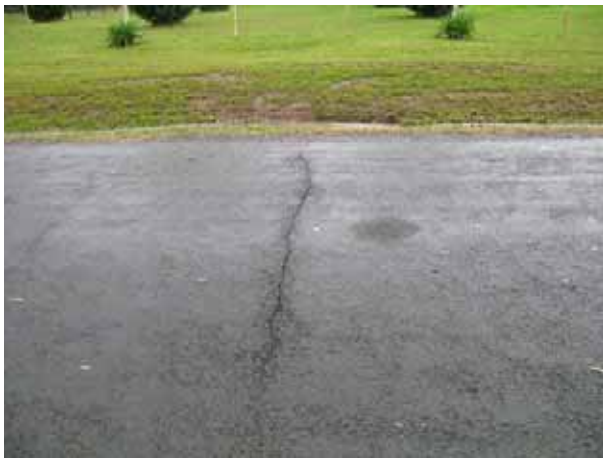
Brundah Road (typical impact to pavement)

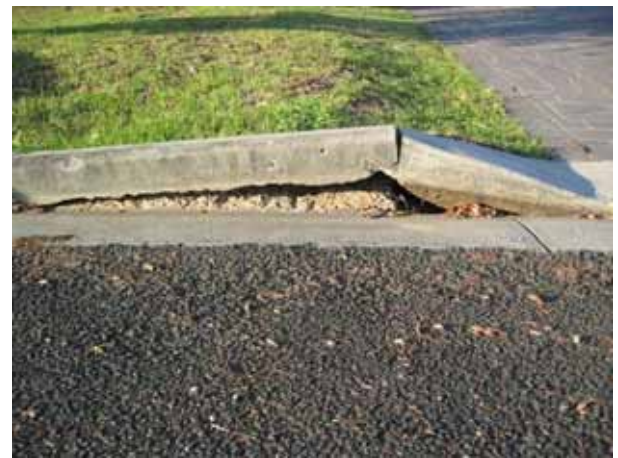
More frequent impacts have been observed to concrete kerbs and gutters. The impacts are most commonly focussed around driveway laybacks and involve cracking, spalling or buckling. A typical buckling impact is shown in Fig. 4.1.

Patterson Street (typical impact to kerb)

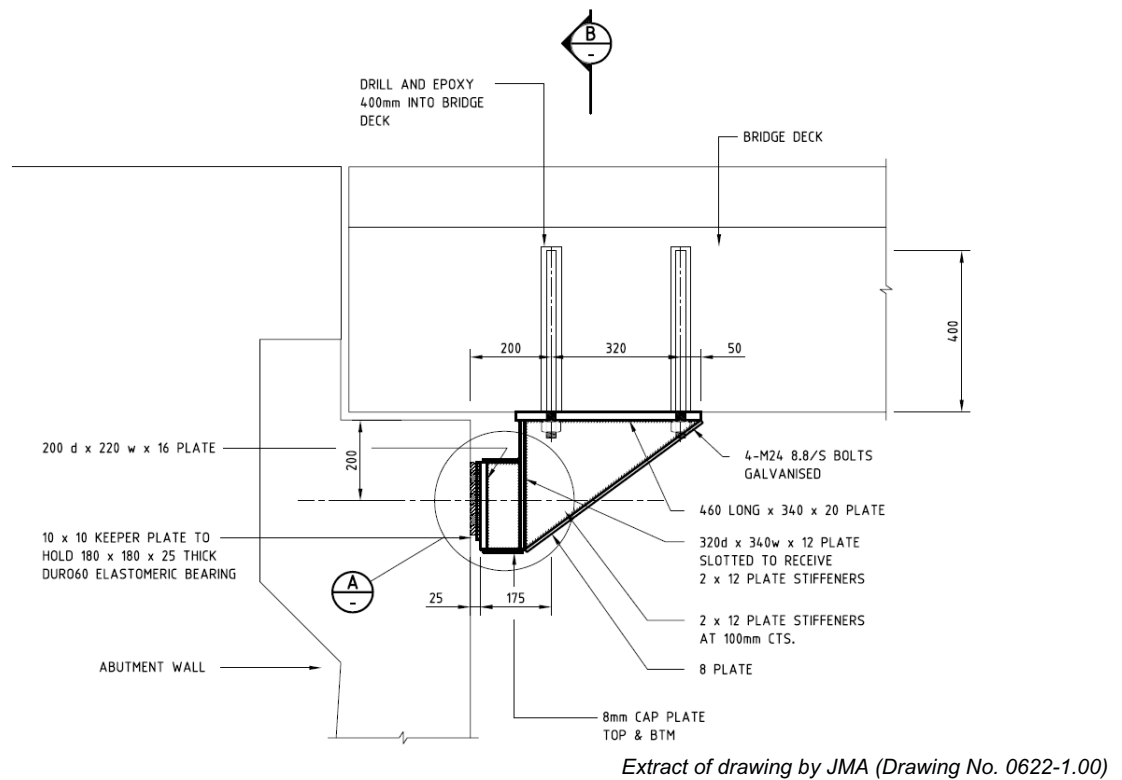
**Fig. 4.5 Design of Mitigation Measures beneath Bridge Deck**

Prior to mining, a structural assessment of Castlereagh Street Bridge was undertaken by John Matheson & Associates (JMA, 2006), based on a site inspection and review of structural drawings that were provided by Wollondilly Shire Council. The assessment identified that in the event of abutment closure, it was expected that the concrete hob behind the abutment will initially crack and shear. This impact was not expected to result in any reduction in stability of the bridge. As abutment closure increased the steel dowels that connected the deck to the abutment walls were expected to shear. This impact was not expected to result in any long-term structural concerns as the abutment walls were designed as freestanding cantilevers. However, JMA identified a potential risk where cracking may occur to the abutment corbel at the time the dowels sheared and that this cracking may have occurred suddenly as the abutment support transferred from a propped cantilever to a freestanding cantilever.

JMA recommended that the abutments could be protected at the moment of dowel failure by the installation of steel brackets bolted to the end of each bridge deck girder (13 number girders and 26 number brackets), which bear against the abutment walls (JMA, 2007). The brackets provided additional support to the abutment walls, ensuring that the dowels could shear without breaking the concrete that surround them. The design of the brackets is shown in Fig. 4.5 and a photograph of the completed installation is shown in Fig. 4.6. The galvanised brackets were installed by Tahmoor Colliery prior to the commencement of Longwall 25.

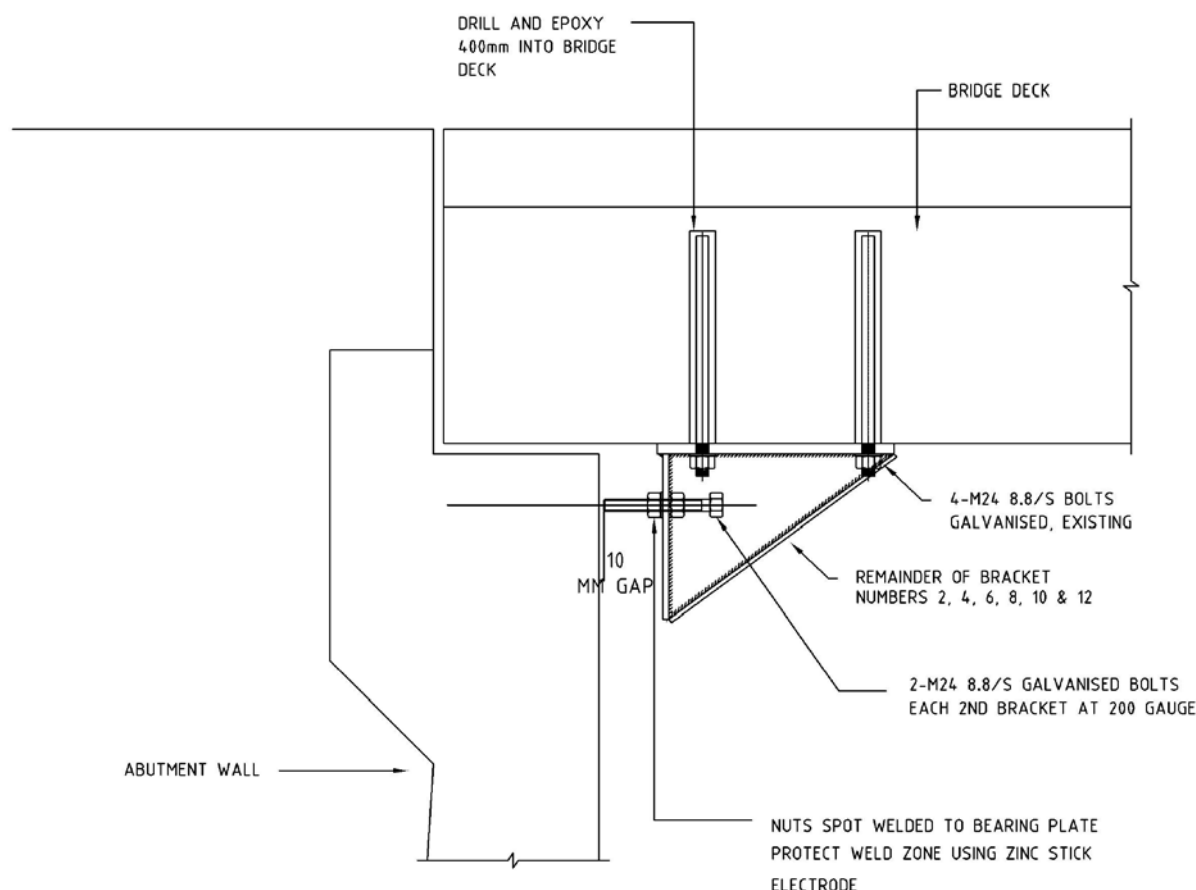
**Fig. 4.7 Bracket Adjustment Detail (courtesy John Matheson & Associates)**

Differential movements between the bridge deck and the abutments had been observed to gradually increase and they exceeded the BLUE trigger level that had been defined in the Longwall 25 Management Plan. The brackets were cut and set back from the southern abutment on Monday, 7 September 2009. Further small movements were observed after the brackets were removed. At the completion of mining, there was a small air gap between the abutment walls and the bracket supports so that there was no pressure on the brackets, abutments or bridge deck, as shown in Fig. 4.7.

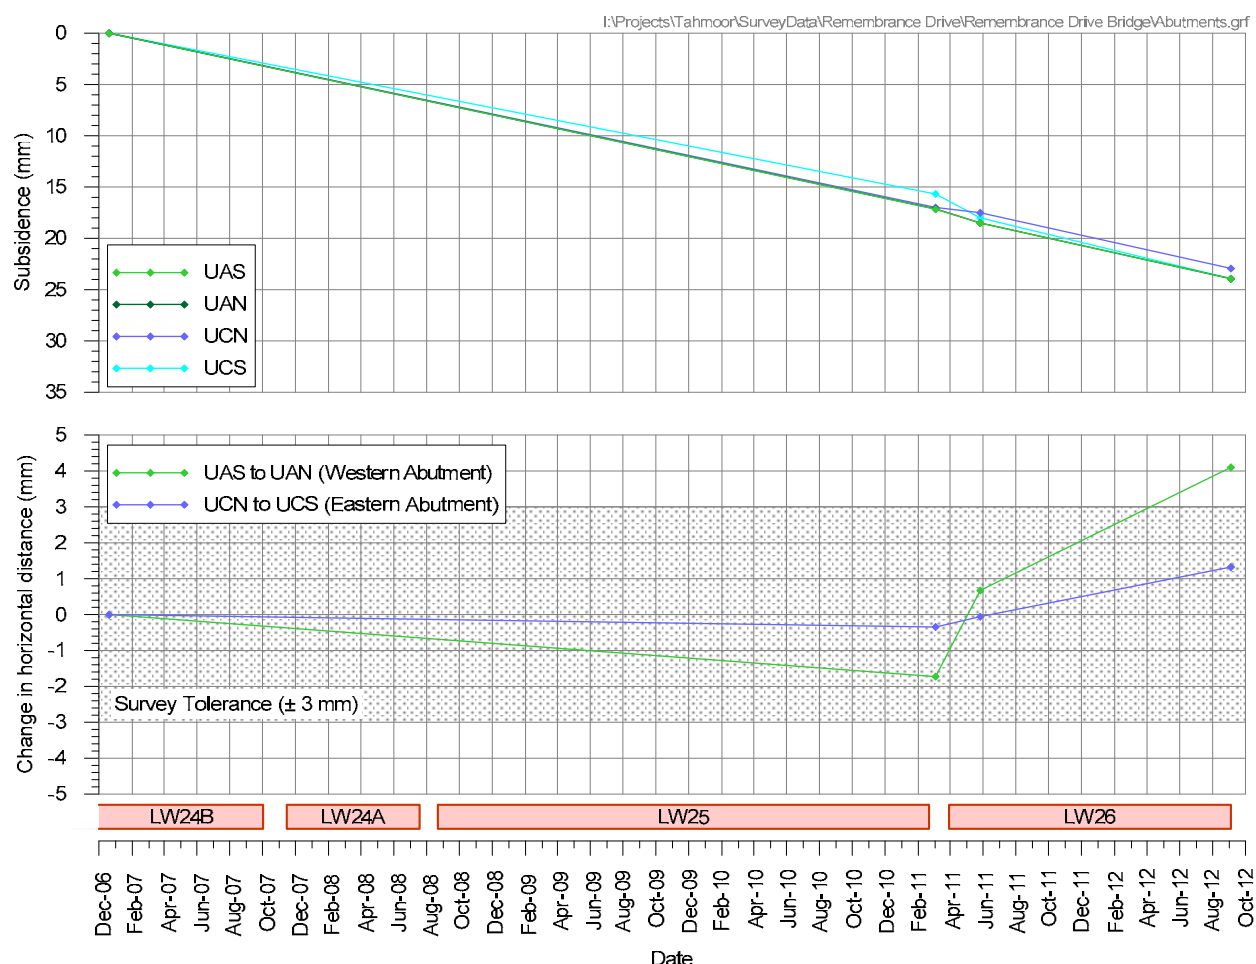
**Fig. 4.12 Observed subsidence and changes in horizontal distances across the abutment of Remembrance Drive (Myrtle Creek) Road Bridge**

Survey marks were installed on the Remembrance Drive Road Bridge prior to the extraction of Longwall 24A. While the Bridge has experienced approximately 25 mm of subsidence, measured changes in horizontal distances between the abutments are very small and close to survey tolerance. No closure has been detected and instead, a small opening has been measured. Vertical subsidence is relatively consistent across all survey marks, indicating that no measureable upsidence has occurred to date.

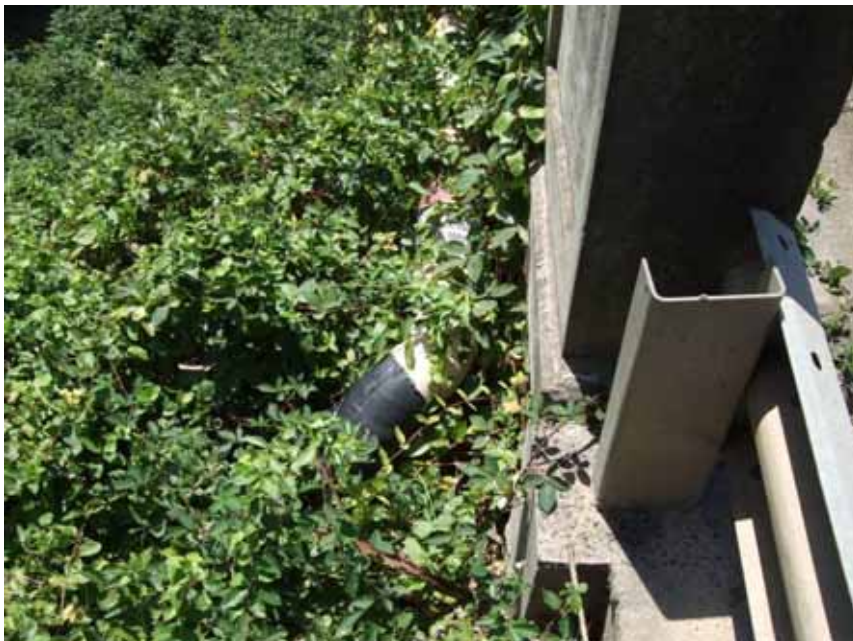
Figure 10 Gas pipeline emerging from the ground next to the southwest corner of bridge

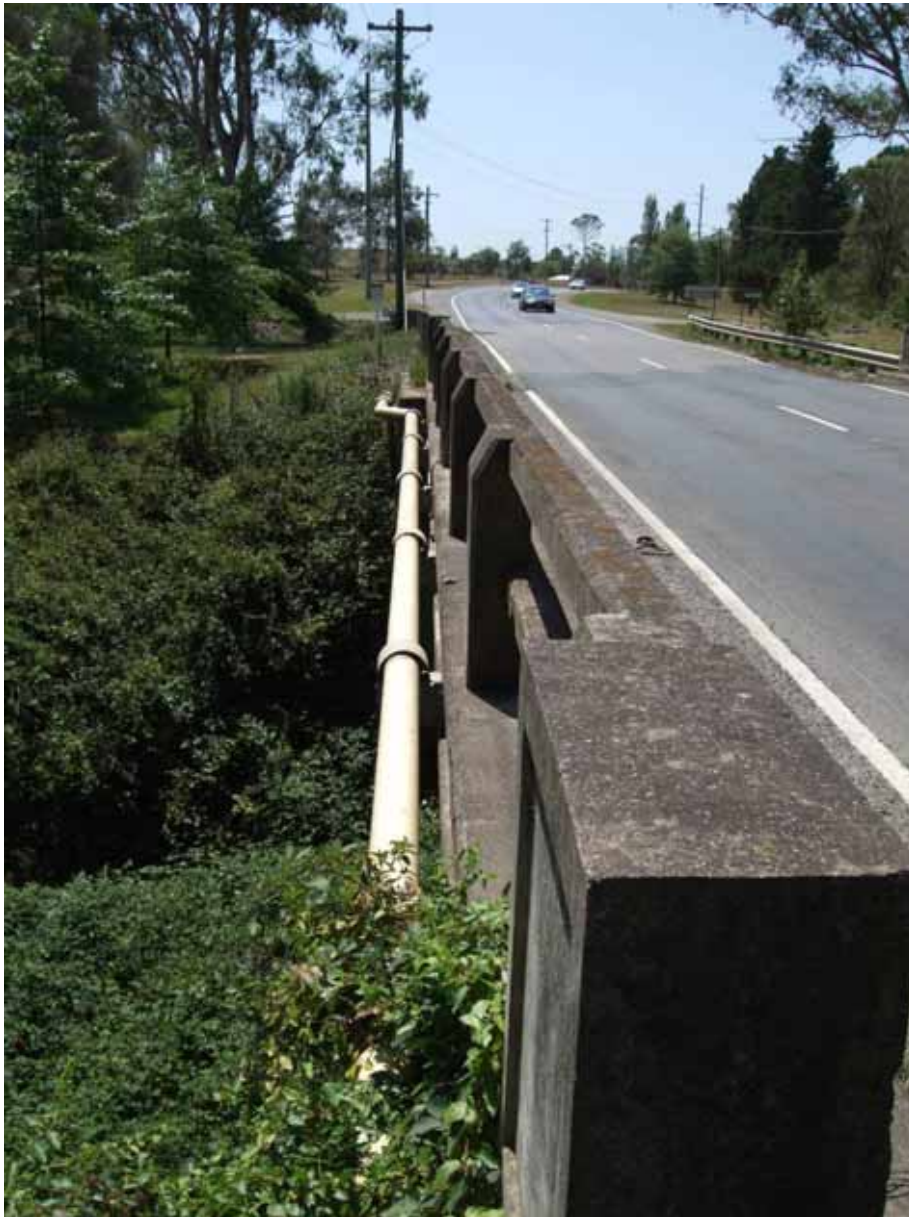
Figure 11 Gas pipe support along bridge.
