SIMEC Mining – Tahmoor Coal

Management Plan for extraction of Tahmoor South LW S4A-S7A adjacent to Wellers Road Overbridge

Revision A

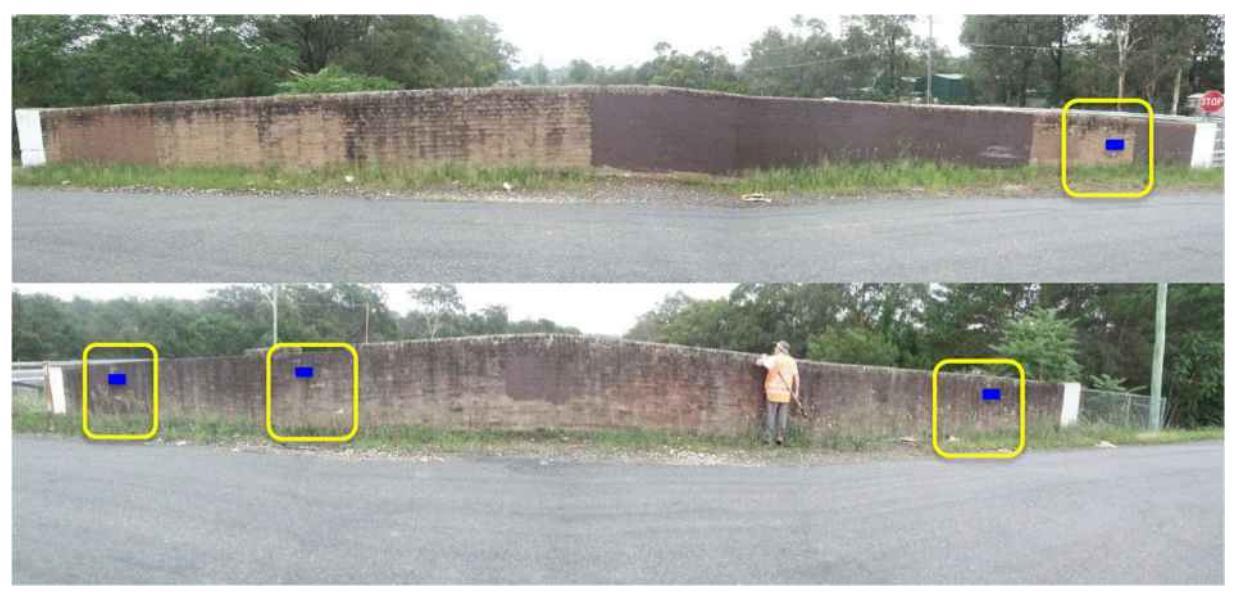
A photograph of the road pavement over the Overbridge is shown in Fig. 3.2. The brick parapet walls have experienced impacts from vehicle traffic.

Photograph courtesy JMA Solutions (2022b) with blue lines where crack gauges are recommended

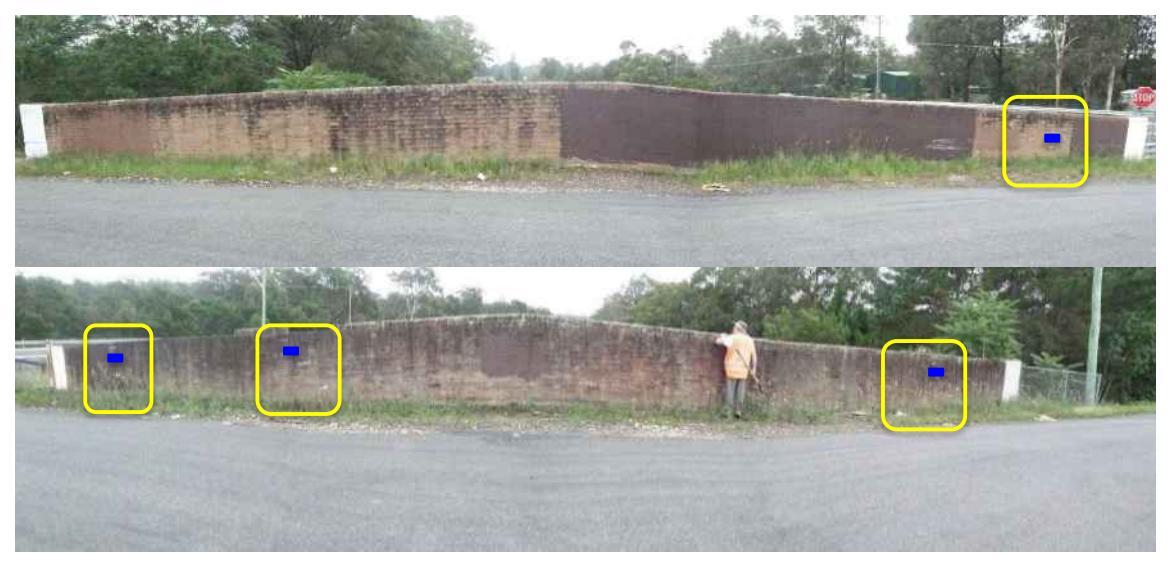
Cracking was observed at four locations on the parapet walls, which could have been caused by the impact of traffic loading that has been superimposed on seasonal temperature effects, see **Figure 3**.

Figure 4 Parapet wall (Sydney top) cracking showing recommended locations for Type G2 crack gauges.

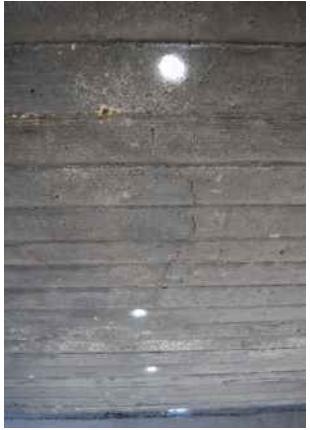
Figure 13: DSC_2866 Crack 1, gauge G1 upside

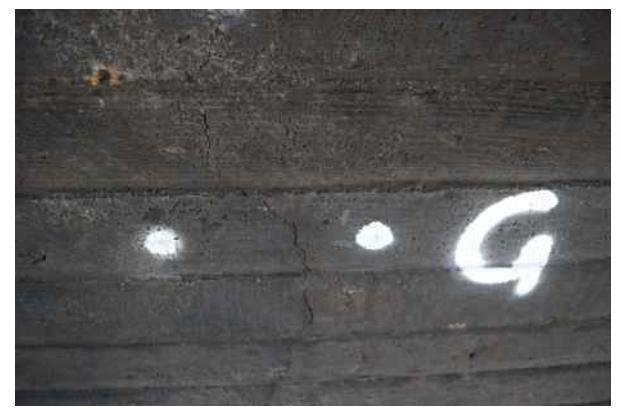
Figure 15: DSC_2869 Crack 1, gauge G1 upside

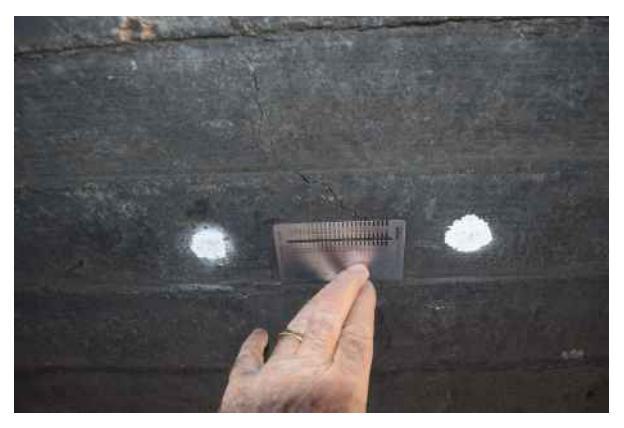
Figure 14: DSC_2868 Crack 1, gauge G1 upside

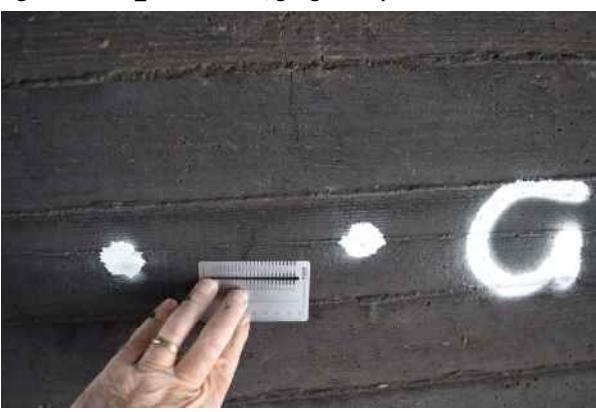
Figure 16: DSC_2870 Crack 2, gauge G2 upside

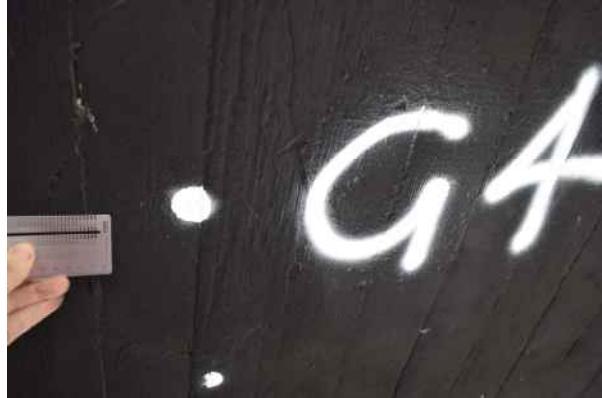
Figure 19: DSC_2873 Crack 4, gauge G4 midspan

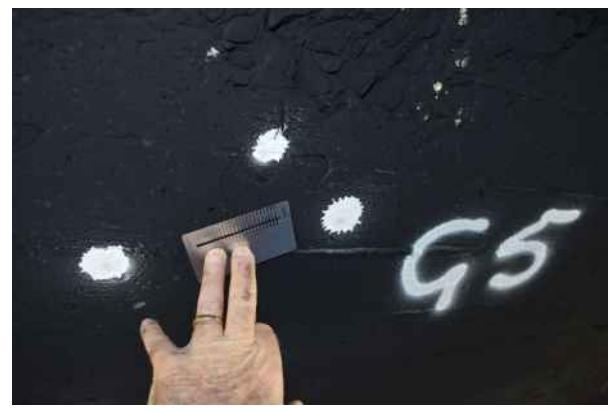
Figure 21: DSC_2875 Crack 5, gauge G5 midspan

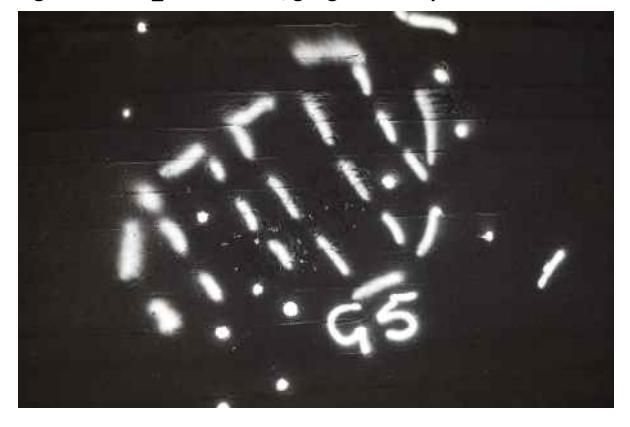
Figure 23: DSC_2877 Rounded aggregate exposed on surface

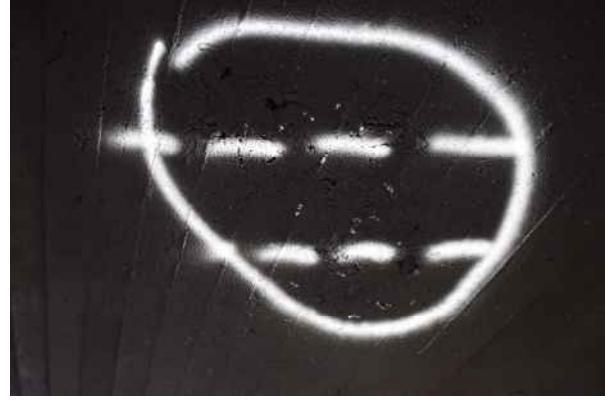
Figure 24: DSC_2878 Rounded aggregate exposed on surface

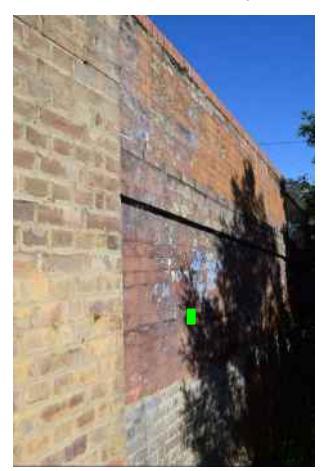
Figure 45: DSC_2891 Gauge G1 on upside 1500mm off buttress

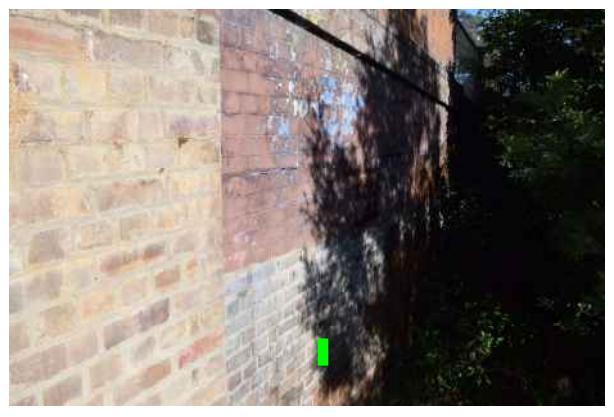
Figure 47: DSC_2893 Gauge G1 on crack low down on upside

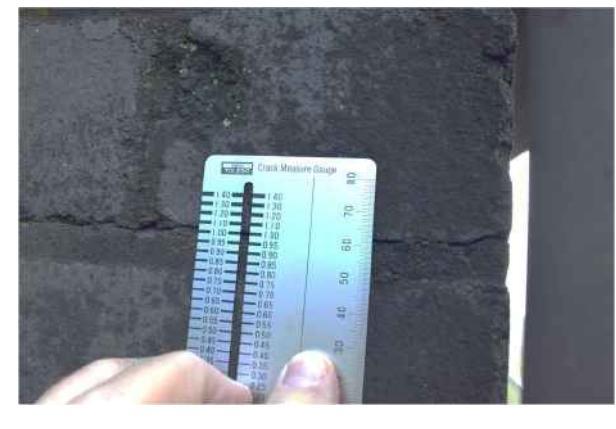
Figure 53: DSC_2837 Underlying crack width < 1mm

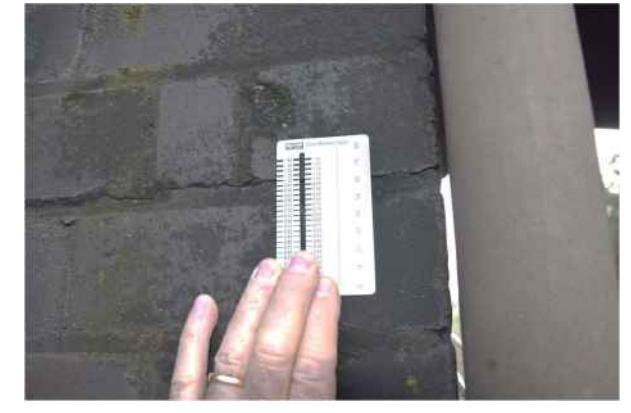
Figure 54: DSC_2838 Underlying crack width < 1mm

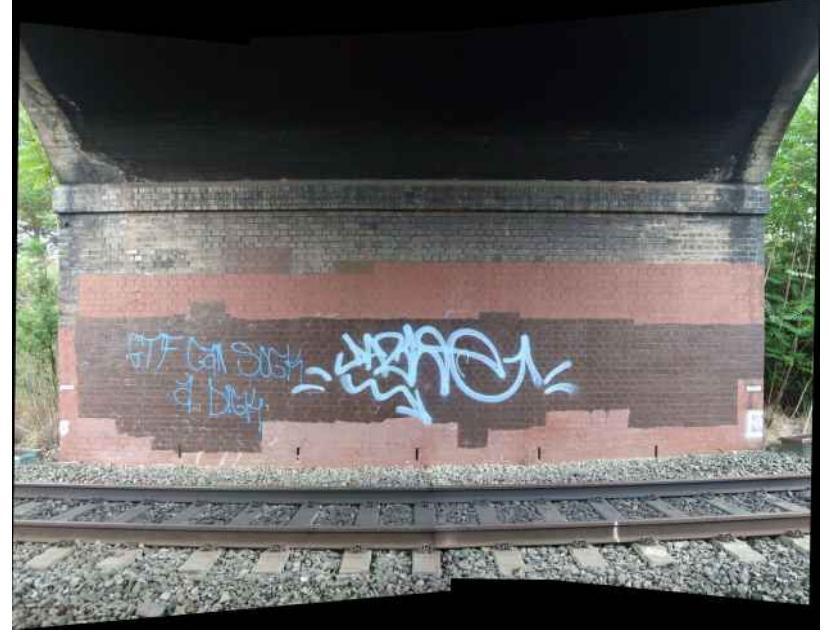
Figure 57: Bridge 101 No noticeable cracking

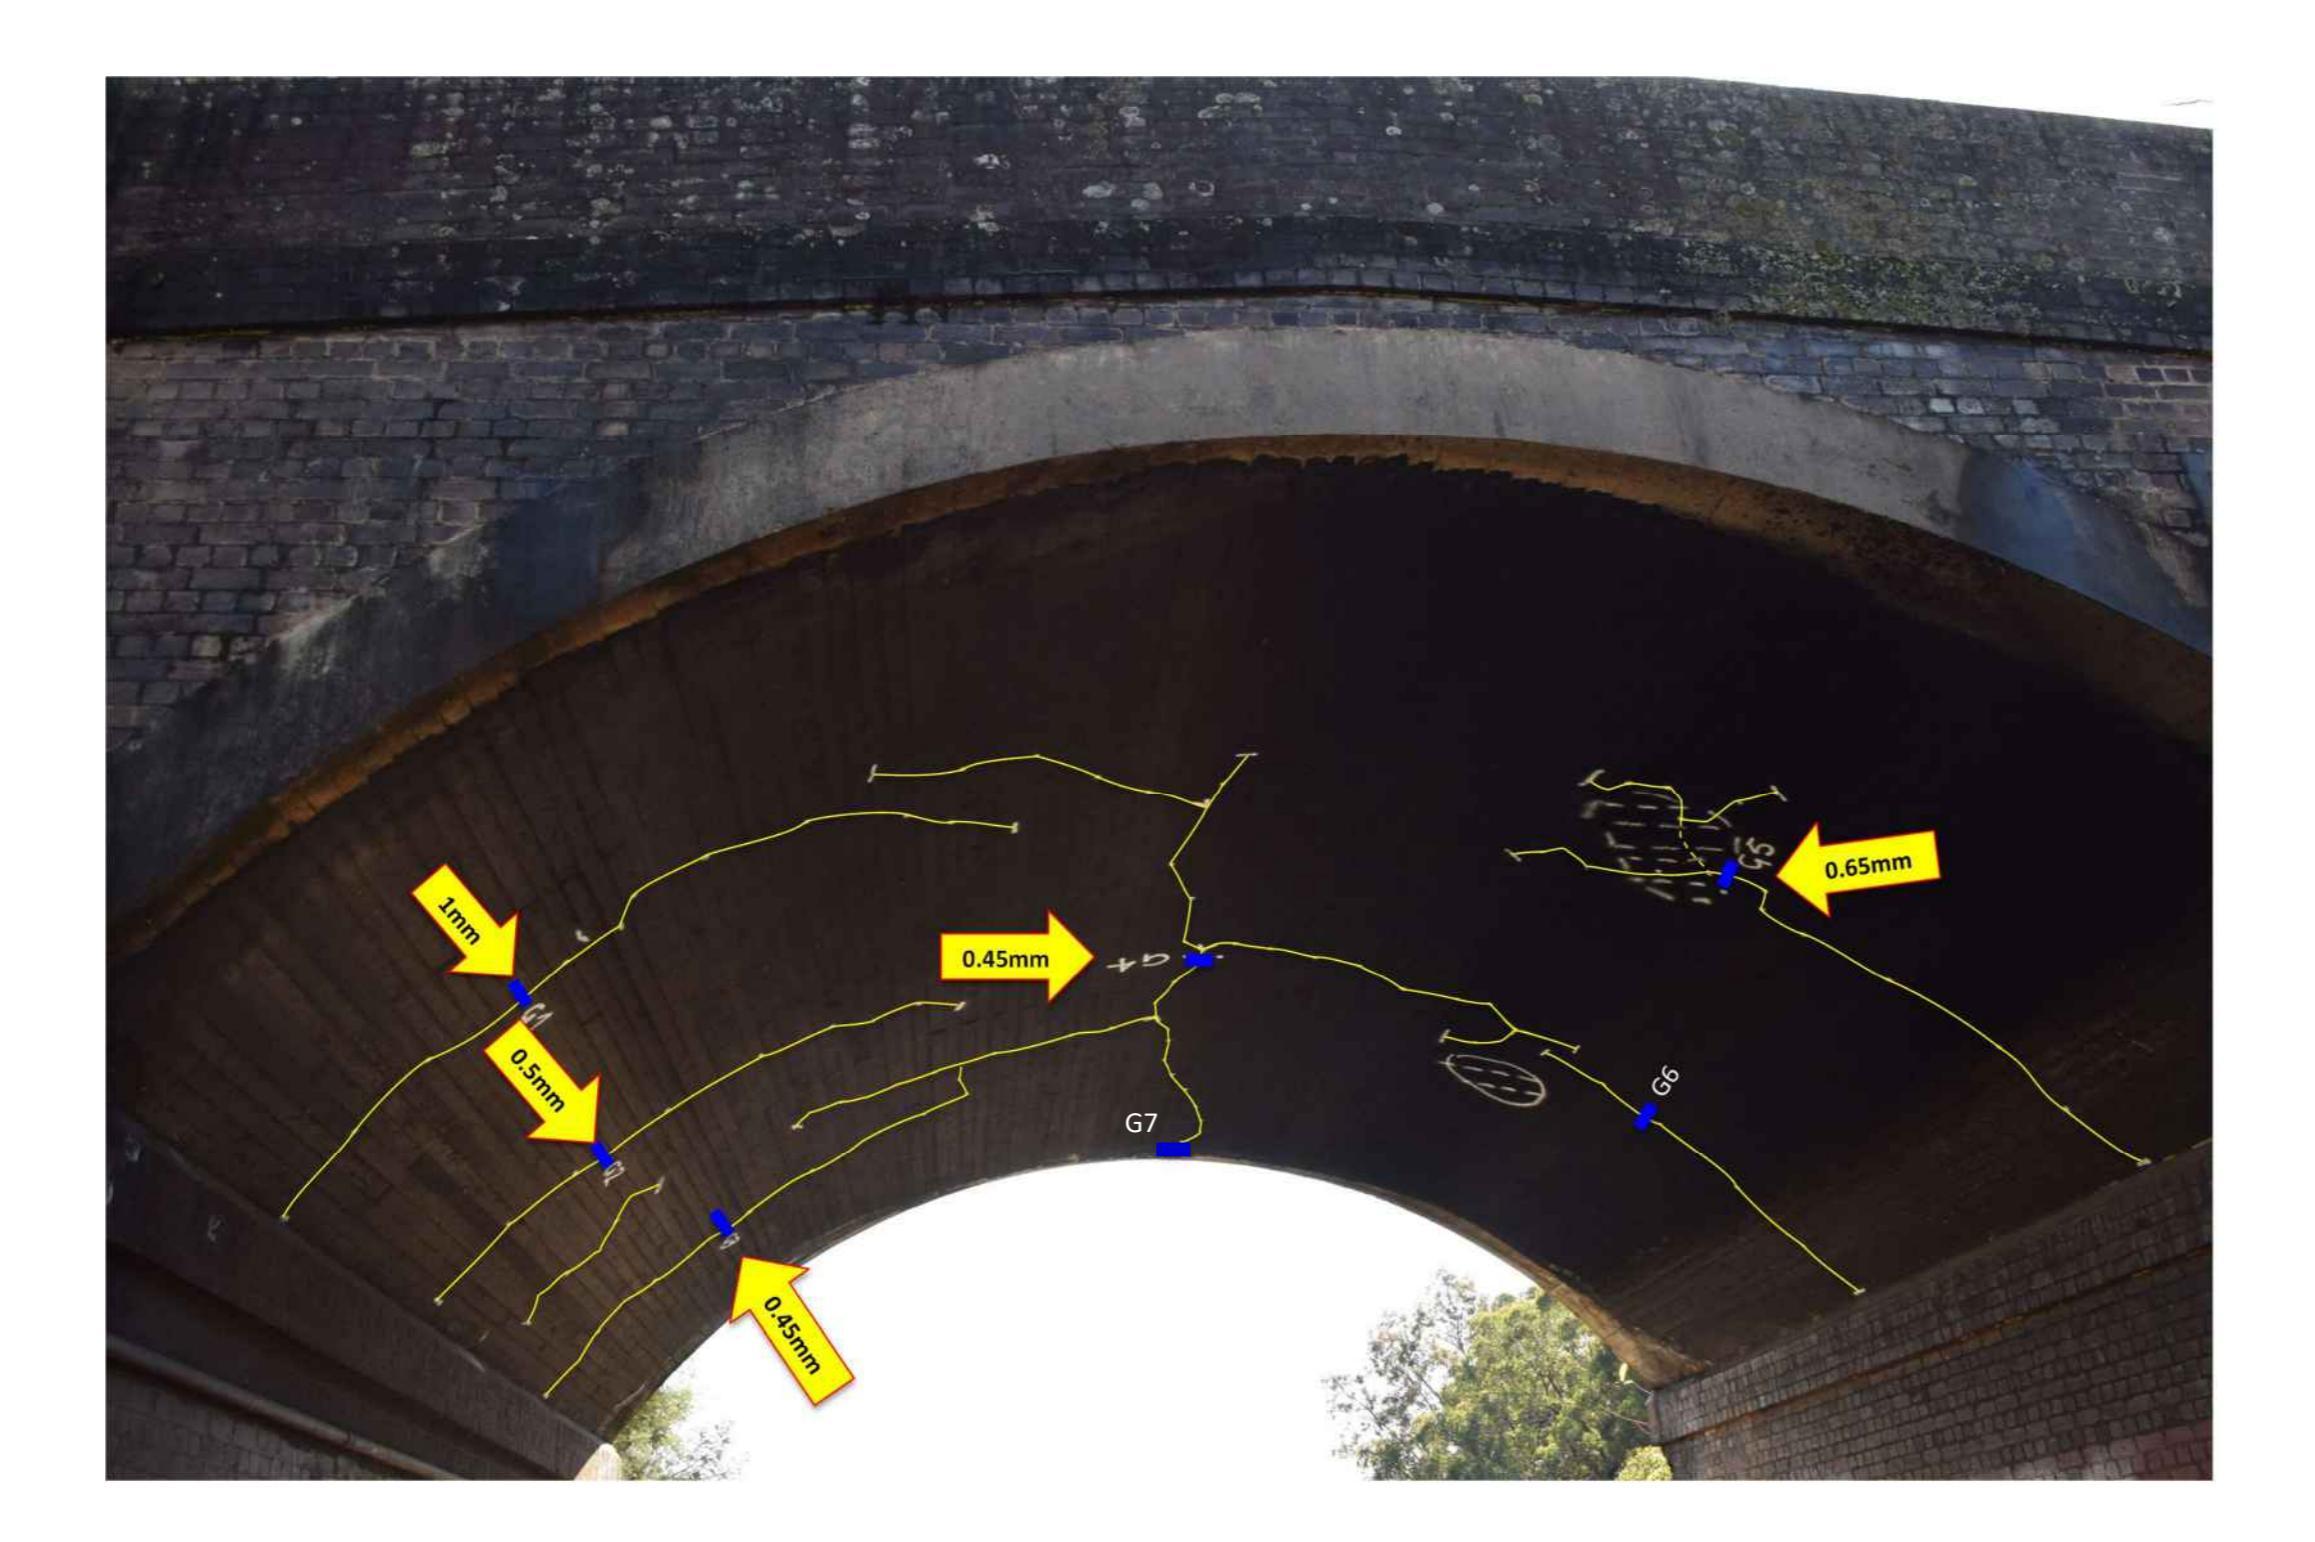
Figure 60 View from the countryside showing the location of seven (7) recommended intrados Type G2 crack gauge locations to monitor for change in width of pre-existing cracks noting that the longitudinal cracks around the circumference could corelate with the locations of 80 lb rails, see Figure 3.

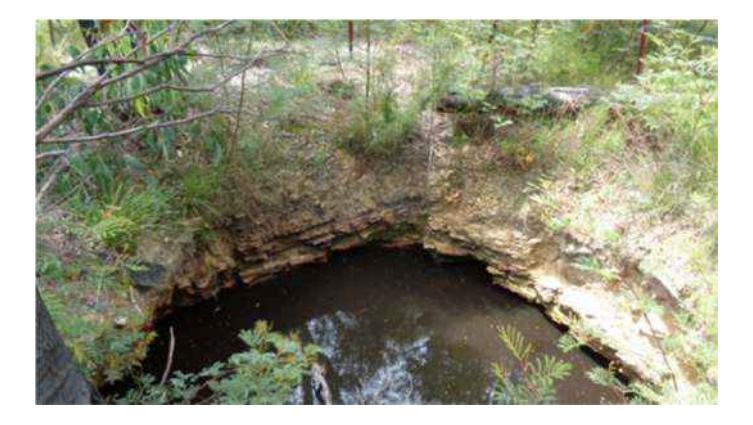
Figure 3 – 99.530 downside well with fractured shale rock indicating a possible fault

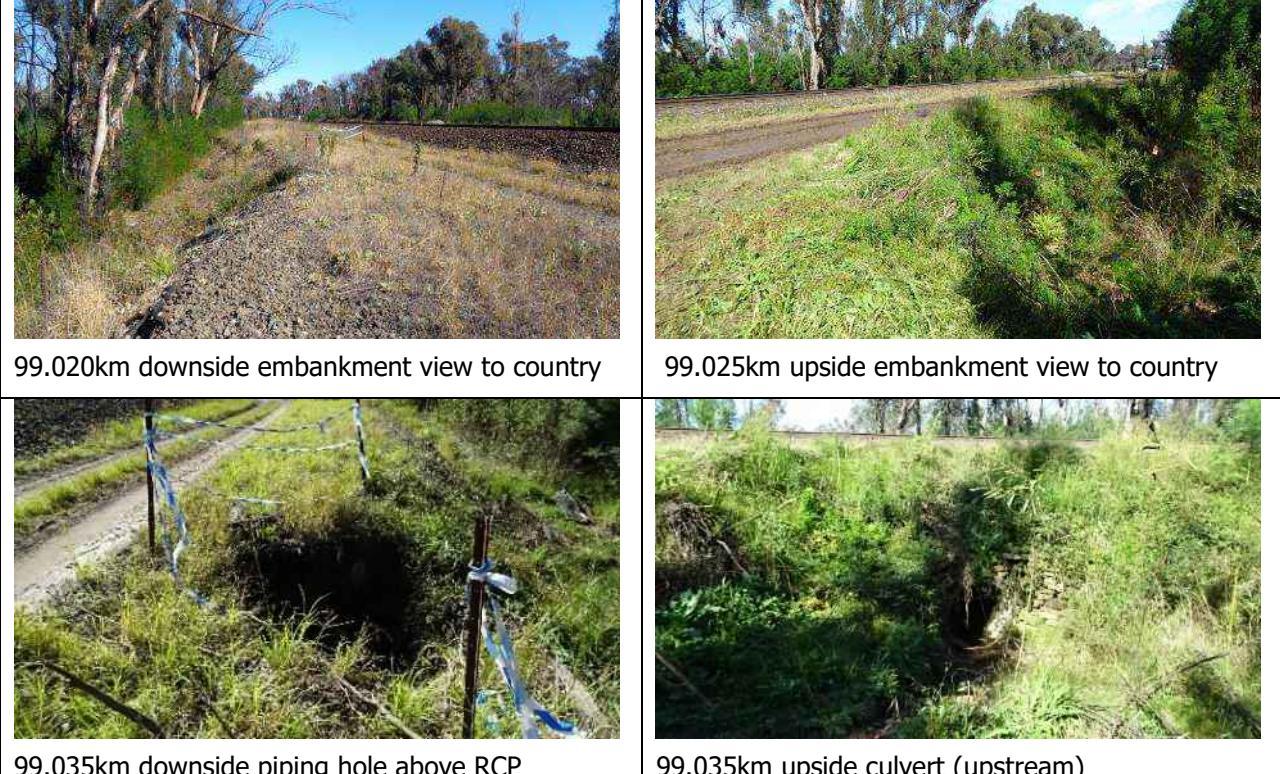
Embankment listed in ARTC Geotechnical Risk Site database as site 13493. Site added to database in June 2020 after reports of a sinkhole at 99.035km above the culvert on the downside edge of the access road with a very low risk classification of 6 (non-active site).

99.035km downside piping hole above RCP extension
