TAHMOOR COAL PTY LTD ABN: 97076663968

Tahmoor South LWS1A-S6A Water Management Plan

Myrtle Creek and Redbank Creek Remediation Progress Review

121171.17, R02, Rev D May 2022

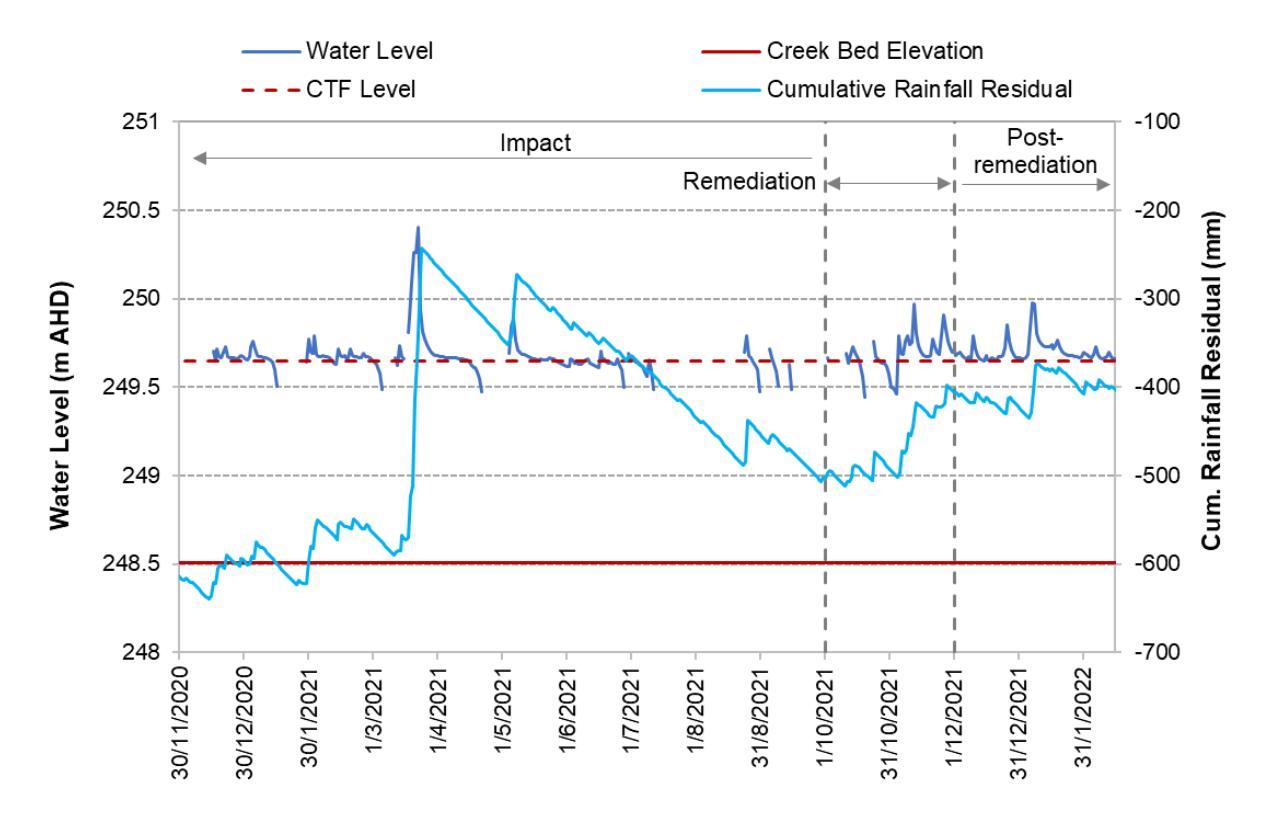
GRAPH 1: MYRTLE CREEK POOL 10 - WATER LEVEL RECORDS AND RAINFALL RESIDUAL

The data presented in Graph 1 illustrates that, prior to remediation, the water level at pool 10 regularly declined below the level of the sensor, as illustrated by gaps in the dataset. From mid-way through the remediation period to post-remediation (early November 2021 to February 2022), the water level remained continuously above the CTF level with pool 10 continuously overflowing to the downstream reach of Myrtle Creek. This period coincided with generally above average rainfall as illustrated by the increasing trend in the cumulative rainfall residual. Maintenance of the pool water level above the CTF level is considered likely due to both the remediation works and above average rainfall recorded during

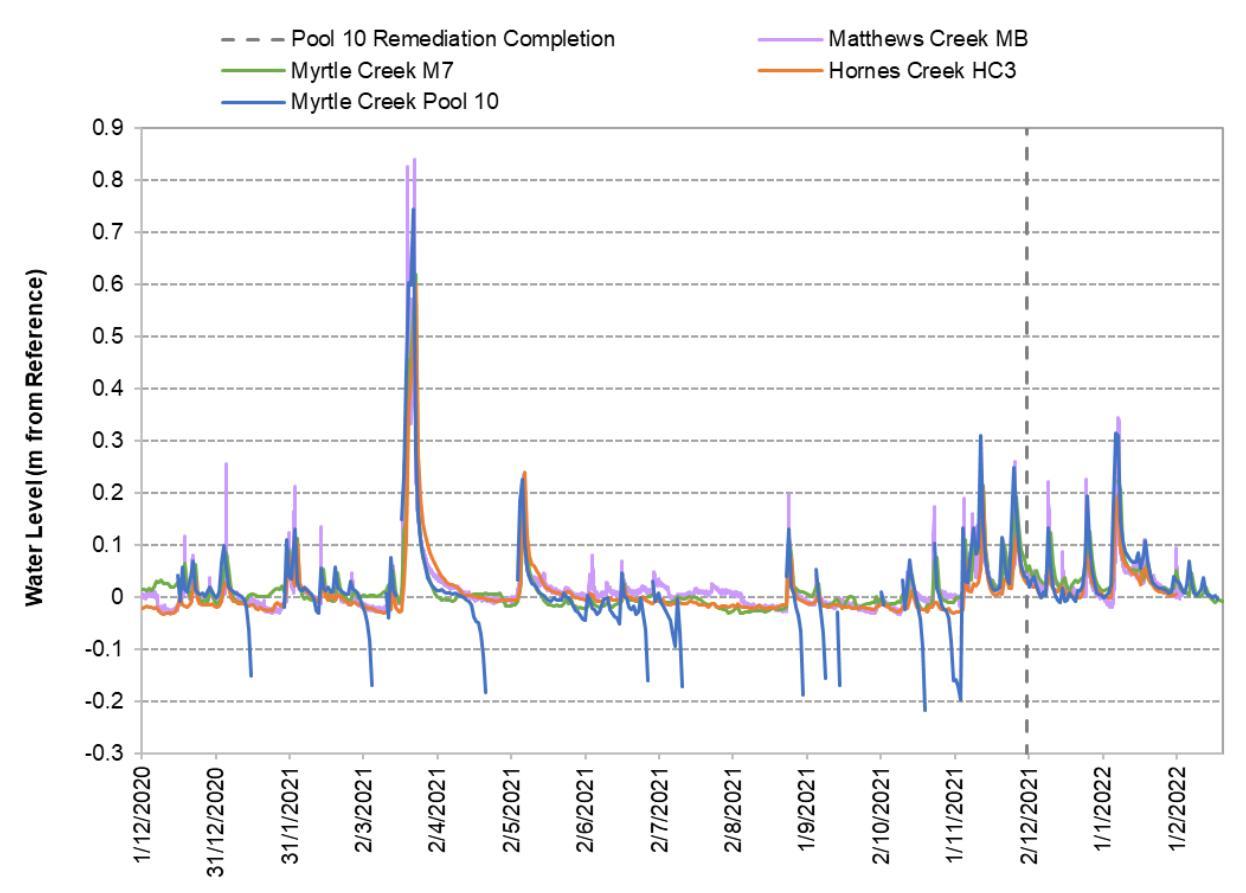
GRAPH 2: MYRTLE CREEK POOL 10 AND REFERENCE SITES - WATER LEVEL COMPARISON

The data presented in Graph 2 shows that the hydrological behaviour of reference sites Myrtle Creek M7, Hornes Creek HC3 and Matthews Creek MB were similar for the period of record although higher water levels tended to be recorded at Matthews Creek MB during rainfall events. There is an evident difference in the pre-remediation hydrological behaviour of pool 10 compared with the reference site water level behaviour. Post-remediation, the water level behaviour of pool 10 is generally consistent with that of the reference sites with similar recessionary behaviour recorded.

Although it is evident that there has been an improvement in the pool 10 water holding capacity postremediation, the area has experienced above average rainfall during this period. As such, additional post-remediation monitoring data, recorded during periods of below average rainfall, is recommended to provide further confidence in the effectiveness of remediation works at pool 10.

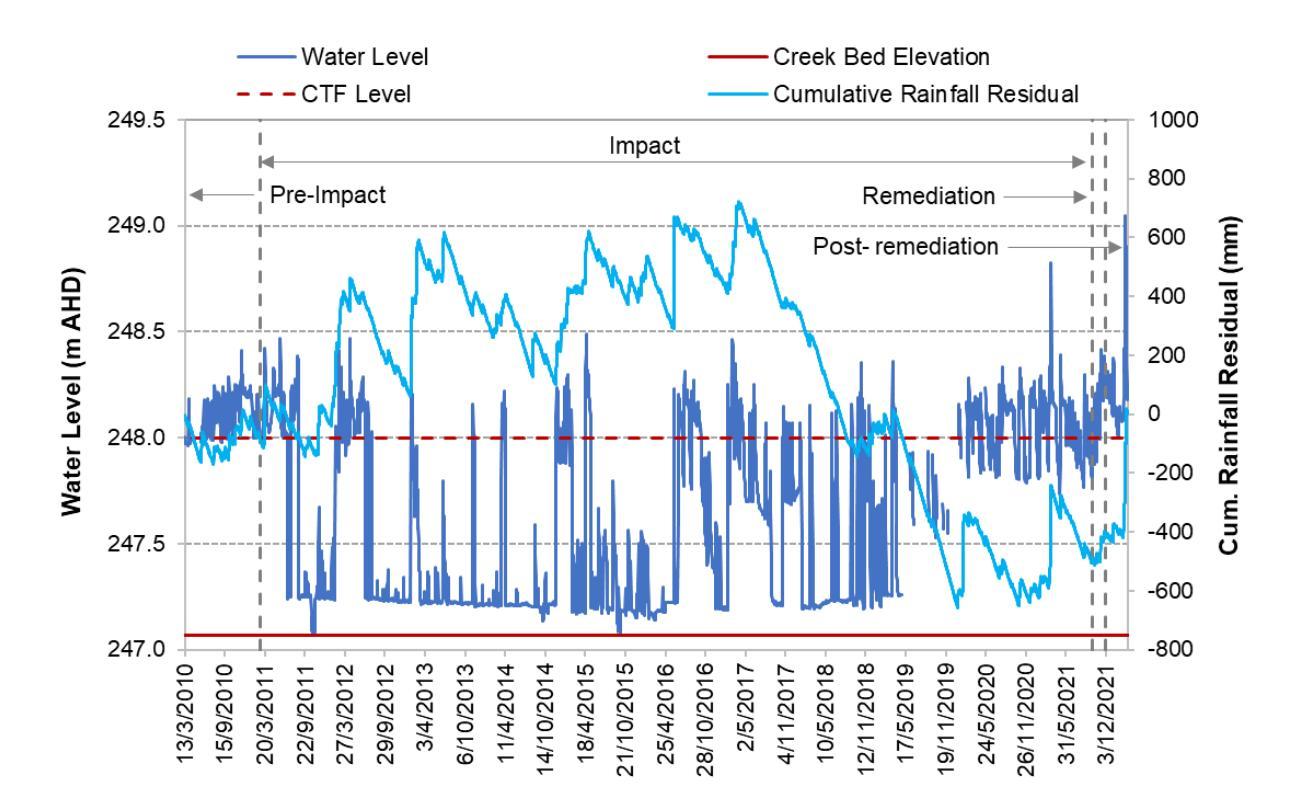
GRAPH 3A: MYRTLE CREEK POOL 11 - WATER LEVEL RECORDS AND RAINFALL RESIDUAL – 2010 TO 2022

Impacts to pool 11 were reported as occurring during mining of LW26 (March 2011 to October 2012) (GeoTerra, 2019), however, the exact date of initial impact was not recorded. During the pre-impact period prior to March 2011, the water level trended was recorded above the CTF level. Following impacts, the water level regularly and rapidly declined to a level close to the pool base. Following

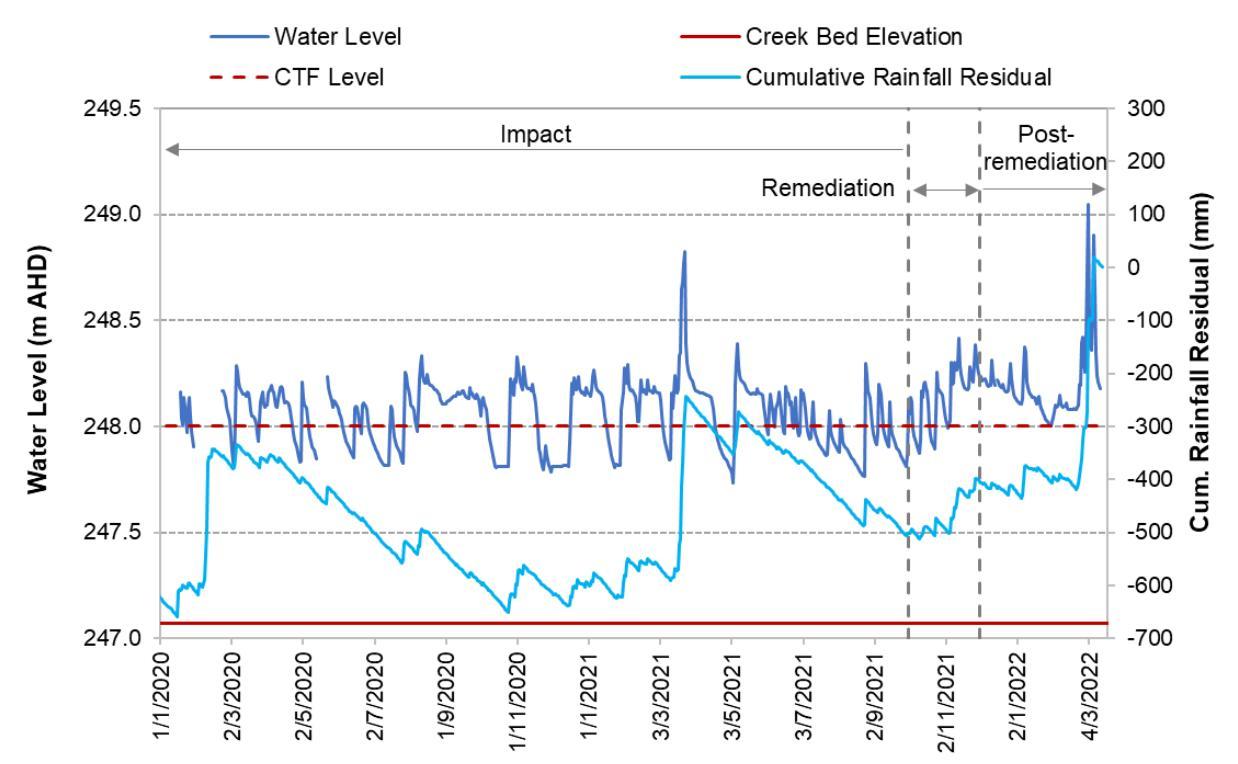
GRAPH 3B: MYRTLE CREEK POOL 11 - WATER LEVEL RECORDS AND RAINFALL RESIDUAL – 2020 TO 2022

substantial rainfall in early 2020, the water level rose and remained elevated although declines in the water level were regularly recorded. From early 2020 to December 2021, the minimum water level recorded was 247.76 m AHD. Post-remediation, the water level has been maintained above the CTF level (248 m AHD), consistent with that recorded during the pre-impact period. It is noted that above average rainfall was recorded during this period and, as such, maintenance of the minimum water level above 248 m AHD is considered likely due to both the remediation works and above average rainfall recorded during this period.

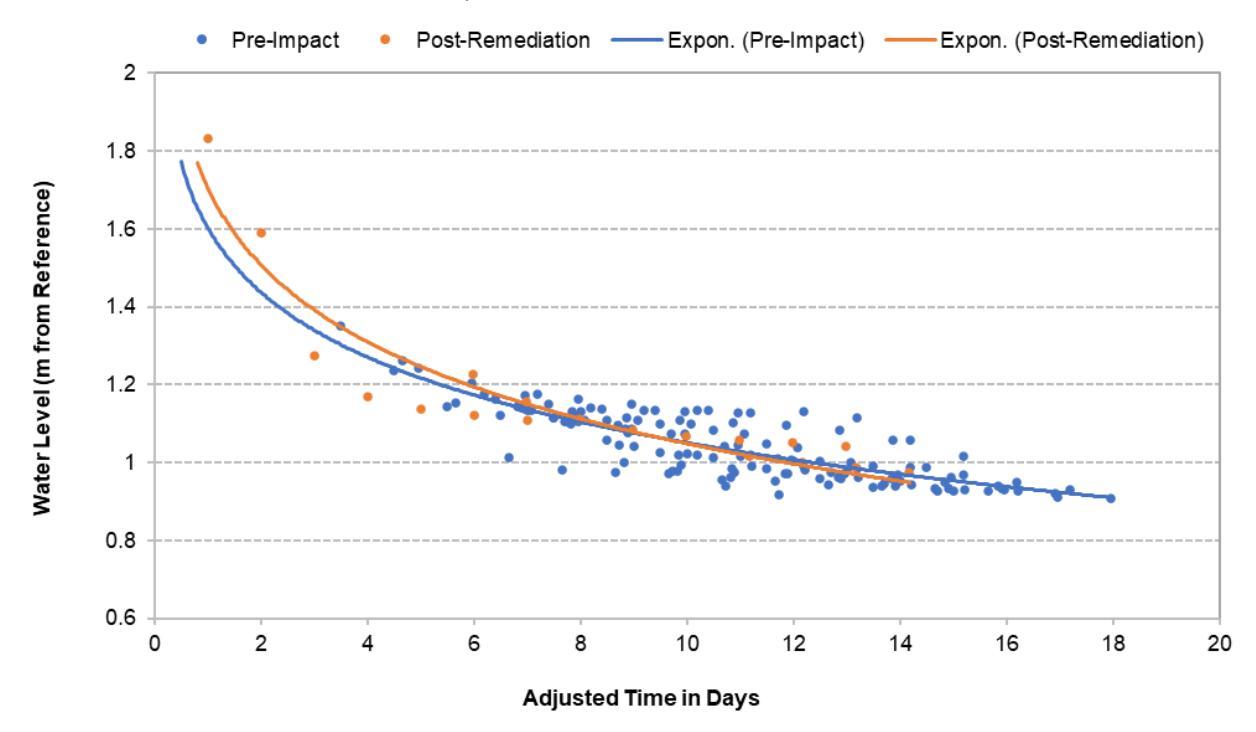
Graph 4 shows that the post-remediation exponential curve is generally consistent with that of the preimpact exponential curve indicating that the water level has declined at a similar rate post-remediation to that of the pre-impact period. The outcomes of the Method 1 preliminary assessment indicate that remediation works have been effective at pool 11. It is noted, however, that only three post-remediation events were available for analysis and above average rainfall was recorded during the post-remediation period. As such, additional post-remediation monitoring data, recorded during periods of below average rainfall, is recommended to provide further confidence in the effectiveness of remediation works at pool 11.

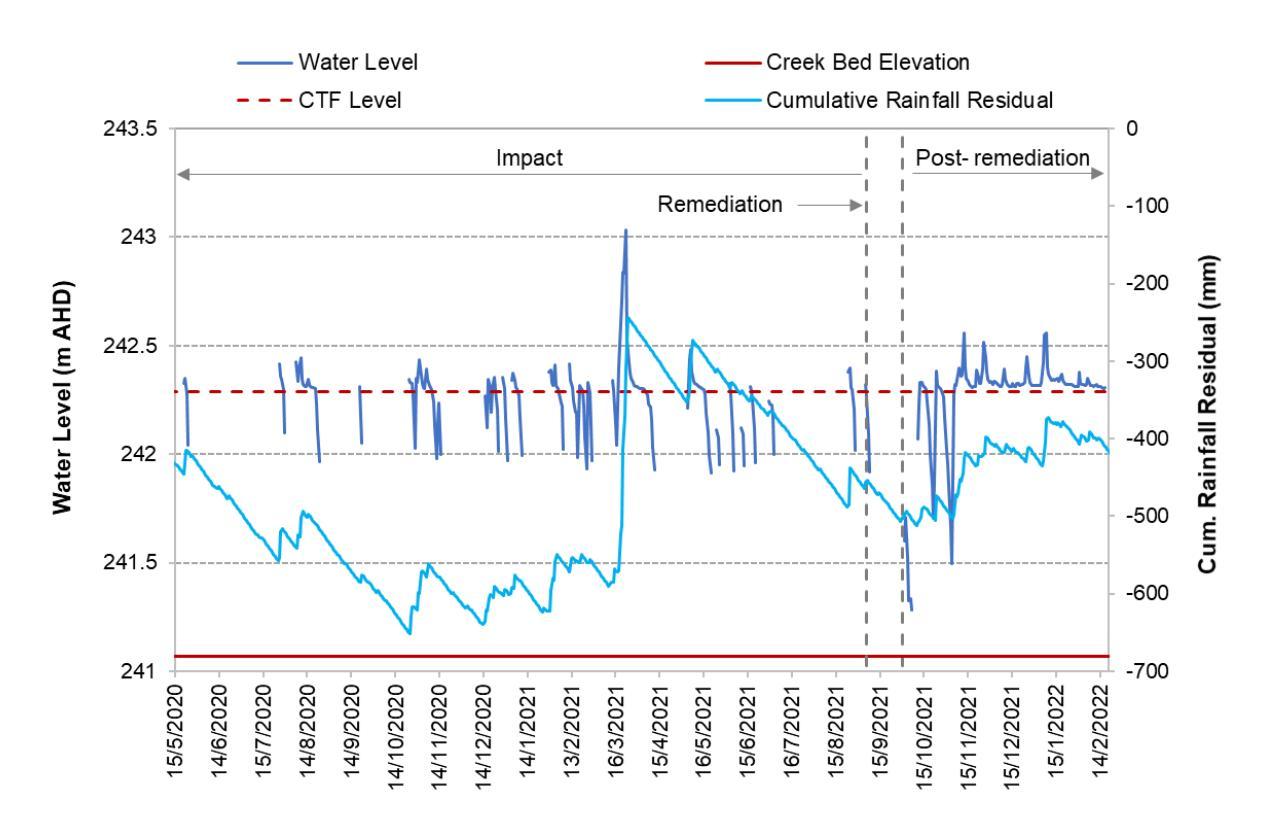
GRAPH 5: MYRTLE CREEK POOL 18 - WATER LEVEL RECORDS AND RAINFALL RESIDUAL

The data presented in Graph 5 illustrates that, prior to remediation, the water level recorded at pool 18 in Myrtle Creek regularly declined below the level of sensor, as indicated by gaps in the dataset. Following the recession test on 8 October 2021, two rapid declines in water level were recorded prior to early November 2021. As stated in Appendix A, there is notable sediment, gravel and boulder deposition in the base of pool 18. It is likely that, immediately following remediation, the moisture content of the hyporheic zone beneath the pool base was low thereby causing the higher infiltration rates.

During and following rainfall events from early November 2021, the water level remained elevated and rapid declines in water level were not recorded. It is presumed that the hyporheic zone was saturated during this period and hence infiltration rates declined. This period coincides with a period of generally above average rainfall as illustrated by the increasing trend in the cumulative rainfall residual. From mid-November 2021, the water level has been maintained continuously above the CTF level with pool 18 continuously overflowing to the downstream reach of Myrtle Creek. Maintenance of the pool water level above the CTF level is considered likely due to both the remediation works and above average rainfall recorded during this period.

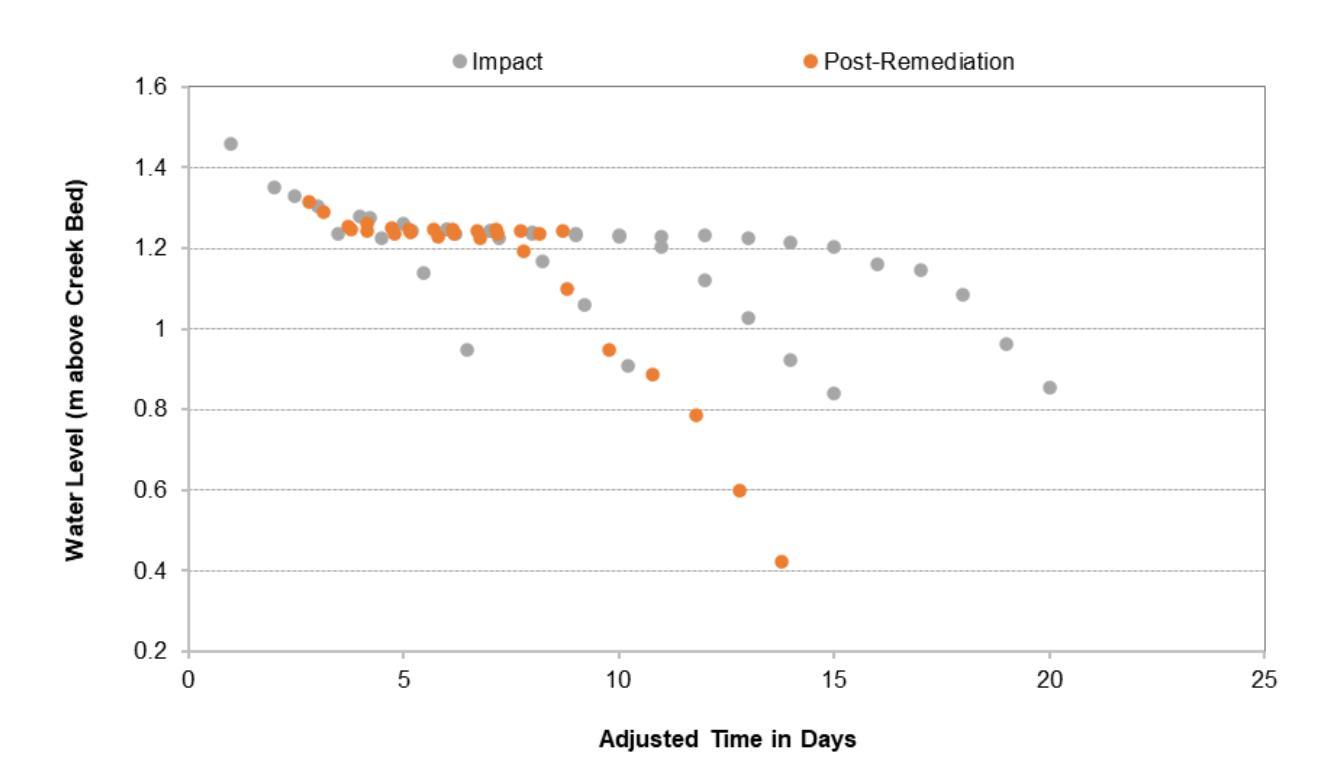
GRAPH 6: MYRTLE CREEK POOL 18 – METHOD 2 RECESSION CURVE COMPARISON

The data presented in Graph 6 indicates that the post-remediation water level has generally declined at a similar rate to the impact period water level. However, it should be noted that two of the recession events are reflective of the rapid declines that occurred during the inferred saturation of the hyporheic zone. Additionally, as the sensor was located at a higher level during the impact period, the impact period recessionary behaviour below 0.8 m depth is unknown.

The outcomes of the Method 2 assessment indicate that there has been an improvement in the pool 18 water holding capacity post-remediation, however, the area has experienced above average rainfall during this period. As such, additional post-remediation monitoring data, recorded during periods of below average rainfall, is recommended to provide further confidence in the effectiveness of remediation works at pool 18.

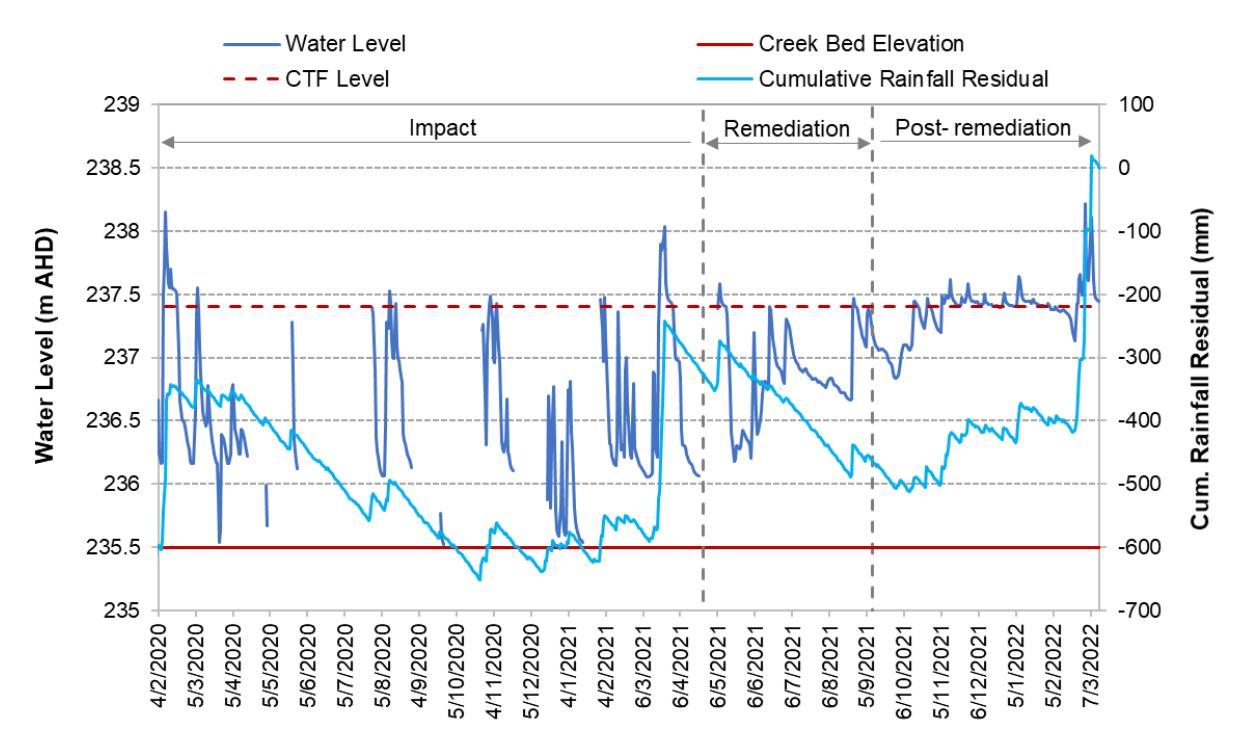
GRAPH 8: MYRTLE CREEK POOL 20 - WATER LEVEL RECORDS AND RAINFALL RESIDUAL

The data presented in Graph 8 illustrates that, prior to remediation, the water level recorded at pool 20 in Myrtle Creek regularly declined below the sensor level, as indicated by gaps in the dataset. During the remediation period, the water level remained above the level of the sensor despite a decline in the cumulative rainfall residual recorded during this period. For approximately two months post-remediation completion, the water level of pool 20 remained elevated although below the CTF level. It is noted that pool 20 is a large pool (refer Appendix A). As such, a reasonable period of above average rainfall would be required to fill the pool to the CTF level. From early November 2021, the water level remained above the CTF level with the exception of a short period in late February 2022.

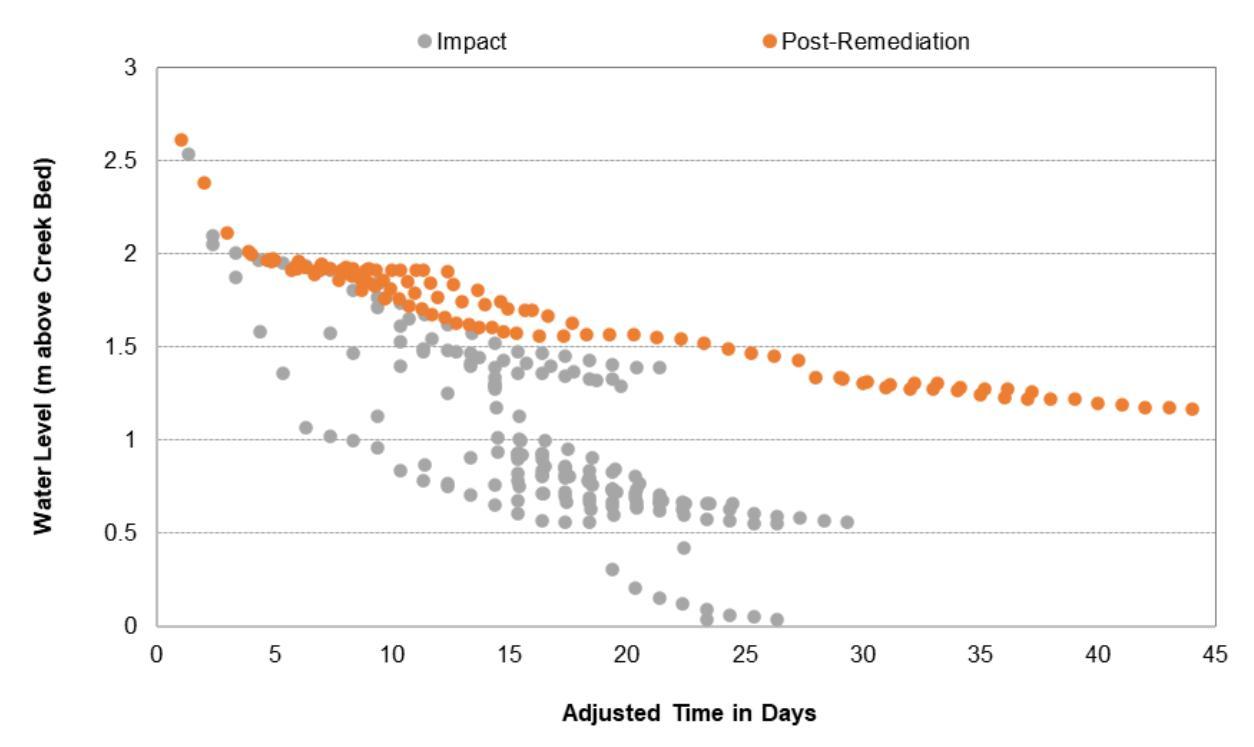
GRAPH 9: MYRTLE CREEK POOL 20 – METHOD 2 RECESSION CURVE COMPARISON

The data plotted in Graph 9 indicates that, during periods of low rainfall, the water level recorded at pool 20 post-remediation has remained at a higher level than that during the impact period and declined at a notably slower rate.

The outcomes of the Method 2 assessment indicate that there has been a notable improvement in the pool 20 water holding capacity post-remediation. As the area experienced above average rainfall during this period, it is recommended that additional post-remediation monitoring data is recorded during periods of below average rainfall to provide further confidence in the effectiveness of remediation works at pool 20.

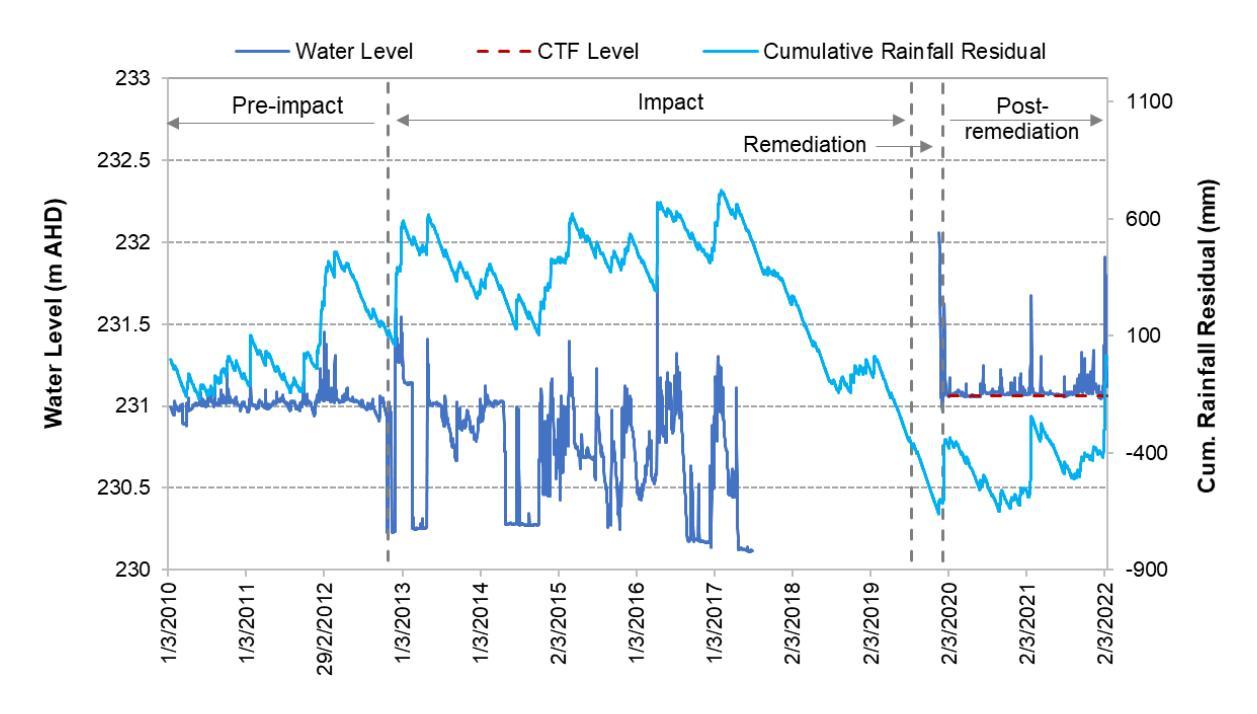
GRAPH 11: MYRTLE CREEK POOL 23 - WATER LEVEL RECORDS AND RAINFALL RESIDUAL

The data in Graph 11 shows a notable change in the water level and water level recessionary behaviour of pool 23 following subsidence impacts. Pre-impact, the water level was maintained above 230.9 m AHD. During the impact period, the water level declined below the level of the sensor on a number of occasions. Following remediation works, the pool water level has been recorded continuously above 231 m AHD, and above the CTF level, for 2 years.

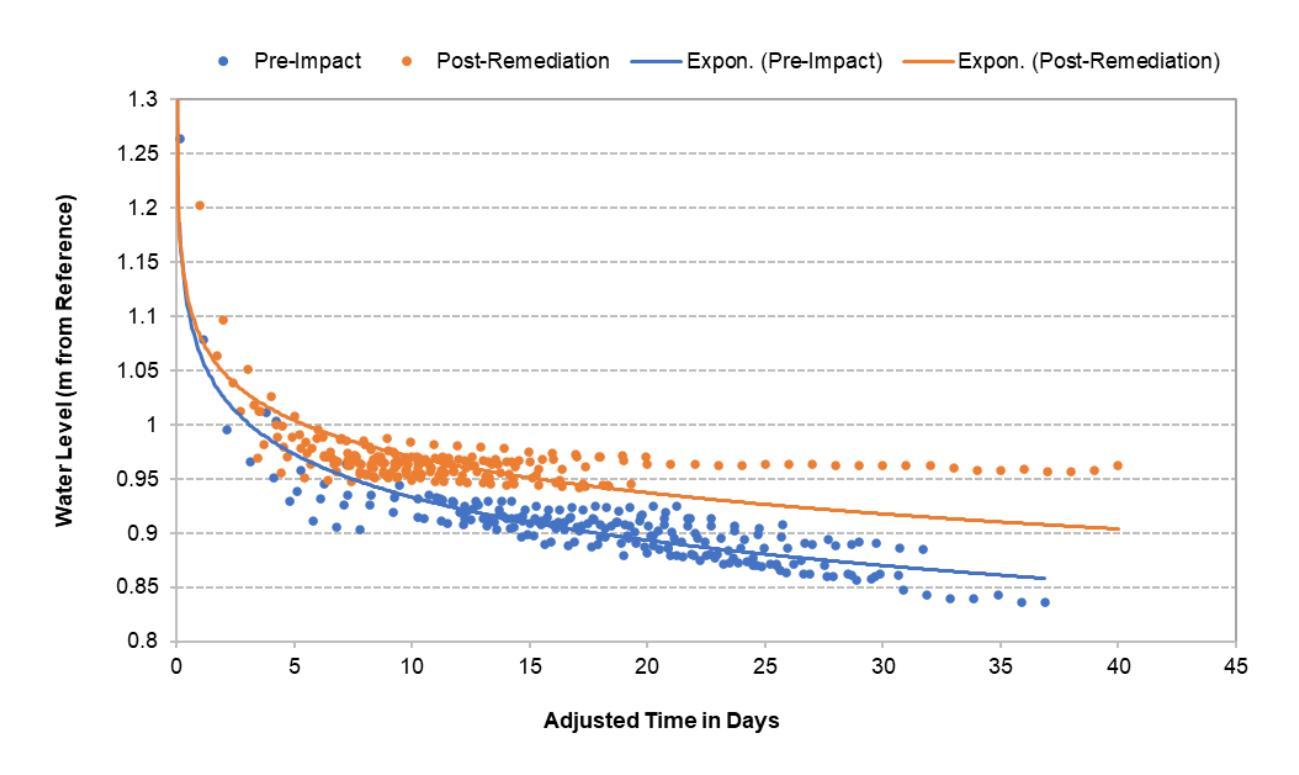
GRAPH 12: MYRTLE CREEK POOL 23 – METHOD 1 RECESSION CURVE COMPARISON

Graph 12 shows that the post-remediation exponential curve is plotted above and is less steep than the pre-impact exponential curve indicating that the water level has declined at a slower rate post-remediation than was recorded pre-impact. This difference may be slightly over-exaggerated due to the potential datum shift, however, if the datum was adjusted, the post-remediation data would still indicate a reduction in the recession rate post-remediation. The results of the recession analysis indicate that the remediation works at pool 23 in Myrtle Creek have been effective in returning the pool water holding capacity to or better than pre-impact conditions.

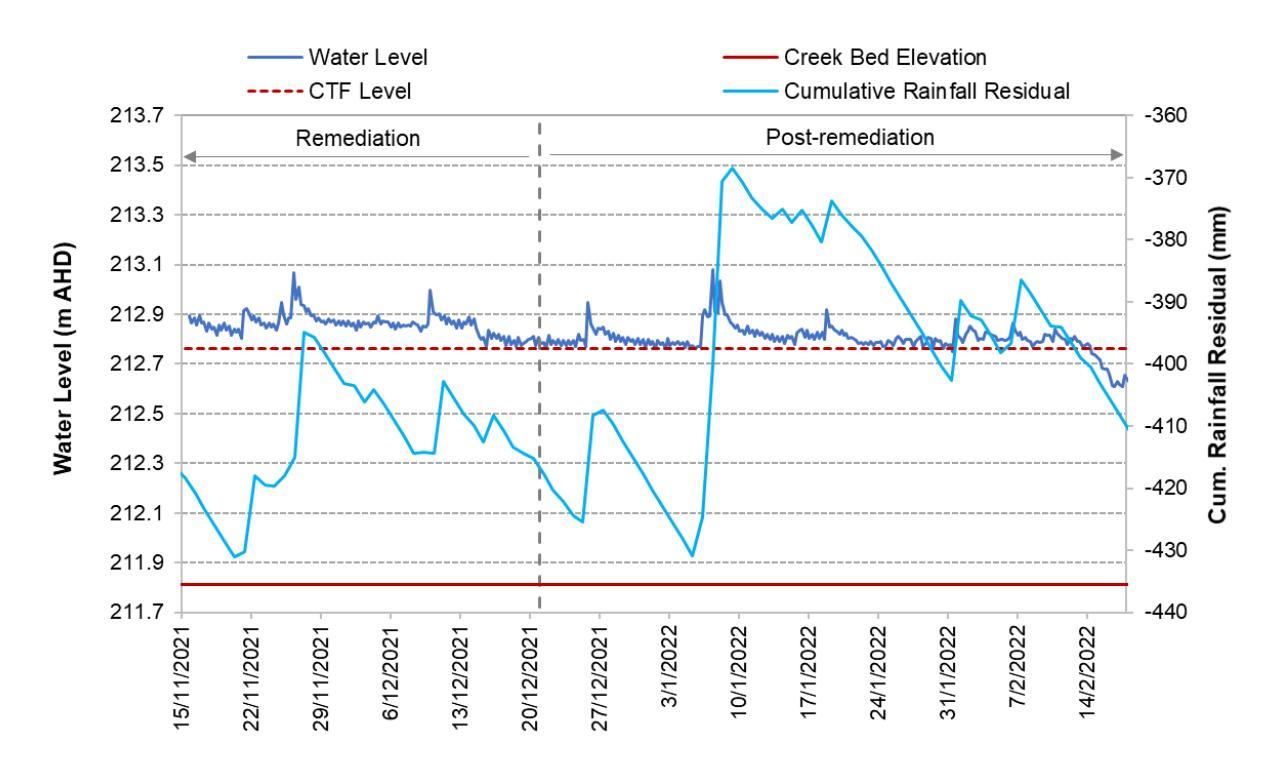
GRAPH 13: REDBANK CREEK POOL RB6 - WATER LEVEL RECORDS AND RAINFALL RESIDUAL

The data presented in Graph 13 shows that, during the remediation period and post-remediation, the pool water holding capacity recovered. This illustrates an evident improvement in pool RB6 water level following the completion of Stage 3 remediation works, in comparison with the visual inspection records for the impact period. The water level has been maintained above the CTF level for the majority of the monitoring period with the exception of a slight decline in water level of approximately 200 mm recorded from mid-February 2022 corresponding with a decline in the cumulative rainfall residual.

As only three months of monitoring data has been recorded post-remediation, additional postremediation monitoring data is recommended to enable further assessment of the effectiveness of remediation works at pool RB6 in Redbank Creek.

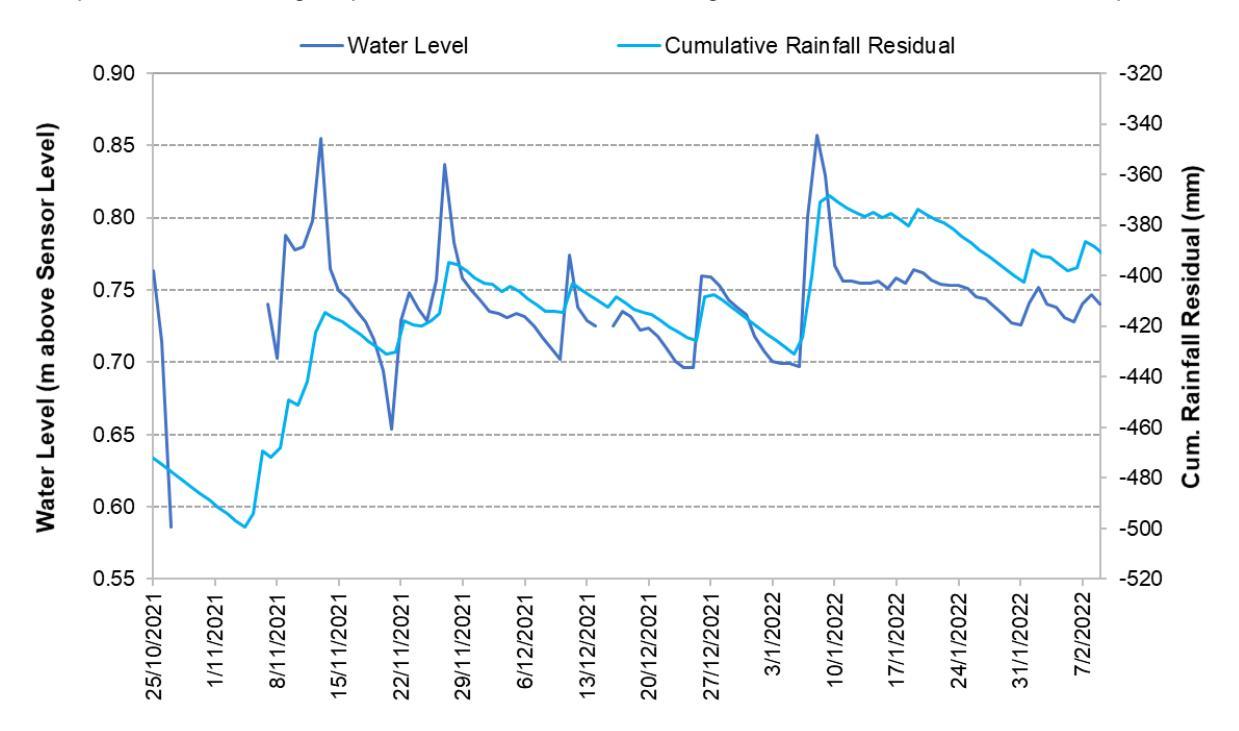
GRAPH 15: REDBANK CREEK POOL RR11 - WATER LEVEL RECORDS AND RAINFALL RESIDUAL

The data presented in Graph 15 shows that the pool RR11 water level averaged 0.74 m during the period October 2021 to February 2022. The water level was recorded above the level of the sensor for the majority of the monitoring period with the exception of late October 2021 to early November 2021 when the water level declined below the level of the sensor during a period of low rainfall. It is noted that pool RR11 was also holding water during a visual inspection conducted in May 2021 (refer Appendix B for photograph).

Additional post-remediation monitoring data is recommended to enable further assessment of the effectiveness of remediation works at pool RR11 in Redbank Creek.

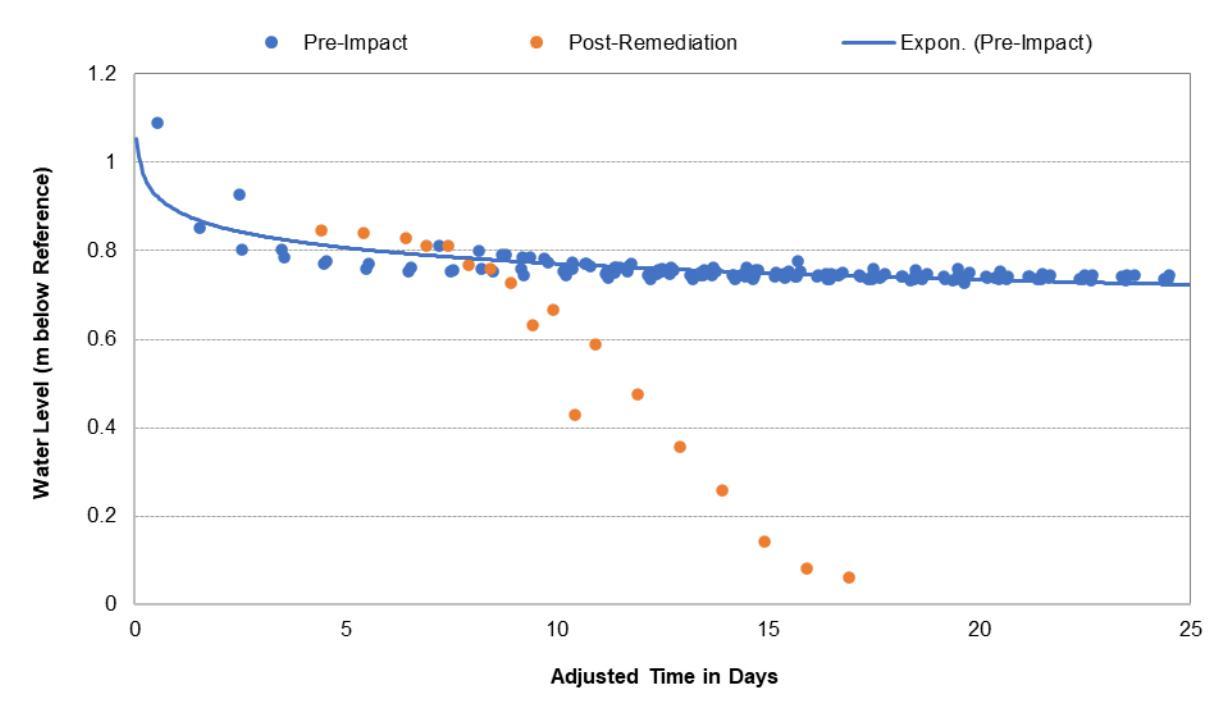
GRAPH 18: REDBANK CREEK POOL RR19 - METHOD 1 RECESSION CURVE COMPARISON

Although preliminary only, the data presented in Graph 18 shows that, above 0.8 m, the water level recession rate post-remediation is similar to that of the pre-impact period recession rate showing an improvement of the pool holding capacity post-remediation. However, below 0.8m, the water level has declined to lower levels post-remediation than was recorded during the pre-impact period.

As only two post-remediation events were able to be assessed, the collection of additional postremediation monitoring data, recorded during periods of low rainfall, is recommended to enable further assessment of the post-remediation recession rate of pool RR19.

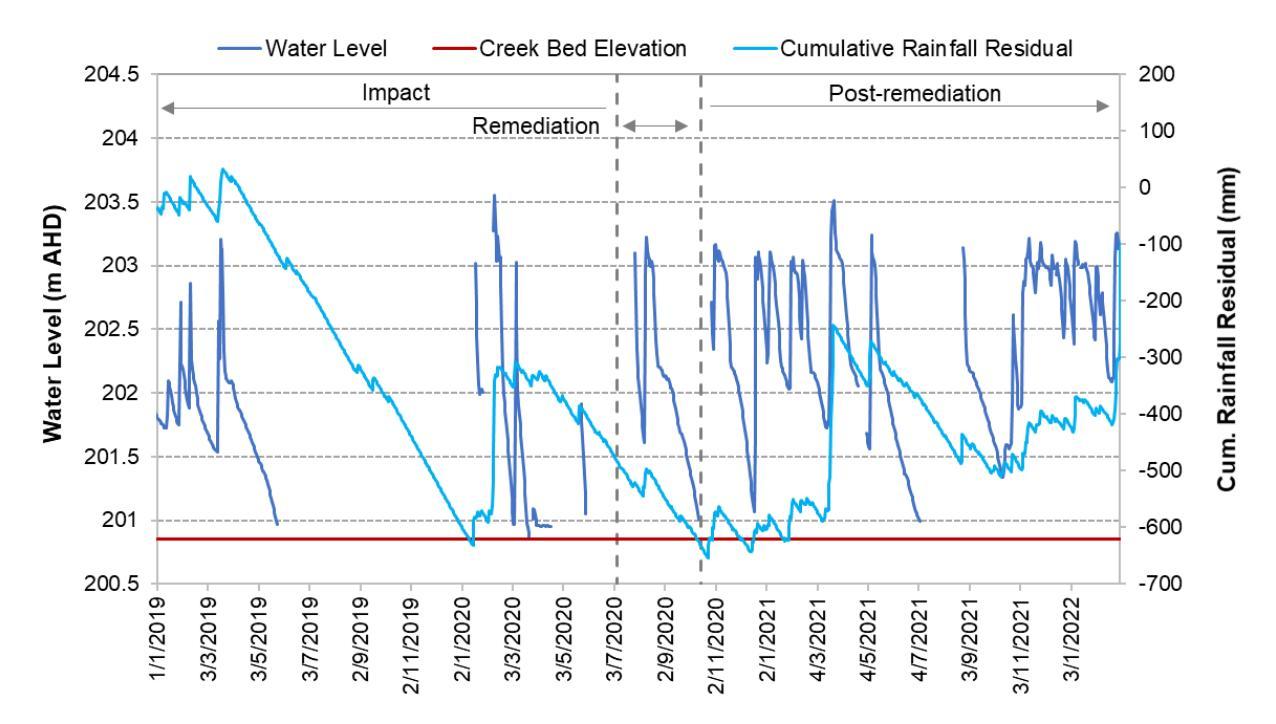
GRAPH 19B: REDBANK CREEK POOL 26 - WATER LEVEL RECORDS AND RAINFALL RESIDUAL – 2019 TO 2022

The data in Graph 19 (A and B) shows an evident change in the water level and water level recessionary behaviour of pool 26 from early 2016 and more substantially from early 2018 as rainfall declined. Prior to impact, the water level was predominately maintained above 202.97 m AHD. During the impact period, the water level declined below the level of the sensor and the pool was reported as dry on a number of occasions (GeoTerra, 2019a).

Following remediation works, the pool has held water more frequently than that during the impact period with the water level rising and falling in response to rainfall events. However, the pool water level behaviour has not returned to pre-impact conditions and the water level has at times declined to a similar minimum level (below the sensor level) to that recorded during the impact period despite above average rainfall during this period.

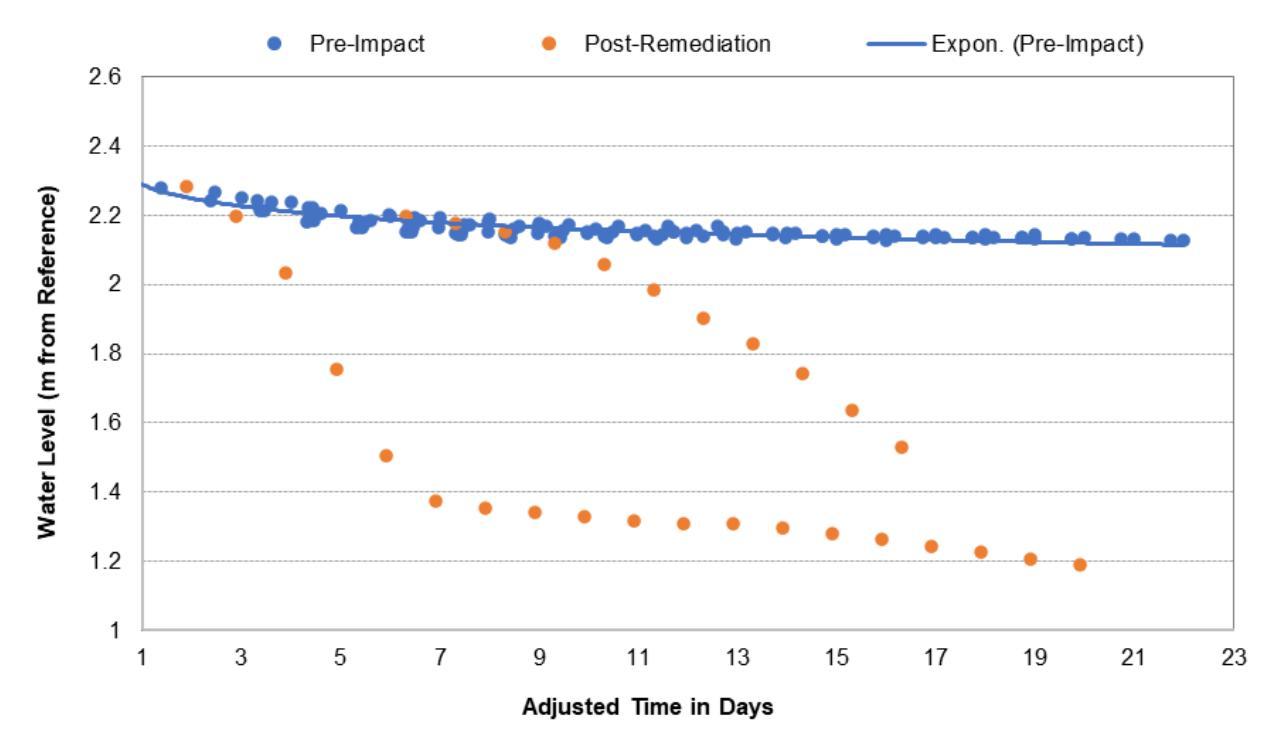
GRAPH 20: REDBANK CREEK POOL 26 - METHOD 1 RECESSION CURVE COMPARISON

Although preliminary only, the data presented in Graph 20 suggests that pool 26 water level declines at a similar rate post-remediation to that recorded during the pre-impact period when the water level is higher i.e. above 2.1 m local datum. Below 2.1 m local datum, the water level has declined at a faster rate and to lower levels post-remediation in comparison to the pre-impact period.

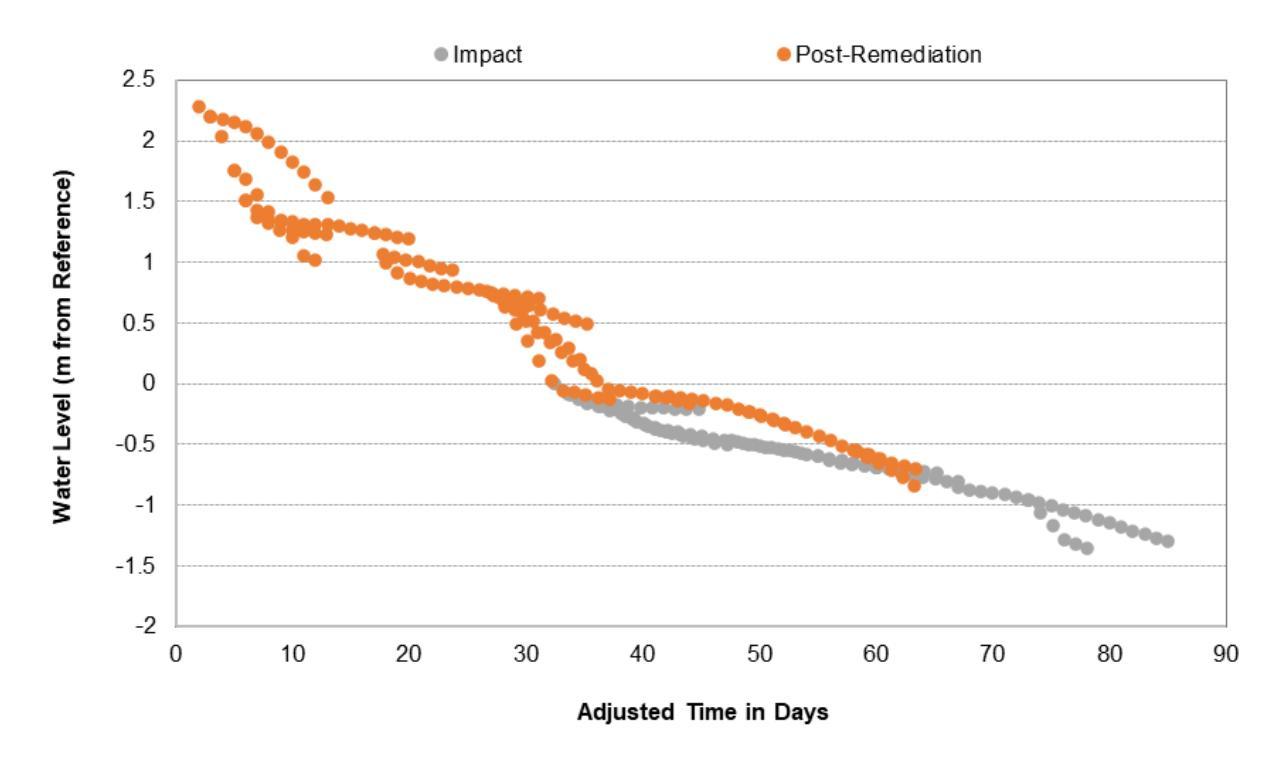
GRAPH 21: REDBANK CREEK POOL 26 - METHOD 2 RECESSION CURVE COMPARISON

The data plotted in Graph 21 shows that higher water levels (above 0 m from reference level) were recorded during the post-remediation dry weather events than were recorded during the impact period. There appears to have been a reduction in the rate of water level decline post-remediation when the water level was approximately 0 to 0.5 m below the reference level. From 0.5 m below the reference level, the water level appears to decline at a similar rate post-remediation to that recorded during the impact period. As shown in Graph 19B, the water level declined to the level of the sensor during one event post-remediation (the gap in the water level record). The full extent of this recession event is not plotted in Graph 21 because only events in which rainfall was not occurring are plotted.

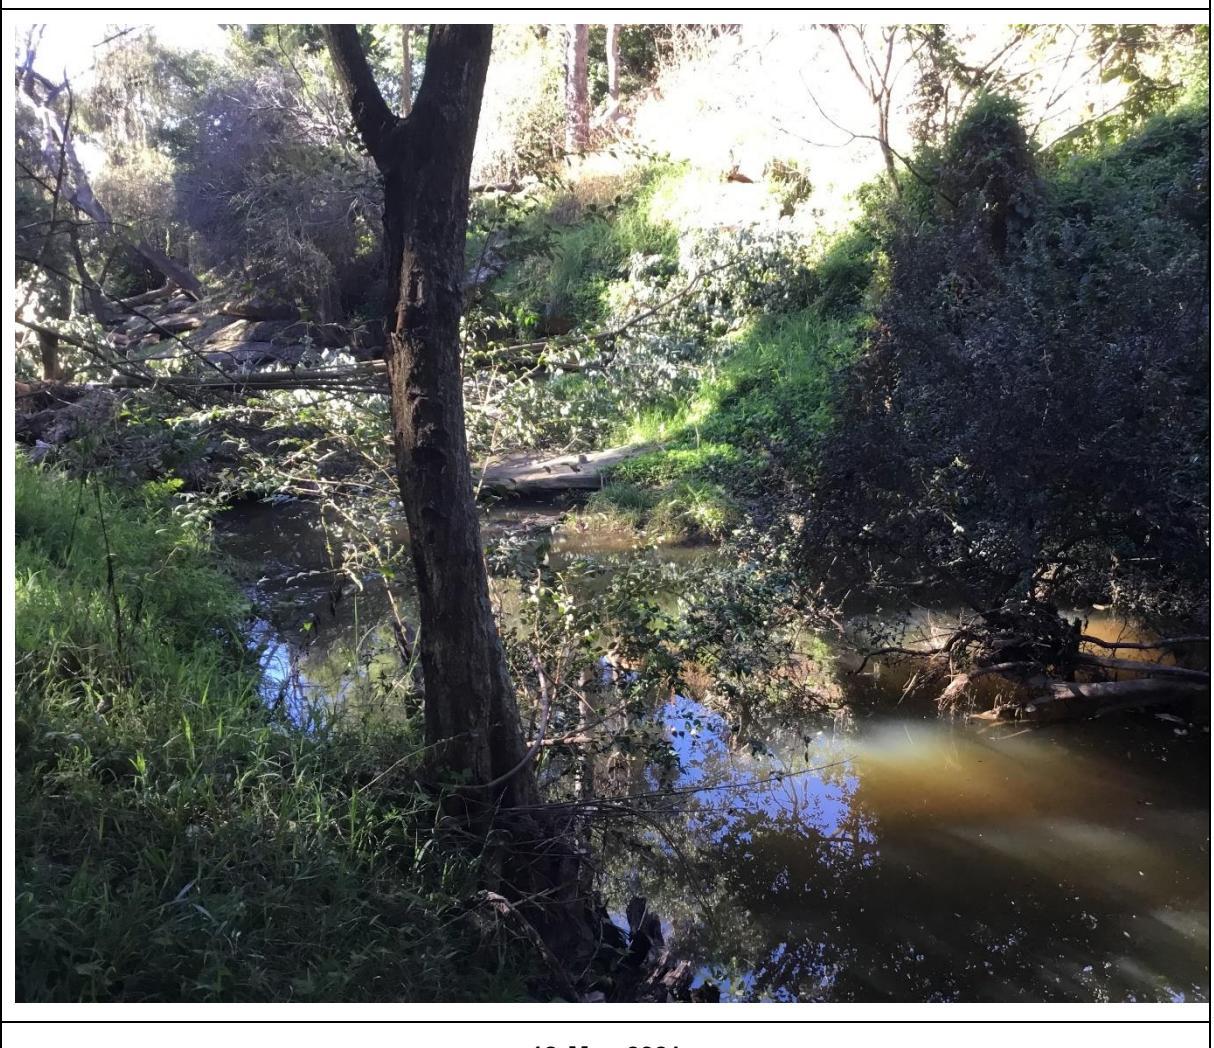
Pool 10 – Downstream View to Rockbar Control

General			
Stream	Myrtle Creek		
ID	Pool 10		
Approximate coordinates	278419 E		
(GDA94) at downstream end of	6211411 N		
pool			
Base RL	Approximately 251 m AHD		
Notable reference points	Water level sensor		
Longwall	Eastern edge of LW26		
Geomorphological Variables			
Description	Elongated pool		
Pool dimensions	Approximately 4 m wide x 20 m lo	ng	
Pool depth at overflow point	Approximately 1 m		
Hydraulic control	Rockbar		
Control features	Shallow rockbar extending across width of pool; obstructed by fallen trees and cut privet; flute holes; notable fractures; horizontal bedding planes		
Bed forms	Bedrock outcrop		
Bed material	Hawkesbury sandstone outcrop; bed not visible		
Valley shape	Left bank [^] : Compound stepped depositional: Approx. 1.5 m high silty/clay banks extending to heavily vegetated benched outcrop	Right bank [^] : Convex upwards: Approx. 8 m high, steeply inclined outcrop overlain with shallow clay/silty soil vegetation. Residential property on overbank.
