TAHMOOR COAL PTY LTD ABN: 97076663968

Tahmoor South LWS1A-S6A Water Management Plan

Myrtle Creek and Redbank Creek Remediation Progress Review

121171.17, R02, Rev D May 2022

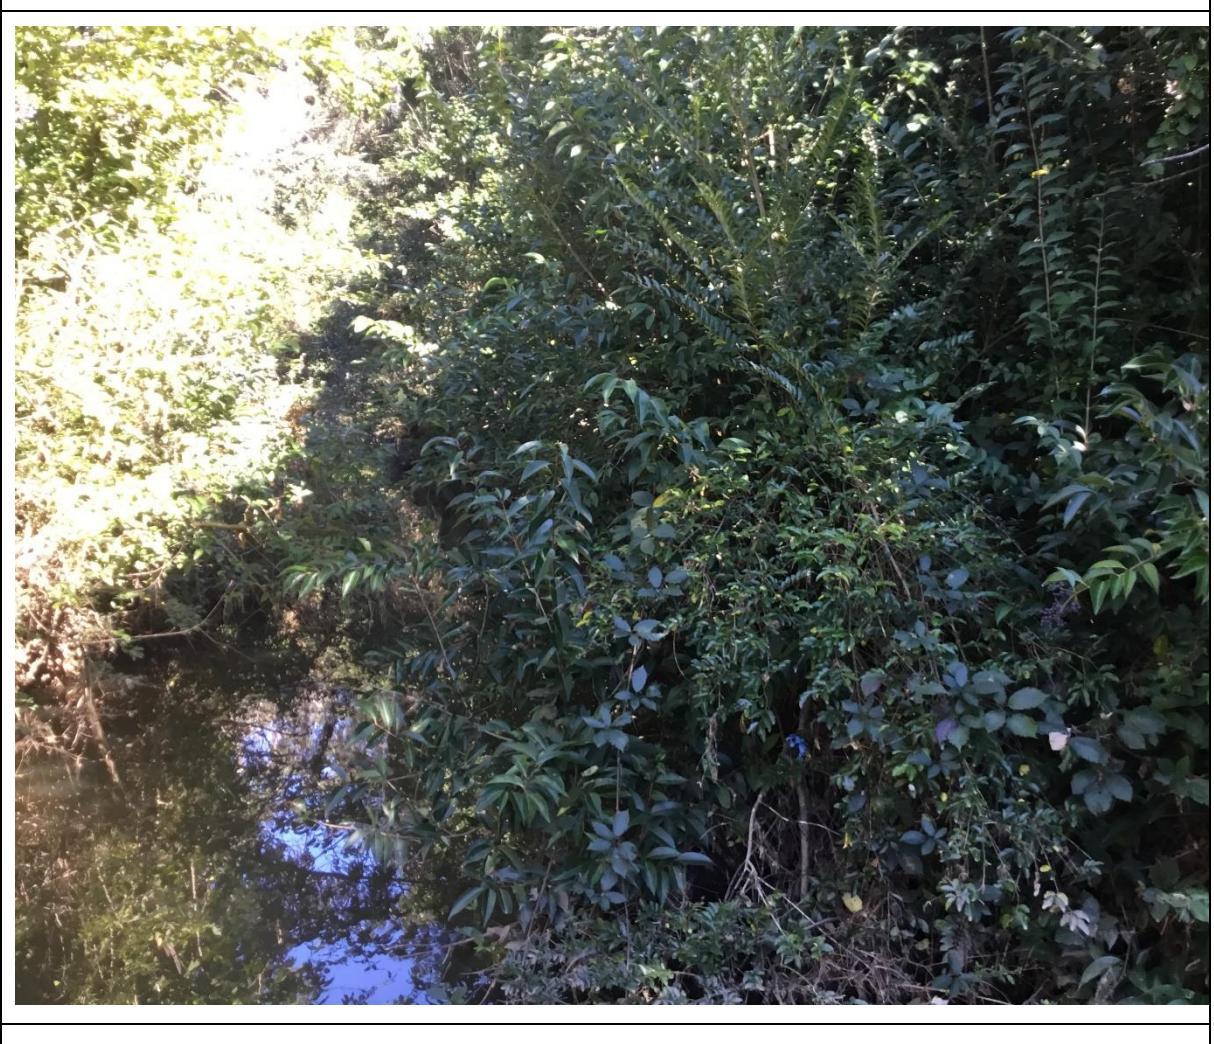
Pool 18 – Upstream View of Pool

General				
Stream	Myrtle Creek			
ID	Pool 18			
Approximate coordinates	2788615 E			
(GDA94) at downstream end of	6211693 N			
Base RL	Approximately 243 m AHD			
Notable reference points	Water level sensor			
Longwan	Eastern edge of LW27			
Geomorphological variables				
Description	Shallow, elongated pool			
Pool dimensions	Approximately 4 m wide x 30 m lo	ng		
Pool depth at overflow point	Approximately 1 m (pool base not	visible)		
Hydraulic control	Rockshelf			
Control features	Elongated rockshelf extending acr depressions and fracturing	oss width of pool; some		
Bed forms	Bedrock outcrop			
Bed material	Hawkesbury sandstone outcrop; notable sediment, gravel and boulder deposition			
Valley shape	Left bank ^A : Compound stepped depositional: Approx. 1.5 m high clay/silt banks, densely vegetated; extending to inclining open grassland	Right bank [^] : Compound stepped depositional: Approx. 1.5 m high clay/silt banks, densely vegetated; inclining to residential property

Bank vegetation type and cover	Left bank^: Grass, wandering jew, privet, gum trees	Right bank^: Grass, wandering jew, privet, willow and gum trees		
Bed vegetation including debris	Pool base not visible			
Pool tree canopy	Substantial canopy coverage			
Channel width	> 10 m			
Uniformity of bed profile	Non-uniform			
Bed scour features	Bank toe undercutting and exposed roots			
Bed eroding or accreting	Eroding			
Catchment landform	Partly confined valley			
Catchment Influences				
Catchment landuse	Predominately farmland to the north and residential development to the south			
Structures	N/A			
Mining related impacts	Fracturing and reduced pool water holding capacity

Surface Water Flow (18 May 2021)			
Pool water depth	Approximately 700 mm		
Connective surface flow	No connective surface flow		
Other observations	N/A

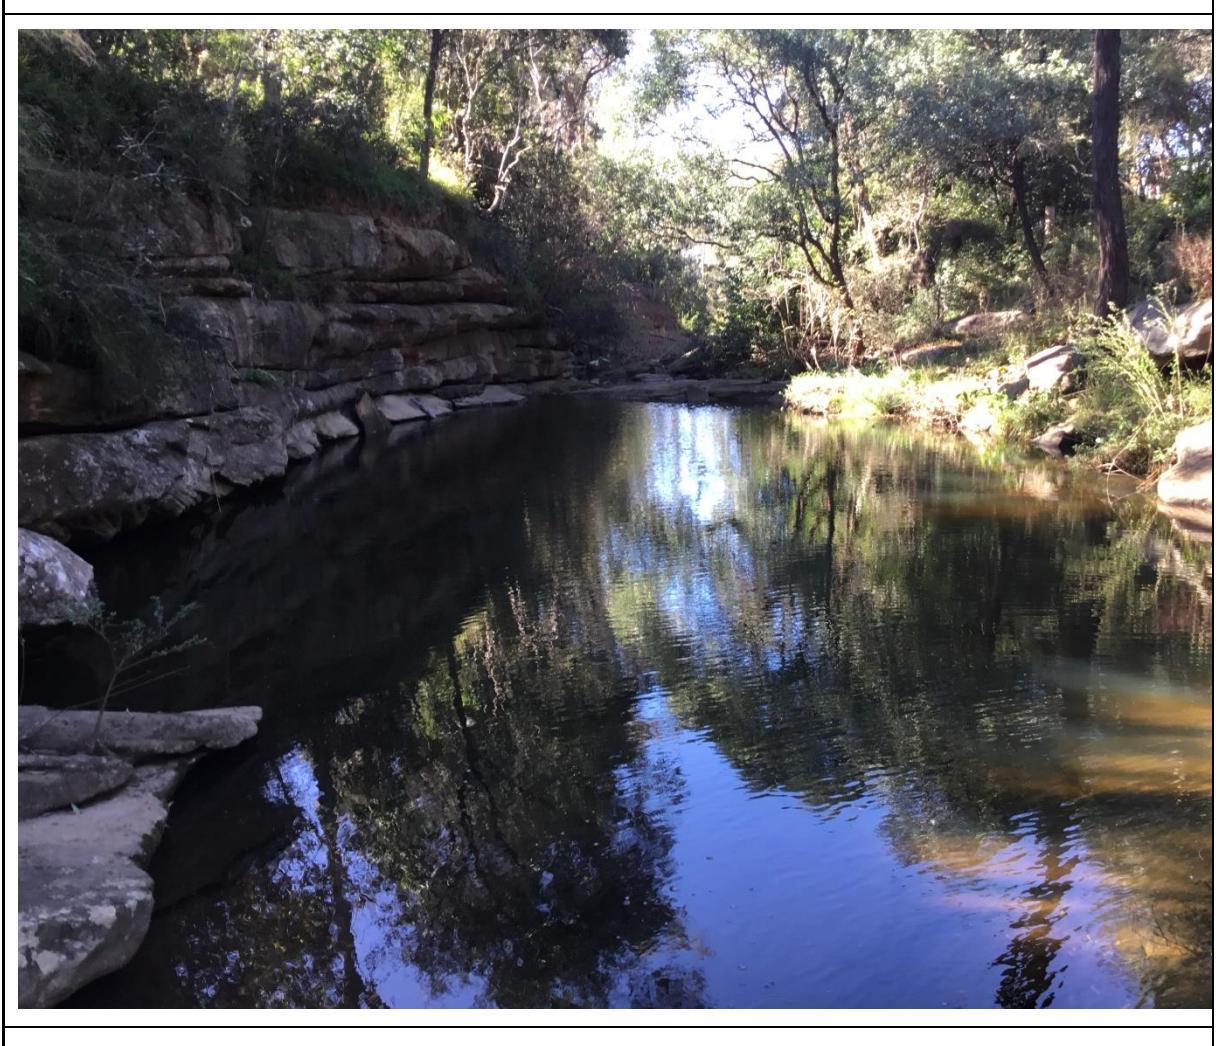
Pool 23 – Downstream View to Rockbar Control

General			
Stream	Myrtle Creek		
ID	Pool 23		
Approximate coordinates	278887 E		
(GDA94) at downstream end of	6211776 N		
Base RI	Approximately 232 m AHD		
Notable reference points	M5 water level sensor		
	Fastern edge of LW28		
Geomorphological Variables			
Description	Flongated pool		
Pool dimensions	Approximately 7 m wide x 25 m lo	na	
Pool depth at overflow point	Approximately 800 mm (pool base	e not visible)	
Hydraulic control	Rockbar	,	
Control features	Raised rockbar extending across width of pool; approximately 7 m wide x 2.5 m long; evident fracturing		
Bed forms	Bedrock outcrop		
Bed material	Hawkesbury sandstone outcrop; bed not visible		
Valley shape	Left bank [^] : Irregular bedrock: Approx. 4 m high sheer outcrop, horizontal bedding; upper shallow soil layer	Right bank [^] : Compound stepped depositional: Approx. 4 m high benched outcrop overlain in parts with soil and vegetation; extending to residential property

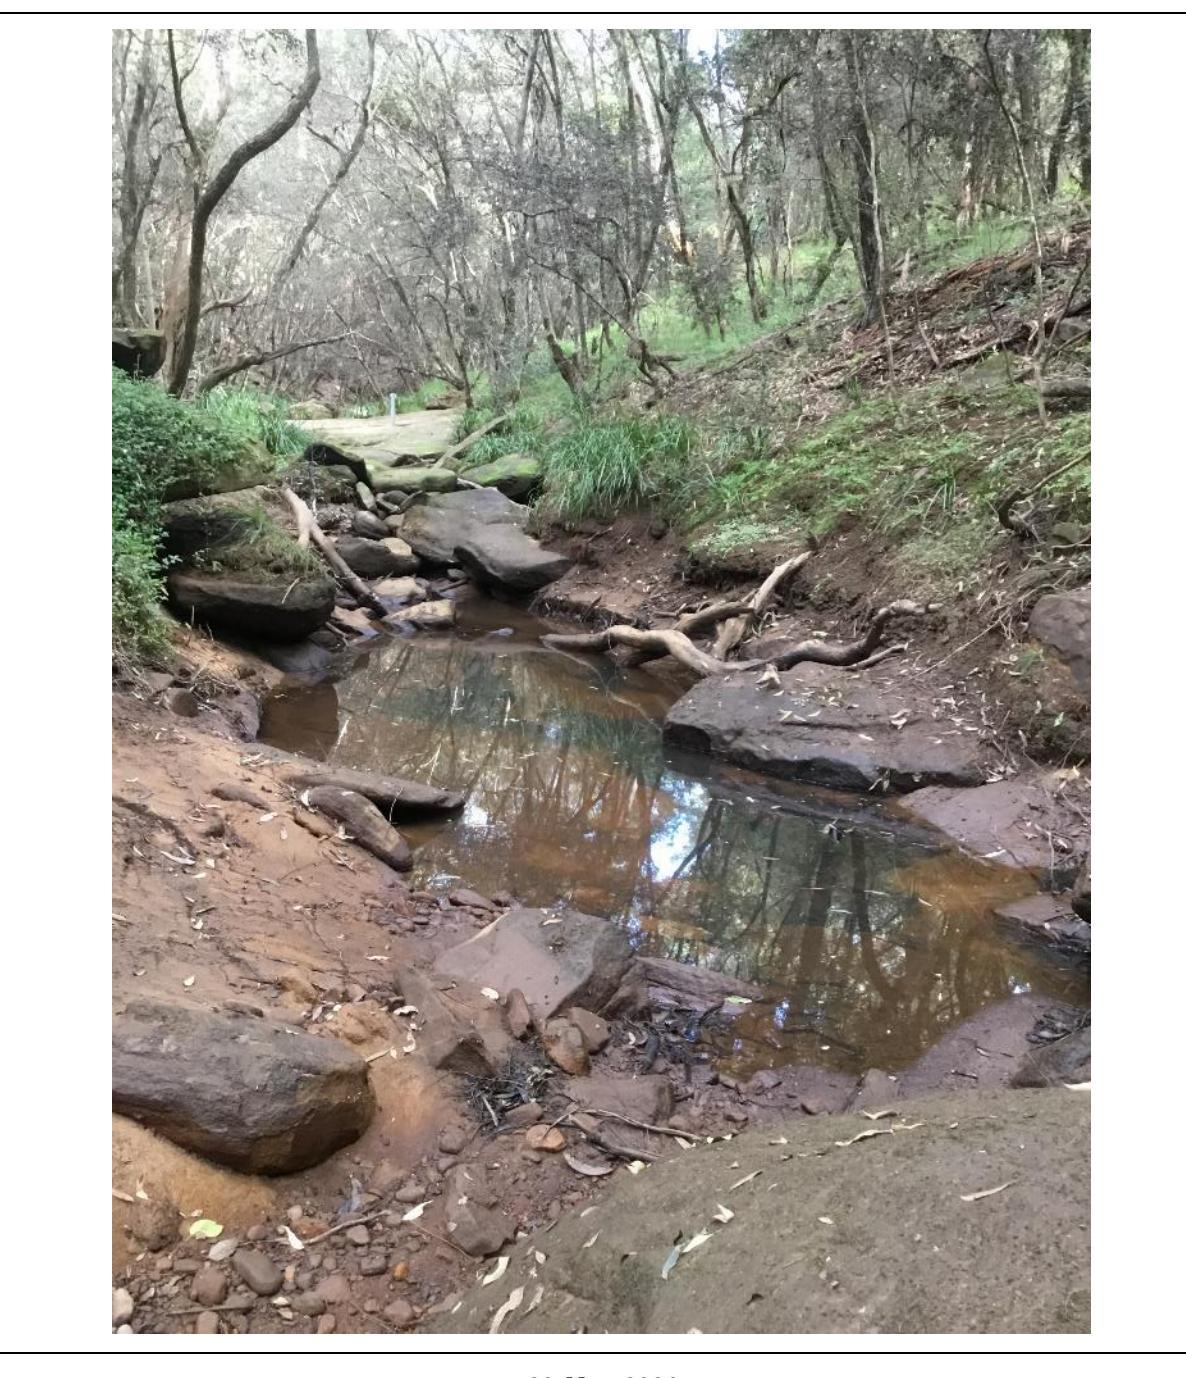
Pool RB6 – Upstream View of Upper Section

General		
Stroom	Bodhank Crook	
	Redbank Creek	
Approximate coordinates		
(GDA94) of pool (DS)	6213382 N	
Pool base RL	Approximately 214 m AHD	
Notable reference points	Rockbar characterization bore	
Longwall	Far east edge of LW29	
Geomorphological Variables		
Description	Series of pools in elongated reach	
Pool dimensions	Variable; < 6 m wide x < 10 m long; full reach approximately 80 m long	
Pool depth at overflow point	Approximately 1 m	
Pool hydraulic control	Rockbar	
Control features	Extends across width of pool; triangular in shape; approximately 7 m wide x 15 m long; semi-regular; one large fracture, other minor fractures; small to moderate flute holes	
Bed forms	Bedrock outcrop with substantial deposition; notable fractures	
Bed material	Hawkesbury Sandstone outcrop Upper reach – bedrock overlain with delaminated sandstone, boulders, sediment and gravel Upstream pool – bedrock overlain with soil/sediment (silty/clay) – tannic Mid to lower reach – bedrock overlain with sand/silt, some gravel – iron staining; horizontal bedding planes in outcrop; interspersed with boulders
