Tahmoor South Project

Environmental Impact Statement

Technical Specialists Report

Geomorphology

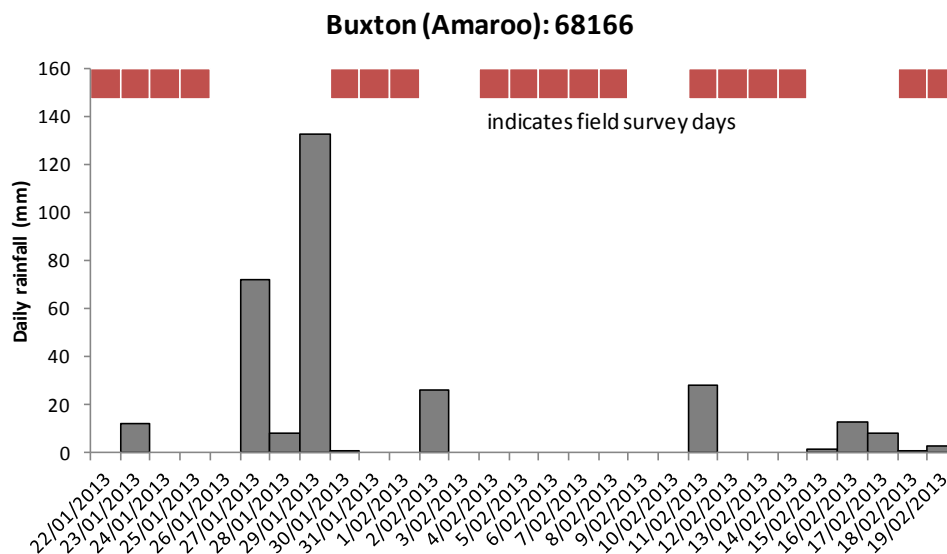
Figure 3. Rainfall at Buxton weather station, 4 km west of Tahmoor Mine, over the period when the field survey was conducted. Daily rainfall observations nominally made at 9 AM and record the total for the previous 24 hours. Source: Bureau of Meteorology (<http://www.bom.gov.au>).

The field survey was undertaken during a relatively wet period, but rainfall was minimal on survey days, except late on 22 January when an intense thunderstorm occurred (Figure 3). A period of unusually heavy rainfall occurred on 27 – 29 January. At Buxton weather station (68166), the 133 mm rainfall that fell on 29 January was the highest January daily rainfall recorded since the station opened in 1967. This was a regional event, and other nearby weather stations also observed a record January daily rainfall on this day [Douglas Park (St. Marys Towers): 68200; Cawdor (Woodburn): 68122; Oakdale (Cooyong Park): 68125; Menangle Bridge (Nepean River): 68216; Menangle Bridge (Nepean River): 68216]. January and February rainfall totals were well above average across the region.

The heavy rainfall experienced early in the fieldwork period meant that for most sites, in-channel pools were full at the time of survey, which helped to facilitate their identification and measurement.

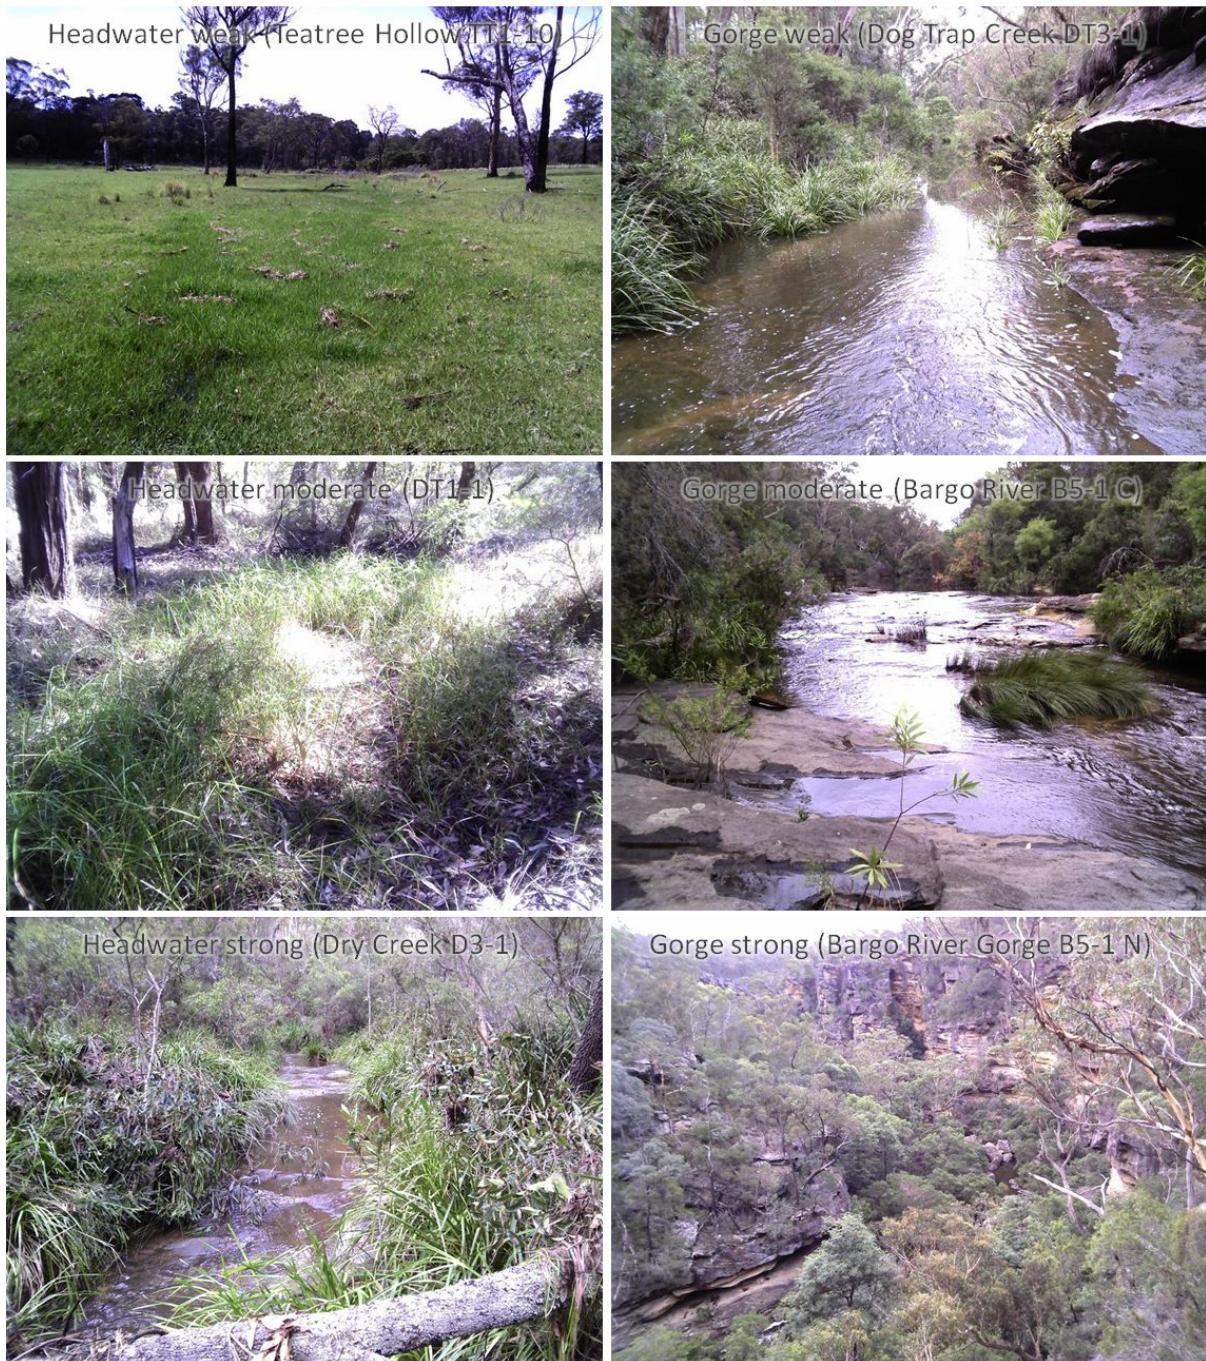
Figure 6. Examples of geomorphic stream types defined for the Geomorphology Technical Report. Note: Headwater weak type also included streams in undisturbed, forested sites.

Stream type	Stream sub-type	Description
Headwater	Headwater weak	Found at the head of stream systems with small catchment areas and low valley depths; indistinct channel; low degree of variability in cross-section and profile form; bed is cohesive material and likely to be densely vegetated with ground cover; in the Study Area, found only on plateau areas
	Headwater moderate	Found in upper- and mid-catchment positions; indistinct channel with low degree of variability in cross-section but variability in profile form; variability in bed materials; can be identified in the field, but not possible to identify from remotely sensed data
	Headwater strong	Symmetrical to irregular V- or U-shape valley; highly variable form including pools and rock outcrops, bed material size tends to be mostly cobble-size and coarser, but is highly variable
Gorge	Gorge weak	Found on tributary streams; symmetrical to irregular, partial vertical slot-shape valleys; upper levels of valleys have low to high rock cliffs while the mid- and lower levels of valleys mostly have steep slopes; channel banks can be low rock cliffs; channel bed has boulders, cobbles, rock bars, rock slabs, falls, cascades and pools, and is mostly free of easily transportable sediment

Gorge moderate	Found on mid- to large-scale river mainstems; moderately deep (< 50 m deep) and wide (generally width/depth > 3.0), symmetrical to irregular, partial vertical slot-shape valleys; side slopes of valleys have distinct rock cliffs, while the mid- and lower levels of valleys have some sections of steep slopes; channel bed has boulders, cobbles, rock bars, rock slabs, falls, cascades and pools, and is mostly free of easily transportable sediment
	Gorge strong	Found on large-scale river mainstems; deep (> 50 m deep) and narrow valley (generally width/depth < 3.0), symmetrical to irregular, mostly vertical slot-shape valleys; side slopes of valleys have high and long rock cliffs; the channel bed has boulders, cobbles, rock bars, rock slabs, falls, cascades and pools, and is mostly free of easily transportable sediment; in the Study Area, found only on the Bargo River and Nepean River mainstems

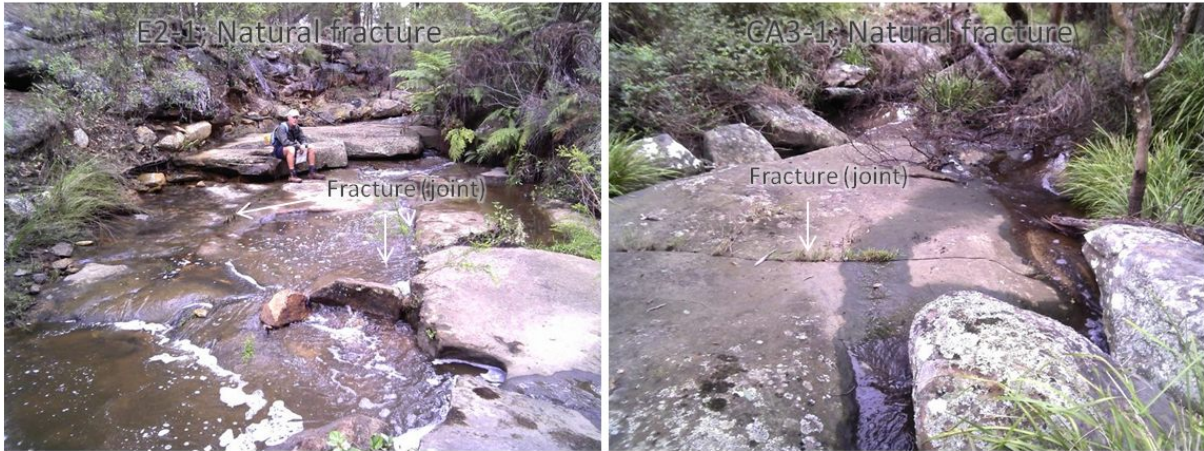
Figure 24. Examples of natural fractures in exposed bedrock. Photographed on 11 February 2013 for E2-1, and 30 January 2013 for CA3-1.

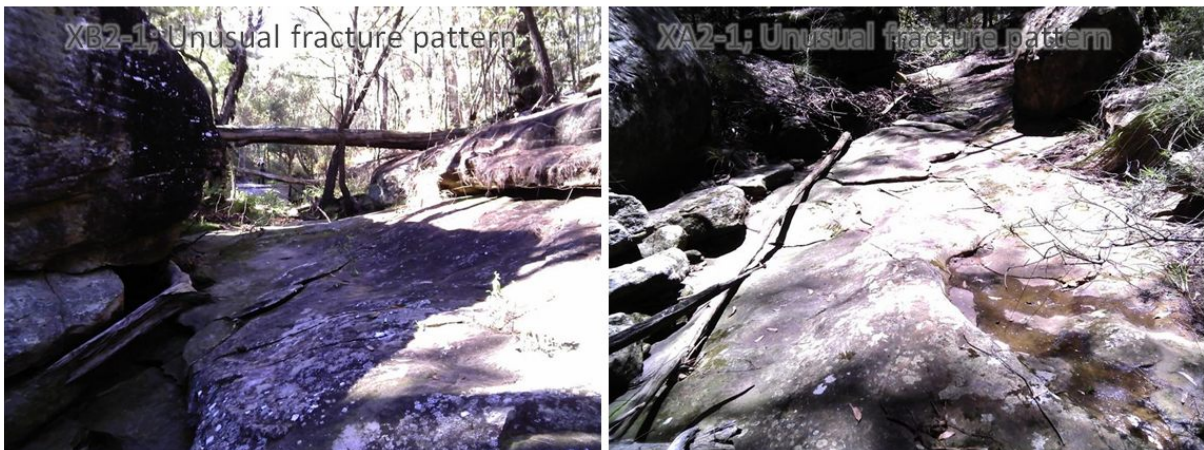
Figure 25. Open fractures in exposed bedrock slabs in creeks XA2-1 and XB2-1. Photographed on 7 February 2013.

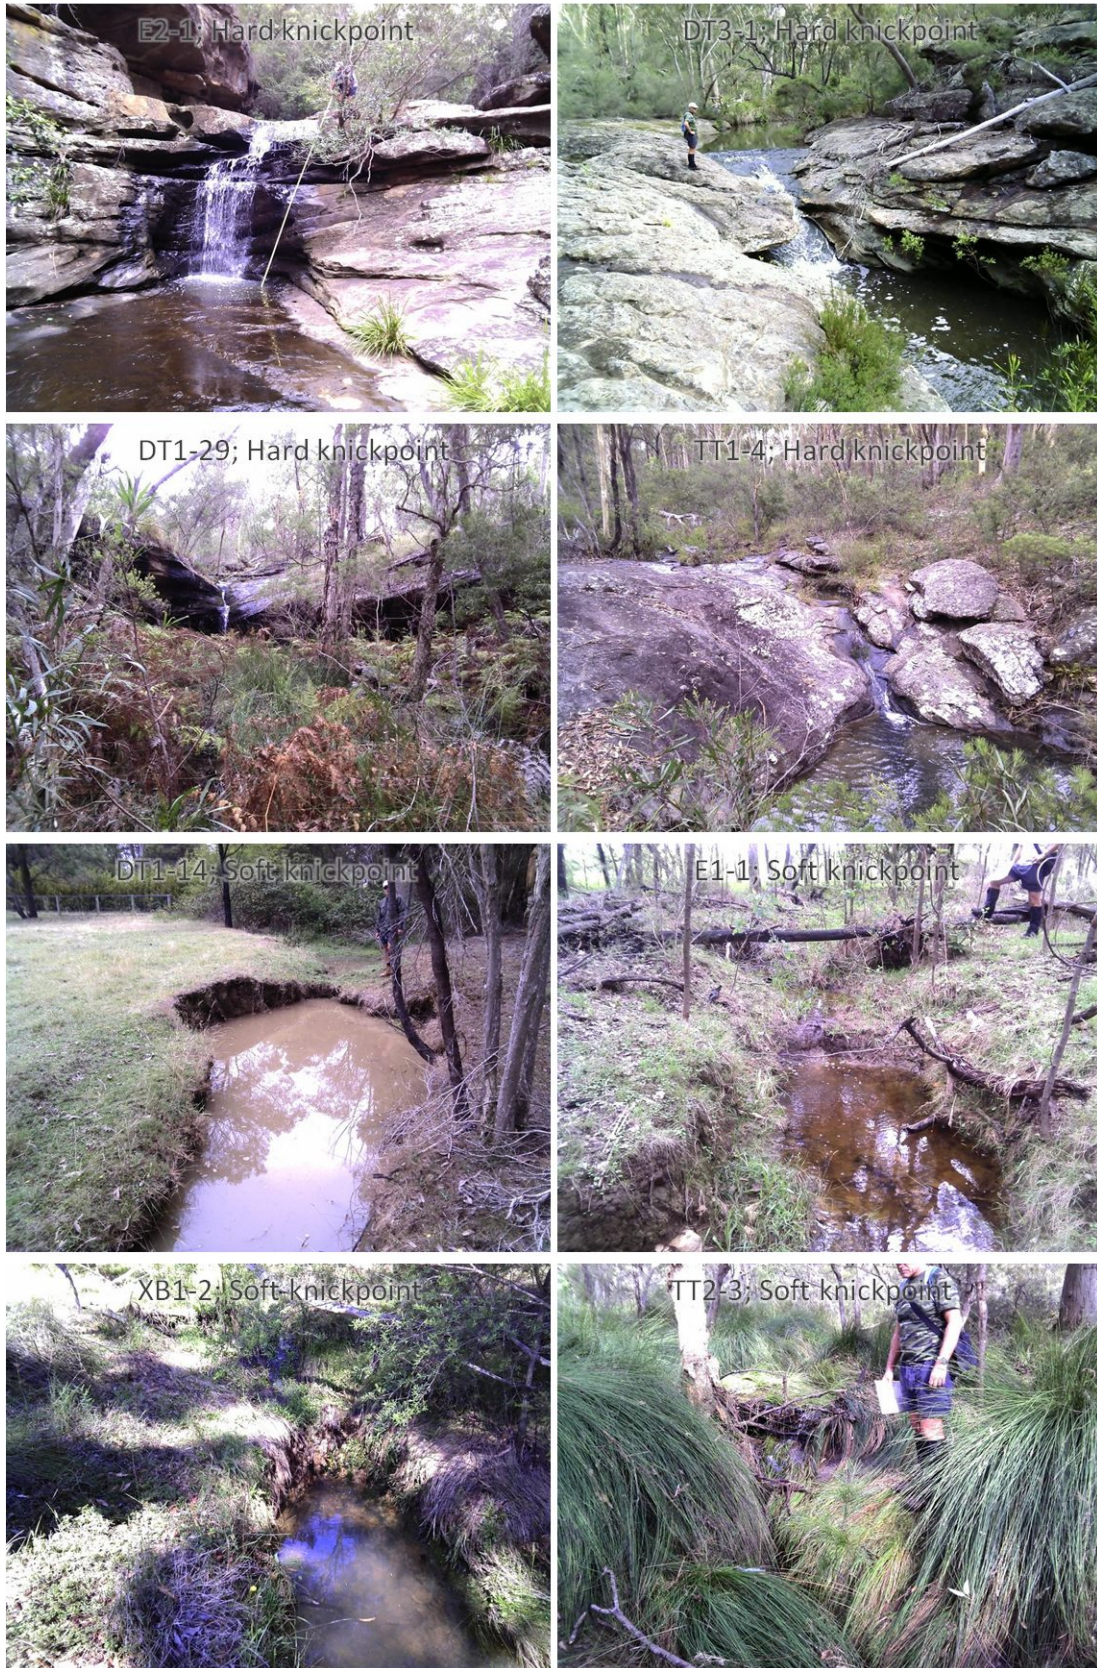
Figure 26. Examples of hard and soft knickpoints. Photography: E2-1, 13/2/2-13; DT3-1; 4/2/2103; DT1-29, 4/2/2103; TT1-4, 5/2/2013; DT1-14, 23/1/2013; E1-1, 11/2/2013; XB1-2, 7/2/2013; TT2-3, 6/2/2013.

practical reasons it was necessary to judge this visually. The type of knickpoint was judged as hard or soft, depending on the material forming the face of the knickpoint. Hard knickpoints were relatively fixed in position, being composed of solid rock, large broken rock, or boulders. Soft knickpoints were formed in erodible material, such as gravel, sand, silt and clay.

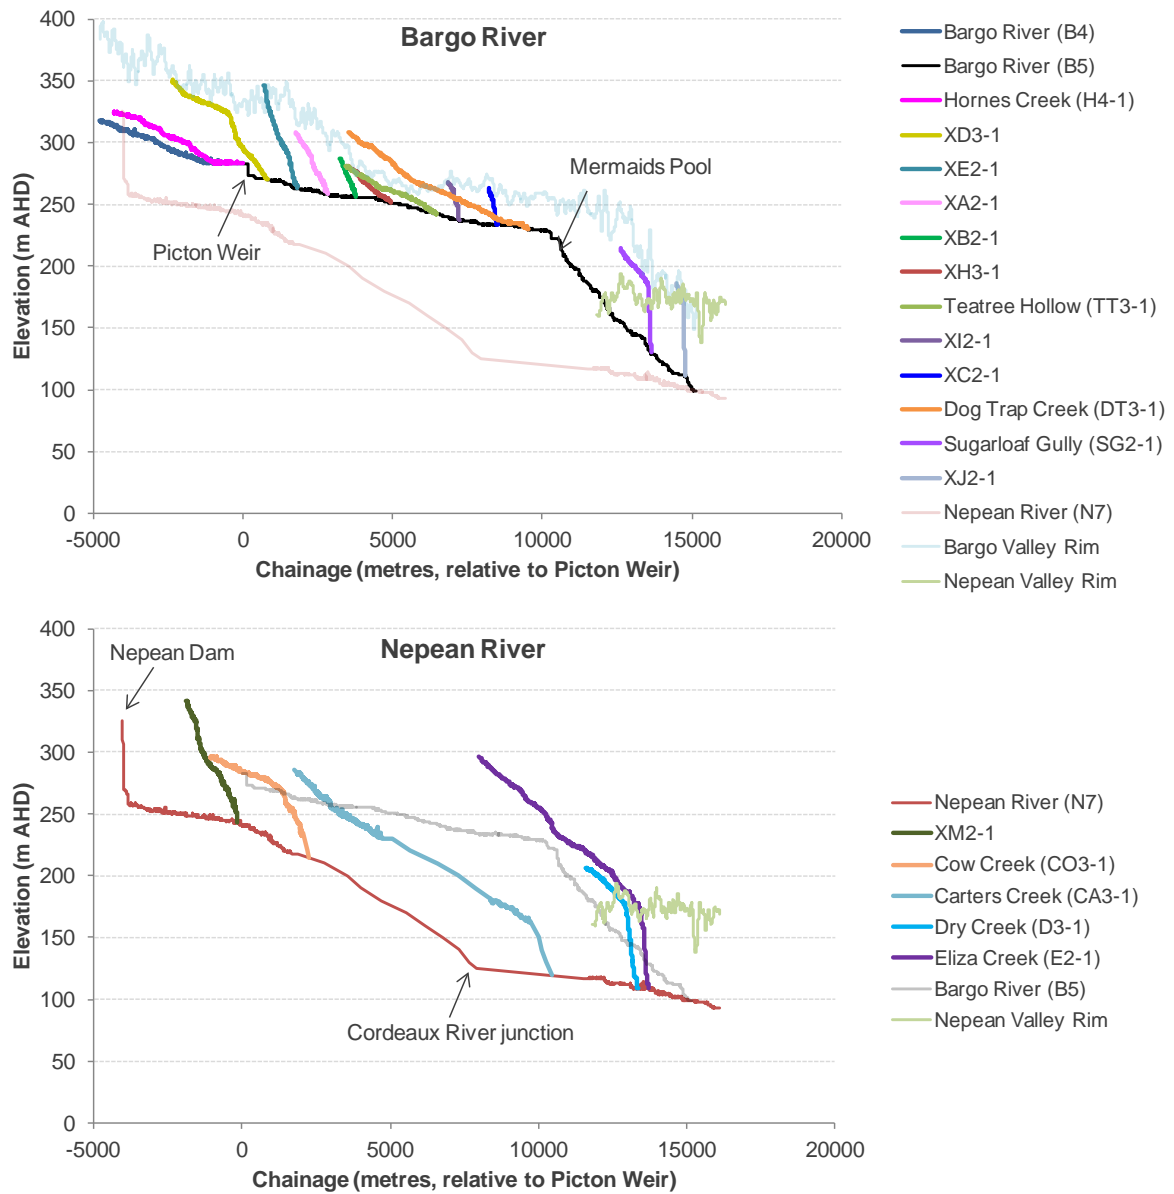
Figure 34. Long profiles of the Bargo River, Nepean River (mostly outside of the Study Area) and most of the tributary streams flowing into and out of the Study Area. Valley rim is the elevation of the thalweg of the river plus the 'valley depth' at the thalweg.

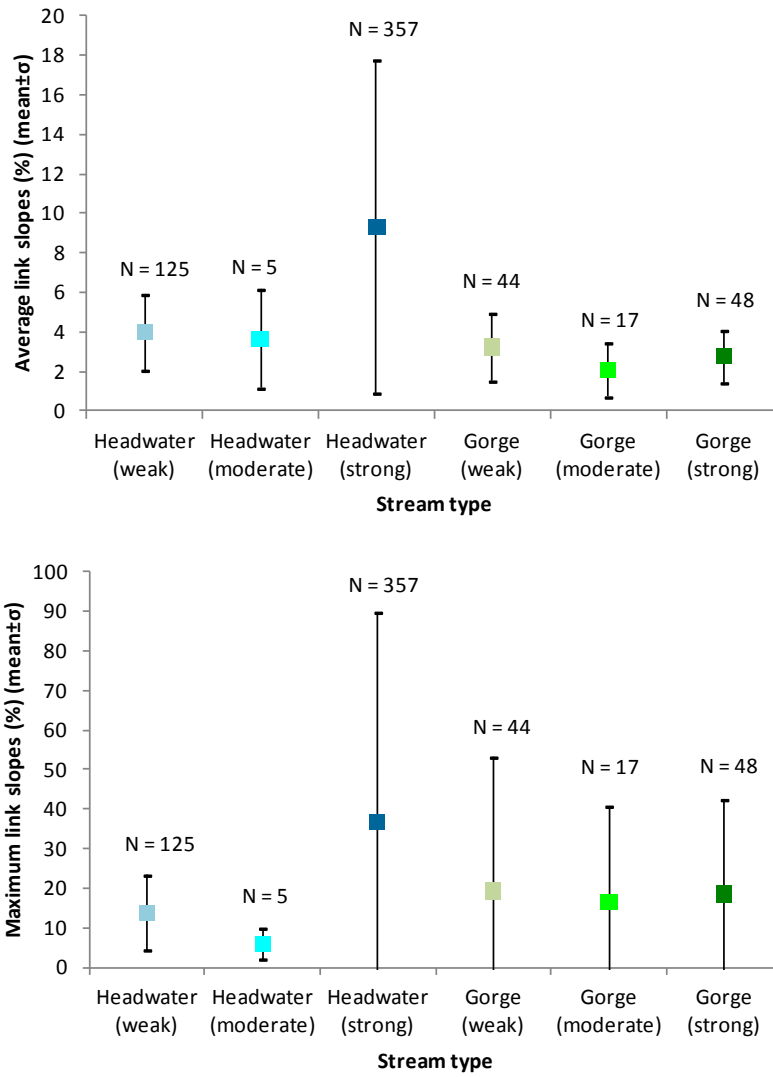
Figure 40. Distributions of slopes of channel links in the Study Area belonging to the six geomorphic type classes.

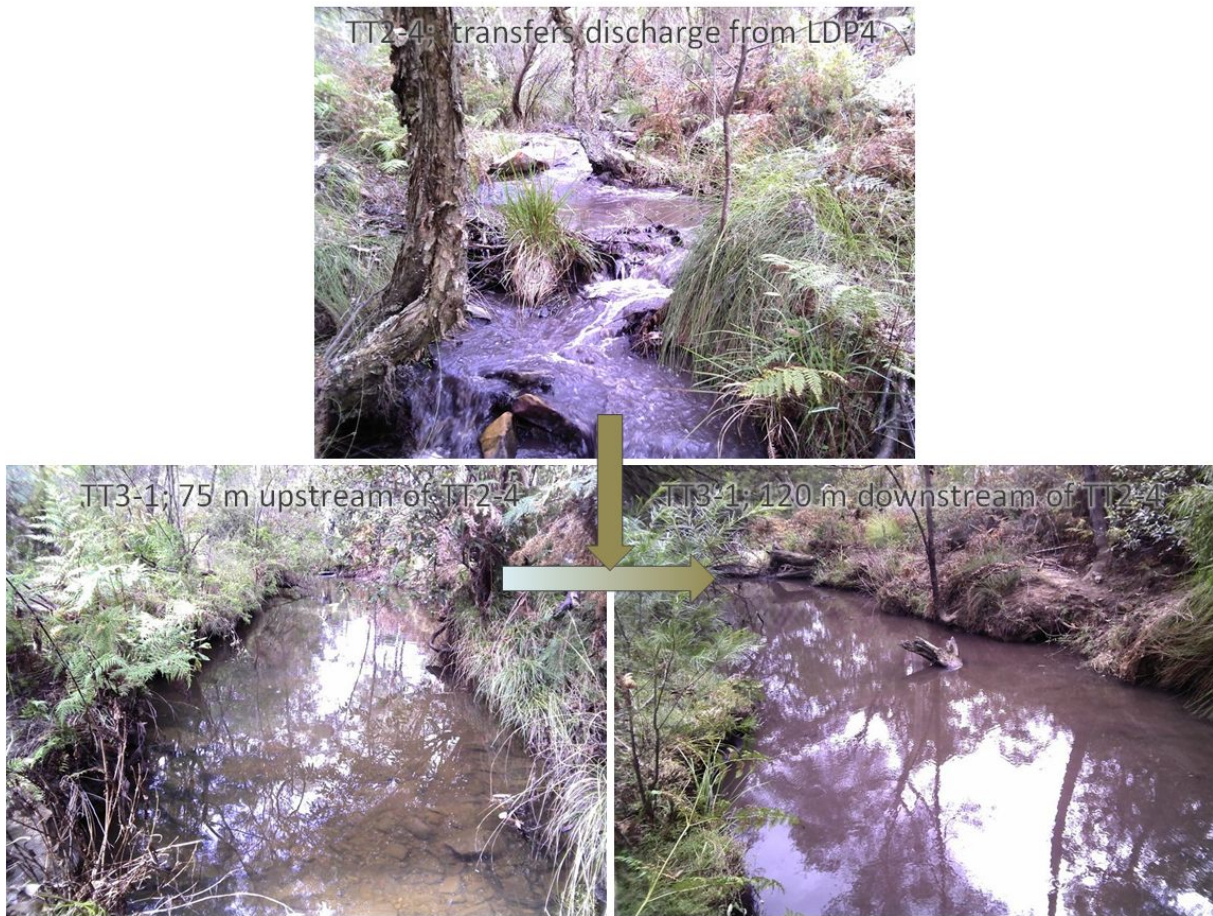
Figure 42. TT3-1 (Teatree Hollow) in the vicinity of where turbid discharge from LDP4 was observed to enter the Hollow via TT2-4. Photographed on 6 February 2013.

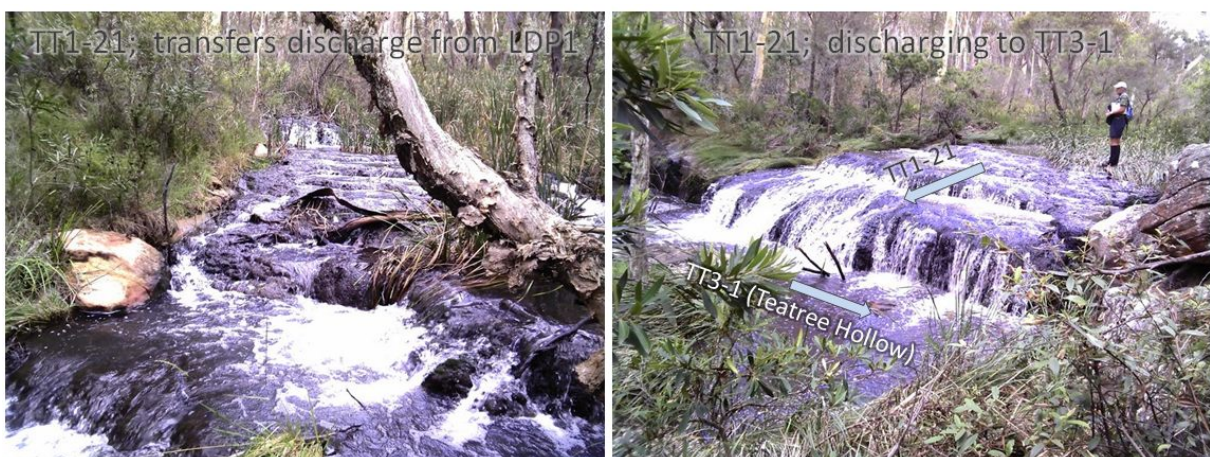
Figure 43. TT1-21 in the vicinity of where it transfers discharge from LDP1 to Teatree Hollow. Exposed bedrock and boulders in the bed were covered by a layer of dark-coloured precipitate. Photographed on 6 February 2013.

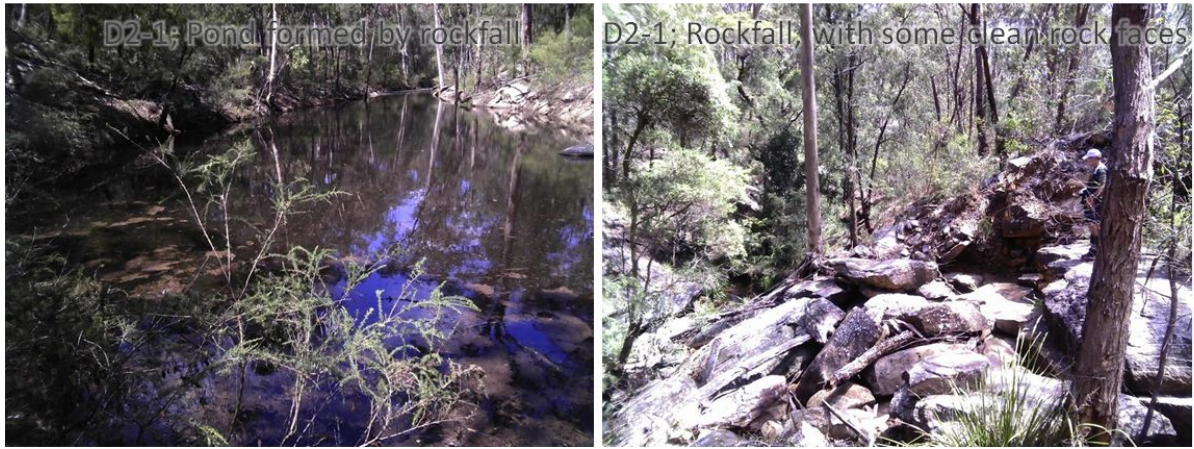
Figure 44. A pond in D2-1 (Dry Creek) created by a significant rockfall. Photographed on 31 January 2013.

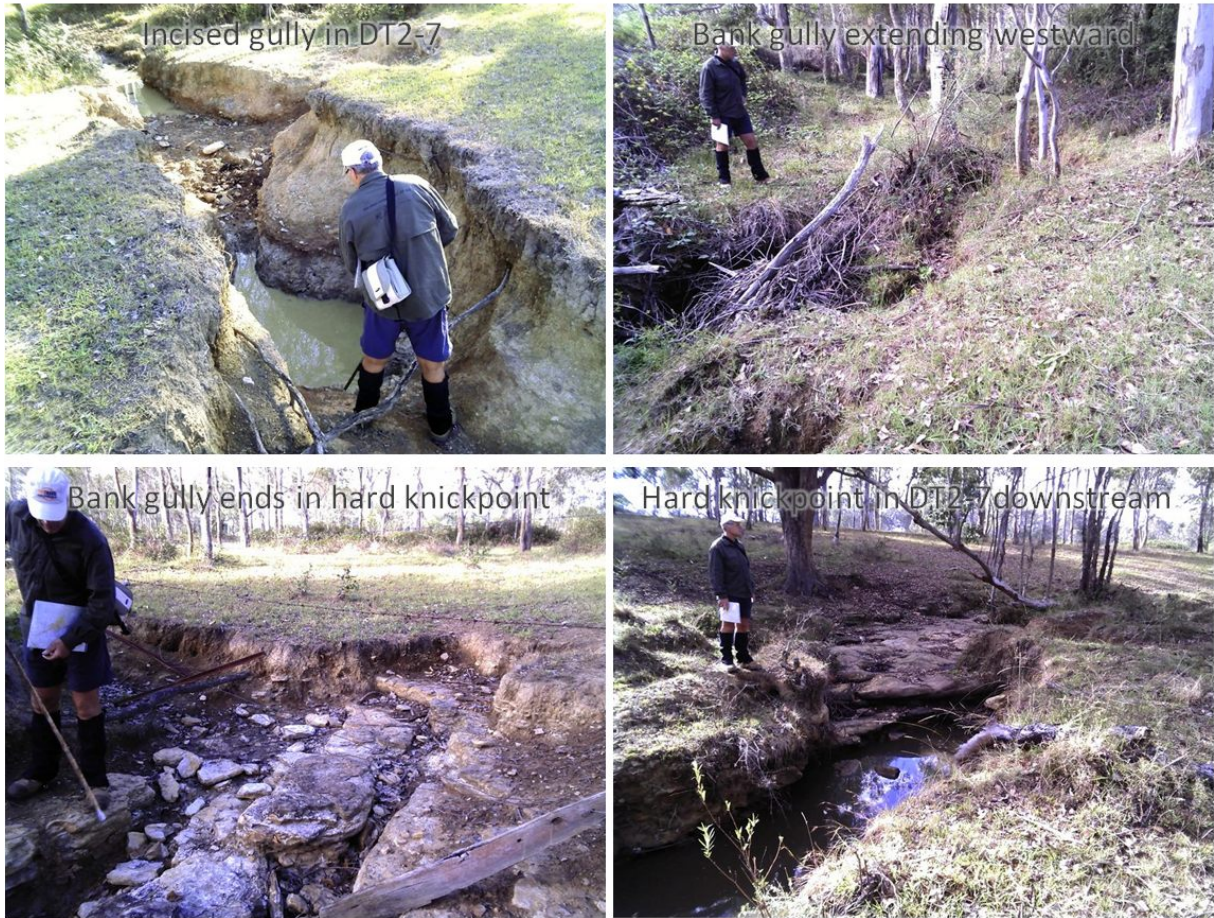
Figure 46. Incised gully on upstream end of DT2-7 (Dog Trap Creek). Photographed on 24 January 2013.

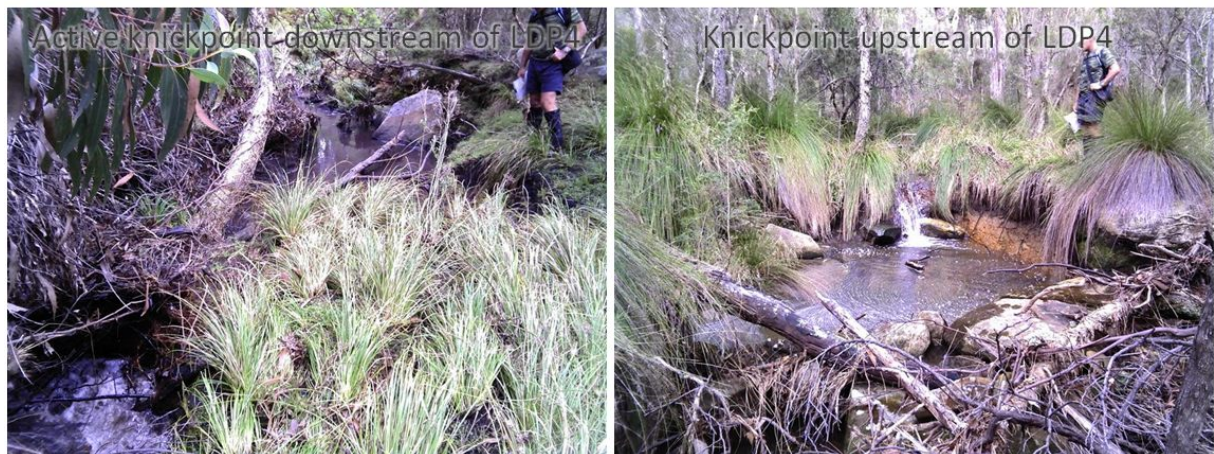
Figure 47. Recently active knickpoint (left) and another soft knickpoint 320 m upstream, both on TT3-1 (Teatree Gully). Photographed on 6 February 2013.

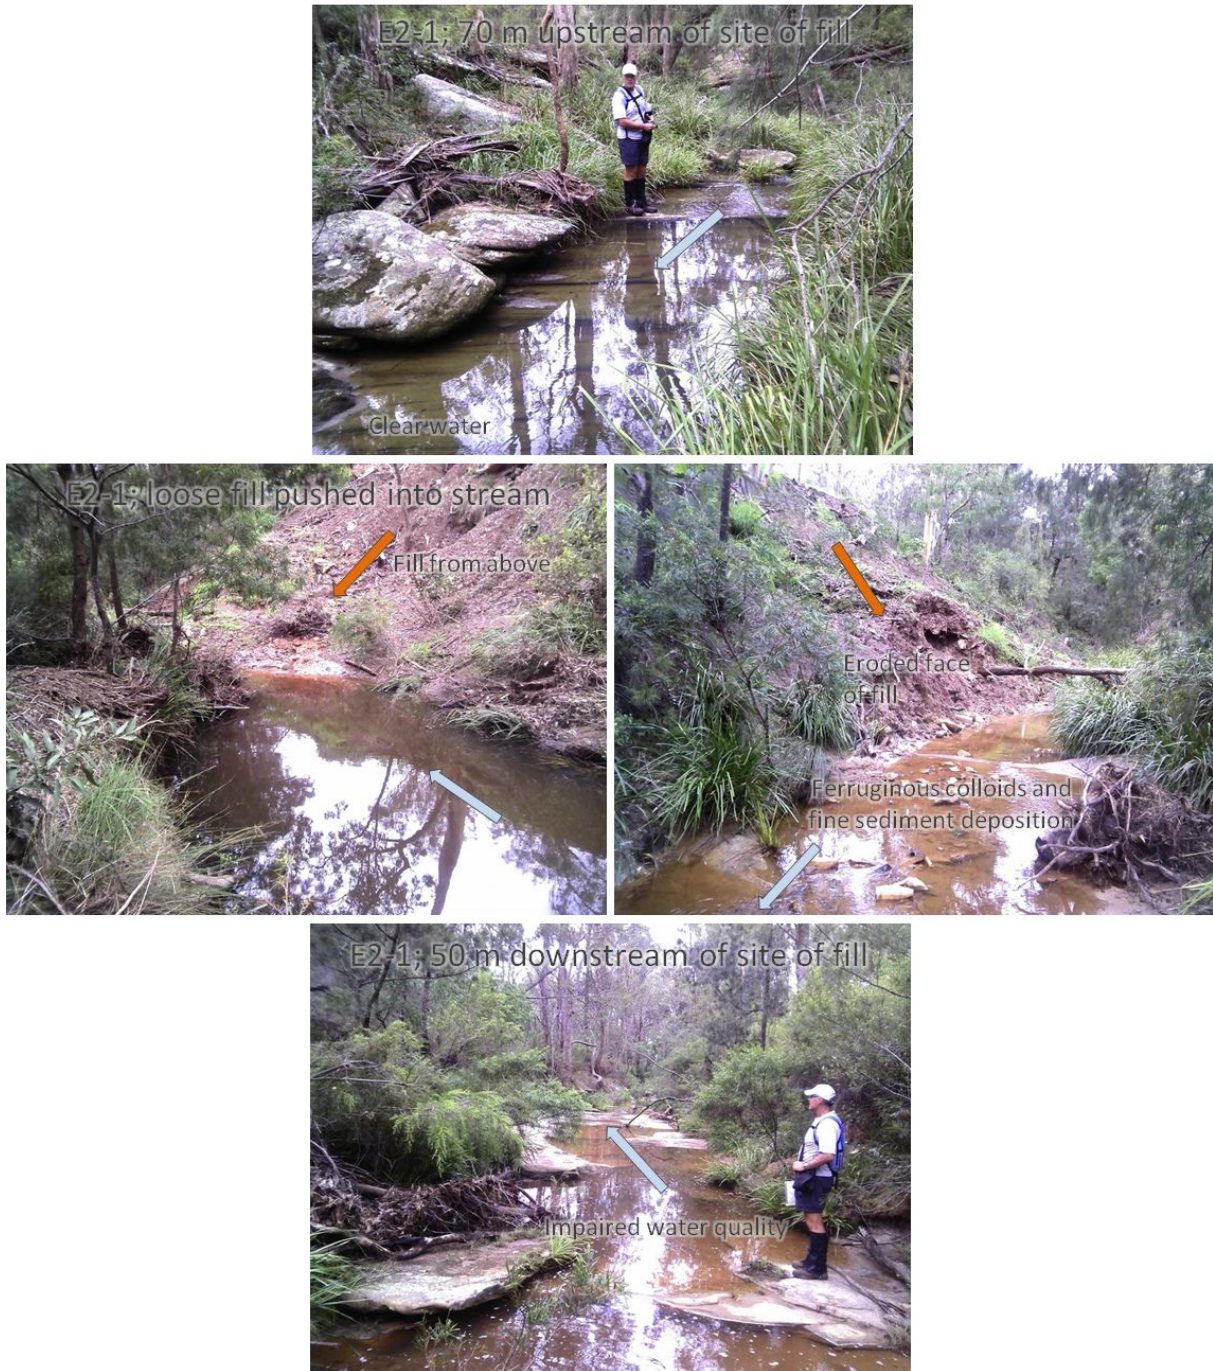
Figure 50. Site where loose fill was observed to have been tipped into Eliza Creek from above. Photographed 11 February 2013.

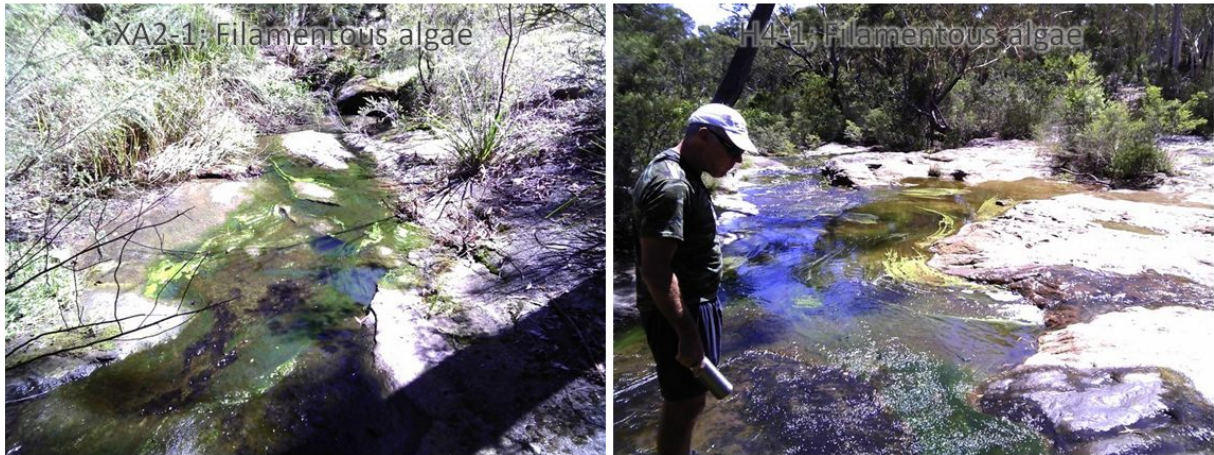
Figure 51. Examples of filamentous algae, observed on creek XA2-1 on 2 February 2013 and Hornes Creek (H4-1) on 8 February 2013.

Low turbidity water, open riparian canopy, and stable substrates can promote excessive growth of filamentous green algae on the stream bed when these conditions occur in conjunction with an enriched supply of nutrients (Welch et al., 1988). Measurement of filamentous algae cover is included in the AusRivAS² physical assessment protocol for the reason that "*Excess filamentous algae growth may be indicative of nutrient enrichment*" (Parsons et al., 2002). Cover of filamentous algae was grouped with the in-channel vegetation cover category in the Geomorphology Technical Report because when present at high levels it can alter the hydraulic properties (i.e. distribution of velocity and depth) and surface properties of the bed.

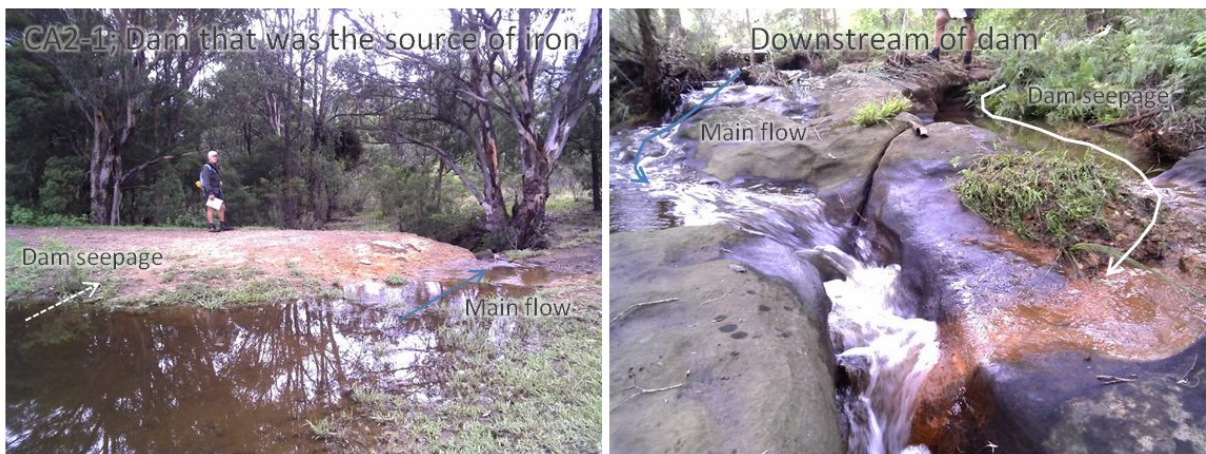
Figure 52. Site where ferruginous seep was observed on Carters Creek. Photographed 30 January 2013.

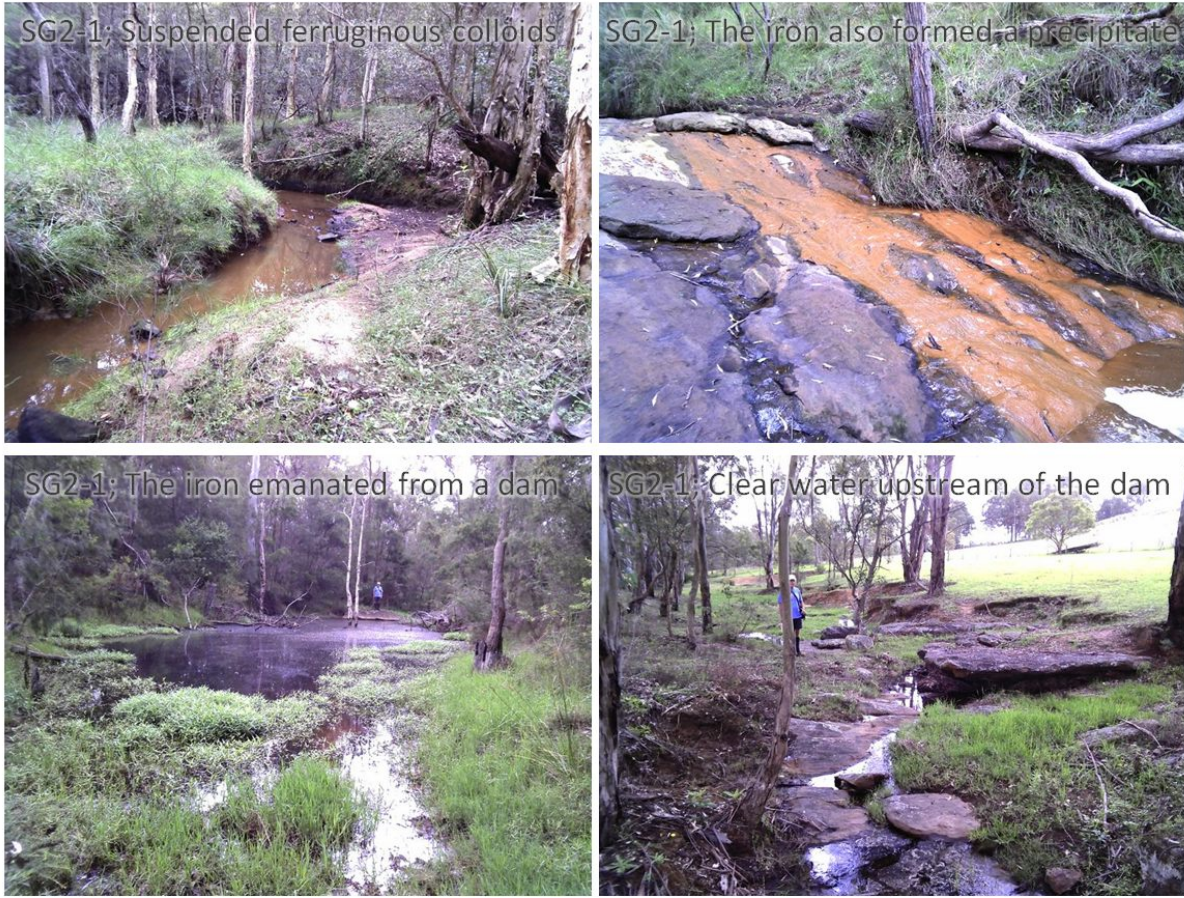
Figure 53. Ferruginous colloids suspended in the water of Sugarloaf Gully over a 310 m long reach. Photographed 13 February 2013.

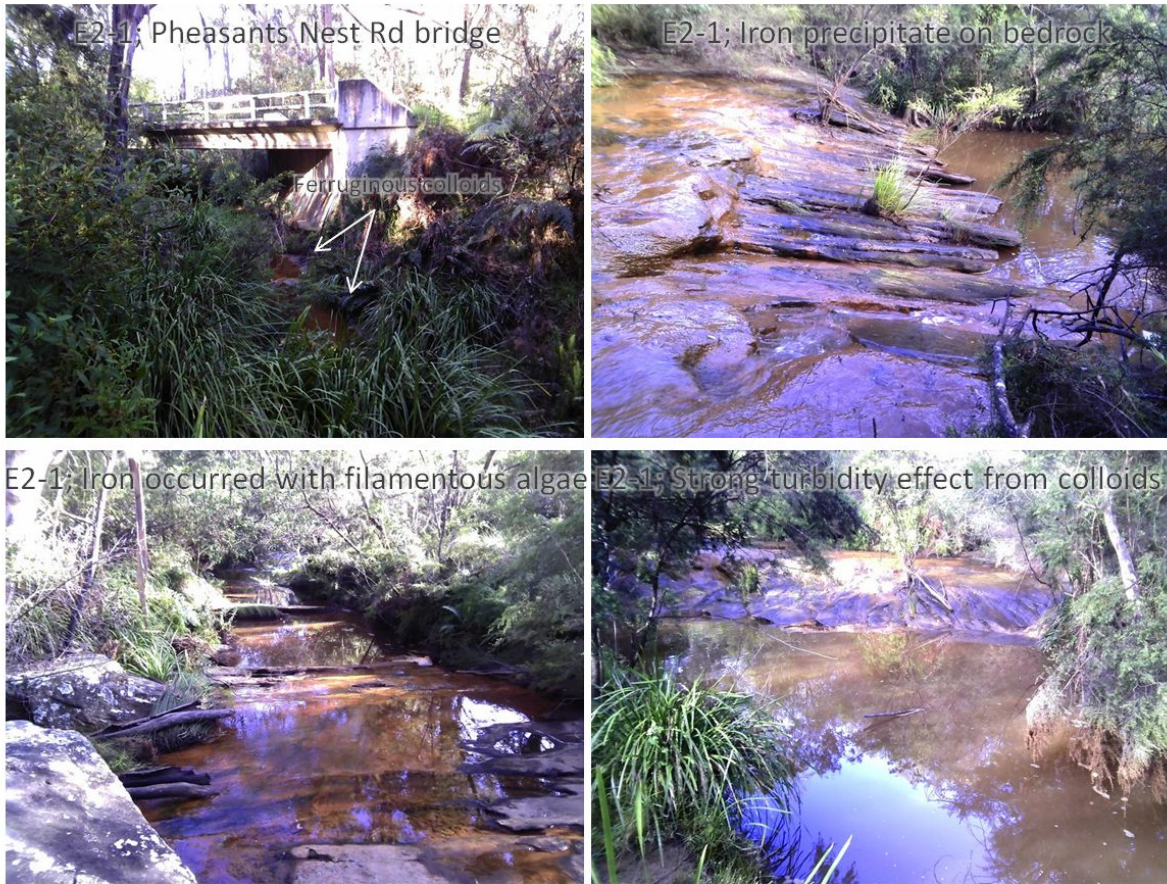
Figure 54. Ferruginous colloids suspended in the water, and iron precipitate on bedrock, of Eliza Creek. Photographed 13 February 2013.
