## Tahmoor Mine Extraction Plan LW W3-W4 Surface Water Technical Report

Prepared for: Tahmoor Coal

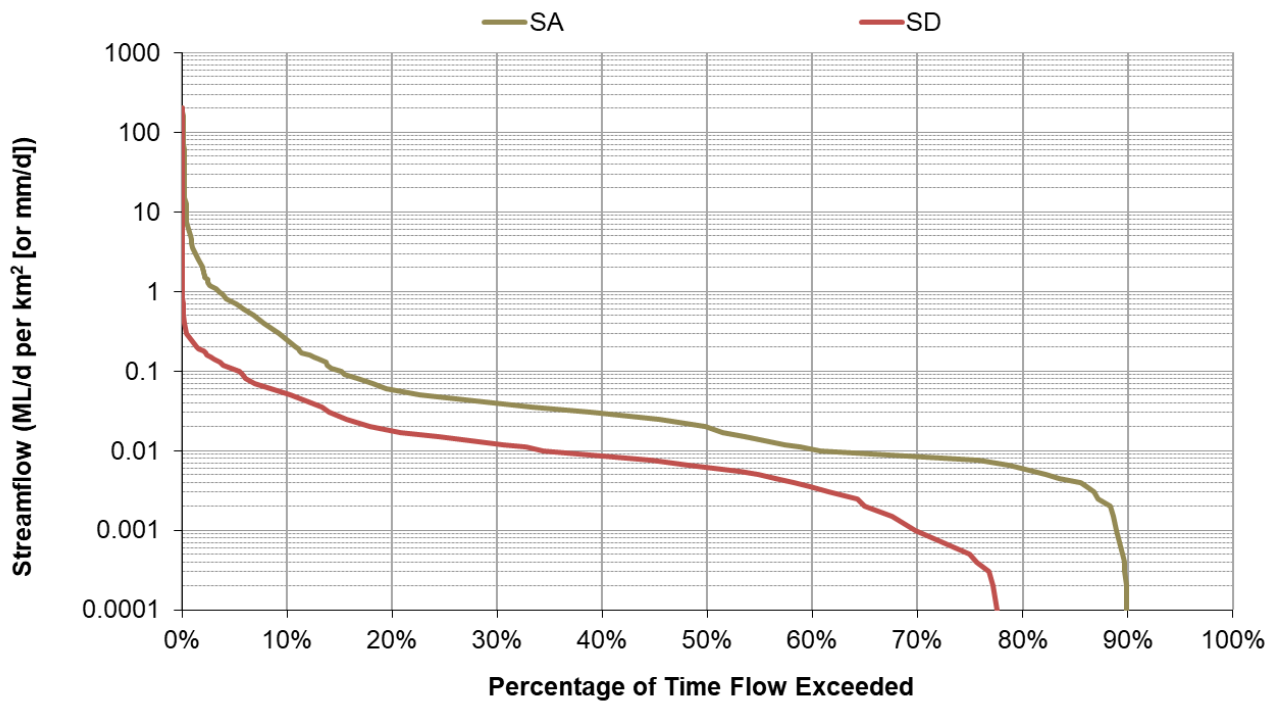
Figure 11 presents the flow duration curves for flow over the control at monitoring sites SA and SD on Stonequarry Creek, derived from water level records for January 2019 to January 2021.

**Figure 11 Stonequarry Creek Monitoring Sites Estimated Flow Duration Curve**

Figure 11 illustrates that flow over the control at monitoring site SA and SD is intermittent with a flow rate of than 0.001 mm/d recorded approximately 89% of the time at monitoring site SA and approximately 70% of the time at monitoring site SD. It should be noted that the streamflow control at monitoring site SD is a wide, flat rockbar and, as such, monitoring of low flow rates is unable to be accurately undertaken at this site. The accuracy of low flow records will influence the percentage of time in which low flow rates are inferred to occur at monitoring site SD. There is also potential that the stream reach between pool SR17 (monitoring site SB) and monitoring site SD is sustained by baseflow discharge (i.e. the stream section is losing to the groundwater system) to a lesser degree than the reach upstream of monitoring site SD (refer Section 3.1.3). The estimated streamflow rates indicate a median flow rate of approximately 0.32 ML/d (0.02 mm/d) at monitoring site SA and 0.27 ML/d (0.006 mm/d) at monitoring site SD.

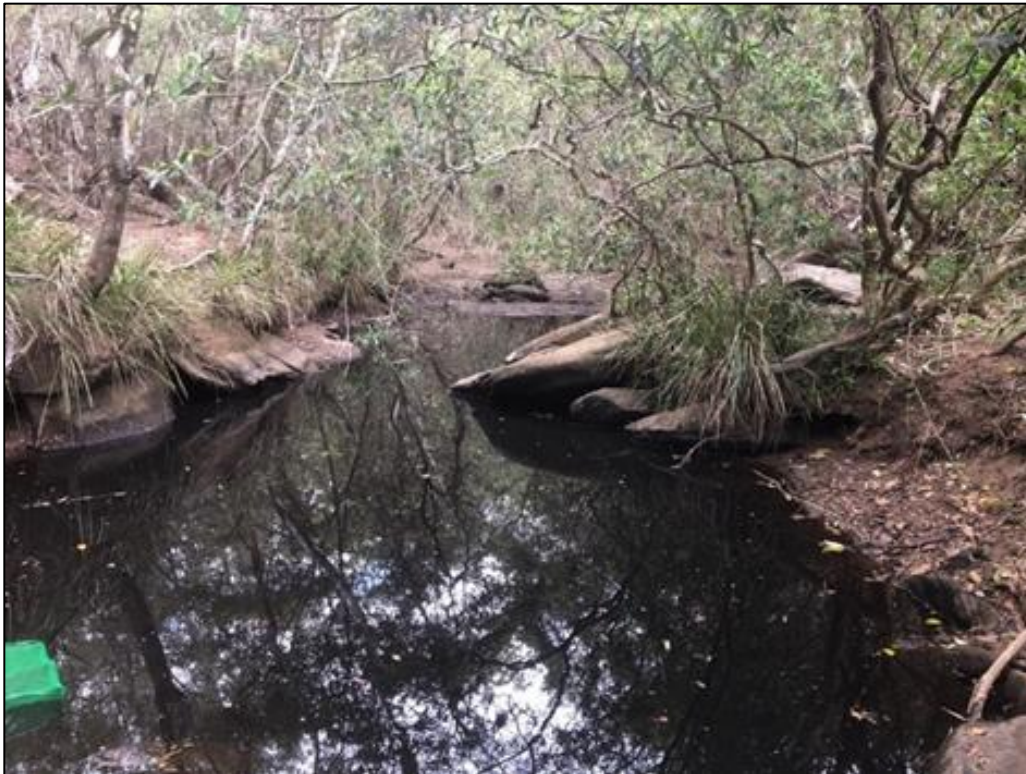
**Photo 1** Matthews Creek Site 7 (Upstream of Cedar Creek Confluence) - Pool with Boulder Field Control (Source: Niche, 2019b; photo dated Spring 2018)

Specific pools in Matthews Creek, Cedar Creek and Stonequarry Creek are shown in Photo 1 to Photo 4 below. It is noteworthy that sections of Matthews Creek are devoid of flow in between reaches which are flowing – this is illustrated in Photo 2.

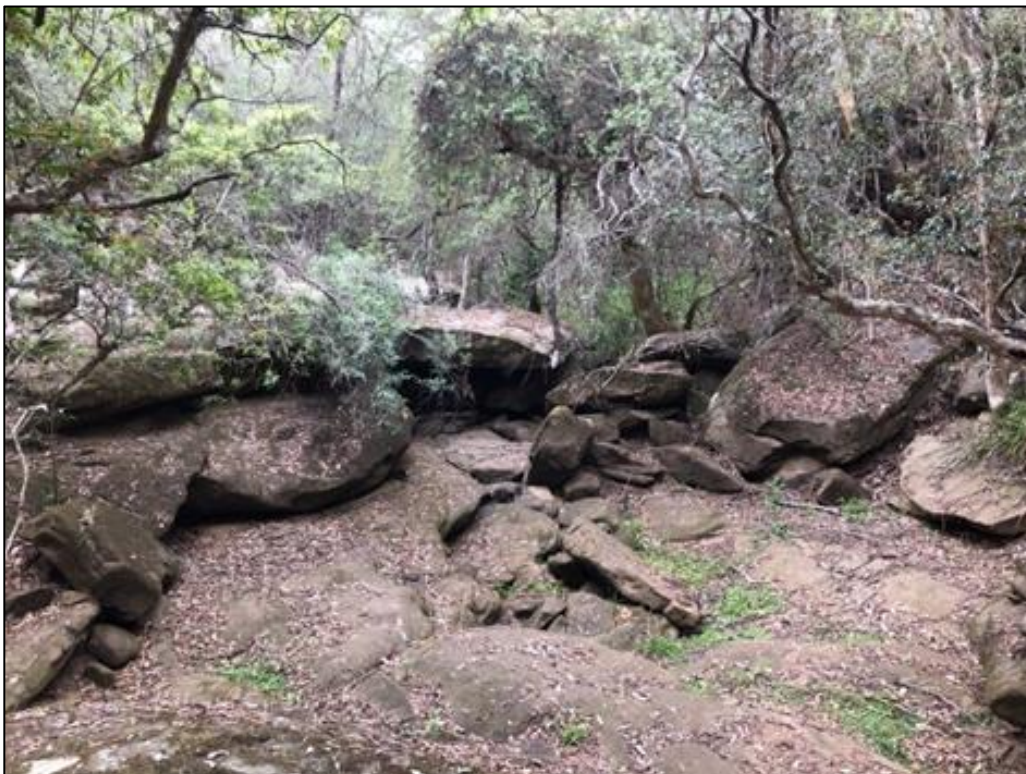
**Photo 2** Matthews Creek Site 8 (Upstream Matthews Creek) - Typical Reach with No Flow (Source: Niche, 2019b; photo dated Spring 2018)

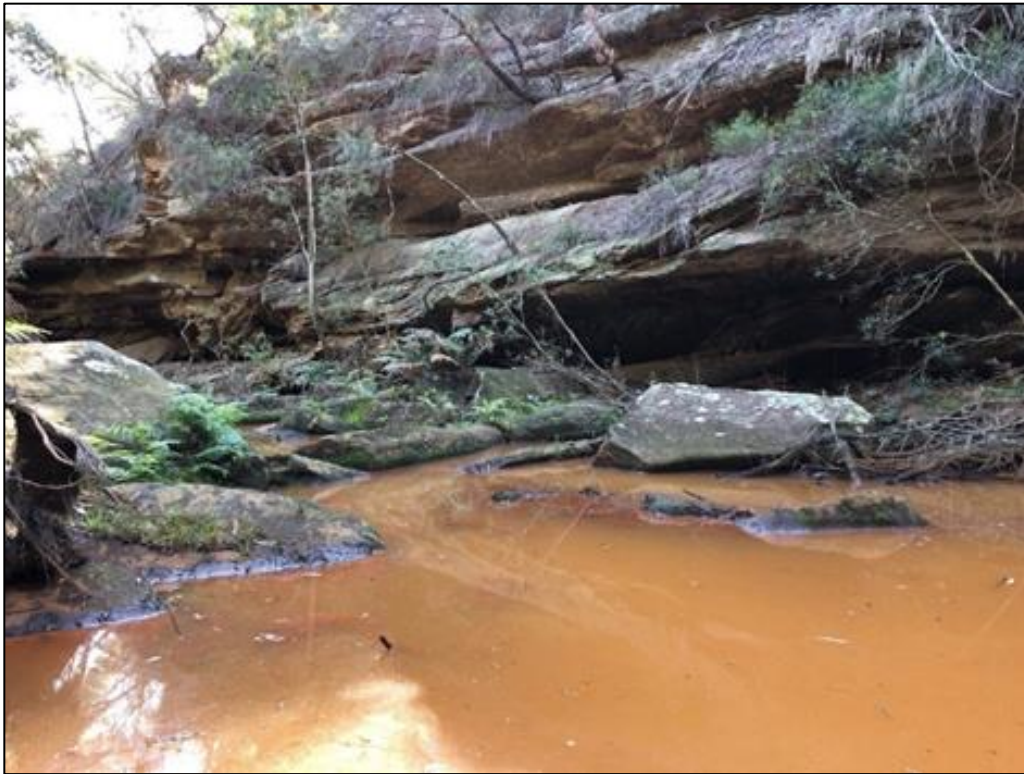
**Photo 3 Cedar Creek Site 6 (Confluence of Matthews Creek and Cedar Creek) - Pool with Rock Shelf and Pre-Mining Iron Staining (Source: Niche, 2019b; photo dated Spring 2018)**

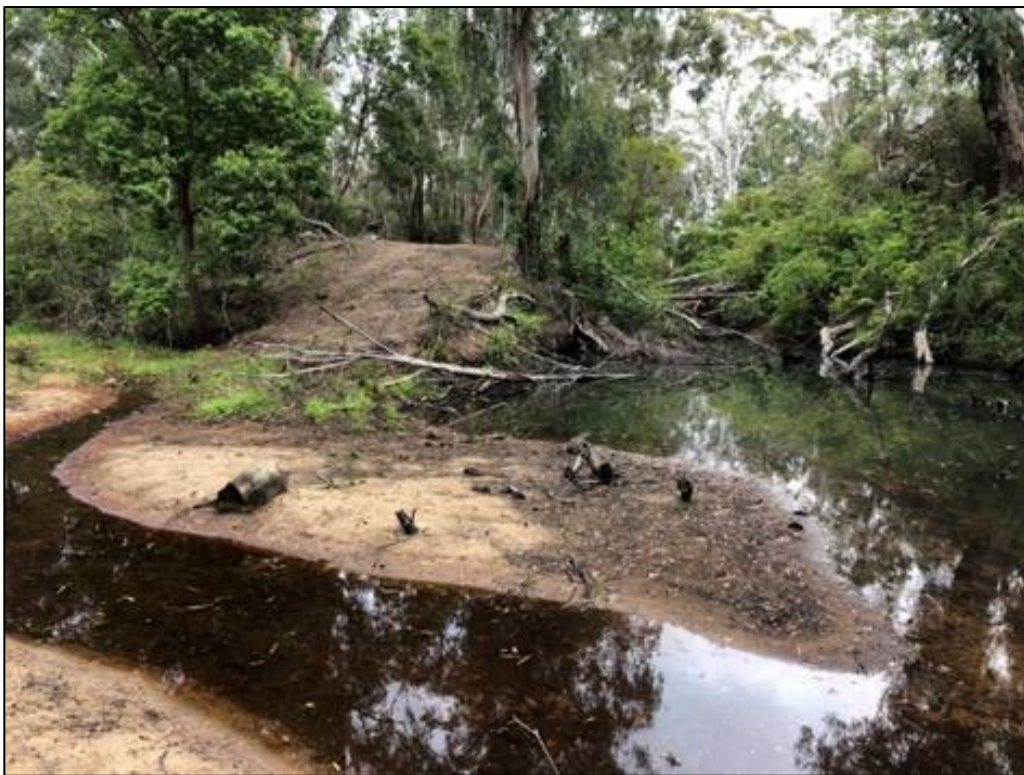
**Photo 4 Stonequarry Creek Site 4 (Confluence of Cedar Creek Stonequarry Creek) – Pool with Alluvium / Colluvium Base Material (Source: Niche, 2019b; photo dated Spring 2018)**

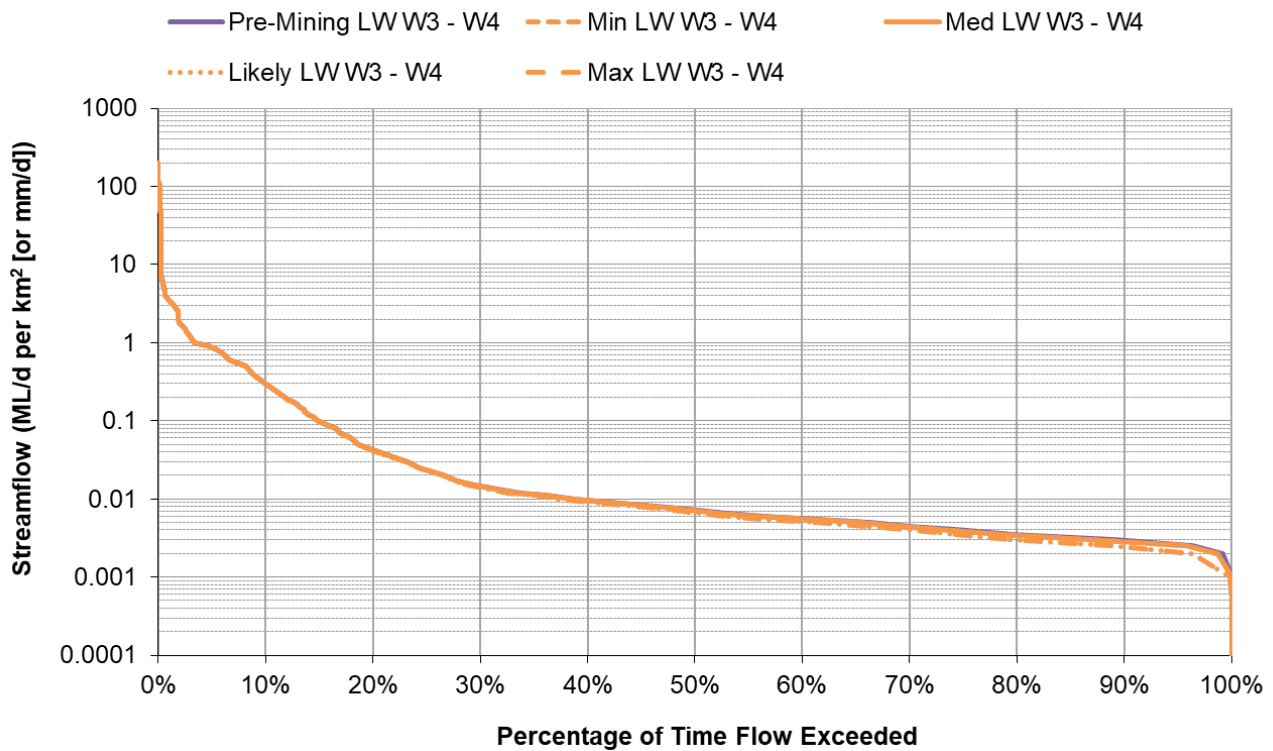
Figure 15 shows the impact of the range of predicted baseflow reduction rates due to mining of LW3-W4 on flows in Cedar Creek at monitoring site CG.

**Figure 15 Flow Duration Curve – Cedar Creek (Monitoring Site CG) Predicted Baseflow Reduction Impact**

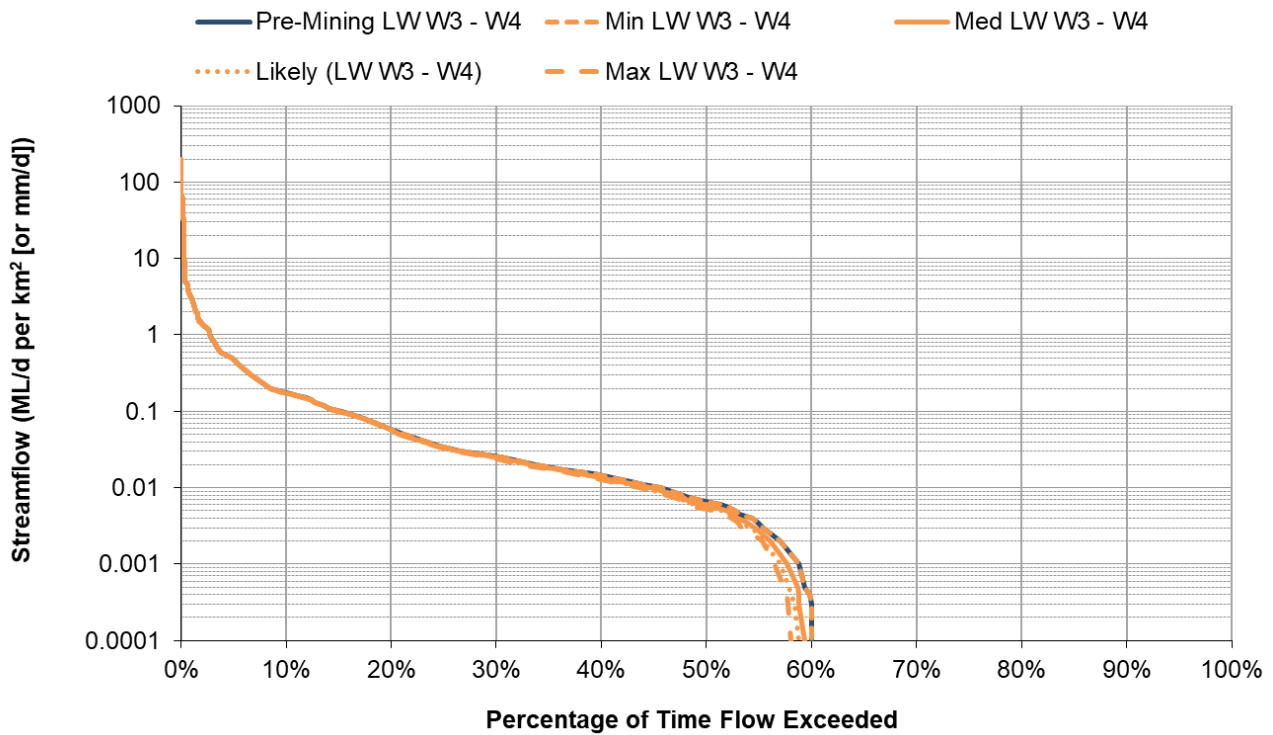
Figure 16 shows the impact of the range of predicted baseflow reduction rates due to mining of LW3-W4 on flows in Matthews Creek at monitoring site MG.

**Figure 16 Flow Duration Curve – Matthews Creek (Monitoring Site MG) Predicted Baseflow Reduction Impact**

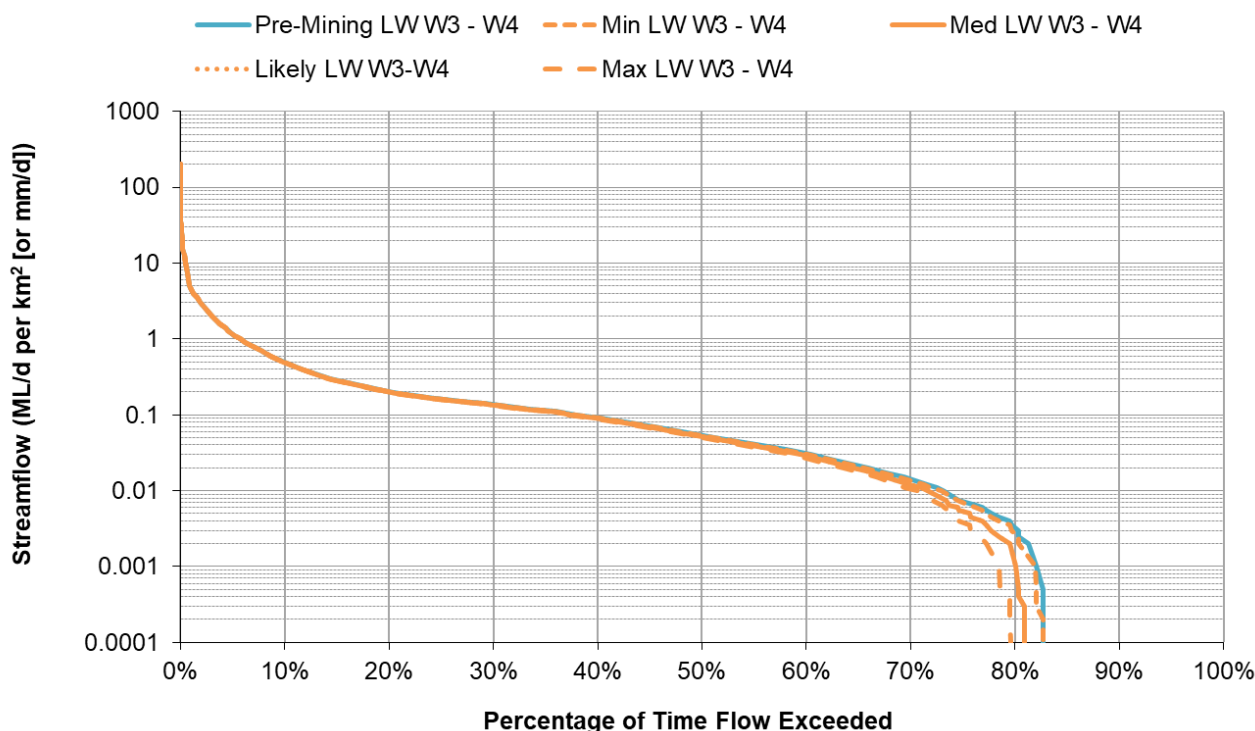
Figure 18 shows the impact of the range of predicted baseflow reduction rates due to mining of LW3-W4 on flows in Redbank Creek at monitoring site RB11.

**Figure 18 Flow Duration Curve – Redbank Creek at Monitoring Site RB11 Predicted Baseflow Reduction Impact**
