# REPORT

## Tahmoor Mine Extraction Plan LW W1 – W2 Amended Surface Water Technical Report

Prepared for: Tahmoor Coal

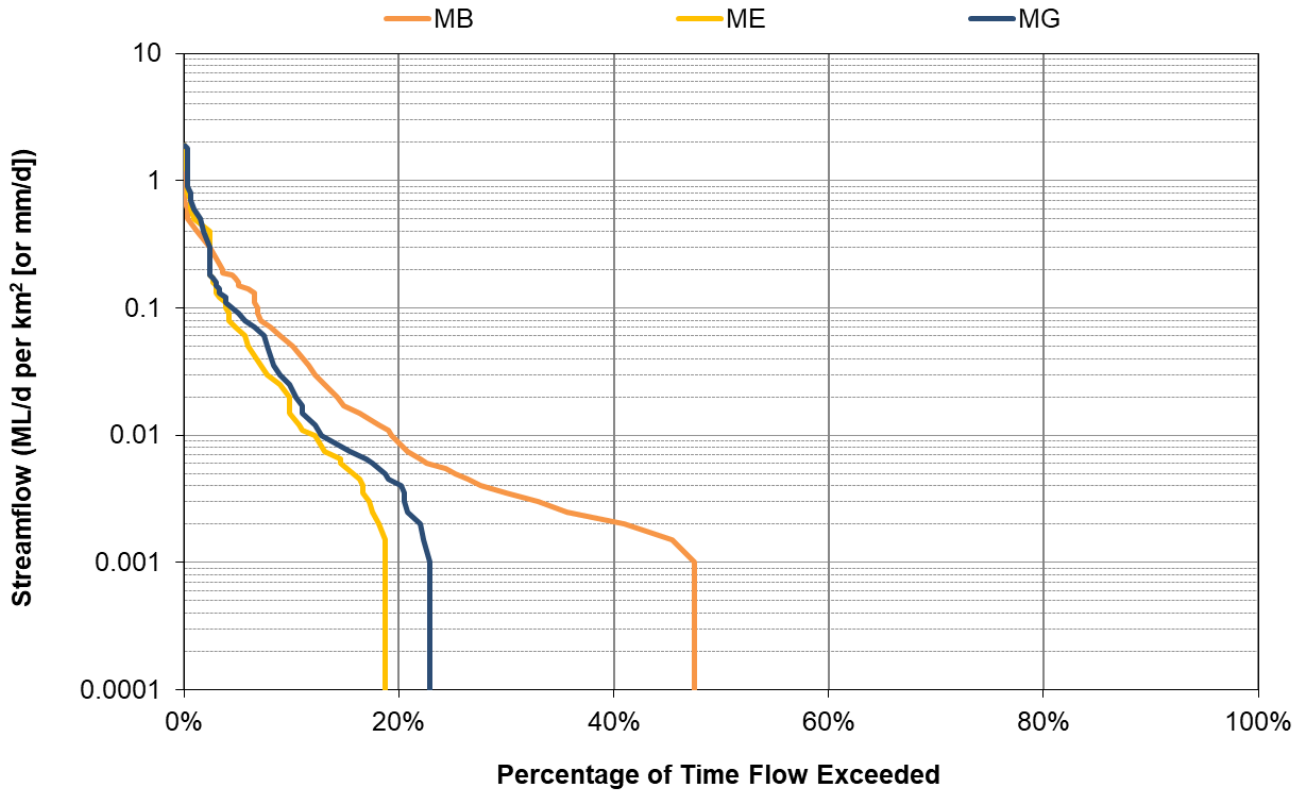
**Figure 6** Matthews Creek Flow Duration Curve

Figure 6 presents the flow duration curves for the monitored pools on Matthews Creek. The estimated rate of streamflow is expressed in ML/d per square kilometre (km<sup>2</sup>) of catchment (or mm/day) to enable direct comparison between sites.

Figure 6 illustrates that the streamflow characteristics for sites ME and MG are similar, with a non-negligible streamflow rate (greater than 0.001 mm/d) exceeded at ME approximately 19% of the time and at MG approximately 23% of the time. Streamflow at MB was recorded a higher percentage of time, with non-negligible flow recorded approximately 48% of the time.

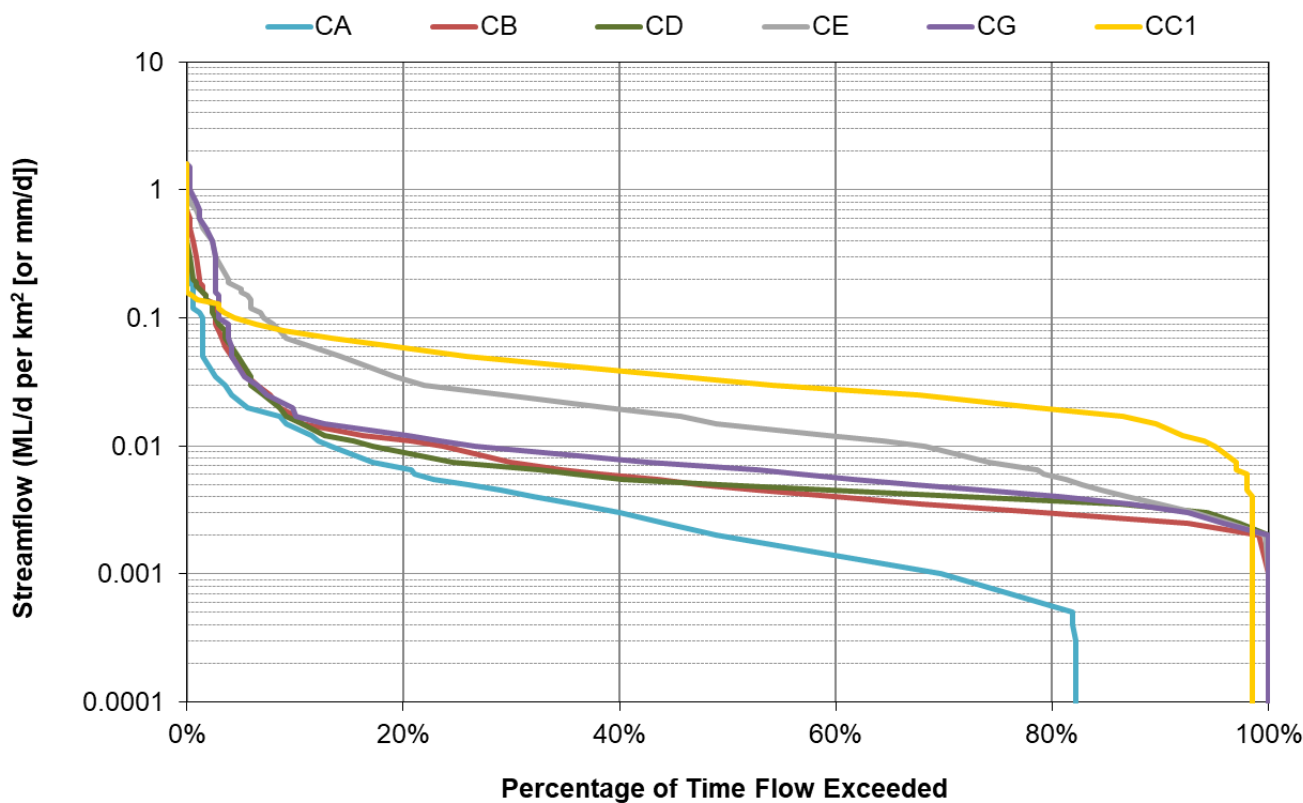
**Figure 7 Cedar Creek Flow Duration Curve**

Figure 7 presents the flow duration curves for the streamflow monitoring sites on Cedar Creek.

Figure 7 illustrates that the streamflow characteristics for sites CB, CD and CG are similar while lower streamflow rates per unit area of catchment were recorded at CA and higher rates were recorded at CE and CC1. The flow rate at CB and CD exceeded 0.005 mm/d (0.12 and 0.13 ML/d respectively) approximately 50% of the time, while the flow rate at CG exceeded 0.007 mm/d (0.19 ML/d) approximately 50% of the time. The flow rate at CA exceeded 0.002 mm/d (0.03 ML/d) approximately 50% of the time, the flow rate at CE exceeded 0.015 mm/d (0.38 ML/d) approximately 50% of the time and the flow rate at CC1A exceeded 0.03 (0.57 ML/d) approximately 50% of the time.

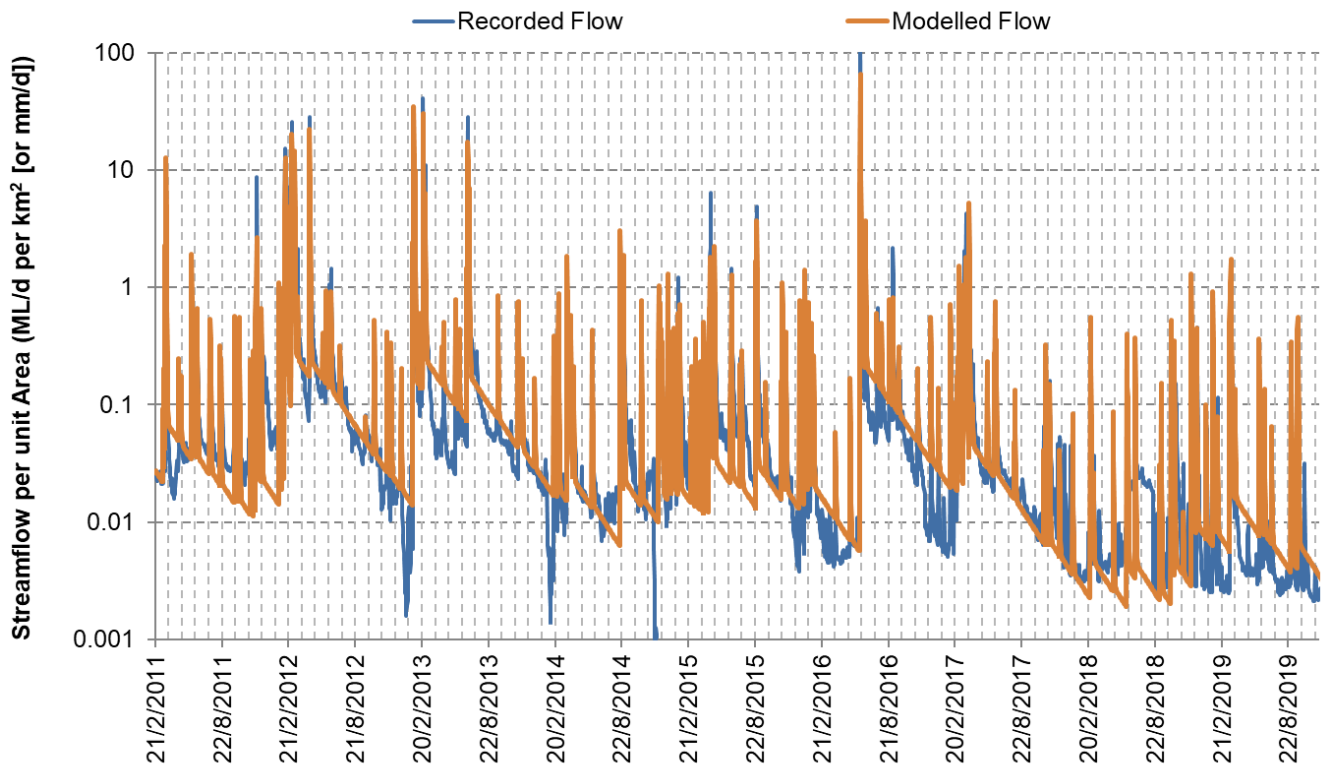
**Figure 10** Recorded and Modelled Flows – Stonequarry Creek at Picton (GS 212053)

The AWBM simulated and monitored flow for Stonequarry Creek at Picton are shown in Figure 10.

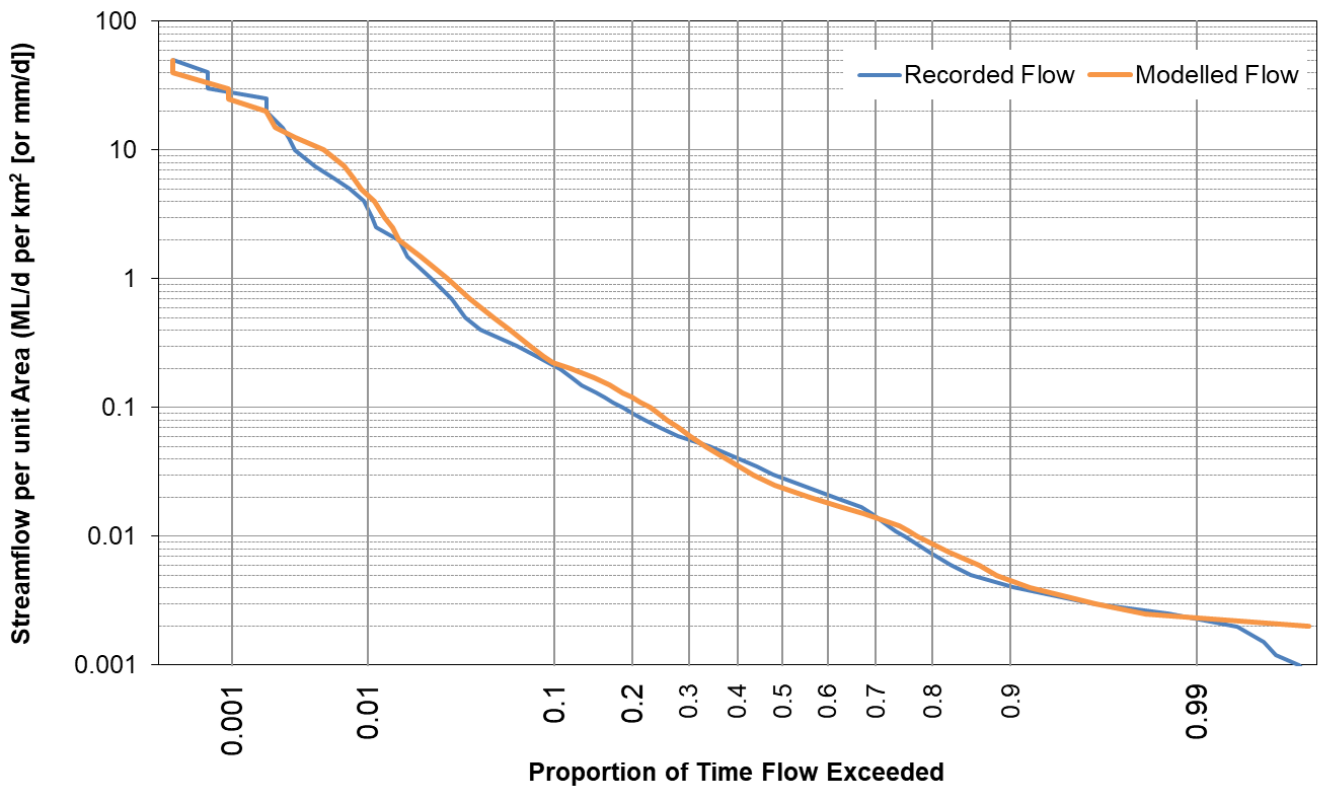
**Figure 11 Modelled and Recorded Flow Duration Curves - Stonequarry Creek at Picton (GS 212053)**

The match between modelled and recorded flows can be assessed by comparing the flow duration curves of recorded and modelled flows – refer Figure 11 which has been compiled for the calibration period.

Table 12 summarises statistical parameters of model fit which have been identified from and calculated in accordance with Vaze et al. (2011).

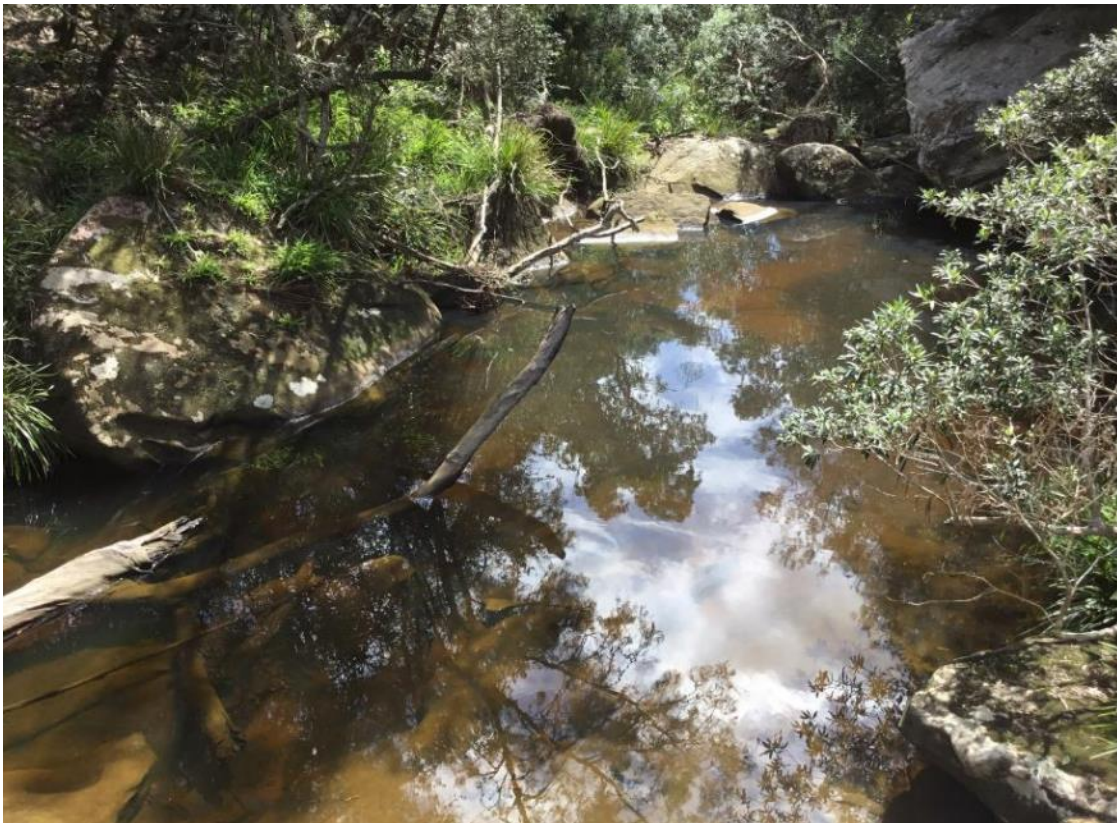
**Photo 1** Matthews Creek Typical Pool with Boulder Field at Downstream End (Site 7 - refer Figure 4)

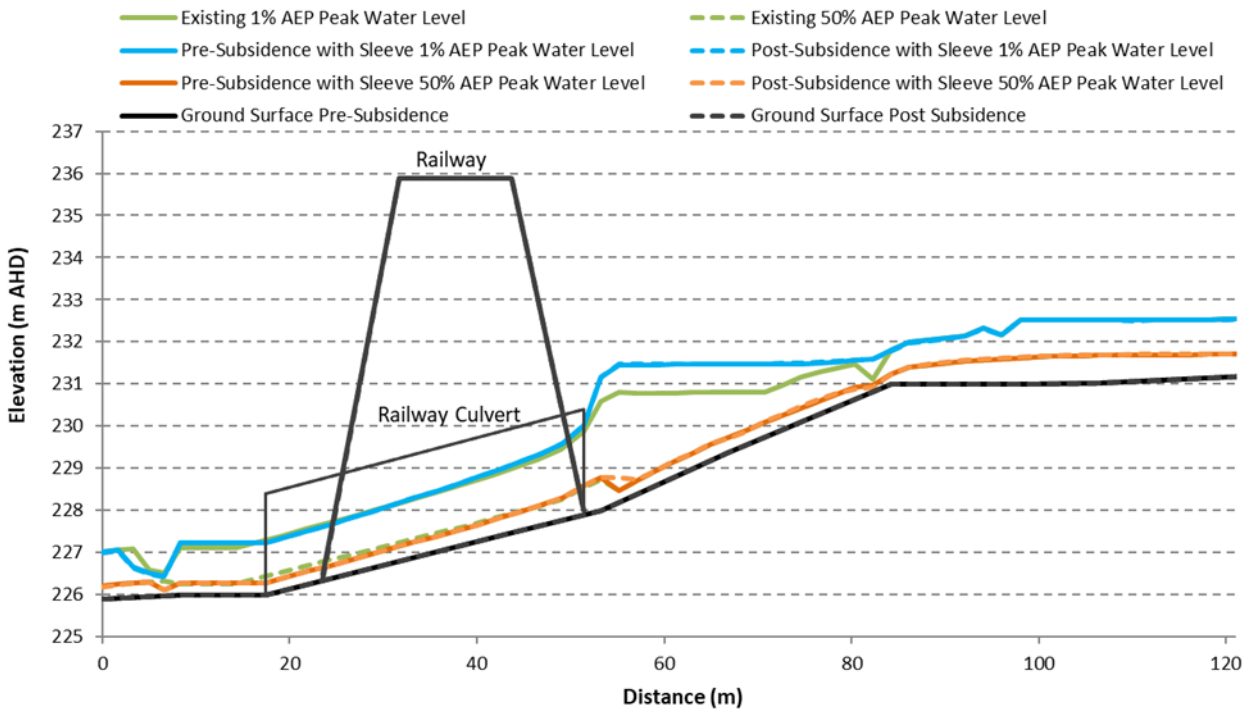
**Figure 16 Rumker Gully Pre and Post-Subsidence Modelled Peak Flood Level**

Figure 16 shows the pre and post-subsidence alignment of Rumker Gully, the railway and railway culvert. The pre and post-subsidence modelled flood levels for the 50% AEP and 1% AEP peak flow rates are also given. Note that modelling included the drain adjacent to (on the southern and western side of) the detention basin (Dam 3 on Figure 12) rather than the detention basin itself.

Figure 16 illustrates that reduction of the railway culvert diameter due to the installation of the concrete pipe sleeve will result in a maximum predicted increase in the 1% AEP flood level of 0.7 m upstream of the culvert. A negligible increase in flood level is predicted for the 50% AEP peak flow for this case.

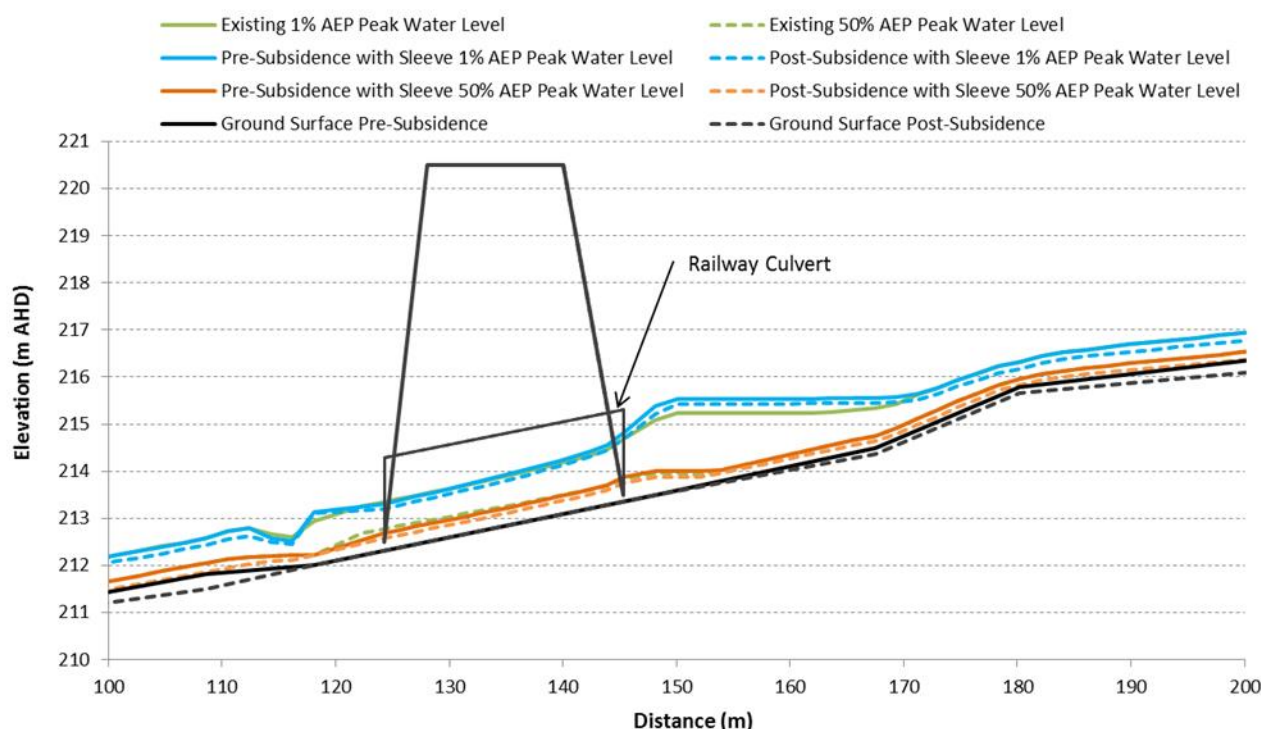
**Figure 17 MC Trib 2 Pre and Post-Subsidence Modelled Peak Flood Level**

Figure 17 shows the pre and post-subsidence alignment of Matthews Creek Tributary 2 (MC Trib 2), the railway and railway culvert. The pre and post-subsidence modelled flood levels for the 50% AEP and 1% AEP peak flow rates are also given.

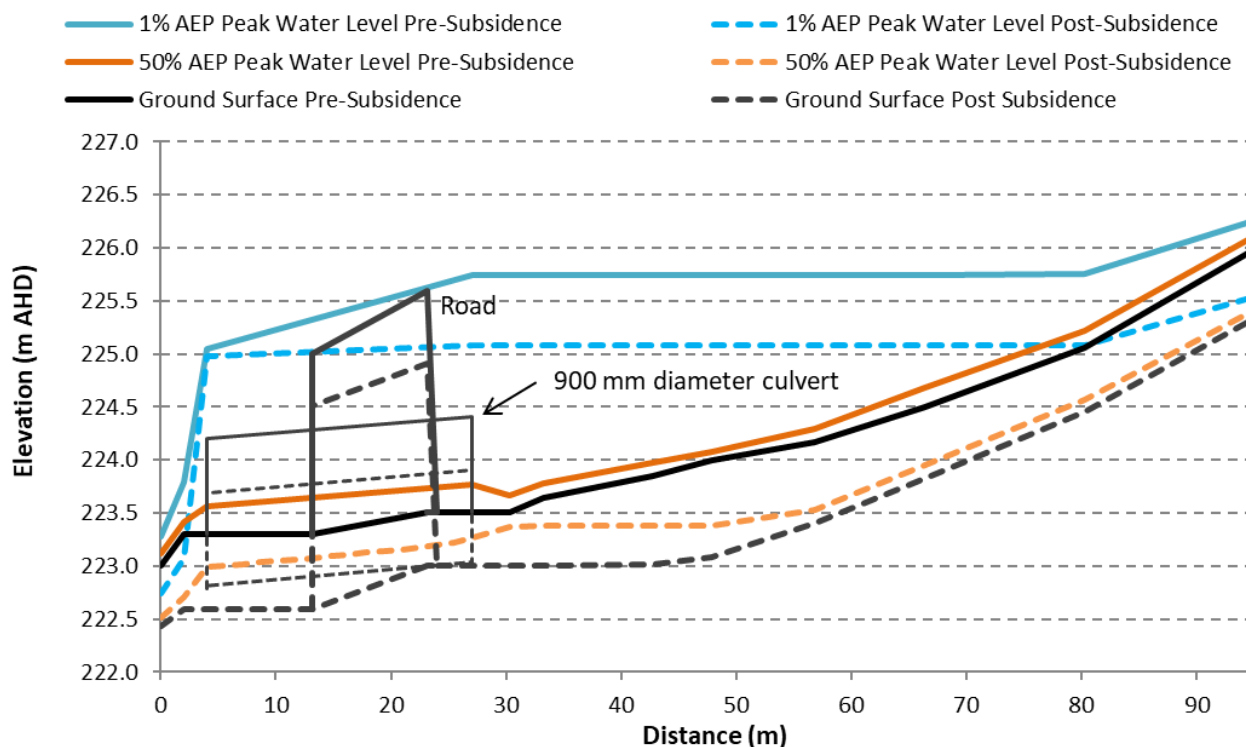
**Figure 18 MC Trib 2a Pre and Post-Subsidence Water Level**

Figure 18 shows the pre and post-subsidence alignment of Matthews Creek Tributary 2a (MC Trib 2a), the Stonequarry Creek Road and road culvert. The pre and post-subsidence modelled flood levels for the 50% AEP and 1% AEP peak flow rates are also given.

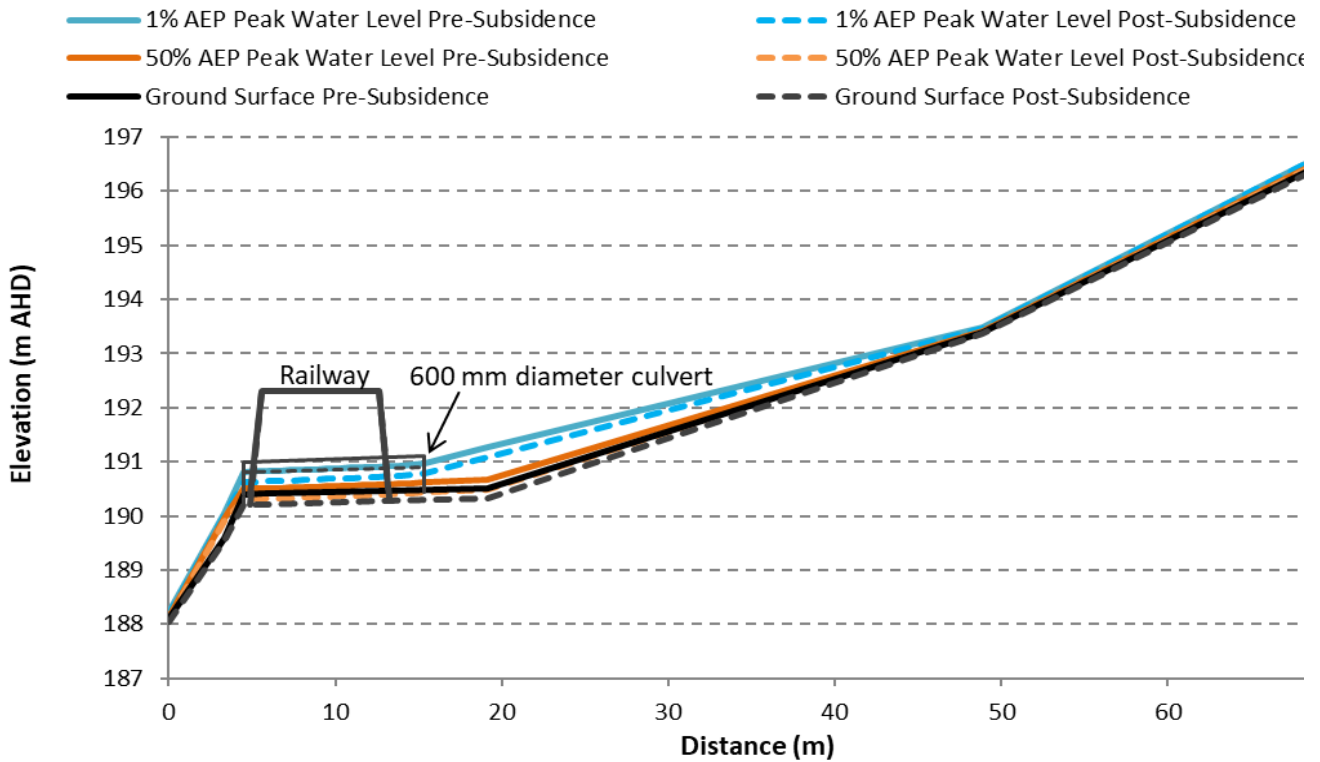
**Figure 21 SC Trib 2 Pre and Post-Subsidence Water Level**

Figure 21 shows the pre and post-subsidence alignment of Stonequarry Creek Tributary 2 (SC Trib 2), the railway and railway culvert. The pre and post-subsidence modelled flood levels for the 50% AEP and 1% AEP peak flow rates are also given.
