Tahmoor Coal Pty Ltd

LAND MANAGEMENT PLAN

**Tahmoor North - Western Domain
Longwalls West 3 and West 4**

May 2021

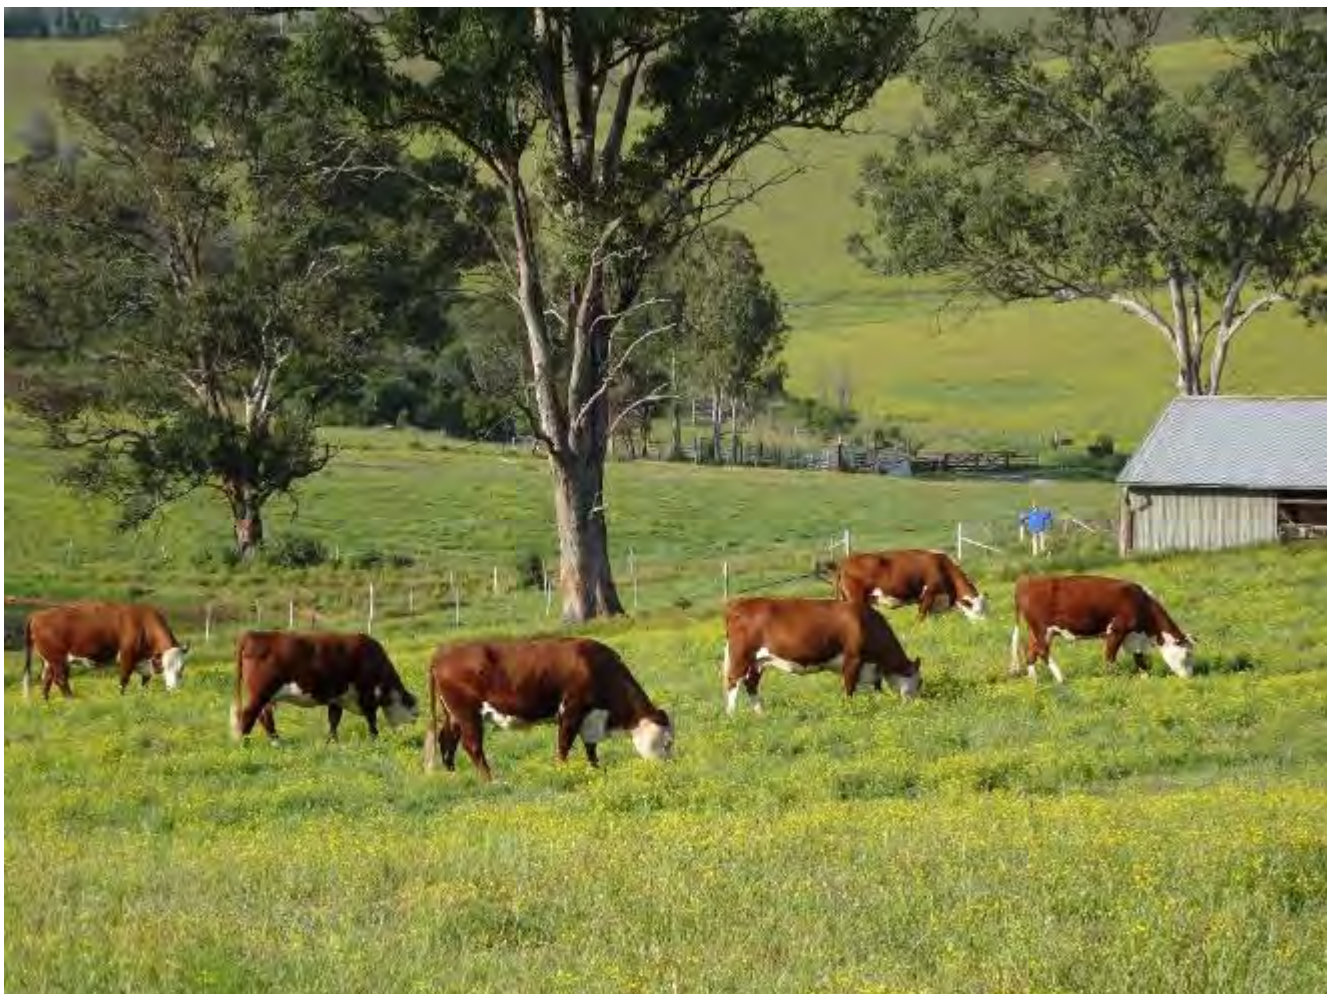
Plate 1 Cattle grazing grass pasture area on cleared hills within the Study Area

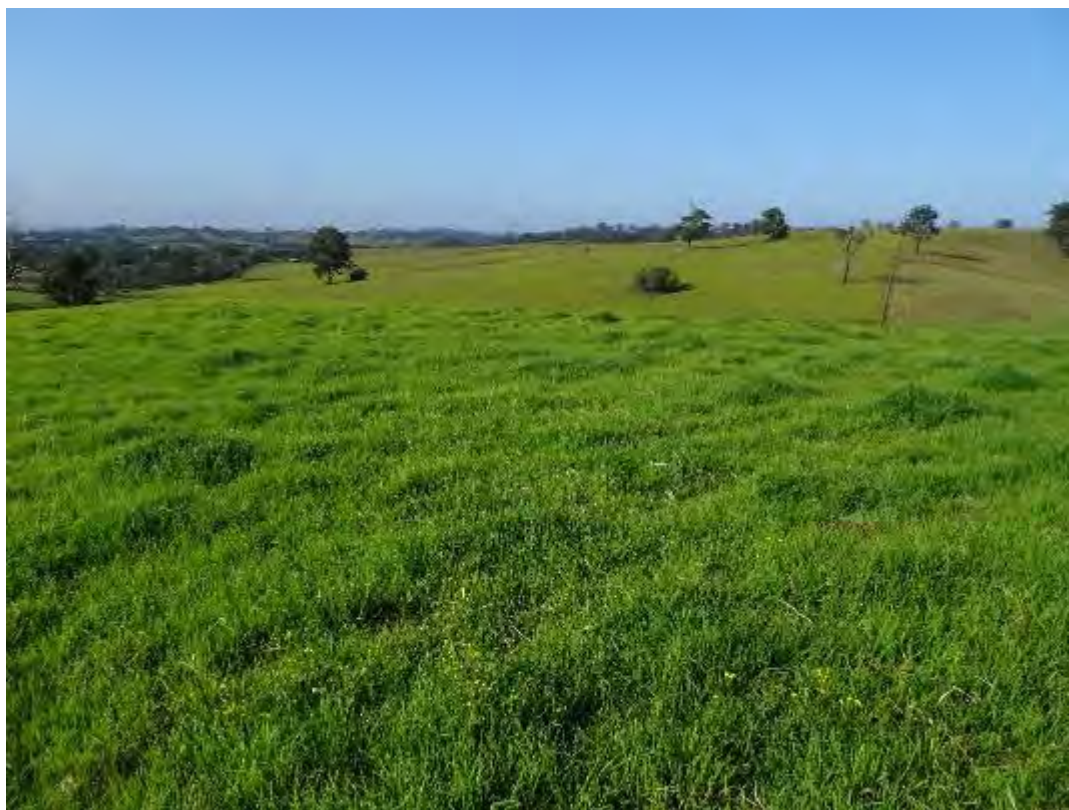
Plate 2 Grass pasture on rolling hills within the Study Area

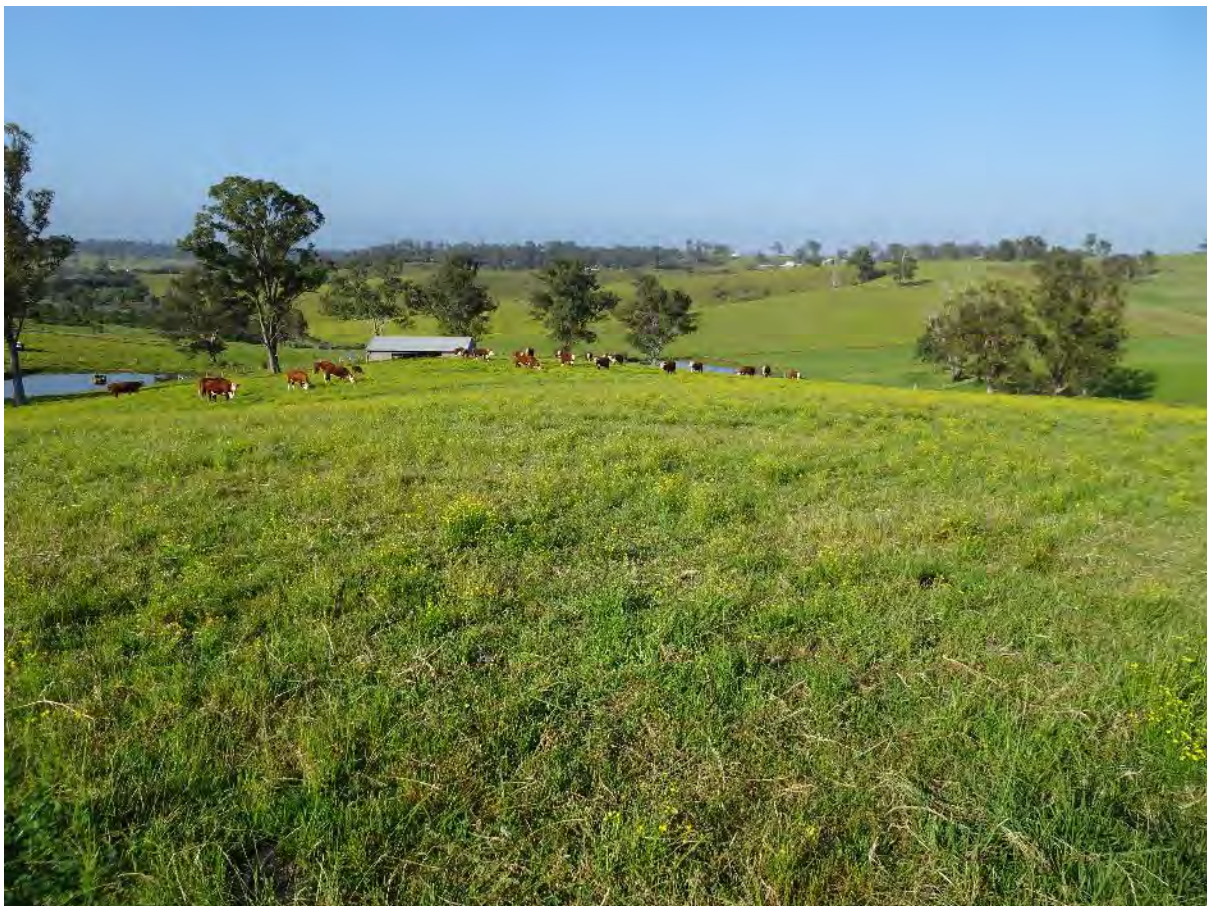
The Luddenham Soil Landscape Unit consists of undulating to rolling low hills, with slopes 5-20% and local relief is 50-80 metres. It occurs on the Wianamatta Group shales and often associated with Minchinbury Sandstone. Vegetation has been extensively cleared, consisting of open-forest. Soils are dominated by shallow Dermosols on crests; moderately deep Dermosols on upper and lower slopes and near drainage lines.

Limitations of this unit include erosion hazard, mass movement potential and moderate surface swelling potential. This soil landscape unit is suited to grazing enterprises.

This soil landscape occurs throughout 78 hectares (24%) of the Study Area.

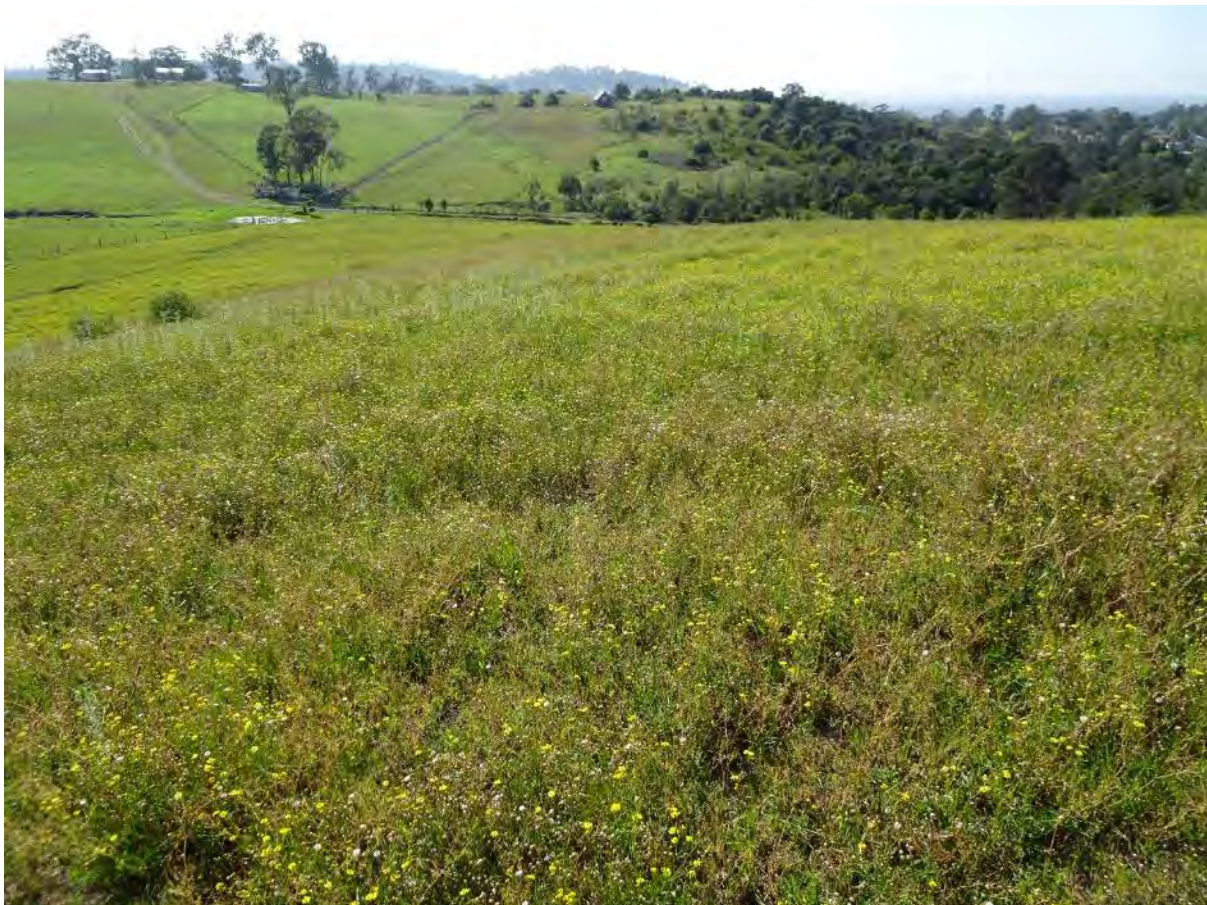
The Monkey Creek Soil Landscape Unit consists of floodplains, valley flats and drainage depressions of the creeks draining the Cumberland Plain. Slopes are generally 1-2% but can locally range to up to 10%, local relief is less than 5 metres. Vegetation has been extensively cleared with isolated stands of river oaks. Dominant soils include Sodosols and Kurosols on floodplains and valley floors, with alluvial soils and Hydrosols and Rudosols on poorly drained depressions and close to recent flow lines.

Limitations of this soil landscape include flood hazards, permanently high watertable and seasonal waterlogging. This soil landscape is capable of both grazing and regular cultivation.

This soil landscape occurs throughout 44 hectares (14%) of the Study Area.

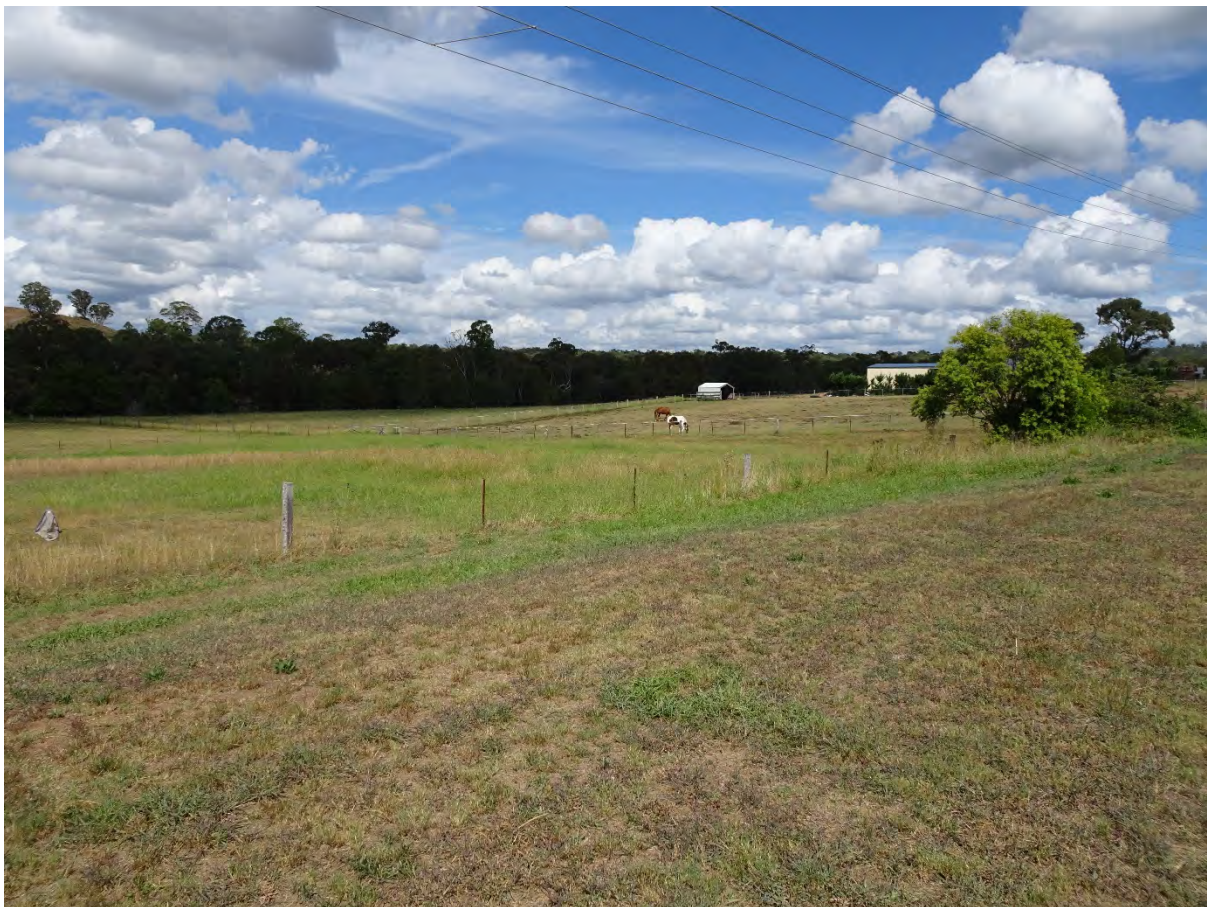
The Picton Soil Landscape Unit consists of steep to very steep sideslopes, with slopes greater than 20% and local relief of 90-300 metres. It occurs on Wianamatta group shales and derived colluvial materials. Vegetation consists of extensively cleared tall open-forest of blue gum and blackbutt. Dominant soils are shallow to deep Dermosols on upper slopes and Kurosols on lower slopes and benches.

Limitations of this soil landscape unit include steep slopes, mass movement hazards, seasonal waterlogging and water erosion hazards. This soil landscape is not suitable for any agricultural enterprise.

This soil landscape occurs throughout 19 hectares (6%) of the Study Area.

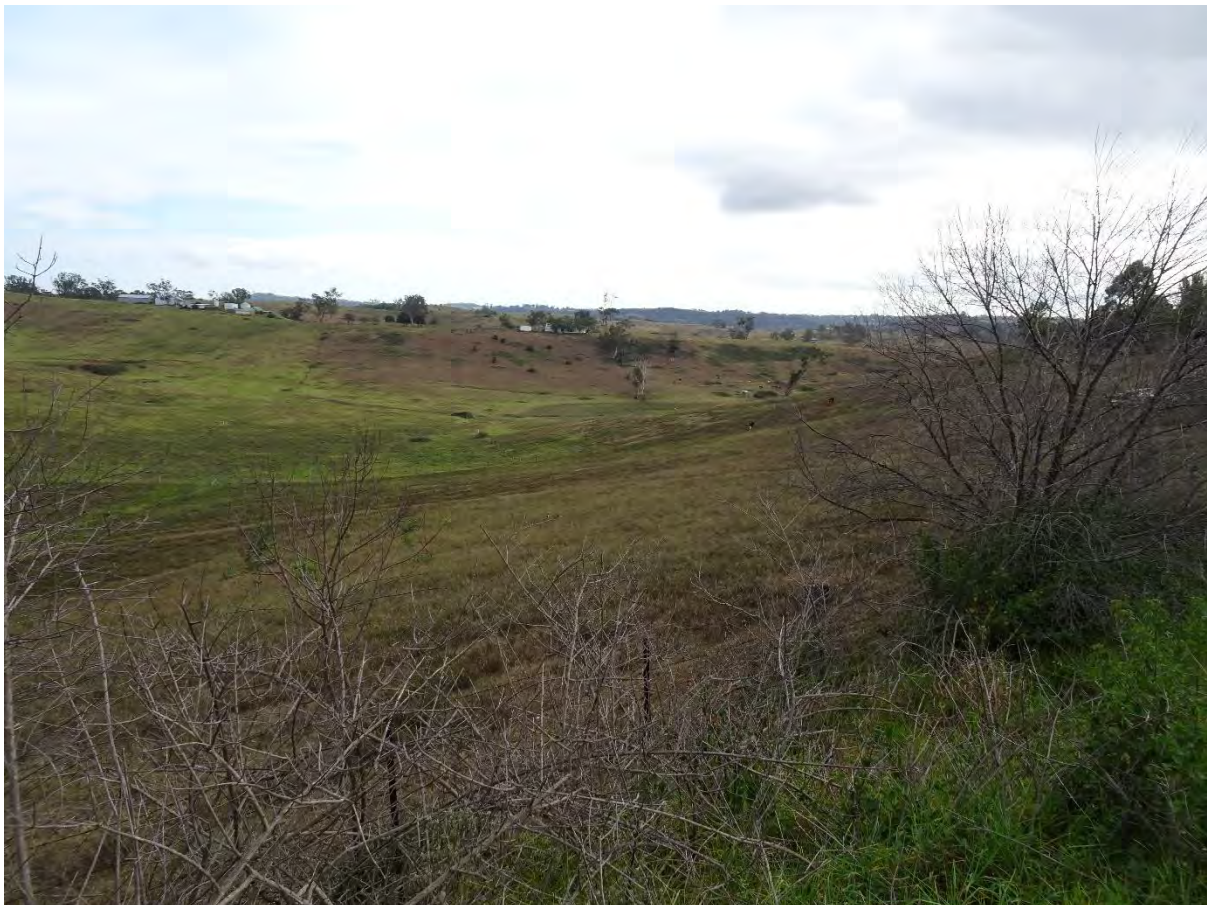
The Lucas Heights Soil Landscape Unit consists of gently undulating crests, ridges and plateau surfaces, with slopes less than 10% and local relief is 10-50 metres. It occurs on the Mittagong Formation geological unit consisting of shale, laminite and quartz sandstone. Vegetation is extensively to completely cleared dry sclerophyll low open-forest and low woodland. Soils are dominated by moderately deep hard setting Kurosols on ridges and plateaus with Kurosols on crests, Kandosols on shoulders of plateaus and ridges and Tenosols on valley flats.

Limitations of this unit include stoniness, low fertility and land surface movement potential. The soil landscape is predominantly suited to grazing enterprises.

This soil landscape occurs throughout 11 hectares (3%) of the Study Area.

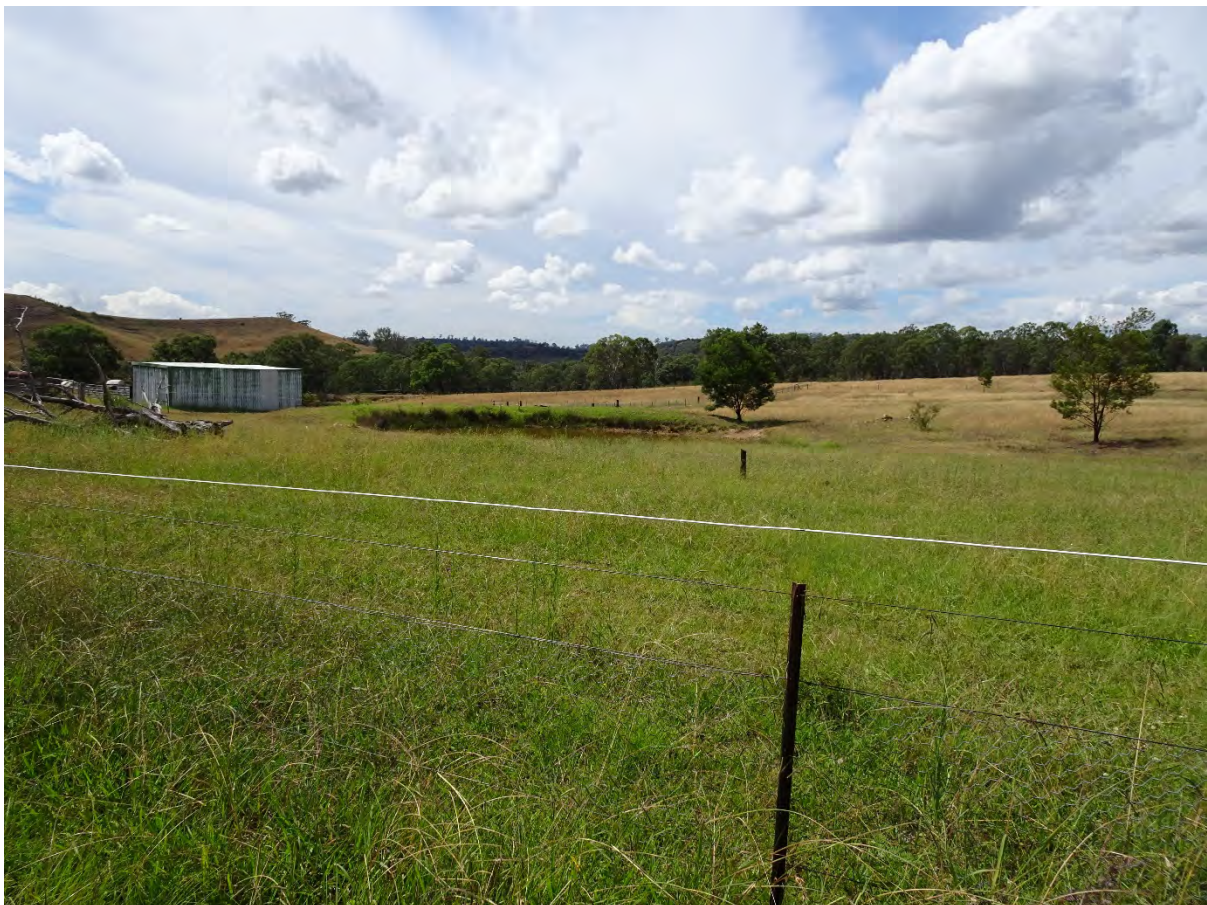
The Hawkesbury Soil Landscape Unit covers rugged, rolling to very steep hills, with slopes greater than 25% and local relief of 100-200 metres. It occurs on the Hawkesbury Sandstone geological unit consisting of sandstone and some shale and laminate. Vegetation consists of mostly uncleared eucalypt woodland, open-forest (dry sclerophyll forest) and tall open forest (wet sclerophyll forest). Soils are dominated by shallow Tenosols and Rudosols associated with rock outcrops; Tenosols and Kandosols and locally deep sands occur on the inside of benches and along joints and fractures. Kurosols are present on shale lenses with Tenosols on valley flats.

Limitations of this soil landscape unit include extreme soil erosion hazard, mass movement (rock fall) hazard, steep slopes, rock outcrop and shallow, stony, highly permeable soils of very low fertility. The Hawkesbury unit is not suitable for any agricultural enterprise.

This soil landscape occurs over less than 1 hectare (<1%) of the Study Area.

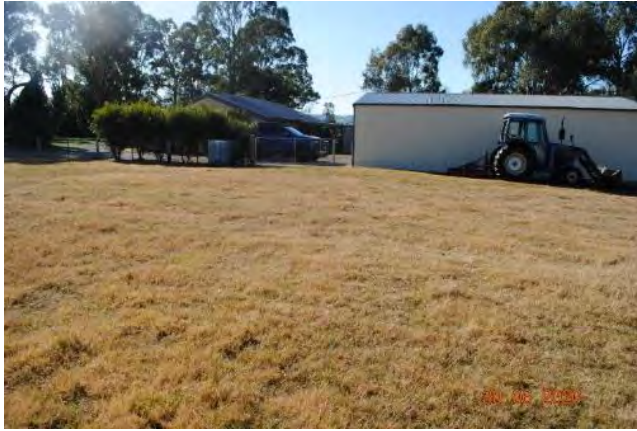
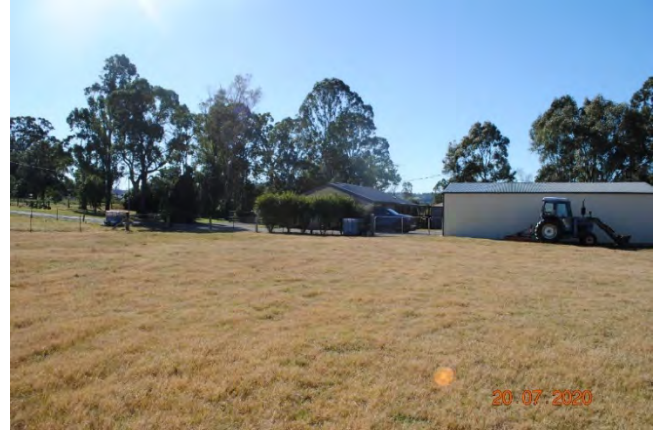
Property Owner east towards sheds (left: June 20; right: current)

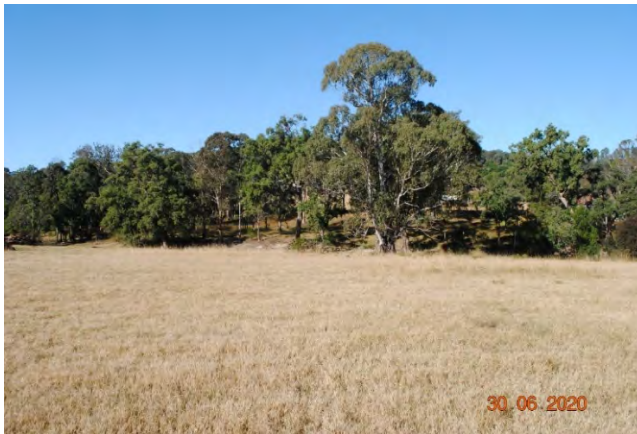
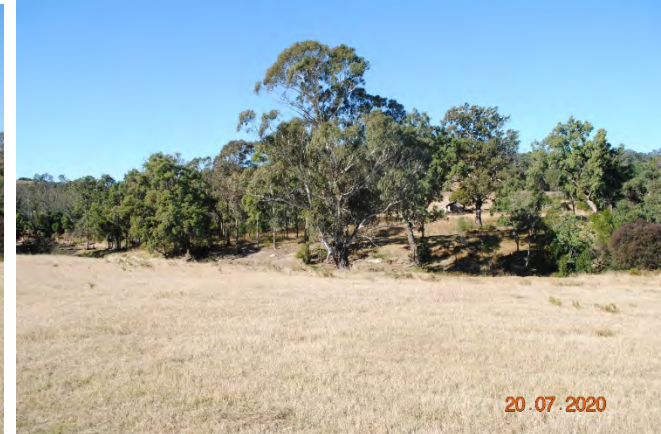
Property Owner south towards Stonequarry Creek (left: June 20; right: current)

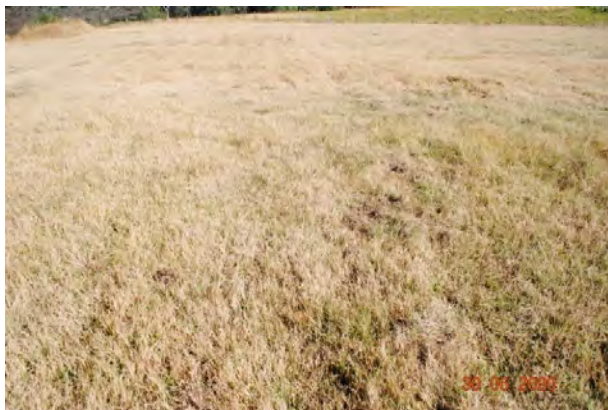
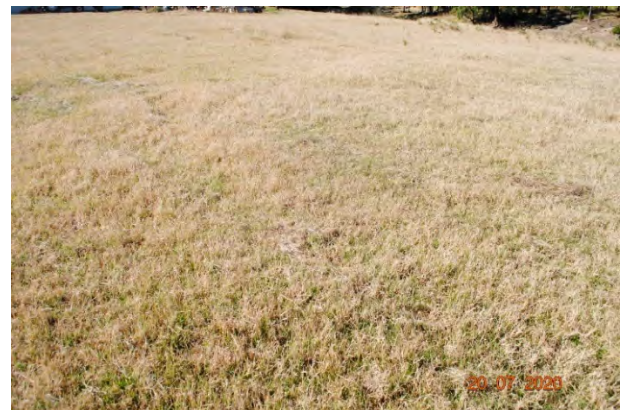
Property Owner ground surface (left: June 20, right: current)

Surface Cracking	Nil	Yes	<i>If yes, depth and width</i>
Vegetation Dieback	Nil	Yes	Eucalypt
Additional Comments	<p><u>February Comments (02/03/2020):</u> No observed changes since January report Significant rainfall has however resulted in grass and shrub growth</p> <p><u>March Comments (27/03/2020):</u> No observed changes since February report Increased vegetation growth</p> <p><u>April Comments (24/04/20):</u> No observed changes since March report</p> <p><u>May Comments (21/05/20):</u> Increased vegetation growth along riverbank due to recent rain. Dieback of paddock vegetation has begun as the change of season approaches.</p> <p><u>June Comments (30/06/20):</u> Seasonal changes corresponding with mid-winter timing</p>
