**SIMEC Mining – Tahmoor Coal
Tahmoor North Western Domain
Longwalls West 3 and West 4**

Management Plan for Potential Impacts to Transport for NSW Infrastructure

**Prepared by Mine Subsidence Engineering Consultants
on behalf of
the Technical Committee**

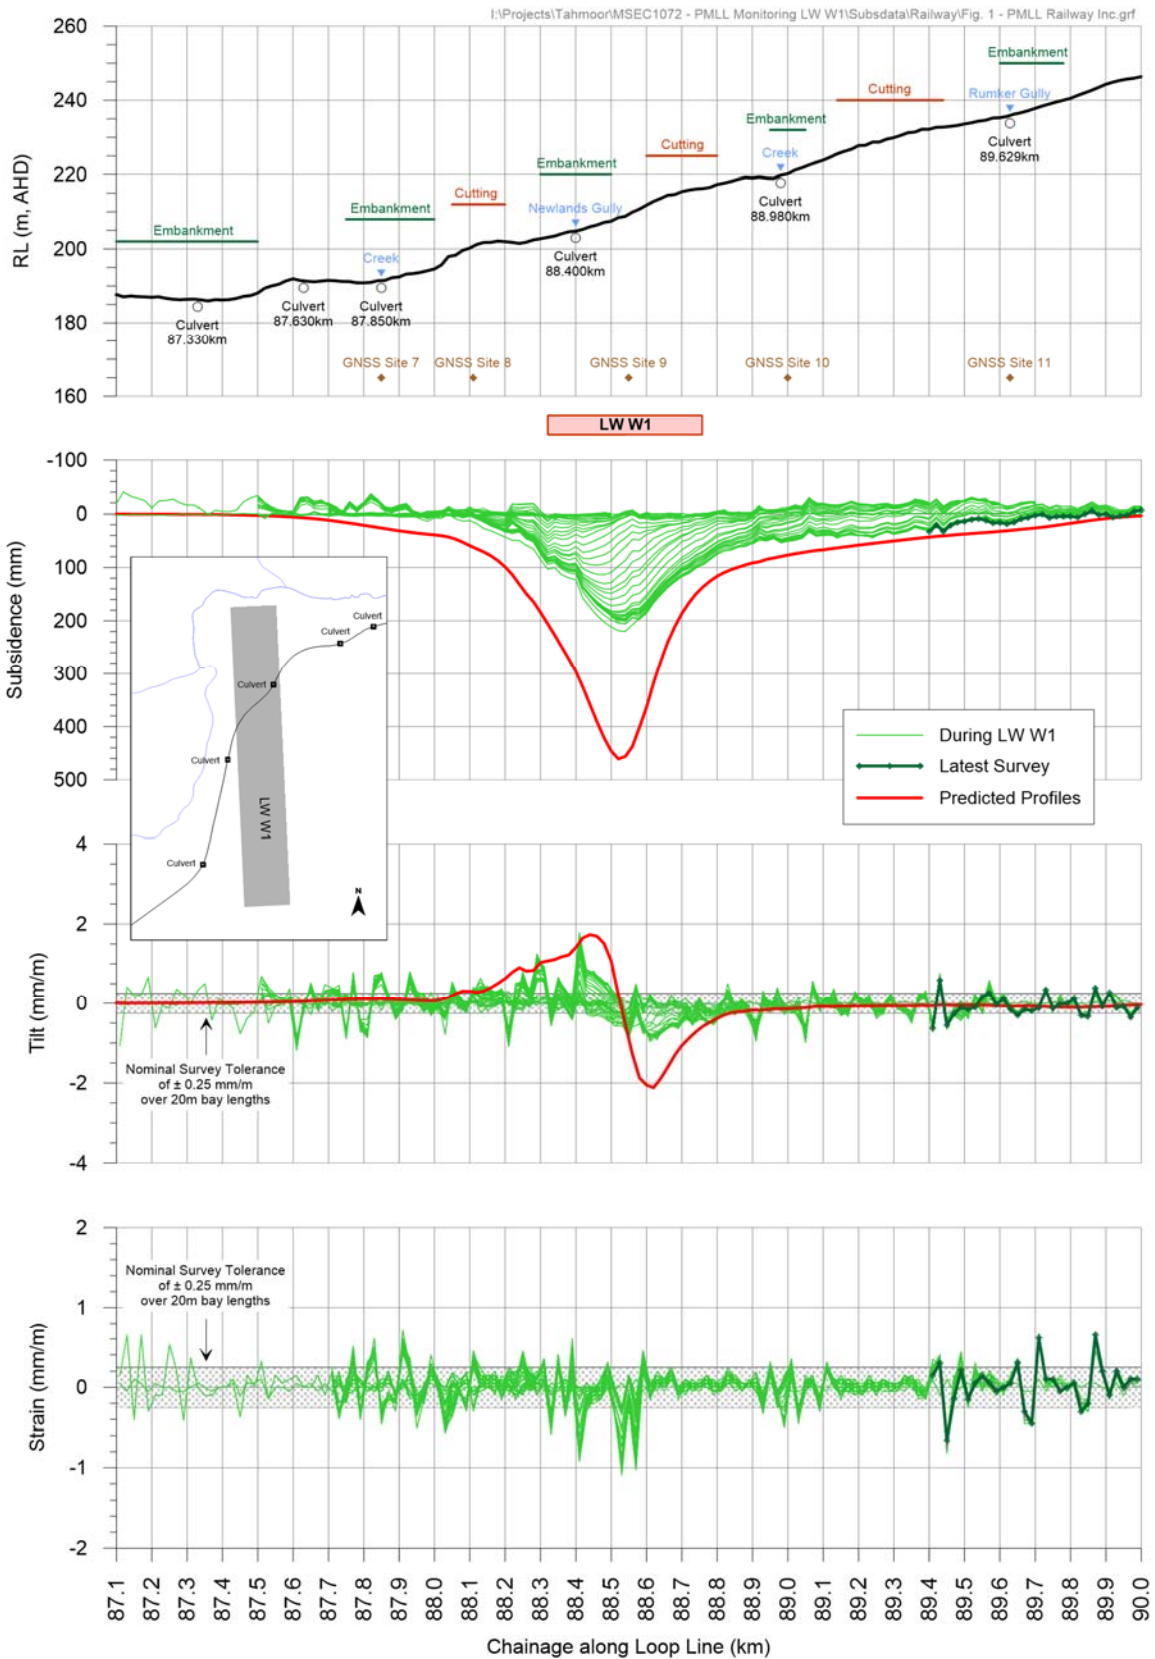
Fig. 2.1 Observed subsidence along Picton-Mittagong Loop Line during the mining of LW W1

A comparison between measured and predicted profiles of vertical subsidence along the Picton-Mittagong Loop Line is provided in Fig. 2.1 after the extraction of LW W1.

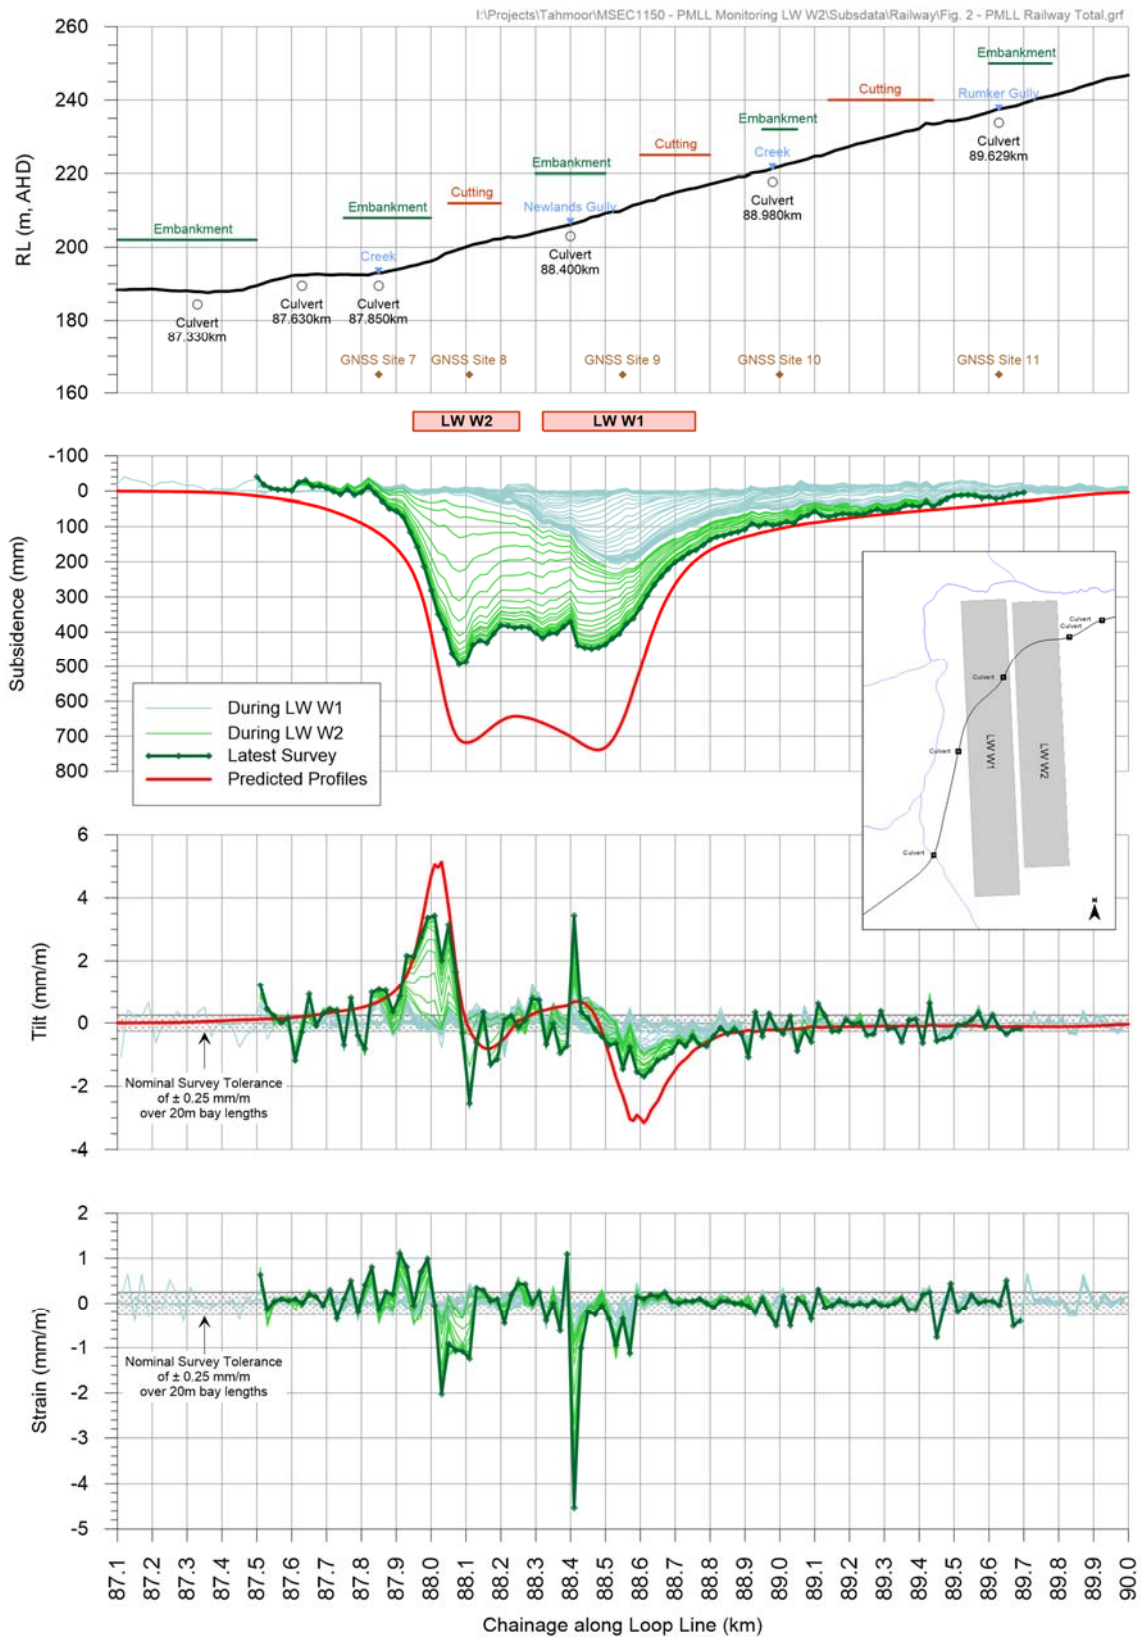
Fig. 2.2 Observed subsidence along Picton-Mittagong Loop Line during the mining of LW W1-W2

As of 1 June 2021, subsidence surveys above LW W2 have measured less subsidence than predicted. Observed subsidence along the Picton-Mittagong Loop Line after the extraction of LW W2 is shown in Fig. 2.2. Observed subsidence along the LW W1 W2 crossline after the extraction of LW W2 is shown in Fig. 2.3.

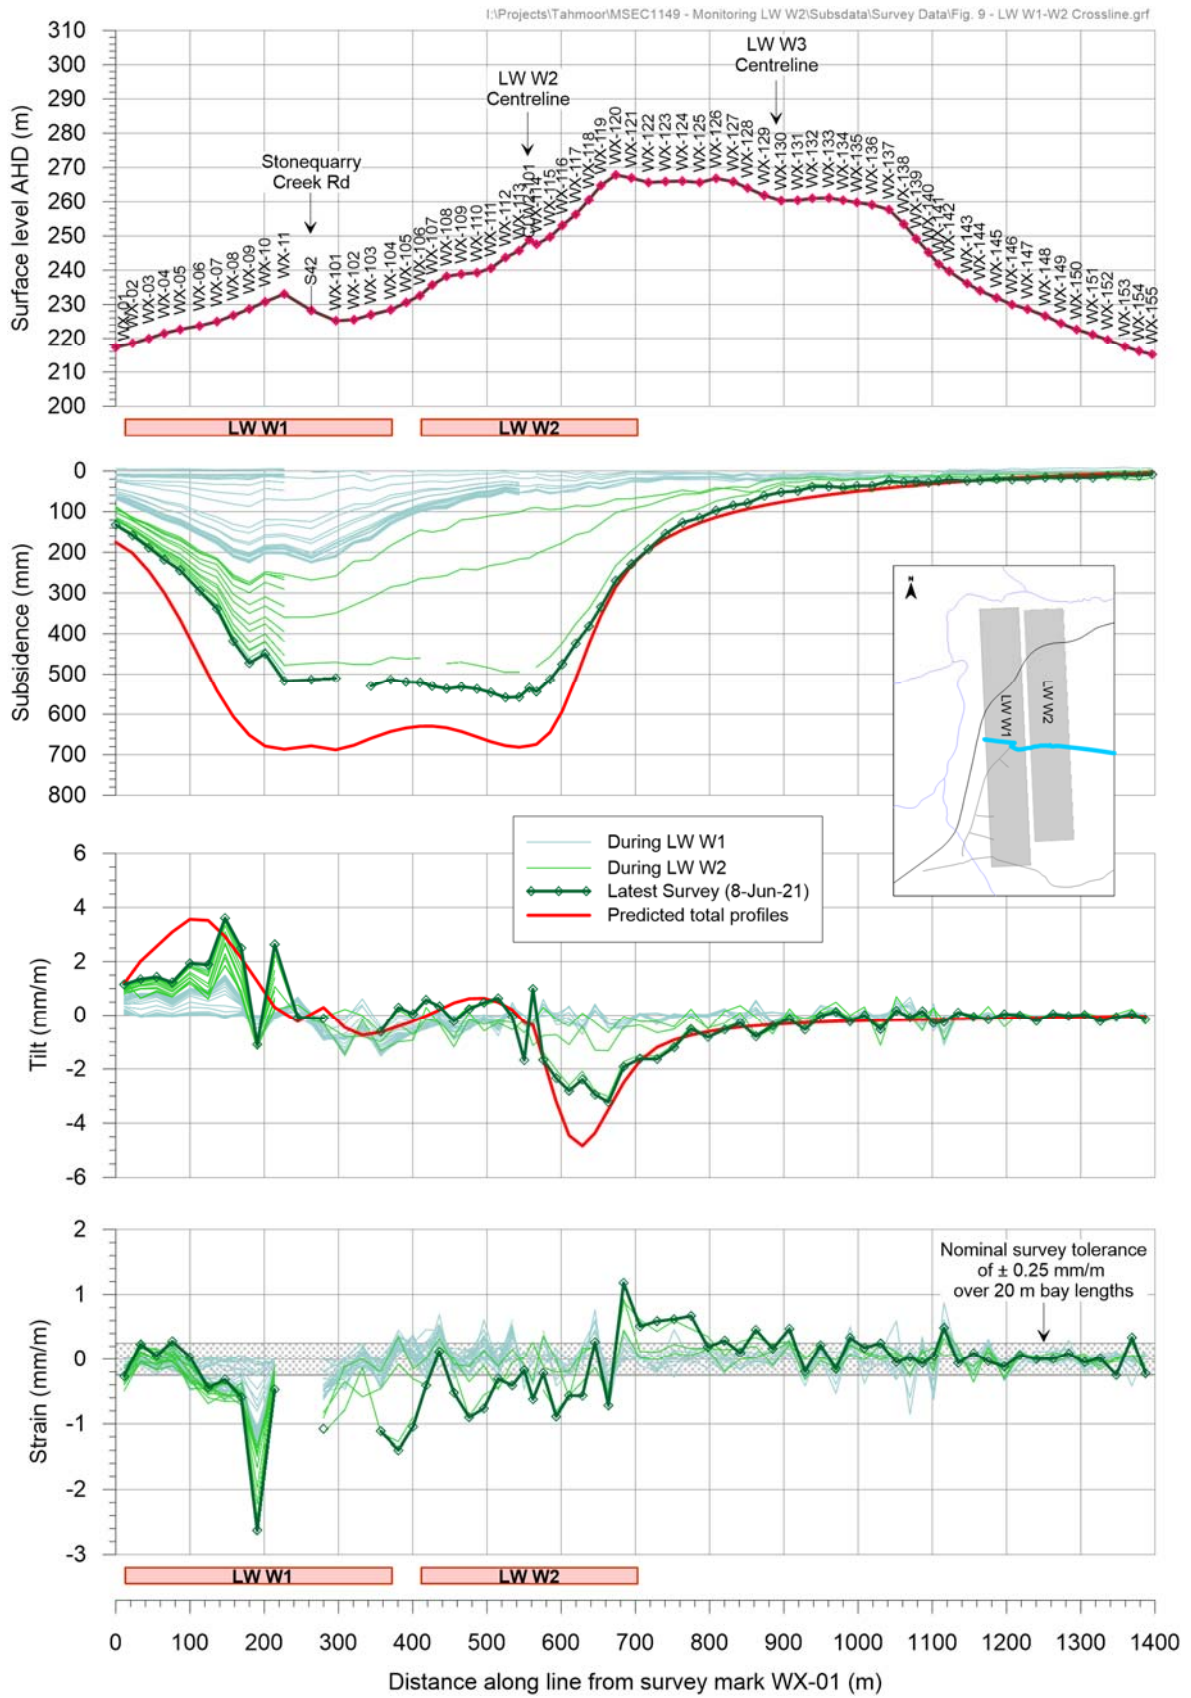
Fig. 2.3 Observed subsidence along LW W1-W2 crossline during the mining of LW W1-W2

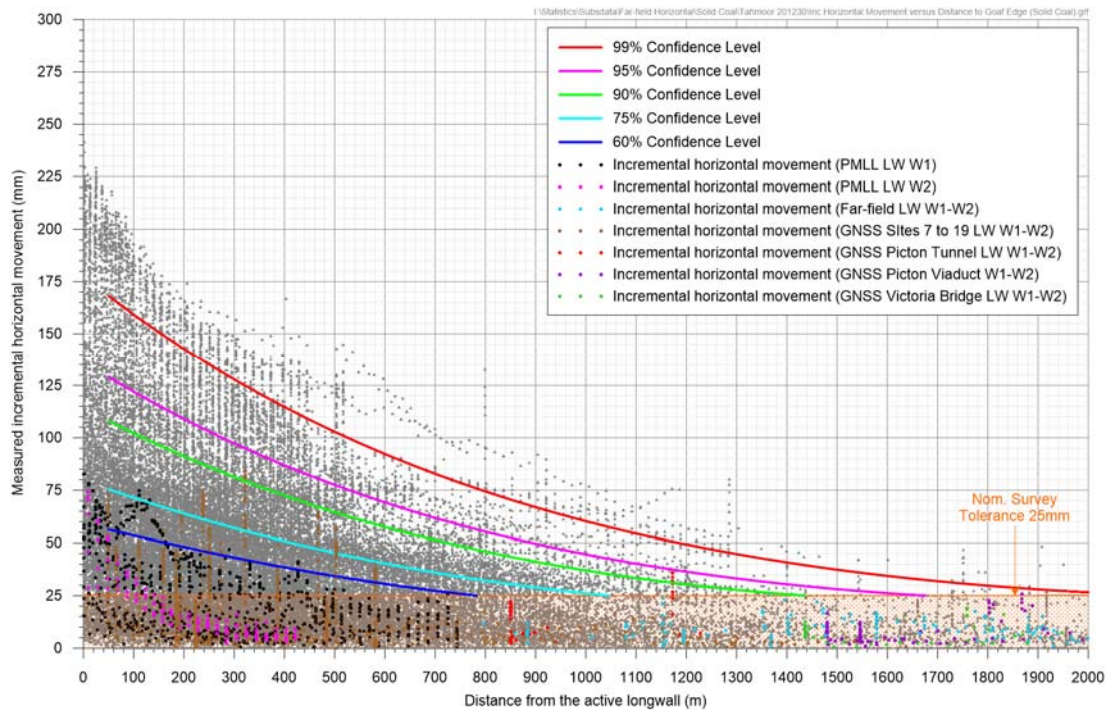
Fig. 2.5 Measured incremental far-field horizontal movements above solid coal only at Tahmoor, Appin, West Cliff and Tower Collieries with LW W1-W2 highlighted

The observed incremental far-field horizontal movements above solid coal only, i.e. outside the extents of extracted longwalls, are provided Fig. 2.5. Survey lines have been selected from Tahmoor, Appin, West Cliff and Tower Collieries.

Observed horizontal movements measured during the mining of LW W1 and LW W2 above solid coal are shown in Fig. 2.5. The results exclude those of survey pegs that are located to the west of LW W1 and surveyed during the mining of LW W2 because their movements were influenced by the presence of previously extracted LW W1. It can be seen that observed movements are within the previously observed range. The highest recorded movements were located to the west of LW W1 on the opposite side of Matthews and Cedar Creeks during the mining of LW W2.

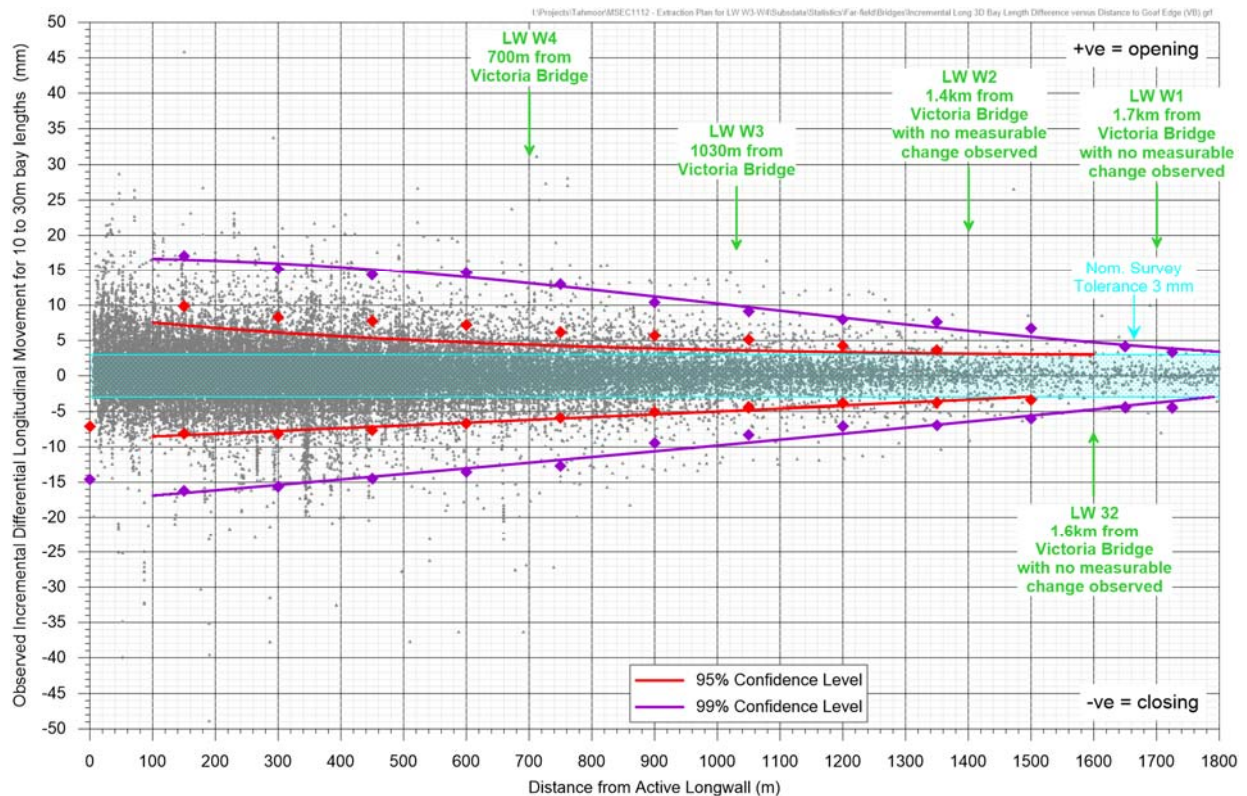
Fig. 2.6 Observed incremental differential longitudinal horizontal movements versus distance from active longwall for marks spaced between 10 and 30 metres

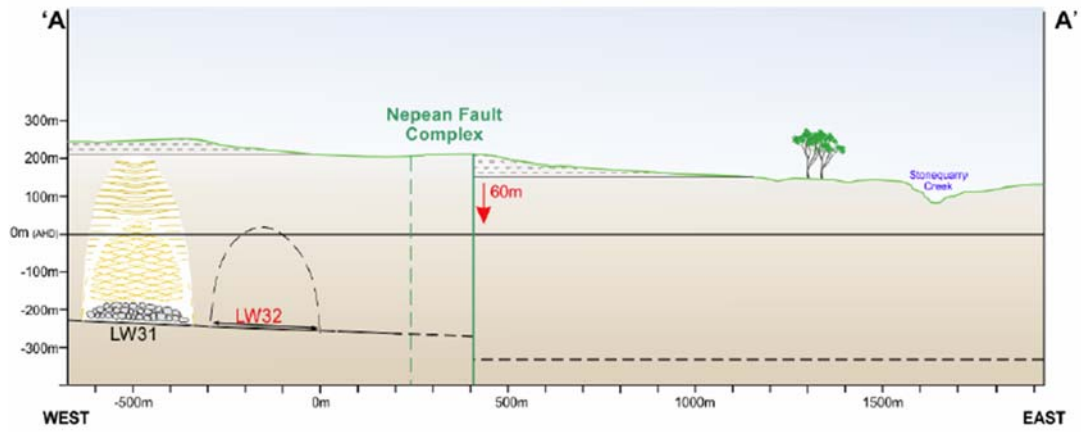
Fig. 2.10 Cross-section of Nepean Fault near Longwall 32 by SCT (2018a)

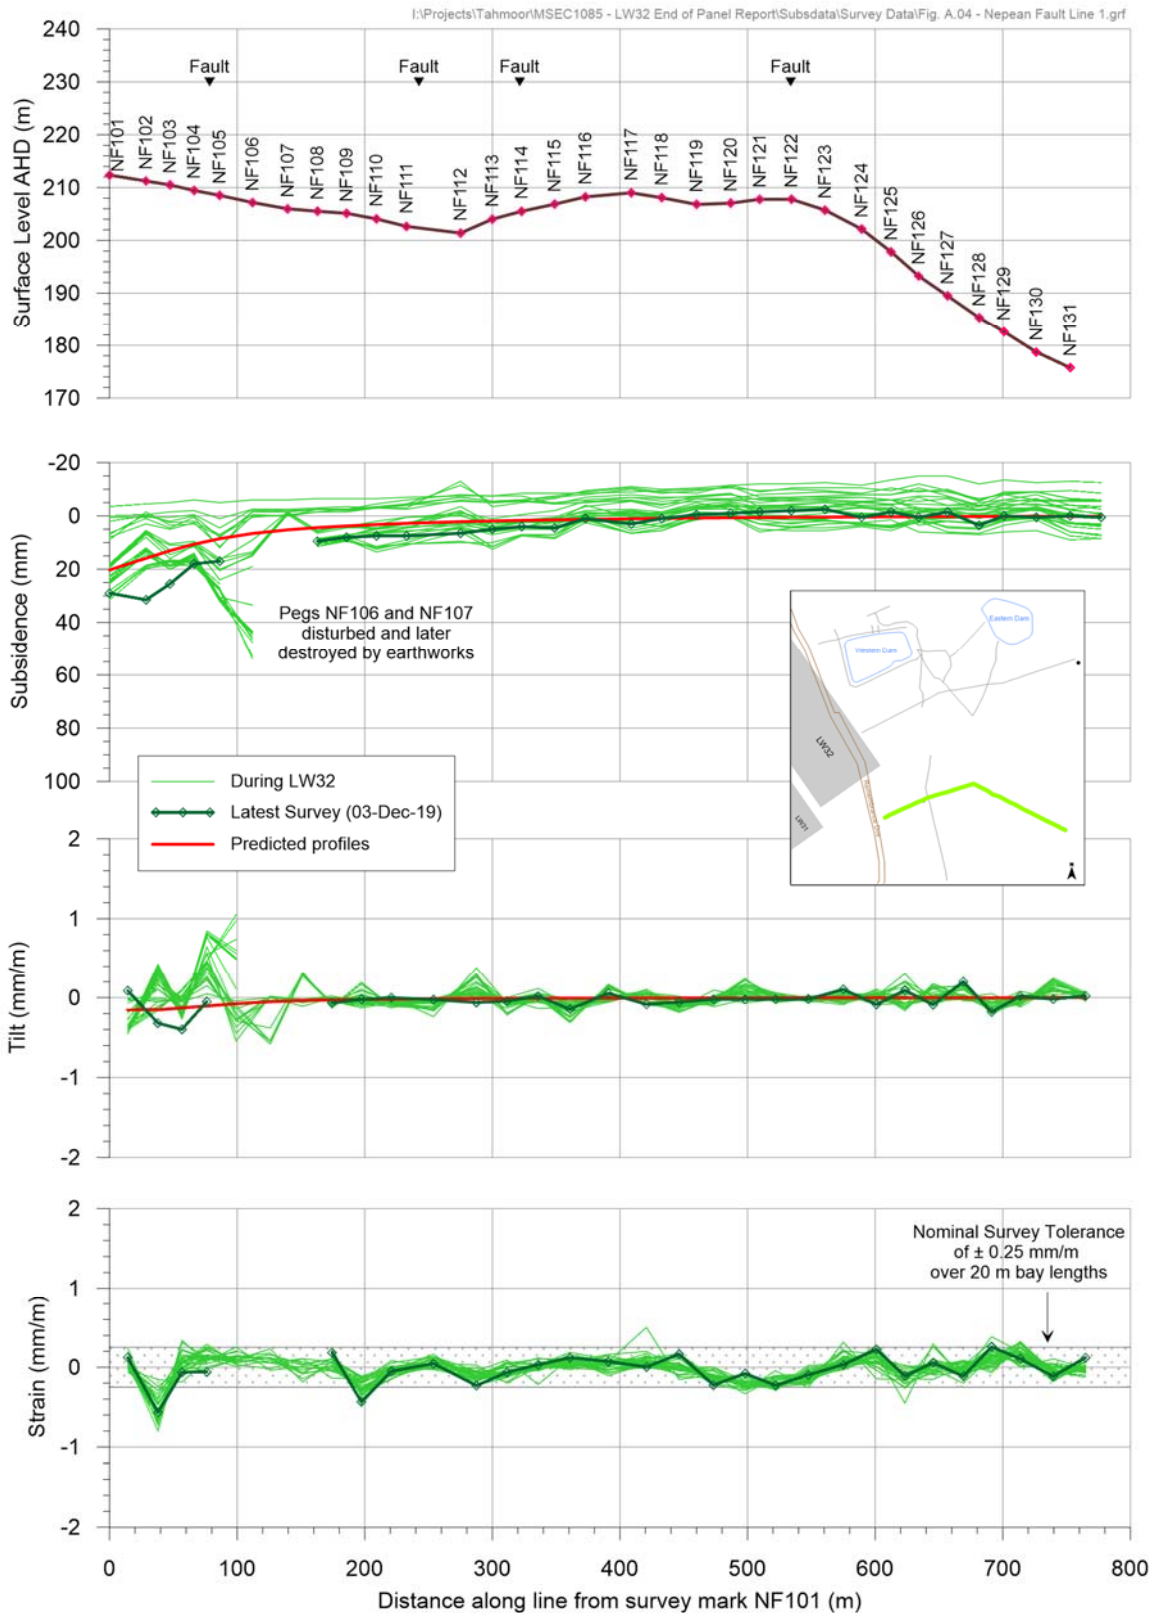
Fig. 2.14 Observed subsidence along the Nepean Fault Line 1 during the mining of LW 32

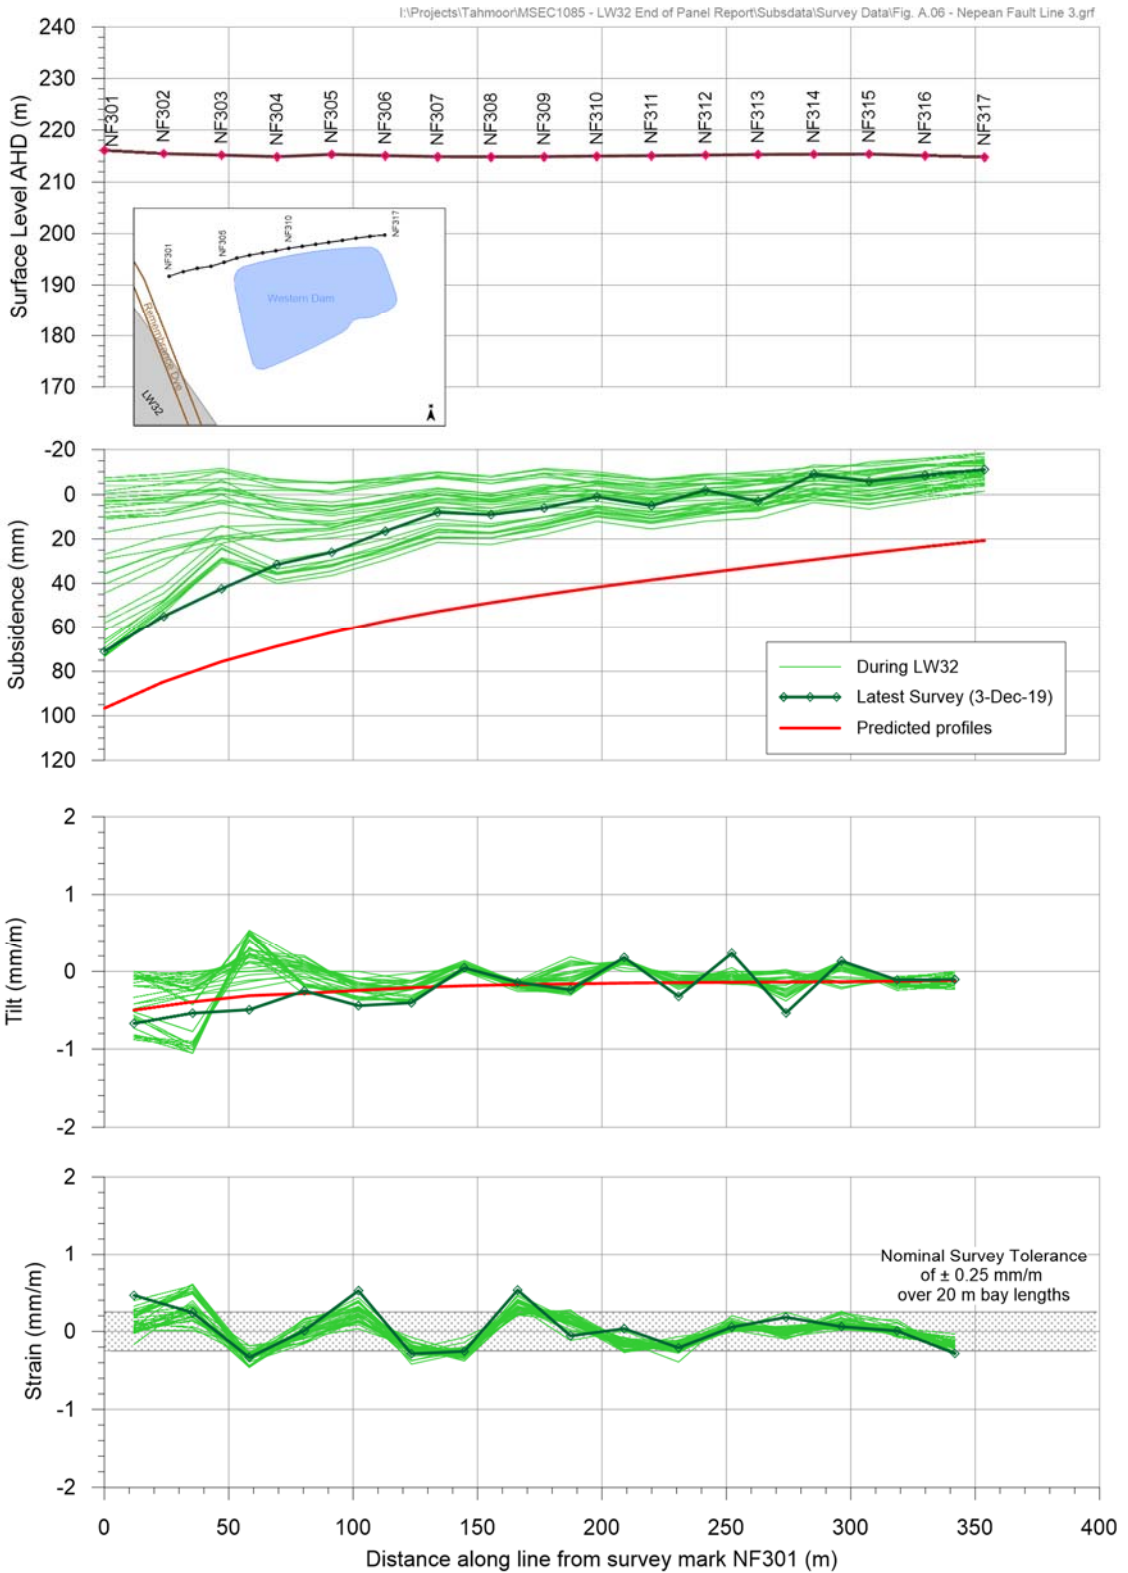
Fig. 2.16 Observed subsidence along the Nepean Fault Line 3 during the mining of LW 32

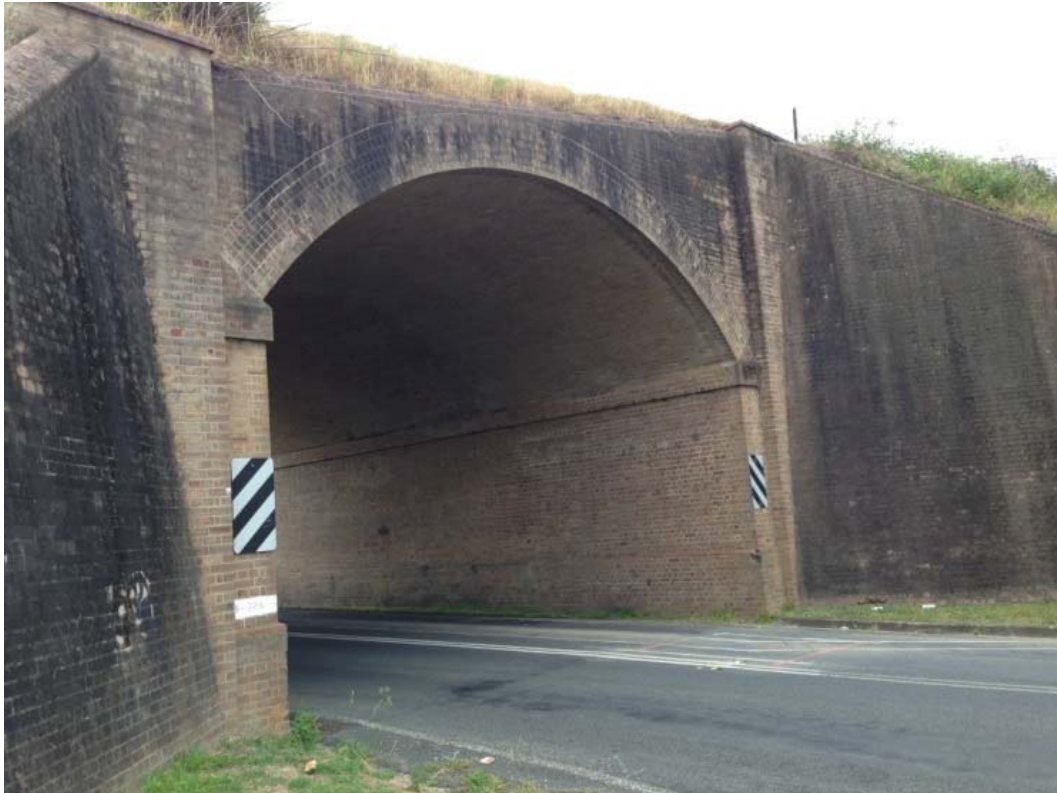
Fig. 2.18 Thirlmere Way Rail Underbridge at 89.326 km

The Thirlmere Way Rail Underbridge (89.326 km) is a single span brick arch structure with brick spandrel walls, as shown in Fig. 2.18.

The Bridge is located approximately 545 metres from the proposed LW W3, and approximately 245 metres from the proposed LW W4. For both longwalls, the closest points to the Bridge are at a longwall corner, where subsidence movements are typically less than those observed to the sides and beyond the ends of longwall panels.

The Bridge is located 630 metres from previously extracted Longwall 32, 1.2 km from previously extracted LW W1 and 850 metres from previously extracted LW W2.

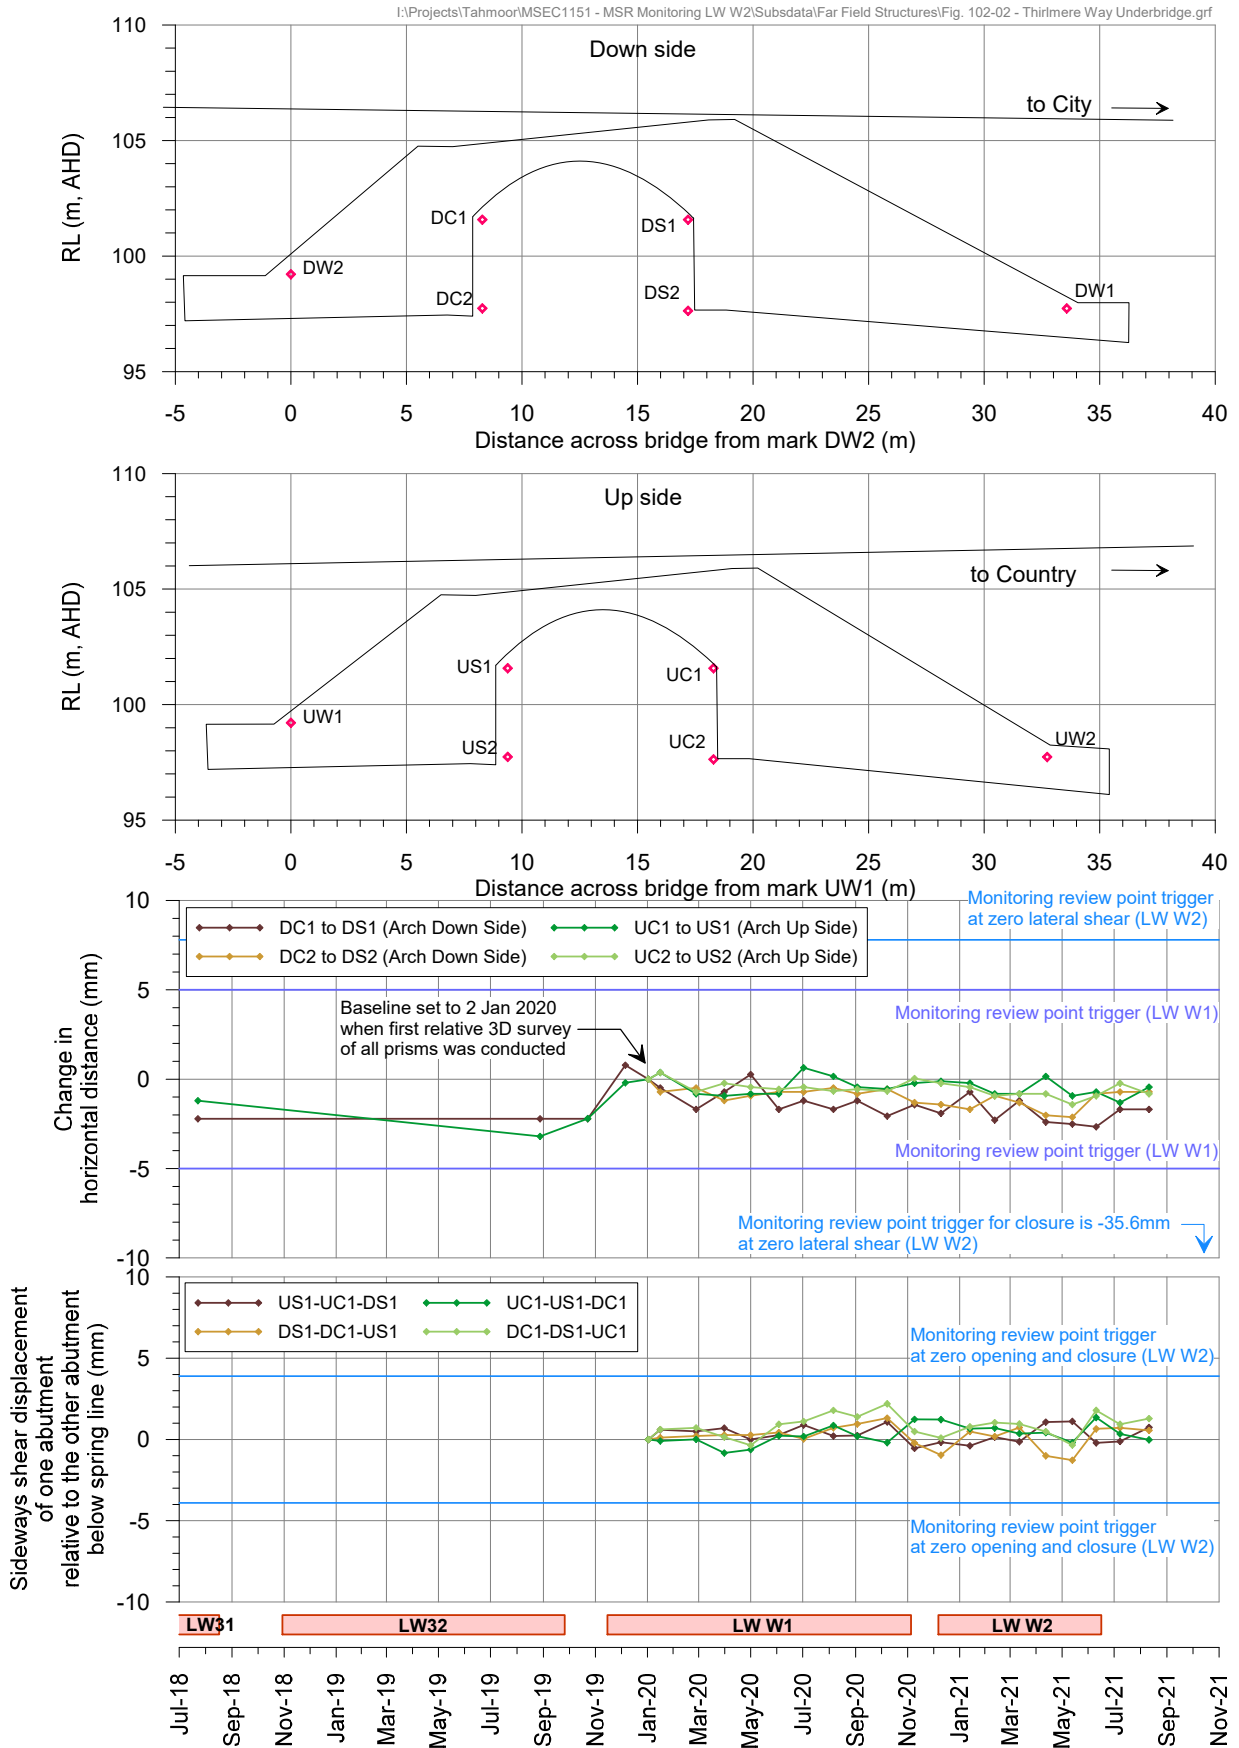
Fig. 2.20 Changes in horizontal distance at Thirlmere Way Rail Underbridge

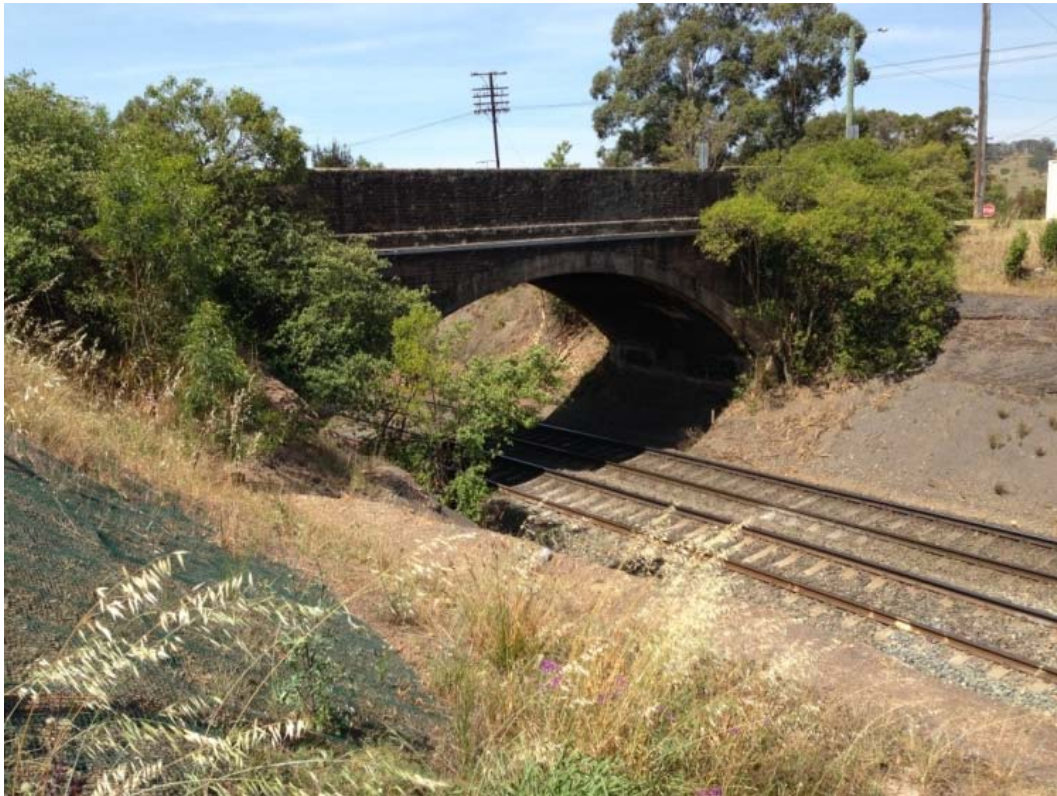
Fig. 2.21 Connellan Crescent Railway Overbridge at 89.080 km

The Connellan Crescent Railway Overbridge (89.080 km) is constructed with masonry abutments and the deck is supported by a reinforced concrete arch, as shown in Fig. 2.21.

The Bridge is located approximately 730 metres from the proposed LW W3, and approximately 400 metres from the proposed LW W4.

The Bridge is located 940 metres from previously extracted Longwall 32, 1.4 km from previously extracted LW W1 and 1 km from previously extracted LW W2.

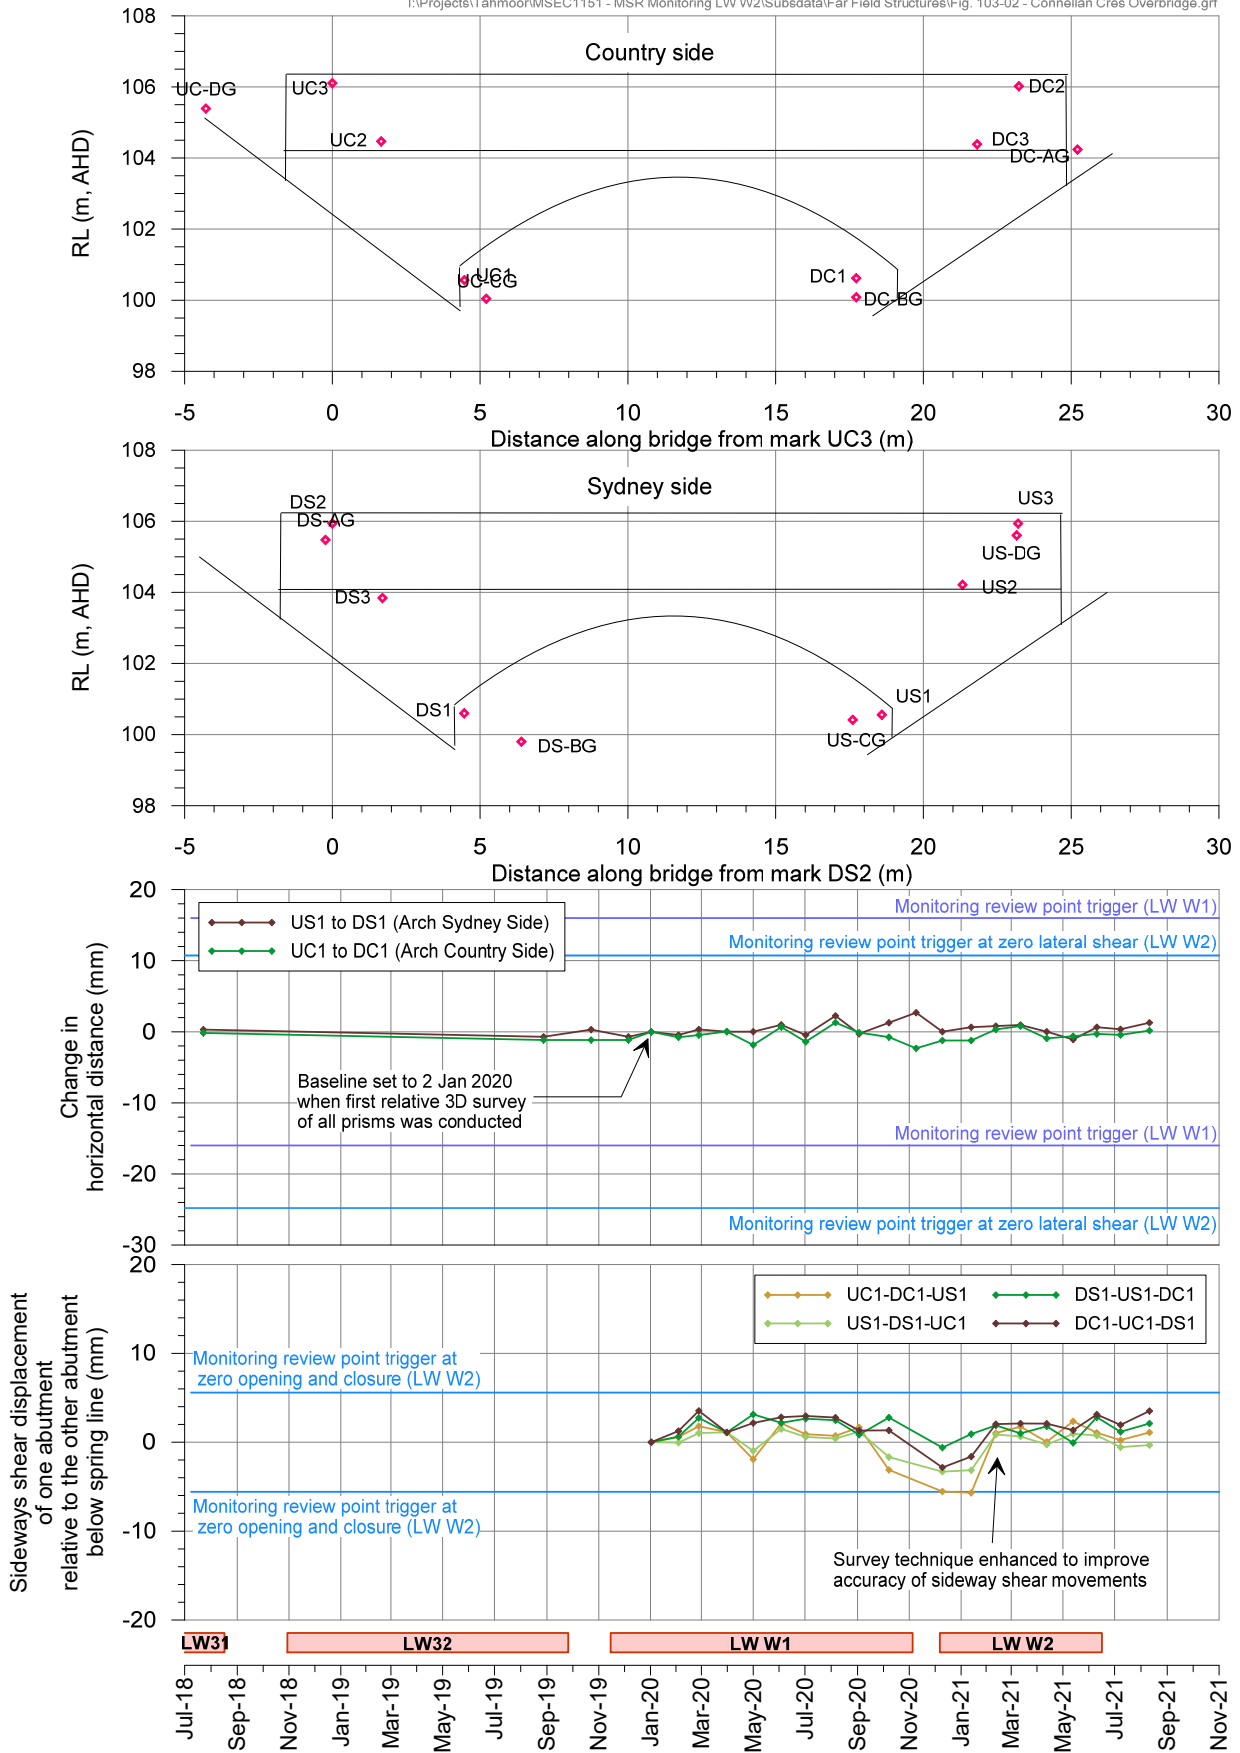
Fig. 2.23 Changes in horizontal distance at Connellan Crescent Rail Overbridge

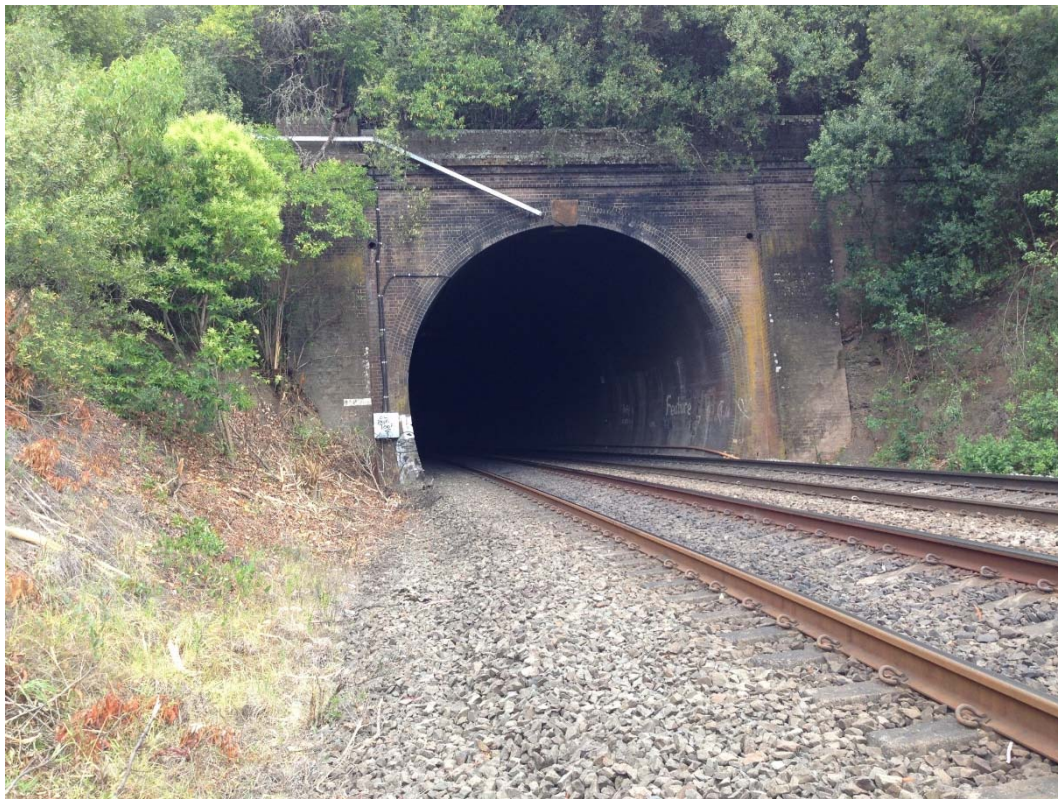
Fig. 2.24 Picton Railway Tunnel – Southern Portal

The Picton Tunnel (87.850 km) is constructed with masonry arches as shown in Fig. 2.24. Except for the initial few metres, the arch is supported by short height unreinforced concrete pedestal walls. The tunnel opening is approximately 6.3 metres high and 8.3 metres wide, and the tunnel is approximately 180 metres long.

The Tunnel is located approximately 430 metres from the proposed LW W3, and approximately 295 metres from the proposed LW W4.

The Tunnel is located 1.6 km from previously extracted Longwall 32, 1 km from previously extracted LW W1 and 750 metres from previously extracted LW W2.

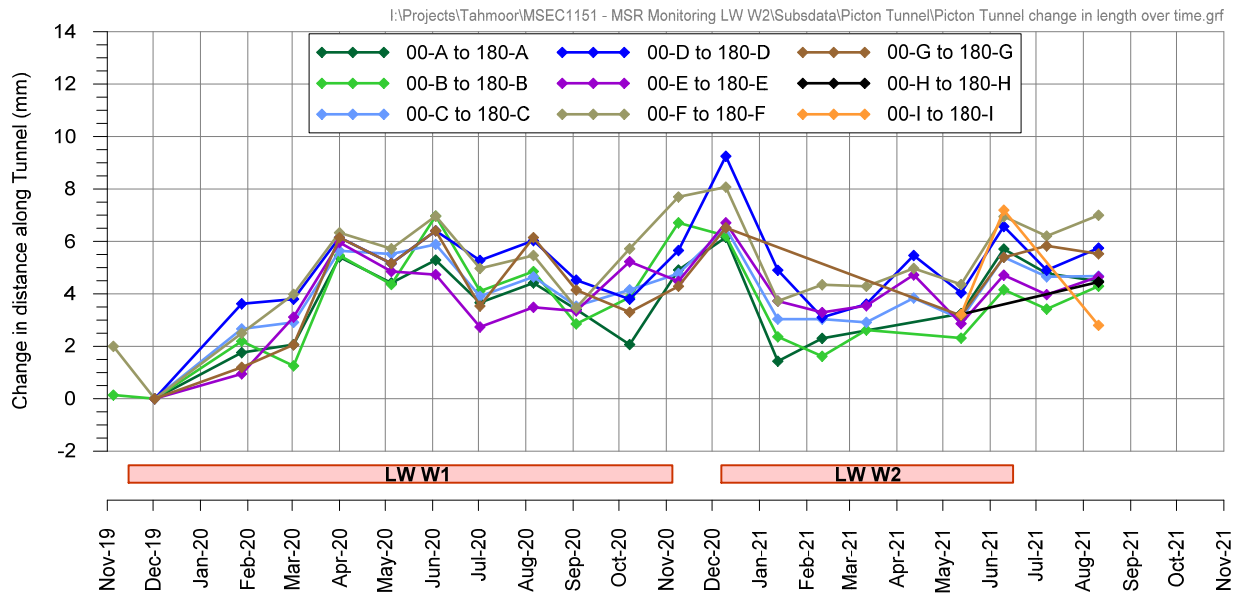
Fig. 2.27 Changes in horizontal distance along Picton Railway Tunnel

Tahmoor Coal installed a vertical inclinometer hole from the surface to the side of the Tunnel in December 2020 prior to the start of LW W2. No measurable changes were observed during the mining of LW W2.

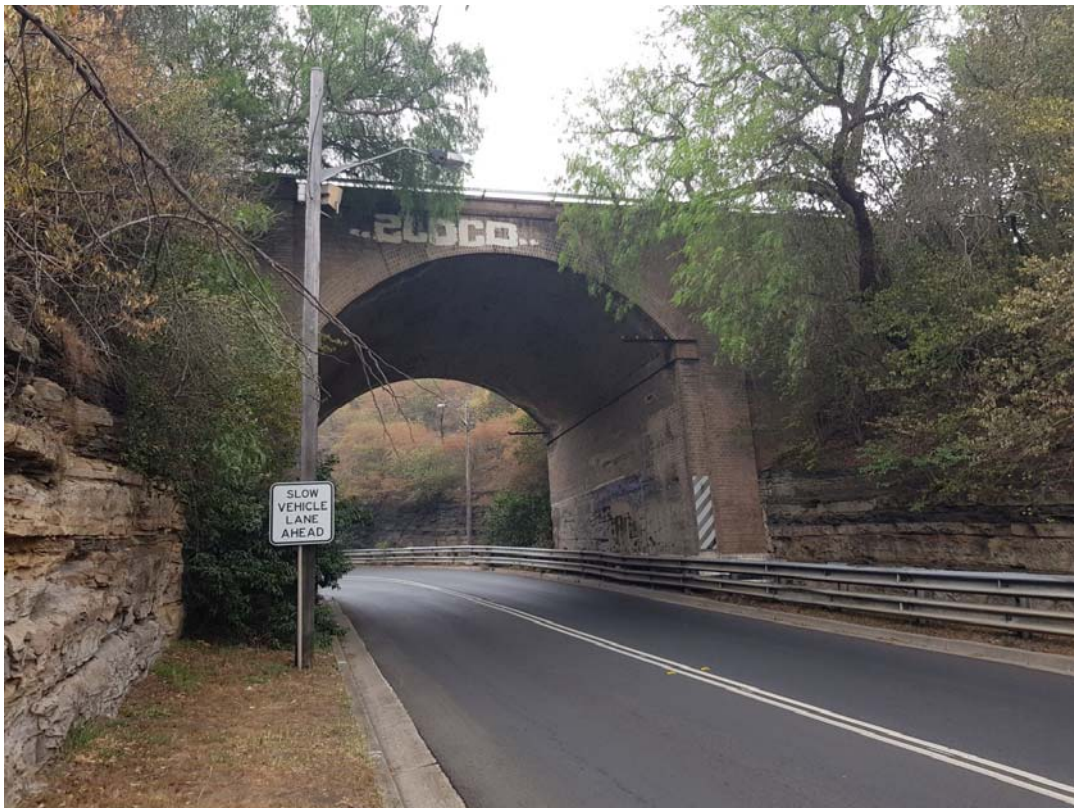
Fig. 2.28 Argyle Street Rail Underbridge at 86.160 km

The Argyle Street Rail Underbridge (86.160 km) is a single span masonry brick arch structure with brick spandrel walls, as shown in Fig. 2.28.

The Bridge is located approximately 930 metres from the proposed LW W3, and approximately 700 metres from the proposed LW W4.

The Bridge is located is located 2 kilometres north-east of previously extracted Longwall 32, 1.6 km from previously extracted LW W1 and 1.2 km from previously extracted LW W2.
