**SIMEC Mining – Tahmoor Coal
Tahmoor North Western Domain
Longwalls West 3 and West 4**

Management Plan for Potential Impacts to Transport for NSW Infrastructure

**Prepared by Mine Subsidence Engineering Consultants
on behalf of
the Technical Committee**

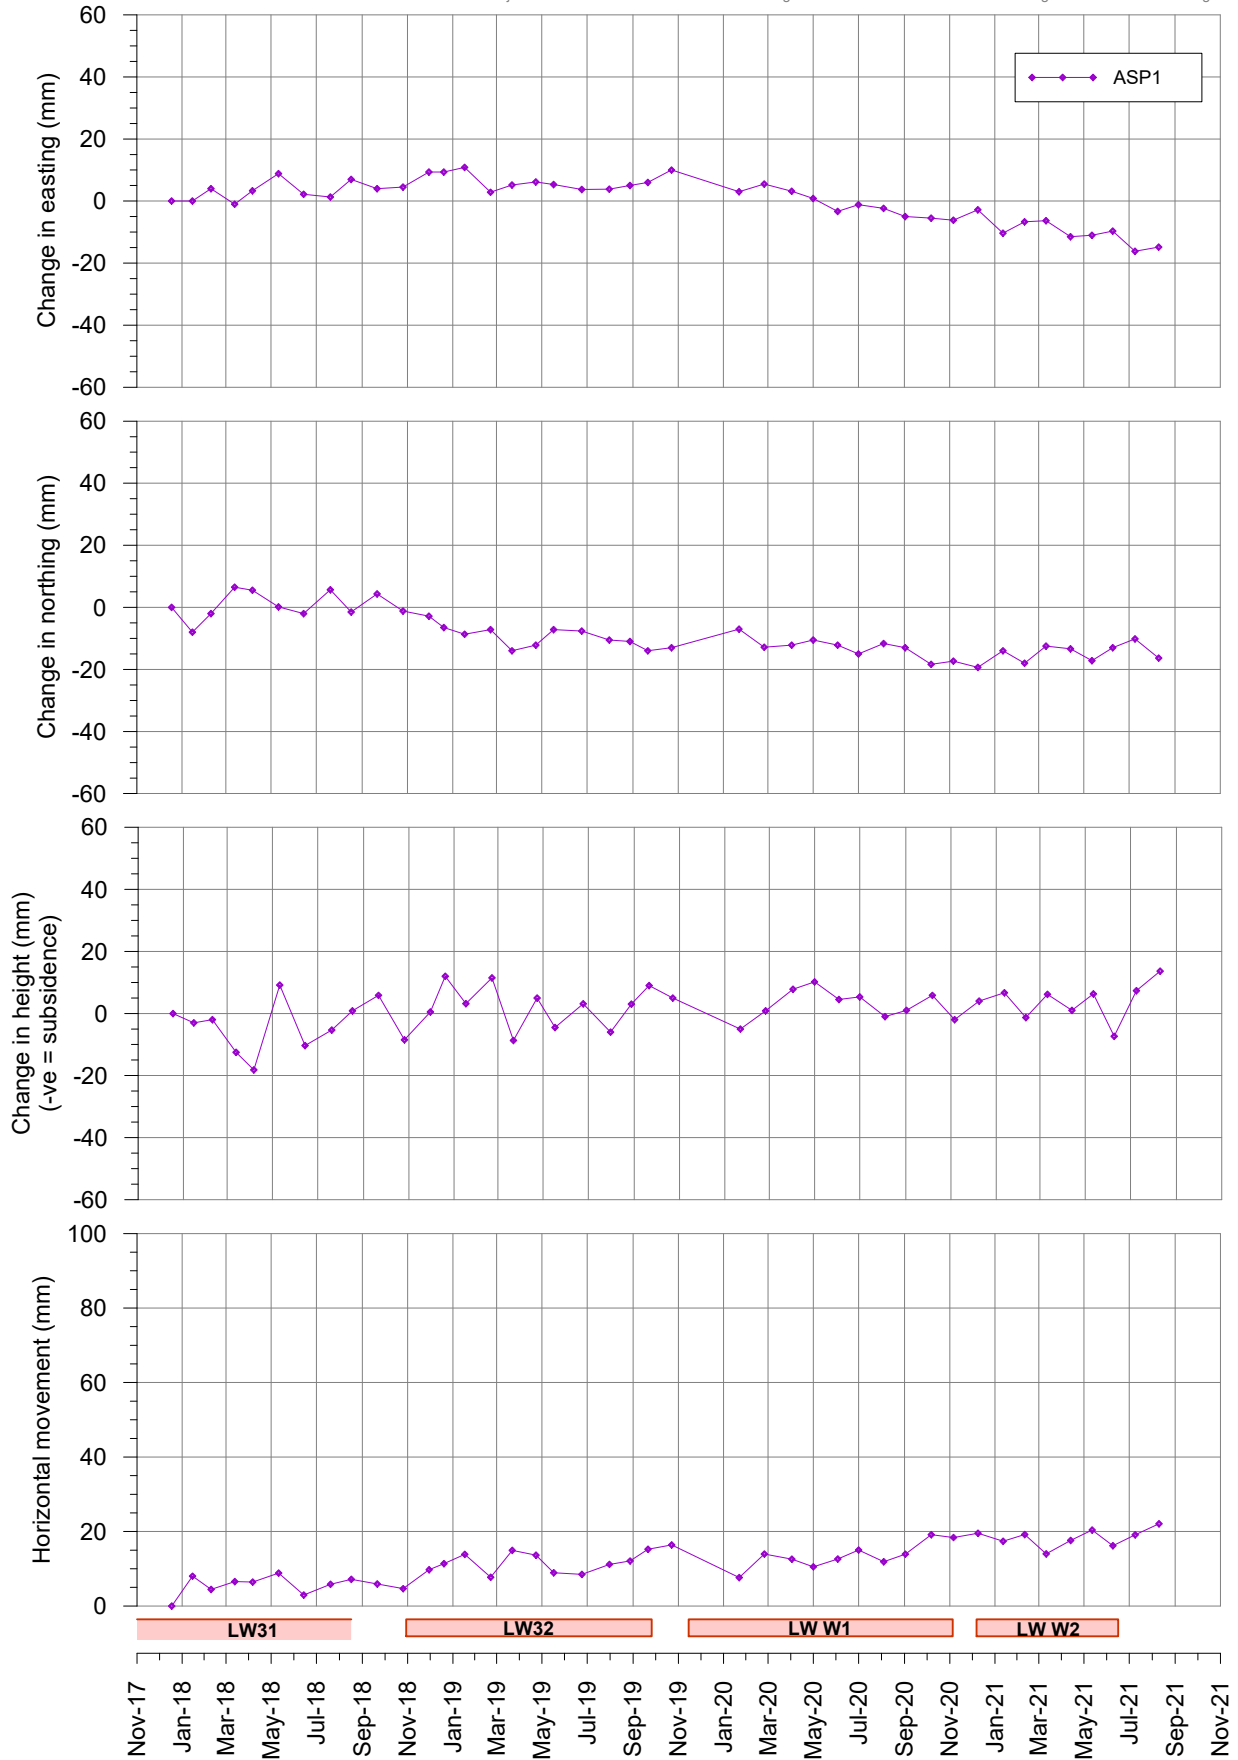
Fig. 2.29 Far-field movements at Argyle Street Rail Underbridge

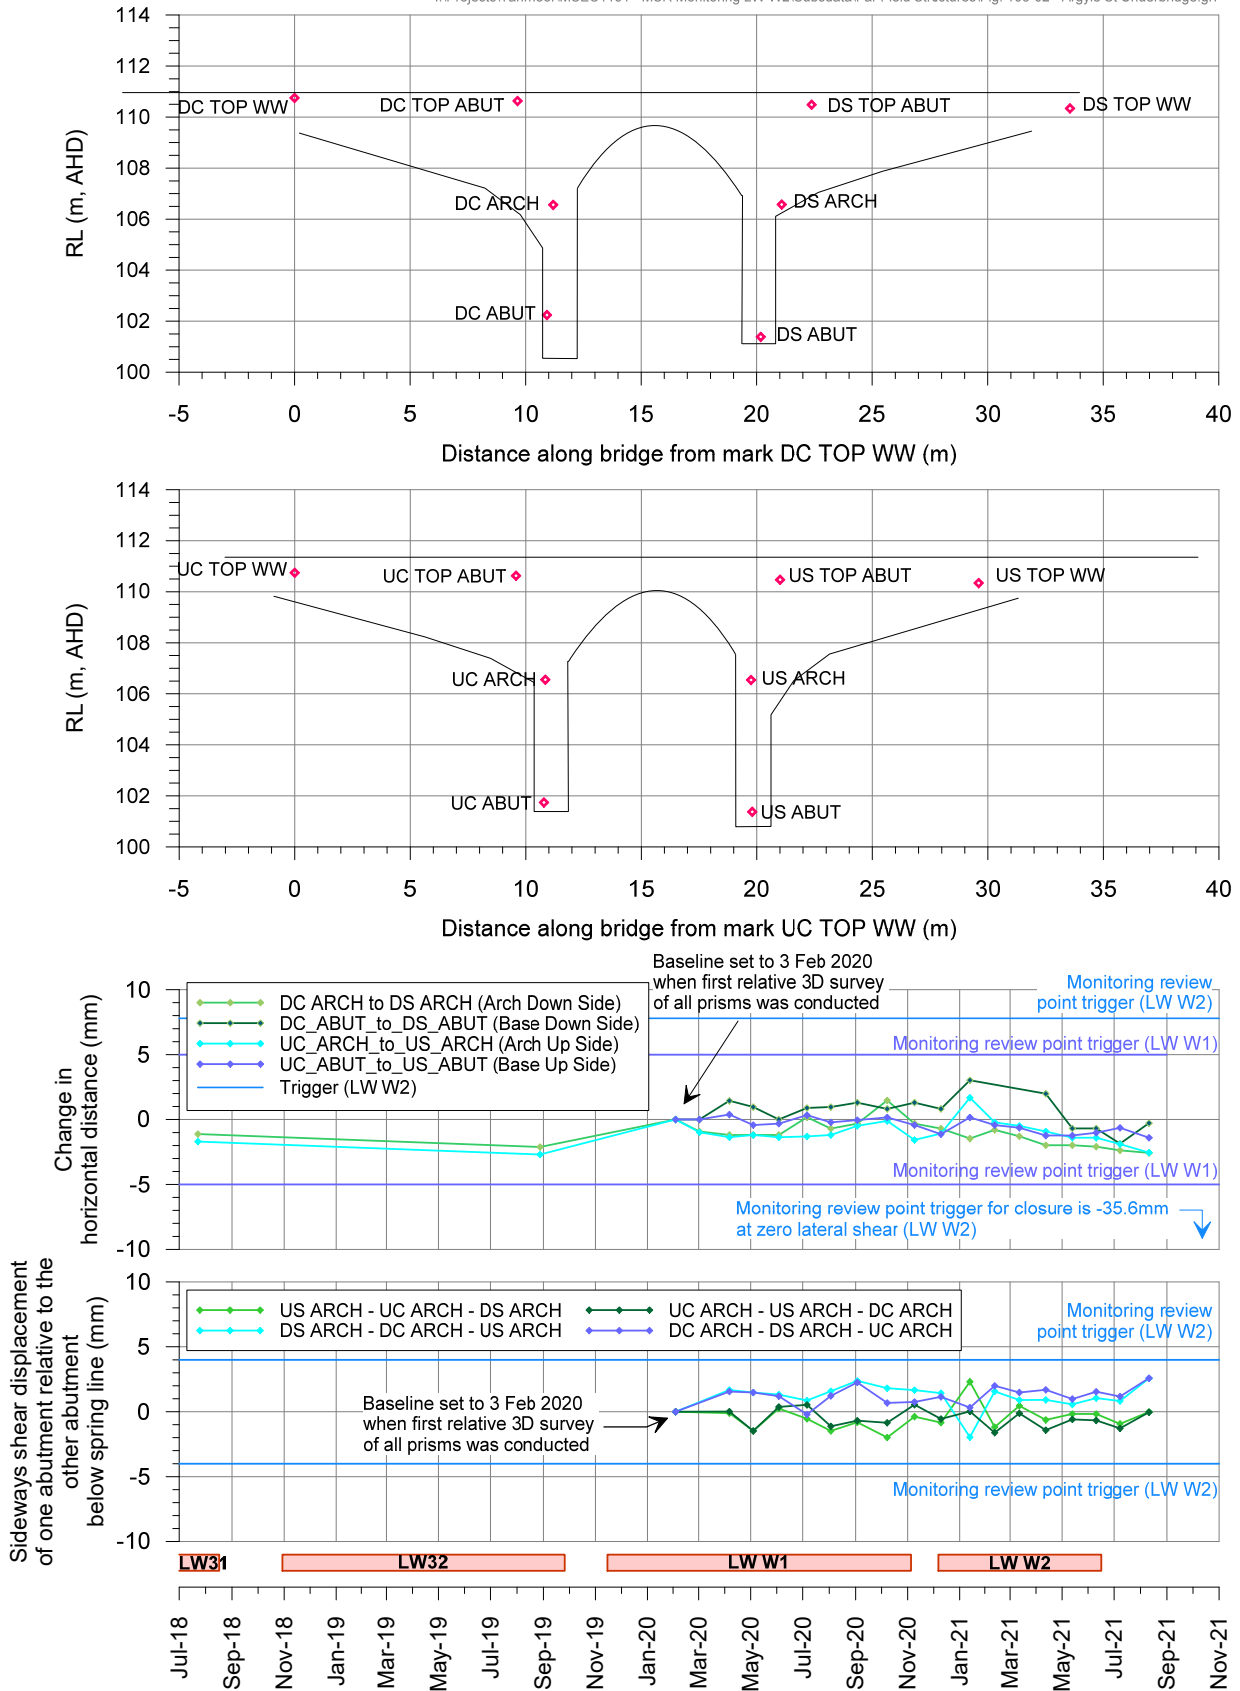
Fig. 2.30 Changes in horizontal distance at Argyle Street Rail Underbridge

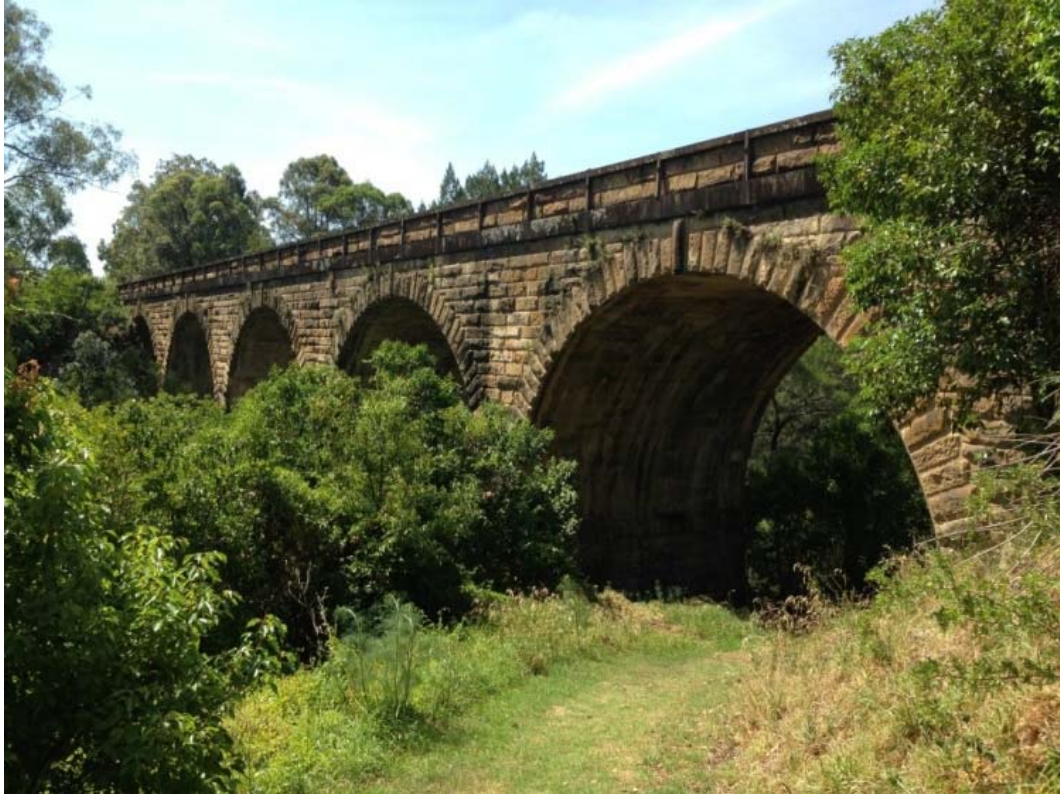
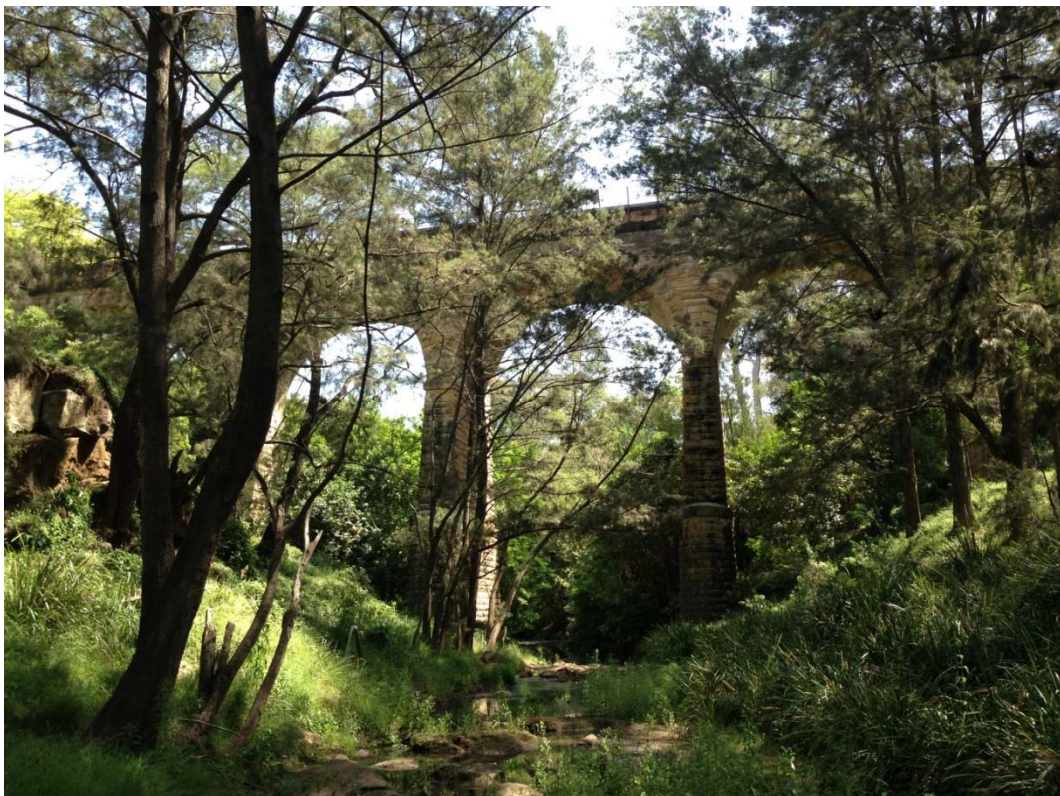
Fig. 2.31 Picton Viaduct at 85.42 km over Stonequarry Creek

The Picton Viaduct (85.42 km) is a five-span stone arch structure across Stonequarry Creek, as shown in Fig. 2.31.

The Picton Viaduct was built in 1867 and is the oldest stone arch railway bridge in NSW. It is an item of heritage significance.

The Viaduct is located approximately 1200 metres from the proposed LW W3, and approximately 850 metres from the proposed LW W4.

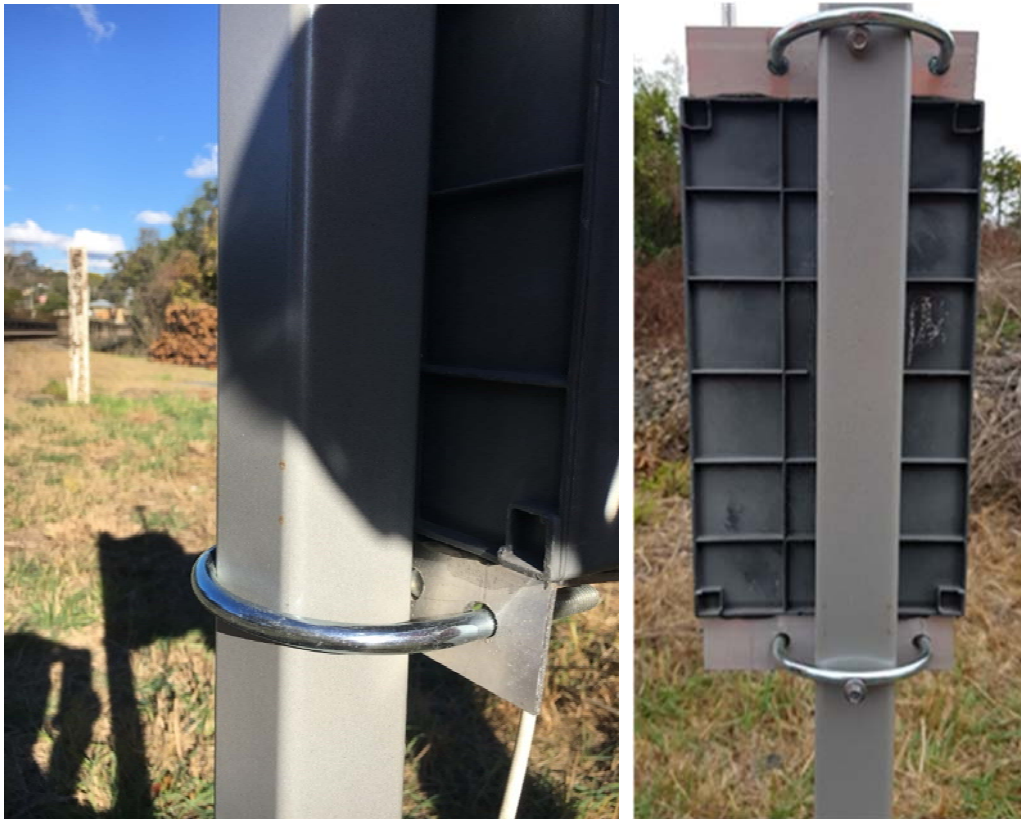
Fig. 2.33 Observed slippage of U-bolt down the post at northern GNSS unit

A site inspection of the GNSS unit found that it had been fixed to the post via U-bolts and the U-bolts had gradually slipped down the post due to vibration from passing trains, as evidenced by rust marks on the post approximately 40 mm above the U-bolt, as shown in Fig. 2.33. Screws have since been installed and no further movement has been observed.

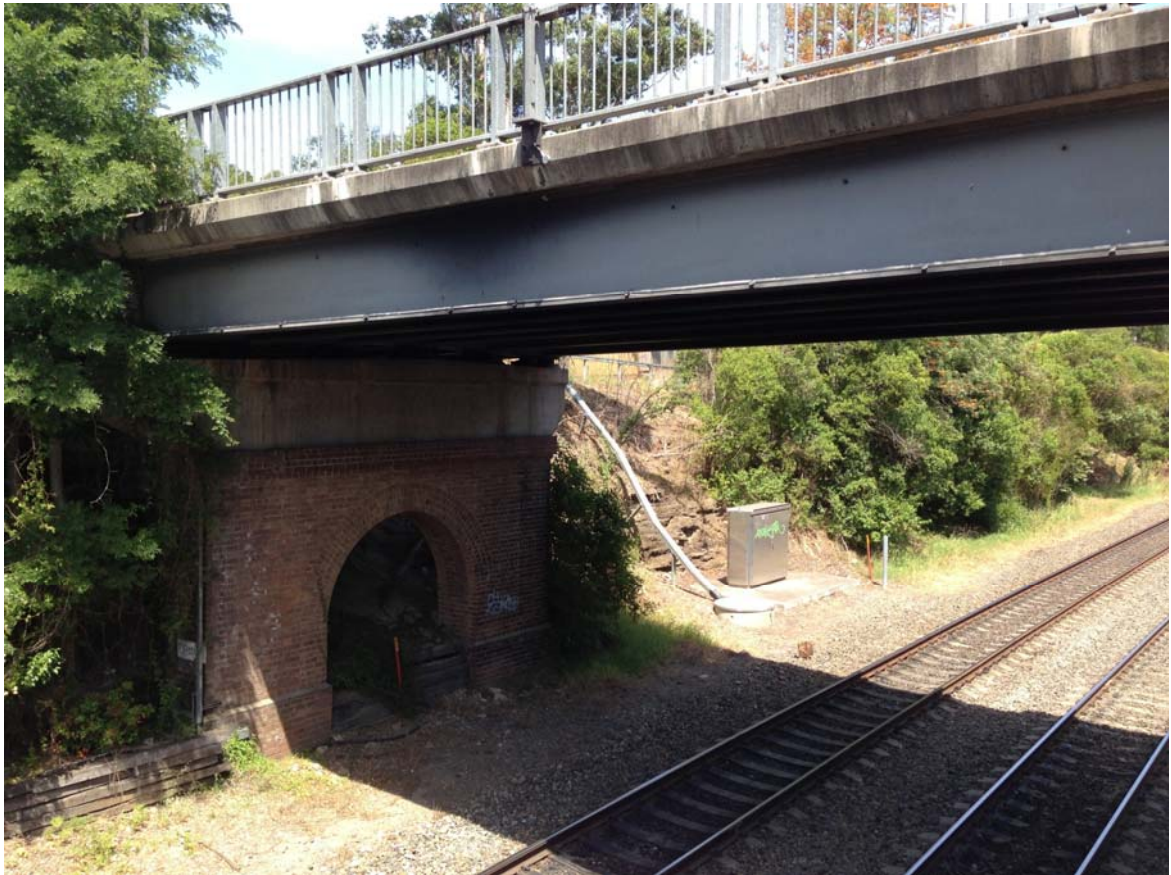
Fig. 2.36 Prince Street Overbridge at 85.17 km

The Prince Street Overbridge (85.17 km) is a steel framed overbridge with steel handrails with the deck supported by bearings on concrete headstocks and brickwork piers, as shown in Fig. 2.36.

The Bridge is located approximately 1290 metres from the proposed LW W3, and approximately 960 metres from the proposed LW W4.

The Bridge is located 1.6 kilometres north-east of previously extracted LW 32, 1.9 km from previously extracted LW W1 and 1.6 km from previously extracted LW W2.

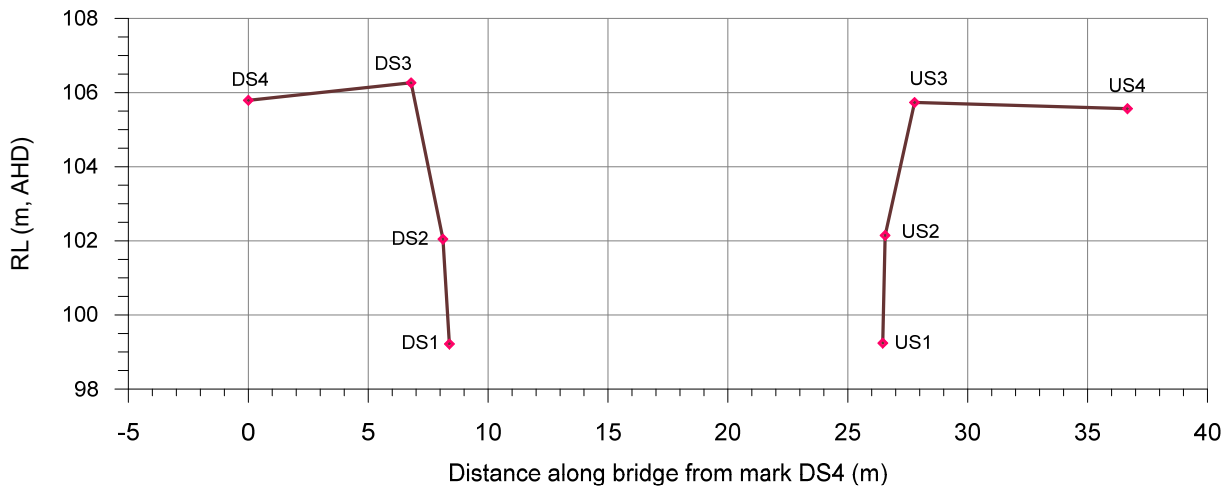
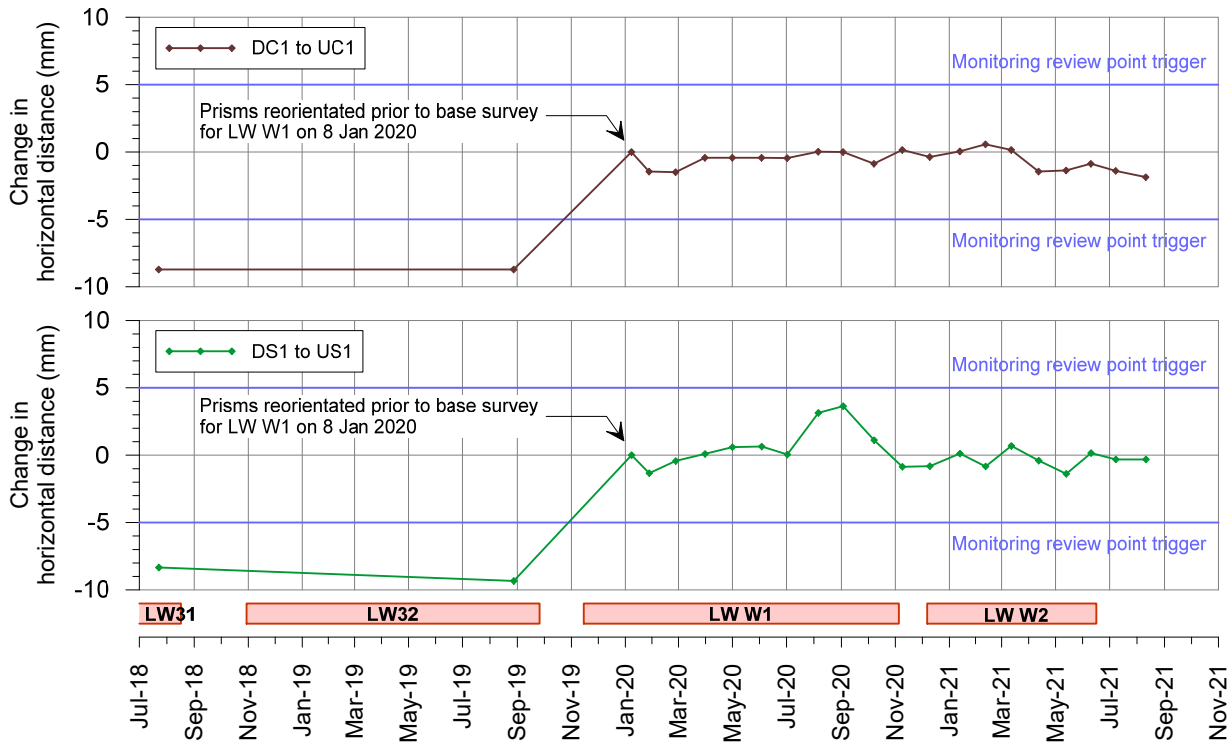
Fig. 2.38 Changes in horizontal distance at Prince Street Overbridge

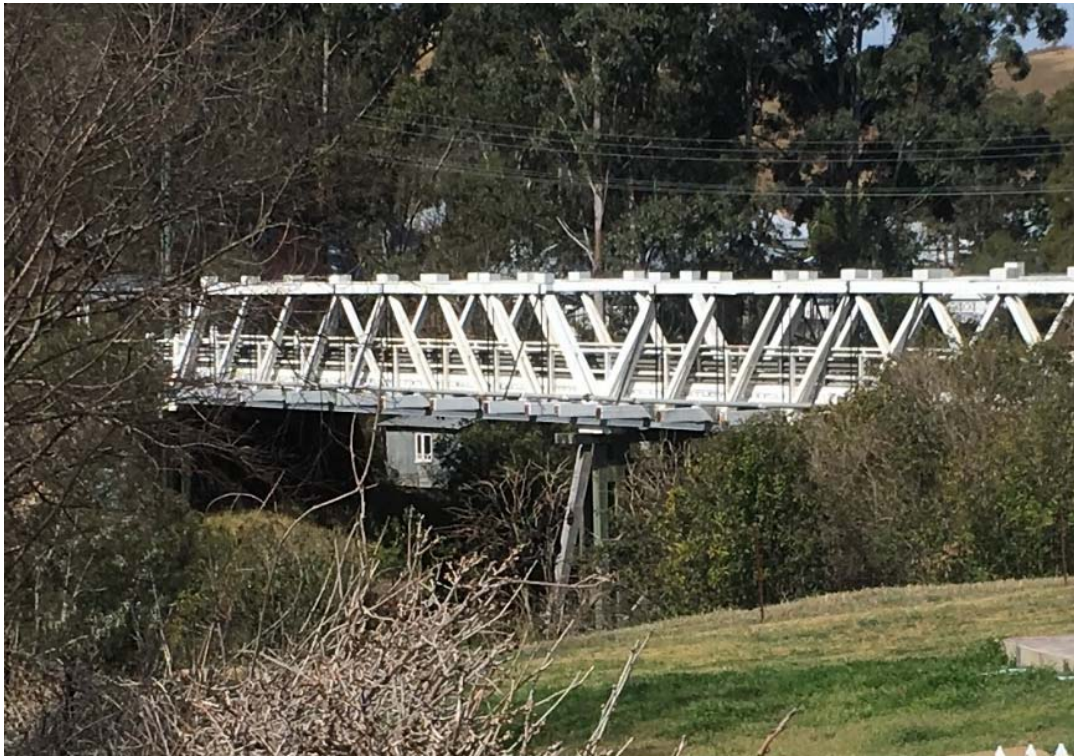
Fig. 2.39 Victoria Bridge

The Victoria Bridge over Stonequarry Creek at Picton consists of three Allan type timber truss spans over 19.5 metre high timber trestles or piers (Cardno, 2019). The Bridge has no approach spans and each of the main spans is 24.7 metres in length. The Bridge can accommodate a single lane of traffic, with a signposted load limit of 5 tonnes. Photographs of Victoria Bridge are provided in Fig. 2.39 to Fig. 2.41.

The Bridge is located approximately 1030 metres from the proposed LW W3, and approximately 700 metres from the proposed LW W4.

The Bridge is located 1.3 kilometres northeast of previously extracted LW 32, 1.7 km from previously extracted LW W1 and 1.4 km from previously extracted LW W2.

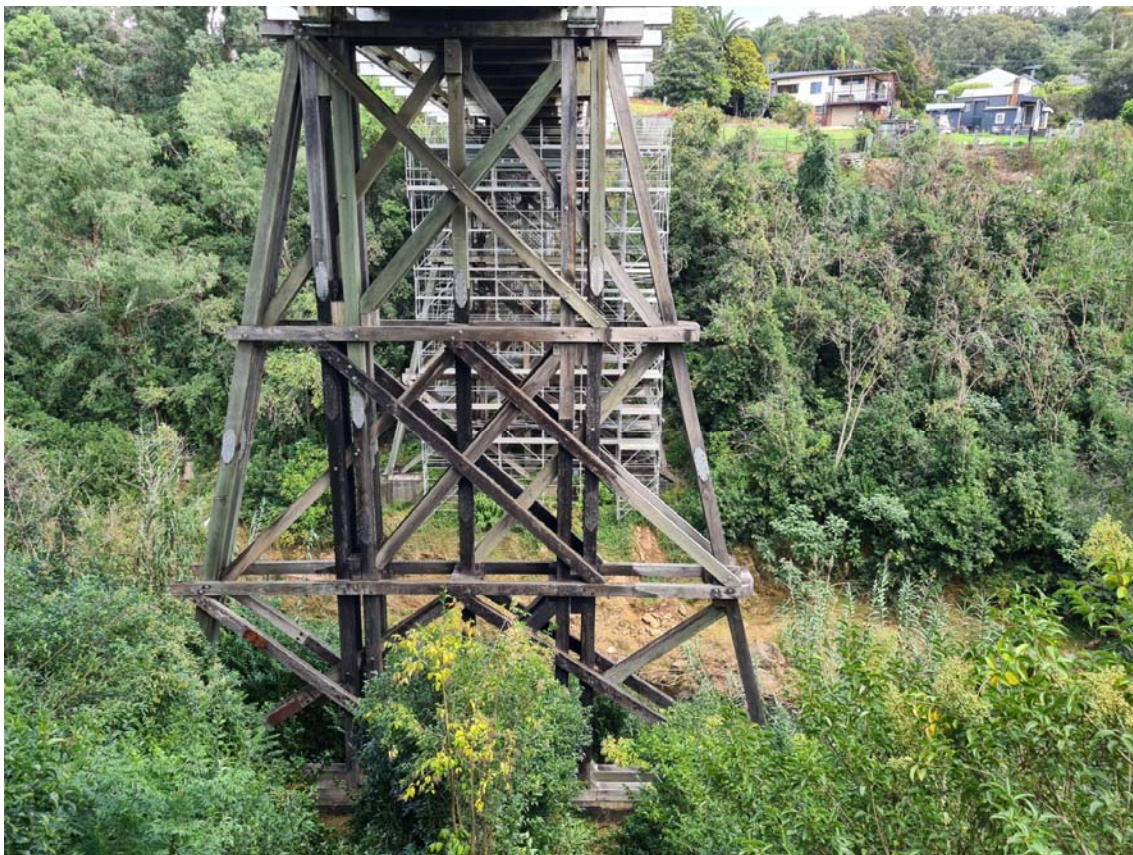
Fig. 2.44 Engineering works at western abutment of Victoria Bridge as at August 2021

The abutment bridge works are currently being conducted and the Bridge is shut to traffic. The works are scheduled to continue until October or November 2021. A photograph of the engineering works underway in August 2021 is shown in Fig. 2.46.

- Replacement of various timber truss members in the top chord and in the piers; and
- Reconstruction of Abutment A at the western end of the Bridge.

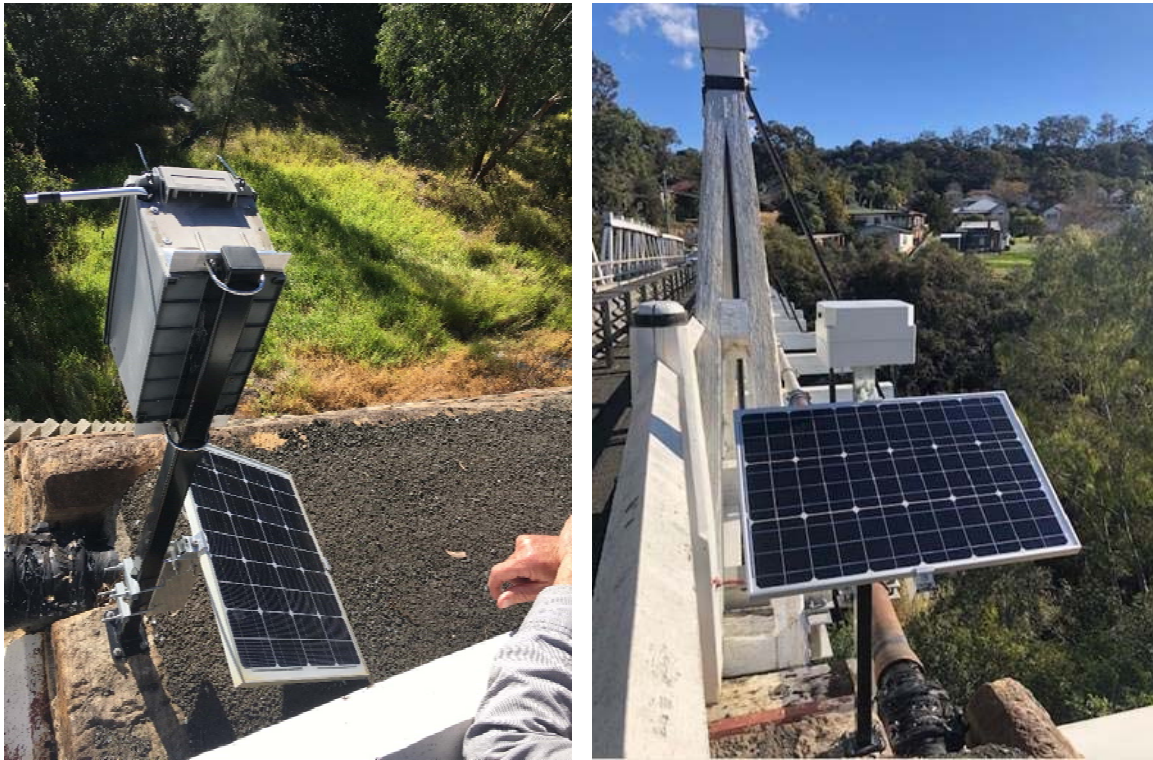
Fig. 2.45 Damaged old and new GNSS Unit 3 at Victoria Bridge on Eastern Abutment B

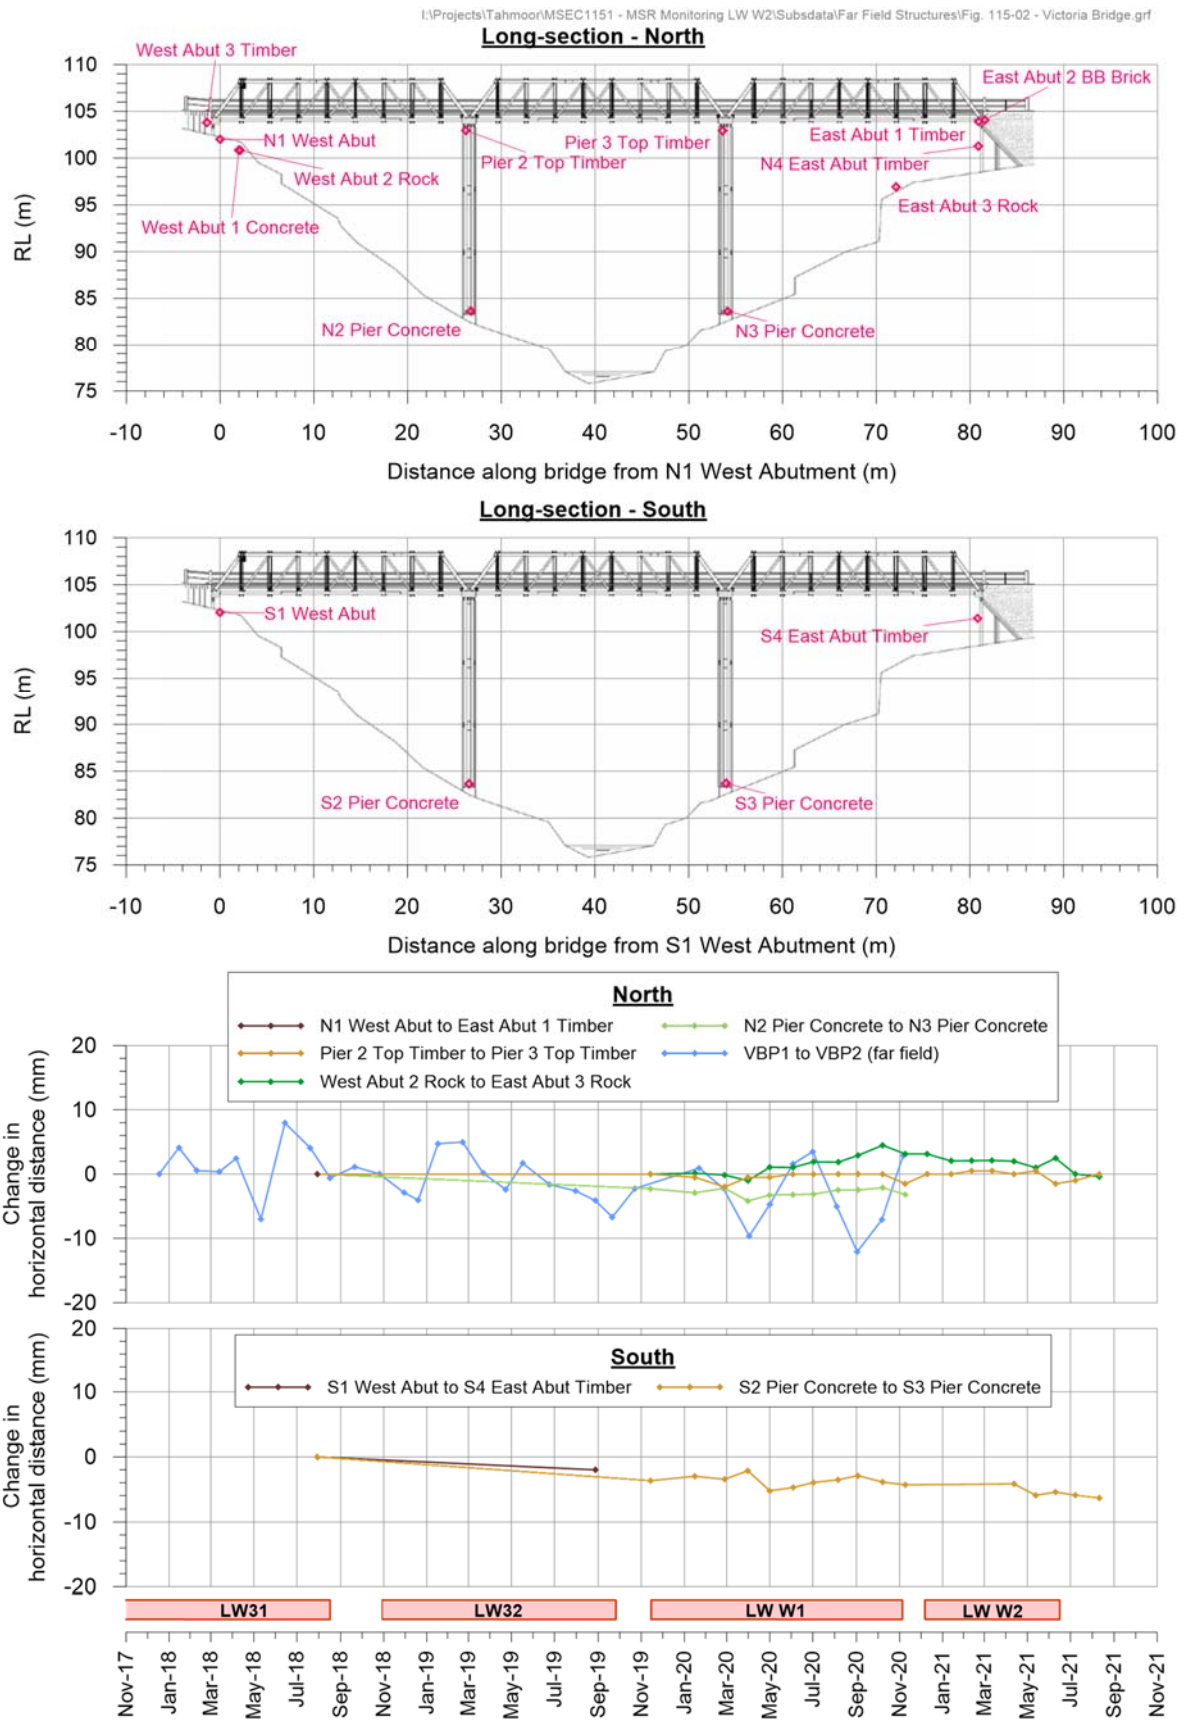
It can be seen from Fig. 2.49 that there were no measurable changes in horizontal distances were observed between the abutments during the mining of LW 32, LW W1 and LW W2.

Eight prisms were installed and surveyed on 30 July 2018 at each end of the Bridge and at the base of the timber trestles, on both sides. A plan view layout of the marks is shown Drawing No. MSEC1173-18-03. The marks have been measured in local 3D coordinates. The survey results are shown in Fig. 2.49.

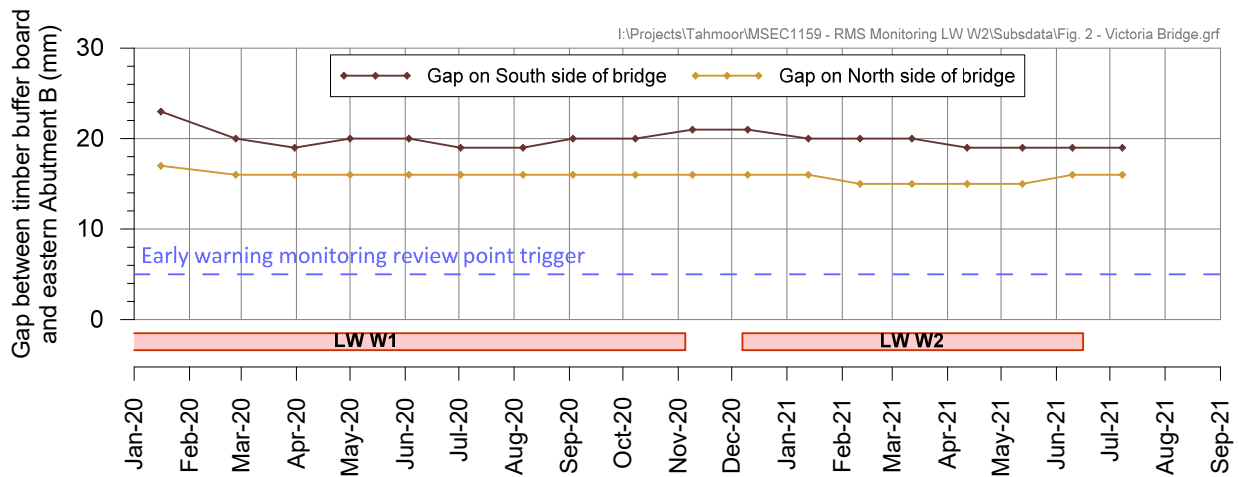
Fig. 2.50 Measured gap between timber buffer board and eastern Abutment B

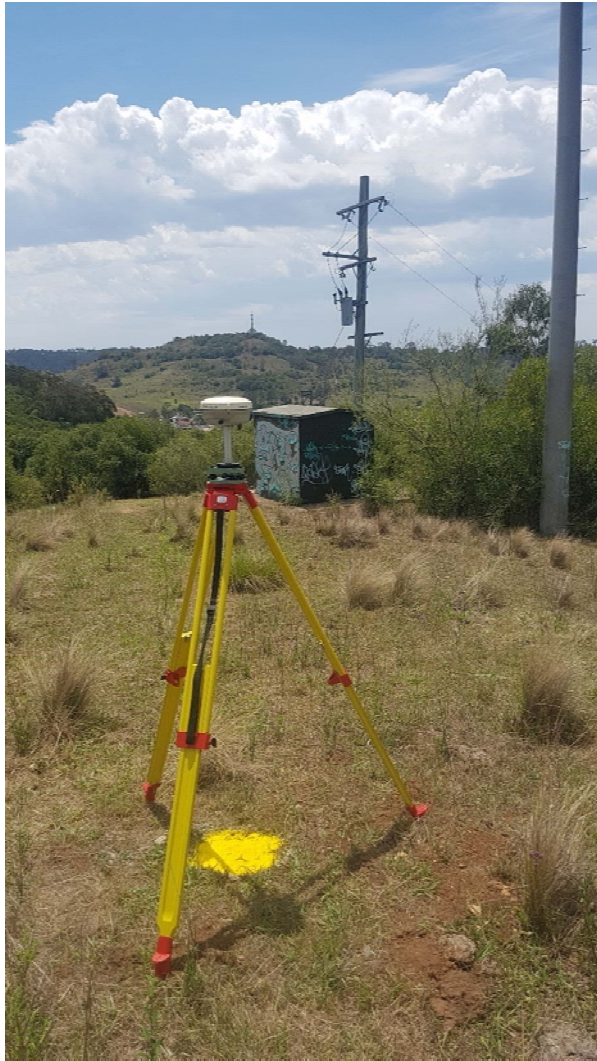
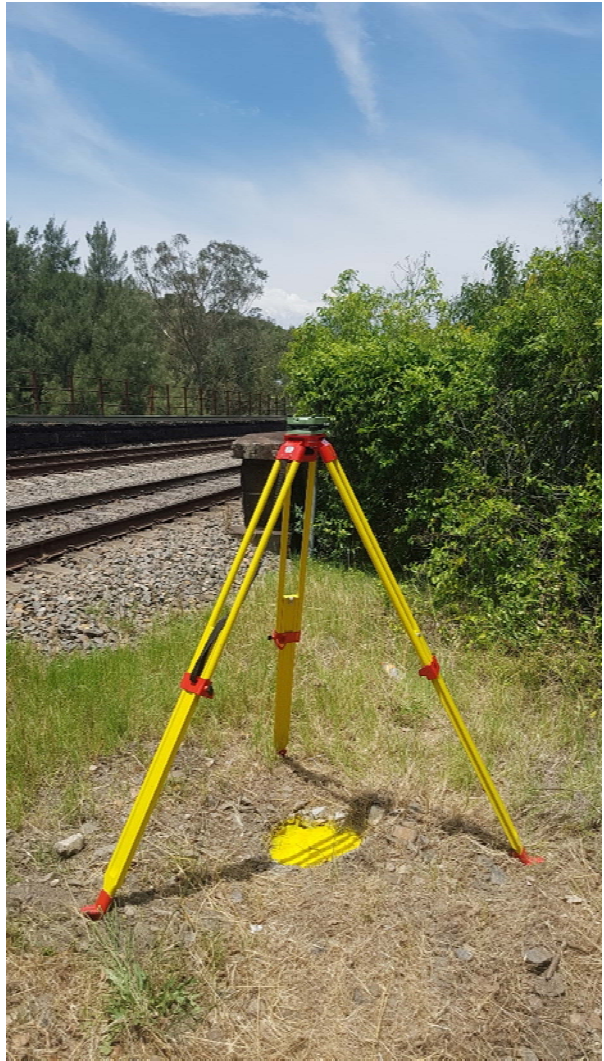
Fig. 4.1 Ground survey peg installed above Picton Tunnel (left) and Picton Viaduct (right)

Ground pegs have been installed at the above locations. Photographs of the survey pegs installed above the Picton Tunnel and Picton Viaduct are shown in Fig. 4.1.

The two units at the Picton Viaduct have been installed in the ground at each end of the Viaduct, as this structure spans the surface expression of the Nepean Fault. The locations are shown in Drawing No. MSEC1073-18-02.

The GNSS system will record an average reading for each day and the data will be reviewed monthly during the mining of LW W3-W4. A more regular review of the data will be considered if significant absolute or differential movements are observed.
