**Tahmoor Colliery - Longwalls 28 to 30**

Management Plan for Potential Impacts to Wollondilly Shire Council Infrastructure

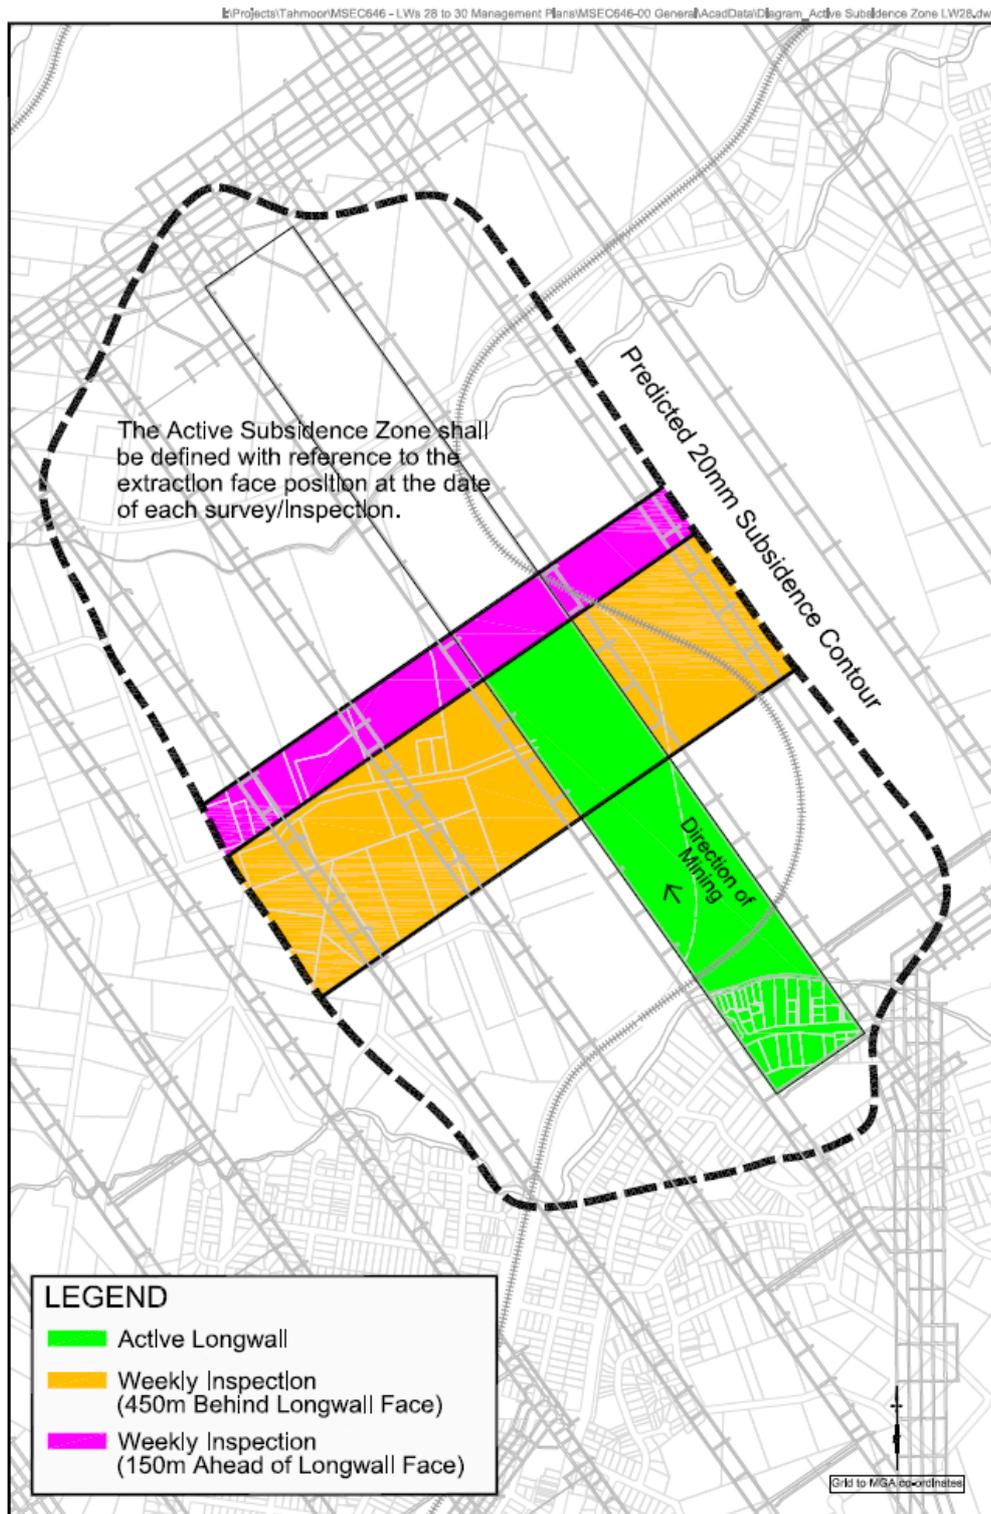
Fig. 1.1 Diagrammatic Representation of Active Subsidence Zone

This is termed the “active subsidence zone” for the purposes of this Management Plan, where surface monitoring is generally conducted. The active subsidence zone for each longwall is defined by the area bounded by the predicted 20 mm subsidence contour for the active longwall and a distance of 150 metres in front and 450 metres behind the active longwall face, as shown by Fig. 1.1.

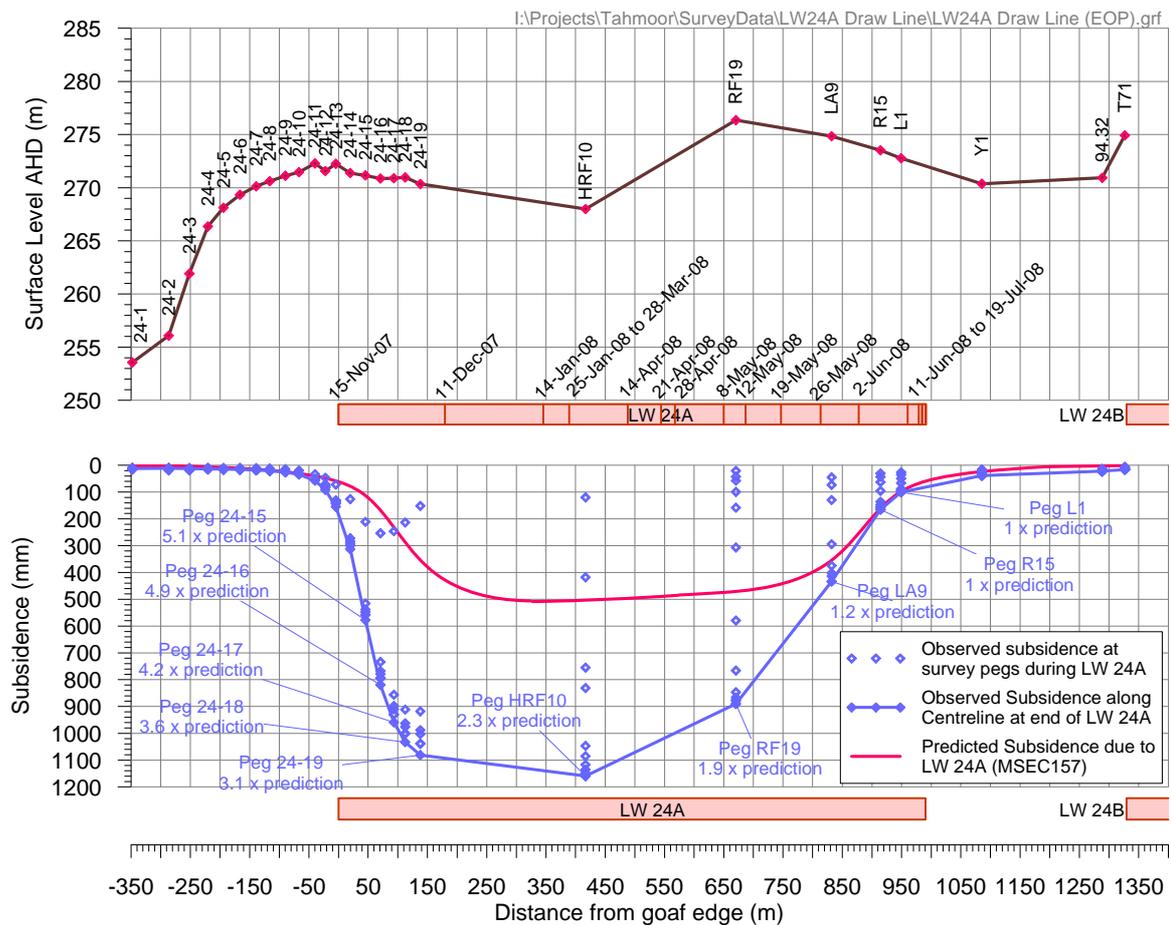
**Fig. 2.1 Observed Subsidence along Centreline of Longwall 24A**

Observed subsidence was greatest above the southern half of Longwall 24A, and gradually reducing in magnitude towards the northern half of the longwall, which was directly beneath the urban area of Tahmoor. These observations are shown graphically in Fig. 2.1, which shows observed subsidence at survey pegs located along the centreline of Longwall 24A.

It can be seen from Fig. 2.1 that observed subsidence was more than twice the predicted maximum value, reaching to a maximum of 1169 mm at Peg HRF10. It is possible that actual maximum subsidence developed somewhere between Pegs HRF10 and RF19, though this was not measured. Observed subsidence was similar to prediction near Peg R15 on Remembrance Drive. Survey pegs RF19 and LA9 are located within a transition zone where subsidence gradually reduced from areas of maximum increased subsidence to areas of normal subsidence.

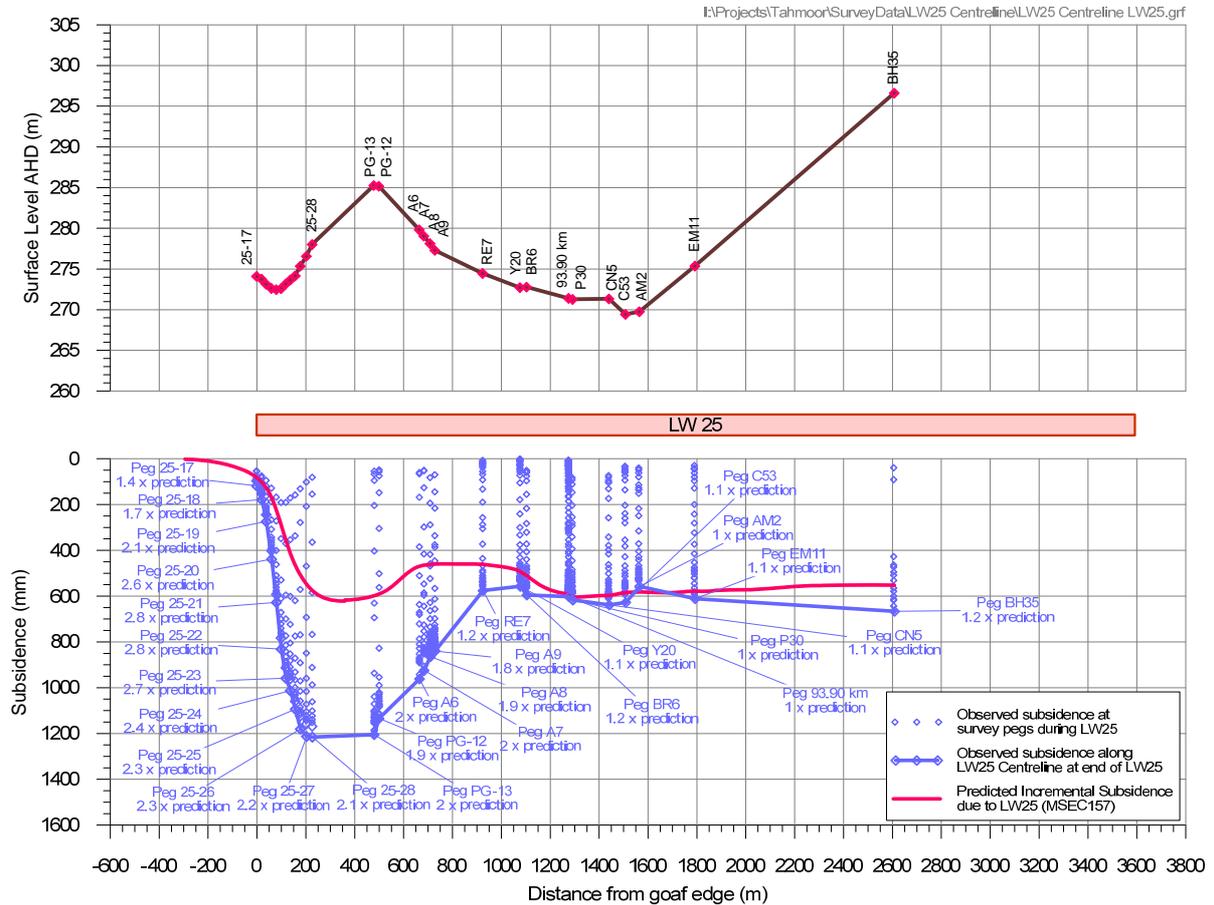
**Fig. 2.2 Observed Subsidence along Centreline of Longwall 25**

Increased subsidence was observed during the first stages of mining Longwall 25. These observations are shown graphically in Fig. 2.2, which shows observed subsidence at survey pegs located along the centreline of Longwall 25.

It can be seen from Fig. 2.2 that observed subsidence was approximately twice the predicted maximum value, with maximum subsidence of 1216 mm at Peg 25-28.

Observed subsidence is similar to but slightly more than predicted at Peg RE7 and is similar to prediction at Peg Y20 and at all pegs located further along the panel. Survey pegs A6, A7, A8 and A9 are located within a transition zone where subsidence has gradually reduced from areas of maximum increased subsidence to areas of normal subsidence.

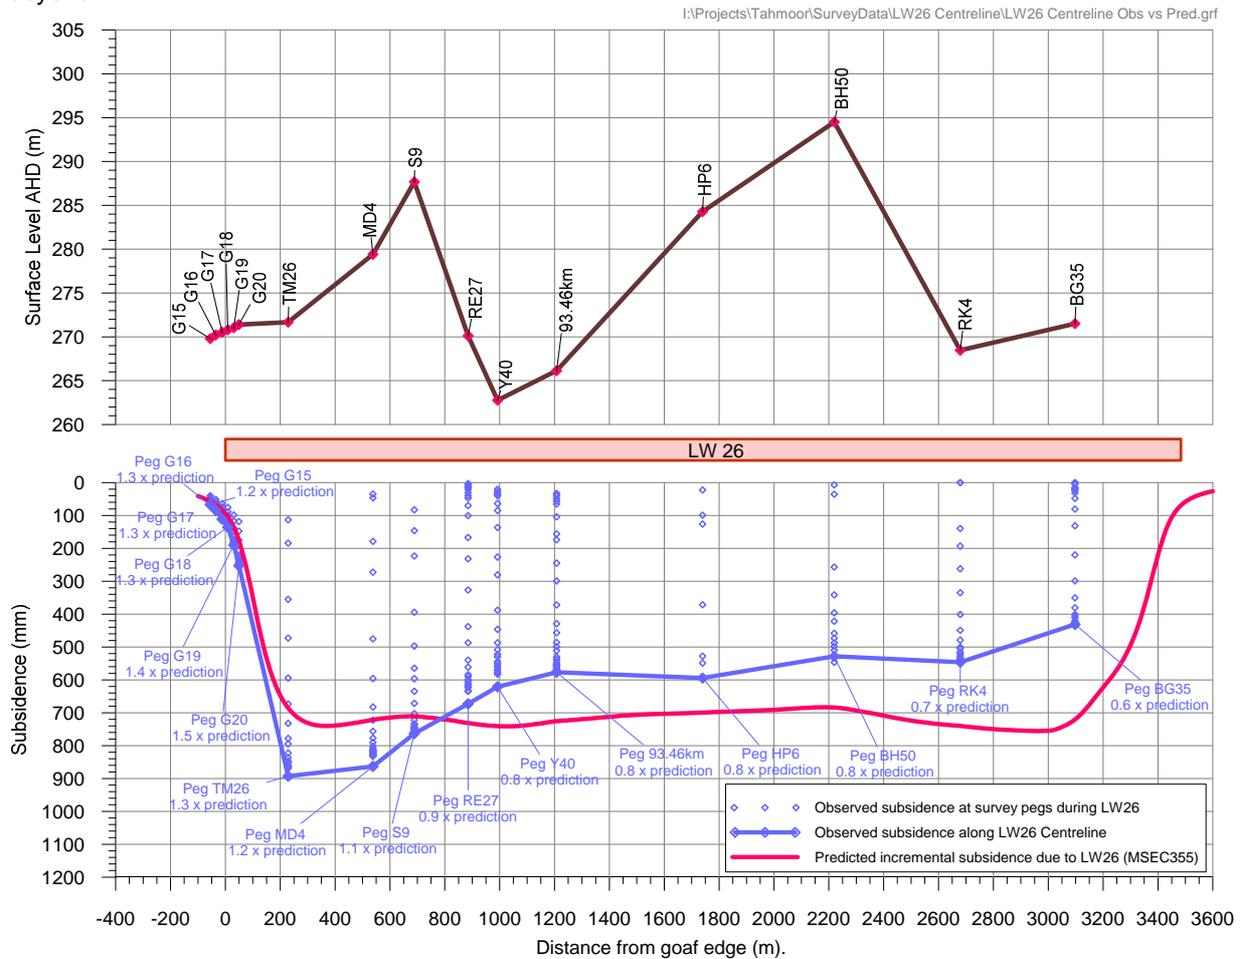
**Fig. 2.3 Observed Subsidence along Centreline of Longwall 26**

Increased subsidence was observed during the first stages of mining Longwall 26, but at a reduced magnitude compared to the subsidence observed above Longwalls 24A and 25. These observations are shown graphically in Fig. 2.3, which shows observed subsidence at survey pegs located along the centreline of Longwall 26.

It can be seen from Fig. 2.3 that observed subsidence was approximately 1.5 times the predicted maximum value, with maximum subsidence of 893 mm at Peg TM26.

Observed subsidence reduced along the panel until Peg Y40 on York Street, where it was less than prediction. Survey pegs S9 and RE27 are located within a transition zone where subsidence has gradually reduced from areas of maximum increased subsidence between Pegs TM26 and MD4 to areas of normal subsidence at Peg Y40 and beyond.

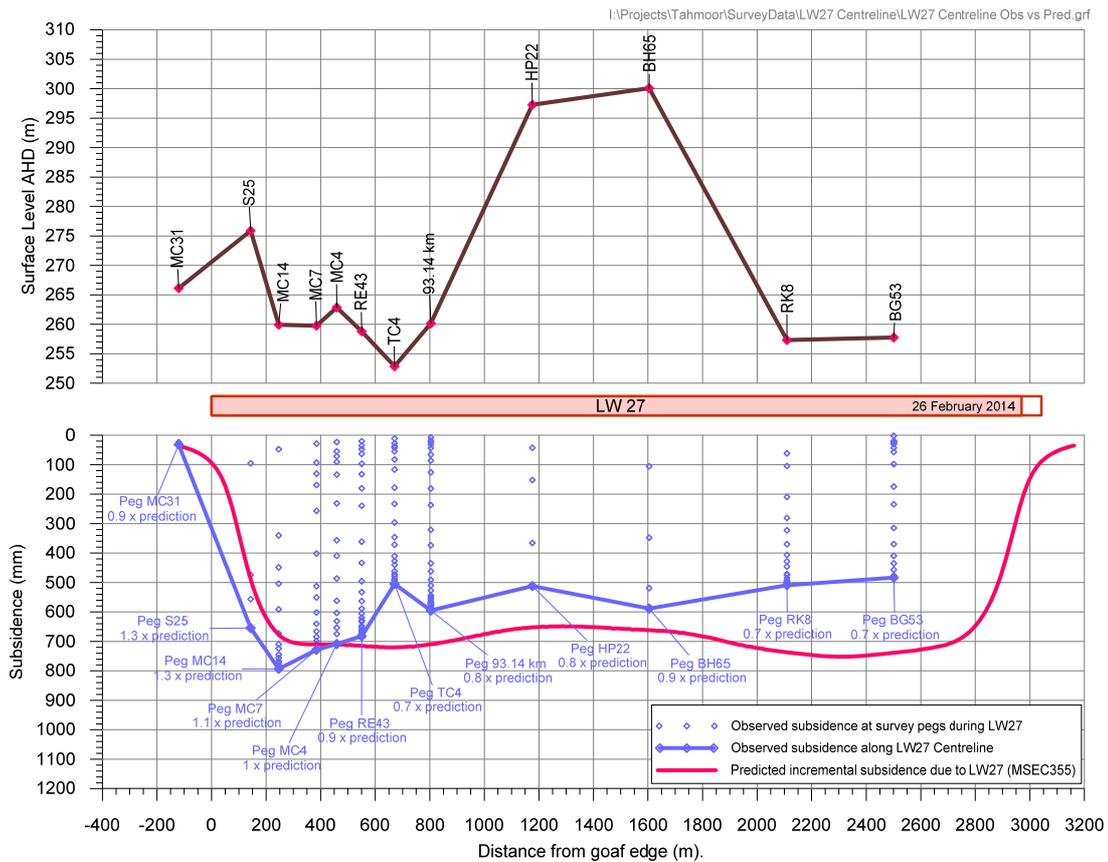
**Fig. 2.4 Observed Subsidence along Centreline of Longwall 27**

It can be seen from Fig. 2.4 that observed subsidence is approximately 1.3 times the predicted maximum value, with current maximum subsidence of 793 mm at Peg MC14.

Observed subsidence reduced along the panel from Peg MC14 until Peg TC4, which is located between Remembrance Drive and Myrtle Creek. Observed subsidence along the centreline returned to normal levels as mining progressed beyond Peg TC4.

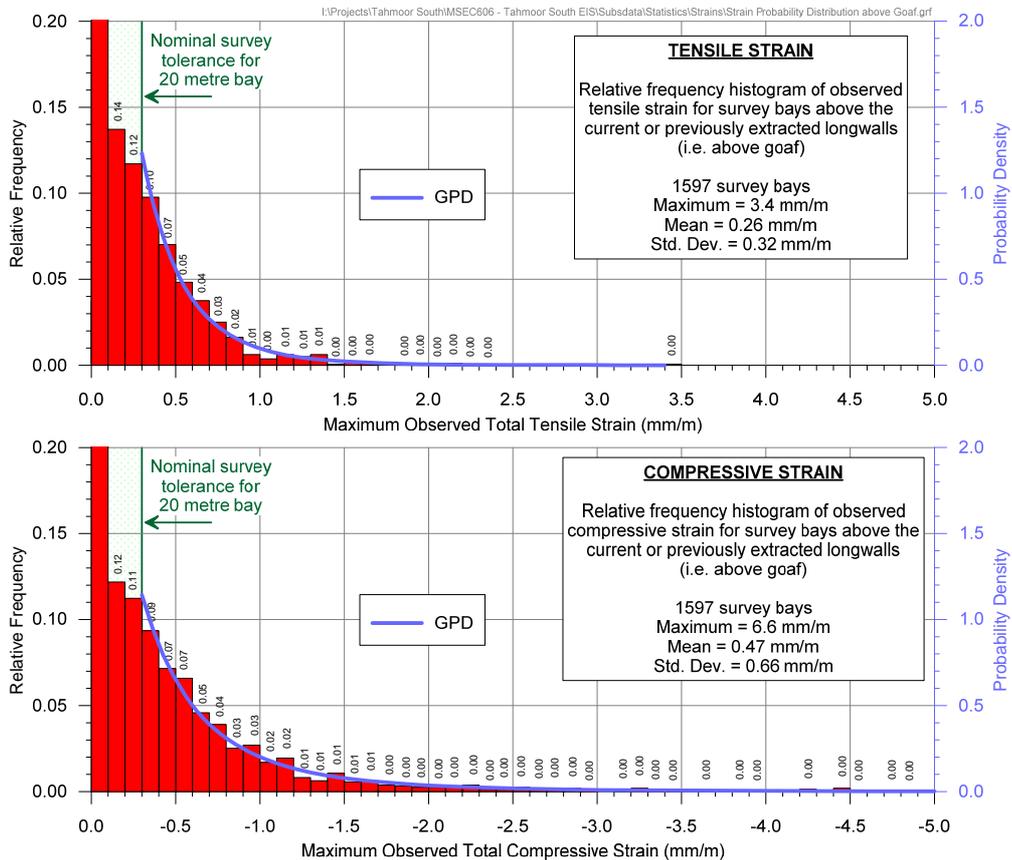
**Fig. 2.5 Distributions of the Measured Maximum Tensile and Compressive Strains for Surveys Bays Located Above Goaf at Tahmoor, Appin and West Cliff Collieries**

The histogram of the maximum observed total tensile and compressive strains measured in survey bays above goaf, for monitoring lines at Tahmoor, Appin Area and West Cliff Collieries, is provided in Fig. 2.5. The probability distribution functions, based on the fitted GPDs, have also been shown in this figure.

The 95 % confidence levels for the maximum total strains that the individual survey bays *above goaf* experienced at any time during mining at Tahmoor, Appin and West Cliff Collieries were 0.9 mm/m tensile and 1.6 mm/m compressive. The strains for the proposed longwalls are predicted to be 30 % to 50 % greater than those previously observed at these collieries and, therefore, it is expected that 95 % of the strains measured *above goaf* would be less than 1.5 mm/m tensile and 2.5 mm/m compressive.

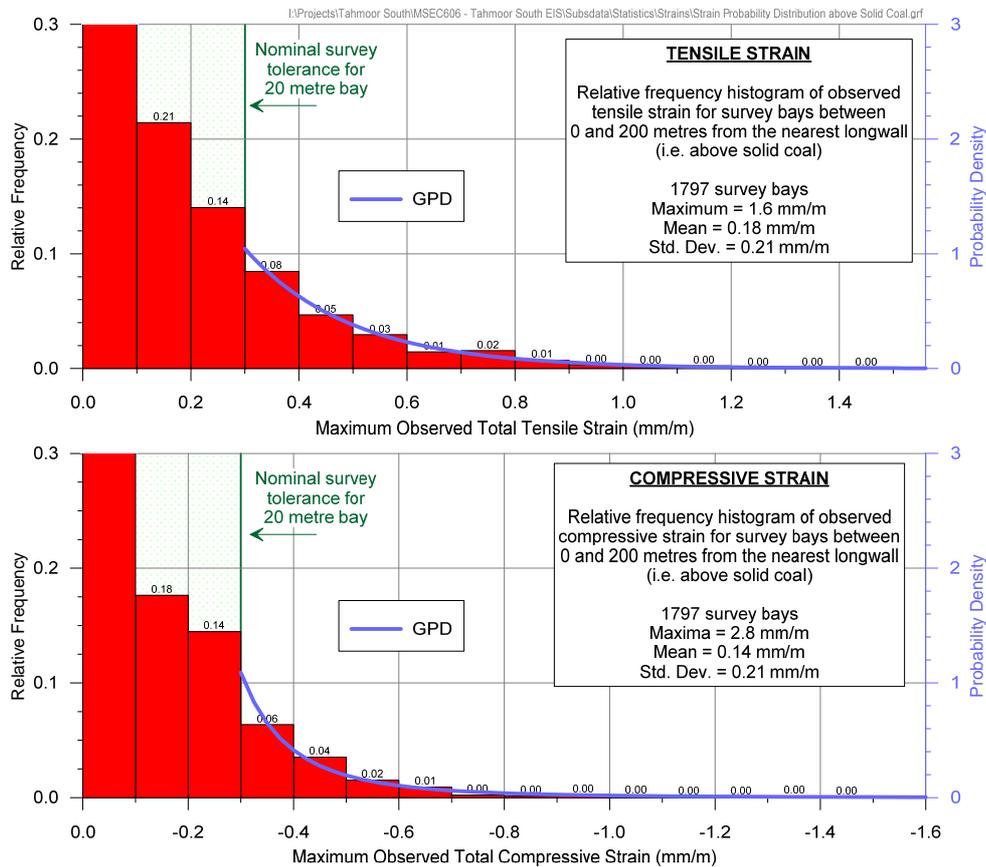
**Fig. 2.6 Distributions of the Measured Maximum Tensile and Compressive Strains for Survey Bays Located Above Solid Coal at Tahmoor, Appin and West Cliff Collieries**

The histogram of the maximum observed tensile and compressive strains measured in survey bays above solid coal, for monitoring lines at Tahmoor, Appin and West Cliff Collieries, is provided in Fig. 2.6. The probability distribution functions, based on the fitted GPDs, have also been shown in this figure.

The 95 % confidence levels for the maximum total strains that the individual survey bays *above solid coal* experienced at any time during mining at Tahmoor, Appin and West Cliff Collieries were 0.6 mm/m tensile and 0.5 mm/m compressive. The strains for the proposed longwalls are predicted to be 30 % to 50 % greater than those previously observed at these collieries and, therefore, it is expected that 95 % of the strains measured *above solid coal* would be less than 1.0 mm/m tensile and compressive.

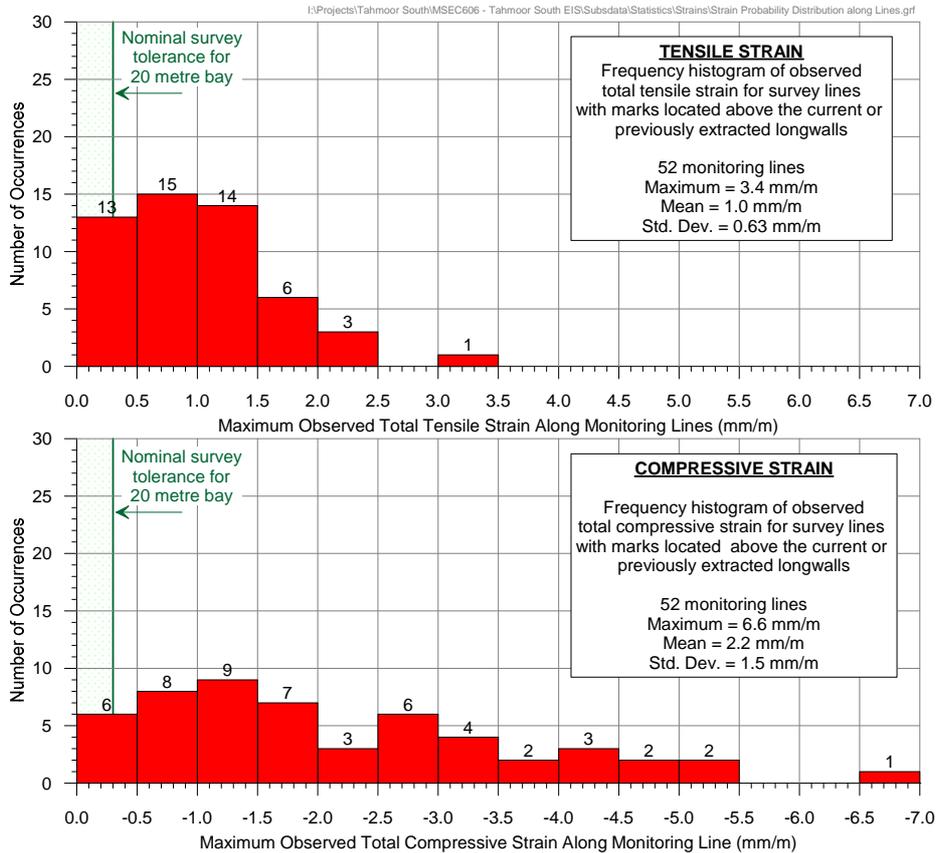
**Fig. 2.7 Distributions of Measured Maximum Tensile and Compressive Strains Anywhere along the Monitoring Lines at Tahmoor, Appin and West Cliff Collieries**

The histogram of maximum observed total tensile and compressive strains measured anywhere along the monitoring lines, at any time during or after the extraction of the previous longwalls at Tahmoor, Appin and West Cliff Collieries, is provided in Fig. 2.7.

It can be seen from Fig. 2.7, that 42 of the 52 monitoring lines (i.e. 92 % of the total) at Tahmoor, Appin and West Cliff Collieries had recorded maximum total tensile strains of 2.0 mm/m, or less. The strains for the proposed longwalls are predicted to be 30 % to 50 % greater than those previously observed at these collieries and, therefore, it is expected that 92 % of the monitoring lines above the proposed longwalls would experience maximum tensile strains of 3.0 mm/m, or less.

It can also be seen, that 45 of the 52 monitoring lines (i.e. 87 % of the total) at Tahmoor, Appin and West Cliff Collieries had recorded maximum total compressive strains of 4.0 mm/m, or less. The strains for the proposed longwalls are predicted to be 30 % to 50 % greater than those previously observed at these collieries and, therefore, it is expected that 87 % of the monitoring lines above the proposed longwalls would experience maximum compressive strains of 6.0 mm/m, or less.

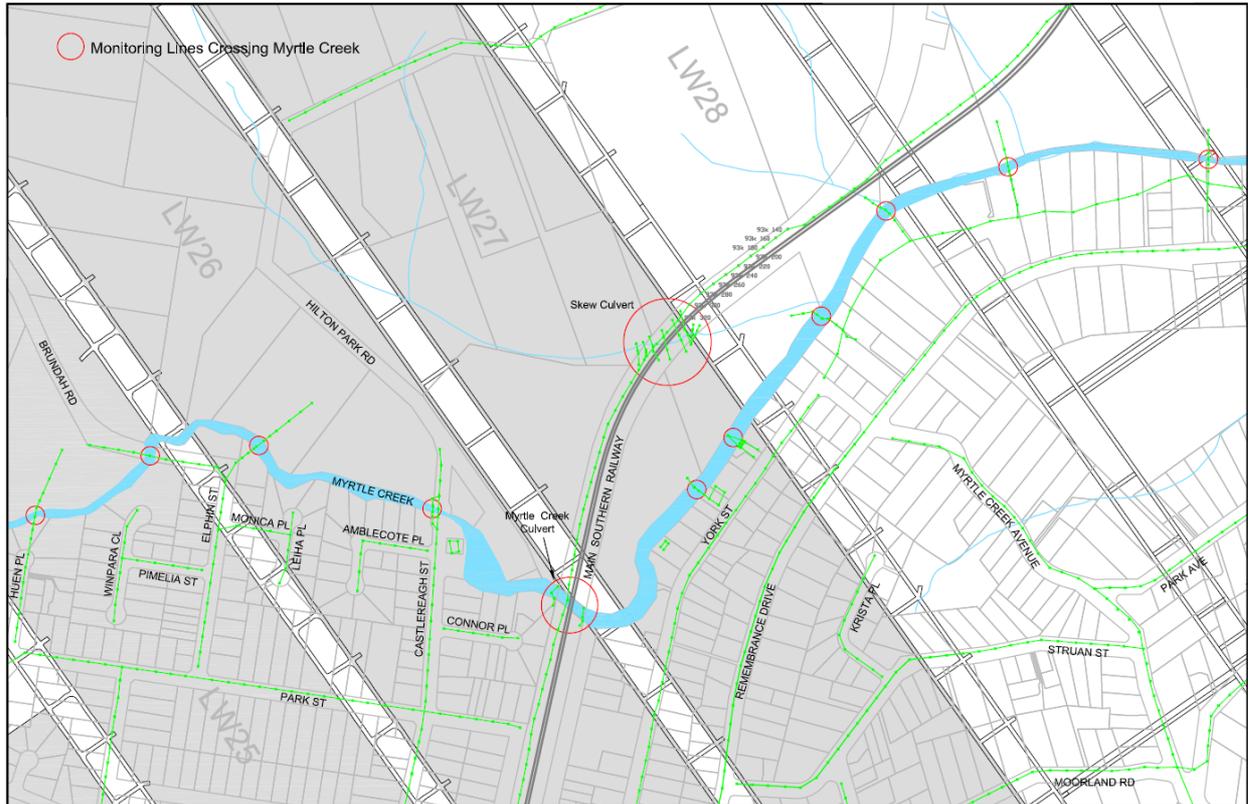
**Fig. 2.8 Monitoring lines across Myrtle Creek and Skew Culvert**

A map of monitoring lines across Myrtle Creek and a small creek that crosses the Main Southern Railway (called the Skew Culvert) is shown in Fig. 2.8.

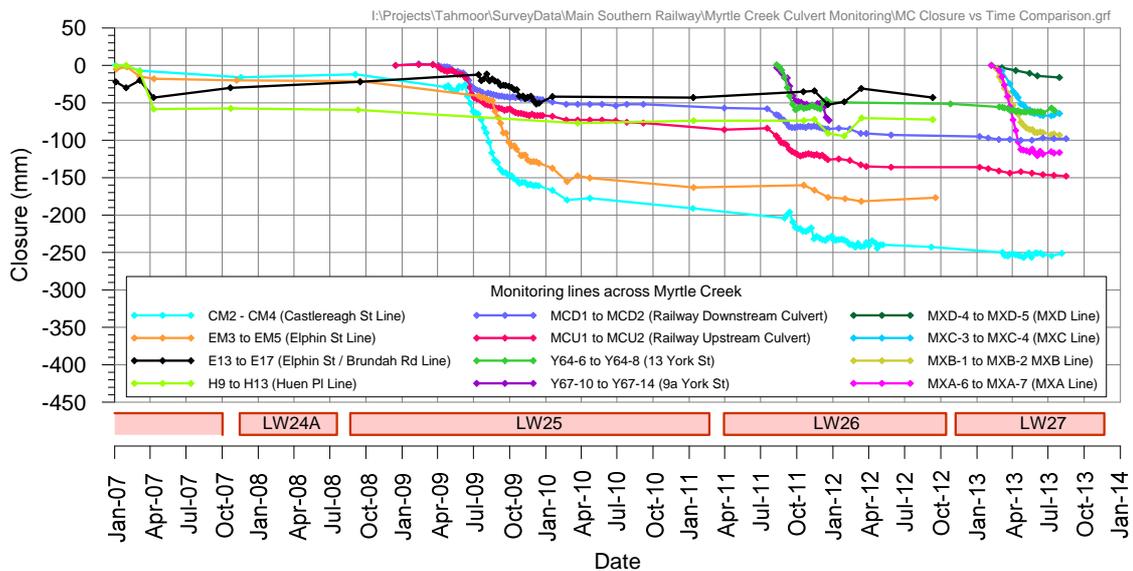
**Fig. 2.9 Development of closure across Myrtle Creek during the mining of Longwalls 24B to 27**

A summary graph showing the development of valley closure across Myrtle Creek at each monitoring line is shown in Fig. 2.9.

It can be seen that observed valley closure has substantially exceeded predictions at the Castlereagh Street crossing, at the crossing of the Elphin-Myrtle monitoring line and to a lesser extent the crossing of the Main Southern Railway during the mining of Longwall 25. It is considered that the reason for the differences in observations may be linked to the change in orientation of Myrtle Creek as the three above-mentioned monitoring lines are located along the same stretch of Myrtle Creek. It is noted, however, that substantially less closure has developed at Castlereagh Street than predicted during the mining of Longwall 27.

Observed valley closure across Myrtle Creek above Longwall 27 has been less than predictions, but greater than previously observed. Predictions for this section of creek were greater than upstream sections because the valley is deeper.

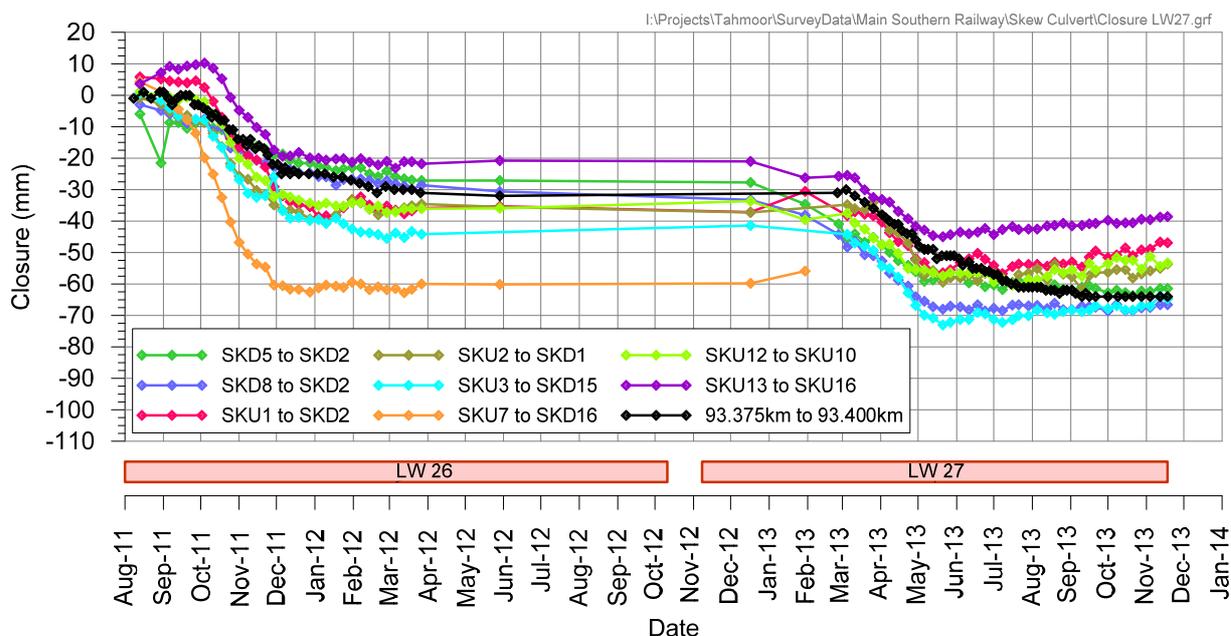
**Fig. 2.10 Development of closure across Skew Culvert during the mining of Longwalls 26 and 27**

The development of valley closure across the creek at the Skew Culvert is shown in Fig. 2.10.

Observed valley closure across the creek at the Skew Culvert has also slightly exceeded predictions, where the differences between predicted and observed closure are relatively small for most cross sections.

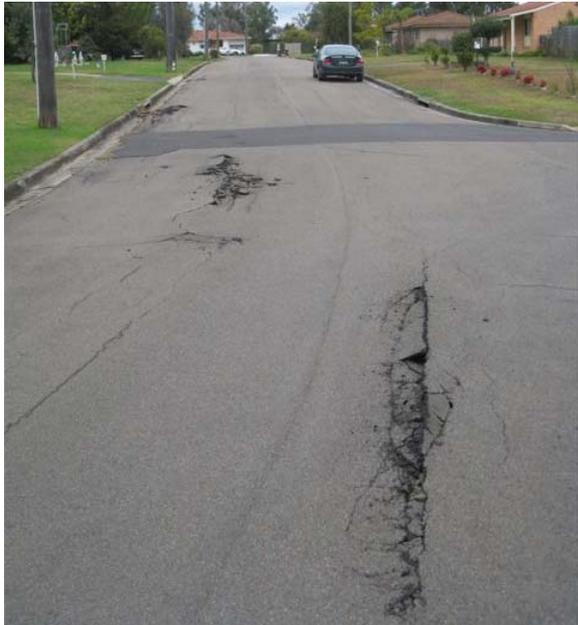
Lintina Street (most severe to date)

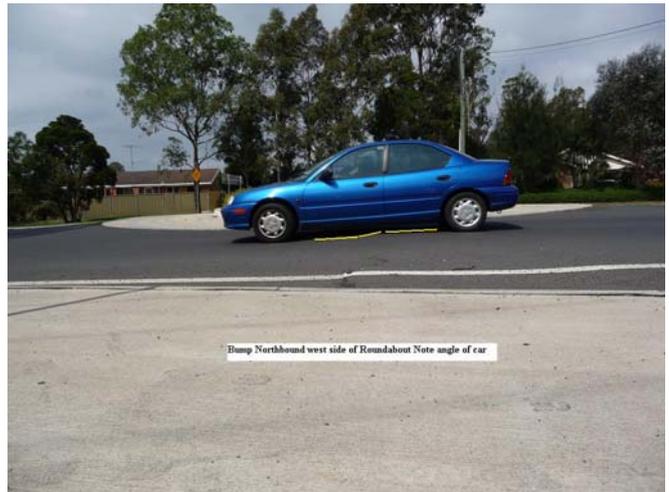
Remembrance Drive (hump at roundabout)

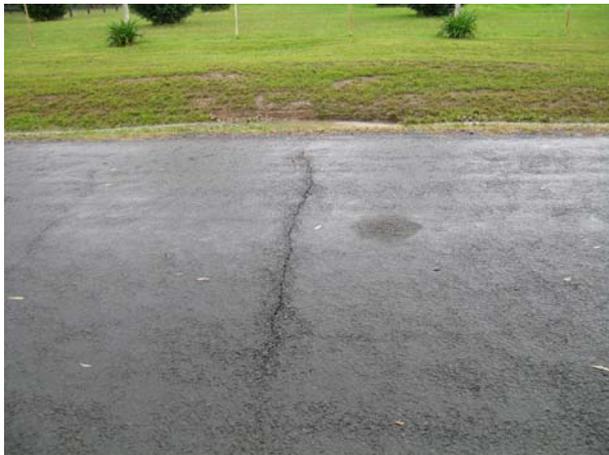
Brundah Road (typical impact to pavement)

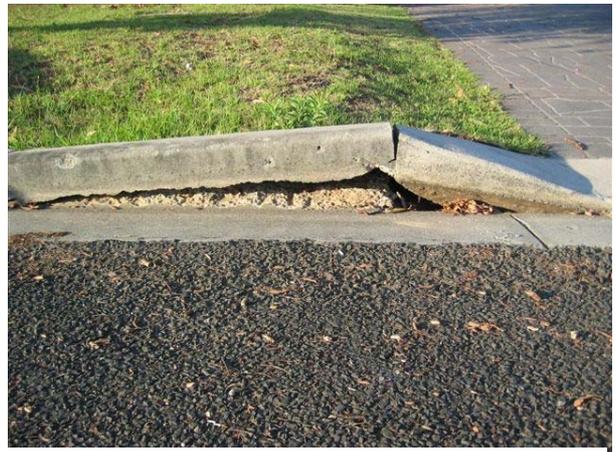
Patterson Street (typical impact to kerb)

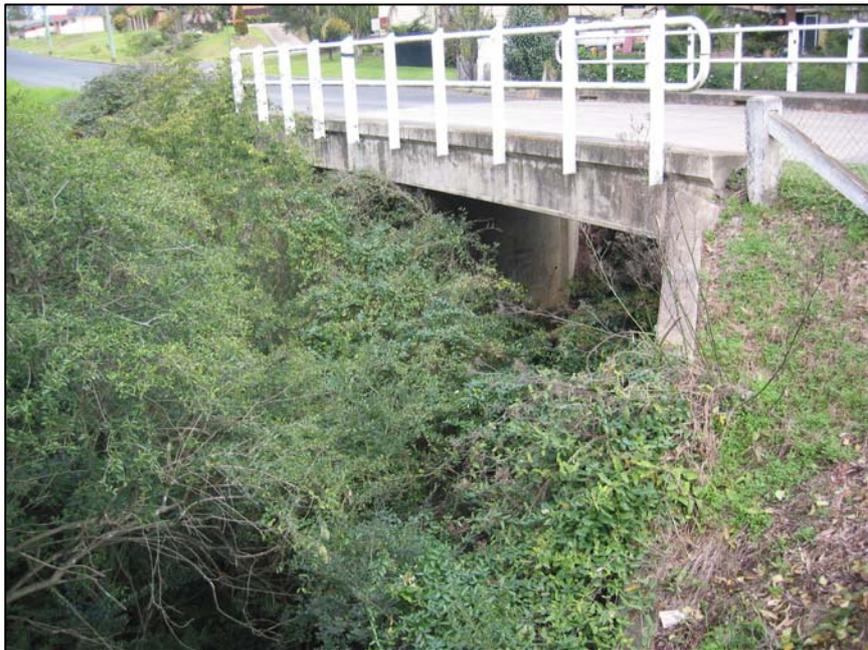
**Fig. 4.4** Castlereagh Street Road Bridge over Myrtle Creek

The Castlereagh Street Road Bridge over Myrtle Creek is a two-lane bridge that provides access for residents to Hilton Park Road. The single-span bridge is constructed with a concrete deck on concrete abutments, as shown in Fig. 4.4. This bridge is located above the previously extracted Longwall 25.

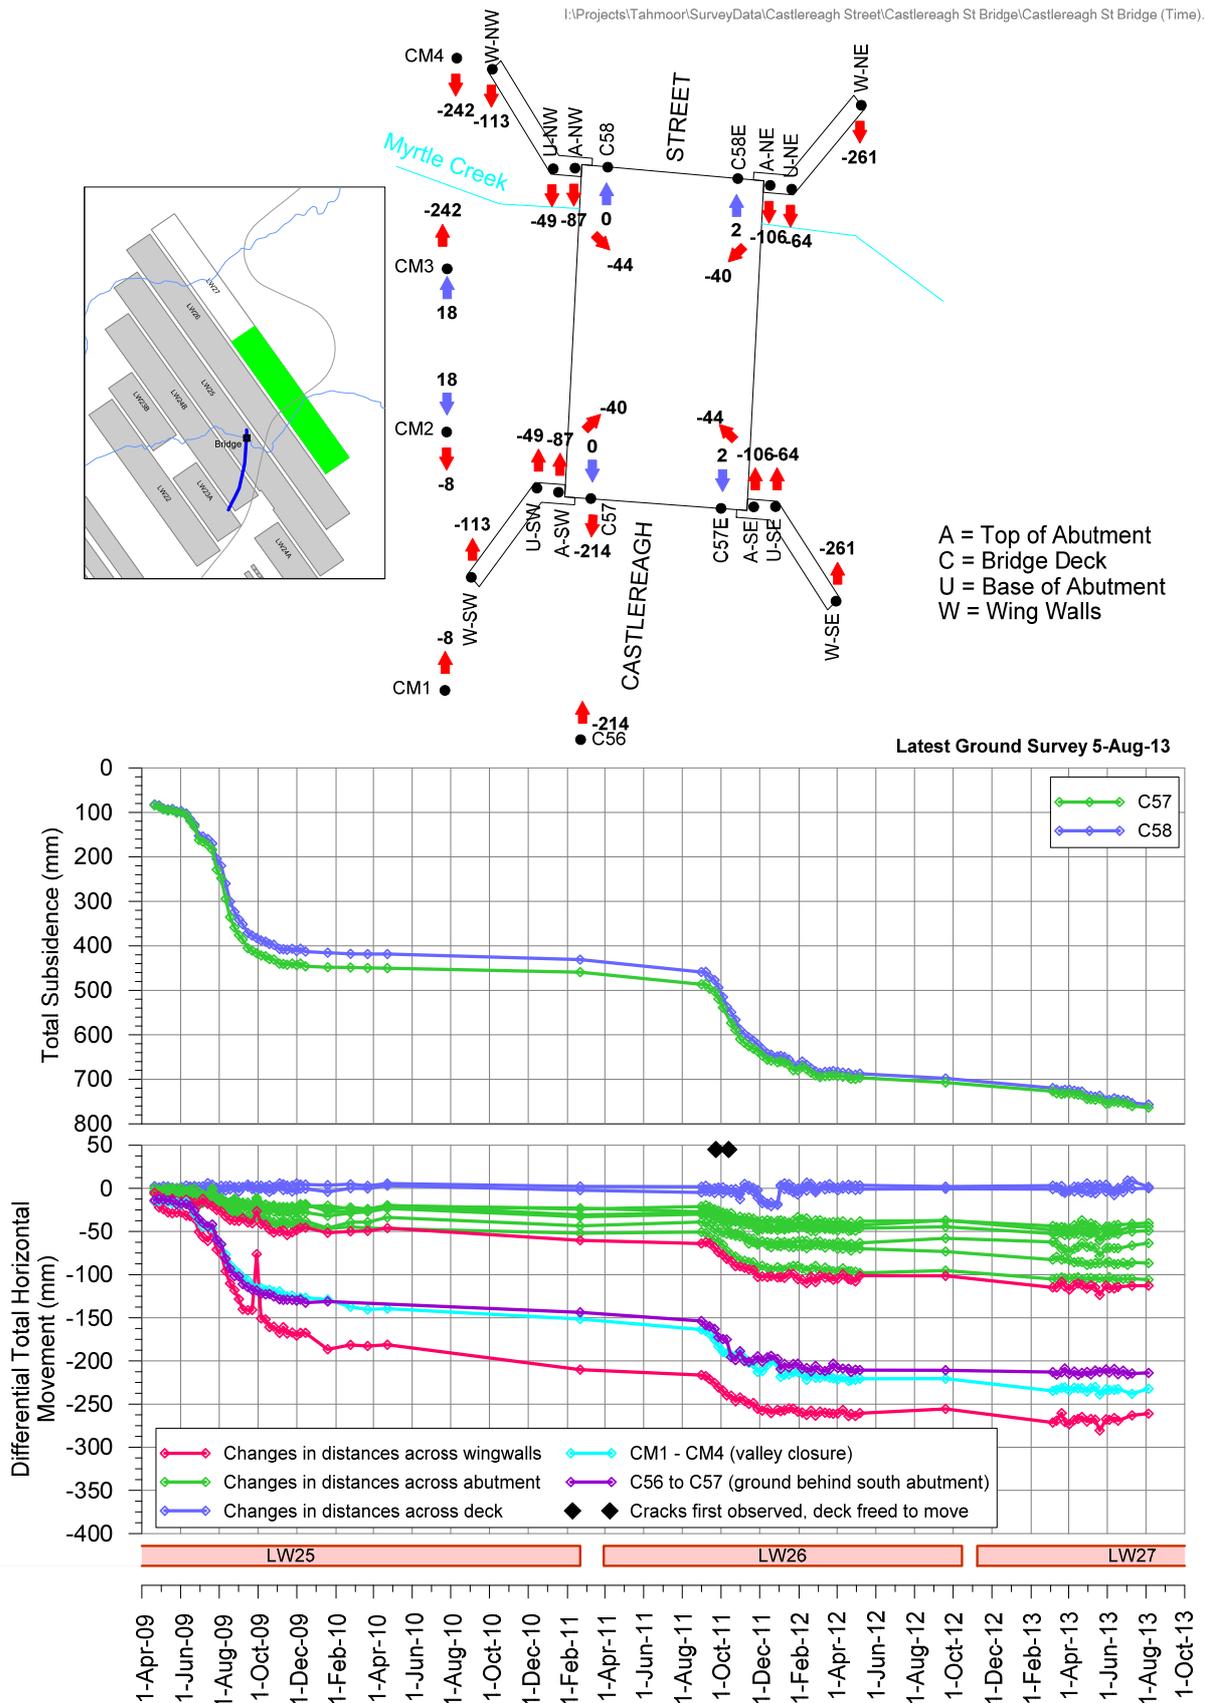
**Fig. 4.5** Development of subsidence and valley closure at Castlereagh Street Bridge

Given that little change was observed during the mining of Longwall 27, and that Longwalls 28 to 30 are located further away from the Bridge, the likelihood of additional movement and impacts is assessed as **RARE**. The consequence of additional damage is assessed as **MODERATE**. The risk is therefore assessed as **RARE / MODERATE → LOW**.

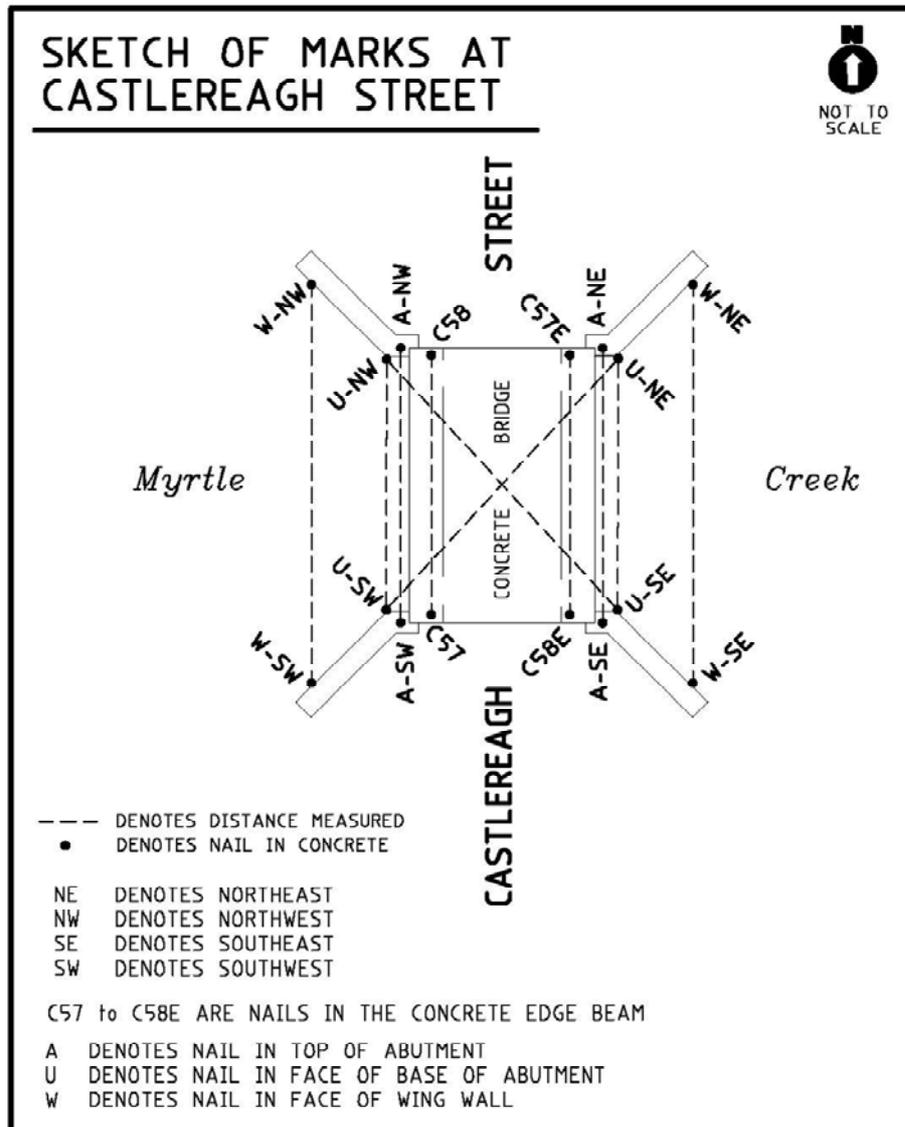
**Fig. 4.6 Location of Survey Marks on Castlereagh Street Bridge**

- Structure survey  
Survey marks have been placed on the top and bottom of the abutment walls, and at the bottom of the wing walls. Marks have also been placed on the bridge deck at each end. The survey marks were installed prior to the influence of Longwall 23A. A sketch of the monitoring mark locations is shown in Fig. 4.6.

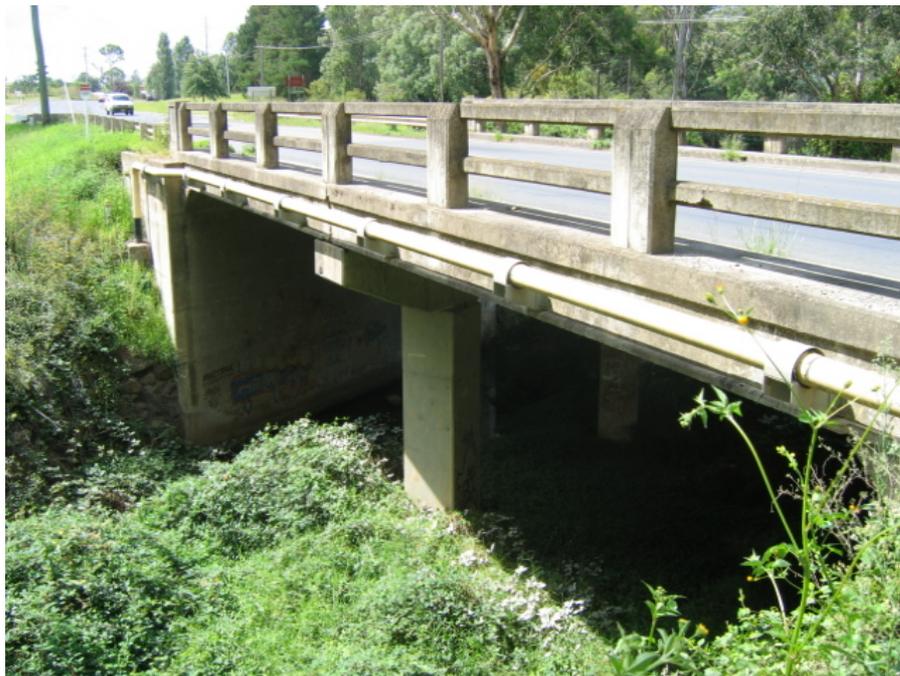
**Fig. 4.7 Remembrance Drive (Myrtle Creek) Road Bridge**

The bridge units have been integrated with a reinforced concrete slab. The reinforced concrete abutments appear to rest on pad and strip footing foundations. The pre-tensioned bridge deck units are connected to the central pier with dowels. The drawings do not include the abutment connections, but it appears that the bridge units rest on a corbel at each end. It is likely that a concrete upstand has been constructed at the ends of the deck.

The bridge was inspected in May 2009 by structural engineer John Matheson & Associates (JMA, 2009). The design of the bridge is not conducive to upsidence and closure movements because it is partly supported by a central pier. Upsidence may cause the central pier to move upwards, relative to the abutments. It is likely that the upstand at the ends of the bridge units will prevent the deck from sliding over the abutments as they close towards each other.

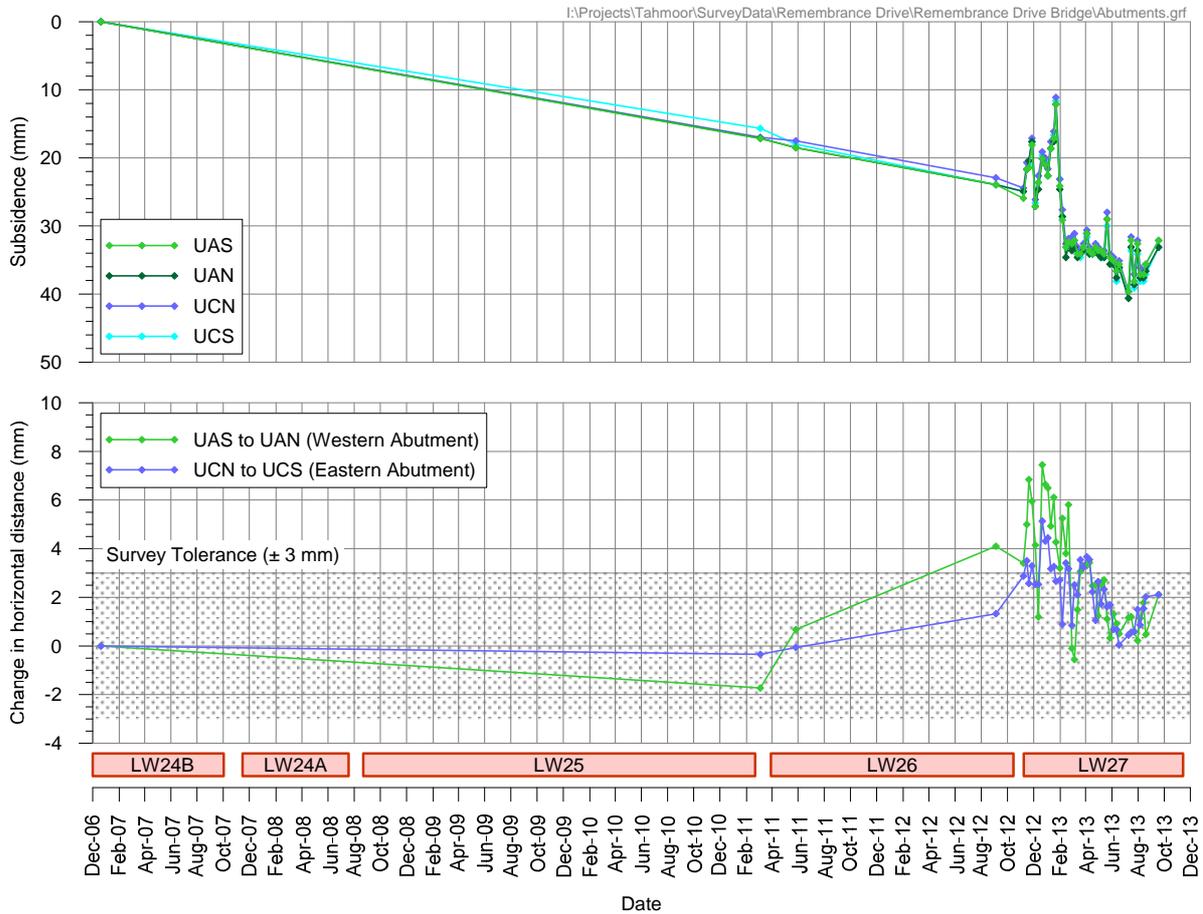
**Fig. 4.8 Observed subsidence and changes in horizontal distances across the abutment of Remembrance Drive (Myrtle Creek) Road Bridge**

By way of comparison, impacts were not observed on the Castlereagh Street Bridge until 23 September 2011 after Longwall 25 had mined directly beneath the Bridge, when the Longwall 26 face was approximately square with it. Approximately 200 mm of valley closure had been observed at this time. In this case, Longwalls 28 to 30 will not mine directly beneath the bridge and are located more than 170 metres away from it. As demonstrated by the predictions, very small changes are predicted during the mining of each longwall and differential movements are expected to develop gradually during these times.

Given the offset distance of the Bridge from Longwalls 28 to 30 and the anticipated very small amount of movement that is expected to occur, the likelihood of the bridge being damaged and requiring repairs during the mining of Longwalls 28 to 30 is assessed as **RARE**. The consequence of this risk is assessed as **MODERATE**. The risk is therefore assessed as **RARE / MODERATE → LOW**.

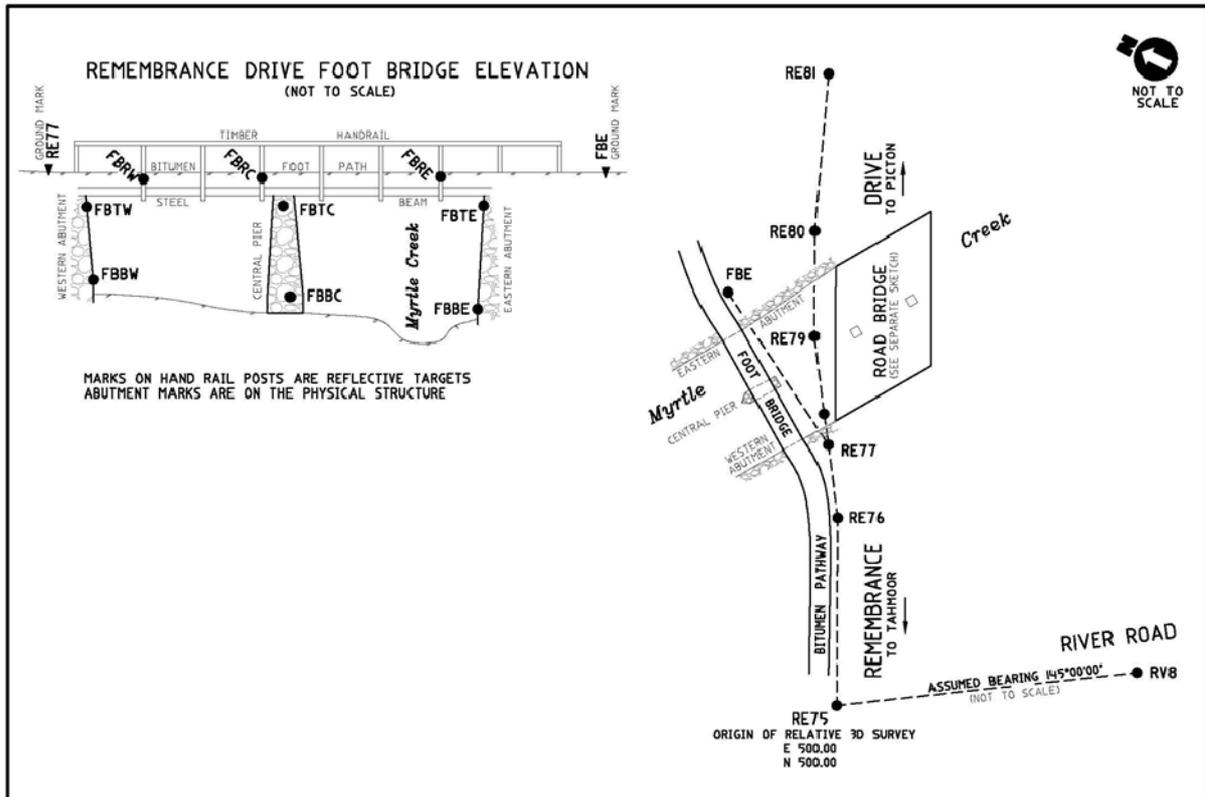
Fig. 4.11 Survey marks on Remembrance Drive (Myrtle Creek) Pedestrian Bridge

A map of survey points is shown in Fig. 4.11.

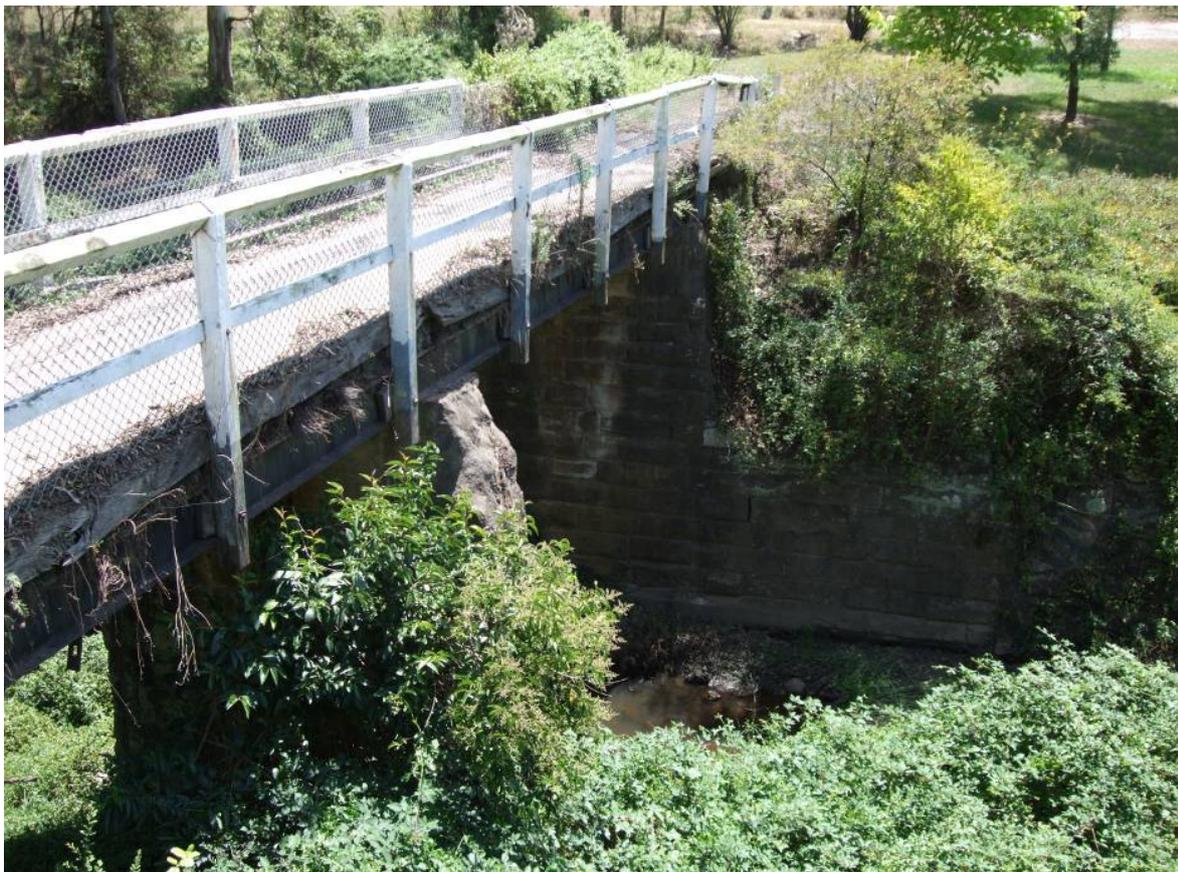
Figure 1

The abutments and central pier have been constructed using sandstone masonry construction with a sand/cement mortar as can be seen in figures 1 and 5. The masonry abutments walls have been constructed with wingwalls returning back into the embankment and the existing drawings indicate that the foundations have been constructed below the riverbed and are likely to have been founded upon rock. The masonry abutment walls and central pier appeared to be in fair condition at the time of the inspection.
