**Tahmoor Colliery - Longwalls 28 to 30**

Management Plan for Potential Impacts to Wollondilly Shire Council Infrastructure

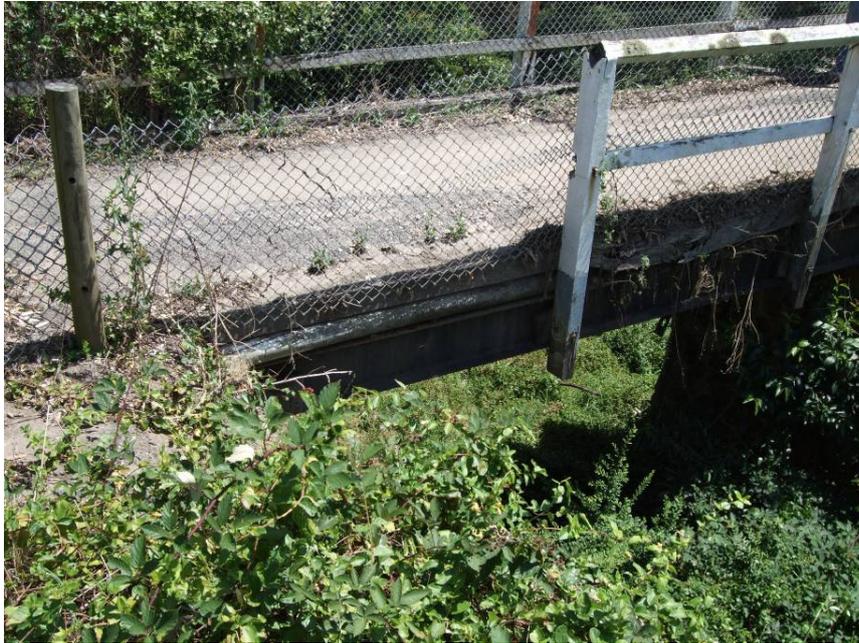
Figure 2

The pedestrian bridge is no longer in use and barrier s have been erected across the both ends of the bridge to prevent pedestrian access as the bridge deck is in poor condition and the timber balustrade posts are severely dilapidated due to rot and/or termite damage and the dilapidated state is clearly visible in figures 2, 3, 6 & 7 in particular. The steel buckle plates show evidence of general corrosion; however, it was not possible to carry out an inspection of the tie rods that were embedded within the tar macadam. The edges of the tar macadam pavement have eroded and fretted due to exposure to wind and rain as can be seen in figures 2, 3 & 6.

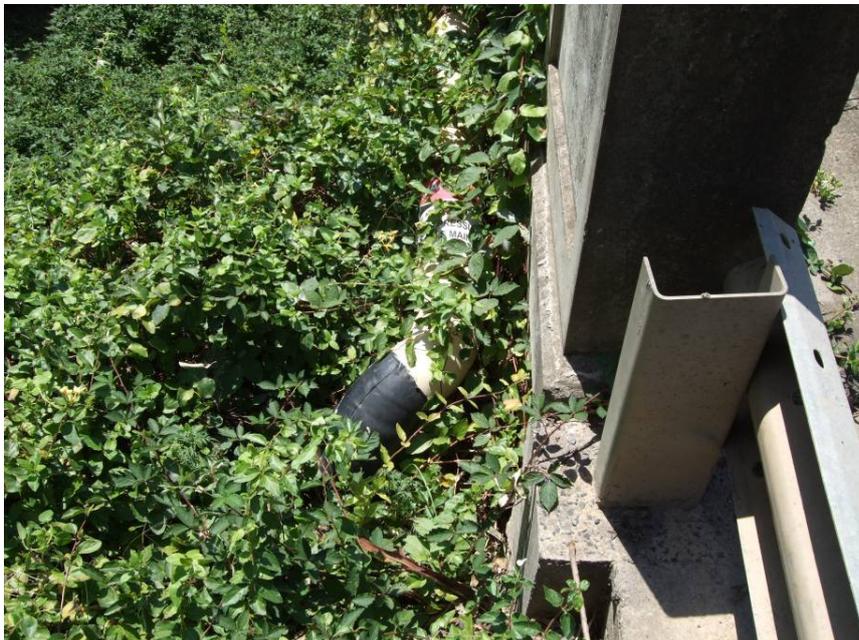
Figure 10 Gas pipeline emerging from the ground next to the southwest corner of bridge

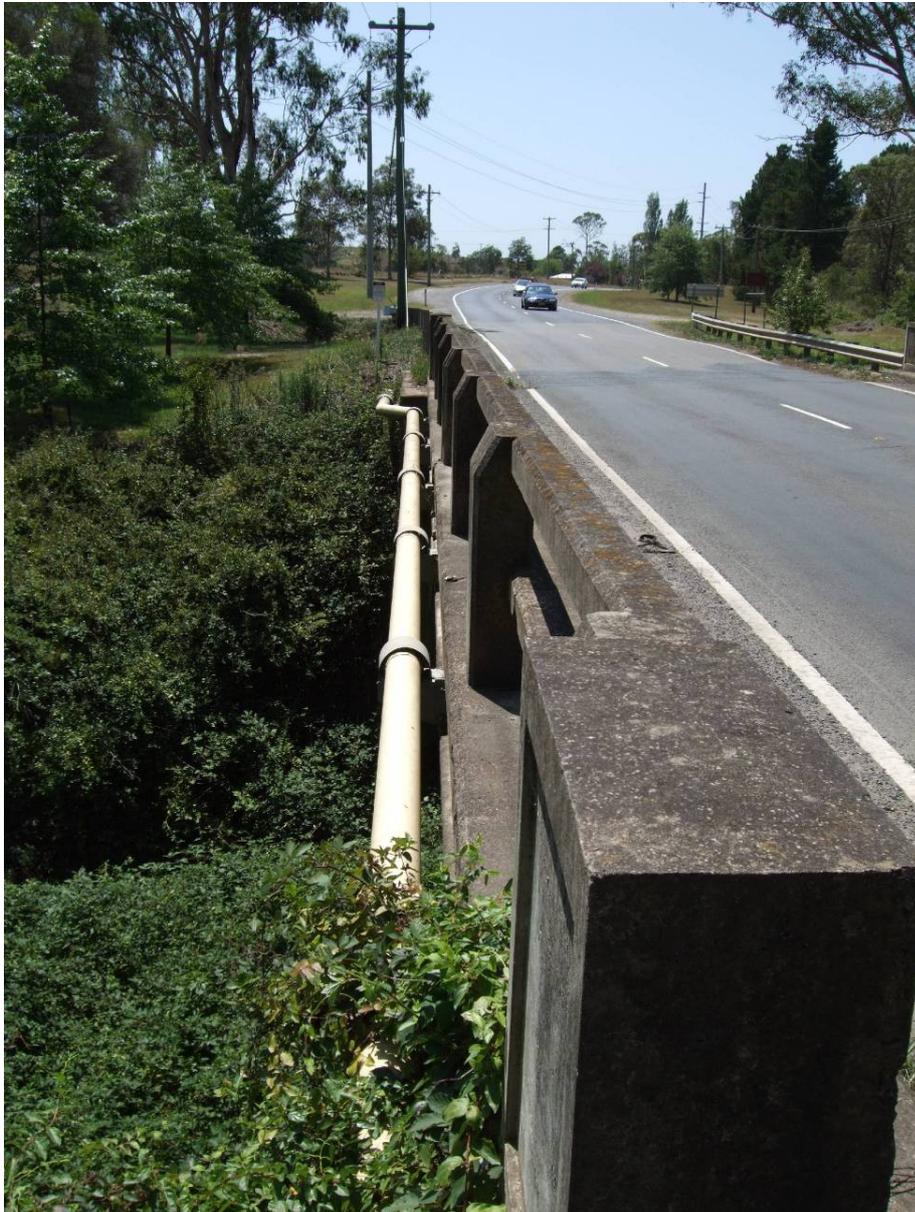
Figure 11 Gas pipe support along bridge.

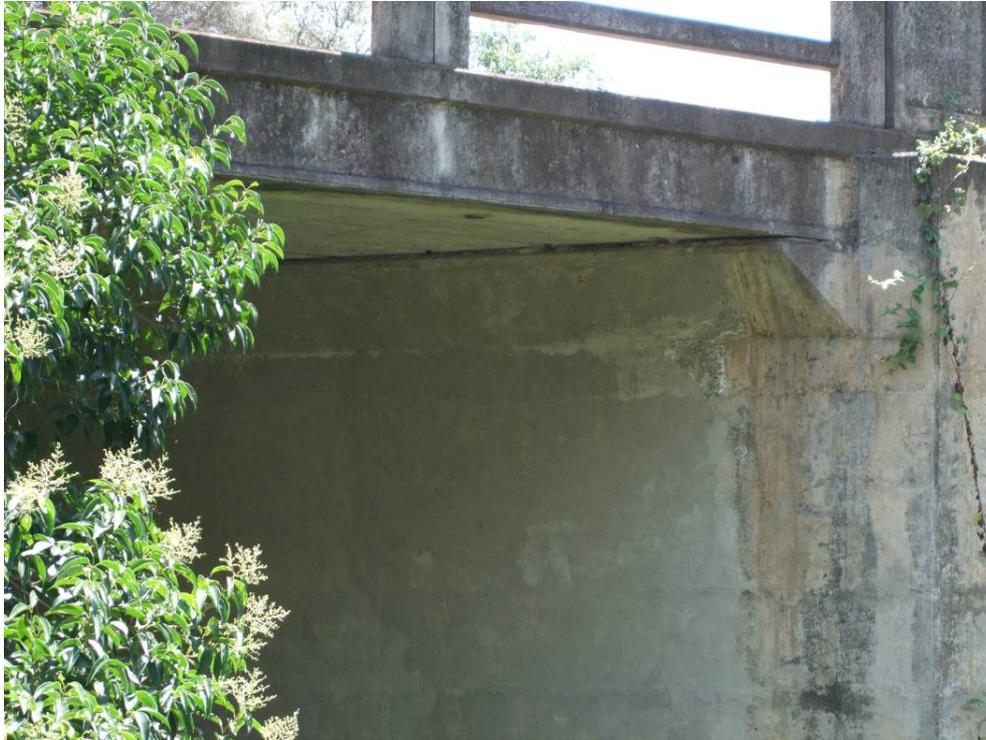
Figure 14

The bridge deck appears to be supported partly upon a reinforced concrete corbel that has been constructed monolithically with the abutment wall and partly upon the abutment wall itself as the barrier post in each corner of the bridge appears to have been constructed upon the bridge deck, refer figure 14. The road surface has cracked behind the abutment wall behind the barrier posts (figure 12), which supports the supposition that the bridge deck continues onto the wall proper. The structural drawings do not show whether or not the deck has been dowelled to both abutment walls. However, experience at the Castlereagh Street Bridge suggests that this is likely.
