# **Tahmoor Colliery Longwalls 25 to 26**

## **WOLLONDILLY SHIRE COUNCIL ROADS, BRIDGES AND CULVERTS**

## **SURFACE SAFETY AND SERVICEABILITY MANAGEMENT PLAN**

**REVISION C**

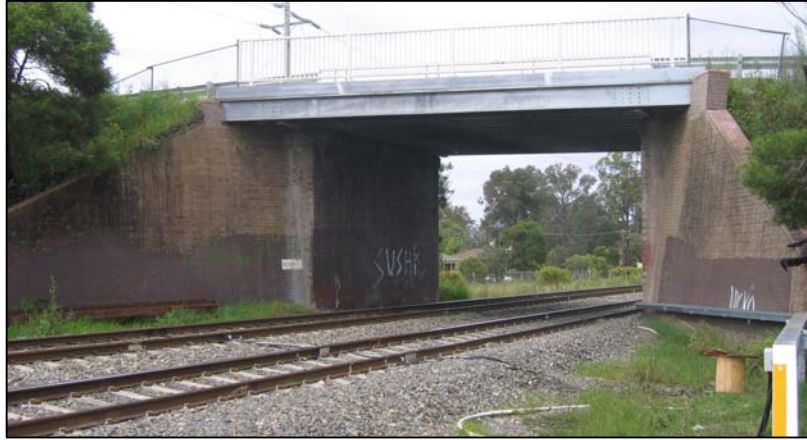
**Fig. 3.3 Thirlmere Way Railway Overbridge**

The Thirlmere Way Railway Overbridge provides the only direct access between the Tahmoor retail and commercial areas and the Tahmoor urban area located west of the Main Southern Railway. This bridge is not owned by Council. The Bridge was strengthened by Tahmoor Colliery prior to the mining of Longwall 24B. A photograph of the bridge is shown in Fig. 3.3.

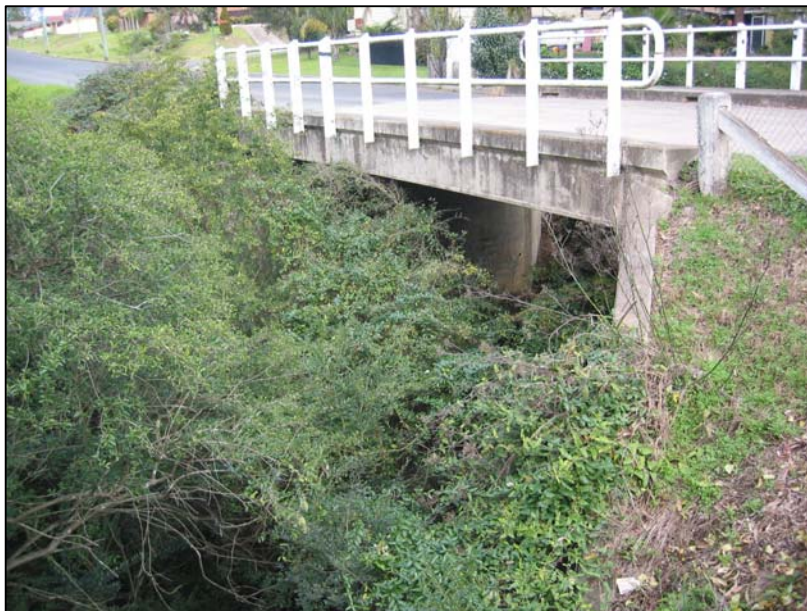
**Fig. 3.4 Castlereagh Street Road Bridge over Myrtle Creek**

The Castlereagh Street Road Bridge over Myrtle Creek is a two-lane bridge that provides access for residents to Hilton Park Road. The single-span bridge is constructed with a concrete deck on concrete abutments, as shown in Fig. 3.4. This bridge is located above Longwall 25.

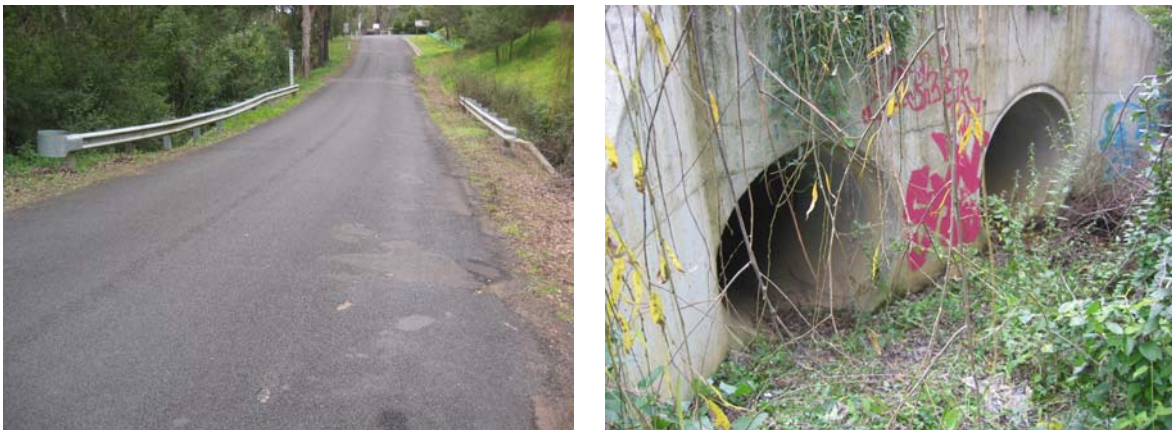
**Fig. 3.11 Photographs of Elphin Street Road Culvert at Myrtle Creek**

It is interesting to observe that no upsidence was noticeable along Elphin Street where it crosses Myrtle Creek. The survey pegs are located on top of a reinforced concrete culvert, which may have masked any upsidence that might have developed. Photographs of the road culvert are shown below.

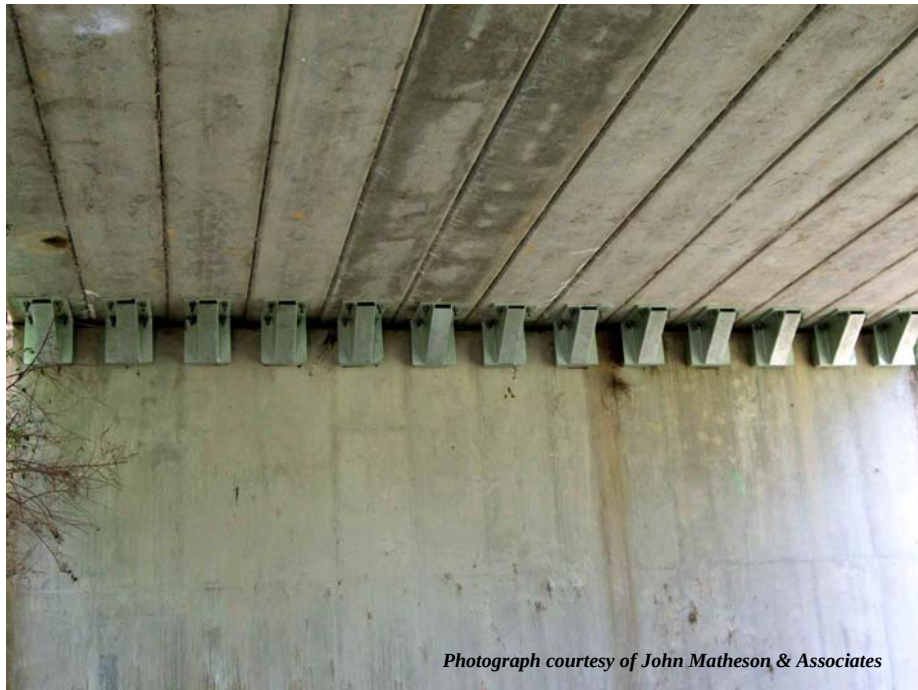
**Fig. 3.13 Photograph of Installed Brackets at Castlereagh Street Bridge**

number brackets), which bear against the abutment walls (JMA, 2007). The brackets provide additional support to the abutment walls, ensuring that the dowels shear without breaking the concrete that surround them. The design of the brackets is shown in Fig. 3.12 and a photograph of the completed installation is shown in Fig. 3.13. The galvanised brackets were installed by Tahmoor Colliery prior to the commencement of Longwall 25.

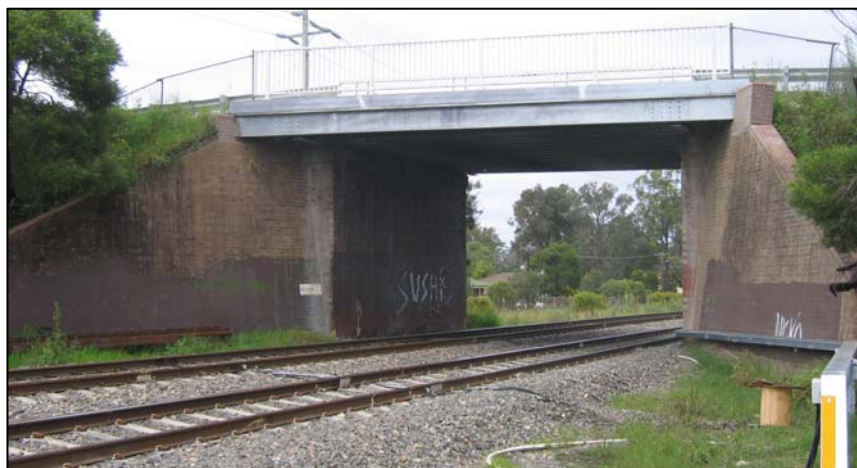
**Fig. 1.1 Thirlmere Way Railway Overbridge**

Tahmoor Colliery proposes to extract coal from the Bulli Seam directly beneath the Main Southern Railway using longwall mining techniques. No impacts were observed at the Thirlmere Way Overbridge during the mining of Longwalls 22 to 24. The Thirlmere Way Overbridge is located directly near the commencing end of Longwall 24B and is expected to experience additional mine subsidence movements during the mining of Longwalls 25 to 26.

The original two-lane bridge was constructed with masonry abutments and a single-span concrete deck. The bridge was designed and constructed in 1919.

Thirlmere Way Railway Overbridge provides direct access between the Tahmoor retail and commercial areas and the Tahmoor urban area located west of the Main Southern Railway. A plan showing the location of the Overbridge is shown in Fig. 1.2 and a photograph is shown in Fig. 1.1.

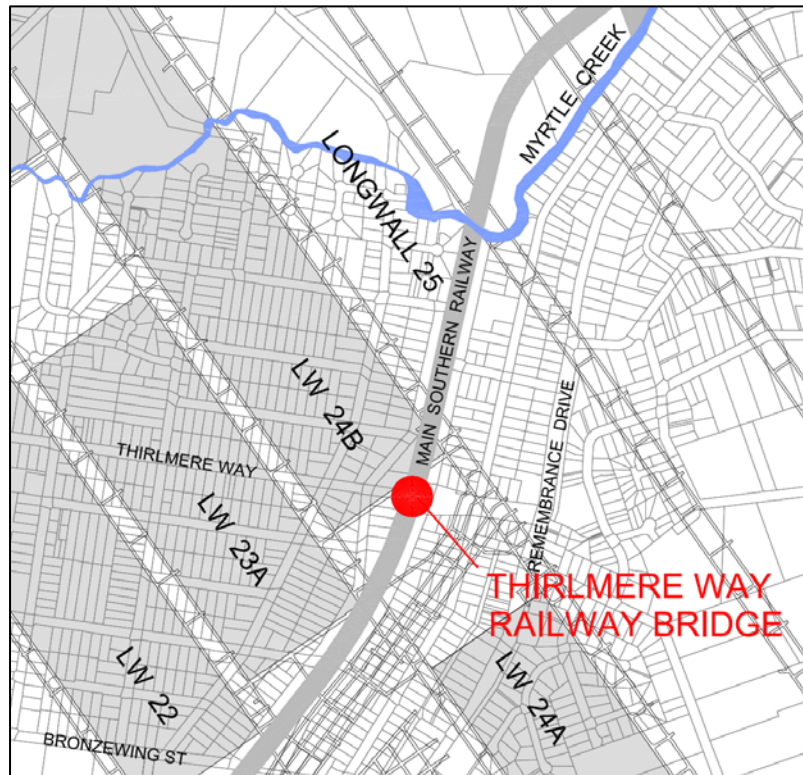
**Fig. 1.2 Location of Thirlmere Way Overbridge**

The Thirlmere Way Overbridge is located at Railway chainage 94.300 km. It is located approximately 140 metres from the closest edge of Longwall 25.

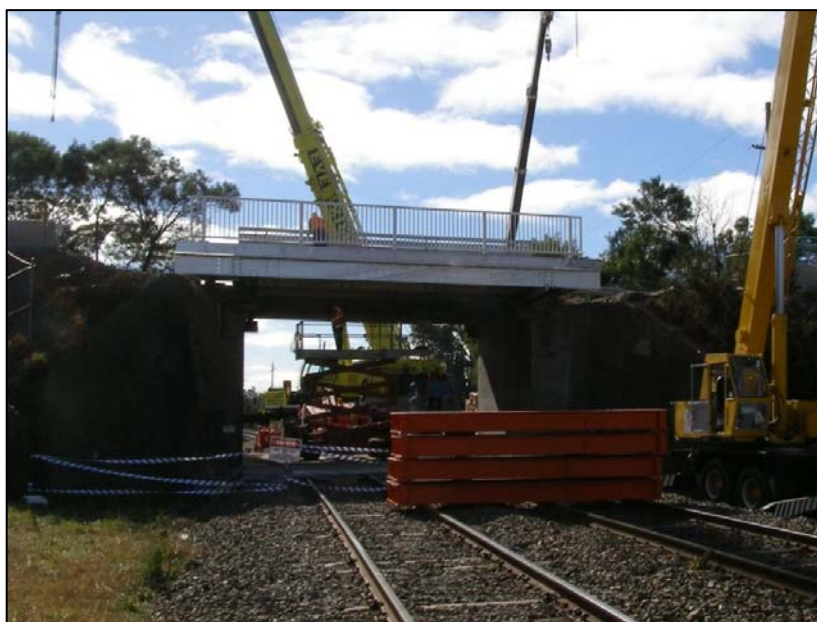
**Fig. 3.4 Thirlmere Way Railway Overbridge**

The bridge strengthening works commenced in May 2006 and are now complete. The existing bridge deck was replaced in June 2006.
