Tahmoor Coal Pty Ltd

2021 ANNUAL REVIEW, AEMR AND REHABILITATION REPORT

March 2022

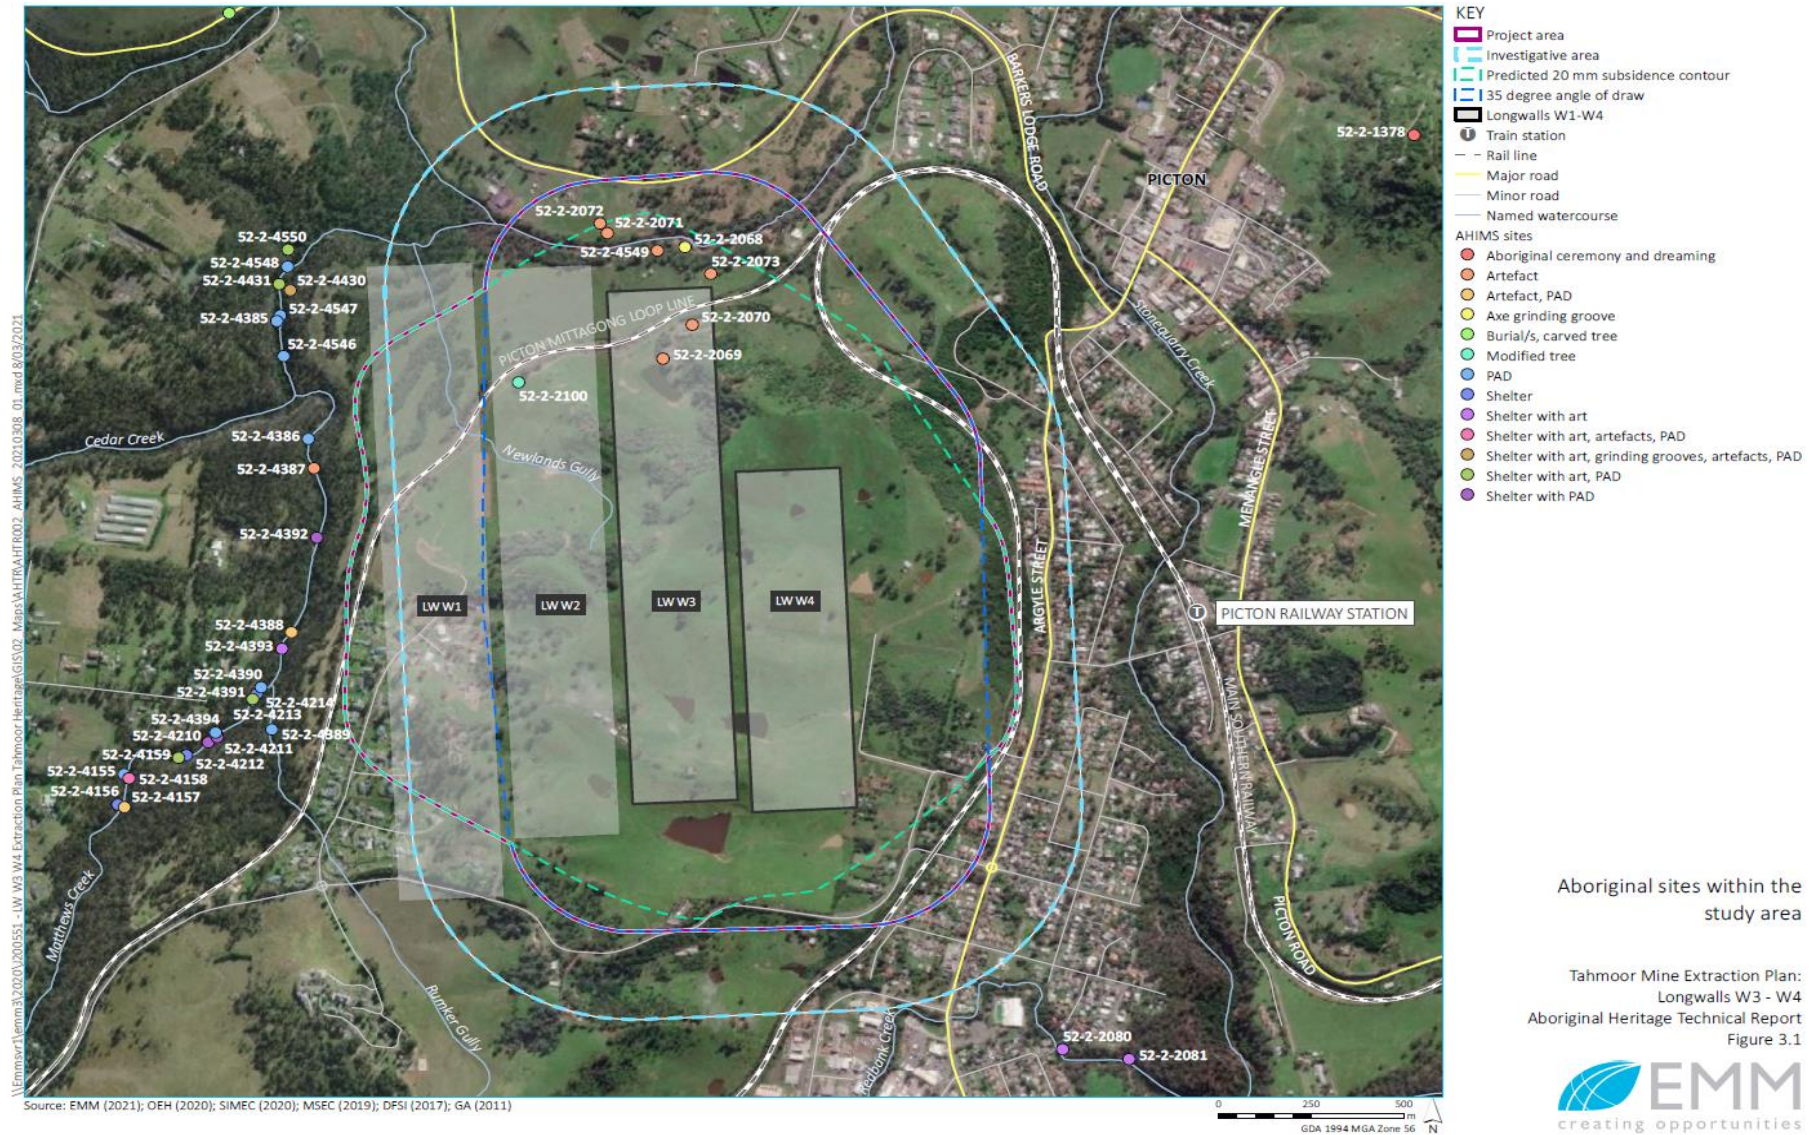
Figure 8 Aboriginal Sites within Study Area for LW W3-W4

Aboriginal sites within the study area

During the reporting period for the Six Monthly Subsidence Impact Reports (13th October 2020 – 20th October 2021), there were no reportable incidents related to Aboriginal Cultural items during the reporting period. However, two (2) level 3 TARP triggers occurred to sandstone culverts in the Picton-Mittagong Loop line during regular monitoring at 88.400km and at 88.980km (refer to **Figure 8**).

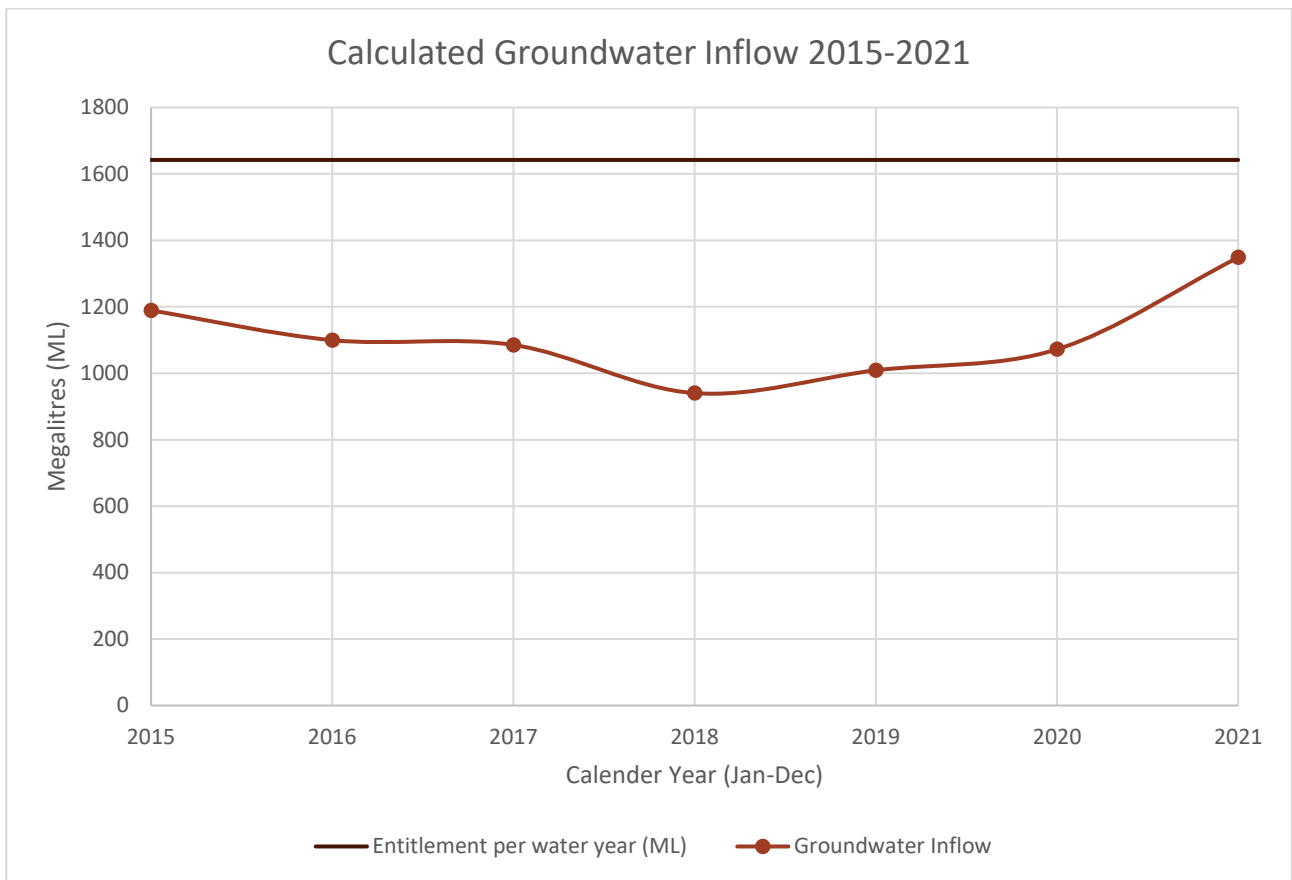
Figure 18 Calculated Groundwater Inflow Annual Volume (Calendar Year).

Please note the following: 'Total Water to Underground' (Water sent from Tahmoor Coal's Recycle Water Treatment Plant and Sydney Water to underground workings), 'Calculated Groundwater inflow' ('Calculated inflow' equals 'Total from' less 'Total to' the mine workings) and 'Total water loss from Underground' (includes vented moisture and water entrained in ROM material extracted).

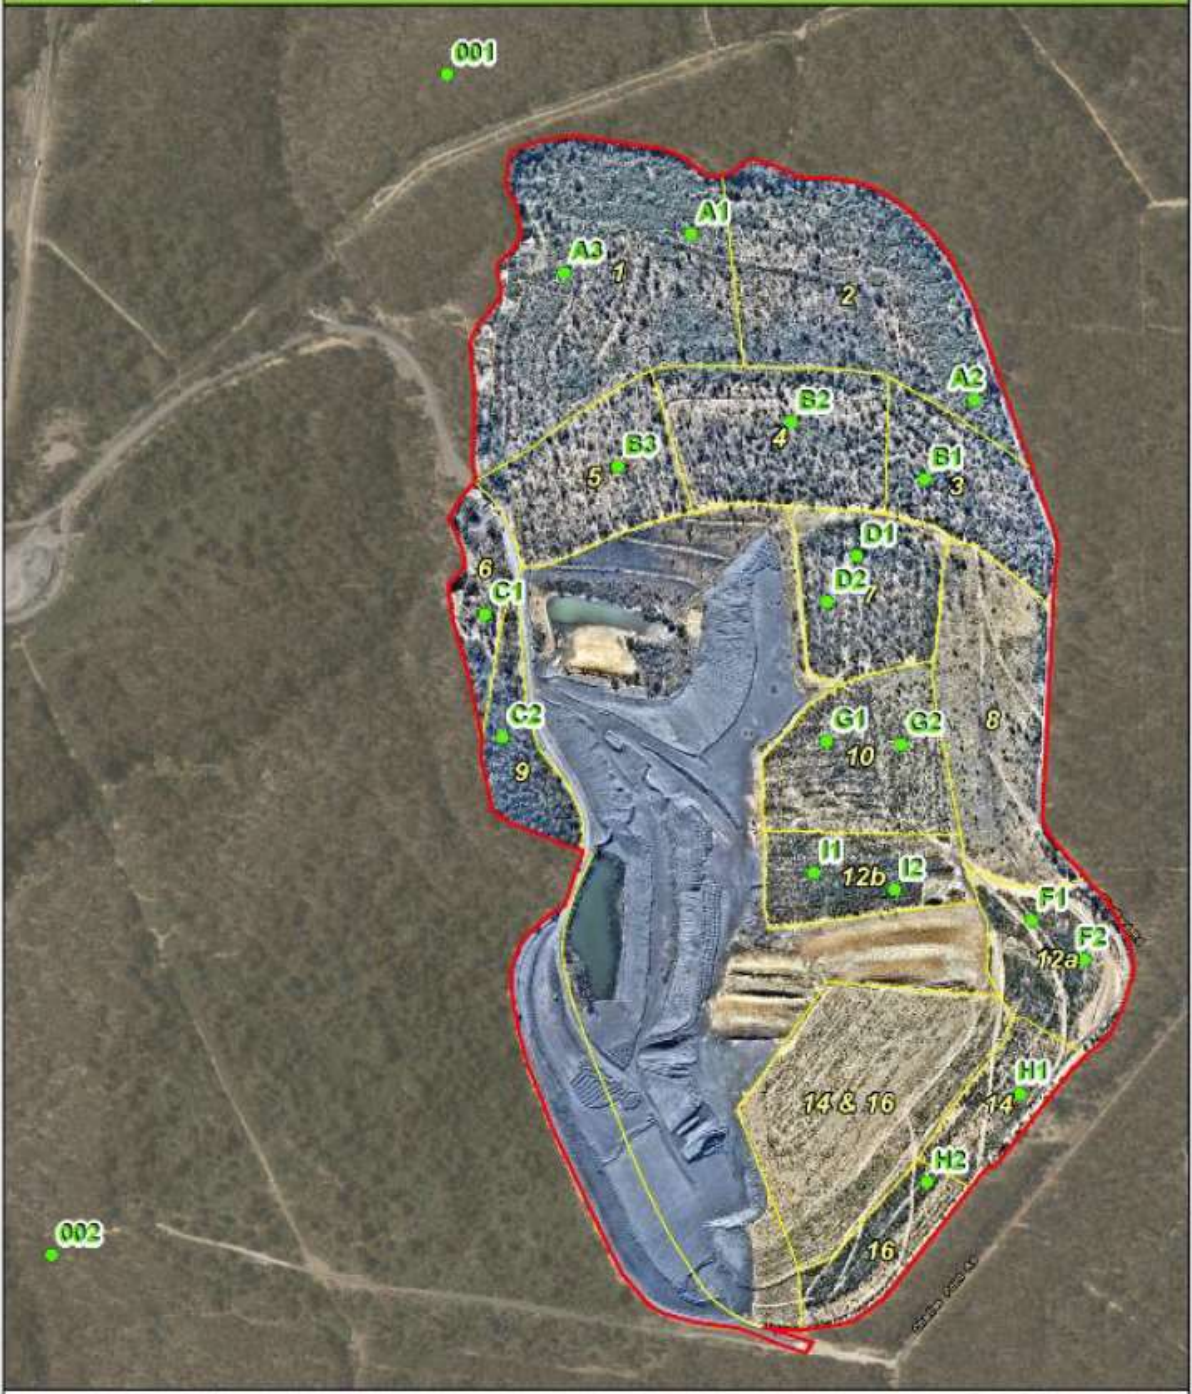
- Refuse Emplacement Area
- Stage Boundaries
- Permanent Monitoring Plots
