SIMEC Mining:  
**Tahmoor South  
Longwalls S3A to S7A**

Management Plan for potential impacts to Picton Weir

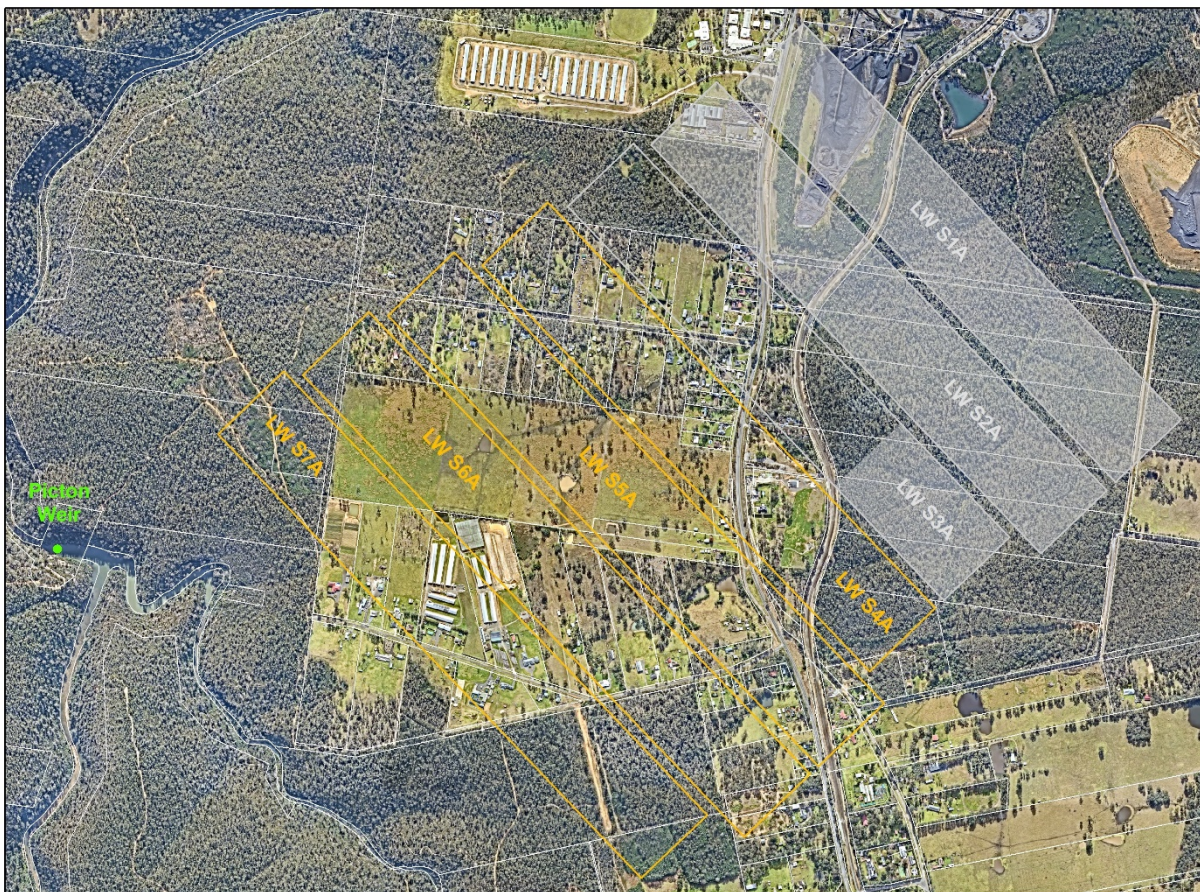
**Fig. 1.1 Location of Picton Weir relative to LWs S1A to S7A**

It can be seen from Fig. 1.1 that the extraction of LWs S1A to S7A will not mine directly beneath the Picton Weir. The mine will progressively extract closer to the Picton Weir with each successive longwall.

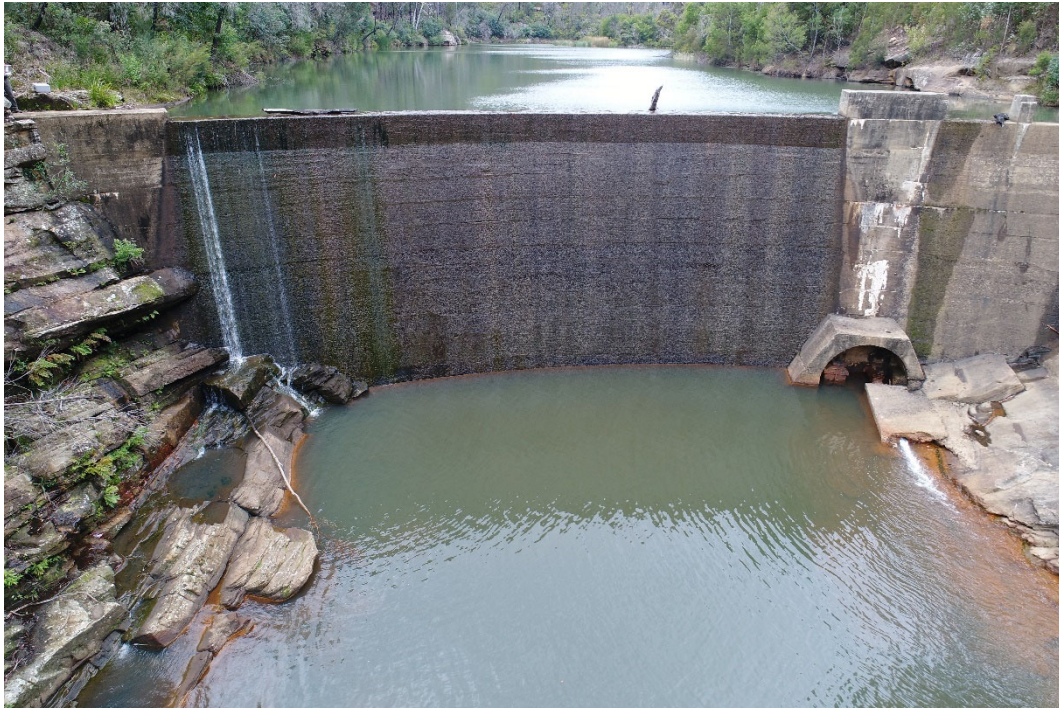
**Fig. 1.2**      **Close up view of Picton Weir**

Photographs of the Weir, taken in September 2023, are shown in Fig. 1.2.

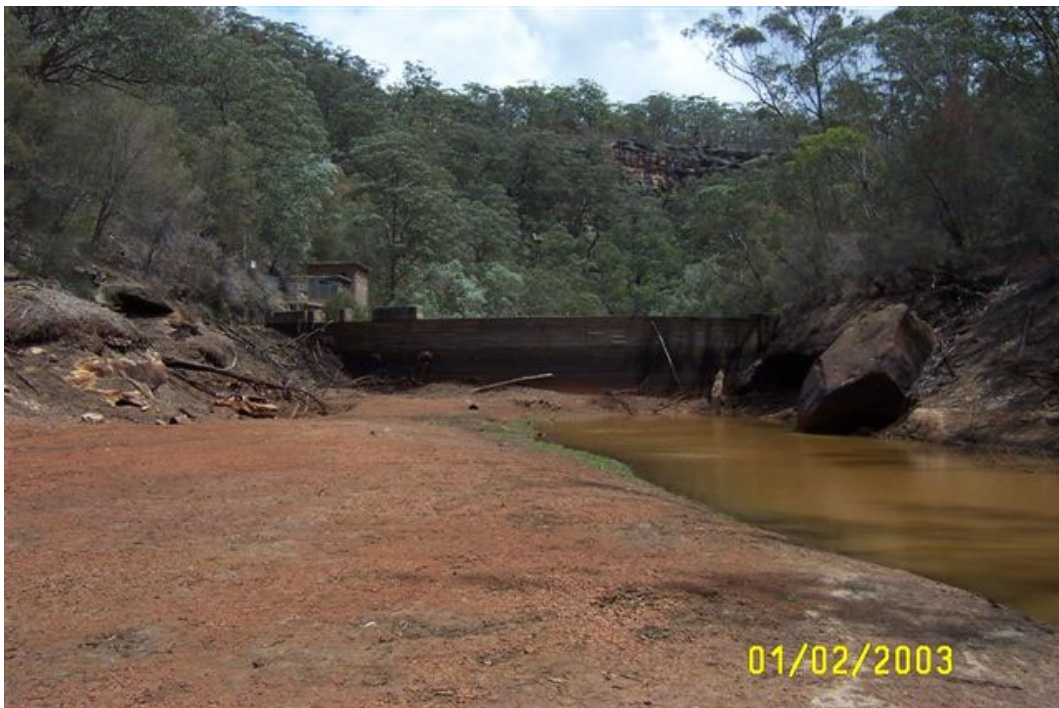
**Fig. 1.6 Silt levels behind Picton Weir in February 2003**

Silt has built up behind the dam wall. A photograph during a period of drought in 2003 is shown in Fig. 1.6. Photographs of the Picton Weir posted on the internet showed similar silt levels in January 2020 during a period of drought.

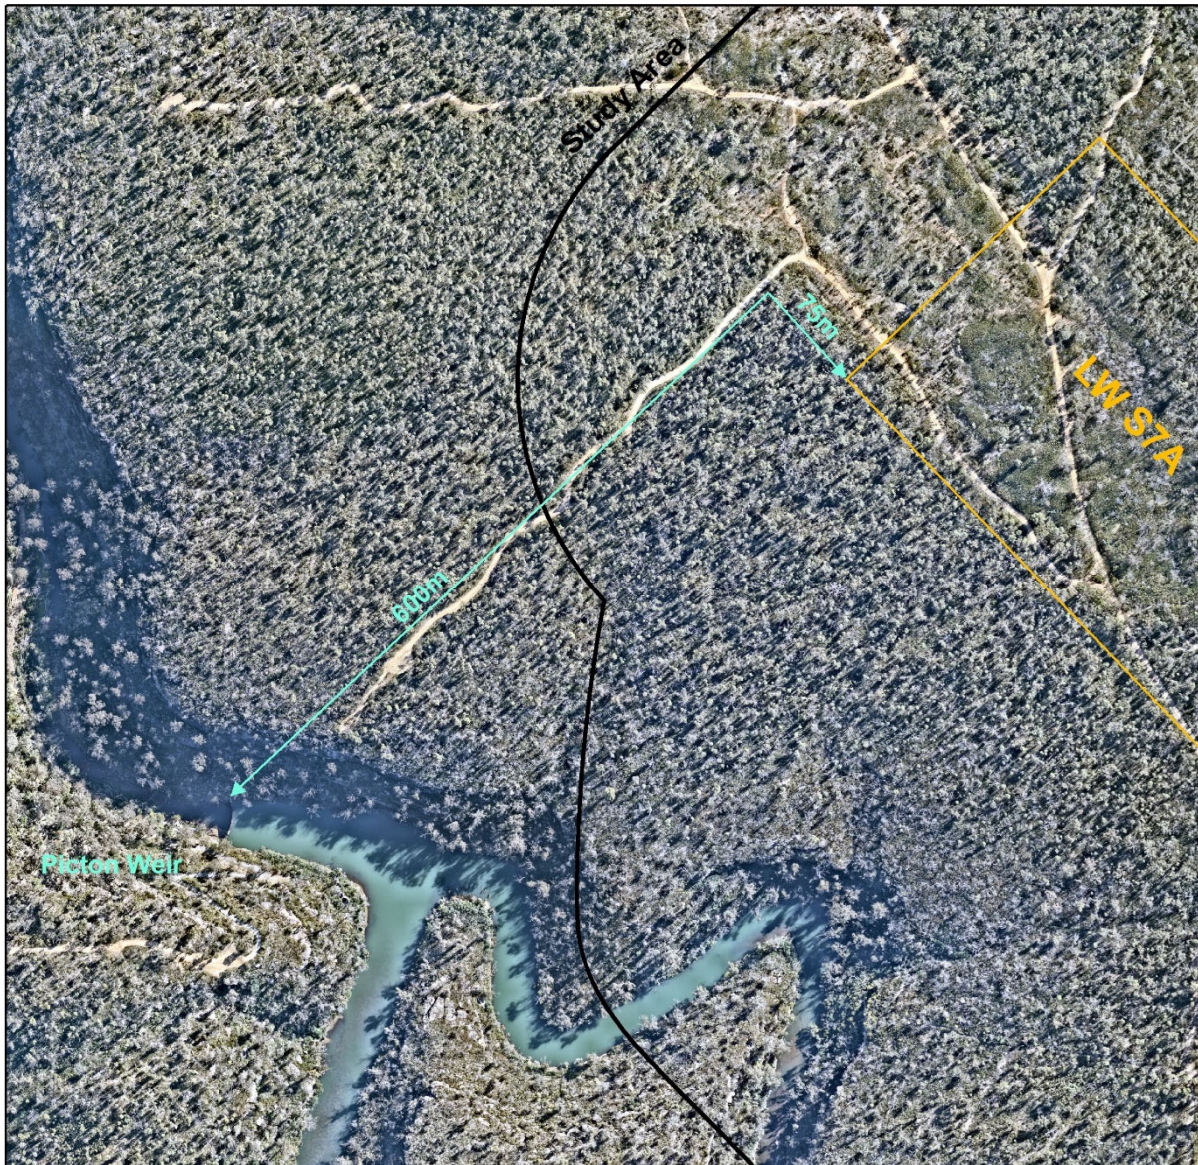
**Fig. 1.7**      **Location of Picton Weir relative to LW S7A**

The Picton Weir is located approximately 605 metres from LW S7A at its closest point. As shown in Fig. 1.7, LW S7A is proposed to approach the Weir from the southeast but stops approximately 75 metres before it is directly square with the Weir. No impacts were reported on the Picton Weir during the mining of previously extracted Longwalls 14 to 19, the closest of which was approximately 1.5 kilometres from the Weir (Longwall 19).

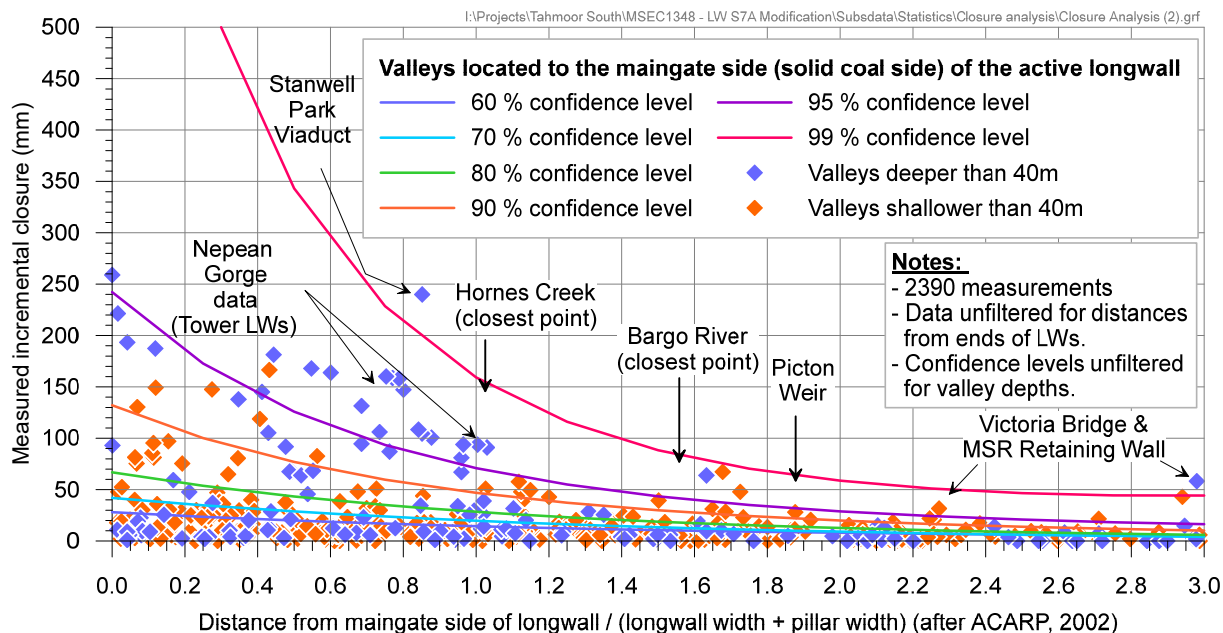
**Fig. 3.4 Observed incremental valley closure against normalised distance from the maingate edge of longwalls / (longwall width + pillar width)**

Similarly, measured incremental valley closure across the Stanwell Park Viaduct during mining at CoalCliff Colliery fits within the confidence level curves when plotted against distance in Fig. 3.2, but becomes an outlier when the distance is normalised due to the narrowness of the extracted panel.

Observed incremental valley closure at sites located above solid, unmined coal, are shown relative to their normalised distances from the maingate edges of previously extracted longwalls in Fig. 3.4.

Closer examination of the statistical analyses found that the calculated confidence levels based on normalised distances were influenced by two outliers, which relate to recently observed closure during the mining of Tahmoor LW W3 and LW W4 across Stonequarry Creek at the Victoria Bridge and a Retaining Wall at 84.687 km on the Main Southern Railway. The observations are discussed in the following section.

While the statistical analyses show that the valley closure prediction at Picton Weir is likely to be conservative, the empirical data presented in Fig. 3.2 and Fig. 3.4 shows that there are two outliers at distances greater than 600 metres from previously extracted longwalls. These relate to recently observed closure during the mining of Tahmoor LW W3 and LW W4 across Stonequarry Creek at the Victoria Bridge (owned by Transport for NSW) and a Retaining Wall at 84.687 km on the Main Southern Railway (operated by the Australian Rail Track Corporation, ARTC).

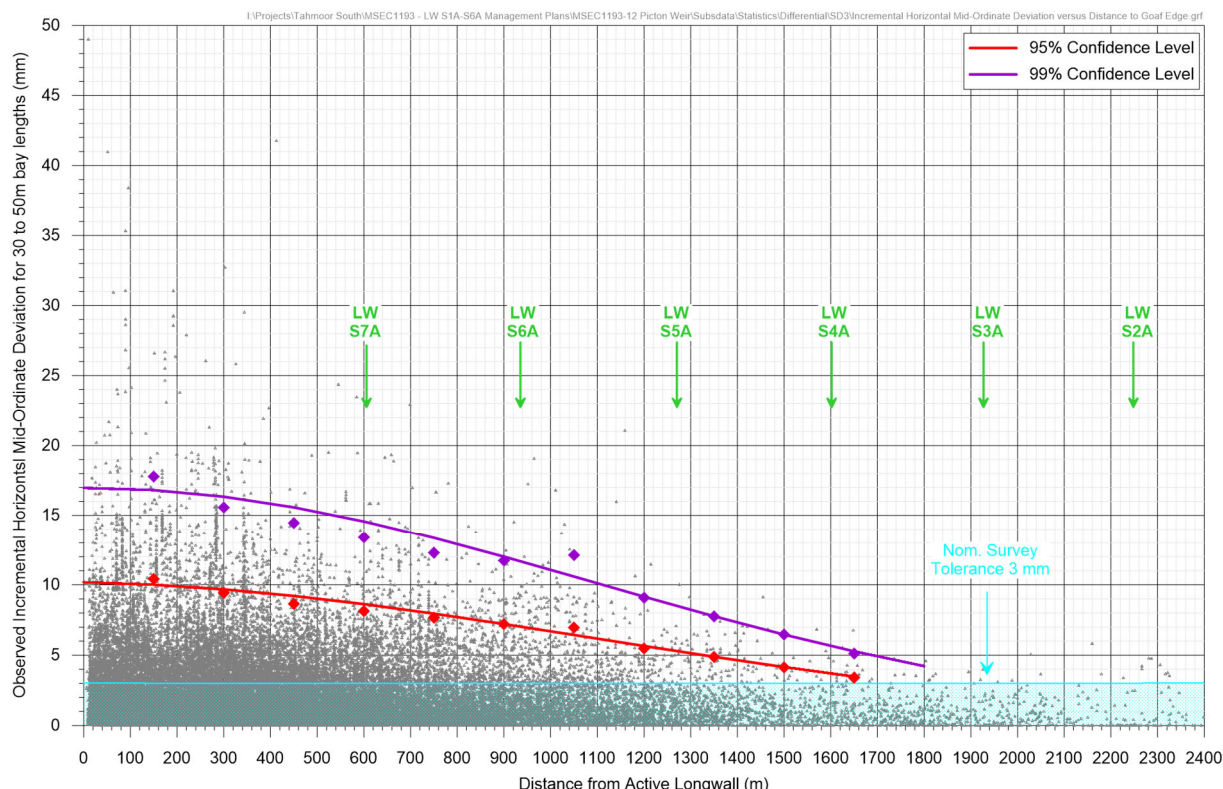
**Fig. 3.14 Observed incremental differential horizontal mid-ordinate deviation versus distance from active longwall for marks spaced between 30 and 50 metres**

It is possible that Picton Weir could experience shear deformations as a result of differential far field movements. In this report, horizontal mid-ordinate deviation has been used as the measure for shear deformation, which is defined as the differential horizontal movement of each survey mark, perpendicular to a line drawn between two adjacent survey marks. The frequency distribution of the maximum total horizontal mid-ordinate deviations measured at survey marks above solid coal, for previously extracted longwalls in the Southern Coalfield, is provided in Fig. 3.14.

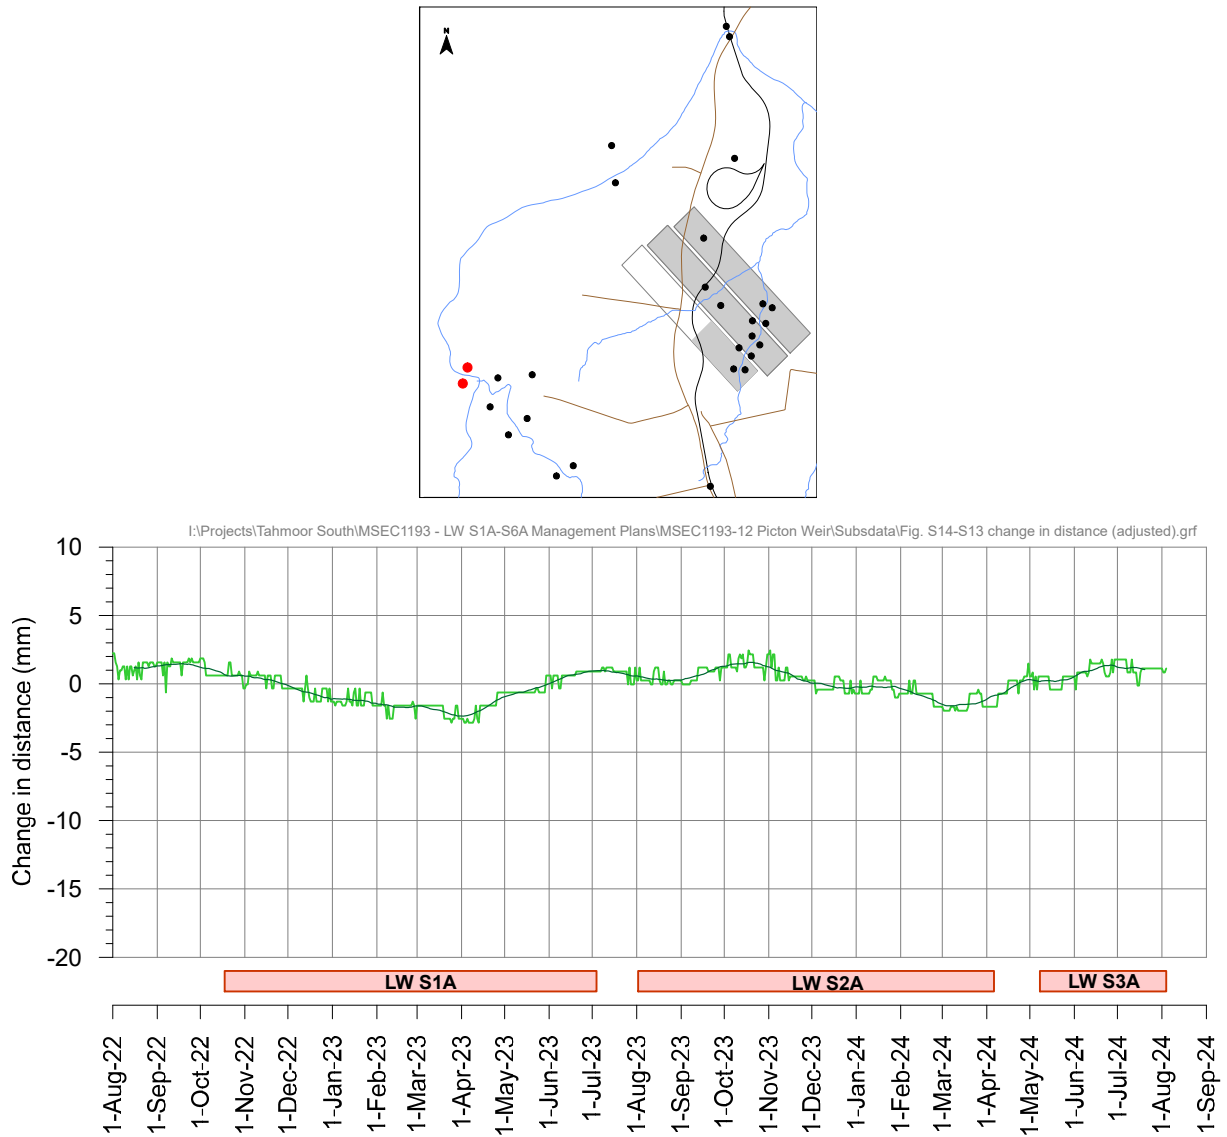
**Fig. 3.17 Observed changes in distance between GNSS S13 and S14 across Picton Weir**

It can be seen from Fig. 3.17 that the seasonal peaks occur in October and April. Given that two years of data have been recorded, the results have been based on the average distance over the last two years. It can be seen that the observed changes oscillate about zero in early December and between May and June each year.
