HERITAGE MANAGEMENT PLAN – TAHMOOR SOUTH DOMAIN – LONGWALLS SOUTH 1A – SOUTH 7A

Tahmoor Coal Pty Ltd

Document Title: Tahmoor South Domain
Longwalls South 1A – South 7A
Heritage Management Plan

Document Number: TAH-HSEC-00364

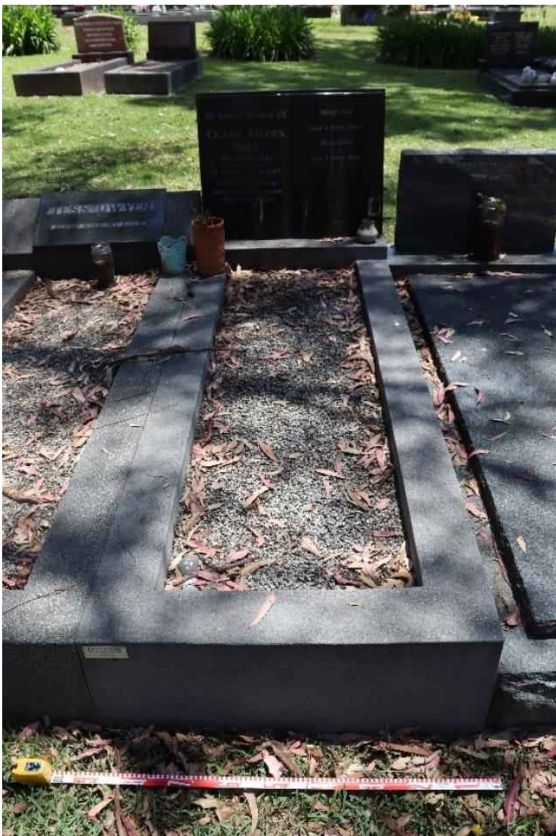
Plate 1 Grave ID R-C48. An open book low monument made of granite, gravel and concrete in good condition.

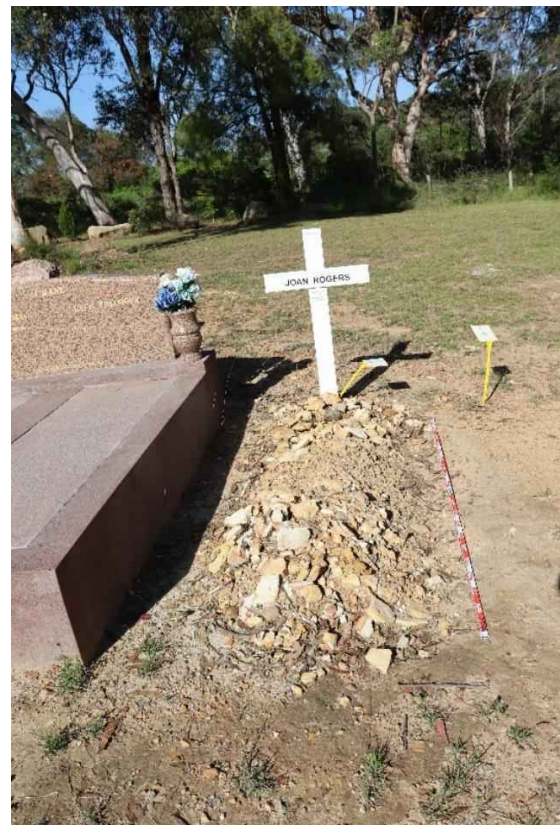
Plate 2 Grave ID A-K7. A mound grave made up of crushed stone marked with a wooden Latin cross.

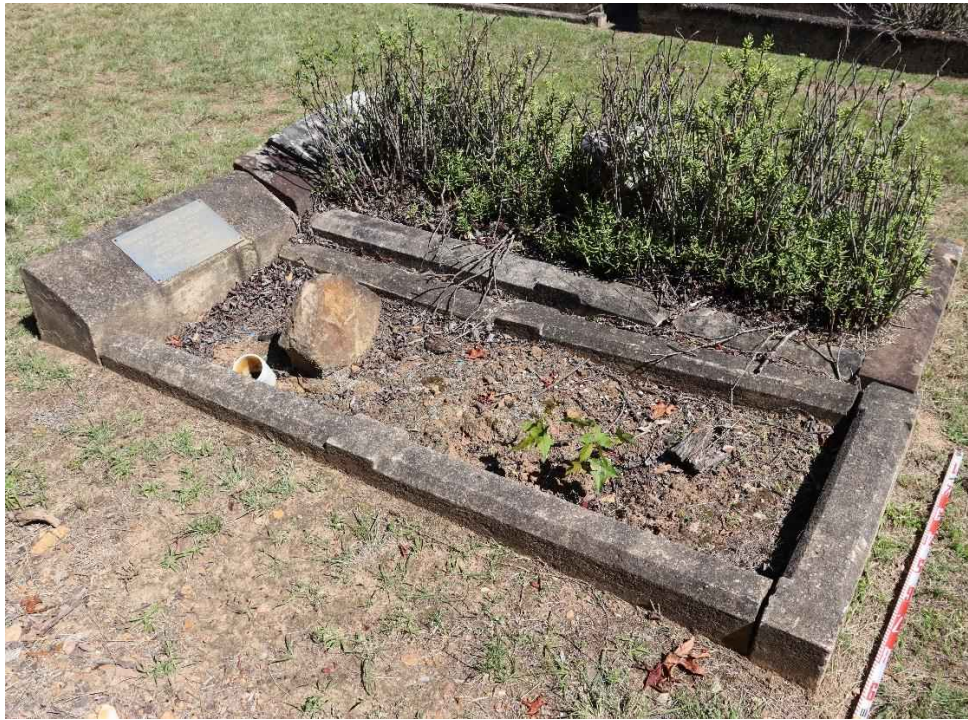
Plate 3 Grave ID A-A6. Low monument, plain kerb grave with a commemorative plaque made of concrete and metal.

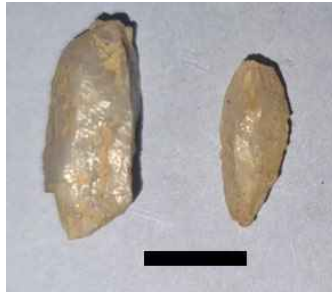
Figure 2. Examples of bipolar cores in the assemblage. Left to right, id=113, id=114. Scale=1cm

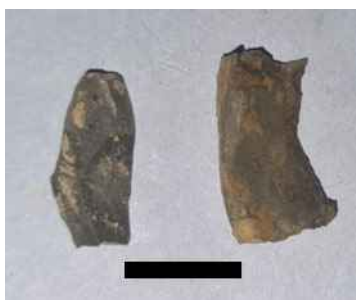
Figure 3. Examples of tools found in the assemblage, left id=93; right id=94. Scale=1cm
