SIMEC Mining:  
**Tahmoor South  
Longwalls S1A to S7A**

Management Plan for potential impacts to Wollondilly Shire Council Infrastructure

Date	Report No.	Rev	Comments
Sep-22	MSEC1193-02	A	Draft for submission to Wollondilly Shire Council
Oct-22	MSEC1193-02	B	Final for submission following review by Bridge Technical Committee
Oct-22	MSEC1193-02	C	Final following review by Wollondilly Shire Council
Aug-25	MSEC1193-02	D	Draft for LW S1A-S7A

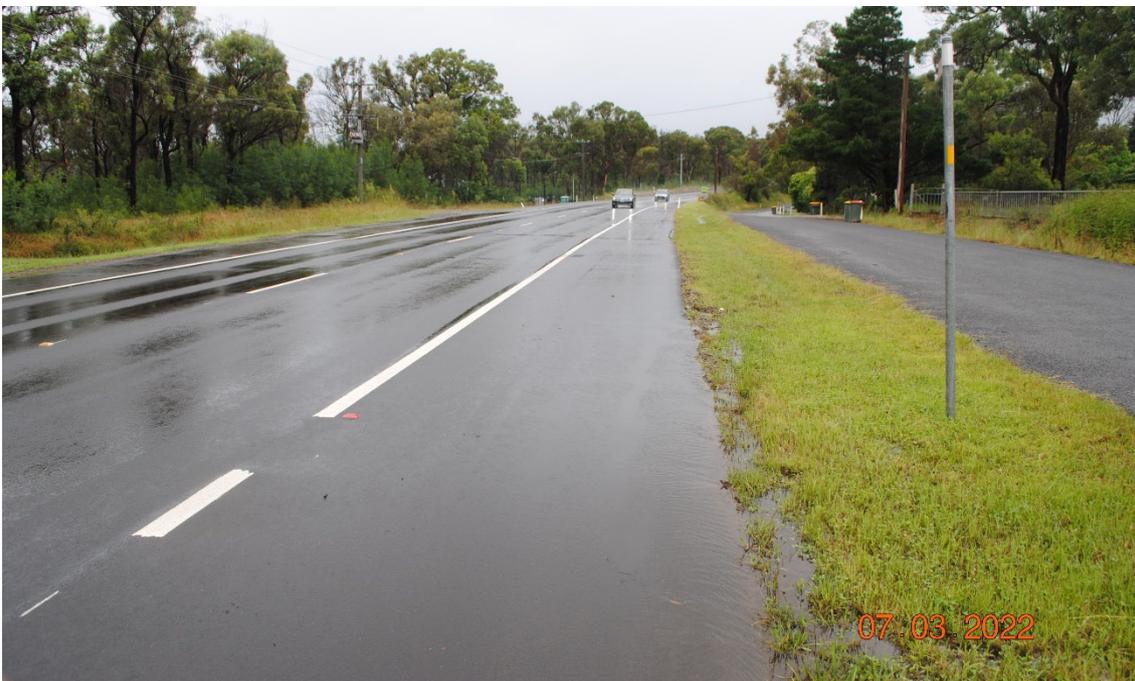
**Fig. 3.18 Remembrance Drive near Caloola Road**

A photograph of Remembrance Drive near the intersection with Caloola Road is provided in Fig. 3.18.

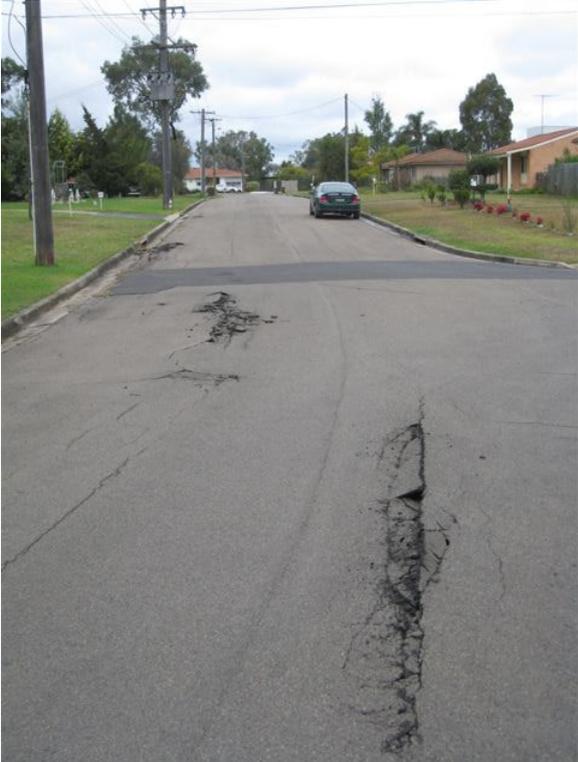
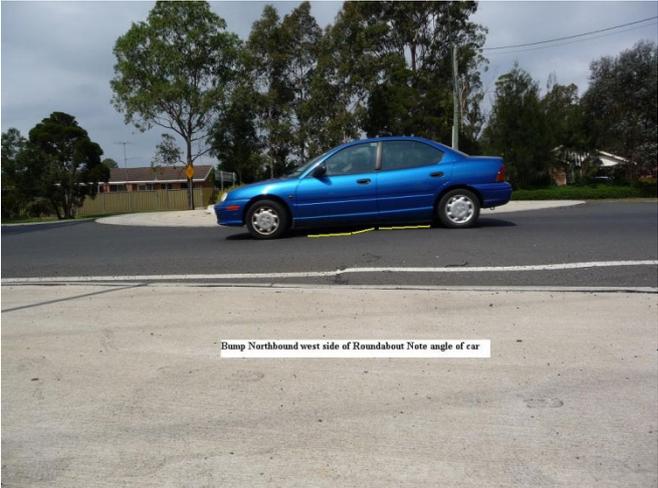
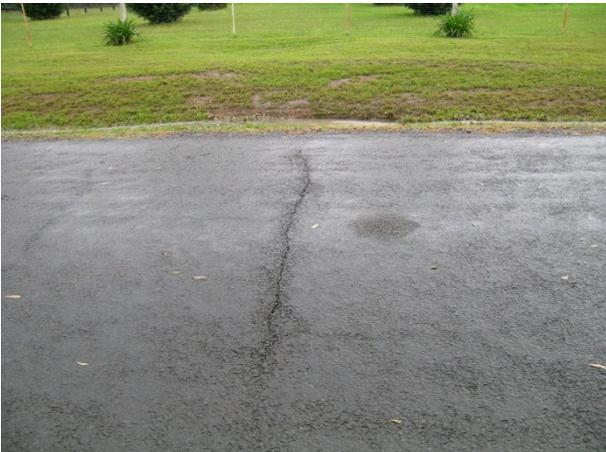
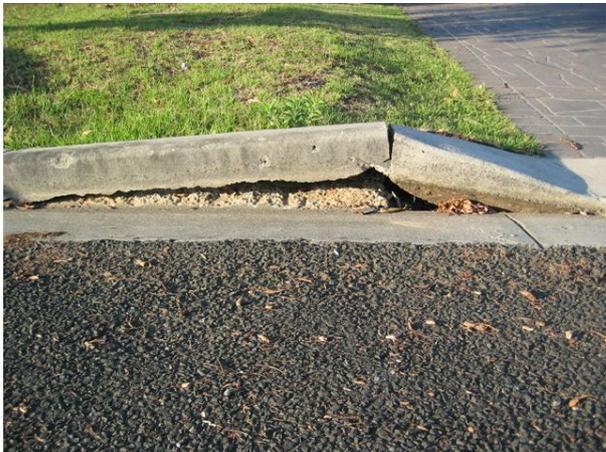
**Fig. 3.24 Impacts on local roads above Tahmoor Mine**

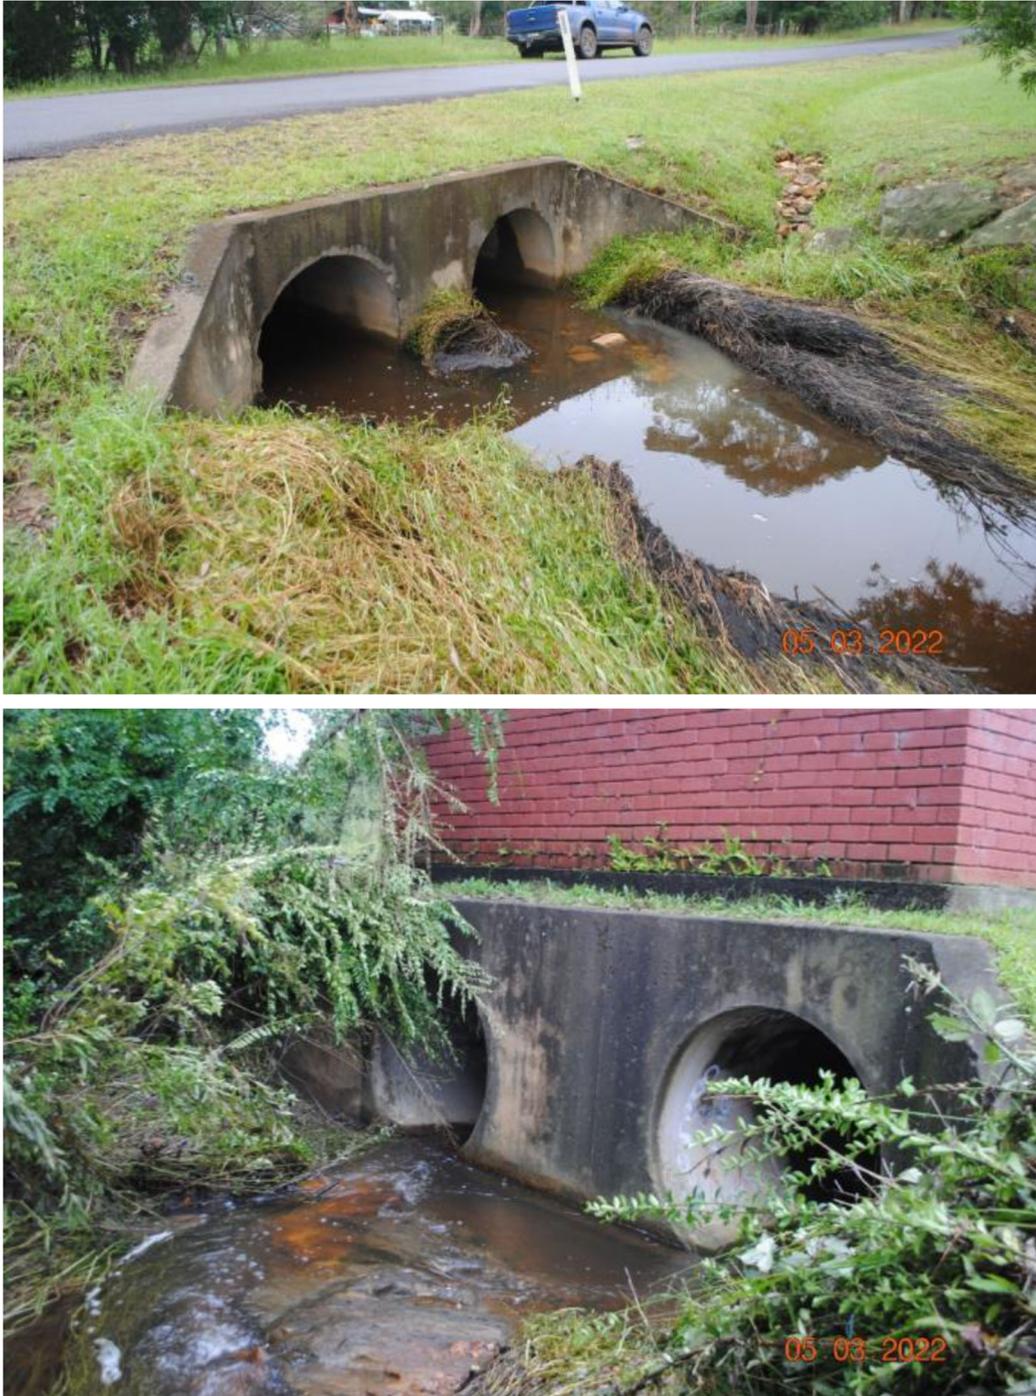
Teatree Hollow crosses between Remembrance Drive at the intersection with Caloola Road. The stream flows under Caloola Road via twin 1.2 metre diameter reinforced concrete culverts, which connect to twin, 1.35 metre diameter reinforced concrete culverts beneath bus stop at the end of Caloola Road. Photographs of both culverts are shown in Fig. 3.25. The culvert carries the pavement over Teatree Hollow and continues beneath Remembrance Drive.

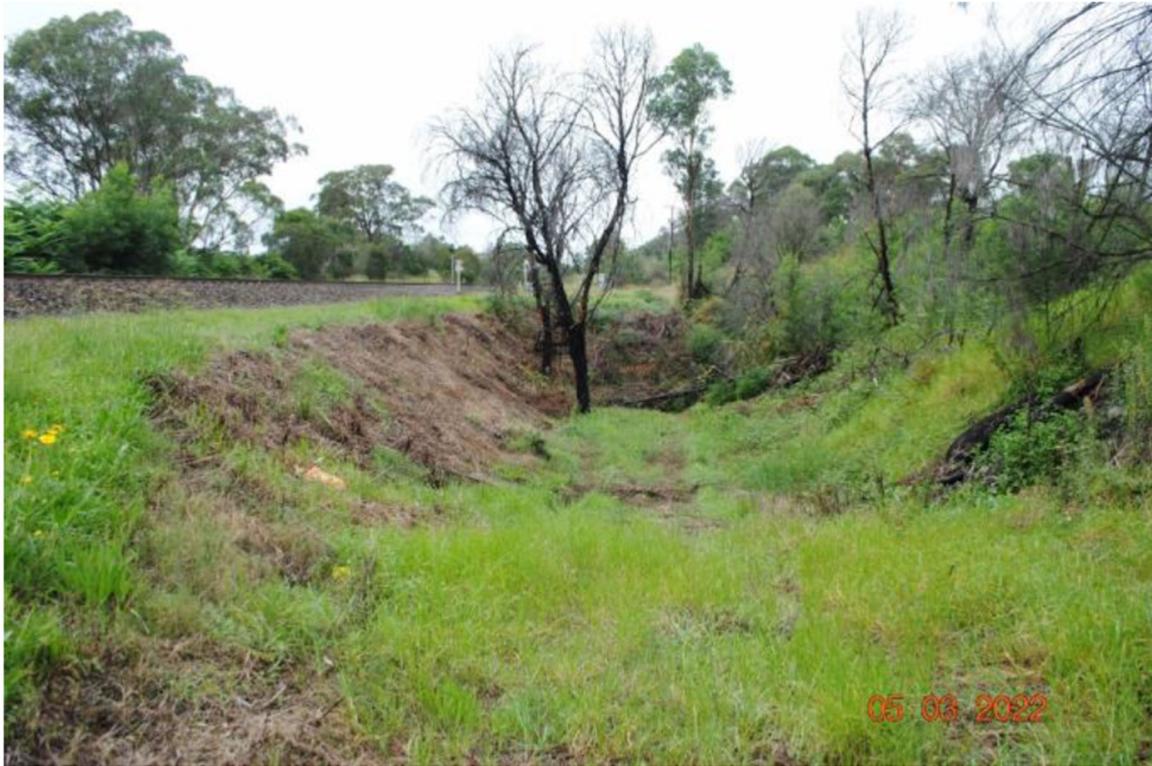
Two culverts are located in close proximity at the intersection between Remembrance Drive, Yarran Road and the Main Southern Railway. The 1800 mm RCP culvert beneath Remembrance Drive drains into a small parcel of privately owned land and a 2000 mm diameter brick arch culvert beneath the Main Southern Railway.

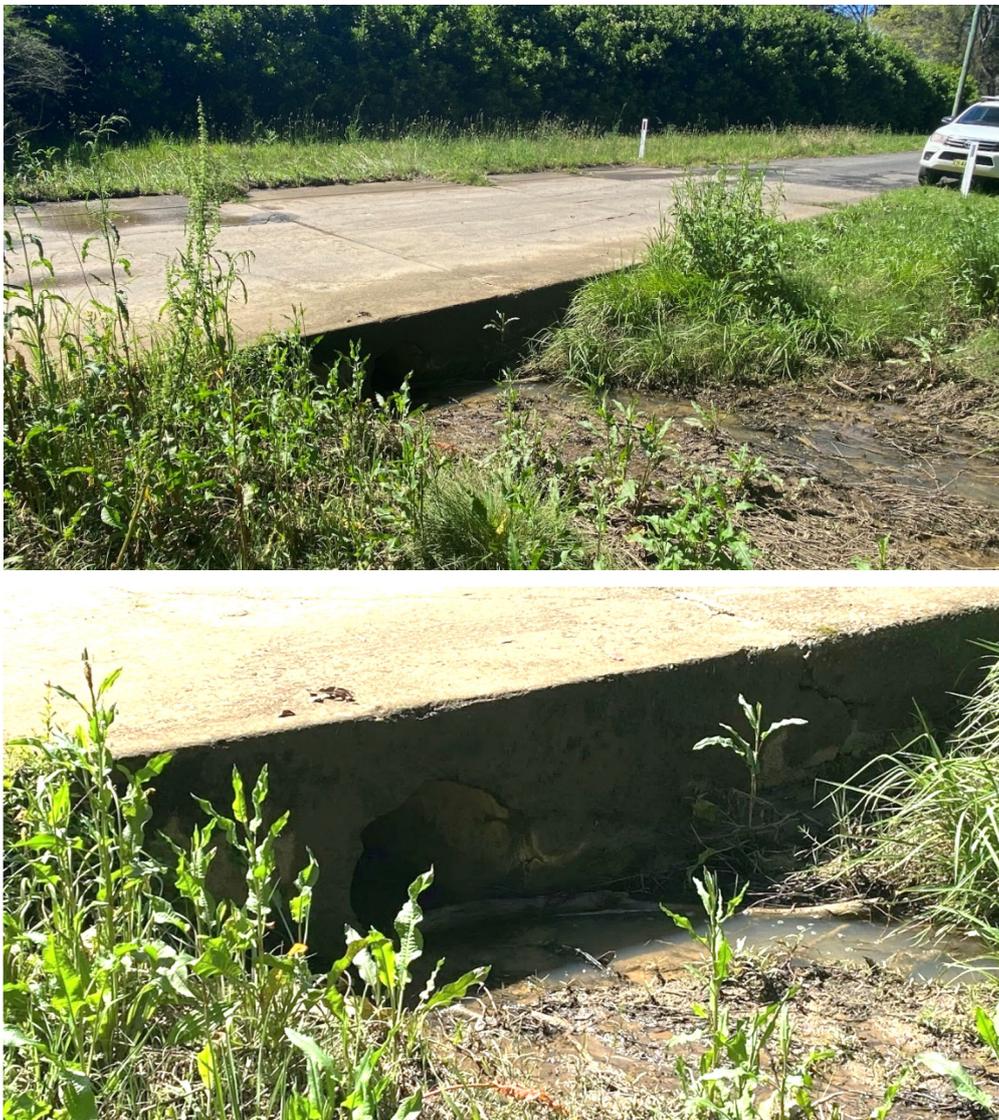
The Causeway consists of a concrete pavement that is approximately 18 metres long, with a 450 mm diameter pipe directly beneath it. A photograph is shown in Fig. 3.27.

**Fig. 3.27 Causeway on Government Road**

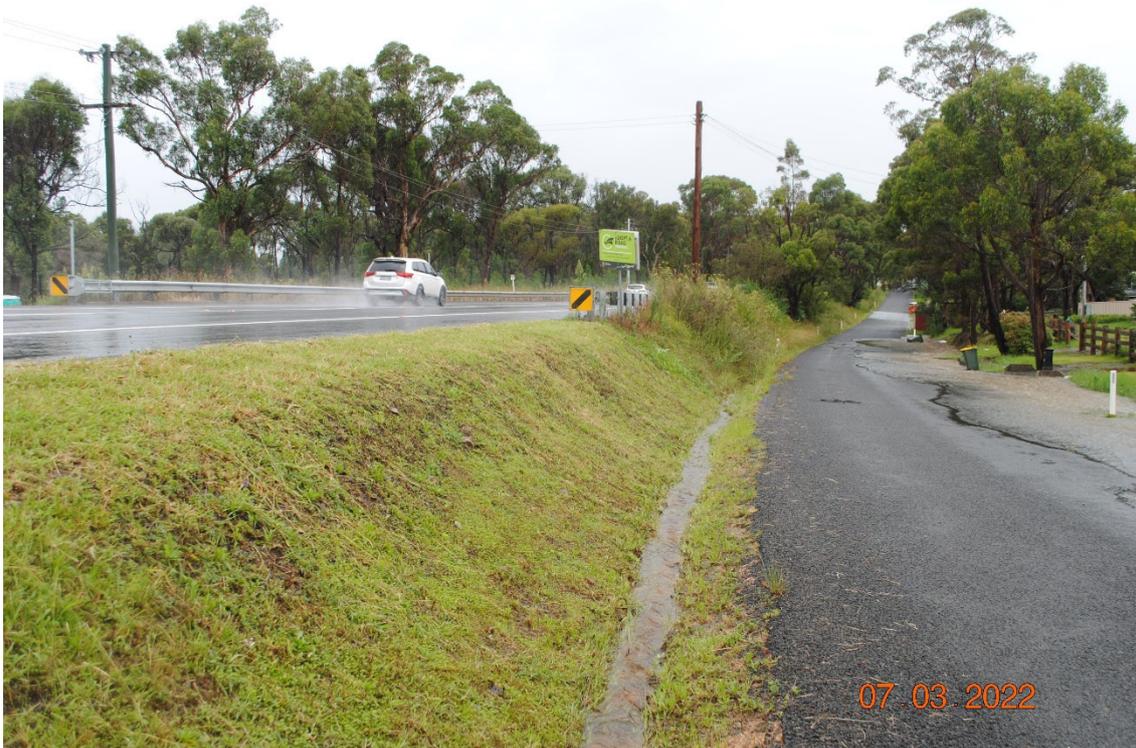
**Fig. 3.28** Remembrance Drive embankment at intersection with Caloola Road on upstream side

Remembrance Drive crosses Teatree Hollow via an engineered fill embankment over twin 1.35 metre diameter reinforced concrete culverts. The embankment is approximately 350 metres long and 4.2 metres high at its highest point. Approach ramps run alongside the embankment on the western, northbound or upstream side of the embankment. A photograph along the road embankment to Remembrance Drive at Teatree Hollow on the upstream side is shown in Fig. 3.28. A side-on view of the embankment from the intersection at Caloola Road is shown in Fig. 3.29. A photograph along the road embankment to Remembrance Drive at Teatree Hollow on the downstream side is shown in Fig. 3.30.

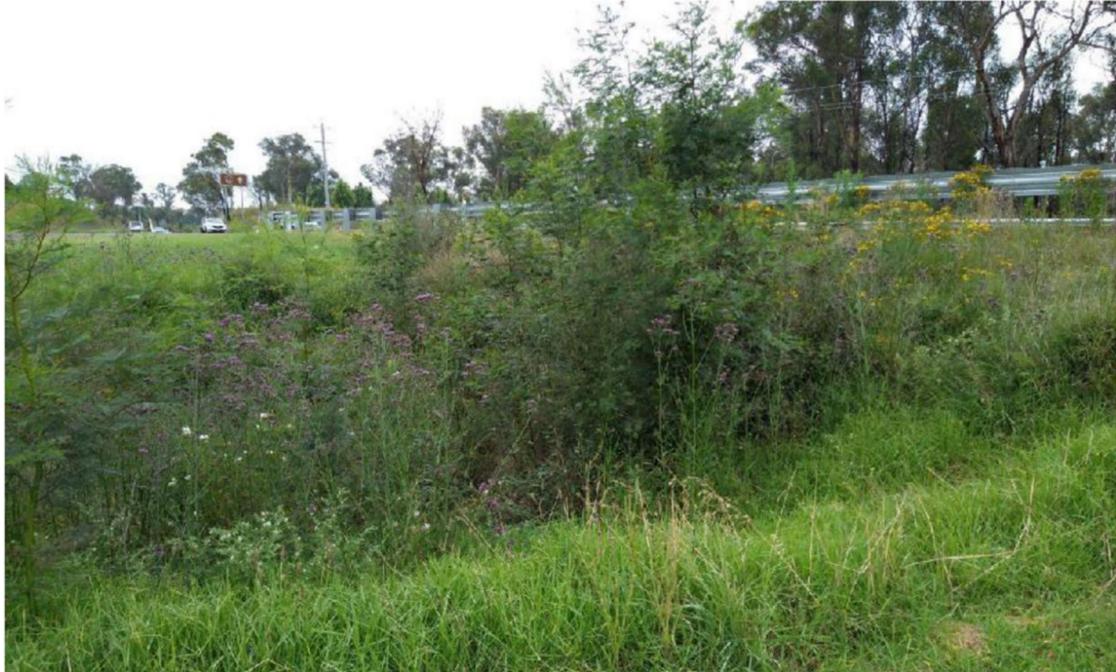
**Fig. 3.31 Remembrance Drive embankment north of Yarran Road on upstream side**

Remembrance Drive crosses a shallow tributary to Teatree Hollow via an engineered fill embankment over a 900 mm diameter reinforced concrete culvert. The embankment is approximately 165 metres long and 3.9 metres high at its highest point. Photographs along the road embankment to Remembrance Drive north of Yarran Road are shown in Fig. 3.31 and Fig. 3.32.

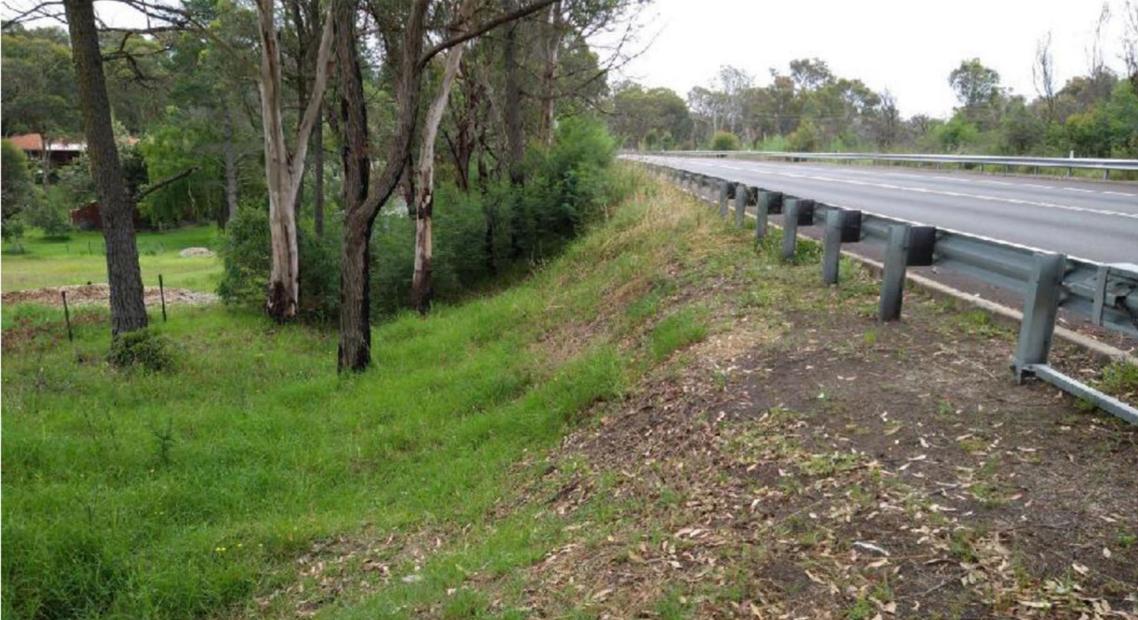
**Fig. 3.33 Remembrance Drive embankment south of Yarran Road on upstream side**

Remembrance Drive crosses a tributary to Teatree Hollow via an engineered fill embankment over a 1.8 metre diameter reinforced concrete culvert. The embankment is approximately 220 metres long and 7.8 metres high at its highest point. Photographs along the road embankment to Remembrance Drive south of Yarran Road are shown in Fig. 3.33 and Fig. 3.34.

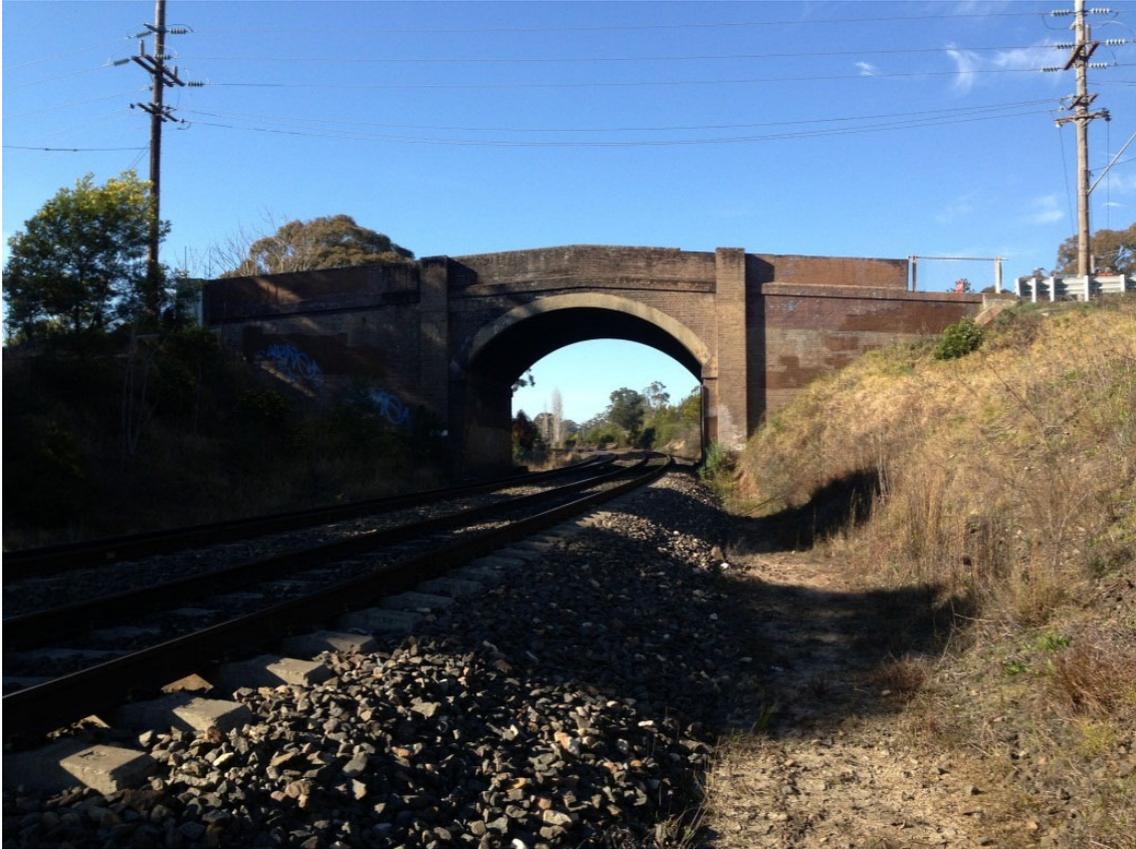
Remembrance Drive intersects Wellers Road via a road embankment. A culvert is located at the northern end of the embankment, immediately adjacent to the Main Southern Railway. The embankment is approximately 250 metres long and 5.1 metres high at its highest point. Photographs along the road embankment to Remembrance Drive at the Wellers Road intersection are shown in Fig. 3.35 and Fig. 3.36.

**Fig. 3.35** Remembrance Drive embankment at Wellers Road intersection

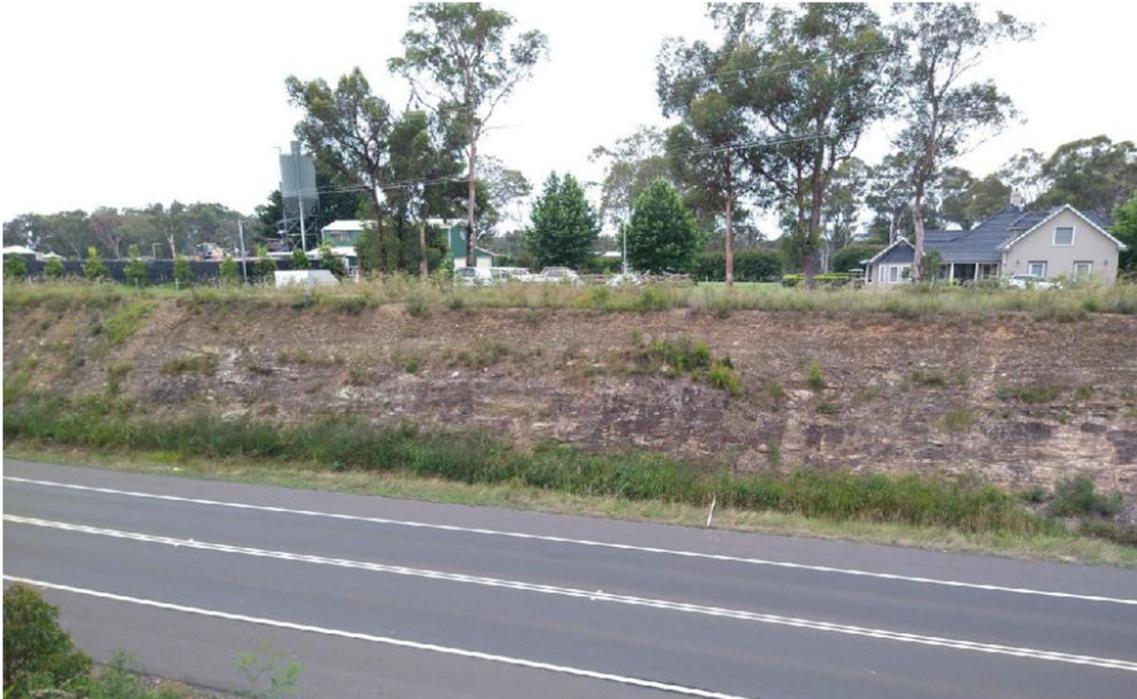
**Fig. 3.37 Remembrance Drive cutting above LW S4A looking east**

Remembrance Drive passes through a rock cutting between Caloola Road and Yarran Road. The cutting is approximately 430 metres long and 5 metres high at its highest point. Photographs along the road cutting are shown in Fig. 3.37 and Fig. 3.38.

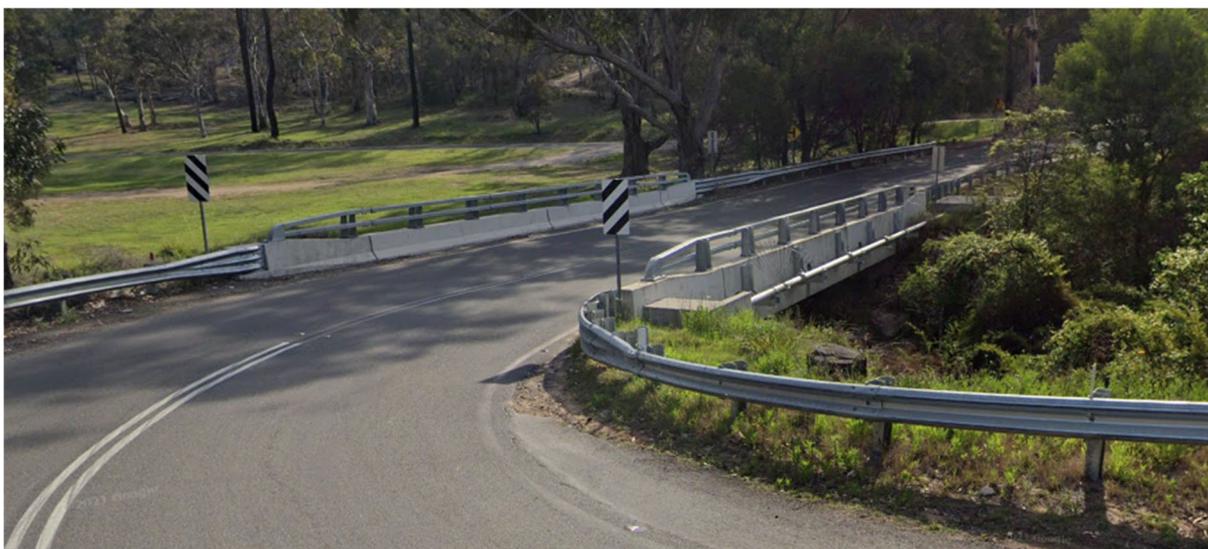
**Fig. 3.39 Bargo River Road Bridge over tributary to Bargo River**

The Bargo River Bridge spans across a tributary to the Bargo River near the Bargo River Reserve. The 14.4 metre single-span dual lane Bridge is comprised of a reinforced concrete deck on reinforced concrete abutments and wingwalls (JMA, 2022b). The approach to the Bridge is shown in Fig. 3.39.

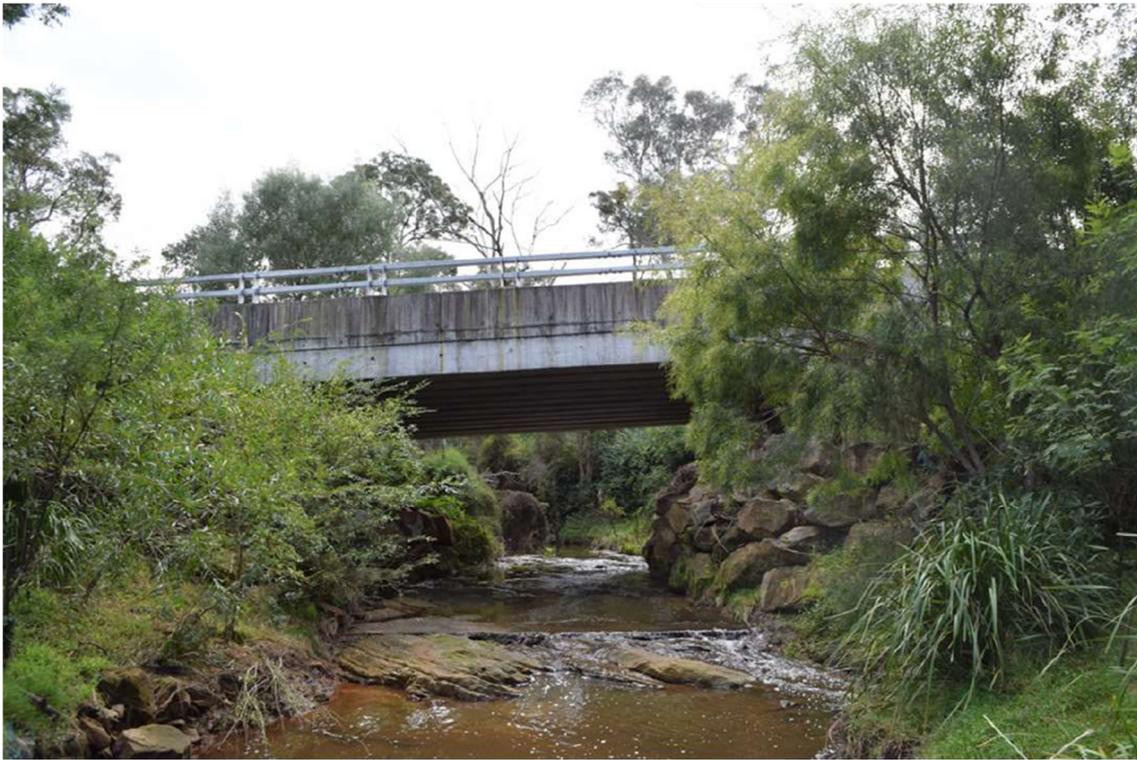
The bridge was constructed in 2013, replacing an old bridge that used to carry traffic along the Old Hume Highway. A photograph of the bridge from stream level is shown in Fig. 3.40 and a photograph of the bridge abutment is shown in Fig. 3.41.

**Fig. 3.40 Bargo River Road Bridge (JMA, 2022b)**

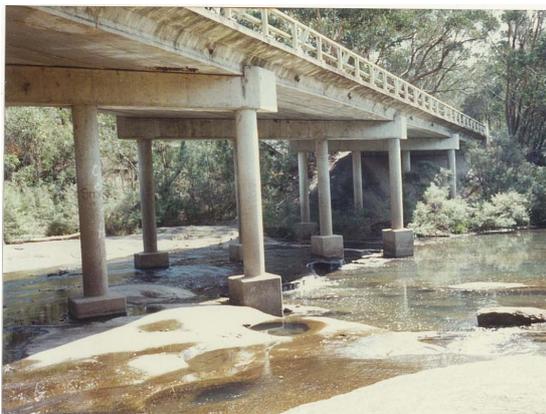
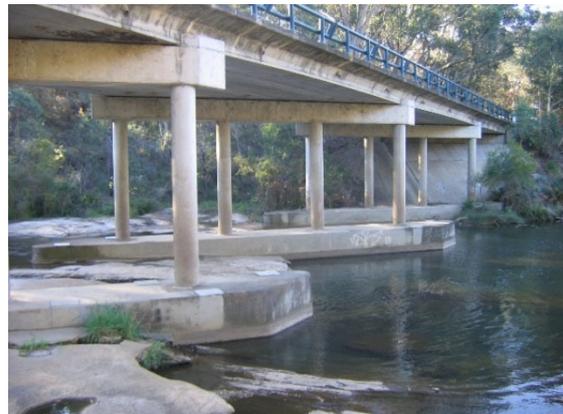
**Fig. 3.43 Rockford Road Bridge over Bargo River**

The Rockford Road crosses the Bargo River between Tahmoor and Pheasants Nest. The six-span dual lane Bridge was constructed in 1966 and comprises reinforced concrete abutments, with intermediate reinforced concrete piers on pad footings, founded in sandstone (JMA, 2022c). The Bridge was modified in 1994 prior to the mining of Tahmoor Longwalls 12 and 13. A photograph of the original and modified Bridge is shown in Fig. 3.43.

Original Bridge (1966)

Modified Bridge (post mining in 1994)

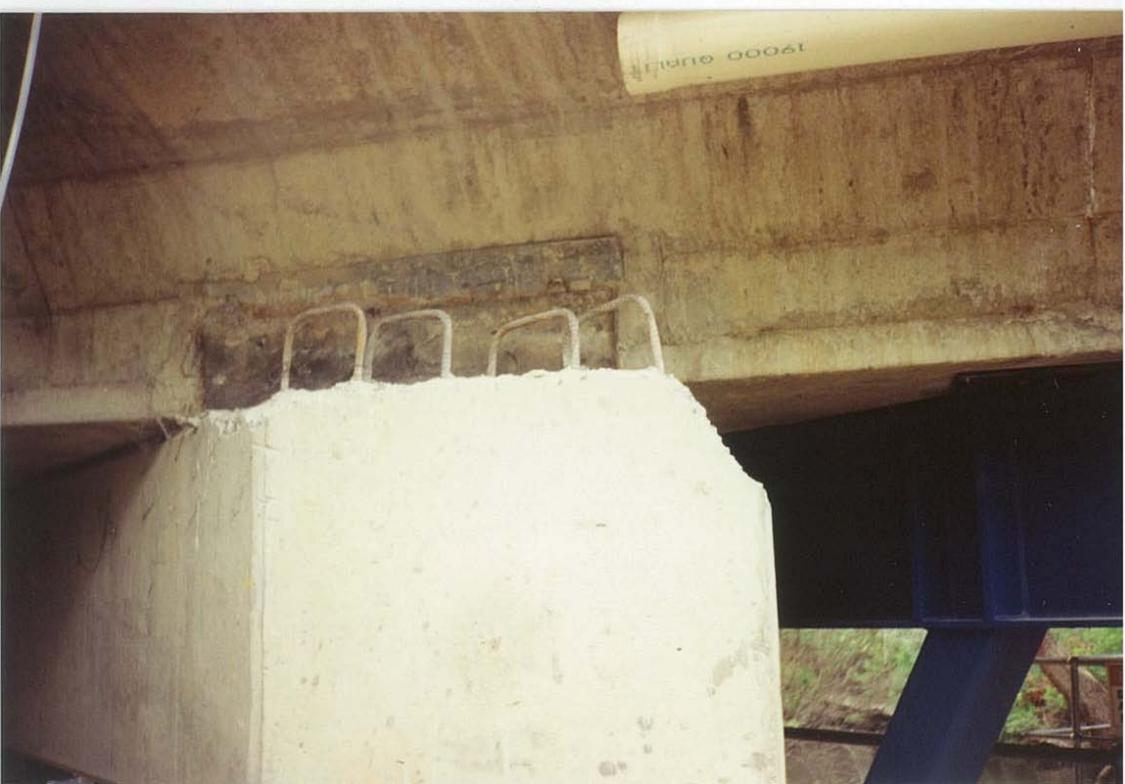
**Fig. 3.45** Headstock bents / upstands removed at Rockford Road Bridge prior to mining of LW12

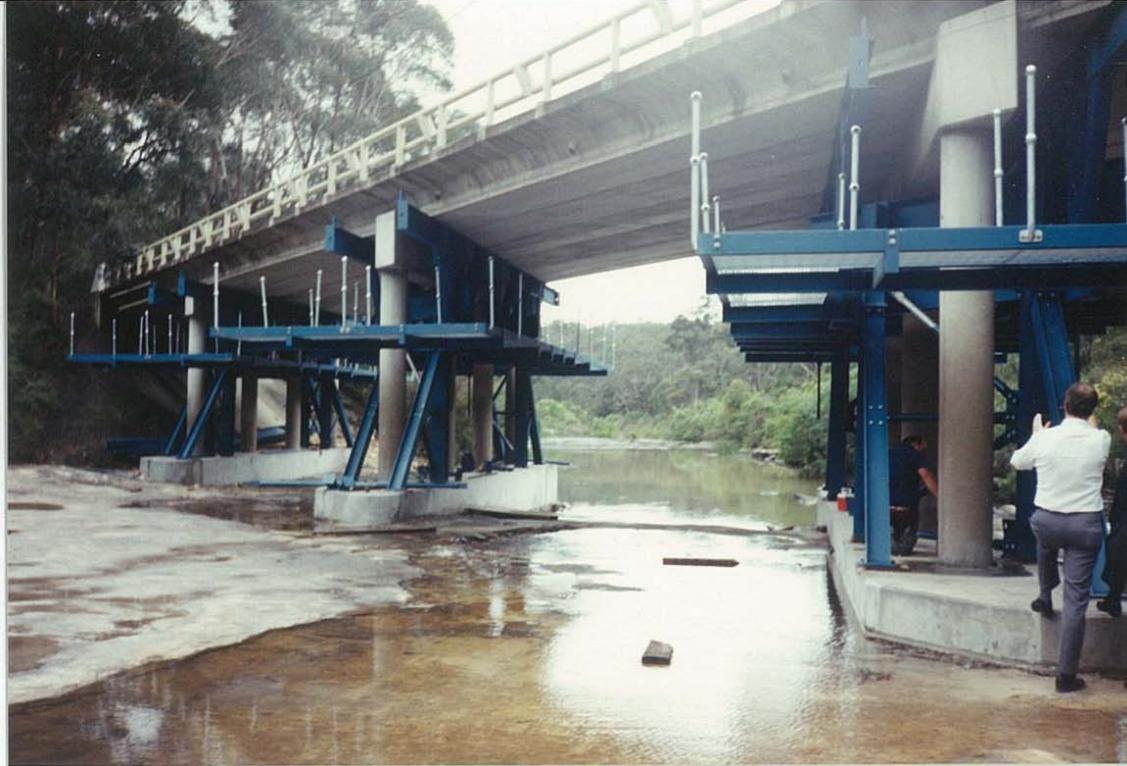
**Fig. 3.46** Jacking frames installed at Rockford Road Bridge over Bargo River

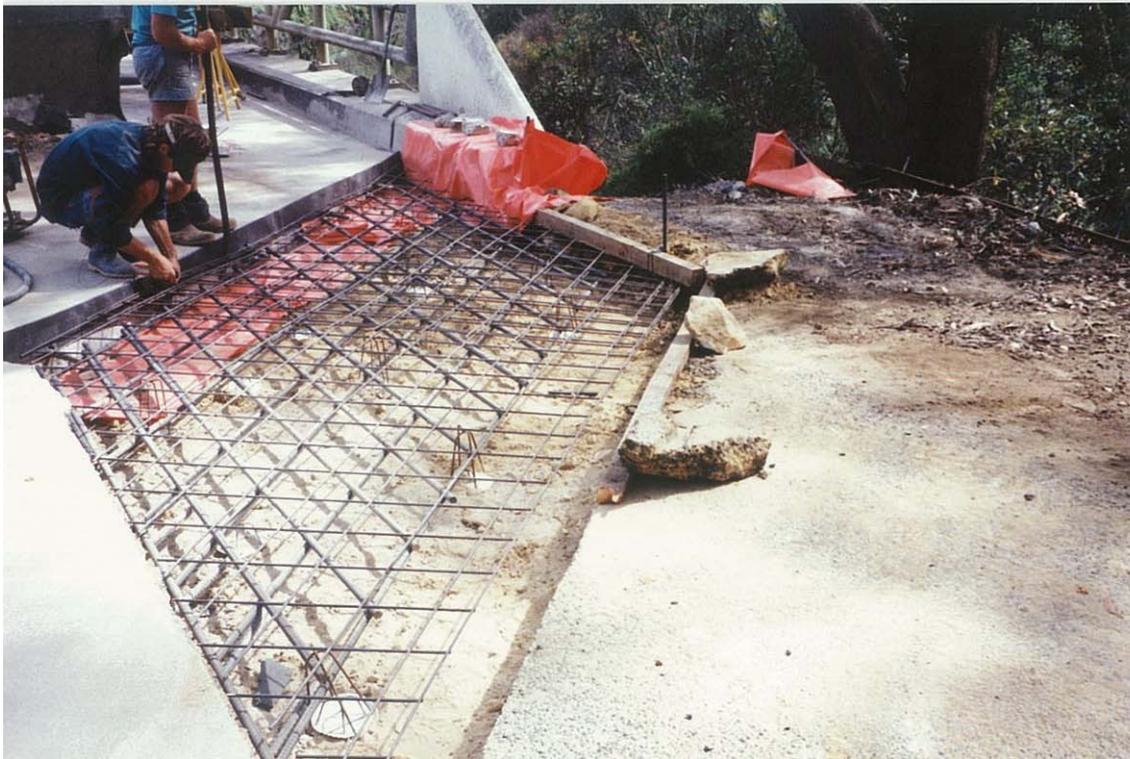
**Fig. 3.47** Modified approach ramps to Rockford Road Bridge over Bargo River

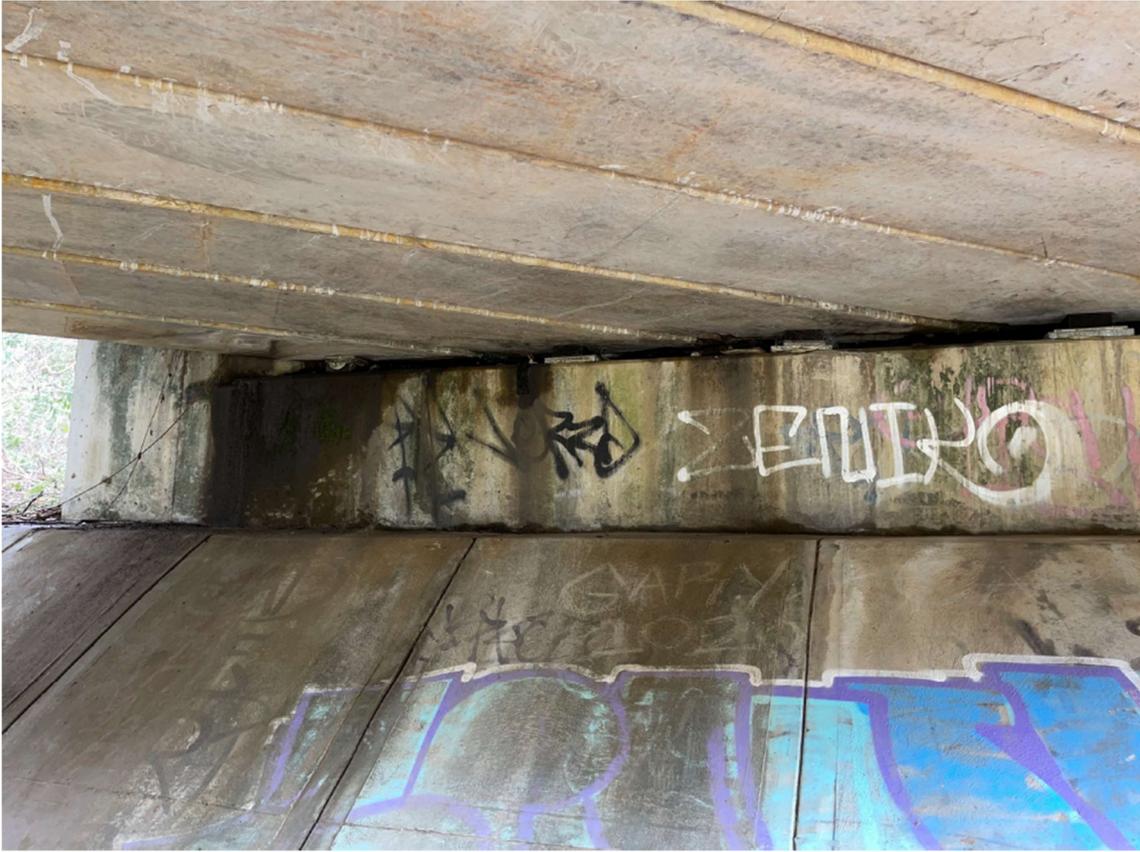
**Fig. 3.48** Current view of Southern abutment of Rockford Road Bridge over Bargo River

Photographs of the bridge modification and jacking works prior to the mining of Longwalls 12 and 13 are shown in Fig. 3.44 to Fig. 3.47. Current photographs of the Bridge are shown in Fig. 3.48 and Fig. 3.49.

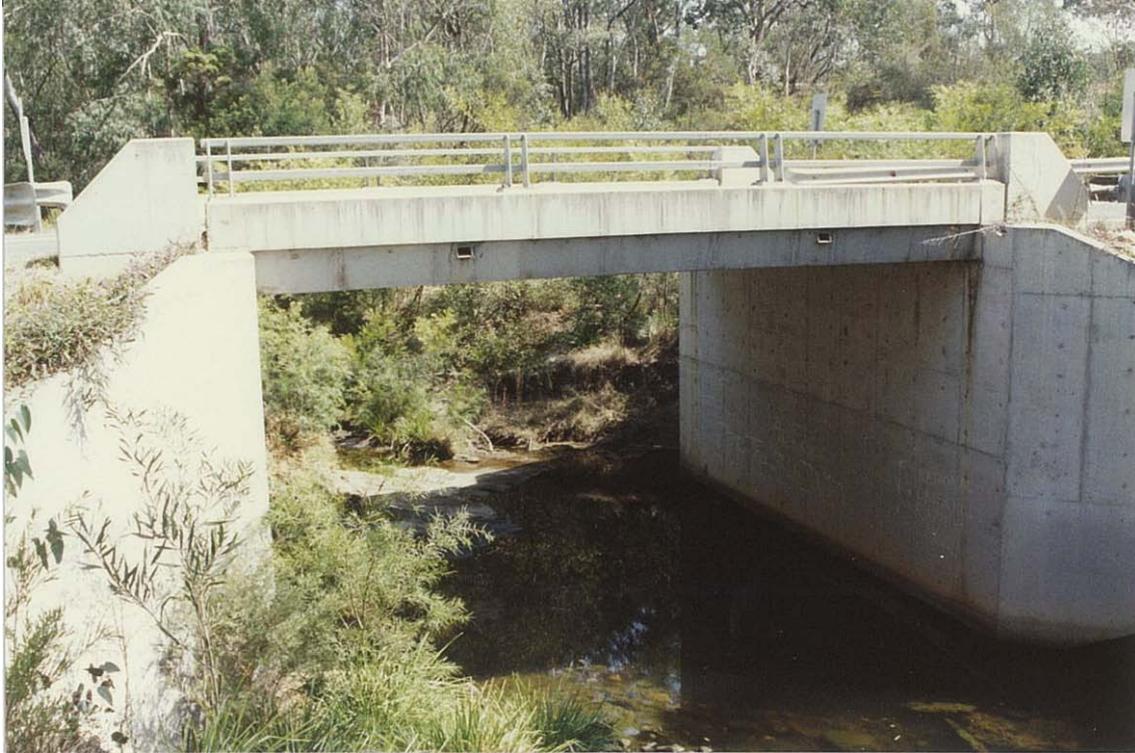
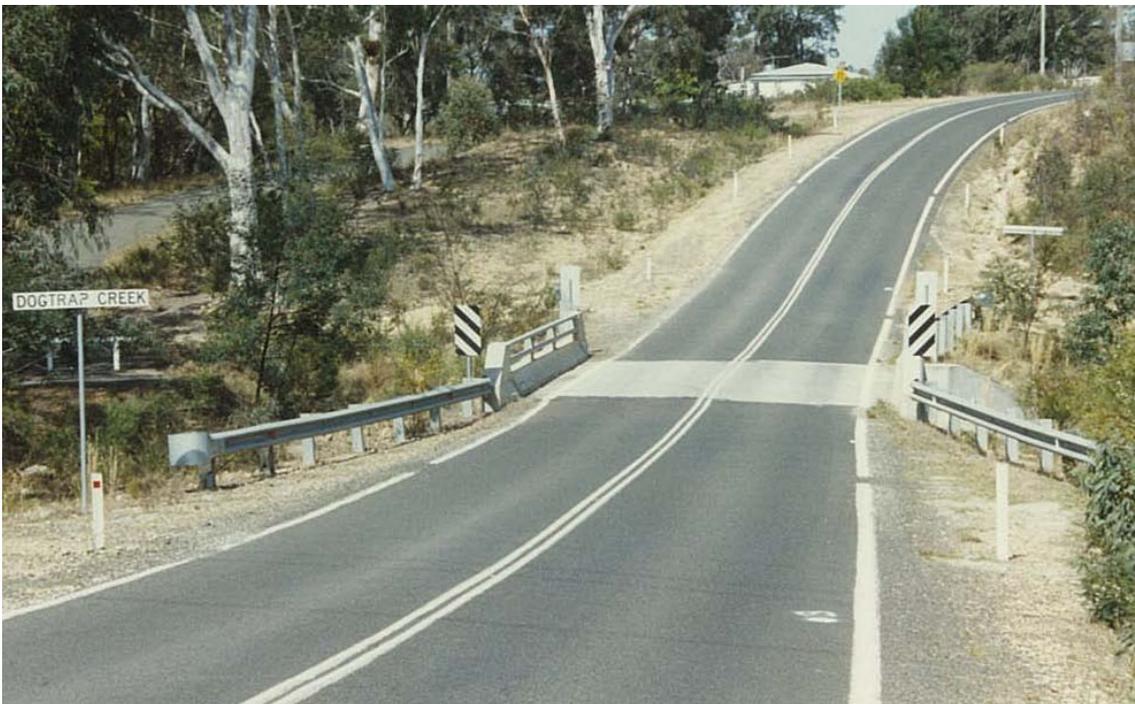
**Fig. 3.56** Arina Road Bridge over Dog Trap Creek prior to mining in 1994

The Arina Road crosses Dog Trap Creek between Tahmoor and Pheasants Nest. The single-span dual lane Bridge spans 8.6 metres and comprises reinforced concrete deck on reinforced concrete abutments (JMA, 2022d). The Bridge was mined directly beneath by Tahmoor Longwalls 12 and 13. Photographs of the Bridge in 1994, prior to mining, are shown in Fig. 3.56. Recent photographs of the Bridge in 2022 are shown in Fig. 3.57.

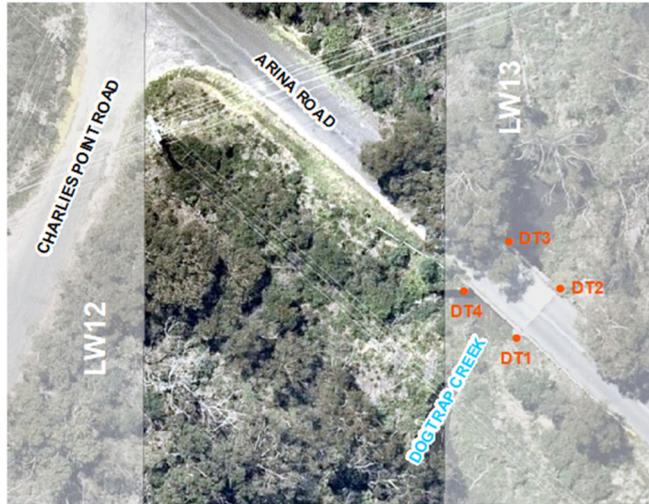
**Fig. 3.59 Observed subsidence, tilt and changes in horizontal distances on the Arina Road Bridge during the mining of Tahmoor Longwalls 12 and 13**

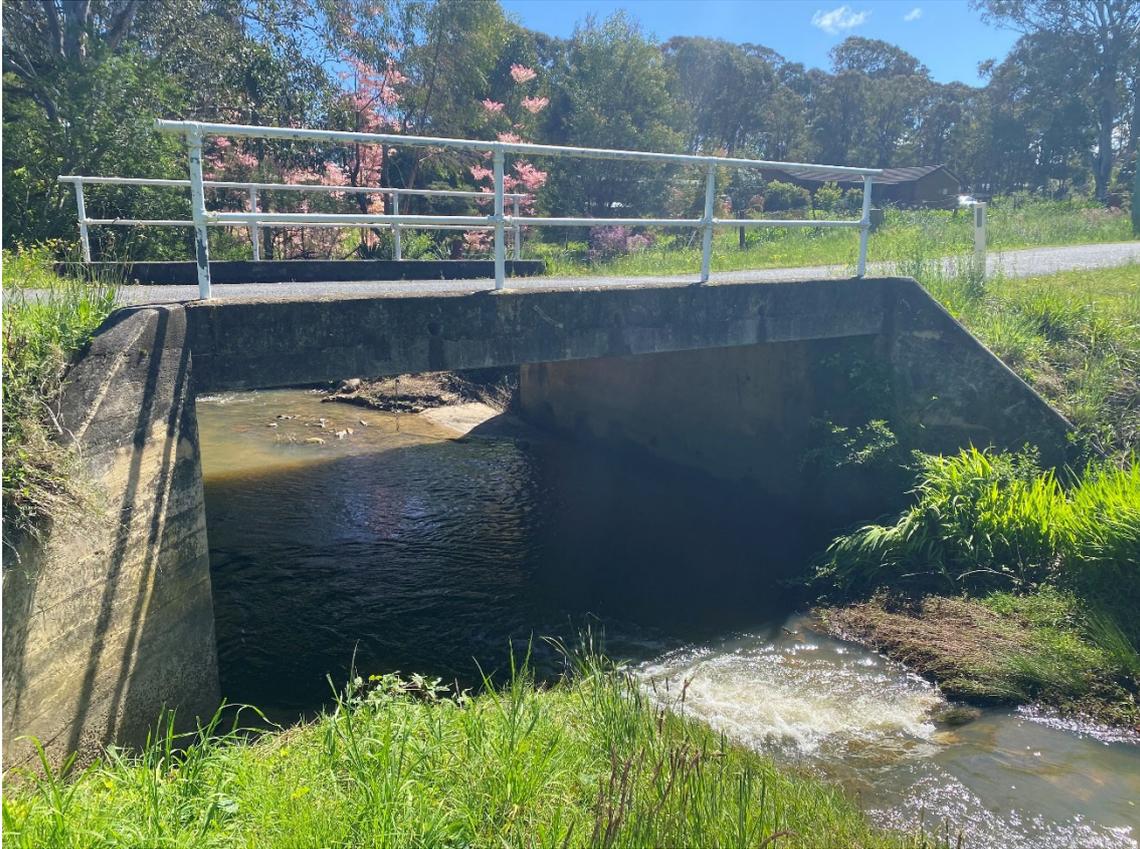
**Fig. 3.60 Kader Street Bridge over Hornes Creek from upstream side**

Kader Street crosses Hornes Creek to the west of Bargo township. The single-span dual lane Bridge spans approximately 6 metres and comprises reinforced concrete deck on reinforced concrete abutments. The Bridge has not previously experienced mine subsidence movements. Photographs of the Bridge are shown from Fig. 3.60 to Fig. 3.63.

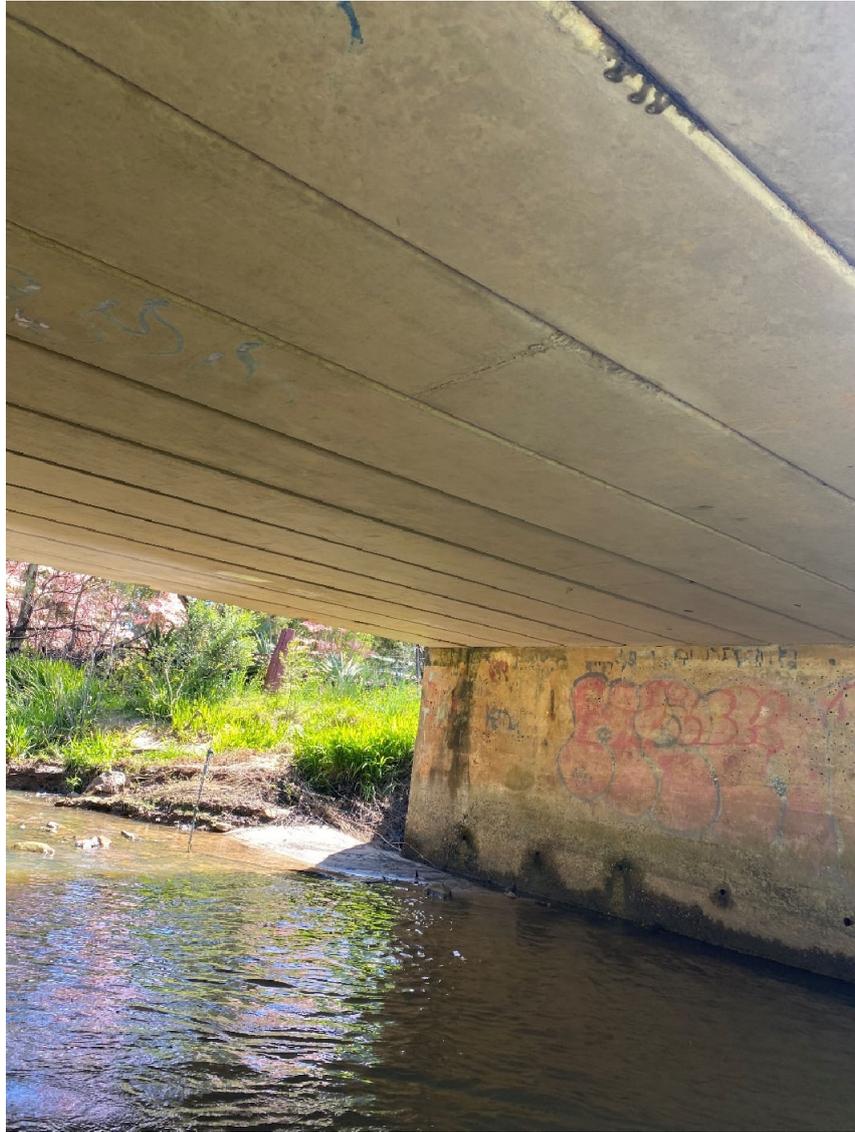
**Fig. 3.62**      **Underside of bridge girders at Kader Street Bridge over Hornes Creek**

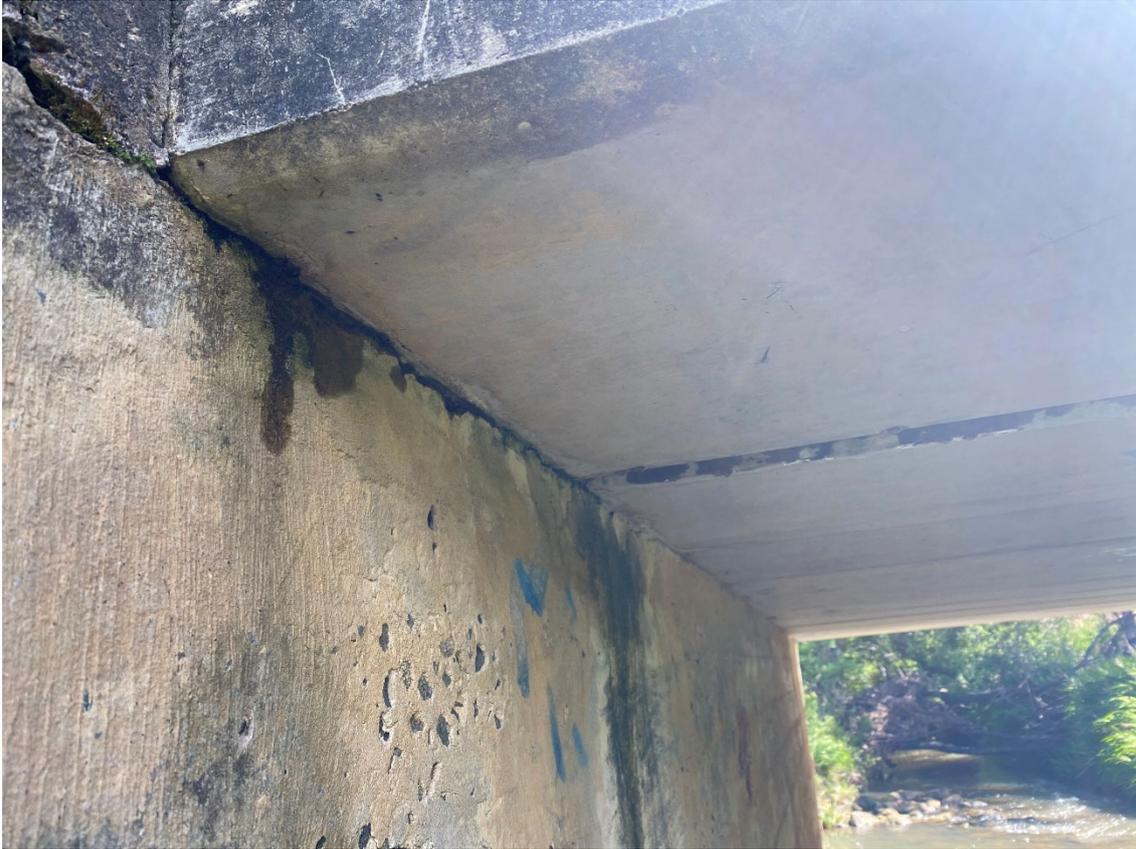
**Fig. 3.63 Bridge deck and abutment of Kader Street Bridge over Hornes Creek**
